# **NONSTRUCTURAL FLOOD PROOFING STUDY FOR ELLICOTT CITY, MD**

**U.S. Army Corps of Engineers, Baltimore District  
2 Hopkins Plaza  
Baltimore, Maryland 21201**

**FINAL  
FEBRUARY 2018**

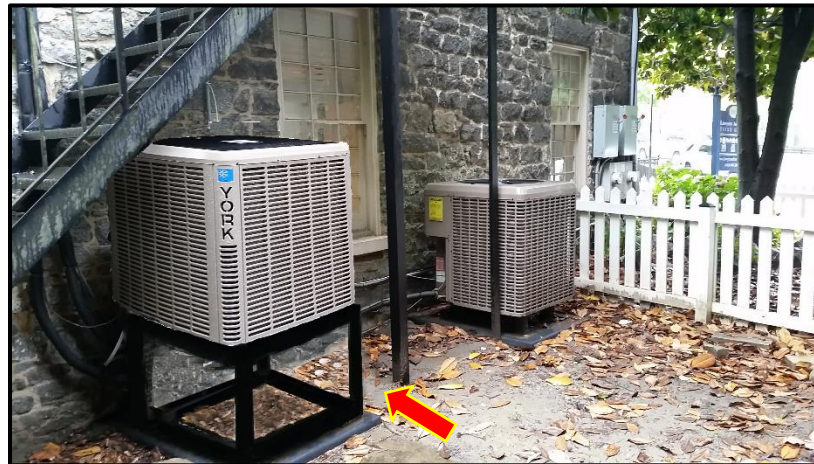
*Rendering of Elevated External Utilities  
(HVAC unit on the left is elevated)*

- iii. Elevate two at-grade HVAC units in place on a single steel platform, approximately 2.75 ft. height.

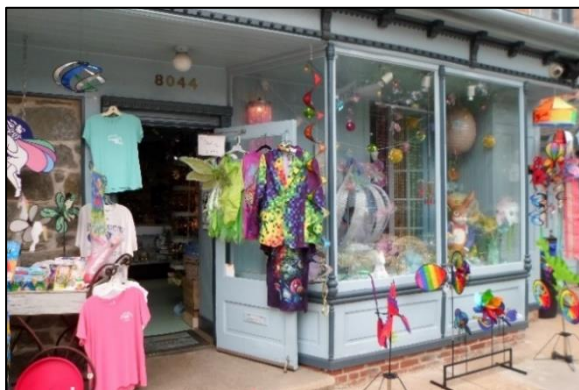
3. Typical entrance door and storefront window

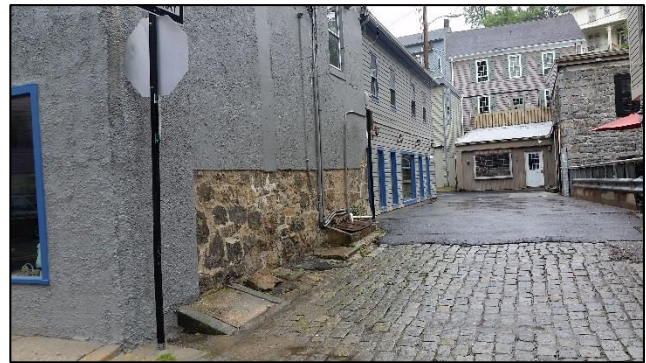
2. West elevation showing adjacent vehicle bridge

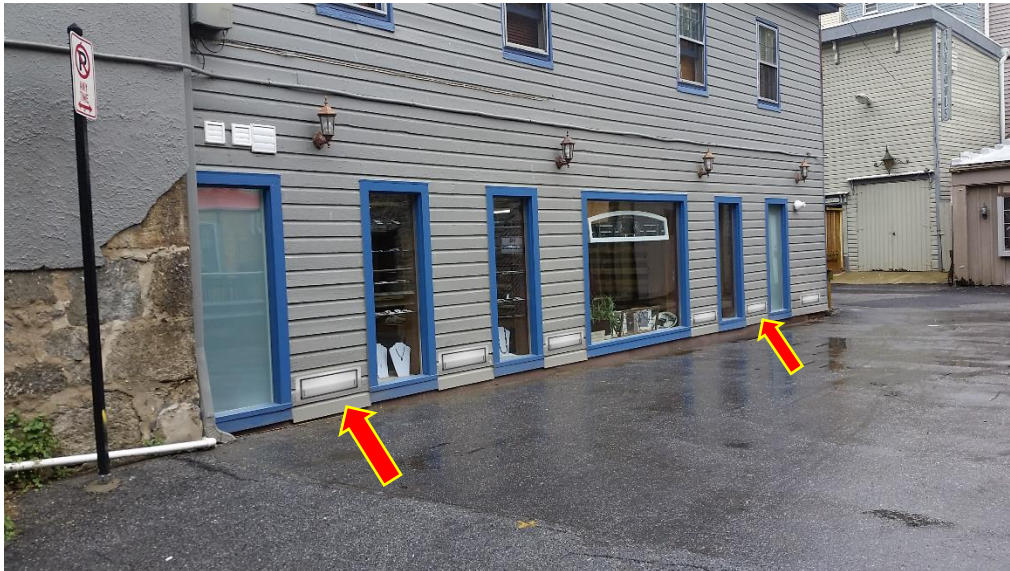
*Rendering of Wet Flood Proofing Louvers/Openings*

- a. **Installation of flood louvers in east and west exterior walls**
  - i. Assume 8 flood louvers total, 2 ft. by 1 ft. each, installed in existing masonry.
- b. **Pumping:**
  - i. Assume 1 skimmer/sump pump and portable emergency generator with suitable capacity to run the pump.

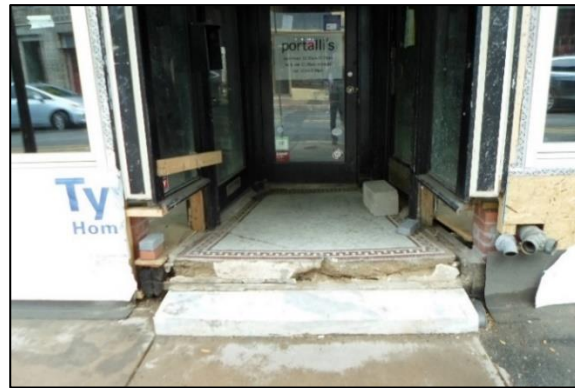
2. Main entrance with new brick wall below windows, either side

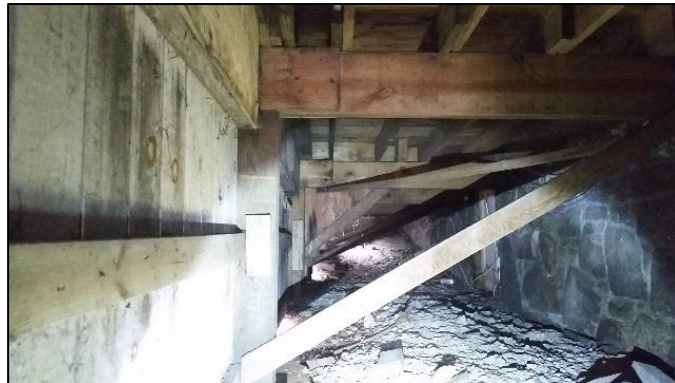
4. Porch framing in basement area

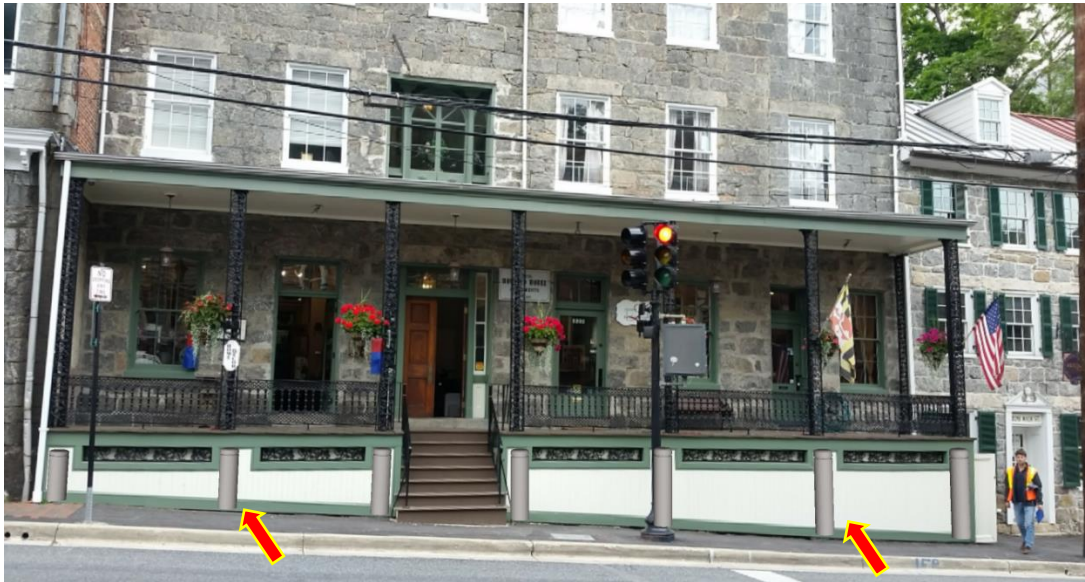
*Rendering of Bollards Armoring Porch  
(Bollards would be hidden behind porch if implemented to minimize historic impacts)*

- a. **Door openings:** Flood proof doorway to interior utility area within crawlspace on south elevation.
  - i. Provide a custom-sized flood proof door and associated framing at one single door location (approximately 3 ft. wide); assume 4 ft. height.
- b. **Armor Porch:** Install bollards for additional protection underneath porch behind wooden face.
  - i. Assume 8 bollards, average 5 ft. height, 3 yd<sup>3</sup> total of concrete for base
- c. **Pumping:**
  - i. Assume 1 skimmer/sump pump for use inside the dry flood proofed utility area and an emergency generator with suitable capacity to run the pump.
- d. **Sewage check valve:**
  - i. Assume one check valve to be placed on sanitary line in order to prevent backflow during flood event.

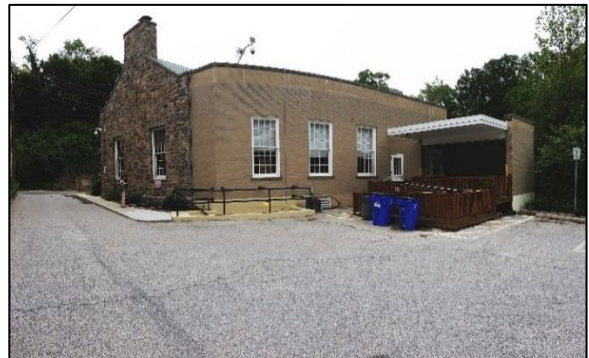
2. South elevation with stair to basement

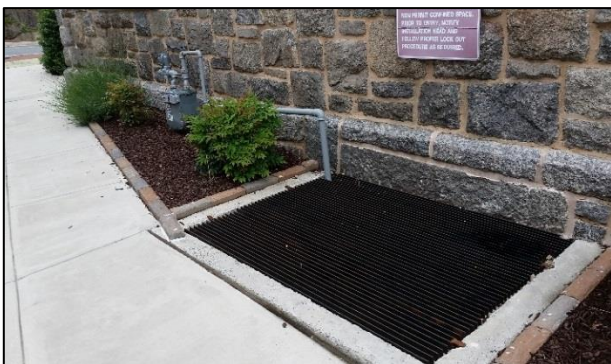
3. At-grade access grate on west elevation

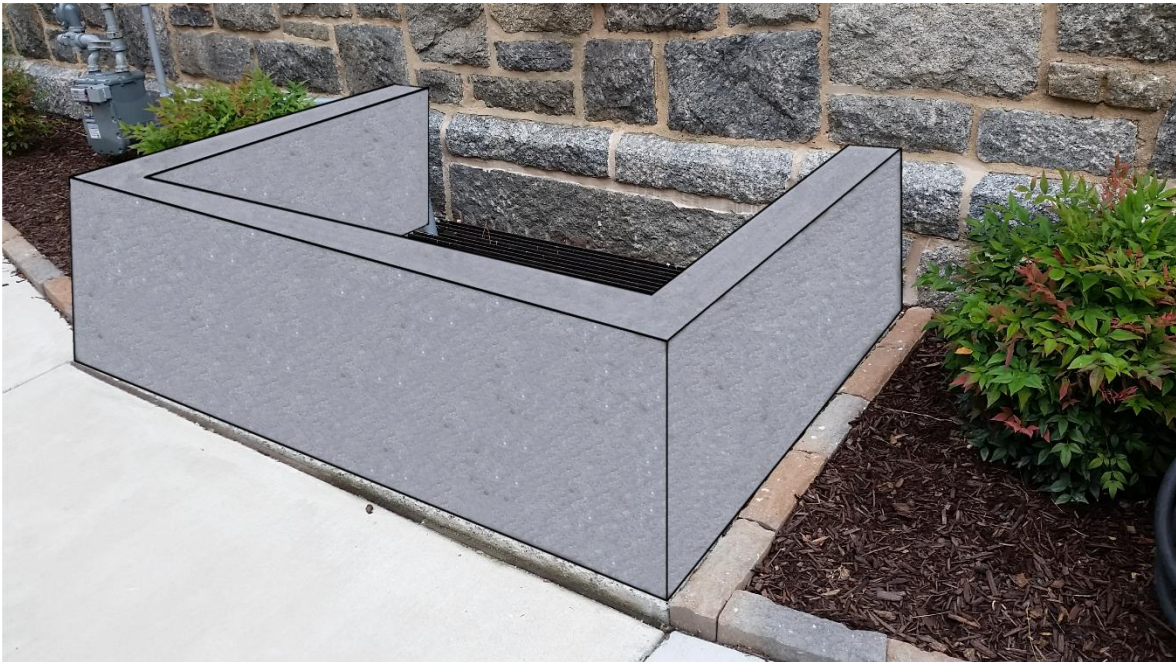
*Rendering of Short CMU Wall Around NW Grate*

- i. Replace seal at utility penetration locations below the DFE to ensure watertightness. Assume four 4 in. penetrations. Match color/texture of existing masonry mortar.

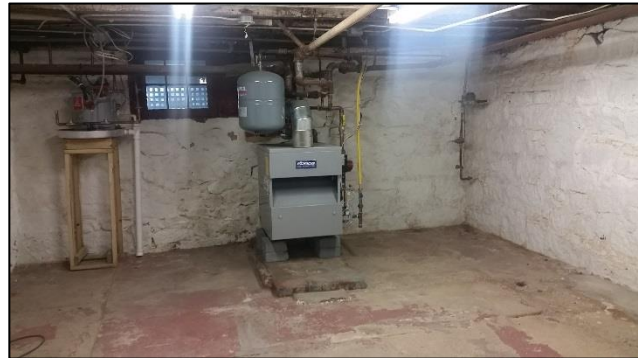
4. Mechanical equipment in basement

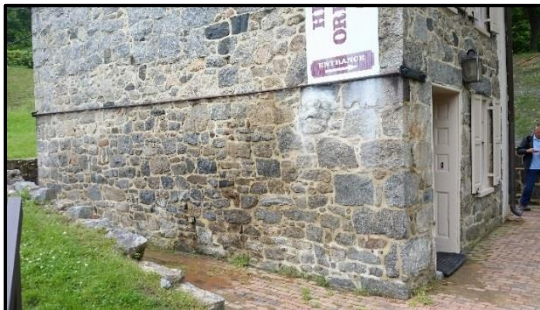
3. East Elevation, Stone foundation and exterior wall

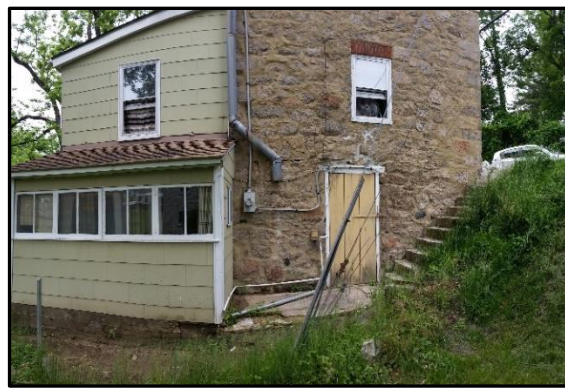
2. West Elevation, Basement Walkout

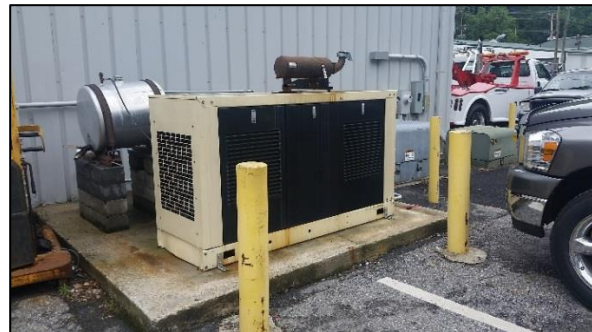
3. Exterior mechanical on north elevation

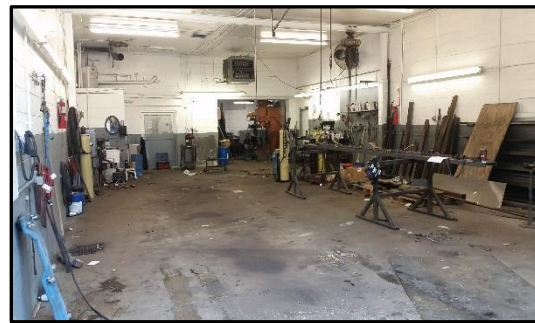
2. Interior of Automotive Repair Shop
