## Valley Mede Storm Drainage

## Inspection Report April 20, 2017 FINAL

**Re:** Valley Mede Storm Drain Investigation

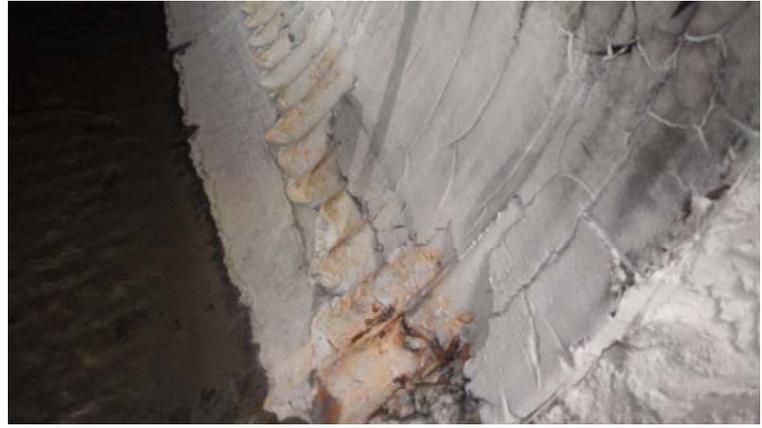
2. The pipe section between MANHOLE 4 and MANHOLE 5 appears to be the oldest in the system and has lost much of its protective material. There are specific locations along this pipe that show minor corrosion, damage, and deformity.
3. The GIS data shows a lateral drain pipe entering the system from the north at STATION 4+43. No pipe was found at this location, however there was evidence that a lateral pipe did enter at this location at one time but was removed.
4. A small debris field was located at STATION 6+68 and continued to STATION 7+00. The debris consisted primarily of 12"-18" diameter riprap and was 4' to 6' wide. This is just downstream of MANHOLE 4 on the overview map.

032.entry 1.station 1+22.loss of protective material.corrosion

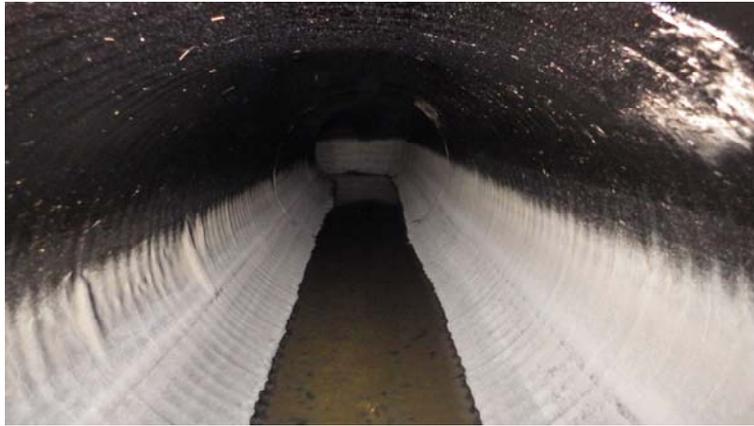
033.entry 1.station 1 +60.pipe deformity

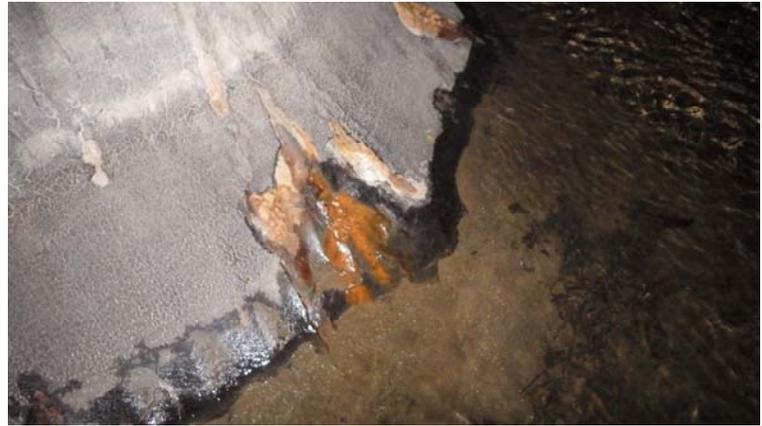
034.entry 1.station 1+97.infiltration

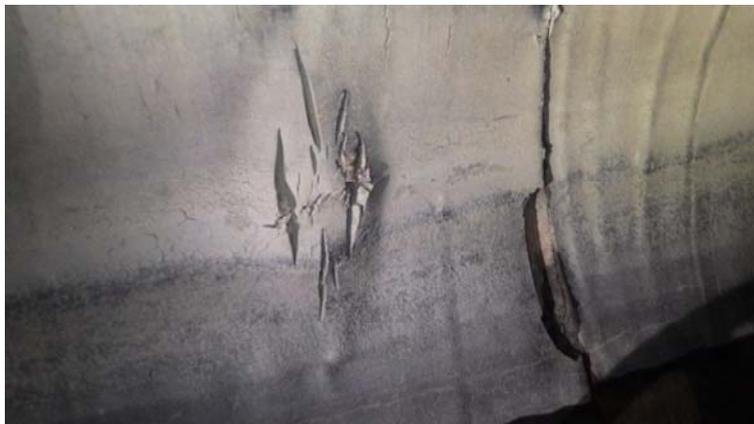
035.entry 1.station 2+28.pipe damage

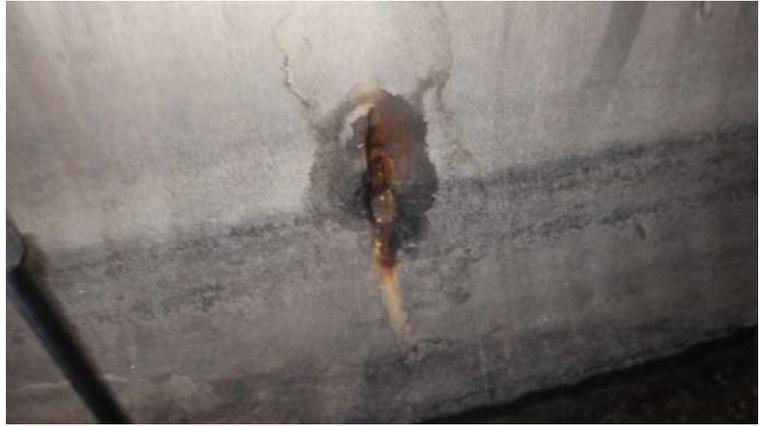
038.entry 1.station 3+14.pipe damage.soil water infiltration

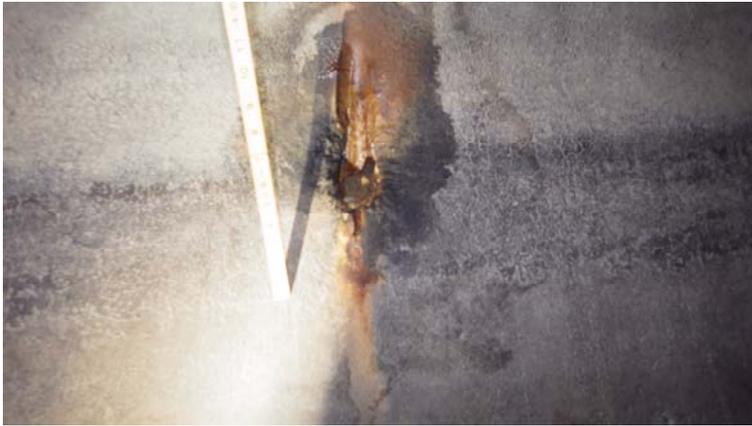
039.entry 1.station 3+14.pipe damage.soil water infiltration

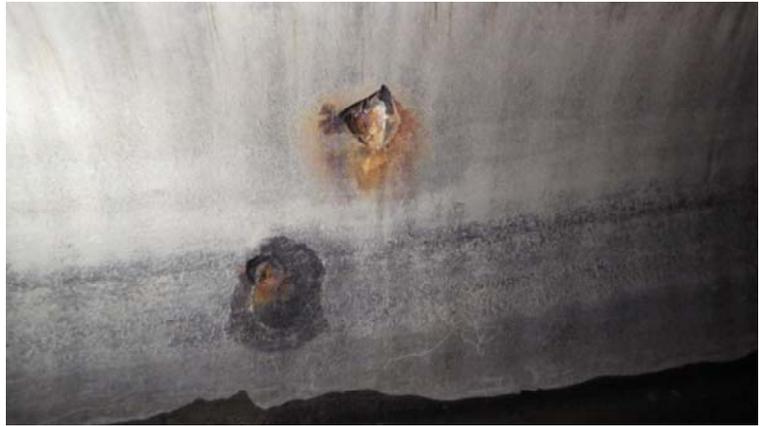
040.entry 1.station 3+53.pipe damage

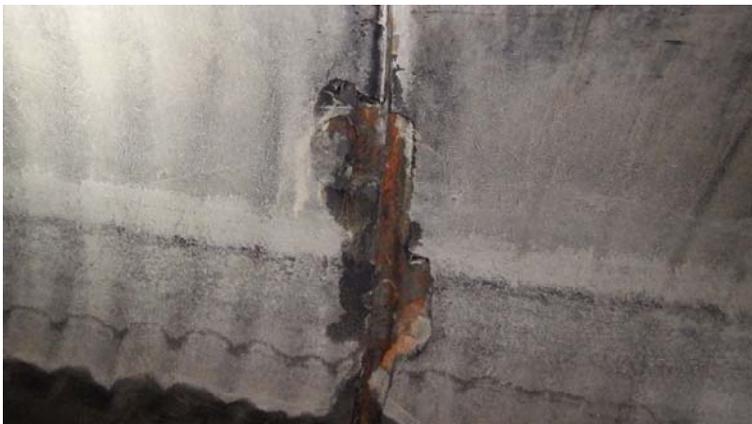
041.entry 1.station 3+59.pipe damage

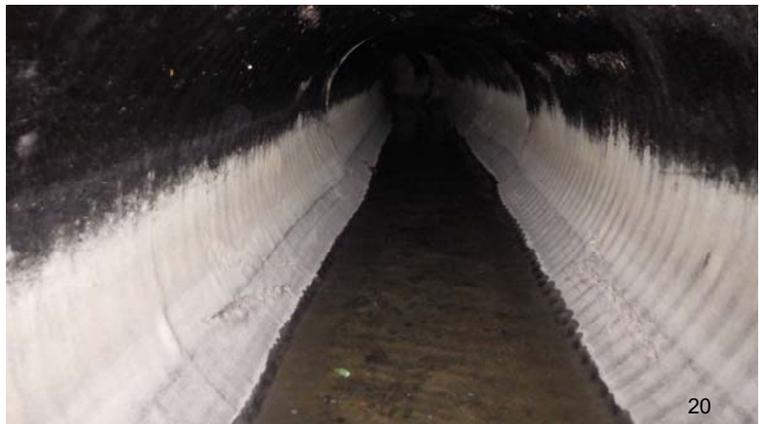
042.entry 1.station 3+59.bulge deformity

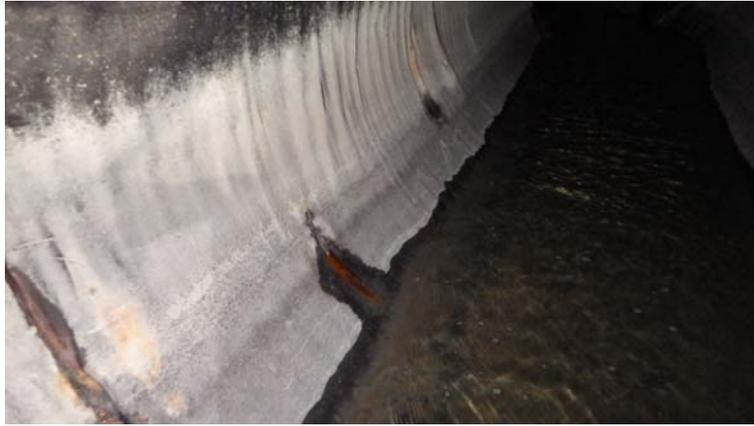
043.entry 1.station 4+00 infiltration continuous

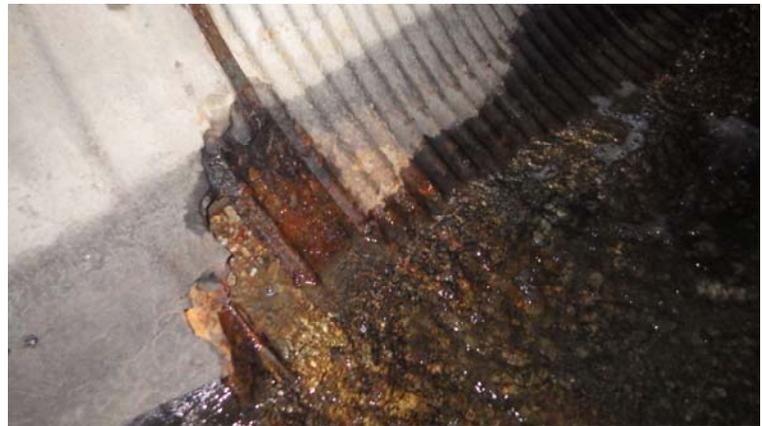
046.entry 1.station 4+33 joint damage soil water infiltration

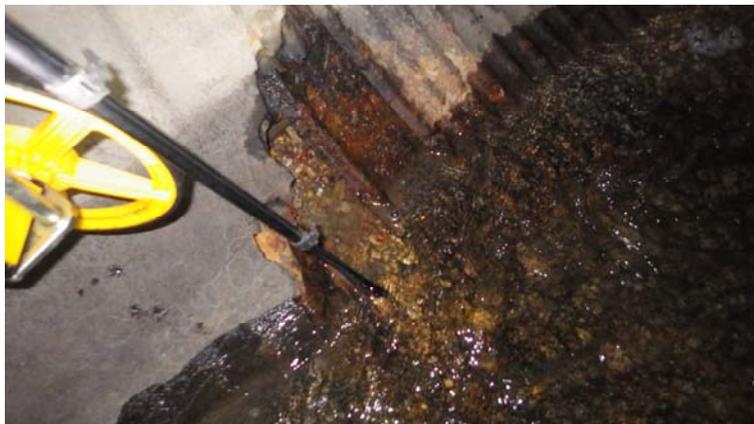
047.entry 1.station 4+33 joint damage soil water infiltration

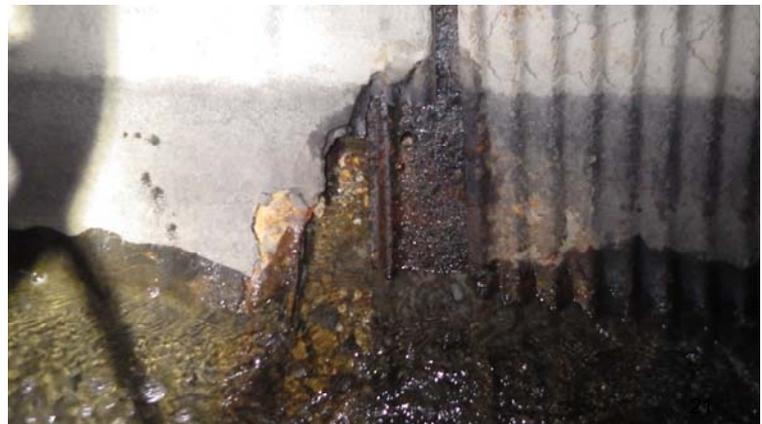
048.entry 1.station 4+33 joint damage soil water infiltration

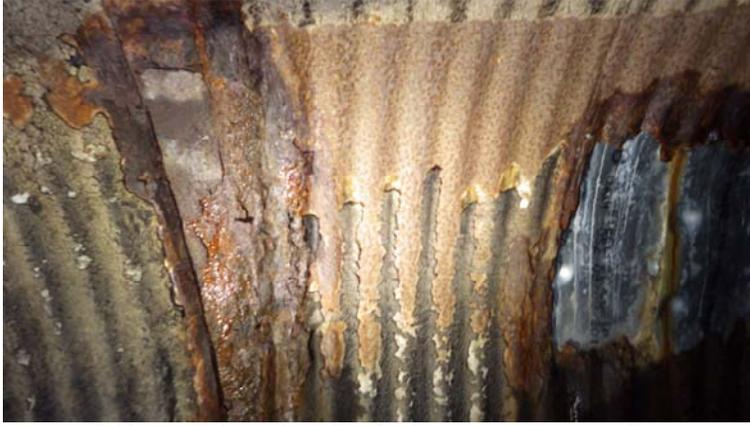
049.entry 1.station 4+40.pipe damage corrosion

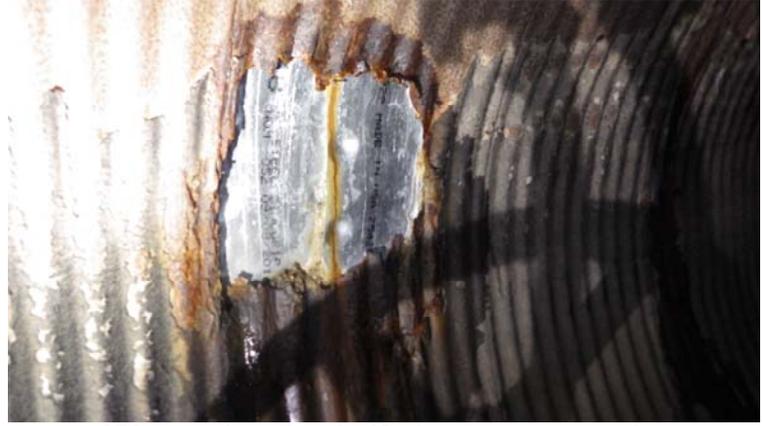
050.entry 1.station 4+40.pipe damage corrosion

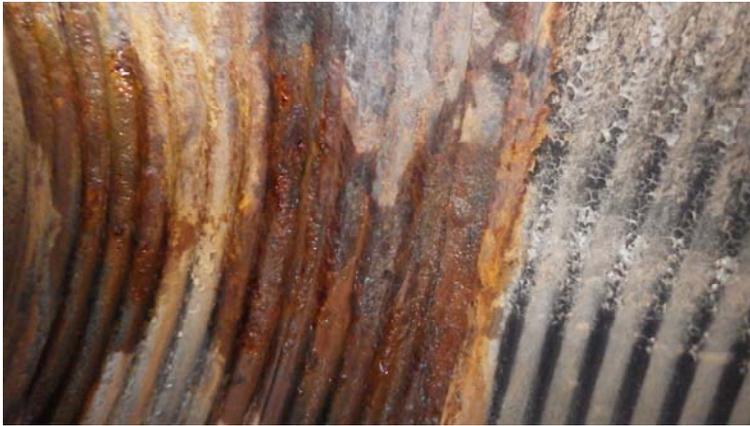
051.entry 1.station 4+40.pipe damage corrosion

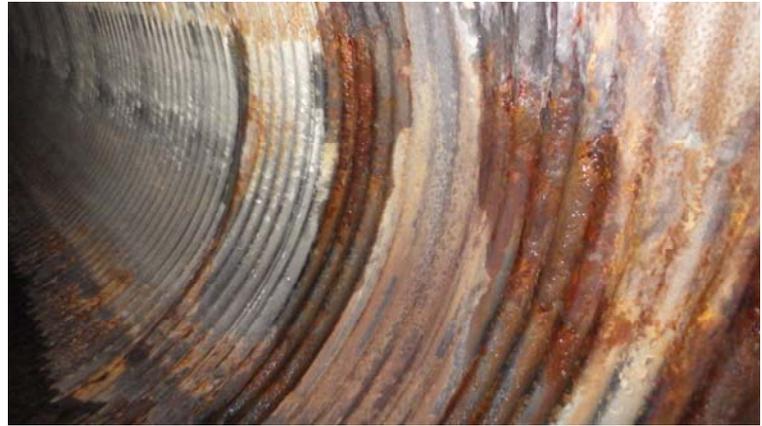
052.entry 1.station 4+40.pipe damage corrosion

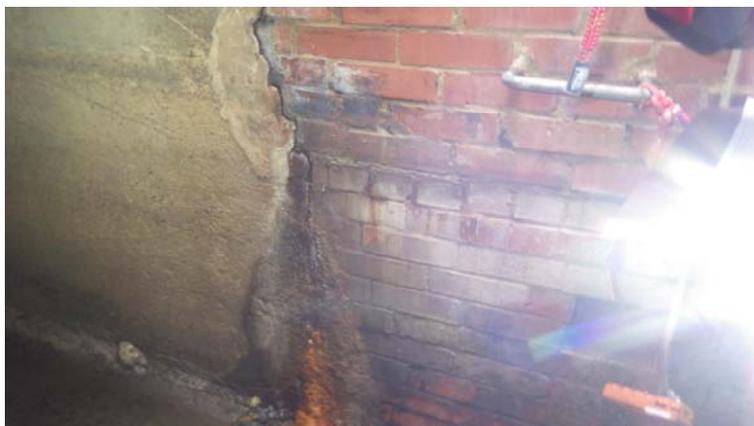
065.entry 1.station 7+17.manhole 4 fracture infiltration

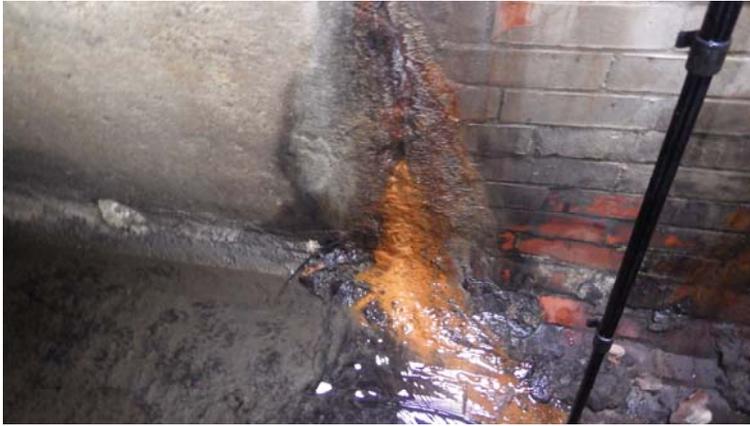
067.entry 1.station 7+17.manhole 4 fracture infiltration

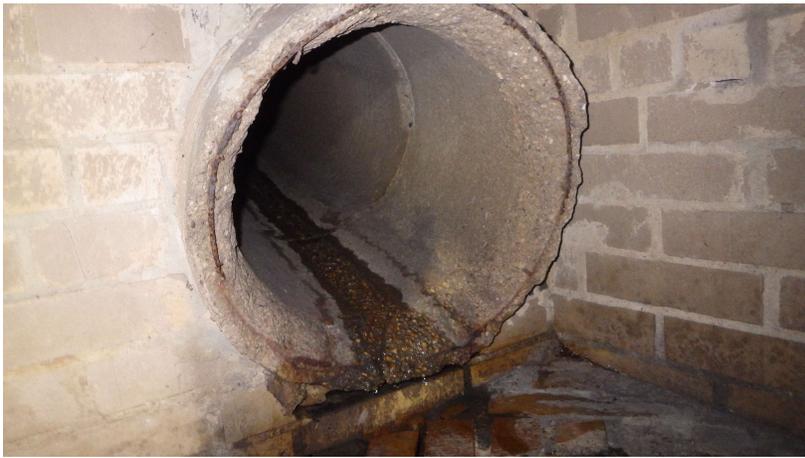
081.entry 2.21 inch RCP.exposed metal

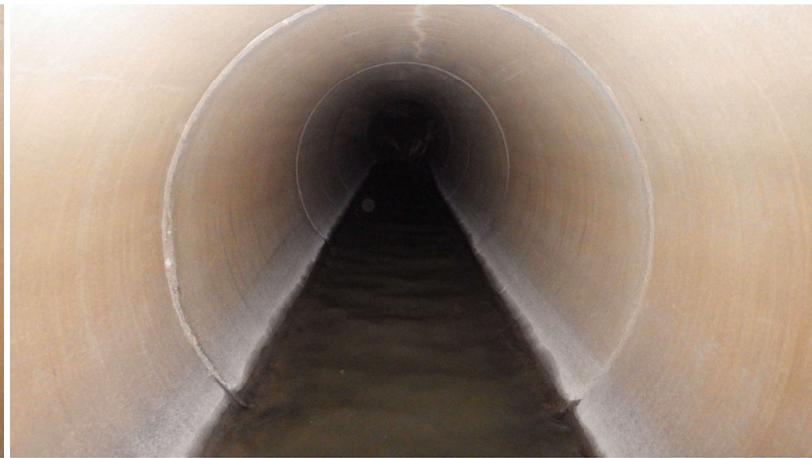
084.entry 2.station 0+50

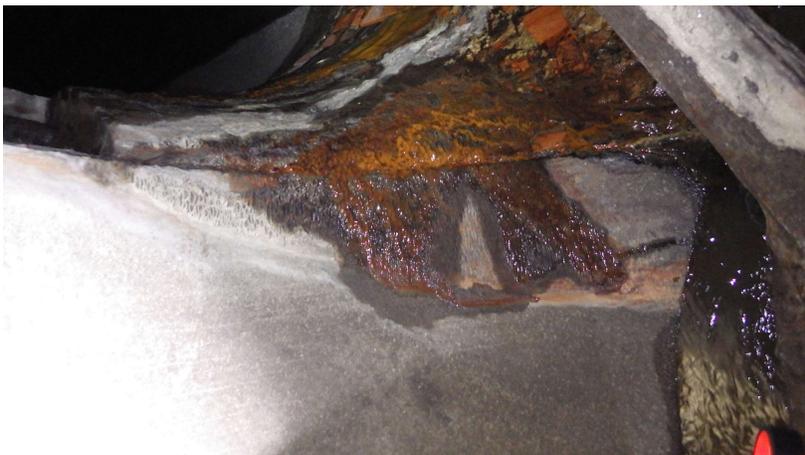
087.entry 2.station 0+98.infiltration

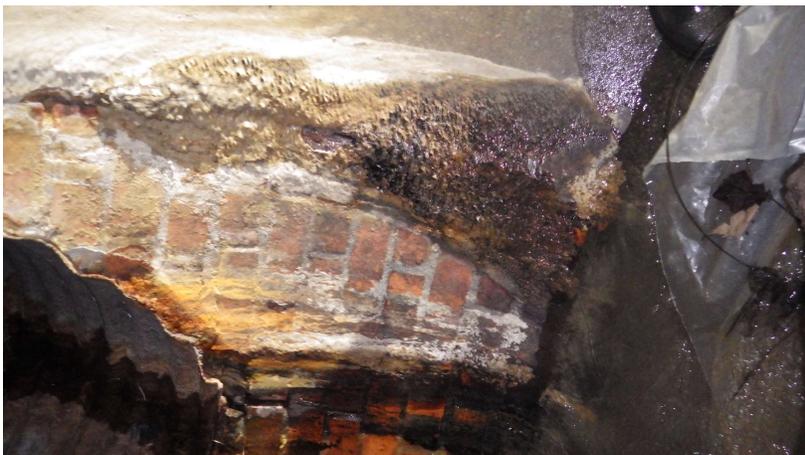
088.entry 2.station 0+98.infiltration at joint

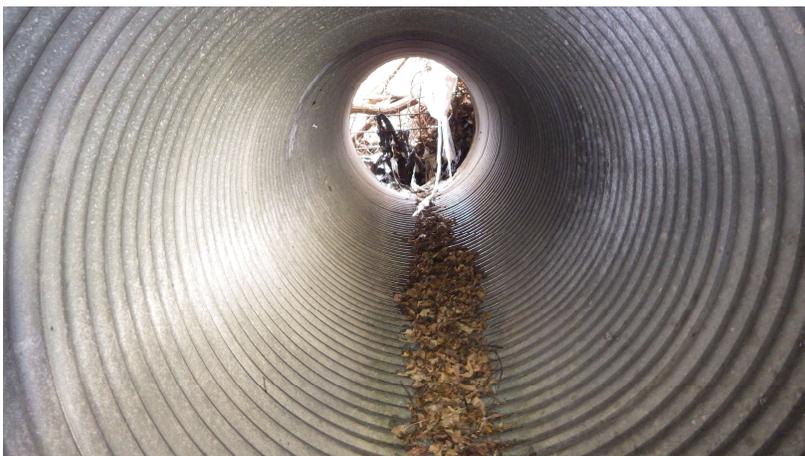
089.entry 2.station 0+98.CMP inlet.debris

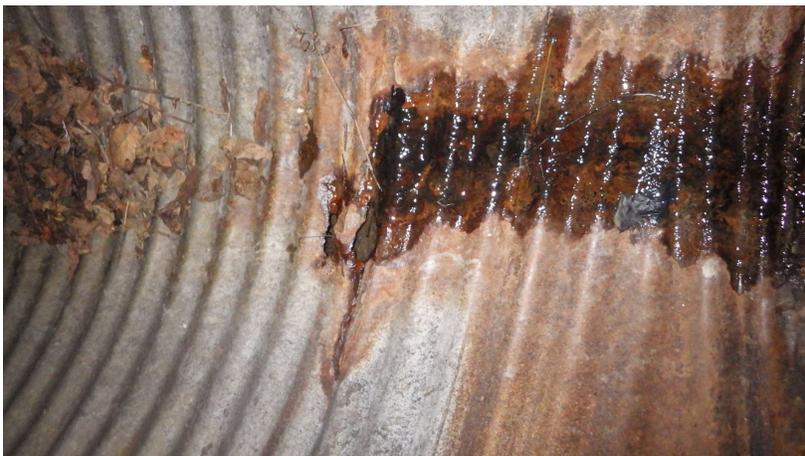
091.entry 2.station 0+98.manhole junction corrosion

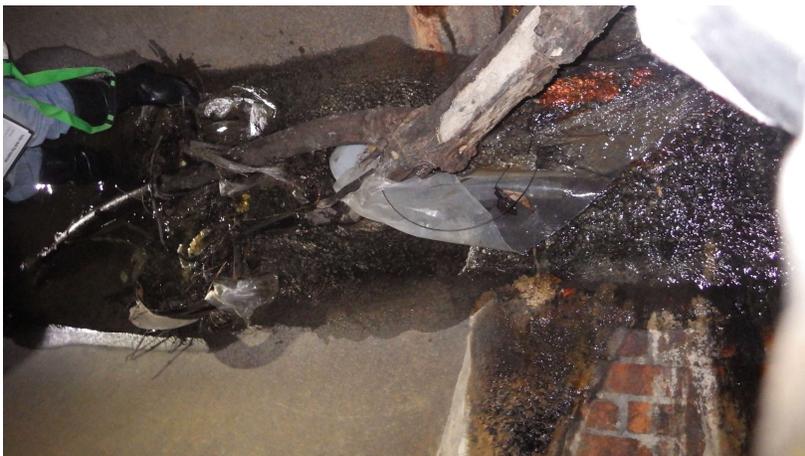
092.entry 2.station 0+98.manhole junction debris

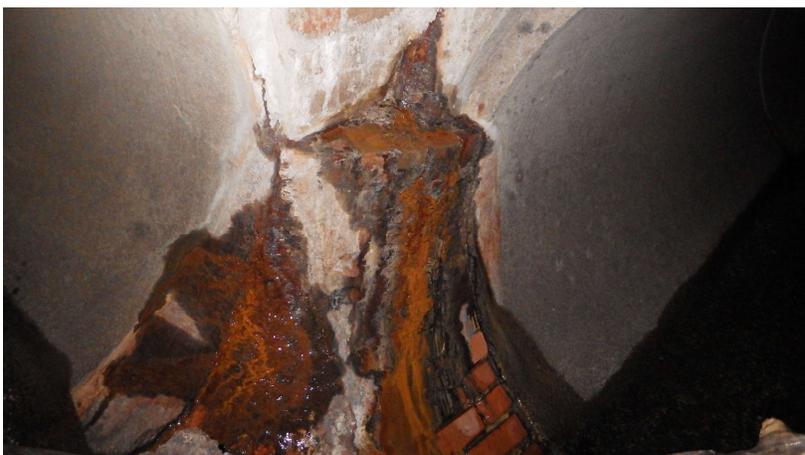
093.entry 2.station 0+98.manhole junction infiltration

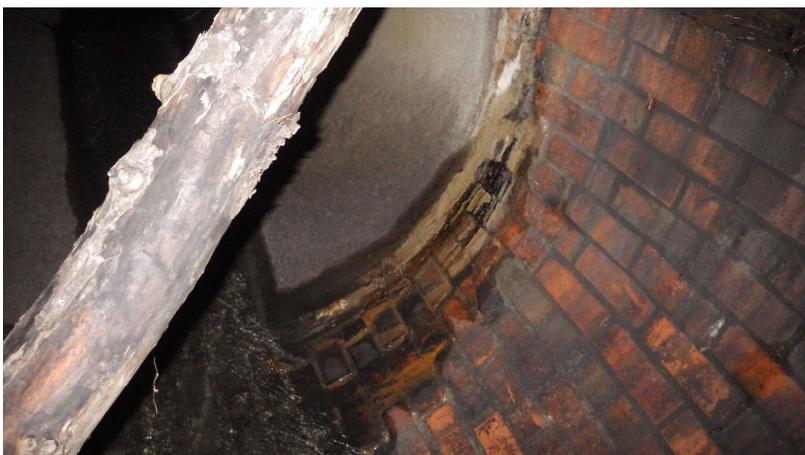
094.entry 2.station 0+98.manhole junction infiltration

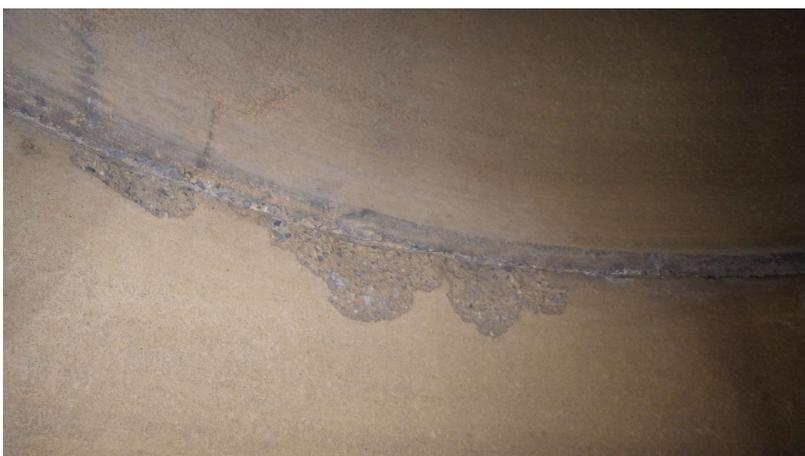
096.entry 2.station 1+15.spalling

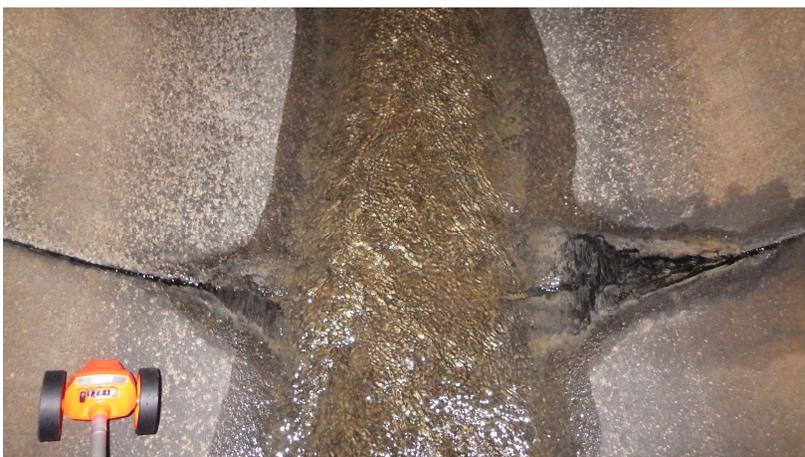
099.entry 2.station 2+04.infiltration

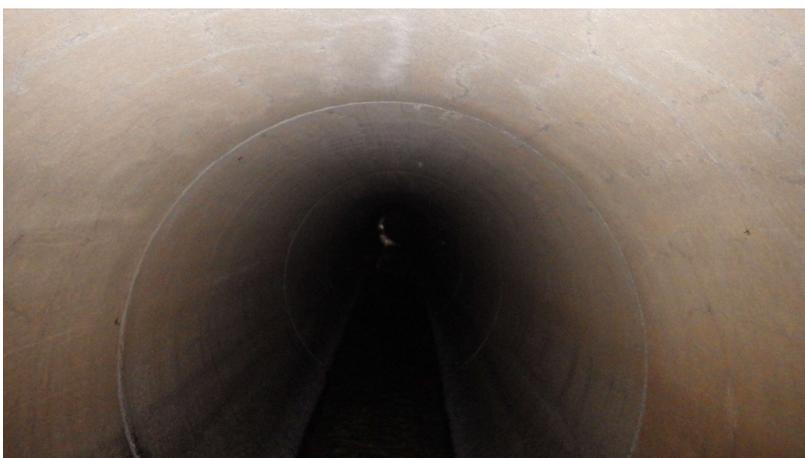
101.entry 2.station 2+04.spalling at joint

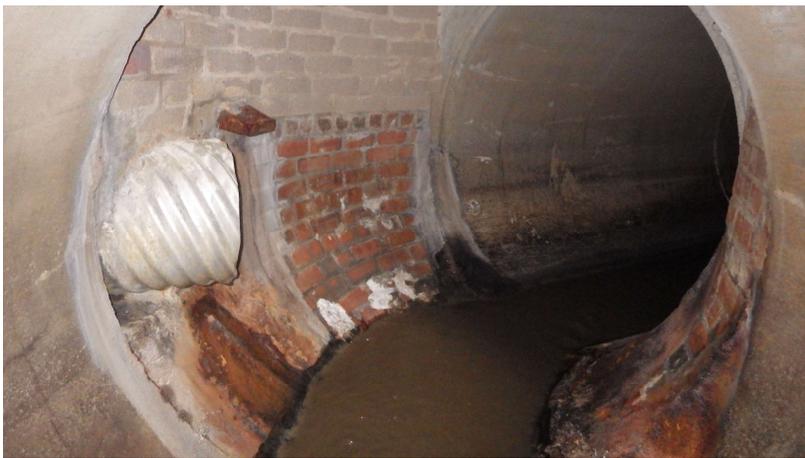
103.entry 2.station 3+00.spalling calcification

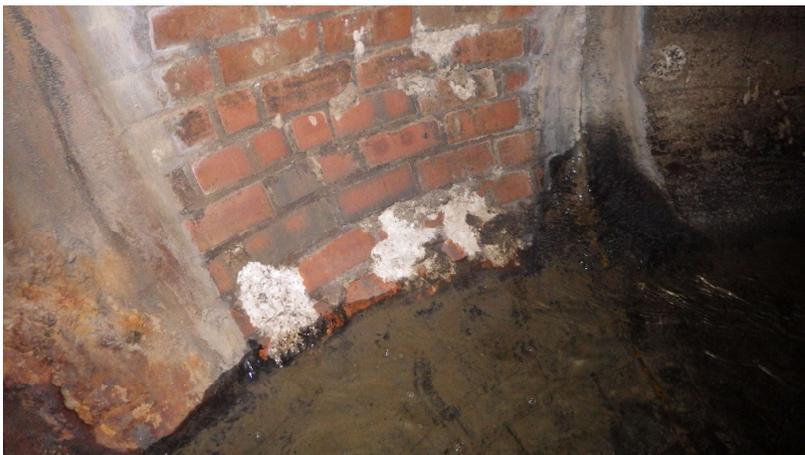
106.entry 2.station 3+41.infiltration calcification

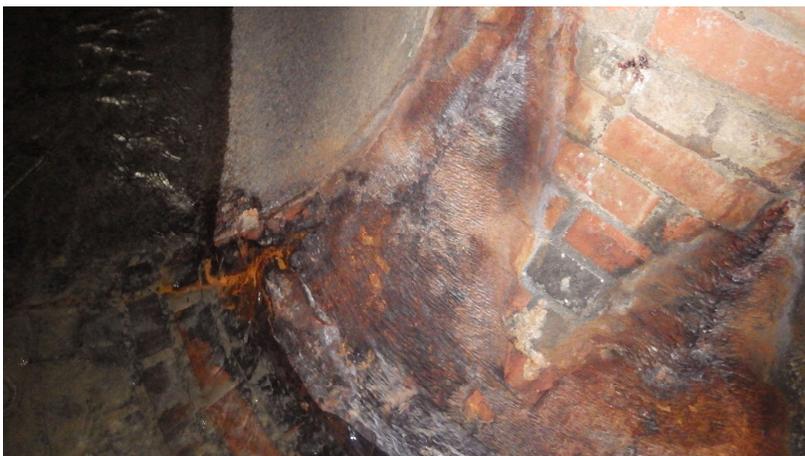
107.entry 2.station 3+41.infiltration calcification

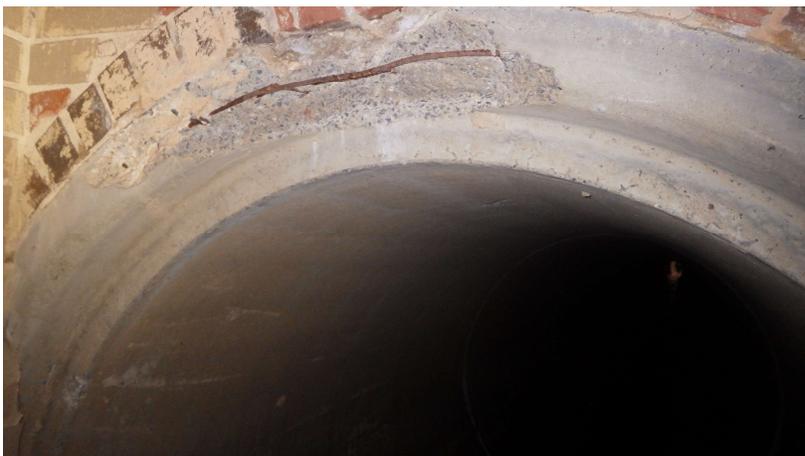
108.entry 2.station 3+41.60inch RCP exposed metal

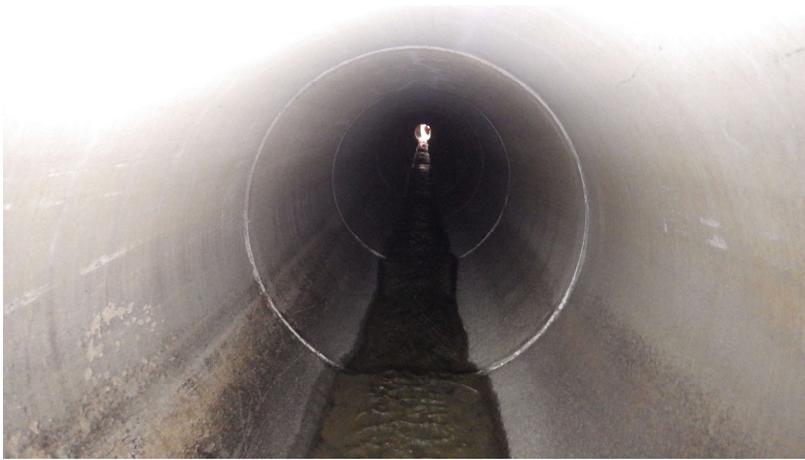
109.entry 2.station 3+45.minor spalling
