N. Apparatus and Equipment

Woodscape Drive Incident Overview: Apparatus and Equipment: Apparatus and Equipment

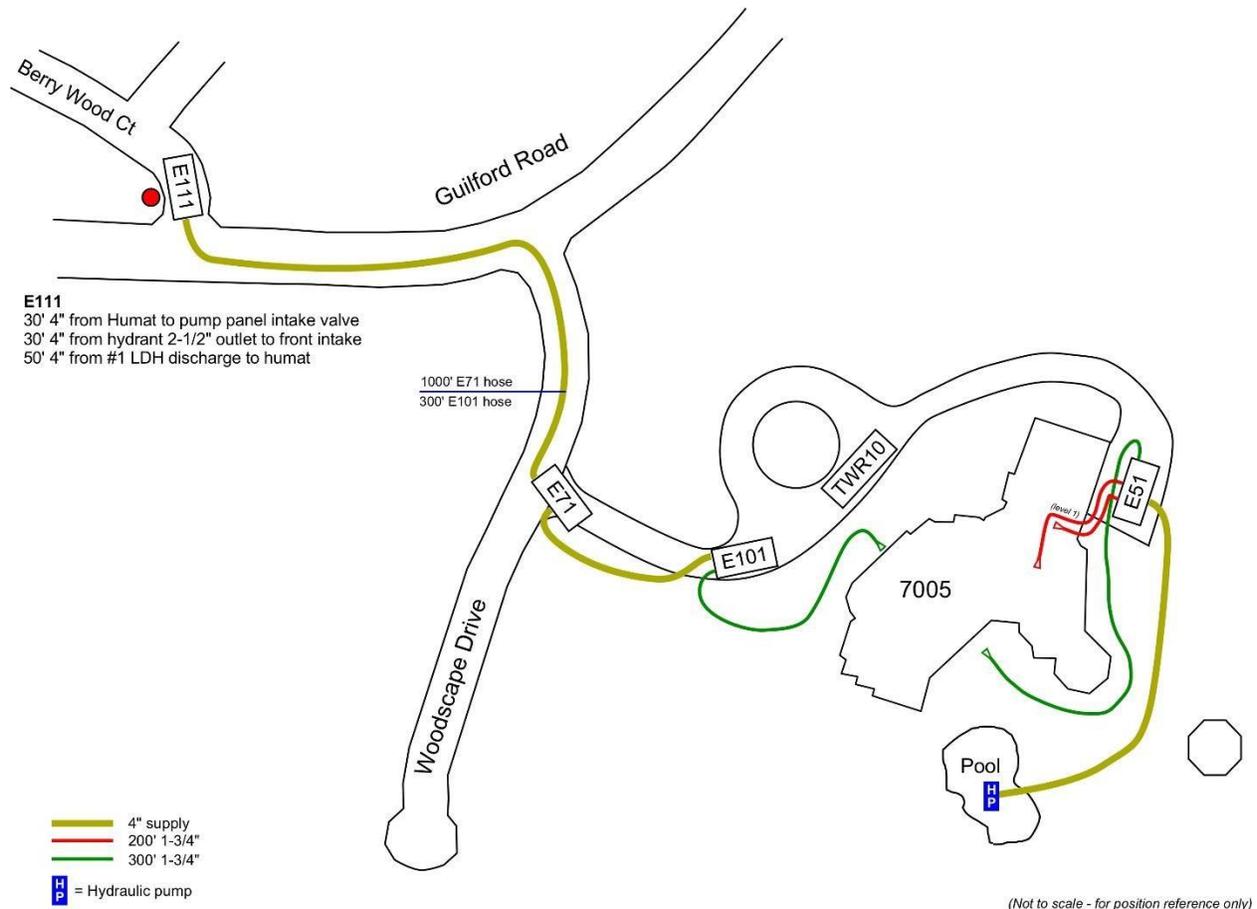
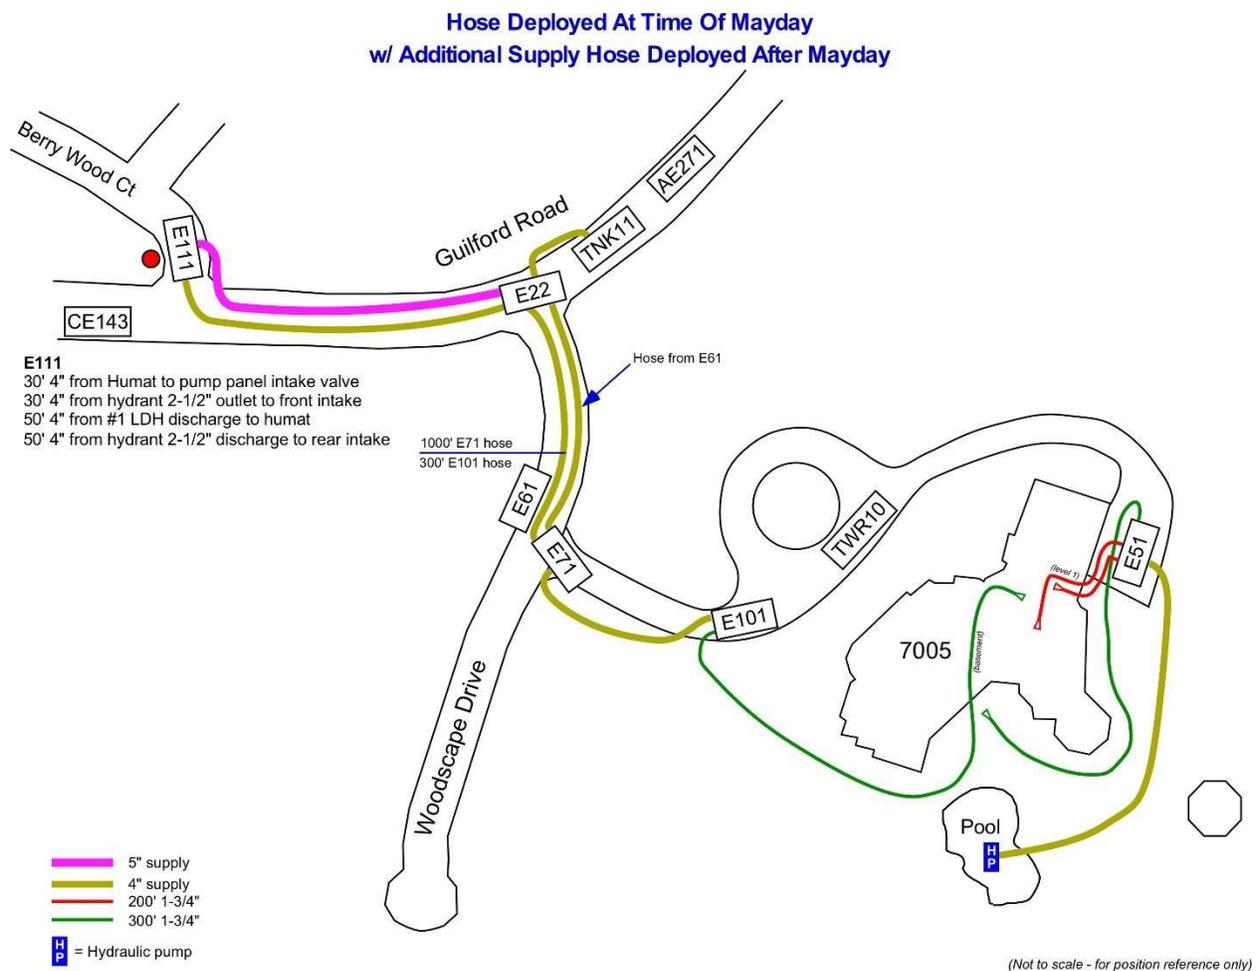
Figure 34 - Hose Deployed at time of MAYDAY and after MAYDAY

A hose-line was deployed from Engine 101 around Side D to Side C, stretching the line to the first-floor deck and over the railing. At some point during operations the hose-line ruptured, causing the line to be shut down while the damaged section of hose was replaced. Engine 101 carries a standard 5-foot Clemens Pack containing two, 75-foot sections of lightweight hose. An engine crew deployed 100 feet of 3-inch hose as a leader line and connected 150-foot, 1³/₄-inch hose from the Clemens Pack.

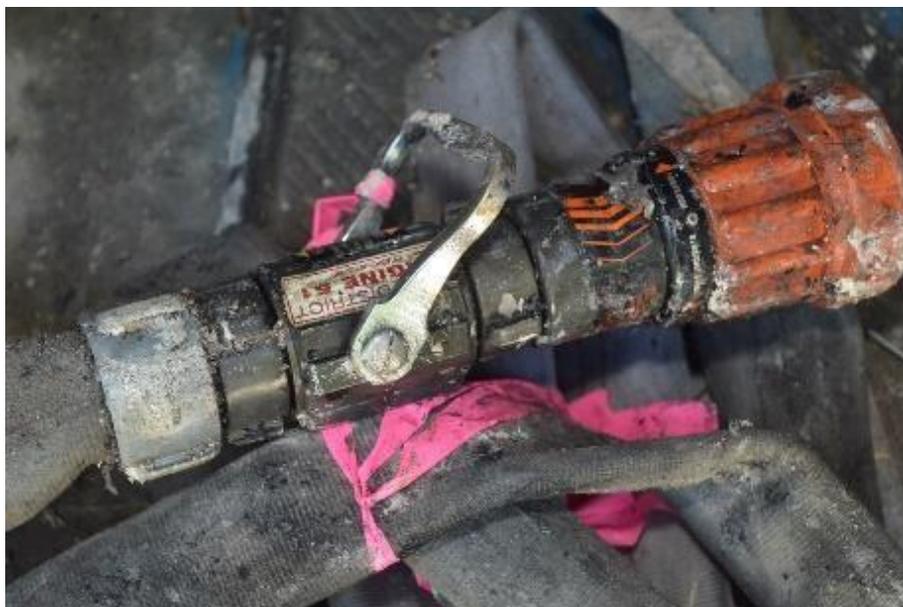
First, the nozzle on the hose line FF Flynn was operating on when he fell through the crawlspace was an Elkhart Brass Chief Fixed Flow Combination Fog Nozzle Tip Model 4000-24. This nozzle was affixed to a model B-275A ball shutoff with a 1 3/8- inch waterway. Based on the independent testing the Nozzle was rated for 200 gpm at 75 psi. Nozzle was flow tested with results of output flow of 227 gpm at 75 psi exceeding the rated flow of the nozzle. The nozzle moved freely from straight stream to full fog and into the flush position without difficulty. The shutoff moved freely, and no leaks were observed when the nozzle was in the closed position with full pressure behind it. In short, the nozzle was fully functional and exceeded its rated capacity on a flow test. All components of the nozzle operated as designed.

Figure 35 – Nozzle FF Flynn had in hand just prior to falling into the crawlspace

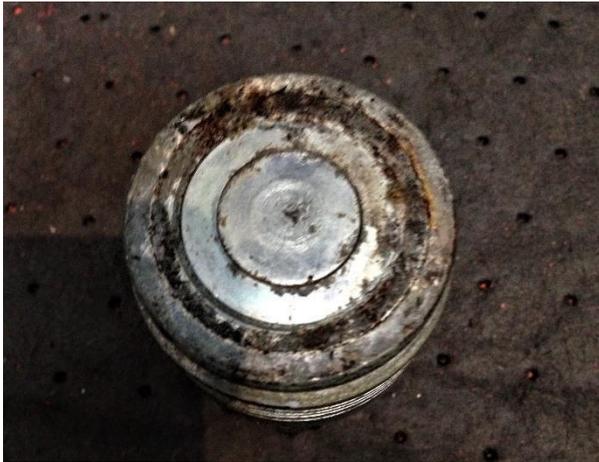
Third, the couplings on Engine 51's 25-foot hydraulic extension hoses were corroded, resulting in a delay in accessing water supply from the pool. Engine 51 is equipped with a hydraulic submersible pump that can be used to supply apparatus or hose appliances with a continuous water supply. The hydraulic pump on Engine 51 is capable of flowing 650 gallons per minute (GPM) as long as the water source can support the demand. The pump is powered by an onboard hydraulic pump and a 165-foot apparatus mounted hydraulic hose line. Engine 51 is also equipped with two 25-foot extension hoses to extend the main hydraulic hose. The pump has a 4-inch storz coupling on the discharge of the pump. The hydraulic pump can be placed in a static water source and operated by the driver of the apparatus. A similar hydraulic pump and components are equipped on Engine 52, Squad 5, Engine 31 and Water Supply 3.

Figure 36 - Top view of corroded hydraulic coupling

Prior to this incident, the hydraulic pump, main hydraulic line, and the 25-foot hydraulic extension lines were not a part of the HCDFRS daily/weekly check sheets. HCDFRS [General Order 510.03 Vehicle Maintenance and Repair](#), Section 1.1, states "[d]aily and weekly checks shall be performed by the vehicle's assigned driver/operator in accordance with the DOT and COMAR inspection standard and then recorded on the appropriate DFRS check sheet." To prevent interrupted water flow at future incidents, HCDFRS should revise its daily and weekly check sheets to include assessment of the hydraulic pump, its lines, and its 25-foot line extensions. The inspection of the hydraulic line extensions should include lubricating and exercising the couplings.

Findings	Recommendations
Replacement Cycle Analyses conducted by Mercury Associates Inc.	
N.2. Engine 51's 25-foot hydraulic extension hose couplings were corroded.	N.2.1 HCDFRS must revise its Vehicle Check Sheet to include the Hydraulic pump, hydraulic lines, and the 25-foot hydraulic line extensions to the Weekly Check Sheet, including lubrication and exercise of the couplings.
N.3. Engine 51's air conditioning compressor locked up on the fireground, threatening pump operations. Operations were only able to continue thanks to FDVFD's mechanic responding to the scene and temporarily fixing the mechanical issue.	N.3.1 A Ground Support representative and a mechanic from the County Maintenance Facility must be added to the on-call availability. N.3.2 All HCDFRS apparatus purchases should be designed in a fashion so that critical apparatus functions run independently from internal climate control.

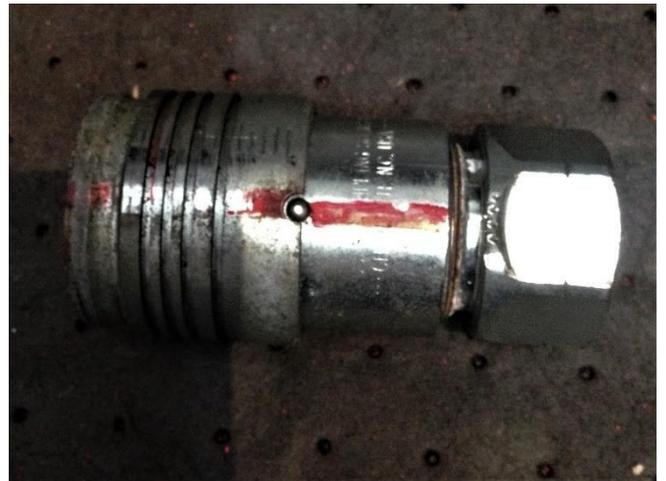
Figure 37 - Side view of corroded hydraulic coupling

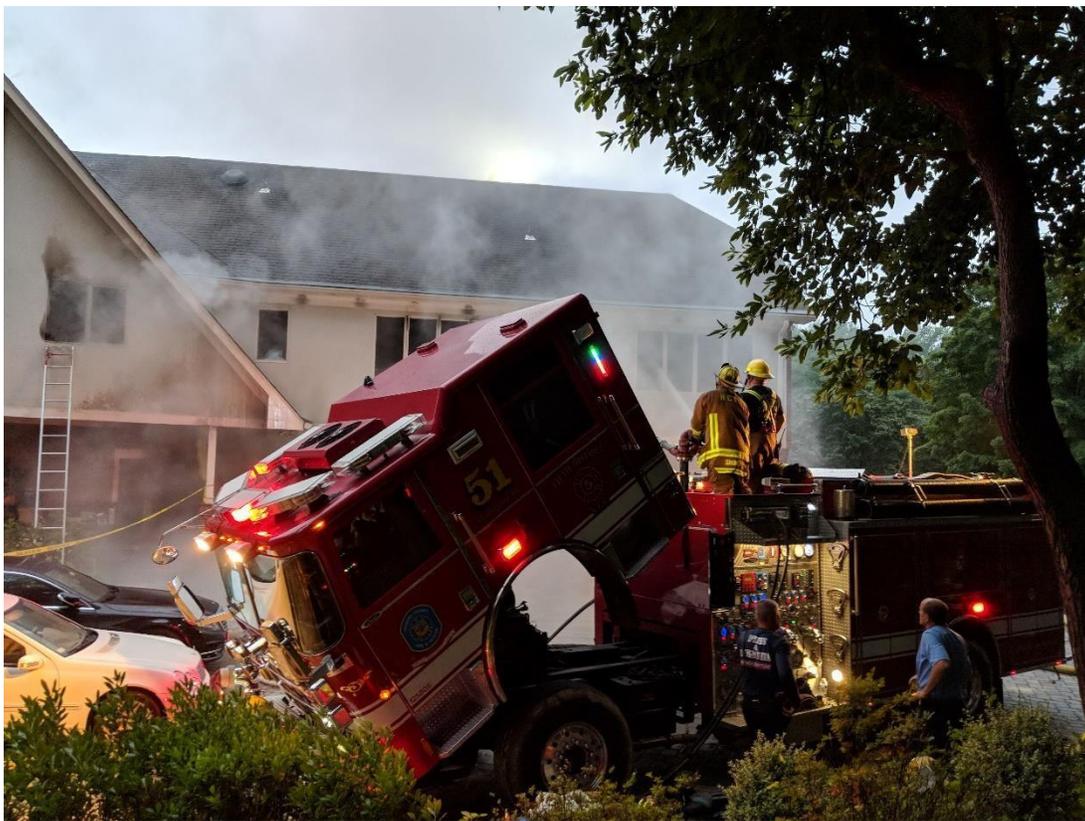
was engaged in pump operations its driver noticed an odor of burning rubber emitting from the engine compartment. Notifying Chief 5A of the unusual odor the Chief contacted FDVFD's mechanic requesting him to respond to the scene. On inspection of the unit, the mechanic found that Engine 51's air conditioning compressor had locked up, causing it to overheat. Because the air condition belt operates other portions of the unit, this mechanical issue threatened pump operations.

Fortunately, the mechanic was able to repair Engine 51 without any interruption to pump operations. To do so, the mechanic first attempted to raise the cab of Engine 51 and disconnect the coil to free the compressor. After this attempt proved unsuccessful, he manually bent the clutch plate away from the flywheel to free the compressor. This temporarily fixed the mechanical problem and allowed Engine 51 to remain in service.

Figure 40 - Engine 51 after on-scene repair

Because FDVFD leadership had the availability of an on-call mechanic to respond to the scene, pump operations continued without interruption. Had Engine 51 been placed out-of-service for mechanical failure, the water supply from the swimming pool would have been lost and another engine driver would have had to pump through Engine 51 adding complexity to an already challenging incident. To avoid such an outcome at future incidents, HCDFRS should consider placing a Logistics representative and mechanic from the County Maintenance Facility to the on-call availability. Additionally, all HCDFRS apparatus purchases should be designed in a fashion so that critical apparatus functions run independently from internal climate control.
