Tiber-Hudson Branch Stream Corridor Assessment 2016

Tiber-Hudson Branch Stream Corridor Assessment

Smith Planning and Design, LLC.

1/15/2017

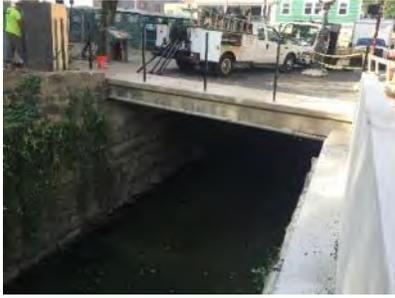
Point # 101
Location: 39.267750, -76.795080
Description: Railroad Crossing at
beginning of Study Area.

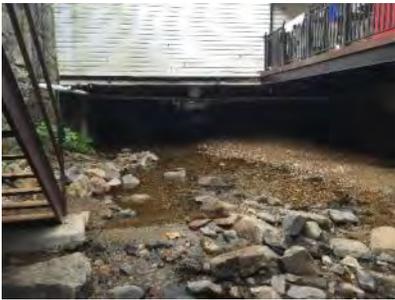
Point # 105
Location: 39.267360, -76.795990
Description: Building Crossing.

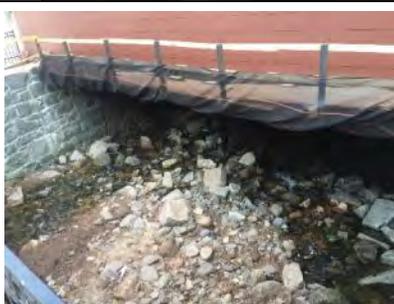
Point # 102
Location: 39.267410, -76.795680
Description: 8' from debris to lower
cord of bridge/sidewalk.

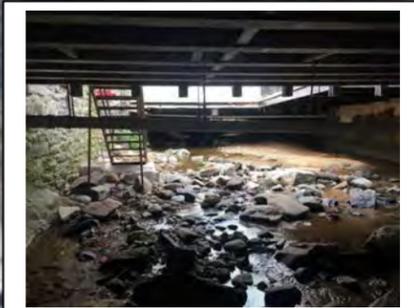
Point # 103
Location: 39.26732, -76.79570
Description: Building crossing.

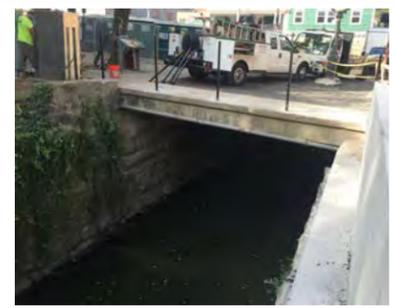
Point # 101
Location: 39.26775, -76.79508
Description: Road crossing. Lower end of tunnel under Maryland Avenue.

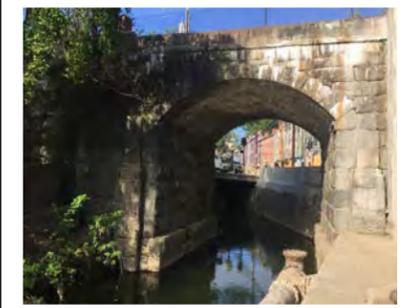
Point # 100
Location: 39.26777, -76.79477
Description: Road crossing. Beginning of study area.

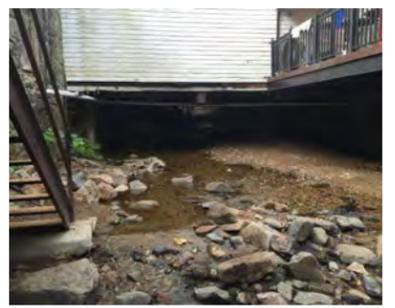
Point # 105
Location: 39.26736, -76.79599
Description: Building crossing with low overhead.

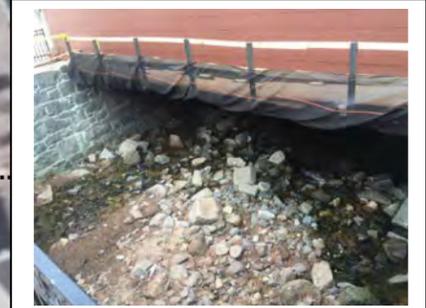
Point # 102
Location: 39.26741, -76.79568
Description: Debris blockage. Boulders and large rocks in channel.

Site 1 is identified as Point 102 within the SCA and is located in the historic downtown section of Ellicott City. More specifically, it is located immediately downstream of the footbridge at Tiber Park. It is categorized as a debris blockage and consists primarily of boulder and cobble accumulation within the channel. This accumulation is occurring due to the slope reduction at the Tiber-Hudson nears its confluence with the Patapsco River. A reduction in slope reduces stream competence, or the ability of the stream system to carry its sediment load. This site is identified as a potential problem/mitigation area because the boulder/cobble accumulation is shifting stream flow directly into a corner created by a ninety degree bend in the stone flood wall. Over time, the continued assault of flowing water on the flood wall can compromise the grouting within the walls and eventually result in failure. One recommendation would be to clean out some of the accumulated material and grade the channel such that flow is redirected away from the walls. A hydraulic structure could be incorporated; however, access to the channel is very limited at this location.

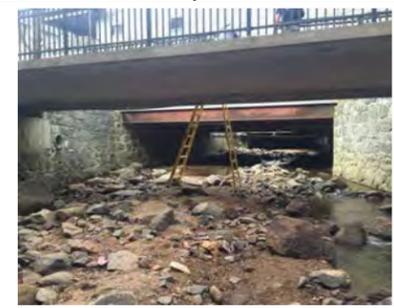
Point # 104
Location: 39.26732, -76.79592
Description: Bridge crossing

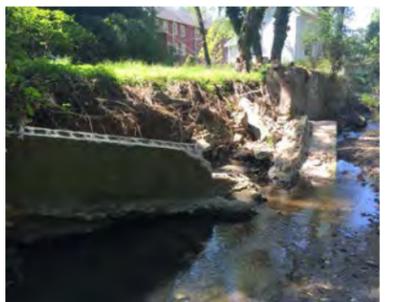
Point # 131
Location: 39.26971, -76.8032
Description: Erosion site. Failed concrete wall on right bank, ~50 ft section.

Site 4 encompasses the stream reach between Point Nos. 131 and 133 within the SCA. This reach experienced significant accelerated bank erosion, losing approximately 10 to 20 feet of streambank laterally in some locations during the flood event. A portion of a block retaining wall failed. A massive central bar is forming within this reach, which results in excessive erosional forces to both streambanks. It is recommended that this reach be evaluated for additional stabilization and restoration alternatives.

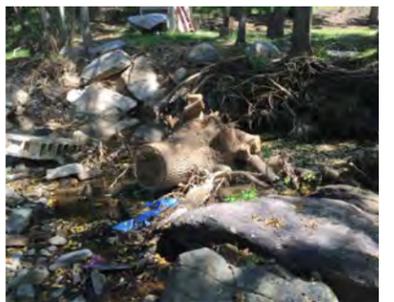
Point # 130
Location: 39.26954, -76.80288
Description: Erosion site.

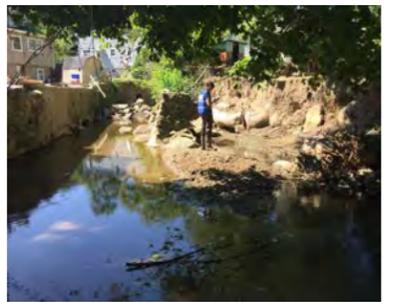
Point # 133
Location: 39.26981, -76.80405
Description: Erosion site. Large scour behind old wall on left bank.

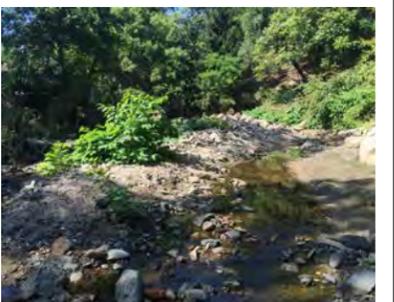
Point # 132
Location: 39.2698, -76.80368
Description: Debris blockage. Large central bar forming with boulders. Channel is over-wide.

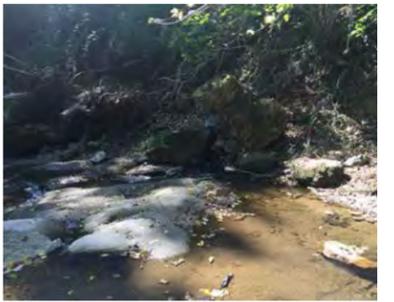
Point # 129
Location: 39.26932, -76.8029
Description: Erosion site. Right bank, large tree failure along bank.

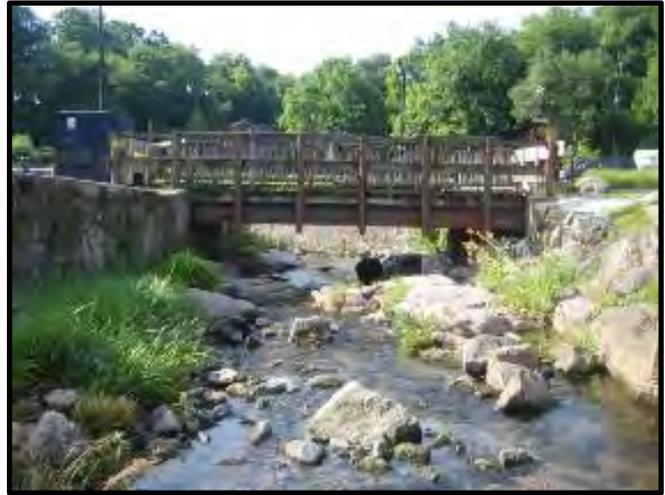
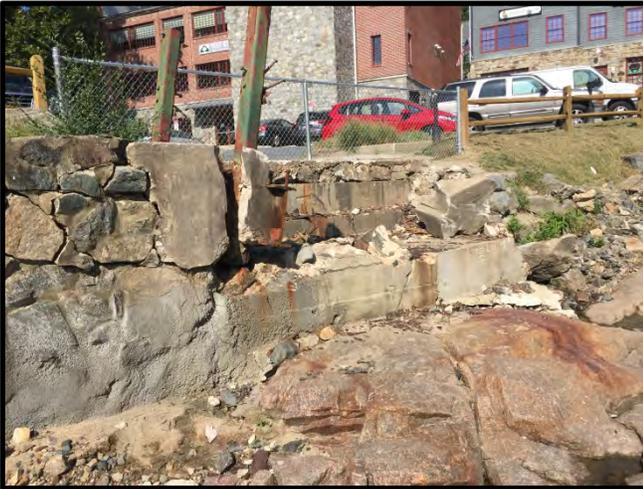
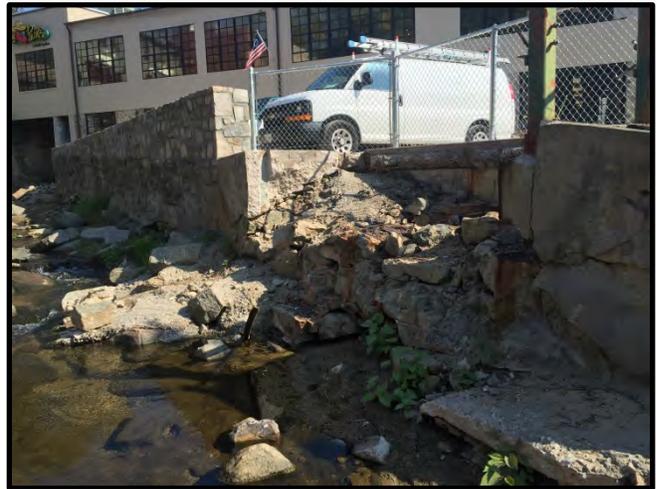
Site 2 is identified as Point No. 116 within the SCA and is located between two parking lots in the downtown area, immediately upstream of the Tiber Branch/Hudson Branch confluence. Previously, this site consisted of an I-beam supported, timber-decked footbridge that provided pedestrian traffic to flow between the businesses arranged around the parking lots. The cross-sectional area available to flood conveyance through this structure was not sufficient to convey flood flow. If a structure is replaced at this location, it should be designed to accommodate a minimum design storm in accordance with Howard County regulations.

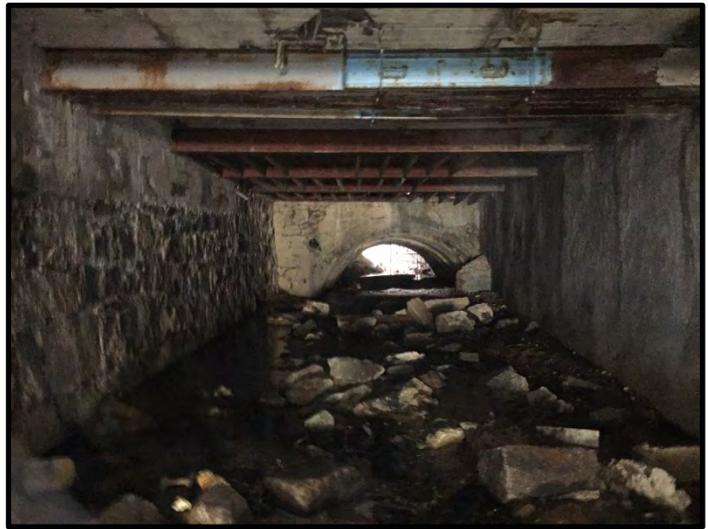
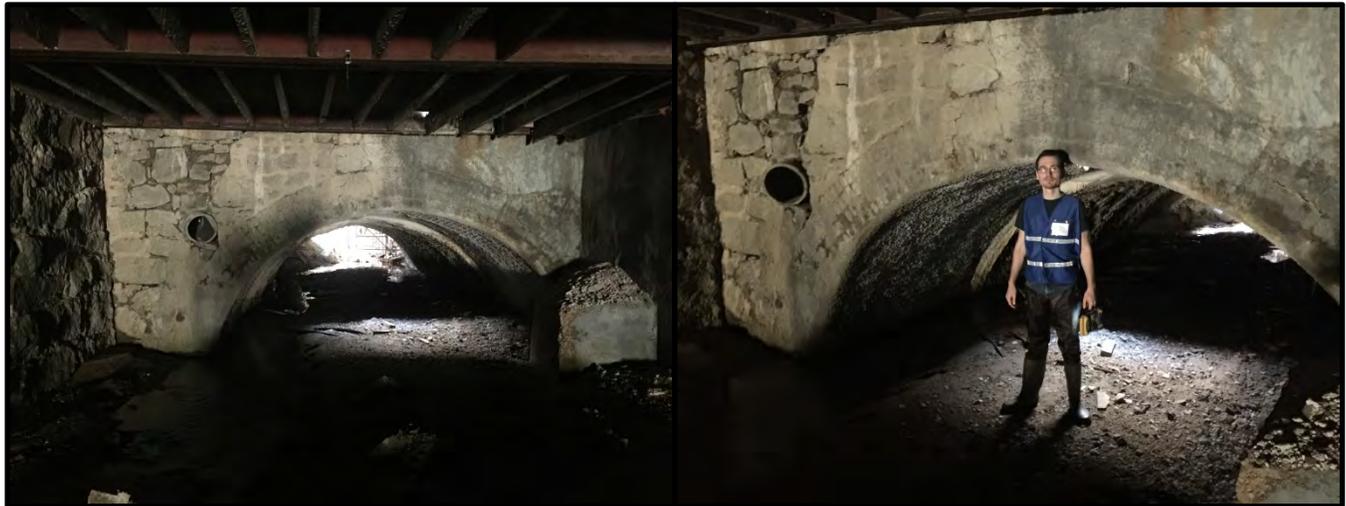
Site 3 is identified as Point No. 118 within the SCA and is located near the upper or western end of historic downtown Ellicott City. This site consists of an archway located within the channel beneath Main Street and several businesses. This archway represents a channel constriction that significantly reduces the cross-sectional area of the potential flood conveyance. Once the flow capacity of the archway reaches its limit during a flood event, it will create a backwater condition within the upstream portion of the channel. Additionally, constriction of the channel increases the possibility that debris can get impinged at the opening, thereby exacerbating the backwater condition and potentially resulting in the flood water 'jumping' from the channel into Main Street. It is recommended to have the archway inspected by a structural engineer to evaluate if its removal would jeopardize the structural integrity of the rectangular conveyance or the surrounding buildings built over this location.

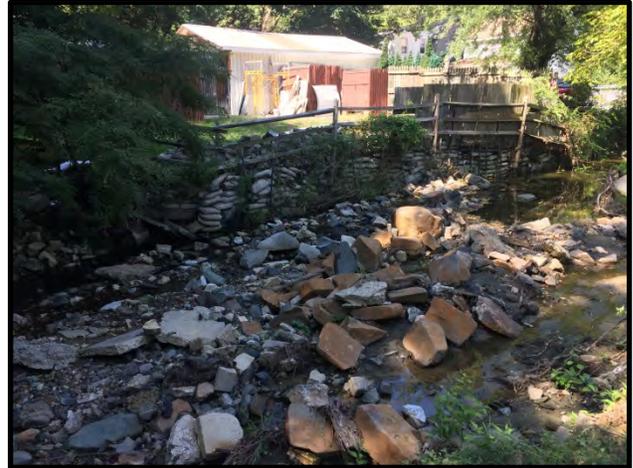
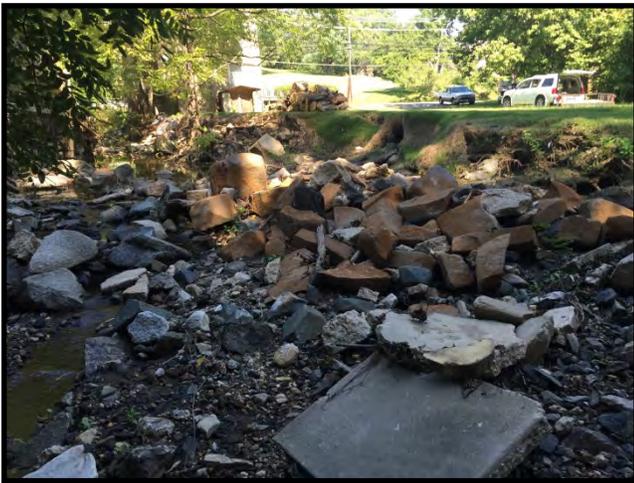
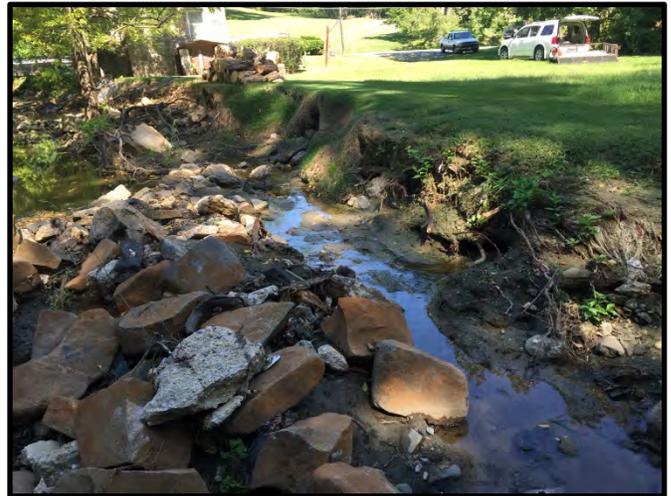
Site 5 is identified as Point No. 149 within the SCA and consists of an erosion site, channelization site, and debris blockage. A concrete bag retaining wall installed to protect the driveway of the adjacent commercial property. It is recommended that this structure be replaced with an appropriate retaining wall. A large accumulation of boulder size material deposited at this location creating a central bar that directed flow into the left bank, resulting in land loss and erosion. Additionally, the left stream bank does not contain vegetation as the floodplain is mowed to the top of bank. A bioengineering plan at this location and agreement with the landowner could reduce the erosion potential at this location.

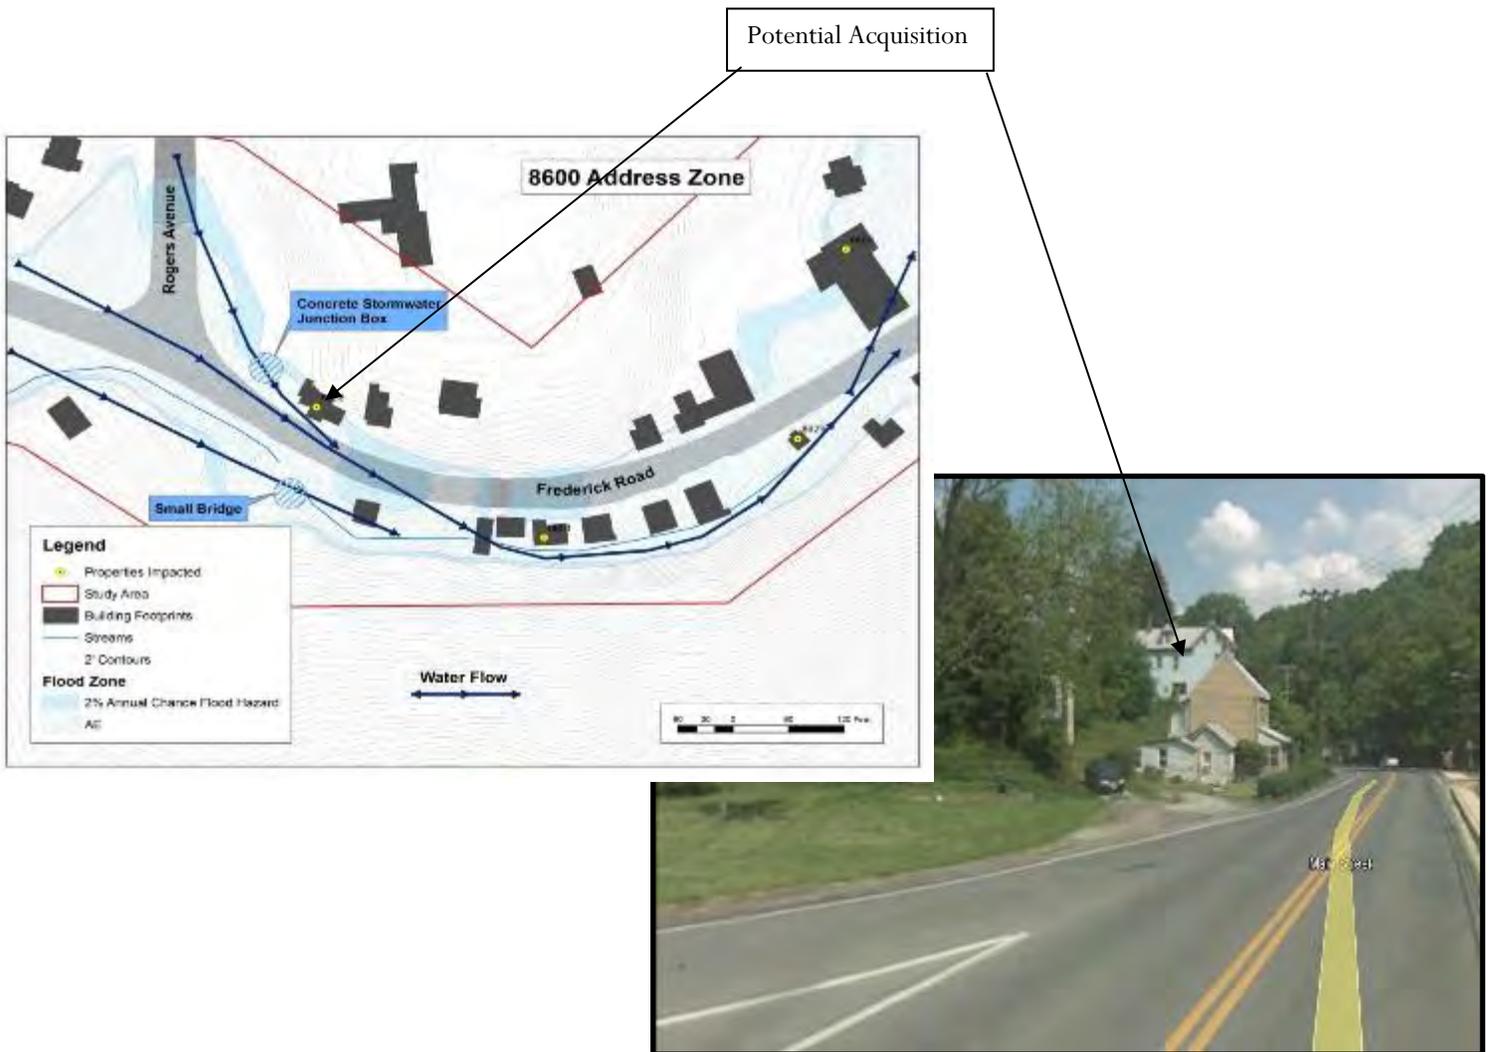
Potential Acquisition

Site 6 consists of a potential flood acquisition project and a stormwater management investigation in the vicinity of the Rogers Avenue and Frederick Road intersection. This area was identified and described within the *Case Study* as the 8600 Address Zone. One structure in particular, located at 8688 Frederick Road, experienced first floor flooding through the windows at the side of the house approximately 3 feet above grade and is recommended as a flood acquisition buyout candidate. Additionally, it was reported that a significant amount of stormwater was flowing down Rogers Avenue to combine with the flows along Frederick Road. A concrete stormwater junction box is located to the northeast of the Rogers Avenue/Frederick Road intersection. Witnesses reported that the manhole access cover was ‘blown off’ the lid of the box. Additionally, they reported that the concrete top was being elevated. This observation would indicate that the junction box and the stormwater pipes leading to it were at capacity, creating sufficient hydraulic pressure to lift the top and remove the manhole cover. With the stormwater system at capacity, excess stormwater would utilize the roadways as the storm conveyance. It is recommended that a stormwater management investigation be conducted to determine the feasibility of installing additional stormwater management facility(s) within this area.

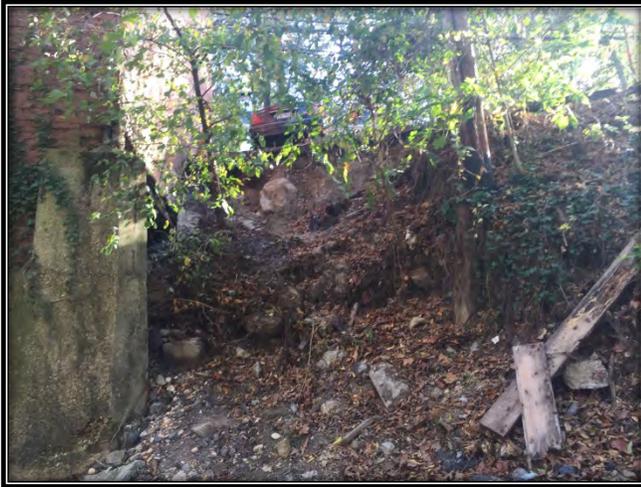
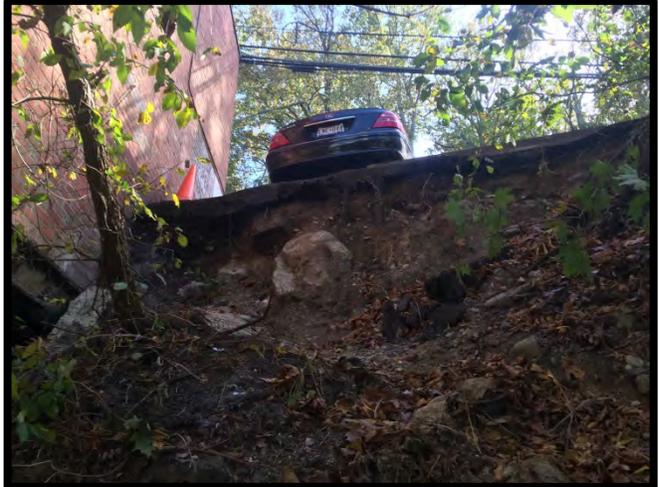
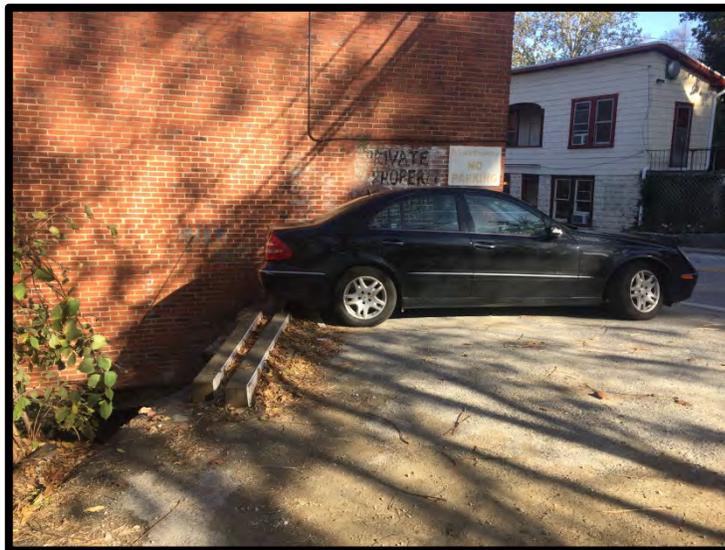
Site 7 is located near Point No. 112 within the SCA and consists of an erosion site along the right bank. The erosion has undercut macadam paving where vehicles are routinely parked. In the event of a failure at this location, a car could potentially be introduced into the stream channel at the upstream inlet of a long section of stream that is bridged by buildings. Additionally, these buildings have concrete support columns within the channel that would have a high probability of creating a blockage due to a vehicle introduced to the channel. A stabilization plan at this location and agreement with the landowner could reduce the erosion and failure potential at this location.
