B. Strategy and Tactics

Woodscape Drive Incident Overview: Strategy and Tactics

Findings and Recommendations: Strategy and Tactics

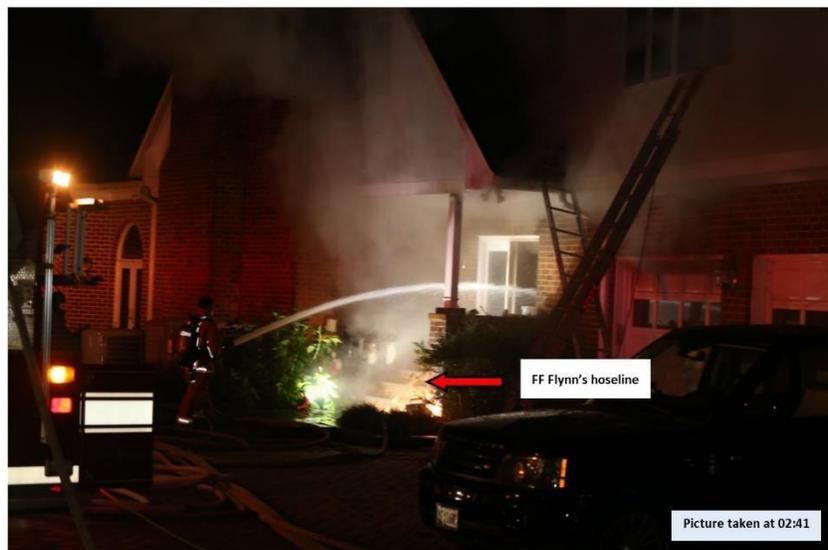
Figure 17: Photograph of Floor 1 entrance 21 minutes after MAYDAY

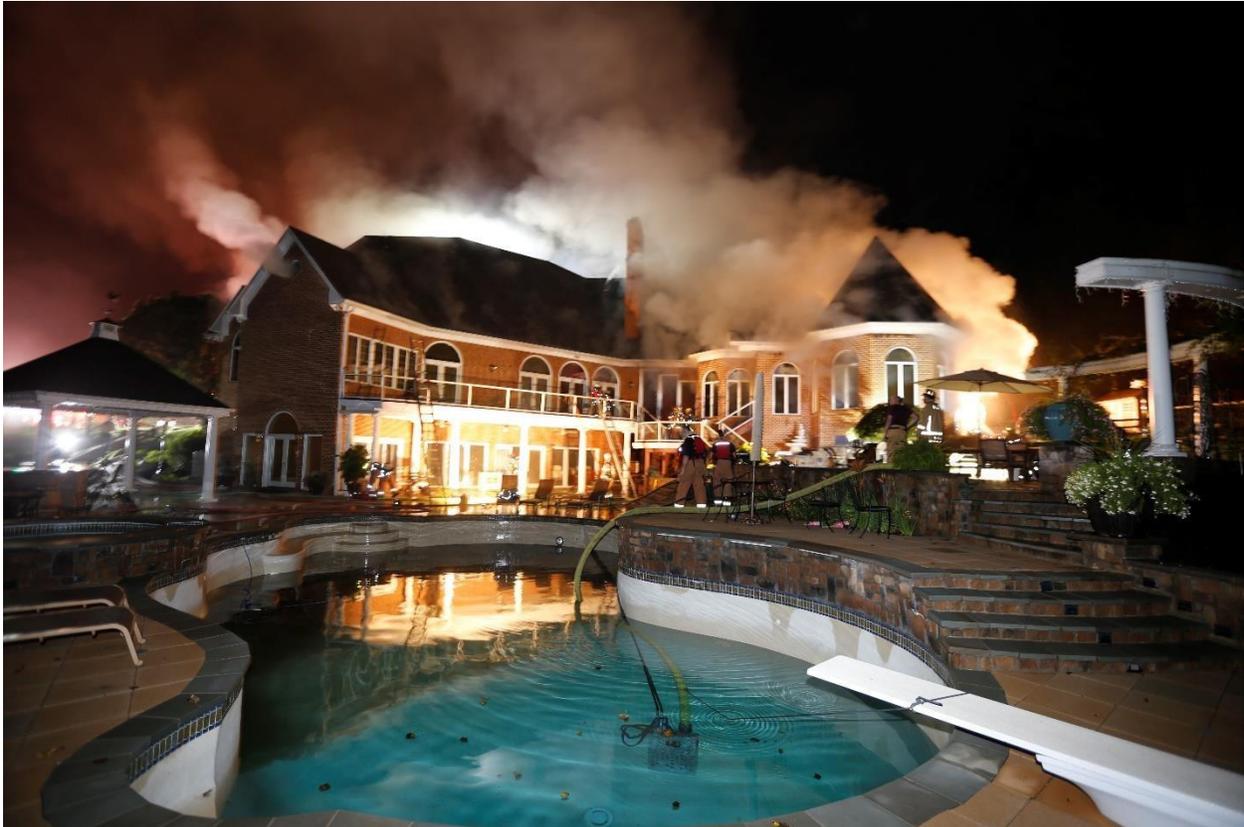
Figure 18: Photograph of hydraulic pump supplying Engine 51

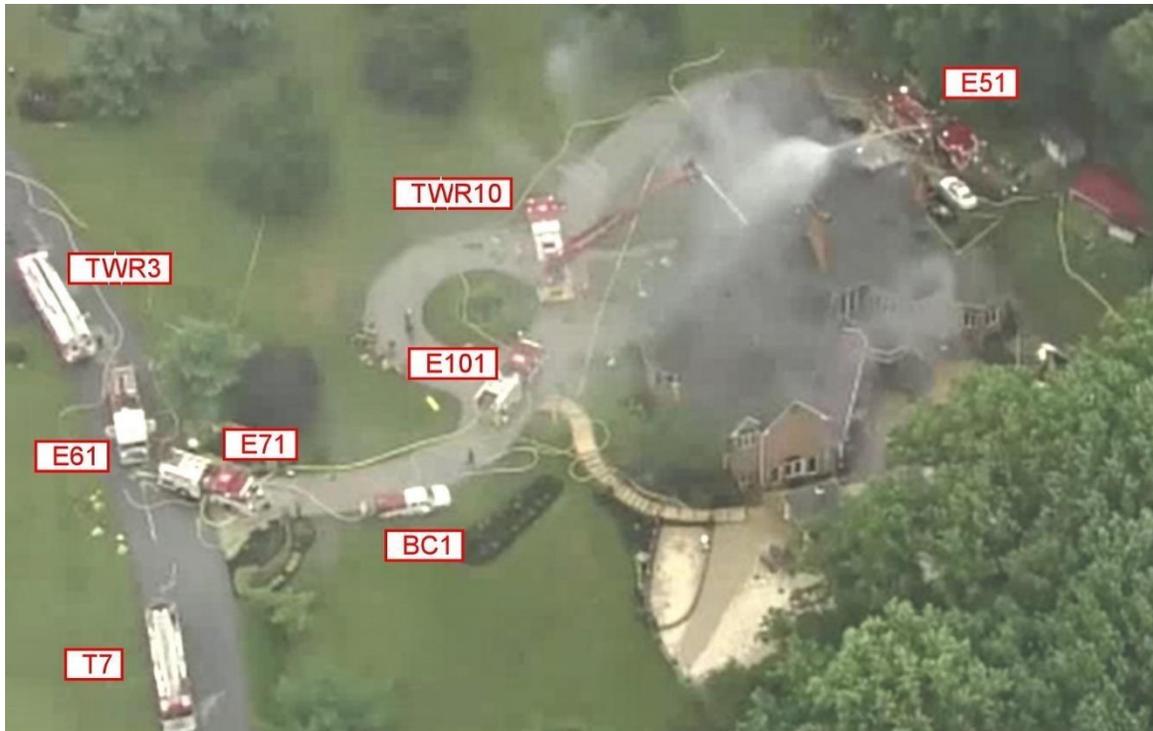
Figure 19 Aerial view of 7005 Woodscape Drive with the location of apparatus
