I. Incident Information

Building Construction

Incident Narrative

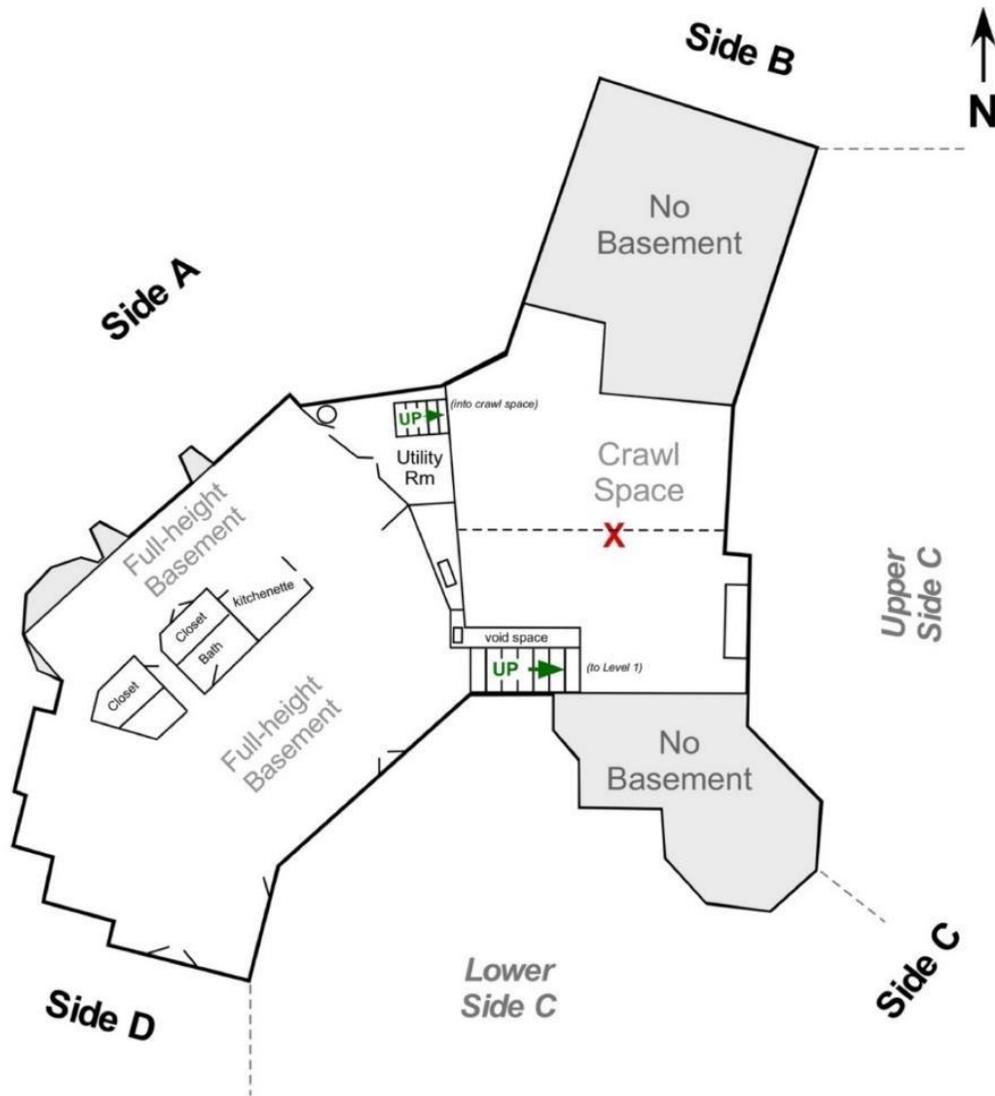
Figure 7 - Sketch of Basement for 7005 Woodscope Drive with approximate location of FF Flynn

There is a full-story basement beneath approximately half of the structure from Side D to approximately the center, ending at a crawlspace. The crawlspace is a unique feature located beneath Floor 1 in the center portion of the structure, accessible only from the basement via a set of stairs at the A/B corner of the crawlspace beneath the area of the Side A first floor kitchen entrance. See [Figure 23 Steps leading from basement to crawl space where FF. Flynn](#) was located for a post-incident photograph of the area. The crawlspace and access to the crawlspace is hidden from general view with no indication of its existence, even under normal occupant activity. Marble tile covers the floor of the Floor 1 family room approximately above Quadrant 3 of the crawlspace. Tongue-and-groove hardwood covers the Floor 1 floor approximately above Quadrant 4 of the crawlspace. The underside of the floor system for Floor 1, which is the crawlspace ceiling, consists of unprotected dimensional lumber supported by unprotected dimensional lumber components. Height of the crawlspace varies due to differing floor levels of the areas above, with an estimated average height of approximately four (4) to five (5) feet. Concrete masonry unit (CMU) block walls bound the crawlspace on all sides. The northern half, approximately Quadrants 1 and 2, of the crawlspace have a platform-type floor assembly of plywood and linoleum on top of moisture barrier. The floor of the southern portion, approximately Quadrants 3 and 4, is earth covered by moisture barrier and plywood panels. The crawlspace contained various household storage items.

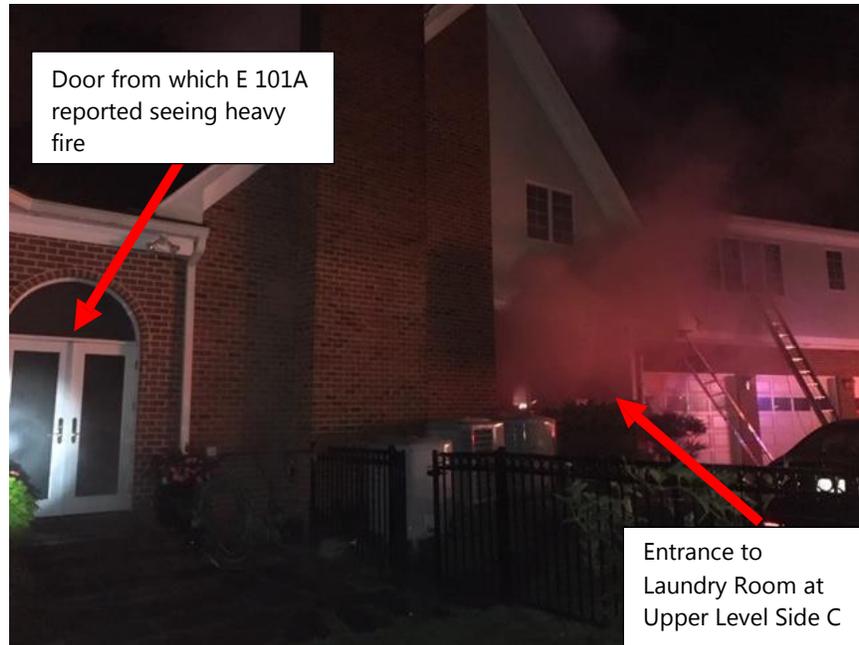
Figure 10: Photograph of Side C with smoke emanating from laundry room door

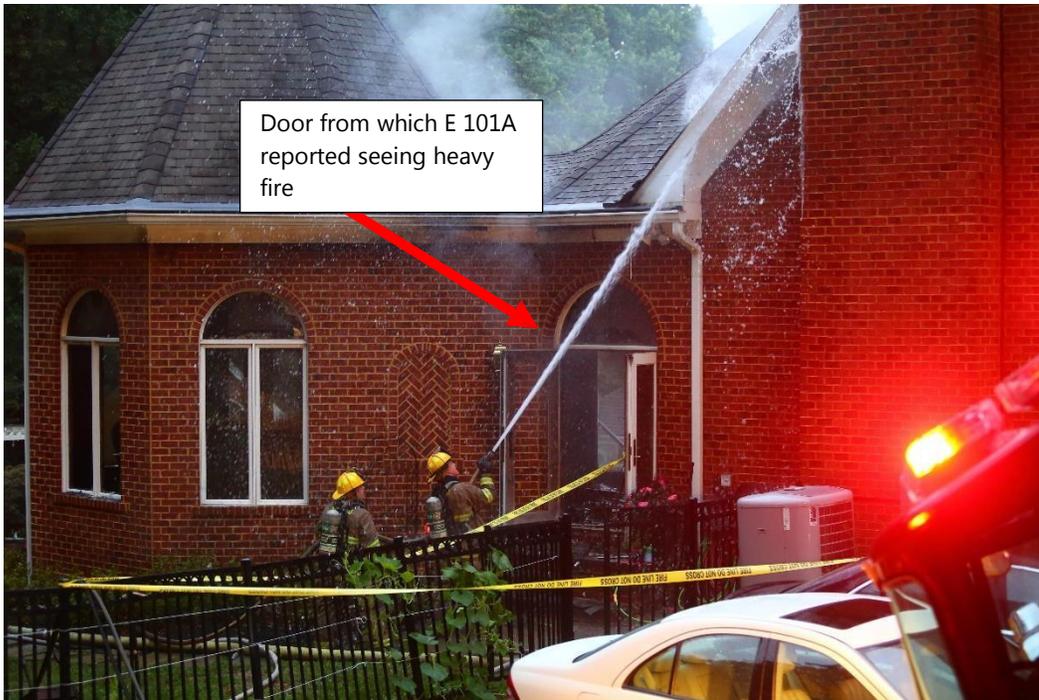
Figure 11: Fire visualized by Tower 10D and E101A behind the open doors in above photo.

Seeing fire on the first floor of Side C, Engine 101A, advised the Incident Commander by radio, "...heavy fire on floor number one Side Charlie...We need to redeploy our line back up to the initial entrance." Engine 101B withdrew from the lower level Side C (basement entrance), abandoning the 300-foot hose line, and went back up the hill toward Engine 51's apparatus. Deploying a second 200-foot hose line from Engine 51, Engine 101's crew made entry into the first-floor laundry room on upper level Side C with FF Flynn on the nozzle of a charged hose line and Engine 101A an unknown distance behind him. Engine 51's crew redeployed their charged hose line from lower level Side C to upper level Side C and made entrance on the first floor behind Engine 101 at approximately 02:17:43.⁵

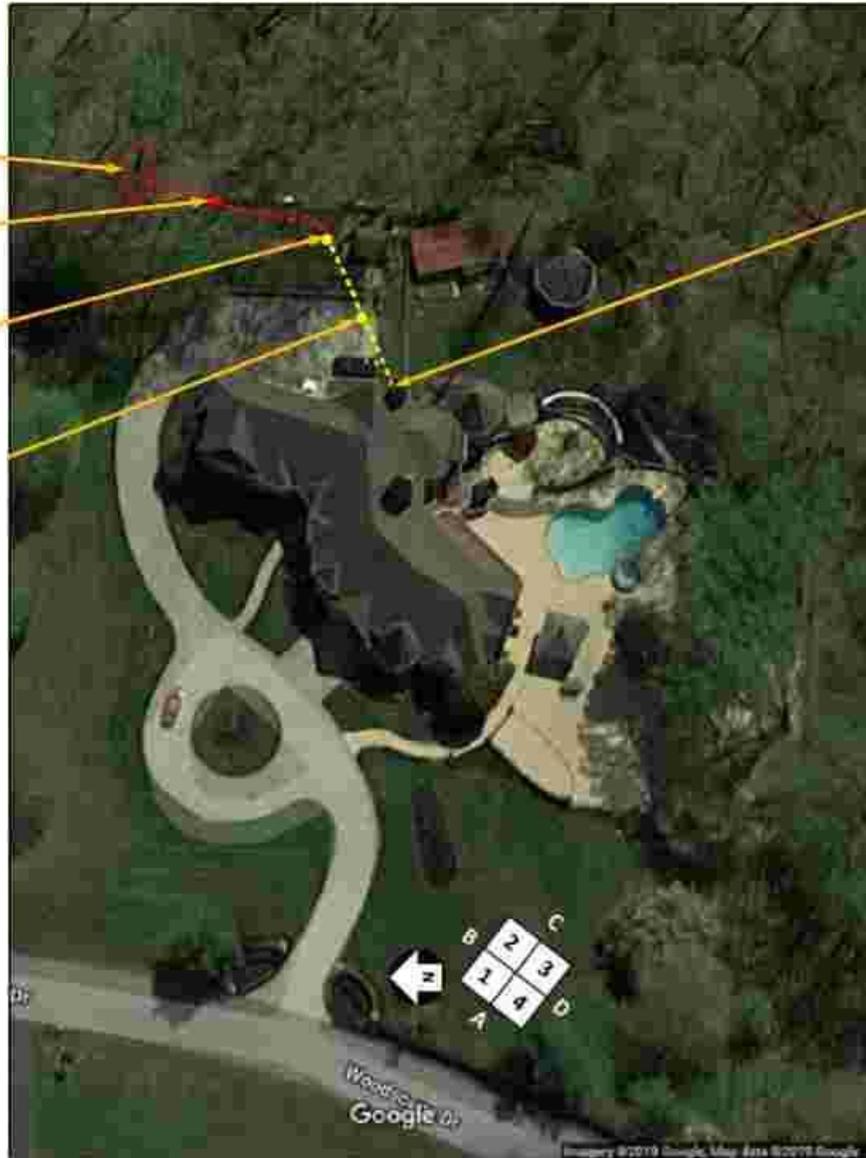
The Origin and Cause Investigation of the fire at 7005 Woodscape Drive incident, conducted by the HCDFRS Office of the Fire Marshal, determined the area of origin to be the unfinished basement crawlspace below the first-floor family room and breakfast area. Investigators identified the ignition sequence of the fire to be a lightning strike which induced the failure of the residential corrugated stainless-steel tubing (CSST) system. This caused the ignition of fugitive gas escaping from the hole formed by the arcing process which then ignited combustible material in the area of origin. The classification of the fire cause was determined to be Natural. Natural fire causes involve fires caused without direct human intervention or action, such as fires resulting from lightning, earthquake, wind, and flood.⁶

Location of tree/lightning strike (Approx.)

Path of lightning travel in ground / visible disturbed earth (Approx.)

Location of underground LPG storage tank valve assembly access (Approx.)

E Estimated travel path of ground service lateral from storage tank to dwelling

Location of LPG underground service lateral riser and entry into dwelling

Figure 15 - Path of lightning travel, photo courtesy of ATFE
