# ELLICOTT CITY RETAINING WALLS INSPECTION REPORT

## STREAM WALLS

## HISTORIC ELLICOTT CITY, MARYLAND

MAY 2016

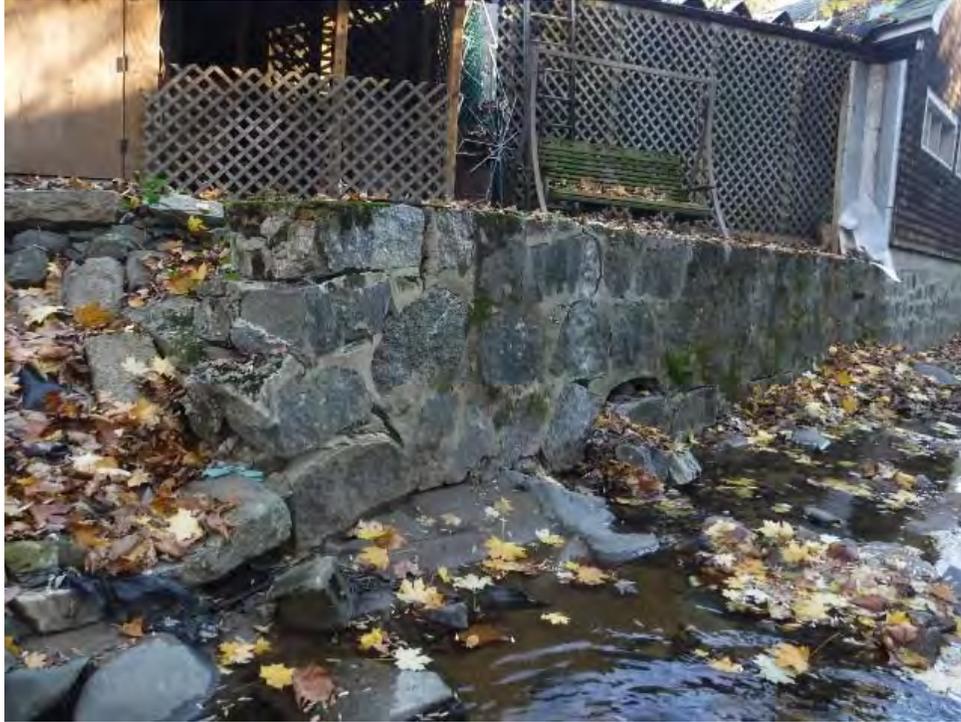
Overall, the wall is in fair condition. Section 1 (western 200') is comprised of stone masonry and has random missing mortar throughout the joints. The west end of the wall is failing with a 20'-0" long x 2'-0" high area of loose and displaced stones along the base (see Photos 1 and 2). There are full-height fractures through mortar joints at 52', 60', 70', and 85' from the west end of the wall, open up to ¼" wide, with ½" horizontal offset (see Photos 3 and 4). There is a large tree at the top of the wall above one of the fractures (see Photo 4). At 65' from the west end, there is a 5'-0" wide x 2'-0" high area of loose and displaced stones (see Photo 4). Between 145' and 200' from the west end of the wall, the wall has failed and the embankment is eroded (see Photos 5 and 6).

*Photo 1 – Section 1, West End, Looking Northeast.  
Note Failing Wall at West End.*

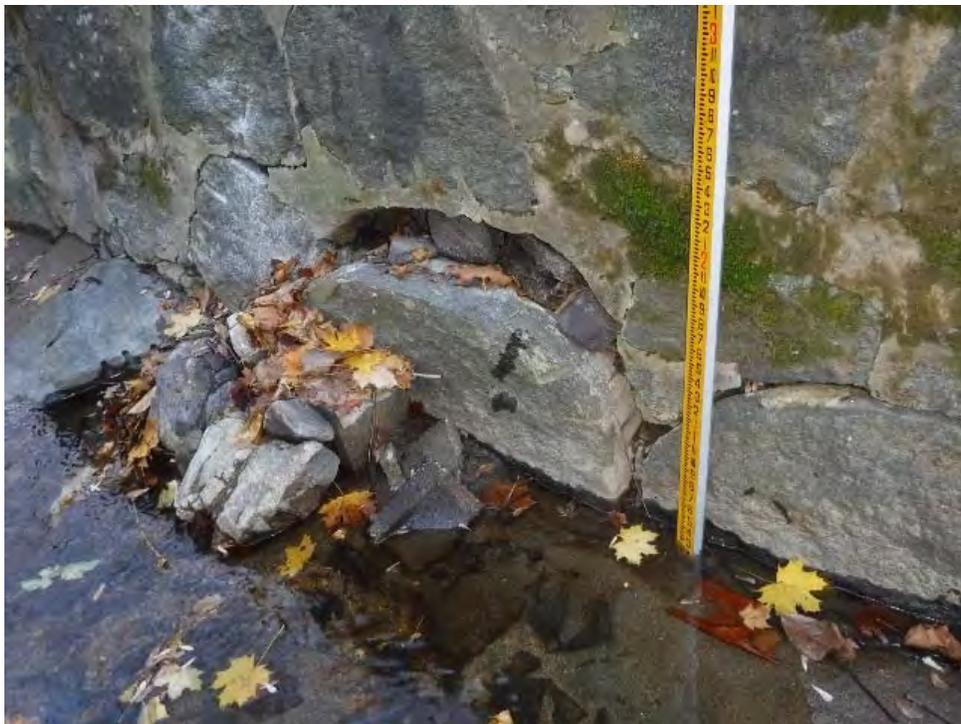
*Photo 2 – Loose and Displaced Stones along Base near West End of Section 1.*

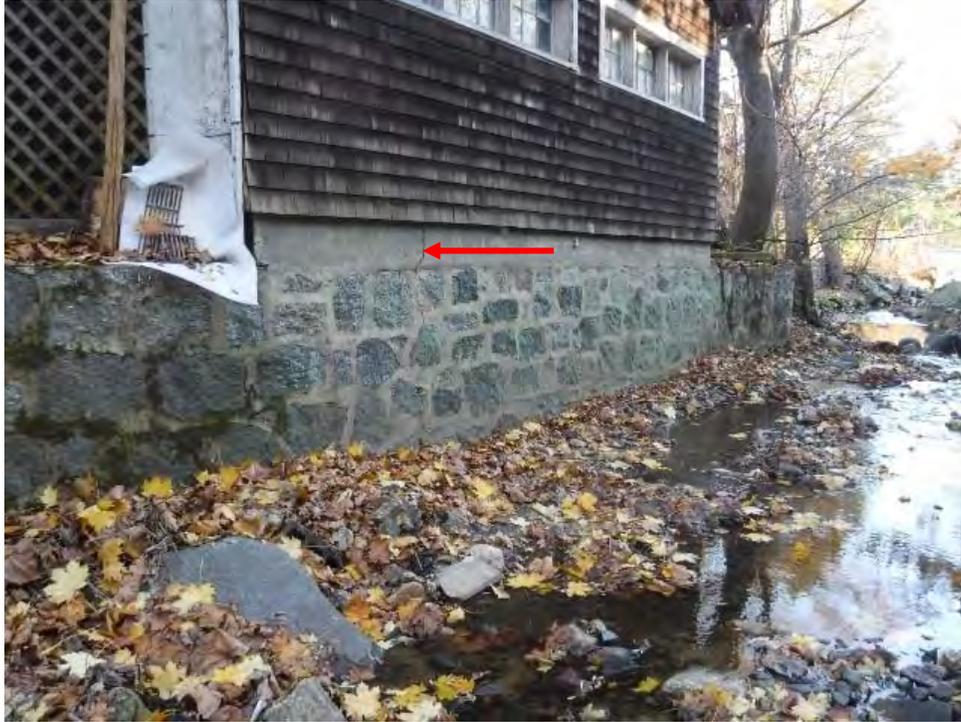
*Photo 3 – Typical Full-Height Fracture at Masonry Joint in Section 1.*

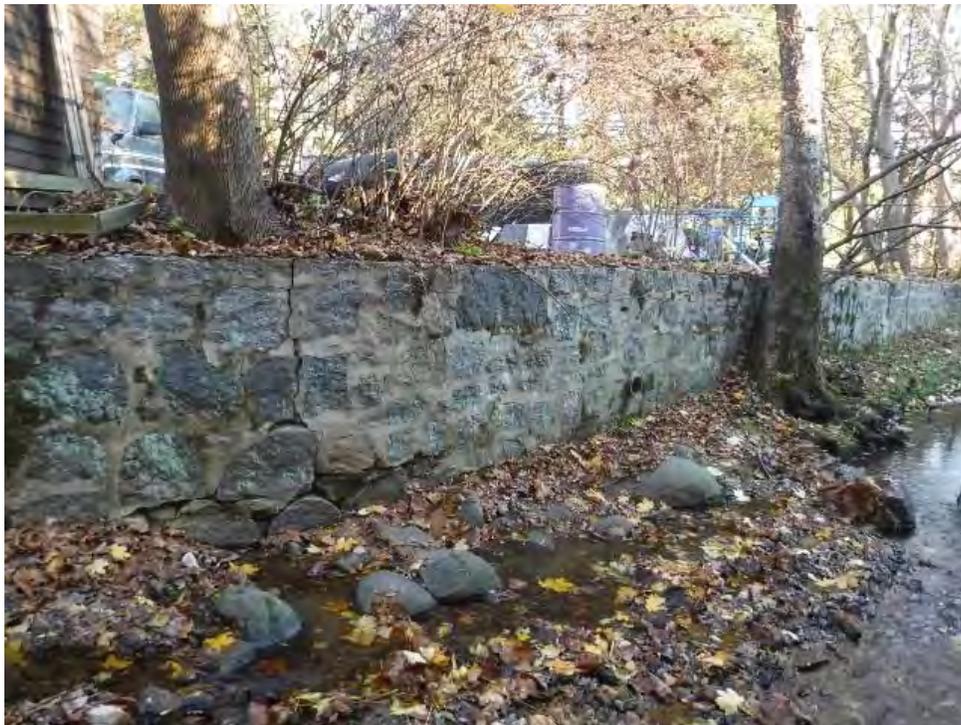
*Photo 4 – Full-Height Fracture with Tree at Top of Wall, and Loose Stones at Base in Section 1, Looking Northeast.*

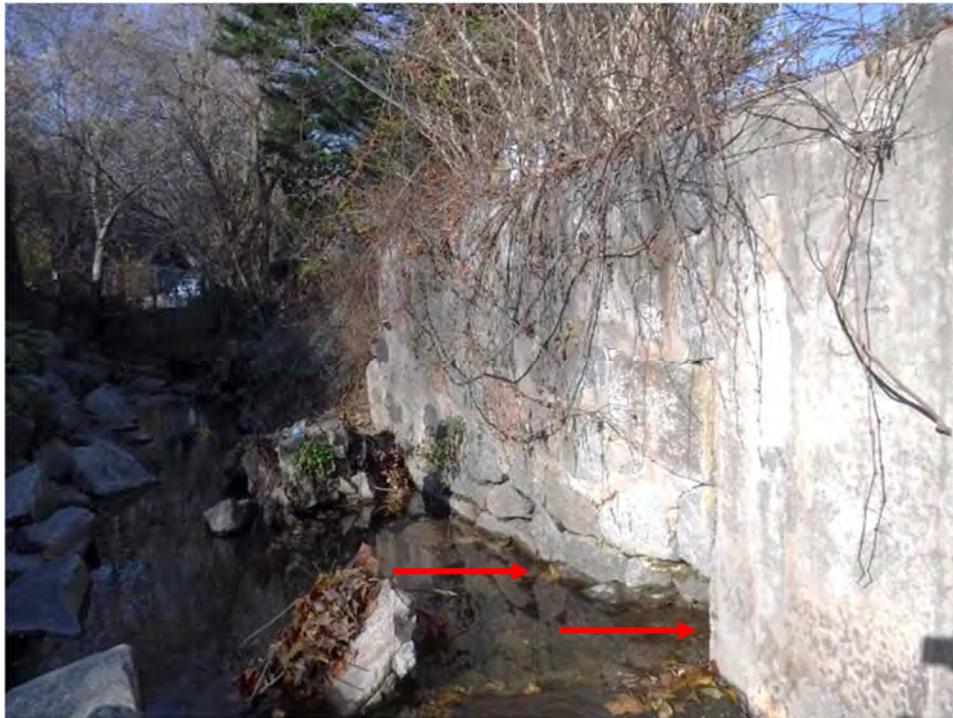
*Photo 8 – Voids along Base of Section 2 Stone Masonry, Looking West.*

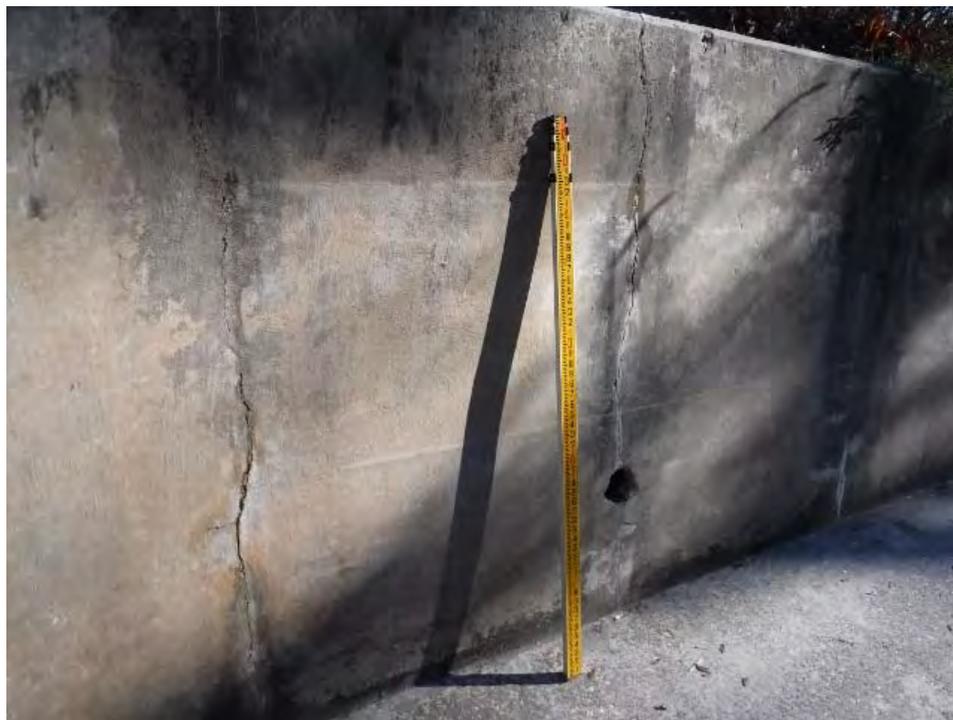
*Photo 10 – Typical Full-Height Cracks in Section 2 Concrete.*

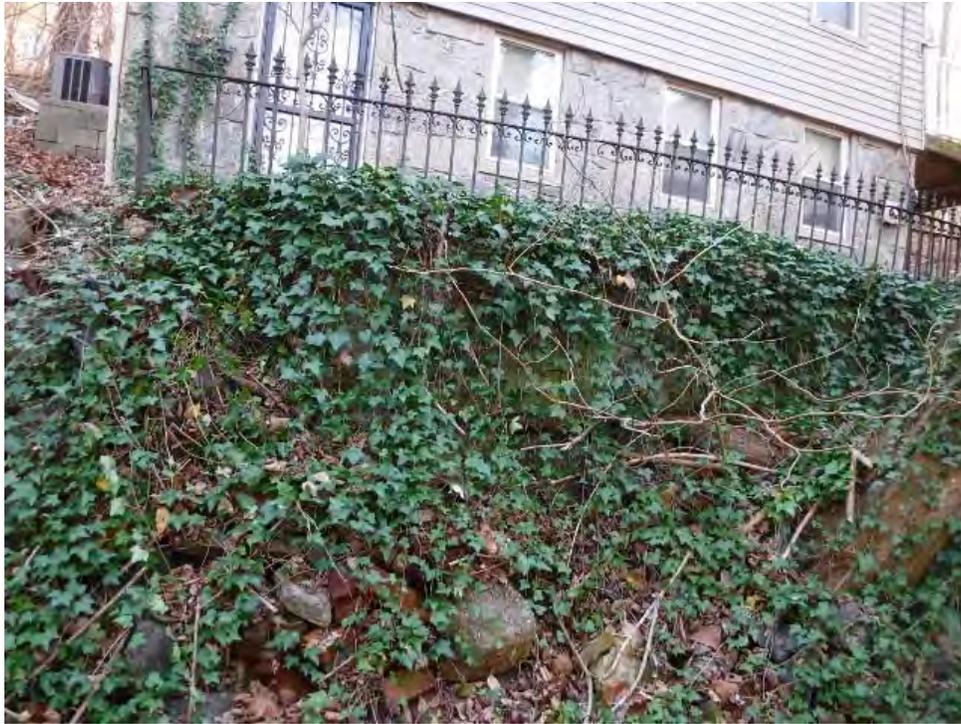
*Photo 13 – Section 5, Looking Southwest.  
Note Vegetation Growth.*

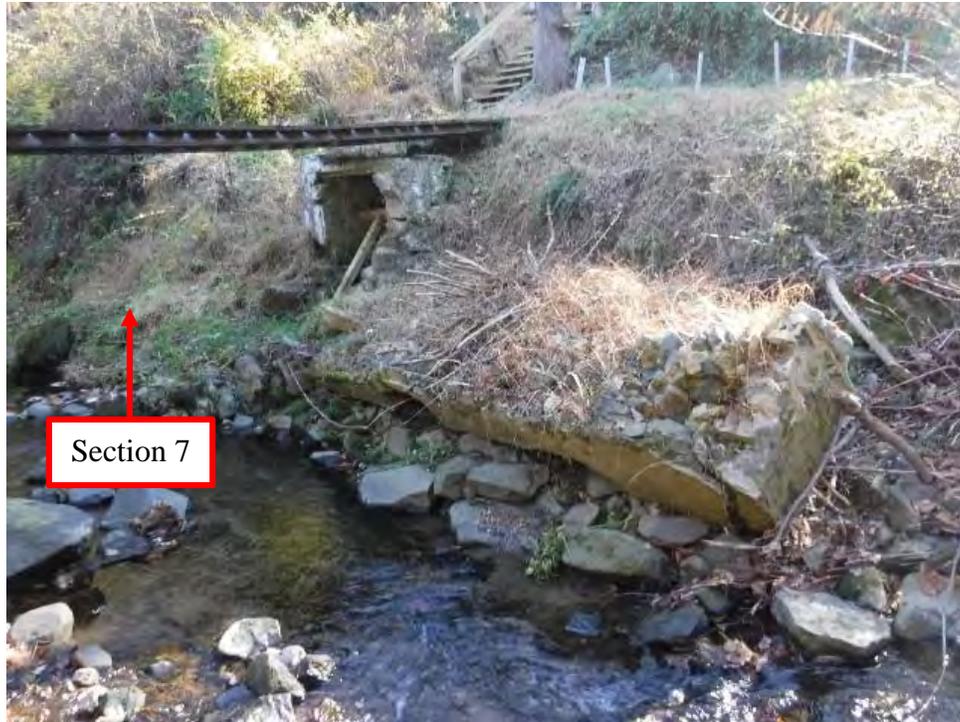
*Photo 15 – Failed Portion of Wall around Pedestrian Bridge at East End of Section 6, Looking Southeast. Section 7 Shown in Background.*

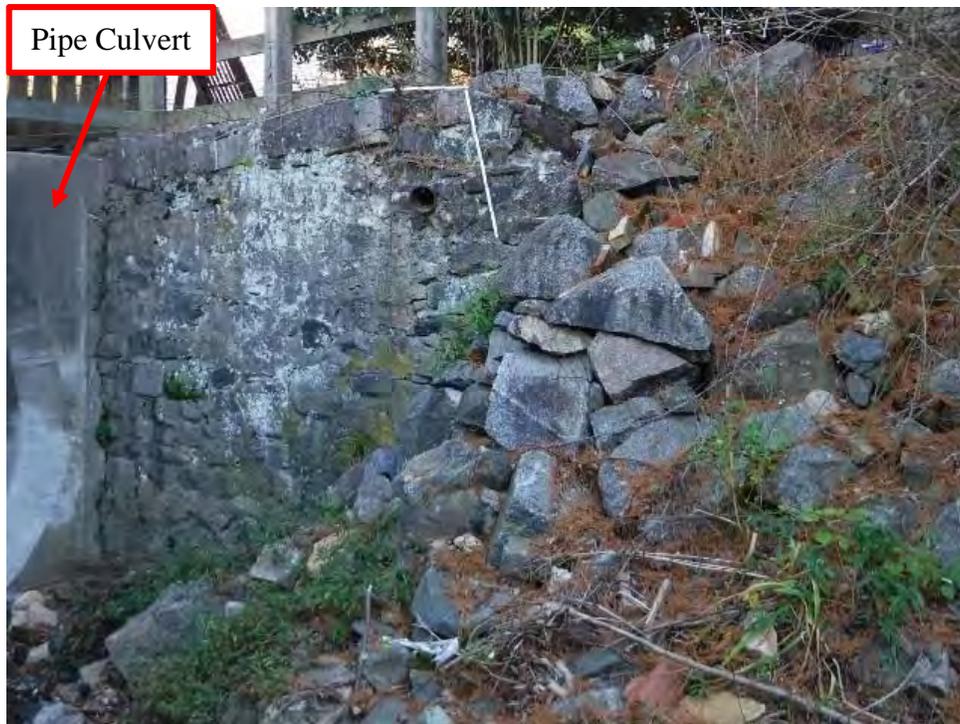
*Photo 16 – Elevation of Section 8, Looking Southeast.  
Note Failed Portion at East End.*

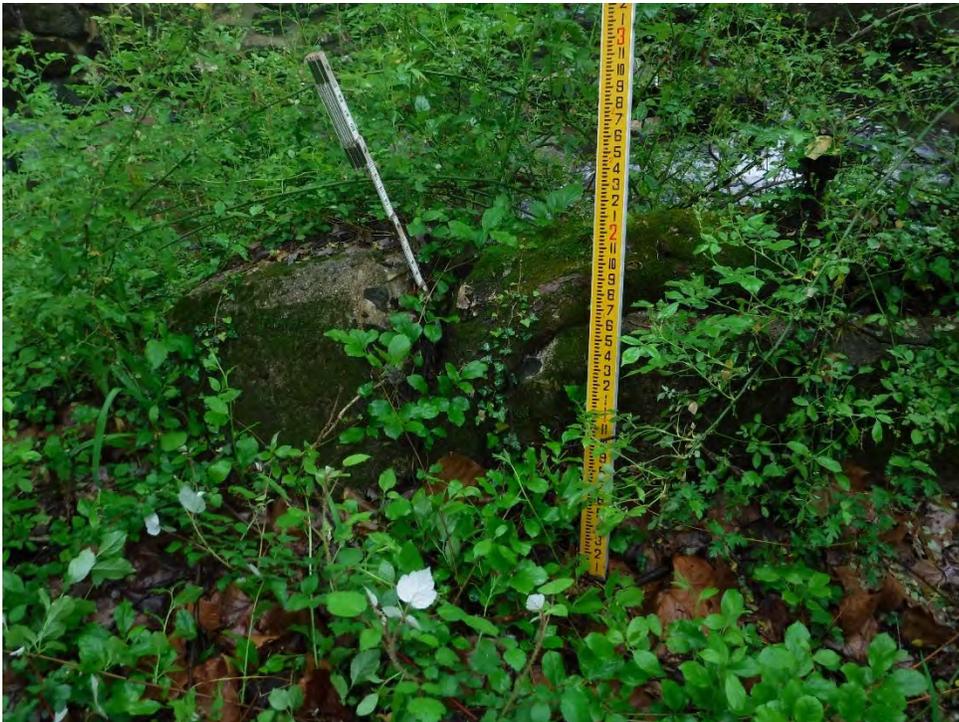
*Photo 2 – Fracture in Concrete Barrier in Section 1, Looking South.*

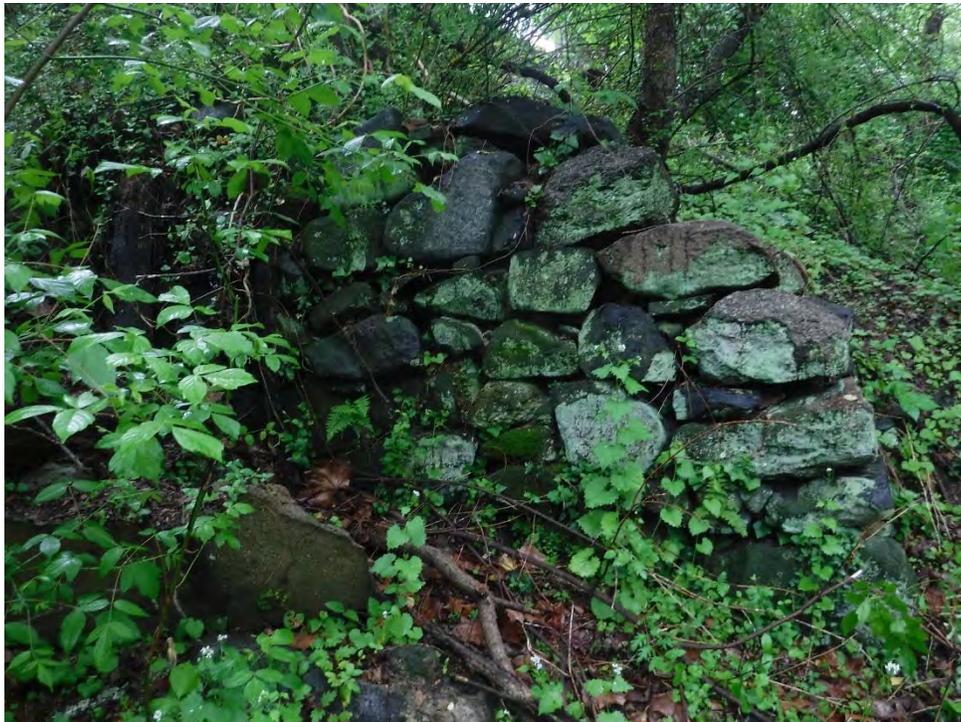
*Photo 4 – Missing mortar and Small Voids at the East End of the Stone Masonry Wall in Section 1.*

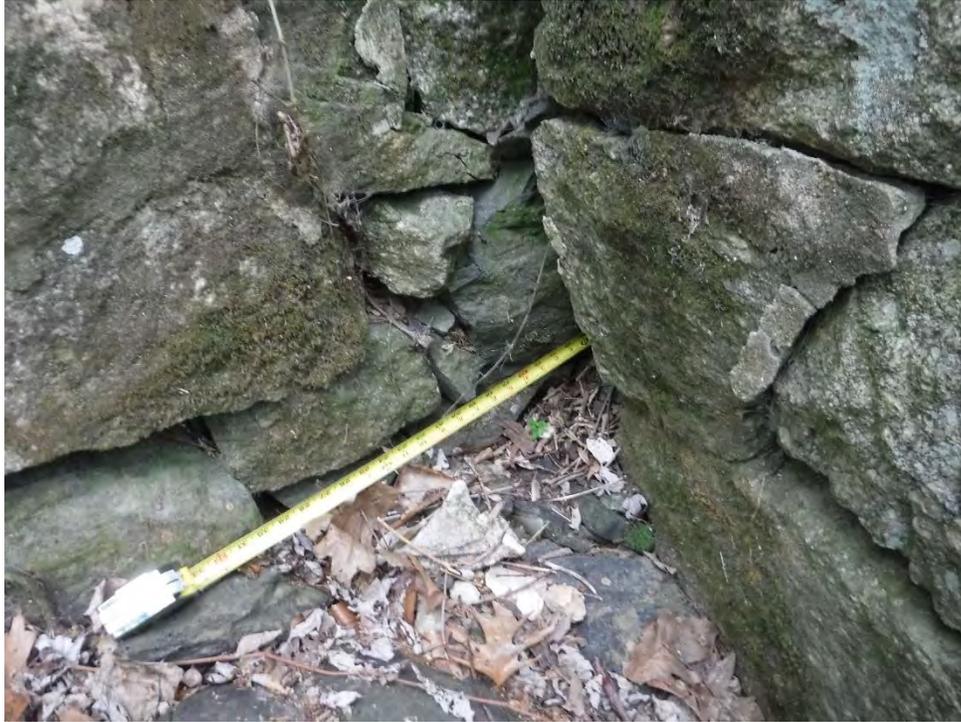
*Photo 3 – Vertical Joint at 18' from East End with Missing Mortar in Section 2.*

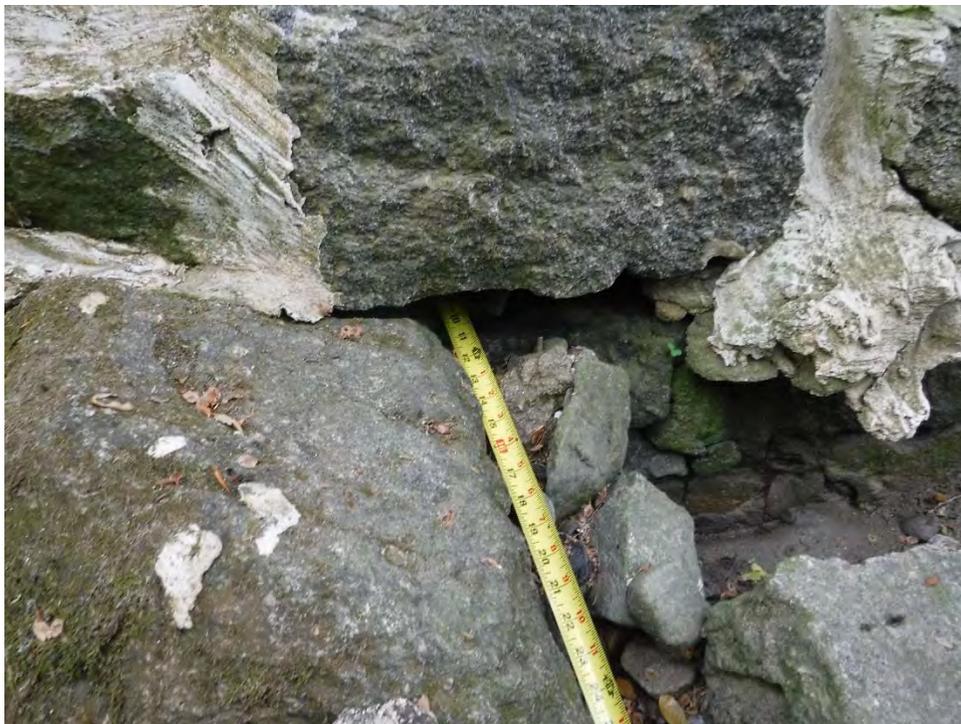
*Photo 4 – Section 2 with Missing Mortar and Random Small Missing Stones.*

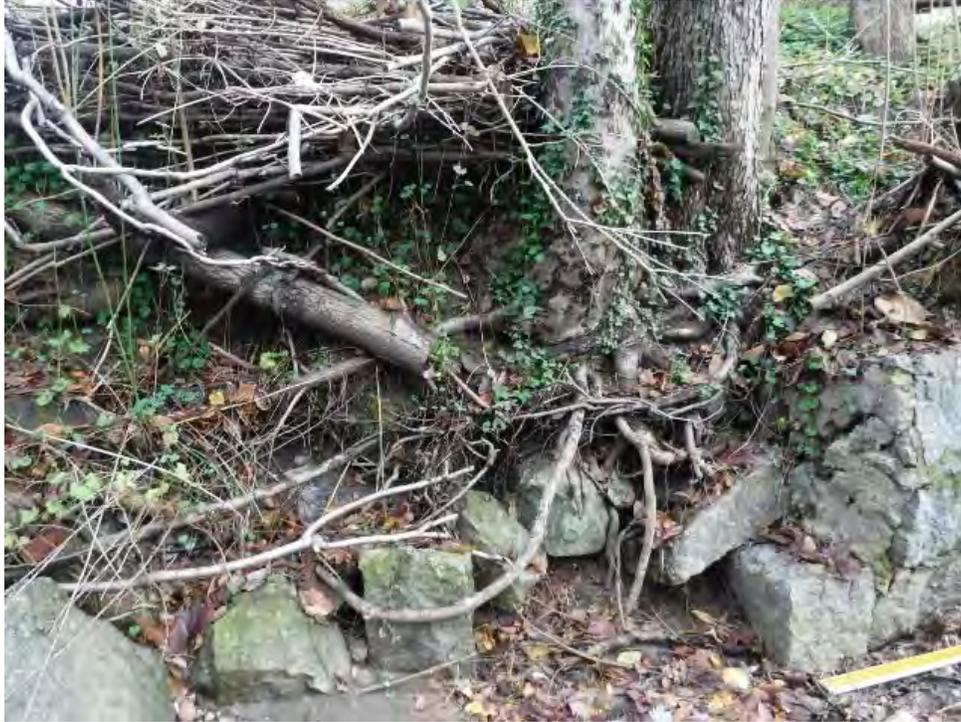
*Photo 5 – Wall Failure and Embankment Erosion at West End of Section 1.*

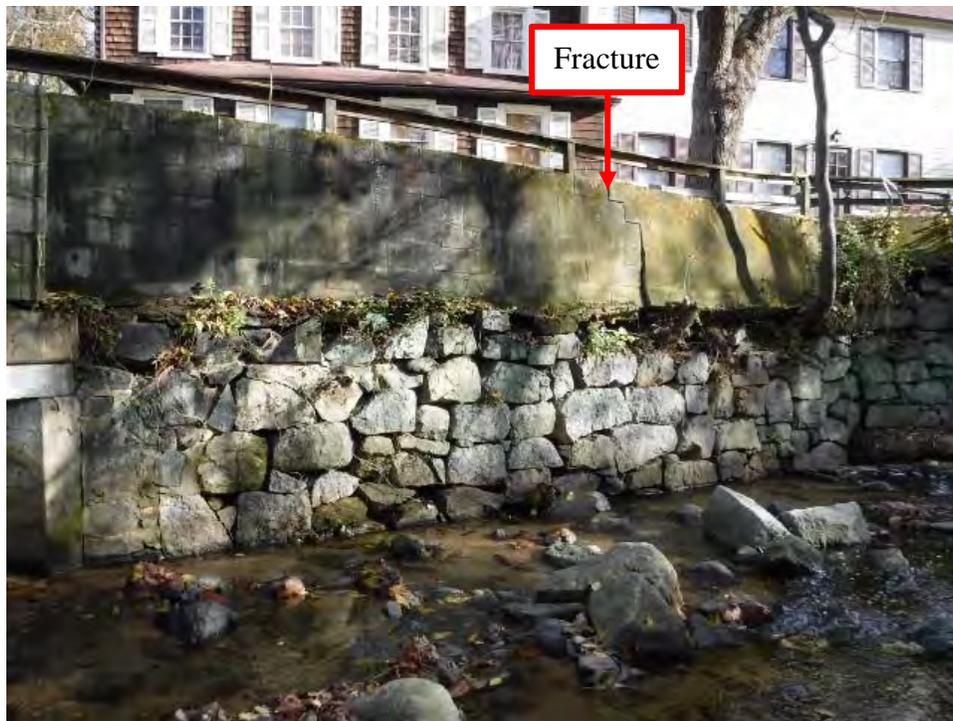
*Photo 9 – Elevation of Section 2, Looking North.  
Note Missing Mortar, Voids, and Fractured Concrete.*

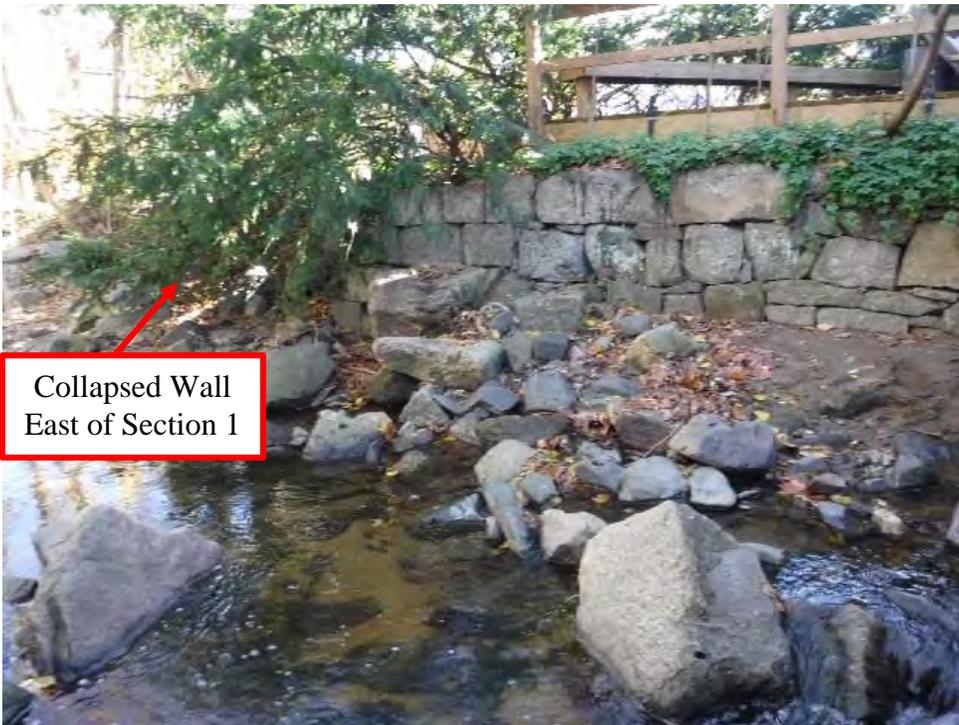
*Photo 2 – Section 1, Looking East  
Note Missing Mortar and Vegetation Growth.*

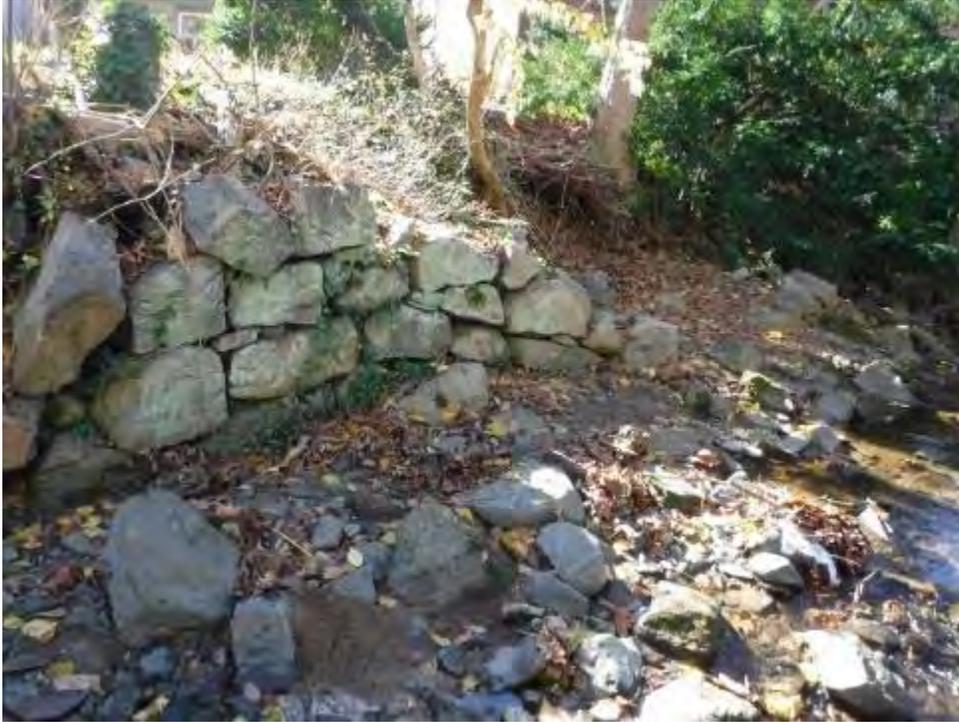
*Photo 3 – Failed Portion of Section 2, Looking Southwest.*

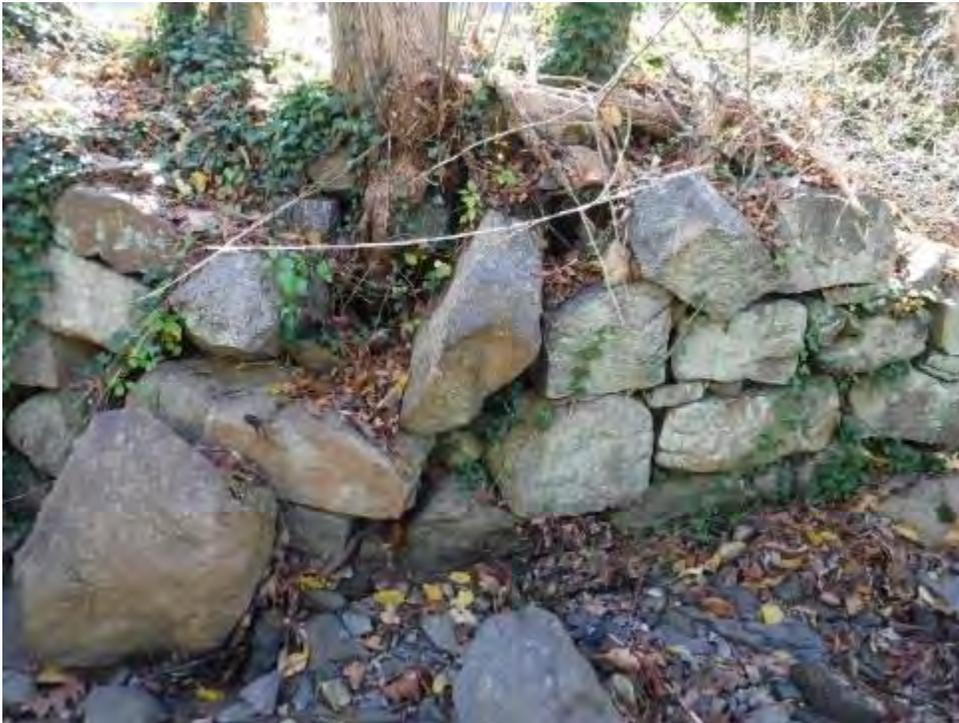
*Photo 4 – Section 2, Loose Stones at Large Tree.*

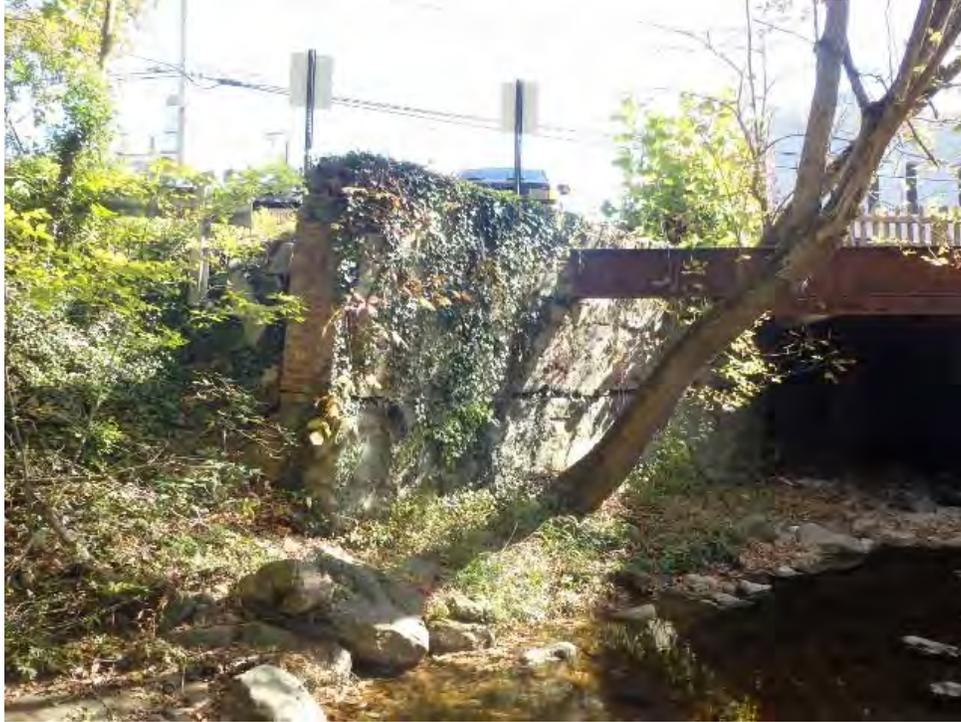
*Photo 1 – Elevation from West End, Looking Northeast.  
Note Mature Tree Growing in Front of Wall.*

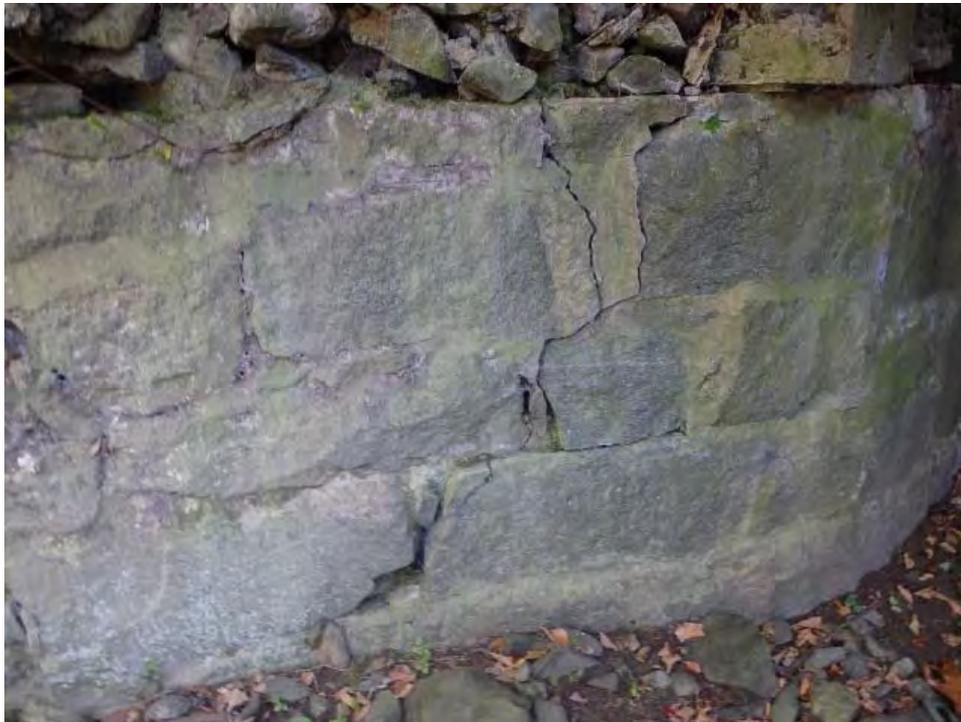
*Photo 2 – Typical Failed Mortar Joint, Portion below Deck Shown.*

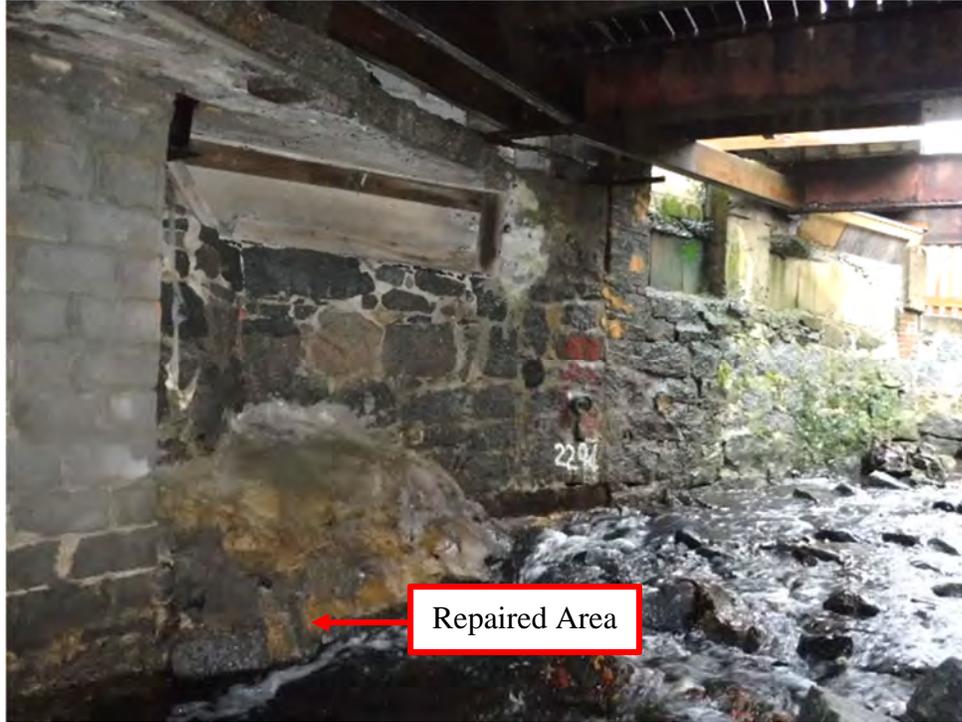
*Photo 1 – Elevation (East Half), Looking Southwest.  
Note Repaired Area at East End.*

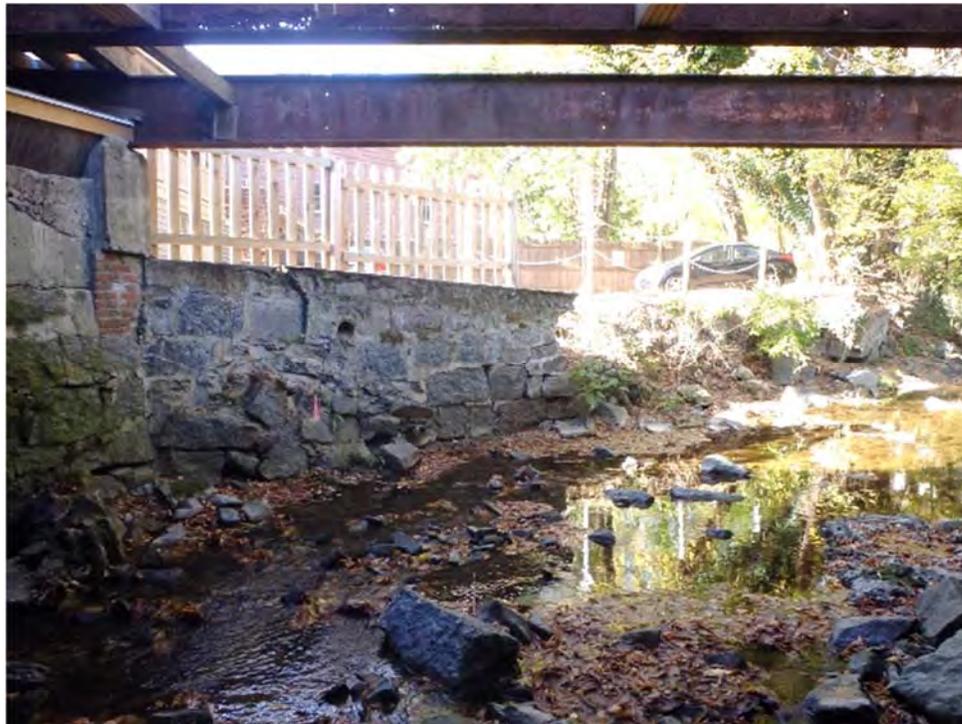
*Photo 2 – Elevation (West Half), Looking Southwest.  
Note Collapsed Wall and Bank Erosion Beyond West End.*

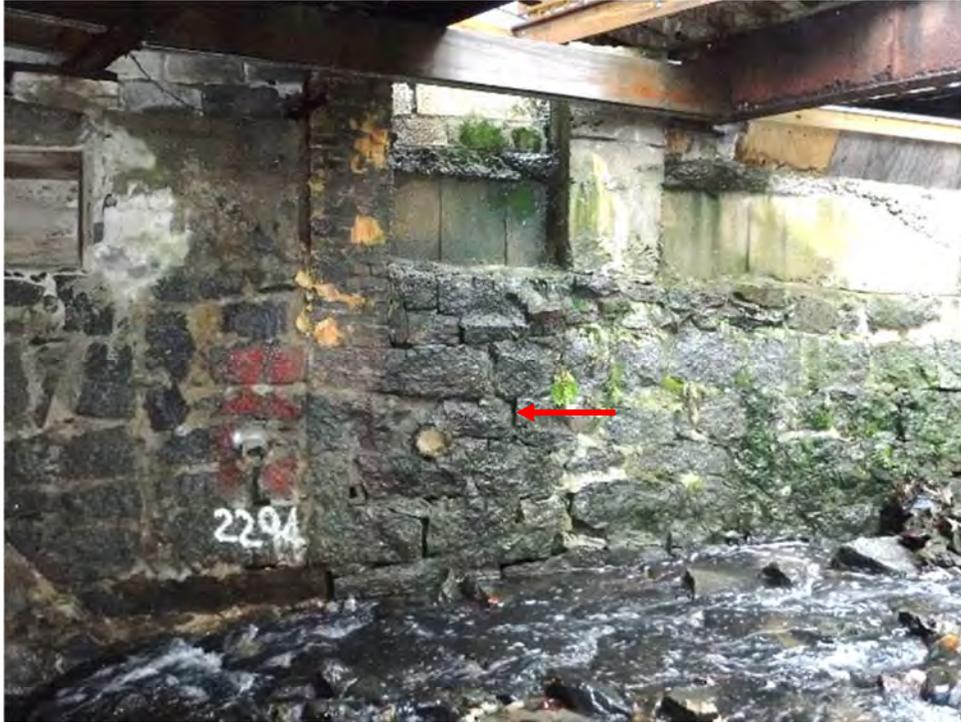
*Photo 3 – Typical Missing Mortar in Joints Throughout East Half of Wall, Portion beneath Timber Deck Shown.*

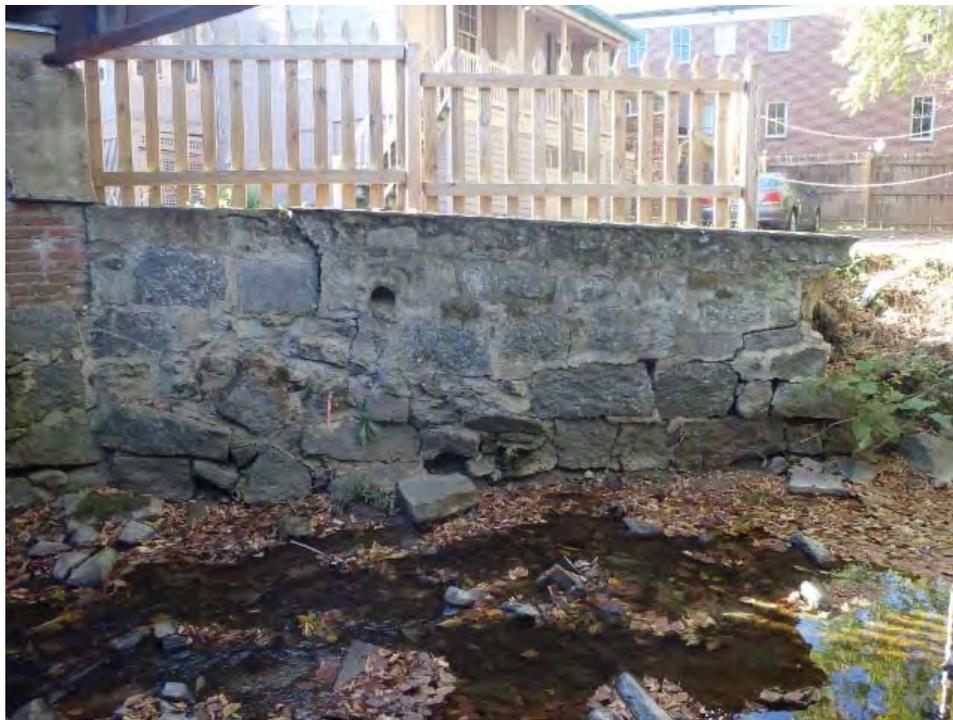
*Photo 4 – Missing Mortar and Loose Stones along Base (West Half), Looking South.*

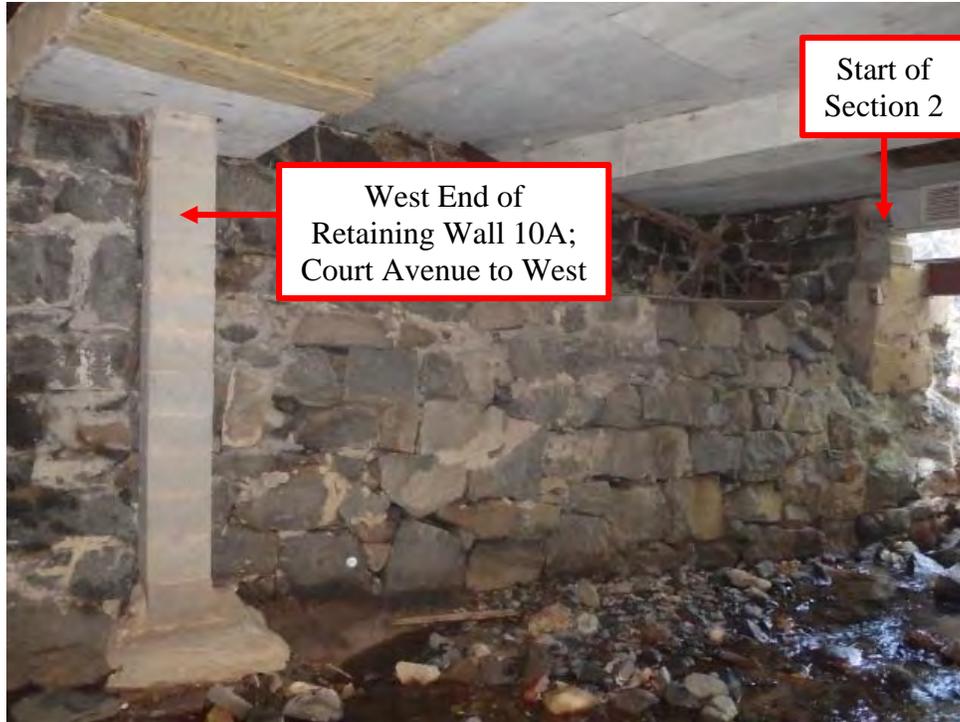
*Photo 1 – Elevation of Section 1 (beneath 8334 Main Street), Looking Northeast. Note Missing Mortar along Base of Wall.*

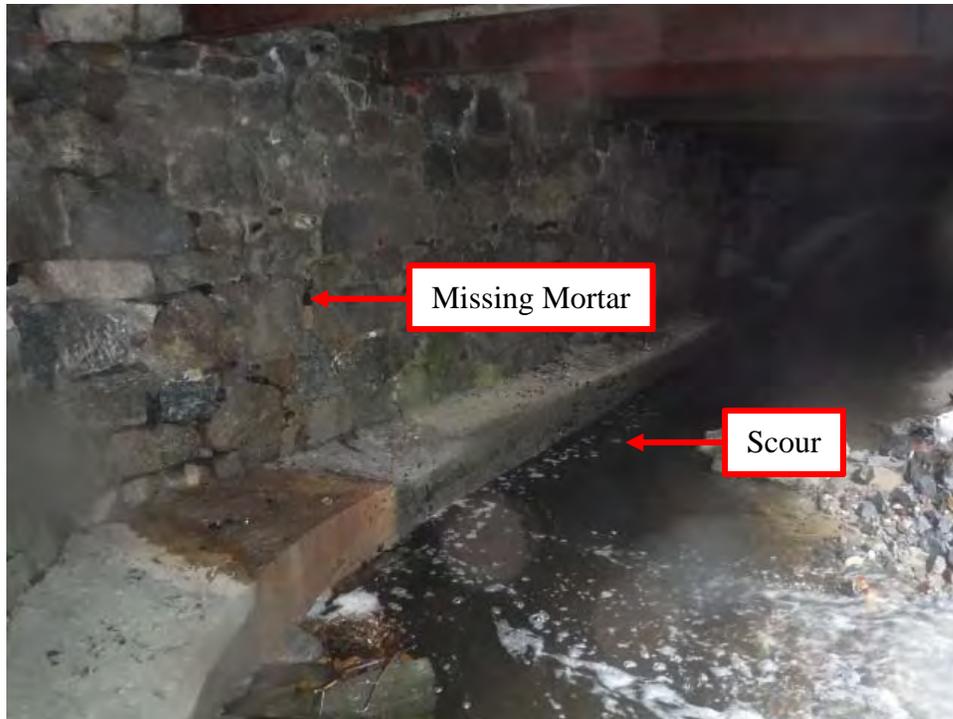
*Photo 7 – Missing Mortar and Scour in Section 4, Looking East.*

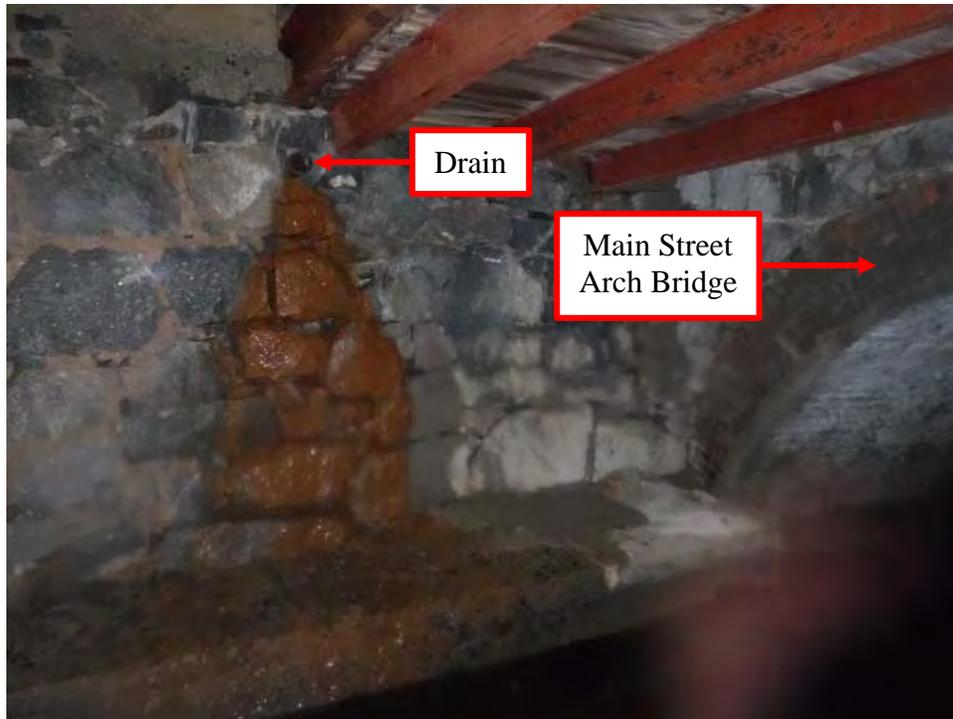
*Photo 9 – Missing Mortar at East End of Wall (Section 4), with Missing Stones and Loss of Fill Beneath Drain, Looking Northeast.*

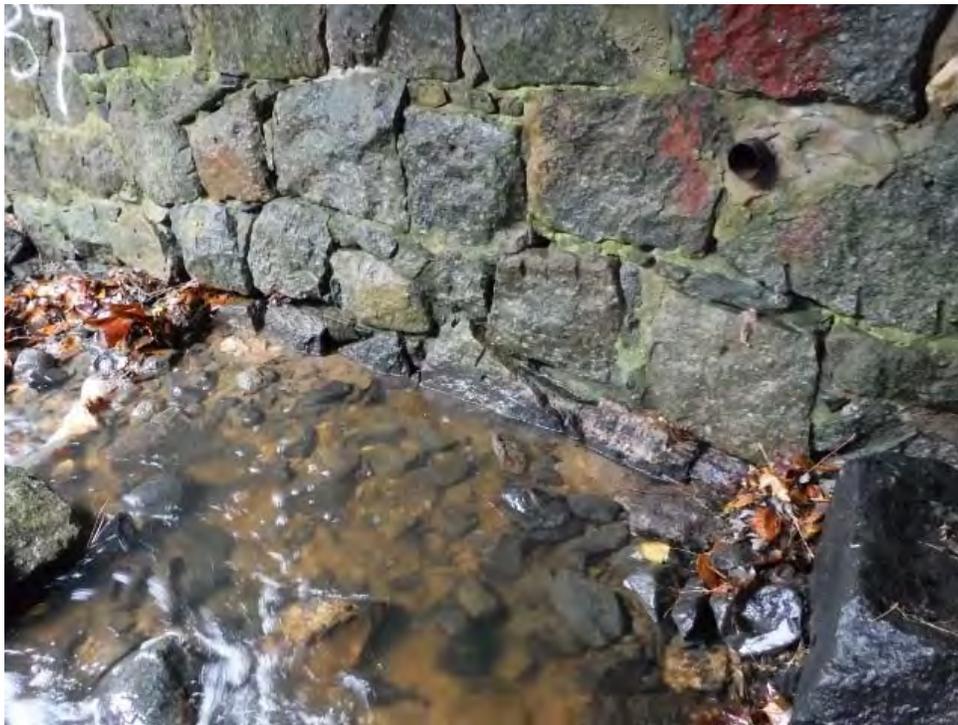
*Photo 2 – Typical Missing Mortar in Joints within Section 1.*

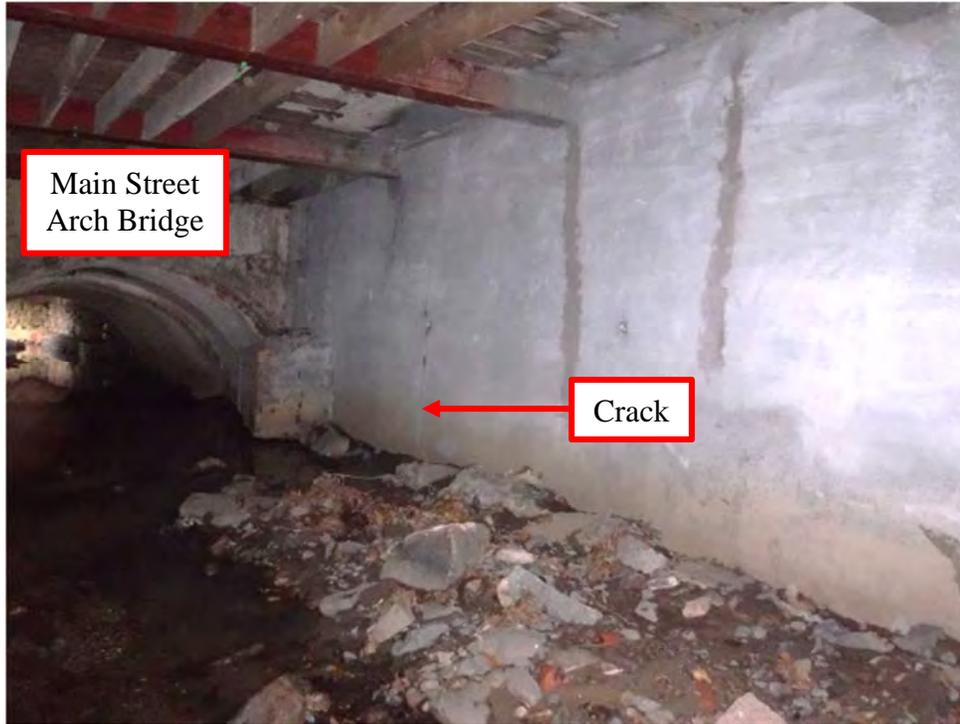
*Photo 1 – Elevation at North End, Looking Northeast.  
Note Vertical Hairline Crack with Efflorescence.*

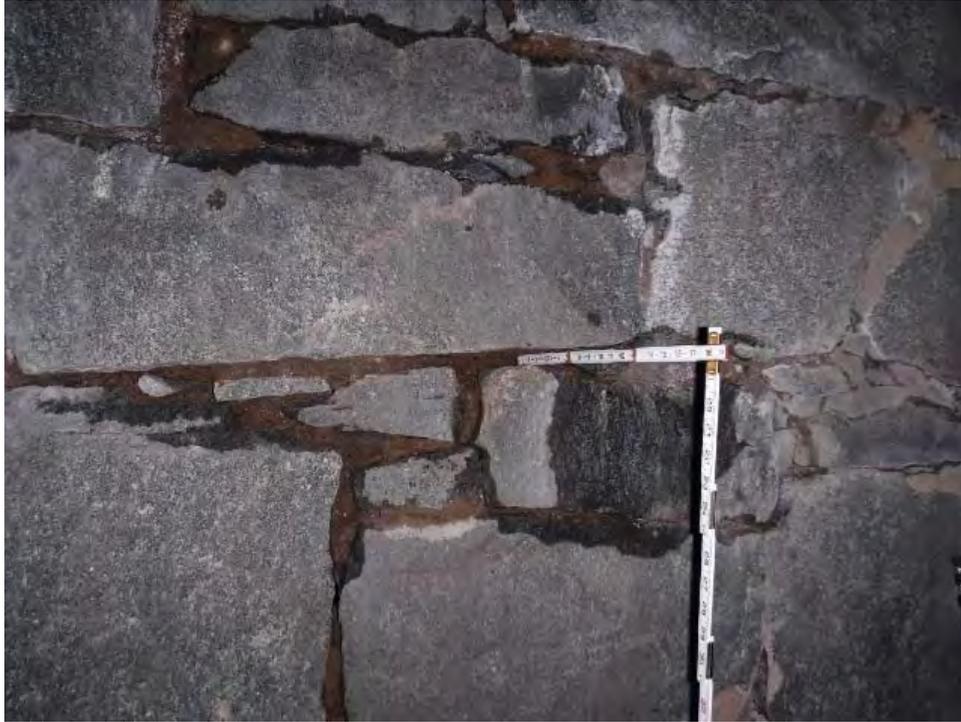
*Photo 3 – Typical Missing Mortar within Northern 50' Length of Wall.*

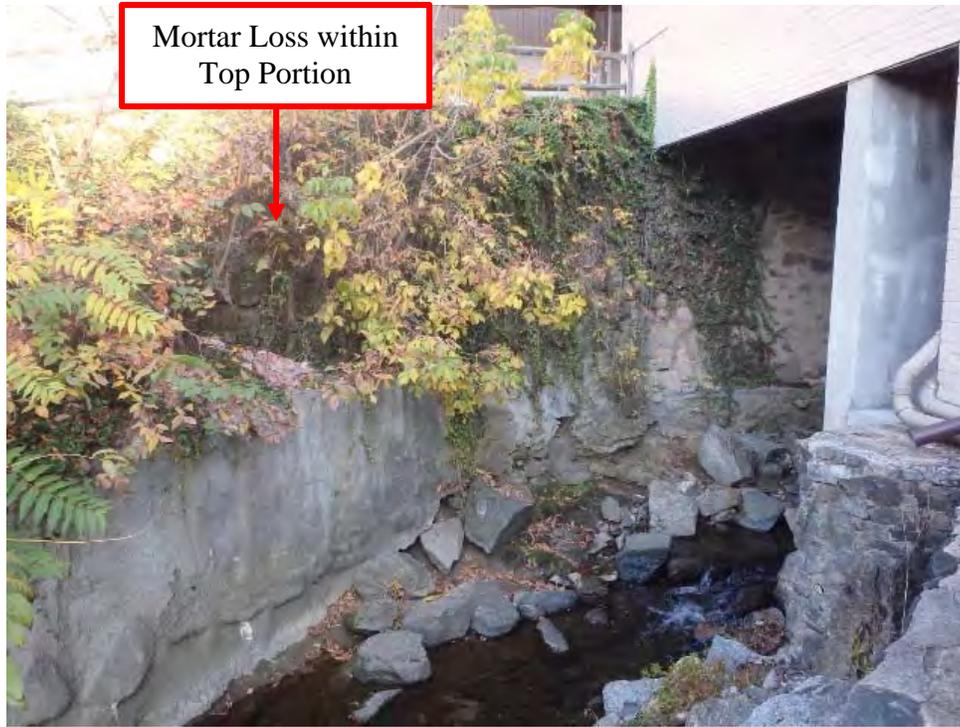
*Photo 1 – Elevation at West End of Section 1, Looking West.  
Note Vegetation Growth and P.A.M. Coating.*

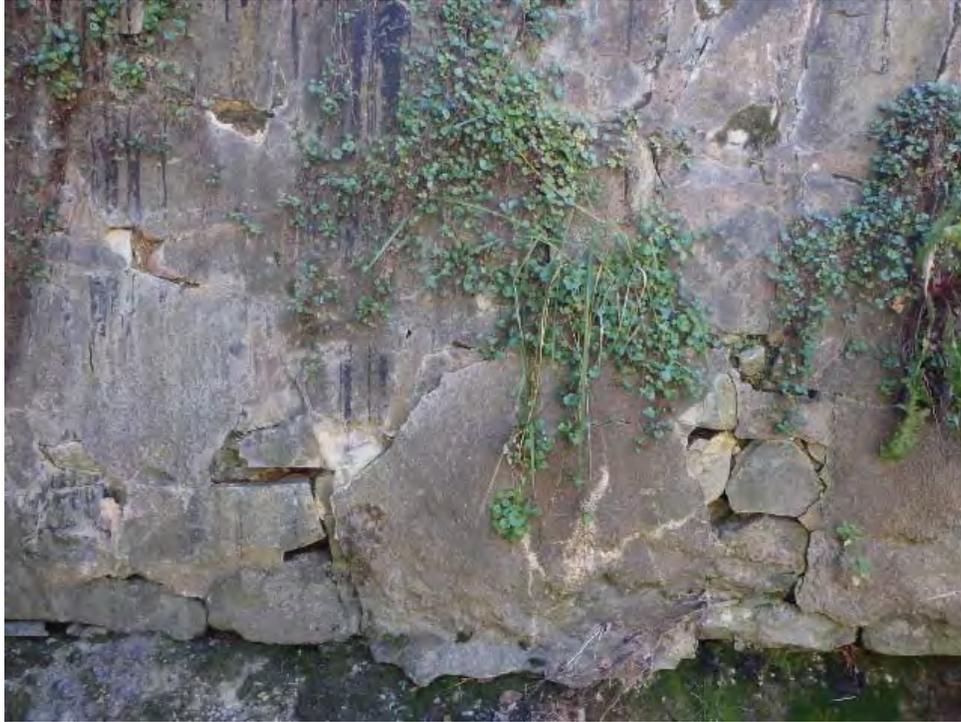
*Photo 9 – Failing P.A.M. Coating at East End of Section 2, With Bulging and Vegetation Growth.*
