# ELLICOTT CITY RETAINING WALLS INSPECTION REPORT

## STREAM WALLS

## HISTORIC ELLICOTT CITY, MARYLAND

MAY 2016

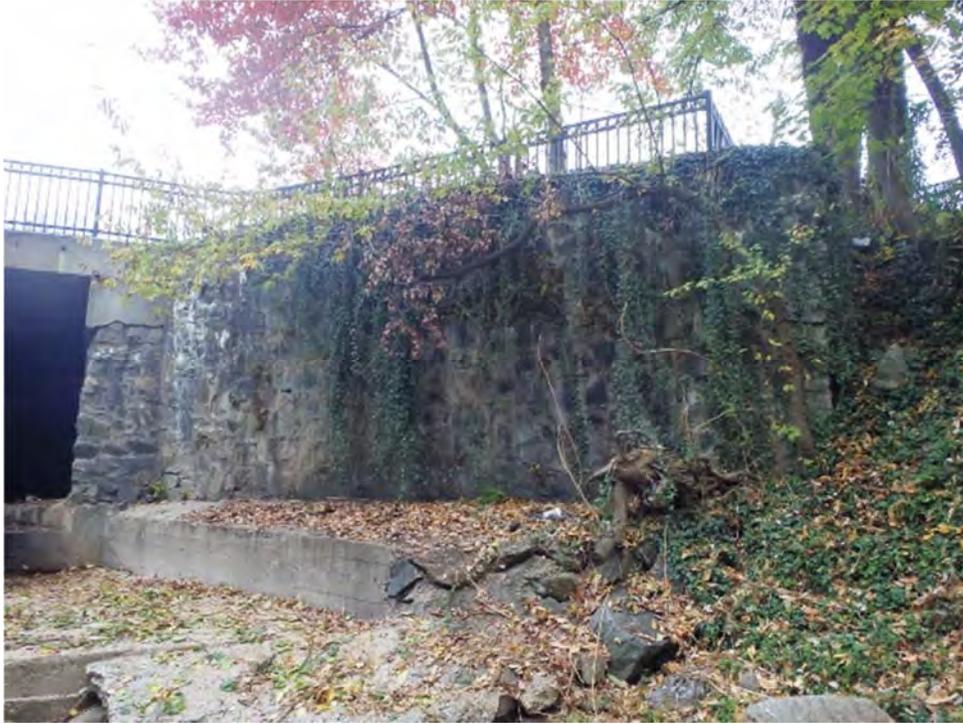
*Photo 1 – Elevation of Section 1, Looking Northwest.  
Note Vegetation Growth and Efflorescence.*

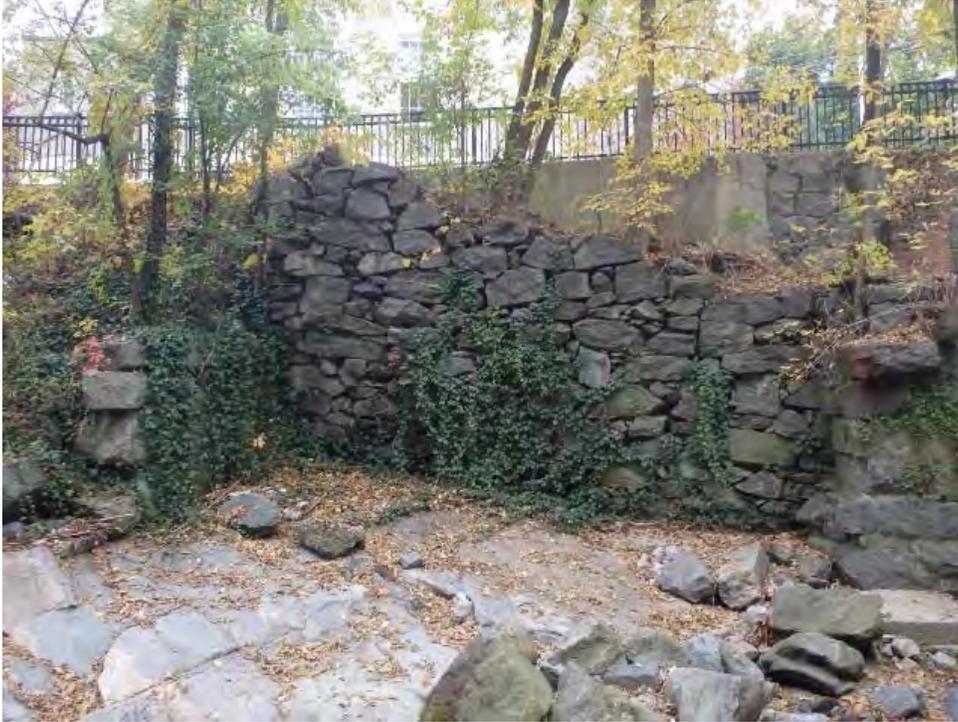
*Photo 3 – Elevation of Section 2, Looking North.  
Note Missing Mortar.*

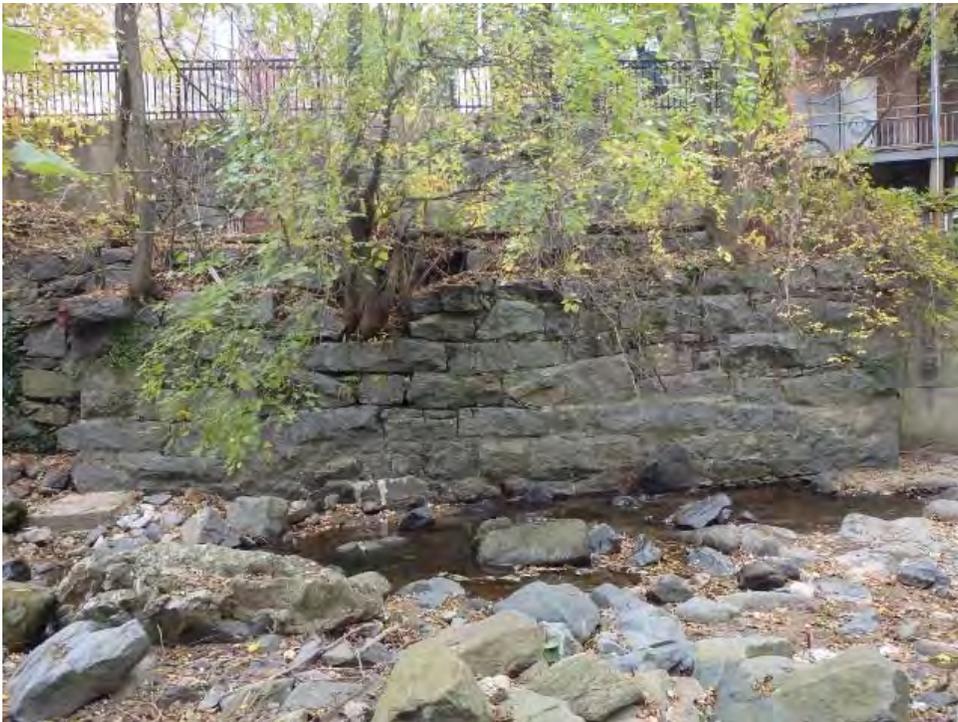
*Photo 4 – Elevation of Section 2, Looking North.  
Note Tree Growth.*

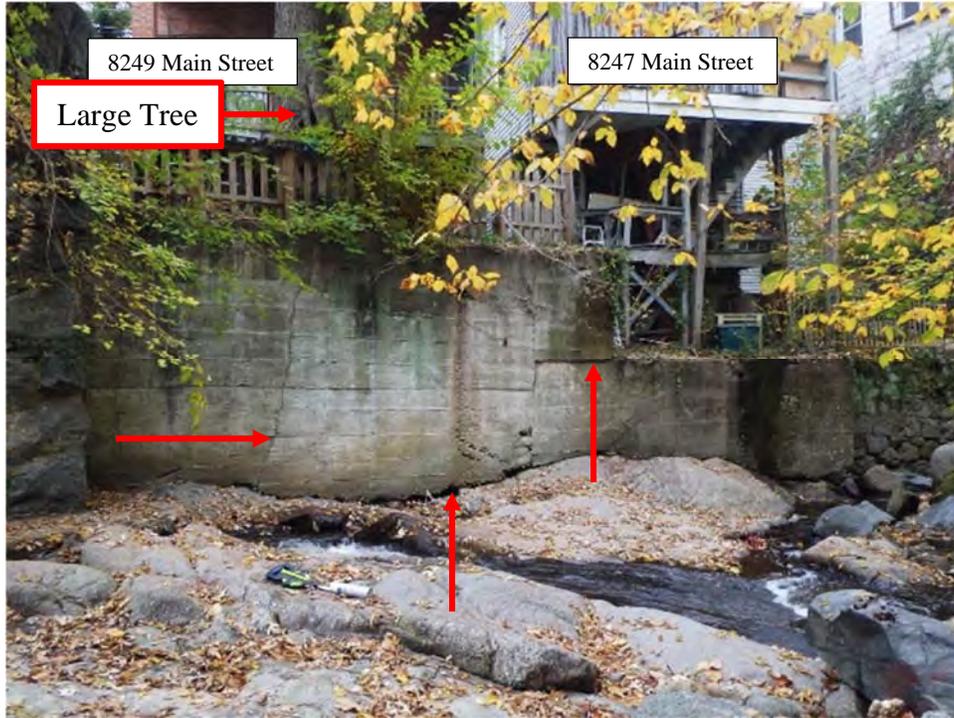
*Photo 5 – Elevation of Section 3, Looking North.  
Note Full-Height Fracture, Undermining, and Leaning Top Corner.*

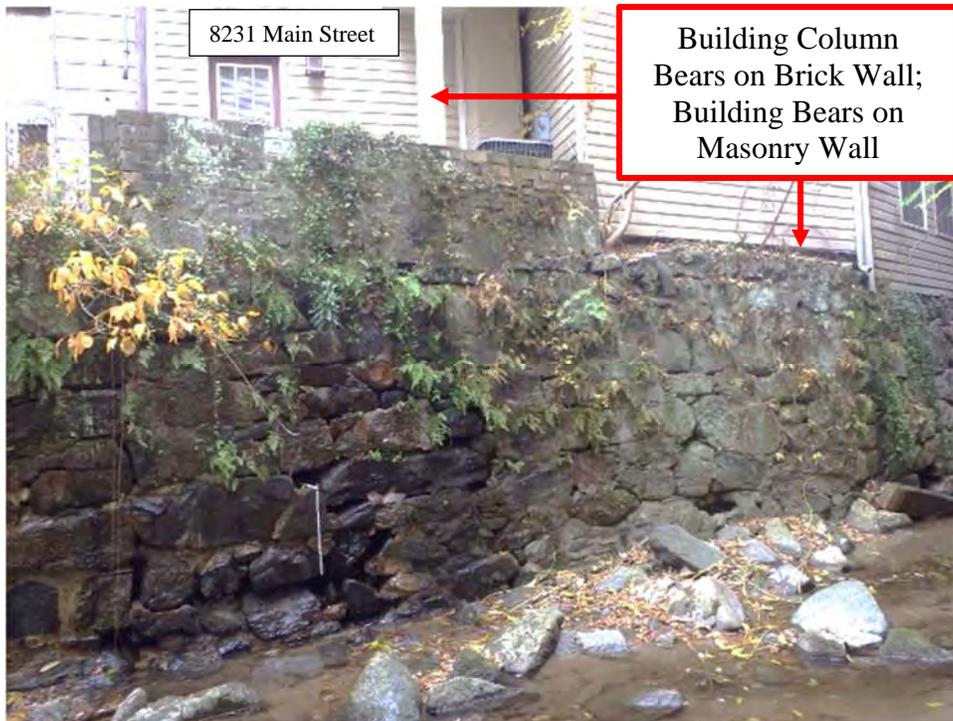
*Photo 13 – Section 4 East Half Elevation, Looking Northeast.  
Note Active Water Leakage and Vegetation Growth.*

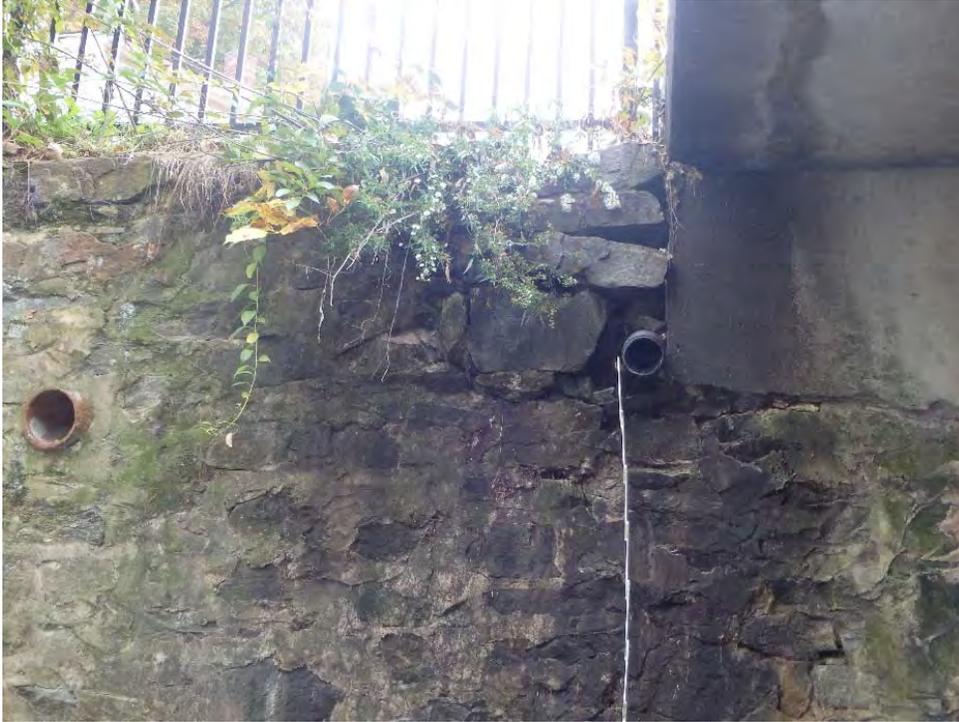
*Photo 3 – Loose Stones at Top West Corner of Section 1, Looking South.*

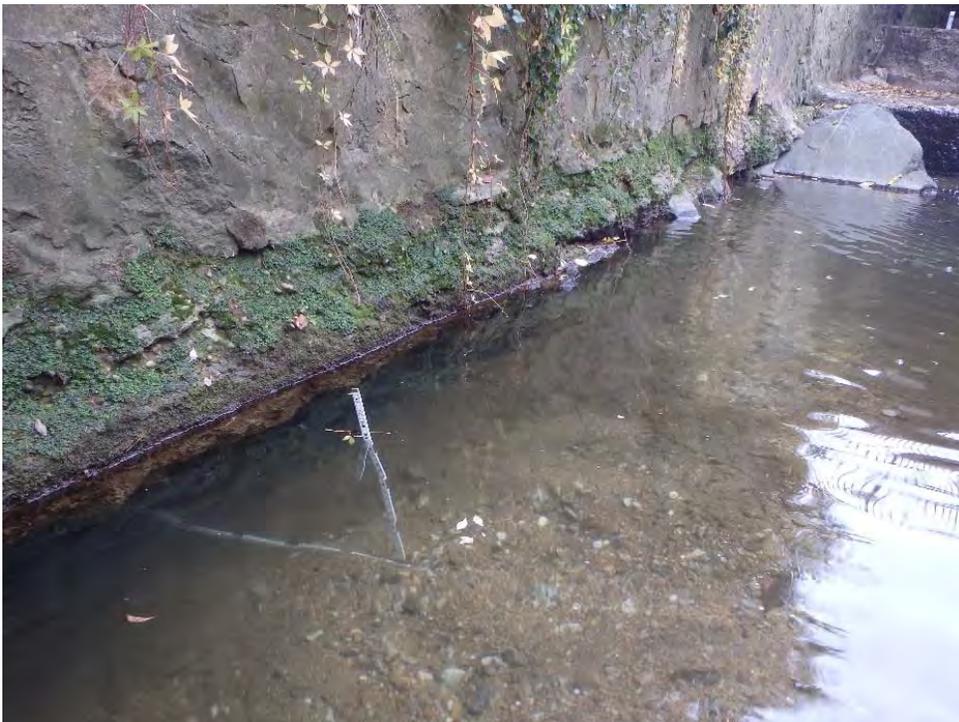
*Photo 4 – Undermining Along East Half of Section 1, Looking Southwest.*

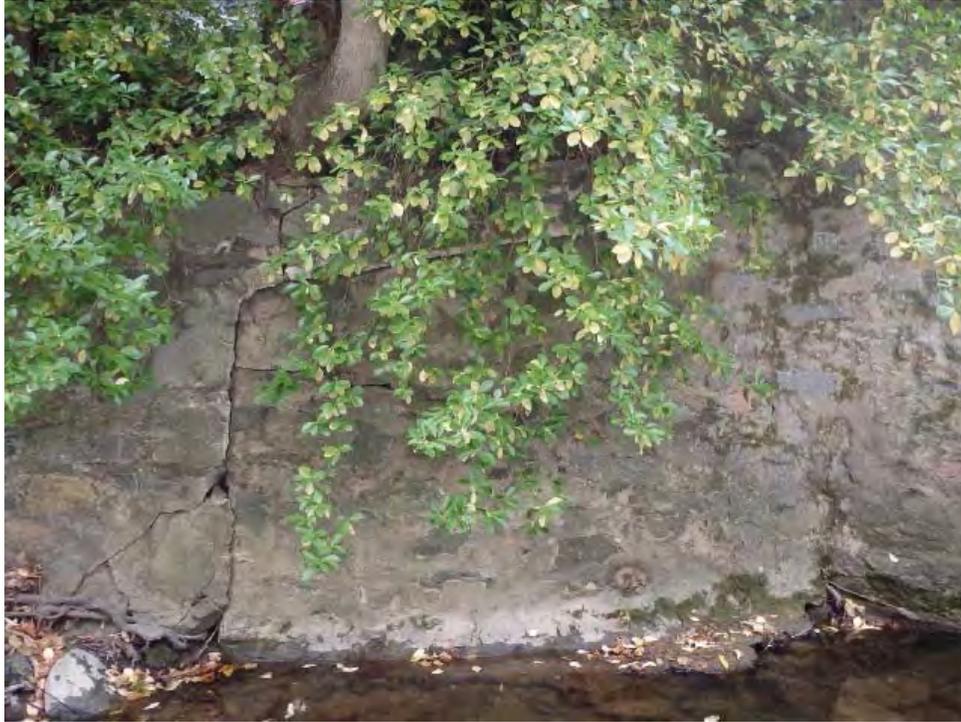
*Photo 11 – Fracture in Section 2 below Tree.*

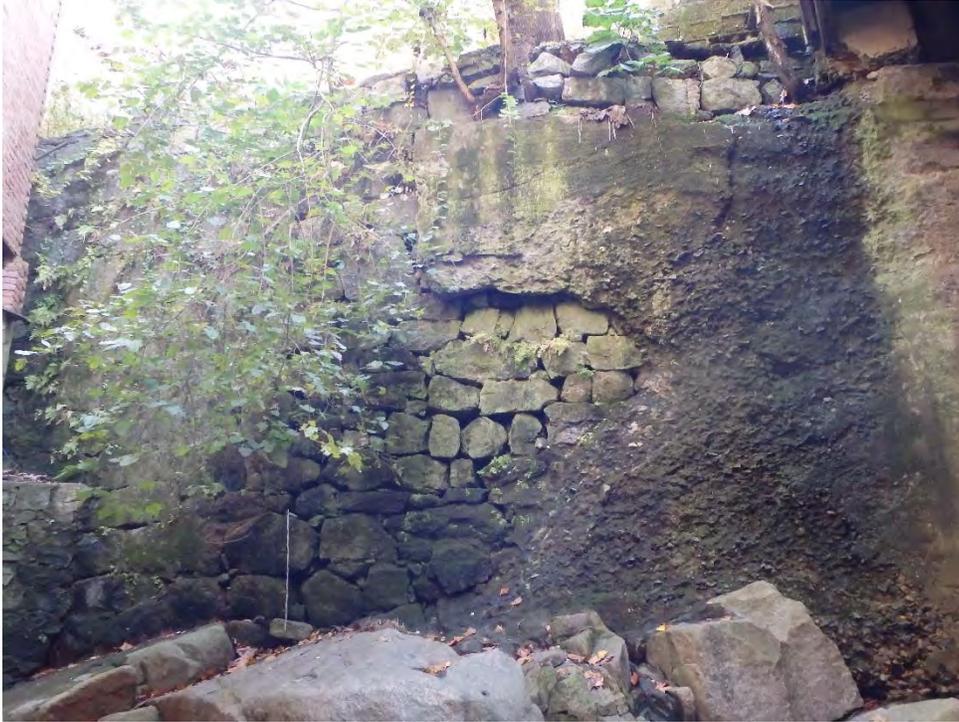
*Photo 17 – Elevation at East End of Section 5, Looking Southeast.  
Note Missing Mortar, Voids, and Large Tree Growth*

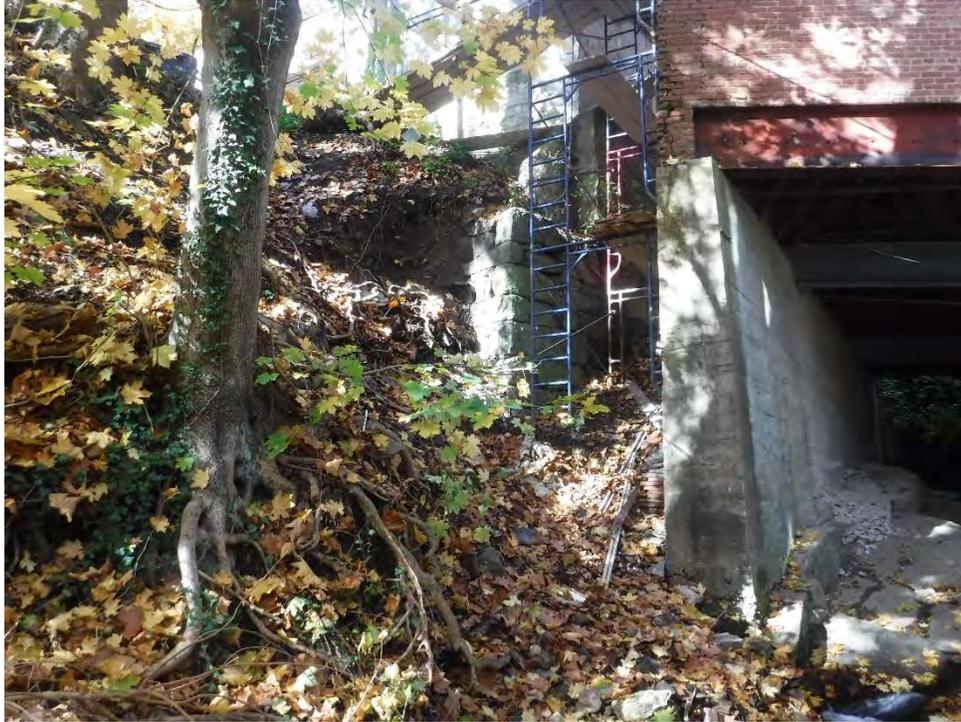
*Photo 21 – Erosion at East End of Section 6, Looking Southwest.  
Note Missing Wall to East of Section 6 (Section 7).*

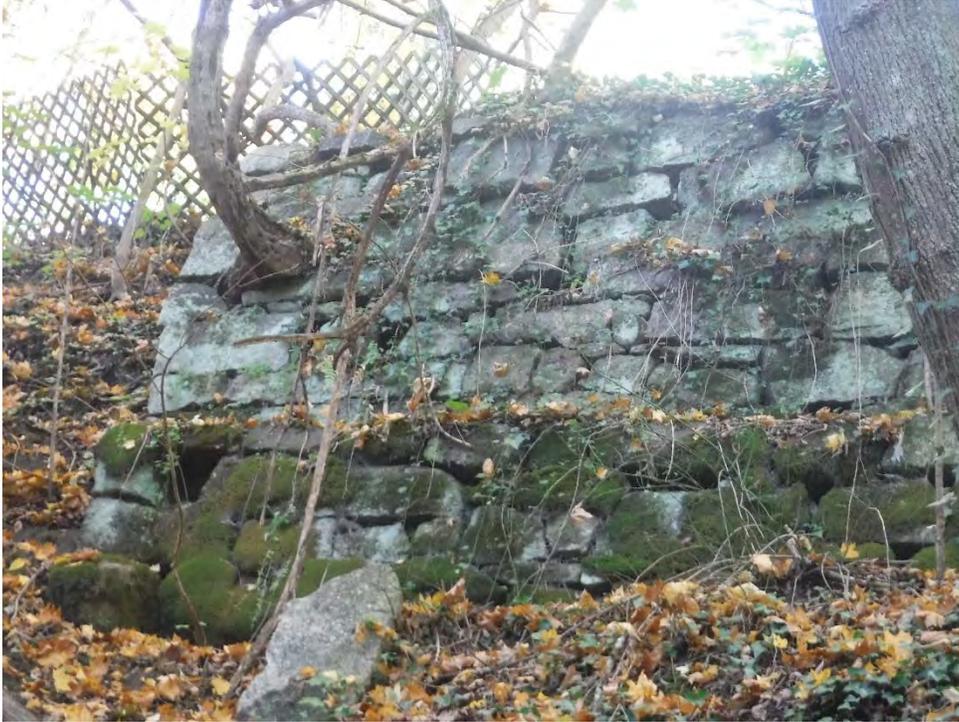
*Photo 23 – Missing Stones/Mortar and Tree Growth at East End of Section 8.  
Note Missing Wall to East of Section 8 (Section 9).*

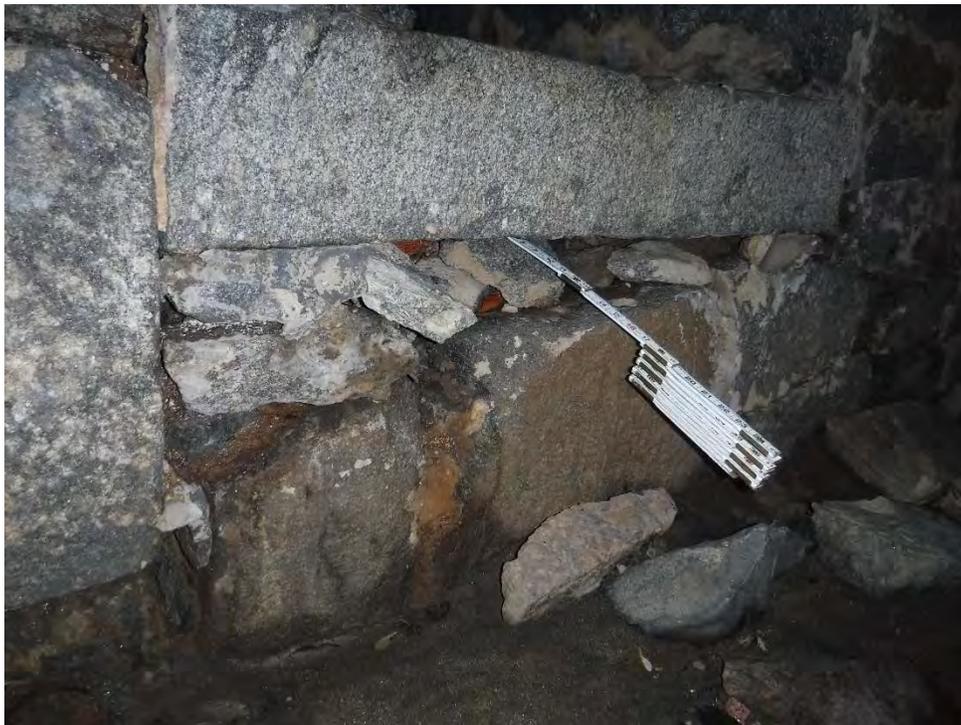
*Photo 26 – Missing Mortar and Stones at Bottom of Wall in Section 10 (at 874').*

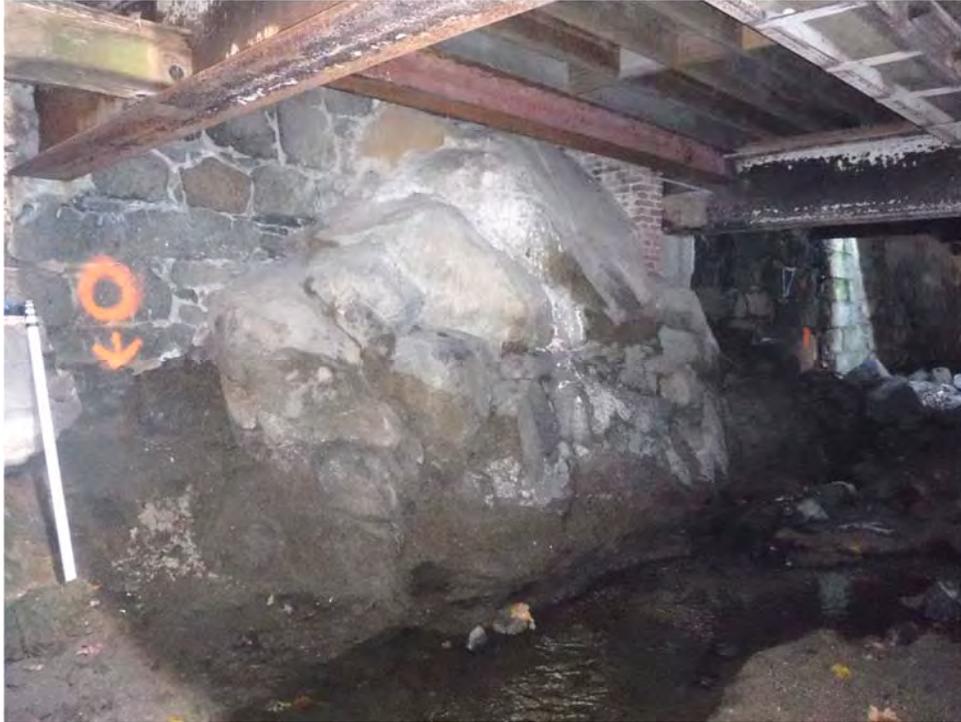
*Photo 27 – Elevation at East End of Section 10, Looking Southwest.  
Note Void at East End (at 827’).*

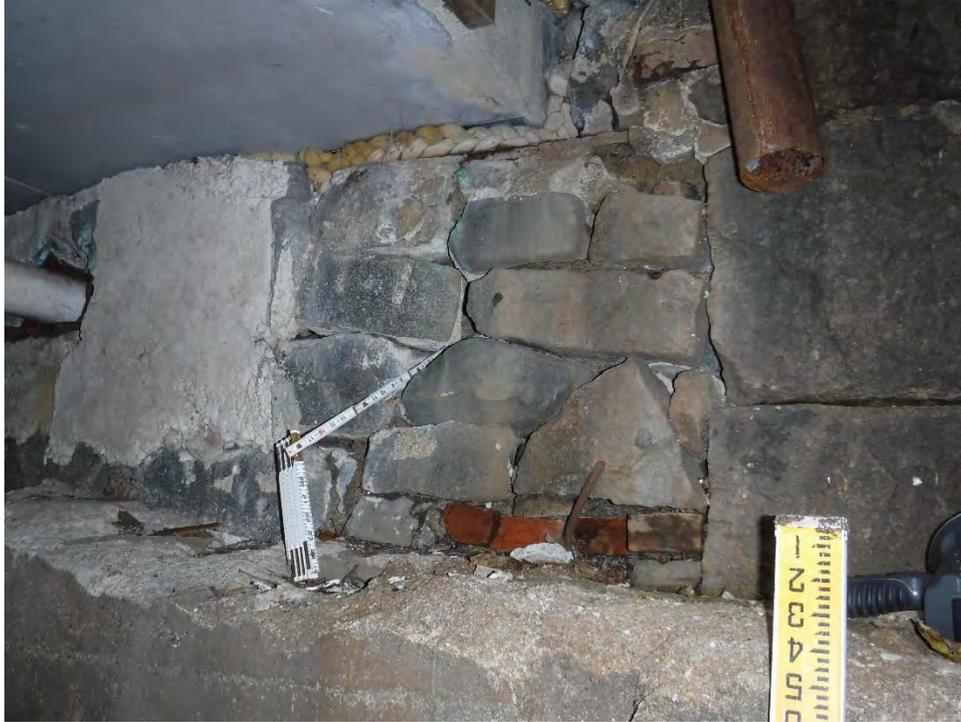
*Photo 29 – Loose Stones and Missing Mortar at Top at West End of Section 11.*

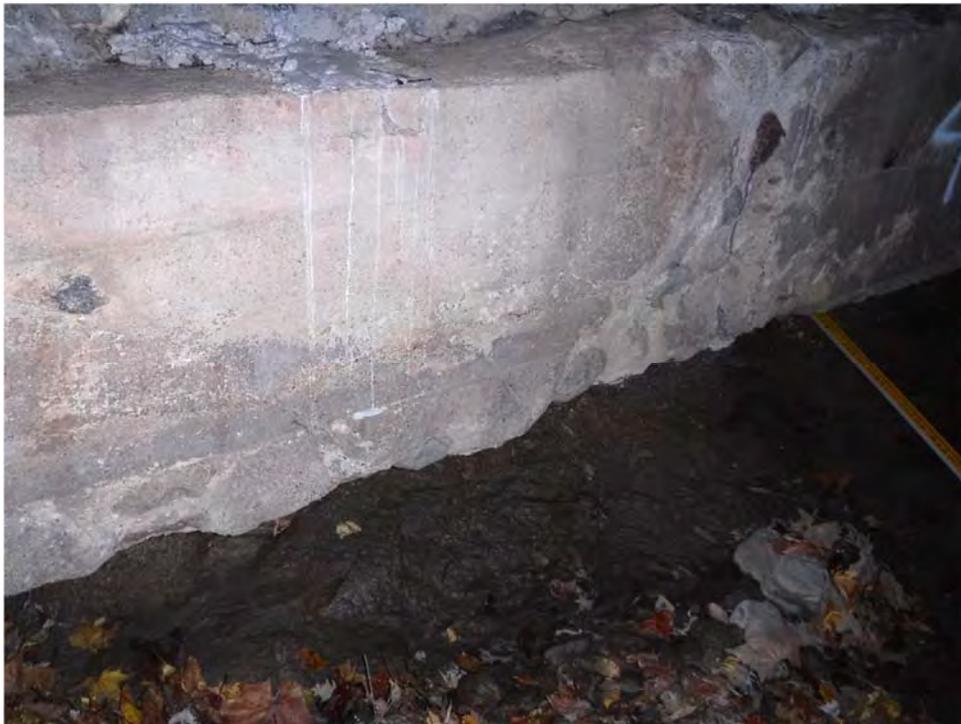
*Photo 30 – Undermining at the West End of Section 11.*

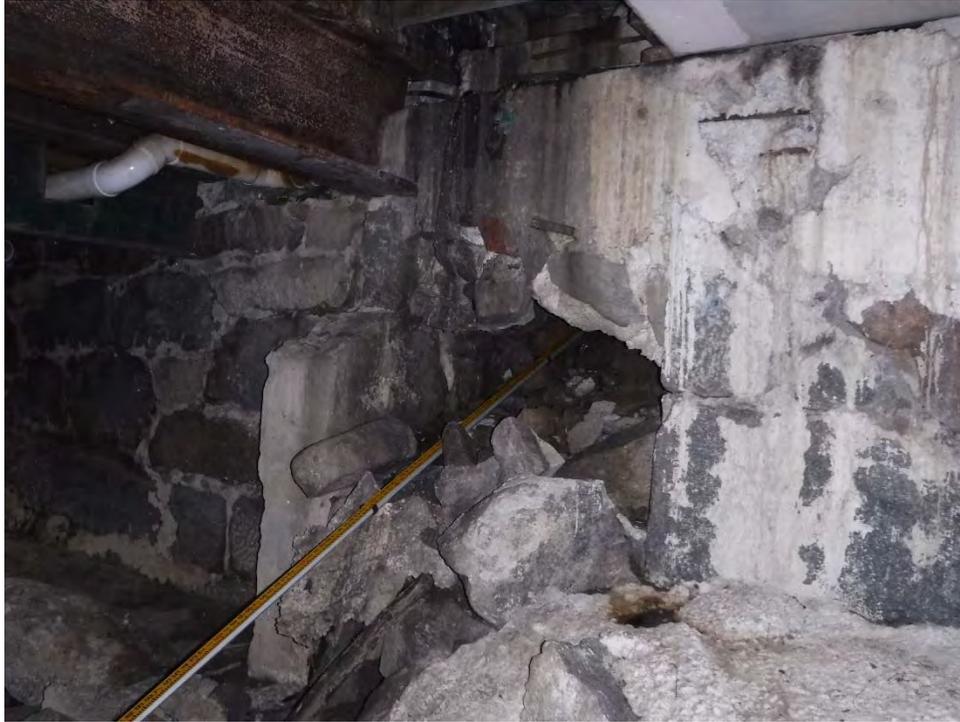
*Photo 31 – Failed Wall with Loose Stones and Loss of Fill in Section 11.*

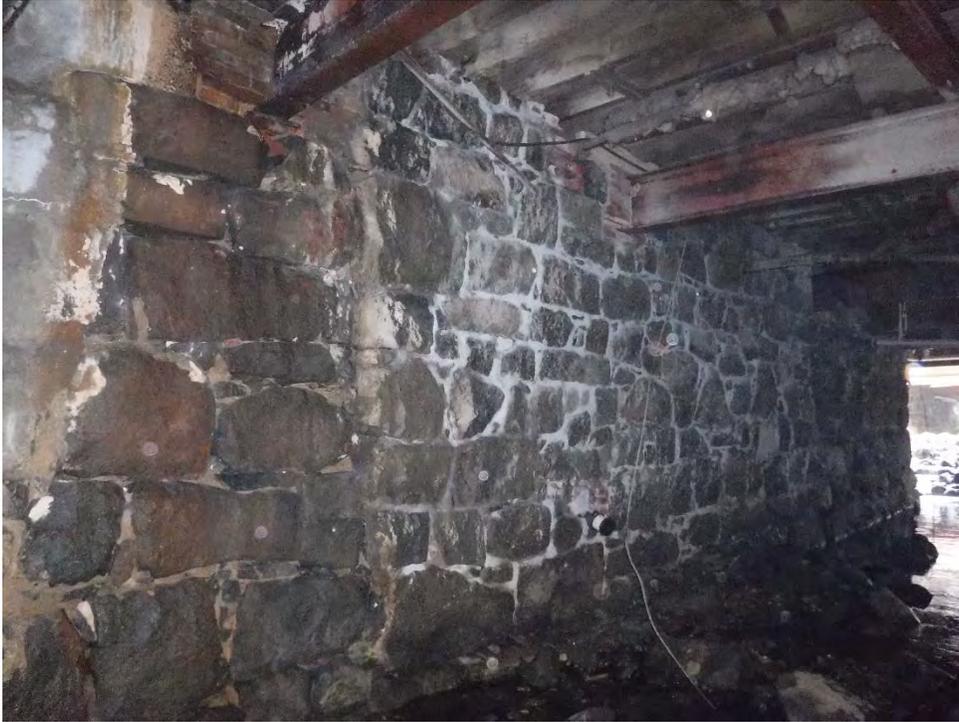
*Photo 35 – Missing Mortar in Section 12, Looking Southwest.*

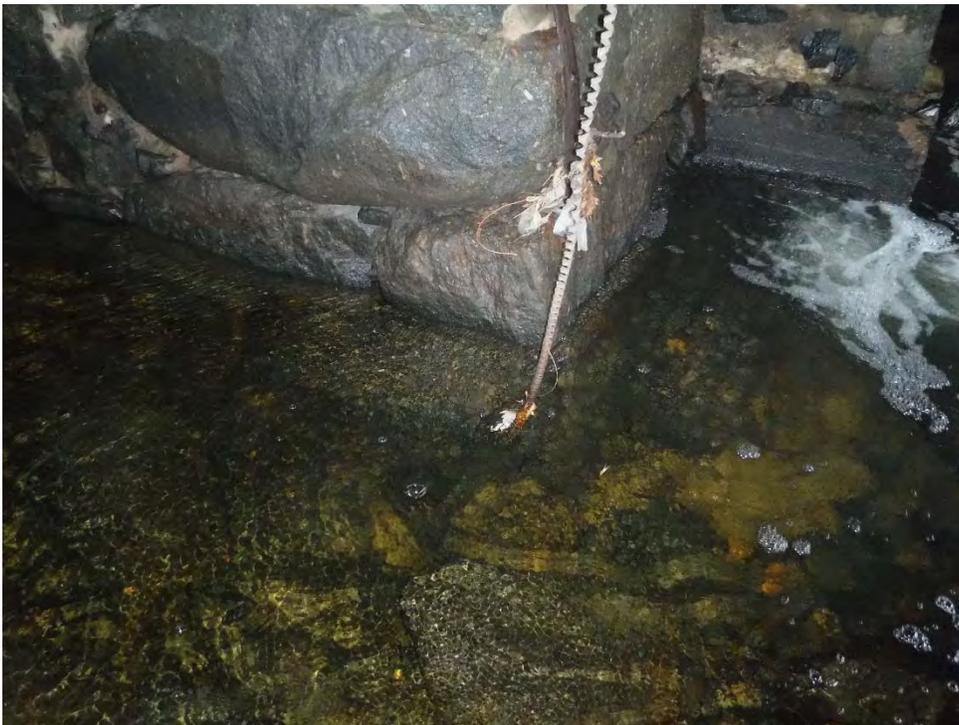
*Photo 36 – Displaced Stone and Scour in Section 12*

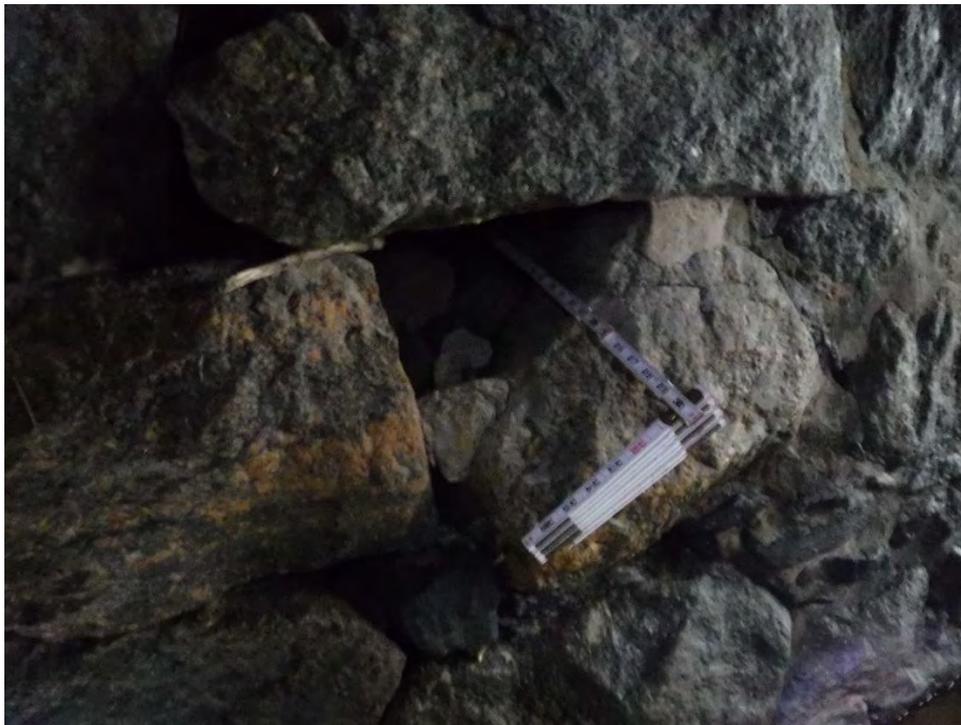
*Photo 38 – Void/Missing Stone in Section 12, 36' from East End.*
