**Final  
Pre-Demolition Hazardous Materials Survey Report  
for the  
Dorsey Building  
at  
9250 Bendix Road  
Columbia, Maryland**

Bureau of Environmental Services  
Howard County Department of Public Works  
6751 Columbia Gateway Drive, Suite 514  
Columbia, Maryland 21046

EA Engineering, Science, Technology, Inc., PBC  
225 Schilling Circle, Suite 400  
Hunt Valley, Maryland 21031  
(410) 584-7000

December 2015

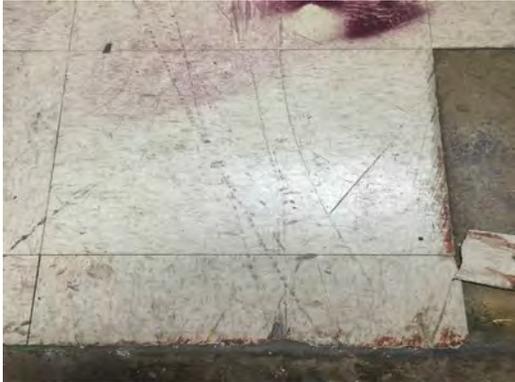
HA Number	Material Description	Material Location	Analytical Results	Quantity	Friability	Condition
007	12" x 12" Floor tile - beige with tan streaks	Room 3, Room 4, Room 5, Room 17, Room 54, Room 58, Room 77, Room 78, Room 79, Room 80, Room 81, Room 106, Room 118, Room 326, Room 344, Room 378, Room 380, Room 383, Room 391, Room 398, Room 412, Room 393, Room 394, Room 395, Room 396, Room 397, Room 399, Room 400, Room 401, Room 402, Room 403, Room 404, Room 405, Room 406	3% Chrysotile	7,358 SF	No	Fair

Photo 1. ACM Positive HA 007

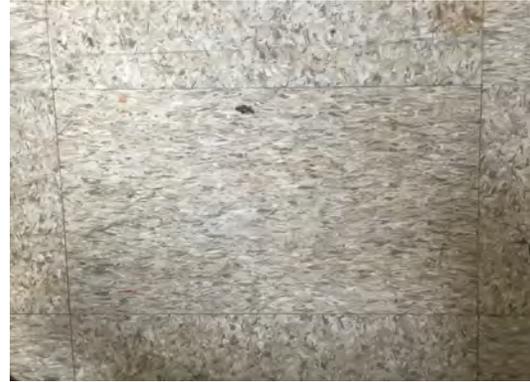
HA Number	Material Description	Material Location	Analytical Results	Quantity	Friability	Condition
010	12" x 12" Floor tile - light brown with white and dark brown flakes	Room 6, Room 7, Room 8, Room 9, Room 57, Room 58, Room 64, Room 69, Room 70, Room 71, Room 82, Room 84, Room 239, Room 327, Room 328, Room 331, Room 344, Room 350, Room 383, Room 391, Room 398, Room 393, Room 394, Room 395, Room 396, Room 397, Room 399, Room 400, Room 401, Room 402, Room 403, Room 404, Room 405, Room 406	3% Chrysotile	12,357 SF	No	Good
034	6"-8" OD mudded elbow of roof drain - gray	Room 93, Room 6	0.75 % Chrysotile 1% Chrysotile	6 EA	Yes	Good
035	Floor tile under plywood - beige	Room 22, Room 23, Room 24, Room 25, Room 26, Room 43	8% Chrysotile	1,615 SF	No	Good
036	Mastic with 035 - gold Layered mastic - black	Room 22, Room 23, Room 24, Room 25, Room 26, Room 43	NAD 8% Chrysotile	1,615 SF	No	Good
040	9" x 9" Floor tile under carpet - beige with black curved lines	Room 49, Room 50, Room 51, Room 27, Room 387, Room 390	8% Chrysotile	1611 SF	No	Good

Photo 2. ACM Positive HA 010

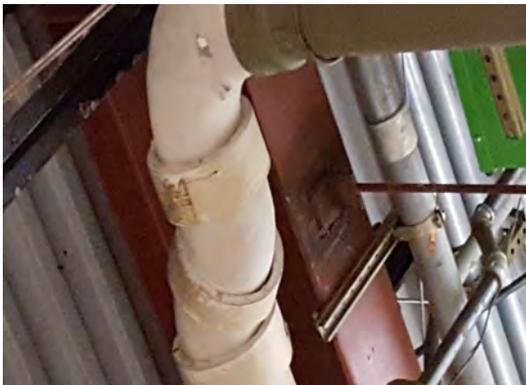
Photo 3. ACM Positive HA 034

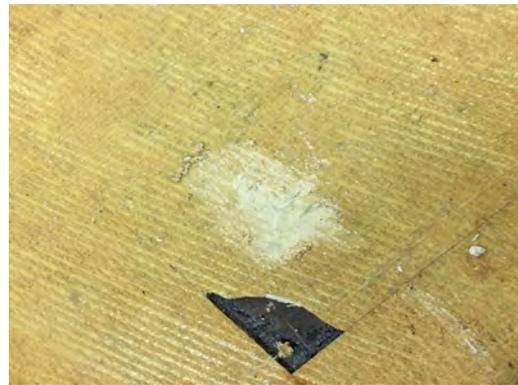
Photo 4. ACM Positive HAs 035 and  
036

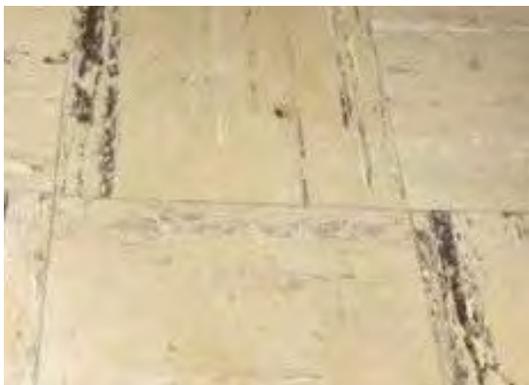
Photo 5. ACM Positive HAs 040 and  
041

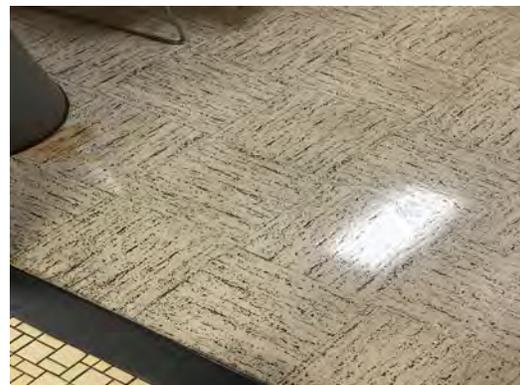
Photo 6. ACM Positive HAs 049 and  
050

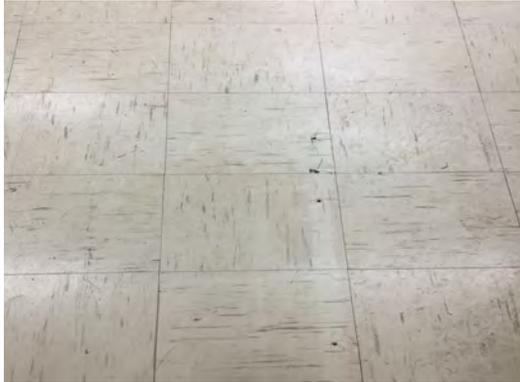
HA Number	Material Description	Material Location	Analytical Results	Quantity	Friability	Condition
055	12" x 12" Floor tile - beige with blue-gray and beige streaks	Room 59, Room 60, Room 61, Room 62, Room 63, Room 72, Room 85, Room 86, Room 87, Room 97, Room 98, Room 99, Room 100, Room 101, Room 102, Room 103, Room 104, Room 105, Room 107, Room 412, Room 416, Room 427, Room 428	2% Chrysotile	18,456 SF	No	Fair
056	Mastic with 055 - black	Room 59, Room 60, Room 61, Room 62, Room 63, Room 72, Room 85, Room 86, Room 87, Room 97, Room 98, Room 99, Room 100, Room 101, Room 102, Room 103, Room 104, Room 105, Room 107, Room 412, Room 416, Room 427, Room 428	5% Chrysotile	18,456 SF	No	Good
076	Mastic with 075 - black	Room 80, Room 81	5% Chrysotile	905 SF	No	Good
079	2"-3" OD elbow on fiberglass pipe - gray	Room 90, Room 91, Room 92, Room 240, Room 261, Room 344	2% Chrysotile	44 EA	Yes	Poor
			Not Analyzed

Photo 7. ACM Positive HAs 055 and 056

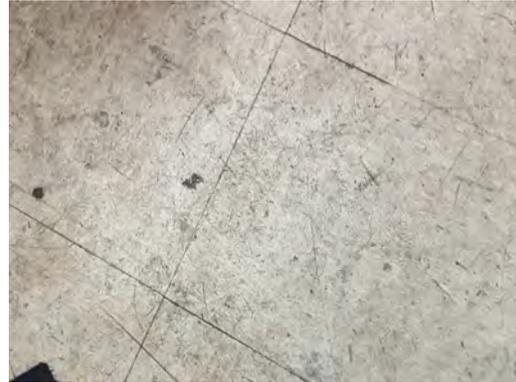
Photo 8. ACM Positive HA 076 under HA 075

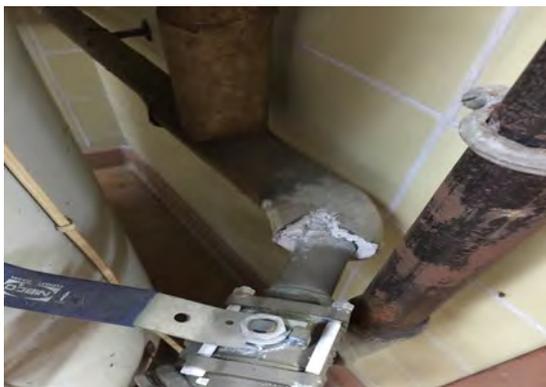
Photo 9. ACM Positive HA 079

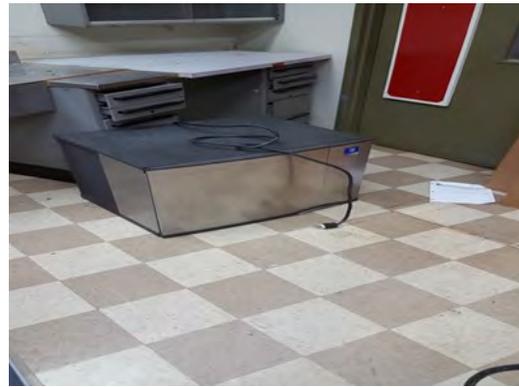
Photo 10. ACM Positive HAs 081, 082, and 083

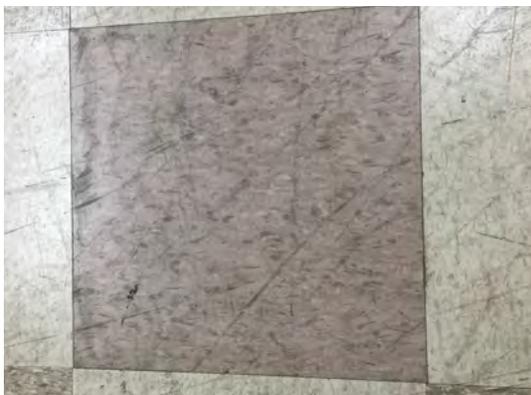
Photo 11. ACM Positive 091 under HA 090

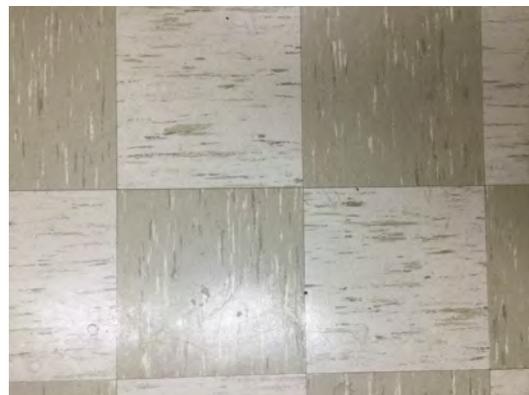
HA Number	Material Description	Material Location	Analytical Results	Quantity	Friability	Condition
096	9" x 9" Floor tile - off white with gray and beige streaks	Room 119, Room 120, Room 121, Room 126, Room 127, Room 128, Room 132, Room 133, Room 349, Room 122, Room 123, Room 124, Room 125, Room 129, Room 130, Room 131, Room 134, Room 135, Room 136, Room 137, Room 138, Room 139	3% Chrysotile	2,590 SF	No	Good
097	9" x 9" Floor tile - gray/green with gray and white streaks	Room 119, Room 120, Room 121, Room 126, Room 127, Room 128, Room 132, Room 133, Room 349, Room 122, Room 123, Room 124, Room 125, Room 129, Room 130, Room 131, Room 134, Room 135, Room 136, Room 137, Room 138, Room 139	3% Chrysotile	2,590 SF	No	Good
098	Mastic with 096 and 097 - black	Room 119, Room 120, Room 121, Room 126, Room 127, Room 128, Room 132, Room 133, Room 349, Room 122, Room 123, Room 124, Room 125, Room 129, Room 130, Room 131, Room 134, Room 135, Room 136, Room 137, Room 138, Room 139	5% Chrysotile	5,180 SF	No	Good

Photo 12. ACM Positive HAs 096, 097, and 098

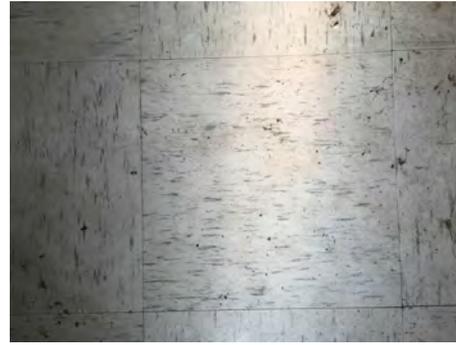
Photo 14. ACM Positive HA 0122

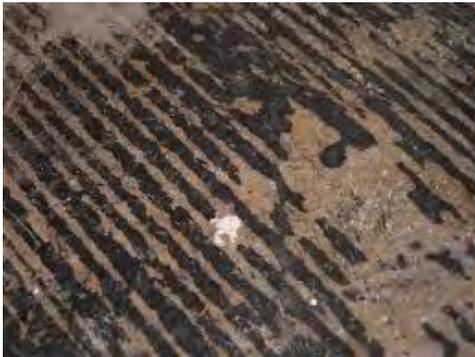
Photo 15. ACM Positive HA 142

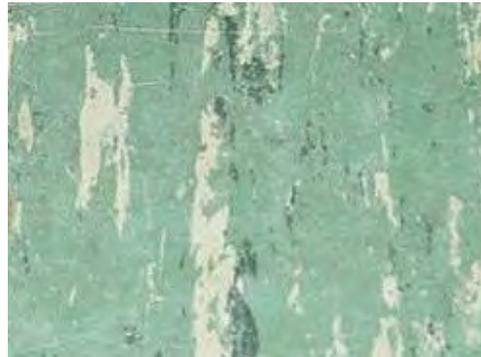
Photo 16. ACM Positive HAs 144 and 145

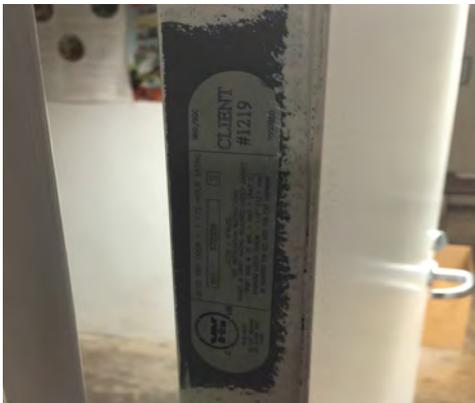
HA Number	Material Description	Material Location	Analytical Results	Quantity	Friability	Condition
154	Metal Fire Door	Room 74, Room 81, Room 89, Room 100, Room 101, Room 102, Room 103, Room 104, Room 132, Room 140, Room 150, Room 154, Room 168, Room 169, Room 175, Room 177, Room 180, Room 185, Room 193, Room 202, Room 215, Room 220, Room 223, Room 233, Room 234, Room 255, Room 331, Room 332, Room 336, Room 340, Room 341, Room 345, Room 354, Room 357, Room 382, Room 414, Room 415, Room 141, Room 142, Room 143,	Assumed	38	No	Good
155	Wood Fire Door	Room 7, Room 37, Room 274, Room 296	Assumed	4	No	Good
156	Flange Gaskets - 8 in. to 12 in. OD	Room 45	Assumed	11	No	Good
157	Roof	Roof	Assumed	197,250	No	Good

Photo 17. Assumed ACM HA 154

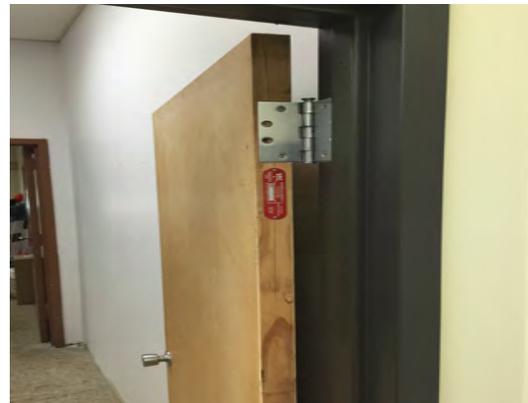
Photo 18. Assumed ACM HA 155

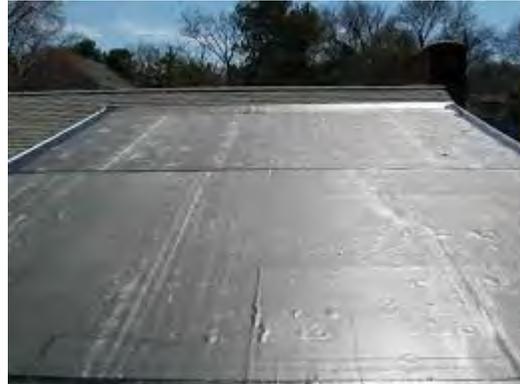
Photo 20. Assumed ACM HA 157 (not actual photo)

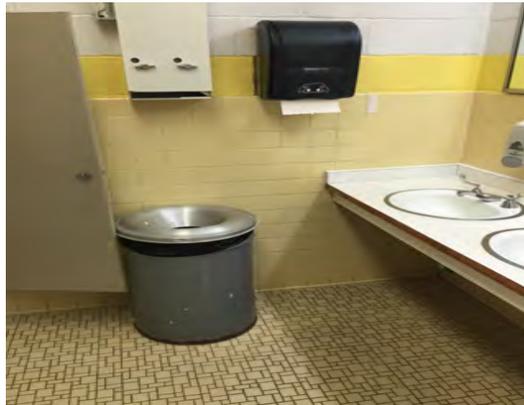
Photo 21. Lead Positive - Ceramic wall

locations not specifically sampled. Although LBP and LCP is not required to be removed prior to demolition activities, contractors working on lead-painted components and/or working in the area of lead-containing paint should be notified of its presence and must adhere to the requirements of OSHA 1926.62. In addition, EA recommends that representative TCLP testing of any possible lead-containing waste (i.e., debris from surfaces with confirmed LBP or LCP) generated during facility renovation activities be conducted to determine waste disposal requirements.

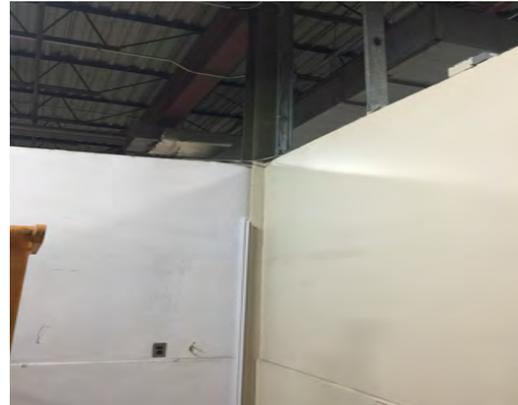
This assessment indicates the presence of lead-based paint (LBP) at, or above regulated levels in connection with the property on metal I-beams, interior and exterior bollards, and interior metal piping as indicated in Section 3.2. Additionally, lead-containing paint (LCP) was identified at various locations throughout the property as noted in Section 3.2.

Photo 22. Lead Positive - Structural (I-beam) beam

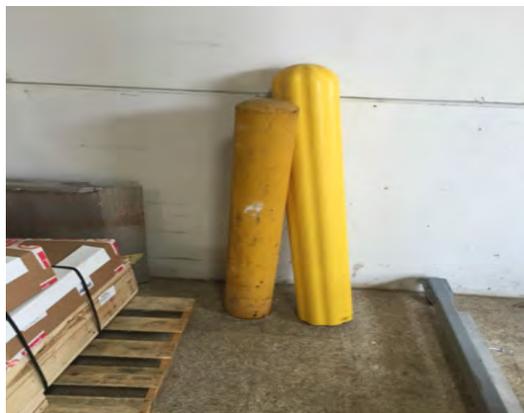
Areas identified as positive for LBP were documented to be in good or fair condition. Interior and exterior bollards had plastic covers that were removed prior to testing the underlying paint surface. Upon removal of the plastic cover, the paint was observed to be in poor condition.

Component	Substrate	Condition	Color	Room	PbC (mg/cm <sup>2</sup> )	Estimated Quantity
Bollard	Metal	Poor	Yellow	Room 9	1.7	120 SF
		Good	Yellow	Room 1	2.3	
		Poor	Yellow	Exterior	3.2	
Door	Metal	Good	Green	Room 89	0.9	50 SF
Pipe	Metal	Good	Yellow	Room 9	2.6	40 SF
Roof Drain	Metal	Good	Yellow	Room 20	2.2	200 SF
Structural Beam (I-Beam)	Metal	Good	Red	Room 274	4.1	6,500 SF
			Red	Mezzanine by Room 94	5	
			White	Room 239	5.9	
			White	Room 295	8	
			White	Room 83	2.5	
			Beige	Room 9	5.2	
			Green	Room 84	6	
			White	Room 87	6.2	
			Beige	Room 1	6.7	
			White	Room 53	8.9	
Wall	Ceramic	Good	Green	Room 106	10.1	2,240 SF
			Green	Room 54	4.4	
			Green	Room 330	4.8	
			Yellow	Room 56	5.1	
			Yellow	Room 329	5.6

Photo 23. Lead Positive - Bollard

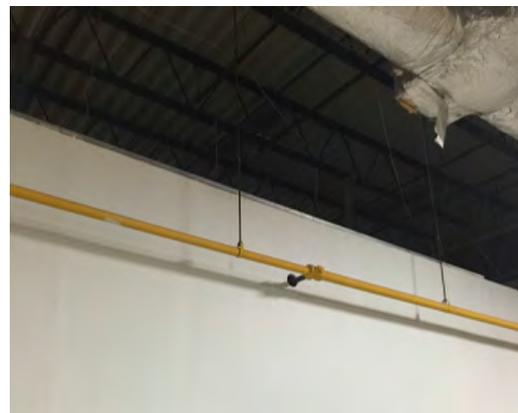
Photo 24. Lead Positive - Pipe

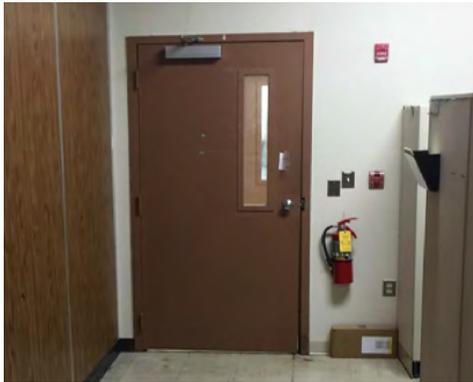
Photo 25. Lead Positive - Metal door
