## **M. Personal Protective Equipment**

### **Woodscape Drive Incident Overview: Personal Protective Equipment: PPE**

## Findings and Recommendations: PPE

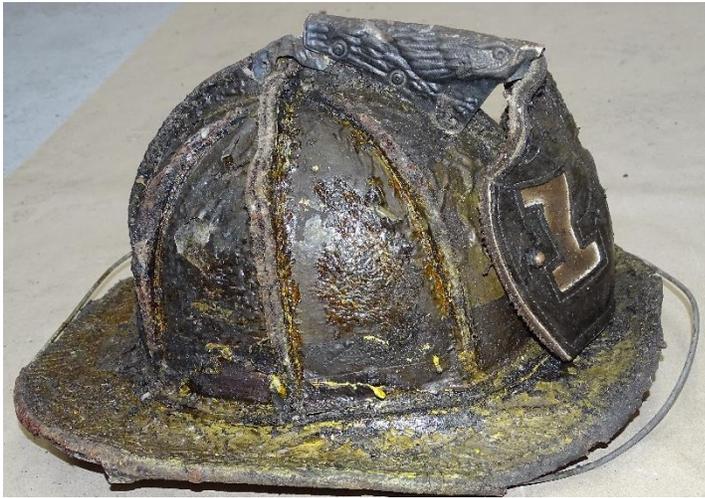
Figure 31 FF Flynn's Personal Helmet

Third, FF Flynn's firefighting boots and personally owned helmet were greater than ten (10) years from manufacture date. Additionally, it was not possible to verify whether FF Flynn's protective hood was within ten (10) years of its manufacture date since there was no manufacture label. Under the NFPA Standard 1971, firefighter personal protective ensembles should be no more than ten (10) years past the manufacture date. While FF Flynn's helmet and firefighting boots should have been retired and replaced, there is no indication that the age of his equipment contributed to his injuries.

<b>Findings</b>	<b>Recommendations</b>
<p>rear tail, some personnel on the fireground did not have their names displayed on the rear of their coats.</p>	<p>to have the member’s last name affixed to the rear tail of the coat. Should multiple members have the same last name, additional lettering would be used to further differentiate those individuals.</p> <p>M.2.2 HCDFRS should assure all personnel have their name affixed to the rear tail of their turnout coats and request name panels for personnel, as necessary.</p>
<p>M.3 FF Flynn’s firefighting boots and helmet were older than ten (10) years from manufacture date.</p>	<p>M.3.1 <a href="#">General Order 530.02, Personal Protective Equipment</a>, should be revised to align with NFPA Standard 1971. These revisions should include:</p> <ul style="list-style-type: none"> <li>○ An explicit prohibition of any modifications to equipment that would compromise or void its NFPA 1971 certification.</li> <li>○ Allowable length of service parameters for all personal protective clothing and equipment items.</li> </ul>

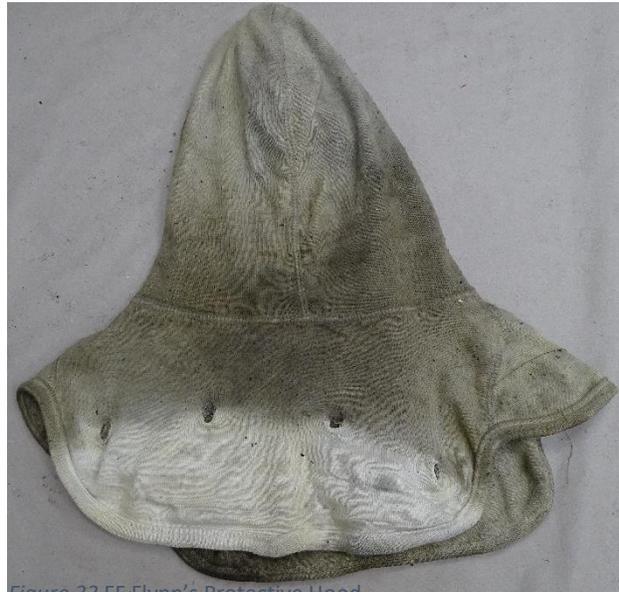
Figure 33 FF Flynn’s Protective Hood

Fourth, the examination of FF Flynn's protective hood revealed holes in the rear bib that matched the size and spacing of the snaps used to attach the coat liner to the outer shell of the turnout coat and collar. Based on this observation, it is likely that FF Flynn had fastened the liner of his coat to the coat shell through the hood, a practice that has been noted among some HCDFRS personnel. Securing the hood in such a way is not recommended because it restricts the

hood from effectively moving in concert with the head of the wearer. When a portion of the hood is stationary, wearer movement can result in gapping that compromises encapsulation and thermal protection. Additionally, this practice creates holes in the hood, voiding the NFPA certification of the garment.

<p>M.4 The examination of FF Flynn’s protective hood revealed holes in the rear bib that matched the size and spacing of the snaps used to attach the coat liner to the outer shell of the turnout coat and collar.</p>	<p>See Recommendation M.3.1</p>
