## Appendix D: PPE Examination Report

**Examination of Selected PPE Worn by Lieutenant Nathan Flynn  
During July 23, 2018 Structure Fire at  
7005 Woodscape Drive, Clarksville, MD**

*Prepared by:*  
Jeffrey O. Stull  
International Personnel Protection, Inc.  
P. O. Box 92493  
Austin, TX 78709

31 October 2018

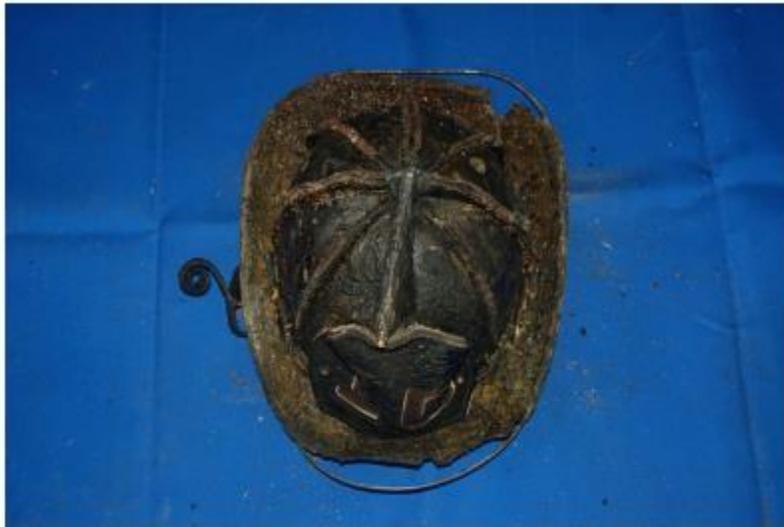
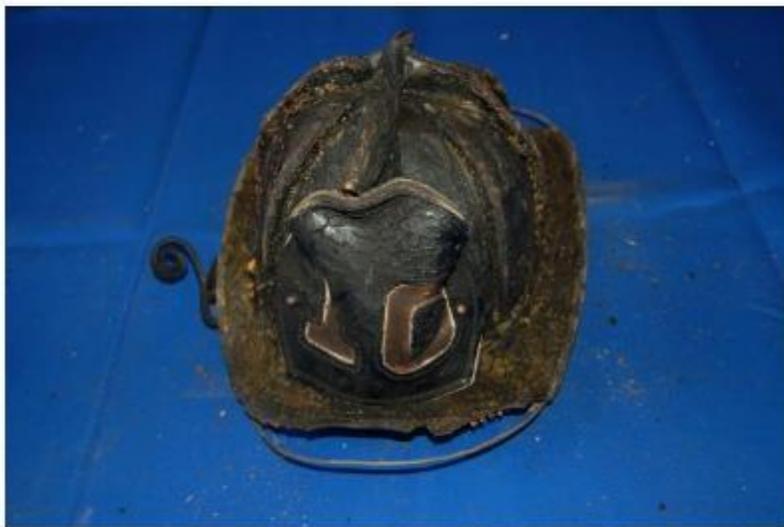
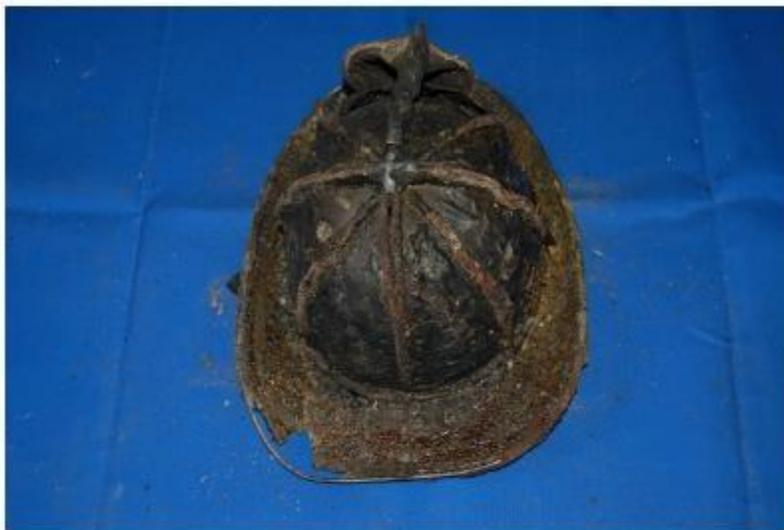
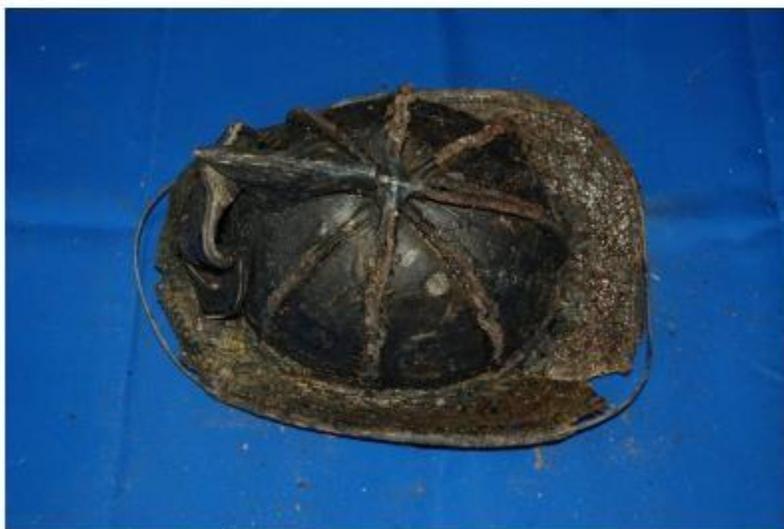
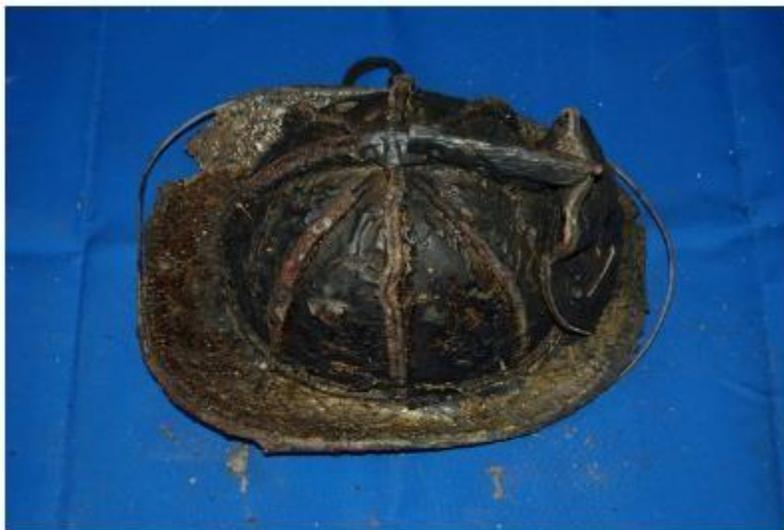
**Protective Helmet.** The protective helmet worn by the Lieutenant Flynn showed extensive thermal damage. The helmet was of a leather construction and the top, front, rear, left, and right views (Figures A-1 through A-5) show that the entire surface was blackened and distorted with significant degradation and shrinkage of the leather, particularly along the front and left back brim areas. For example, Figure A-2 displays a darkened and distorted shield along with separation of the front brim from the underlying wire rim. Damage to the back brim of the helmet is shown in Figures A-3 and A-4. Figure A-6 provides a view of the underlying brim showing equal levels of damage and distortion of leather surfaces. This view also shows the severe soiling and charring of the extended helmet ear covers. The interior side of the ear covers shows the knit lining material is less soiled and includes some molten residue towards the front as seen in Figure A-7. A close-up of the charring on the back brim is provided in Figure A-8, which also depicts the inability to read the warning label. Product label information seen through the helmet suspension is shown in Figure A-9. It is noted that the helmet was manufactured in June 2007 (over 10 years old as of the accident date). The certification label provided in Figure A-10 shows that the helmet was certified to the 2007 edition of NFPA 1971.

**Figure A-1. Top of Lieutenant Flynn's Protective Helmet**

**Figure A-2. Front of Lieutenant Flynn's Protective Helmet**

**Figure A-3. Rear of Lieutenant Flynn's Protective Helmet**

**Figure A-4. Left Side of Lieutenant Flynn's Protective Helmet**

**Figure A-5. Right Side of Lieutenant Flynn's Protective Helmet**

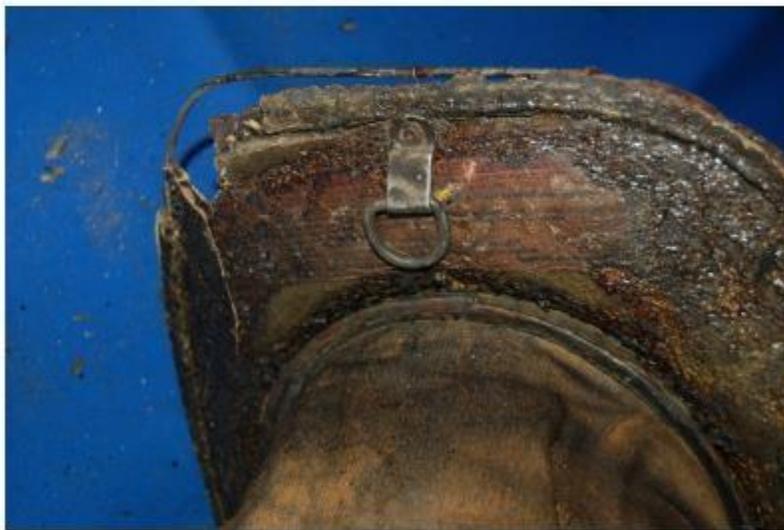
**Figure A-8. Close-Up of Charring on Warning Label and Underside of Back Brim for Lieutenant Flynn's Protective Helmet**

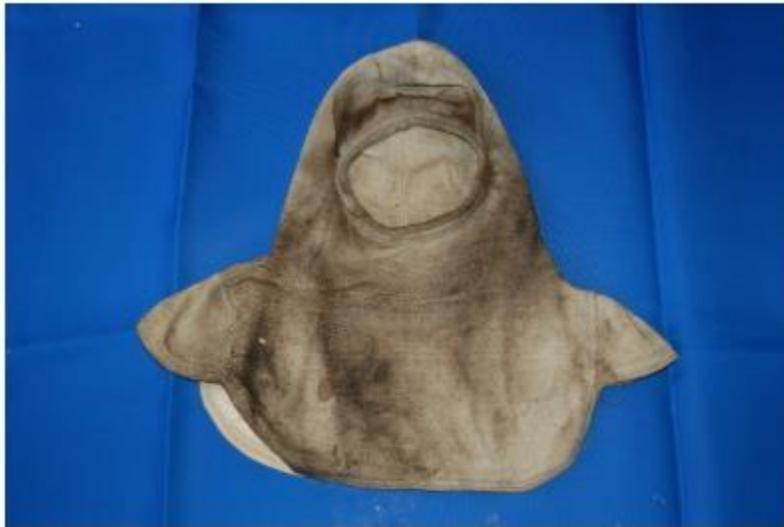
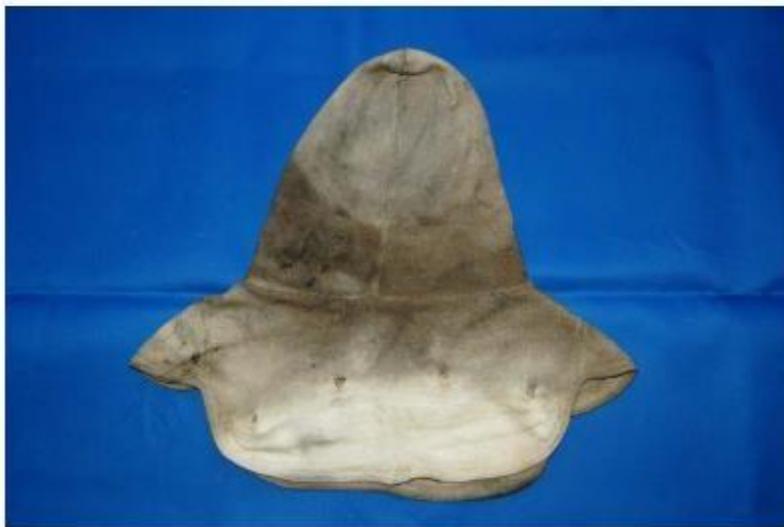
**Protective Hood.** Photographs for the front and back of the protective hood are provided in Figures A-11 and A-12. However, there was no product label present in the hood and no way to identify its manufacturer, model number or style name, date of manufacture, or certification. The hood appears to be a 2-ply 100% Nomex or Nomex blend knit. The pictures of the hood show moderate to heavy soiling with the heaviest soiling around the face opening and on the front of the bib. The latter suggests that the front hood bib was either worn out, or pulled out sometime during the time that Lieutenant Flynn was on the fireground. There are also some reddish brown spots on the left side of the hood bib, which could be dried blood. The soiling pattern on the back of the hood (Figure A-12) extended from below the helmet to a series of four holes in a circular arc on the back of the hood. Soiling was heaviest towards the left side. Information from the department conveyed that the holes were likely the result of intentional modification of the hood

**Figure A-11. Front View of Lieutenant Flynn's Protective Hood**

**Figure A-12. Back View of Lieutenant Flynn's Protective Hood**

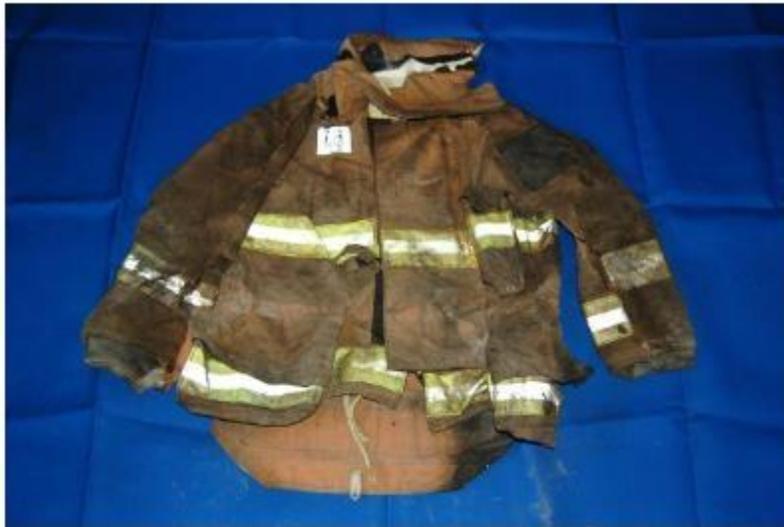
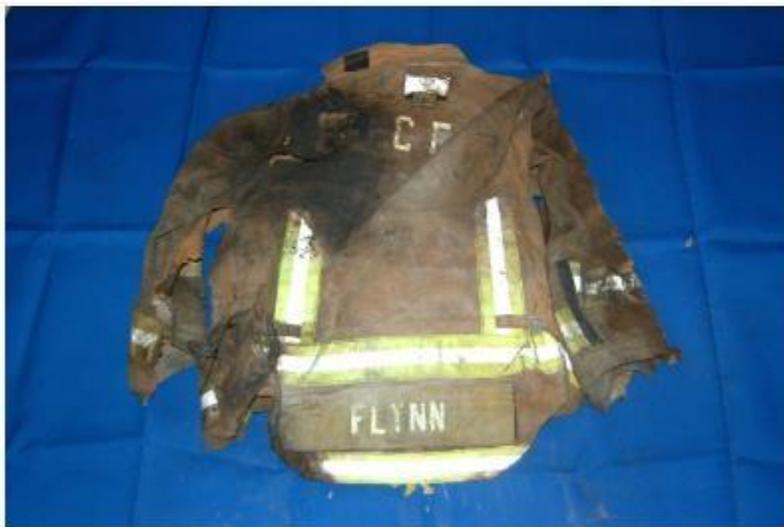
**Protective Coat Shell.** Figures A-15 and A-16 provide front and back views of exterior side for the Lieutenant Flynn’s protective coat outer shell. The coat outer shell was actually cut along the length of the sleeves and shoulder. Nevertheless, the coat was positioned together for the photographs as if the coat was still intact. The greatest damage of the coat appears on the left side and particularly at the upper left back shoulder and lower left back side. Both sleeves are heavily soiled, more than much of the other parts of the outer shell. Figures A-17 and A-18 further show damage to the offset trim bands near the sleeve ends, primarily on the back of the sleeves. Figure A-19 provides a close-up of the deteriorated department patch on the left upper sleeve. The extensive charring and break open of the outer shell at the upper left back shoulder area are shown in Figure A-20. This picture also shows missing lettering on the left back of the coat that likely burned away. Similar severe damage is shown on the lower left side of coat next to the left bottom cargo pocket in Figure A-21. The photograph in Figure A-22 shows the pull tab for the coat drag rescue device (DRD) in place, indicating that it was not deployed during the extrication of Lieutenant Flynn from the fireground.

**Figure A-15. Front of Lieutenant Flynn's Protective Coat (Exterior Side)**

**Figure A-16. Back of Lieutenant Flynn's Coat (Exterior Side)**

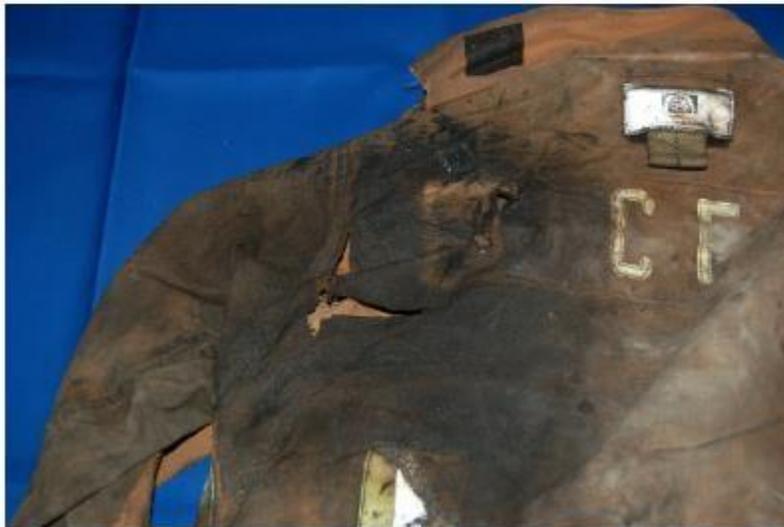
**Figure A-20. Close-Up of Thermal Damage to Left Back Shoulder Area of Lieutenant Flynn's Protective Coat**

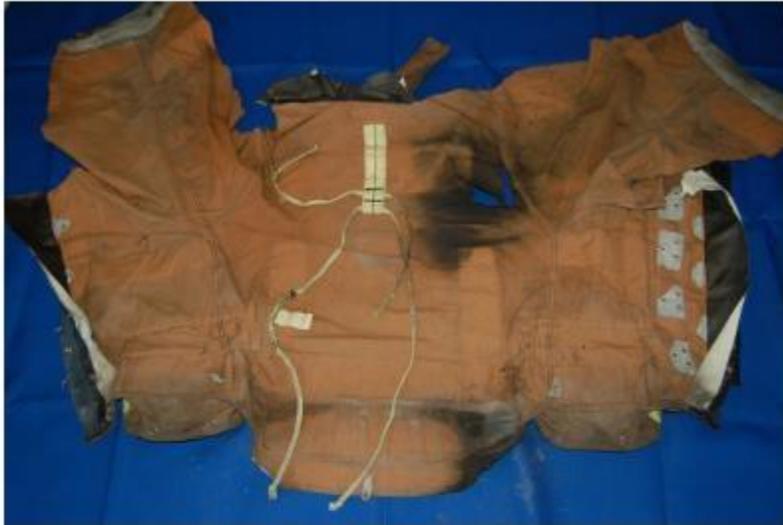
Figure A-23 shows the entire interior view of the protective coat outer shell. The ability for observing charring is best illustrated with this photograph since charring will usually penetrate through the entire outer shell layer whereas soiling generally does not. This charring is most evident in the upper left back and shoulder as well as the lower left side on the back coat tail area. A close-up of this damage is shown in Figures A-24 and A-25. The interior side of the collar is shown in Figure A-26, which shows heavy soiling and suggests that the collar was not in the required raised orientation during the fire event. The coat outer shell product identification label appears on the right closure facing material in Figure A-27.

**Figure A-23. Shell Interior of Lieutenant Flynn's Protective Coat**

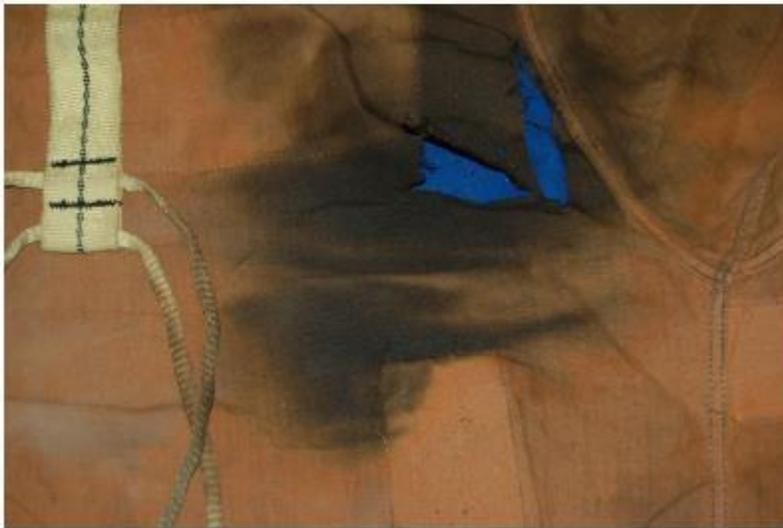
**Figure A-24. Charred Area at Left Shoulder on Shell Interior of Lieutenant Flynn's Protective Coat**

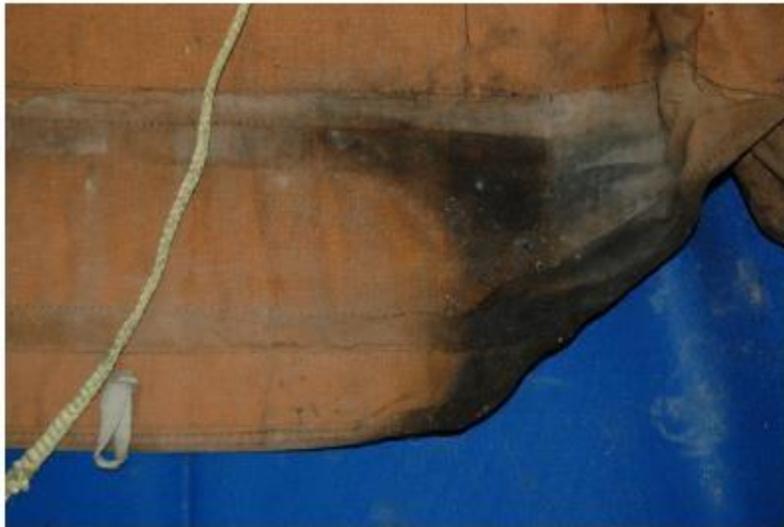
**Figure A-25. Charred Area at Lower Left Side on Shell Interior of Lieutenant Flynn's Protective Coat**

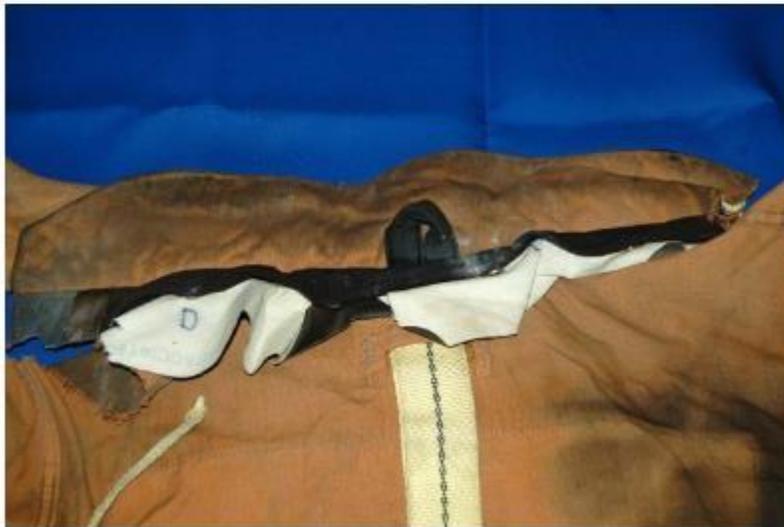
2. The patterns of soiling on the interior side of the collar suggest that the collar was not in a raised position. It is important for the collar to be raised since this wearing position helps to provide further thermal insulation to the firefighter's neck, which are not protected by the ear covers, which should also be fully extended downward. The protective hood by itself does not offer the same insulation as the other elements of clothing.

**Figure A-26. Close-Up of Collar Interior on Outer Shell Lieutenant Flynn's Protective Coat**

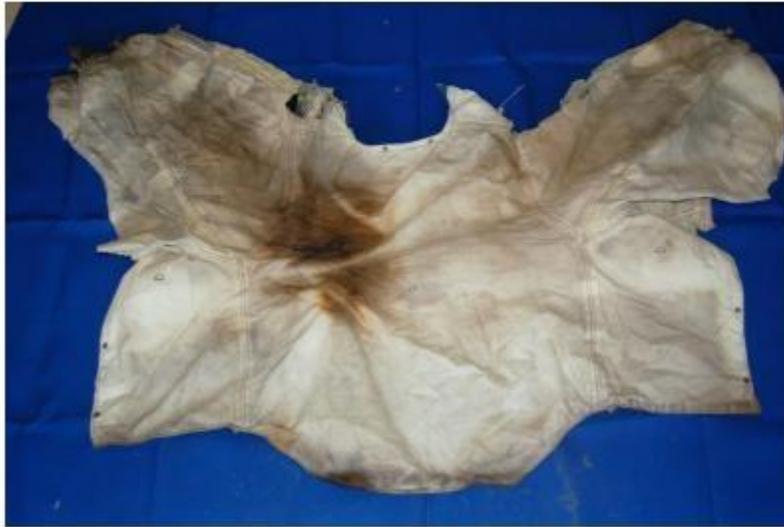
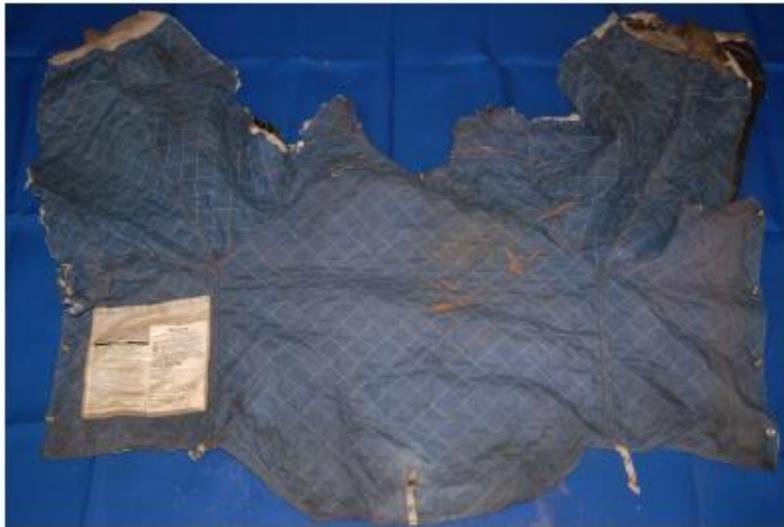
**Protective Coat Liner.** Photographs of the moisture barrier and thermal barrier sides of the protective coat lining are provided in Figures A-28 and A-29. These photographs show the extreme heat penetration at the left upper shoulder and back areas of the protective coat. Close-up views of the damaged areas at the back on the moisture barrier side (Figure A-30) and corresponding areas on the thermal barrier layer facing the Lieutenant Flynn (A-31) indicate heat penetration through all 3 principal layers of the protective coat. Figure A-31 further shows a close-up of melting for the moisture barrier film and seam tapes in the same upper back shoulder area as found inside the liner. Additional insulation designed into the coat in form of sewn on strips (referred to as “dead air panels” by Honeywell) is present at the upper back along both shoulders and over the upper and lower arms as shown in Figures A-33 and A-34. An elbow insulation layer is also present. Figure A-32 shows some light charring near the shoulder area on the left side of the garment at the interior batting. Product labels appear in Figure A-35 with a close-up of the product compliance label in Figure A-36 (NFPA 1971-2013). The product label indicates that the coat was measured for “Norman.”

**Figure A-28. Moisture Barrier Side of Lieutenant Flynn's Protective Coat Liner**

**Figure A-29. Thermal Barrier Side of Lieutenant Flynn's Protective Coat Liner**

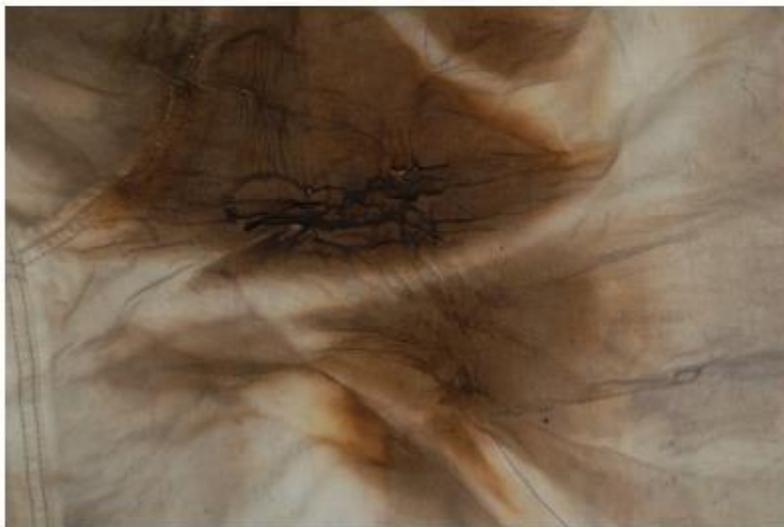
**Figure A-30. Close-Up of Charring at Shoulder Upper Back of Lieutenant Flynn's Protective Coat Liner (Moisture Barrier Side)**

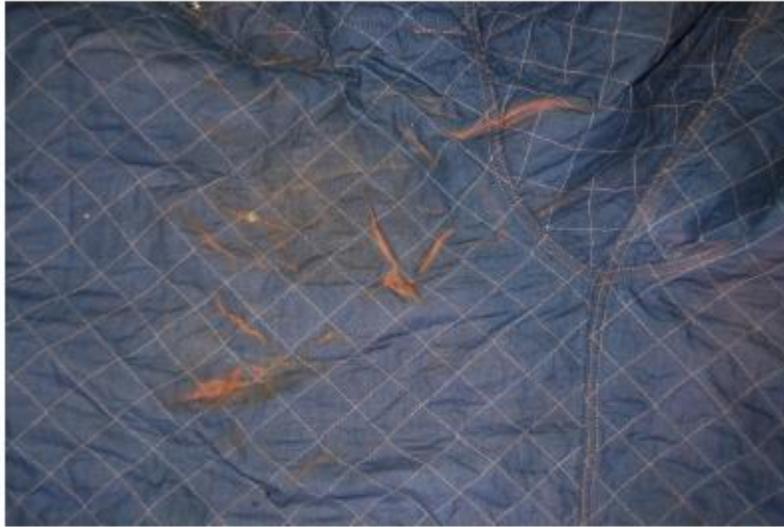
**Figure A-31. Close-Up of Charring at Shoulder Upper Back of Lieutenant Flynn's Protective Coat Liner (Thermal Barrier Side)**

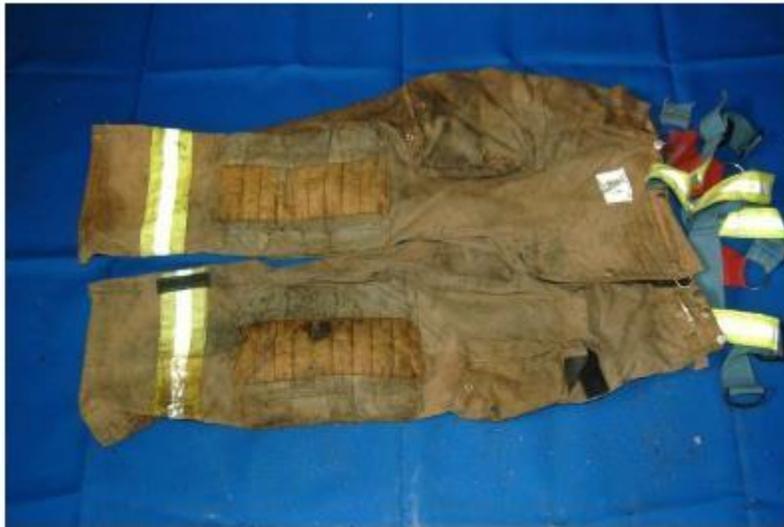
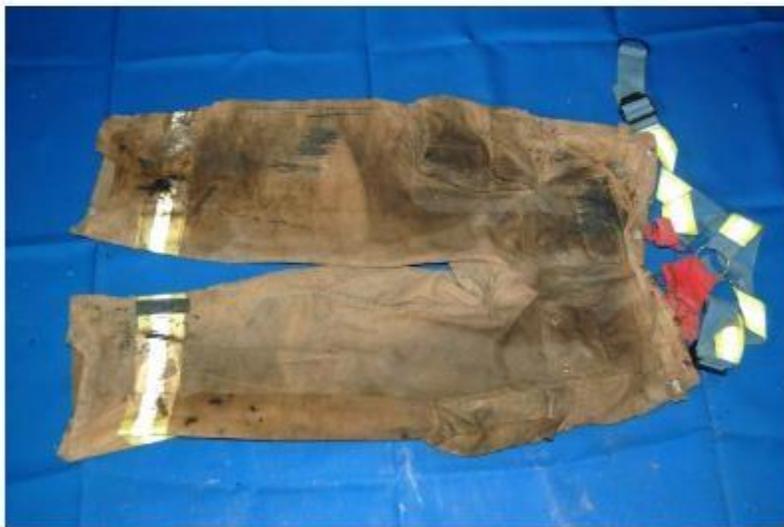
**Protective Pants Shell.** The front and back of the exterior side of outer shell for Lieutenant Flynn's protective pants are shown in Figures A-37 and A-38. The front of the pants shows moderate soiling along the front of the pants with the heaviest soiling at the left knee area where there is a melted resin-like deposit on the right side of the knee reinforcement; there is also a stain at the bottom of the right lower leg in the cuff area (see Figure A-39). The back of the pants show thermal damage with charring along the majority of the left leg particularly on the back pants pocket, upper leg cargo pocket, and lower pant leg. Damage to the back left pants pocket is seen in Figure A-40 while the disintegrated lower trim band on the back of the left leg is shown in Figure A-41. In comparison, the back lower right leg is shown in Figure A-42, which shows melted resin on part of the trim band and char marks to right of the lower back leg. The interior front and back sides for the pants outer shell are pictured in Figure A-43 and A-44. In these photographs, there is some penetration of charring as seen in left side of the pants (opposite of what is seen in the picture) primarily on the lower leg, though there is no internal charring in the back pocket area because of the multiple layers of fabric in the pants design element. The burn mark above the trim band on the right leg can clearly be seen on Figure A-45. The pants outer shell product identification label appears on the right closure facing material in Figure A-46.

**Figure A-37. Front of Lieutenant Flynn's Protective Pants (Exterior)**

**Figure A-38. Back of Lieutenant Flynn's Protective Pants (Exterior)**

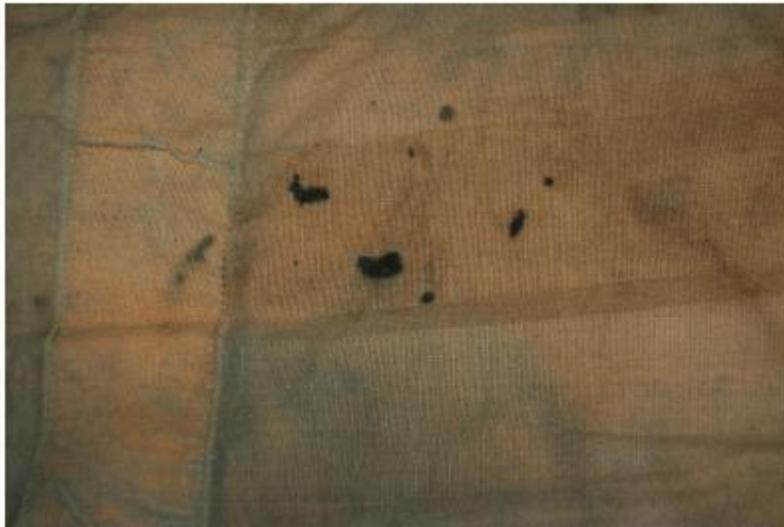
**Figure A-45. Close-Up of Charring to Back Lower Left Leg of Lieutenant Flynn's Protective Pants (Shell Interior)**

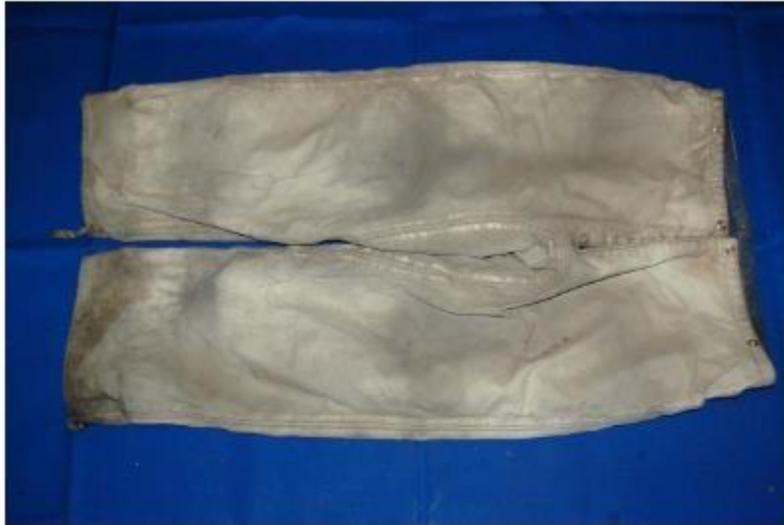
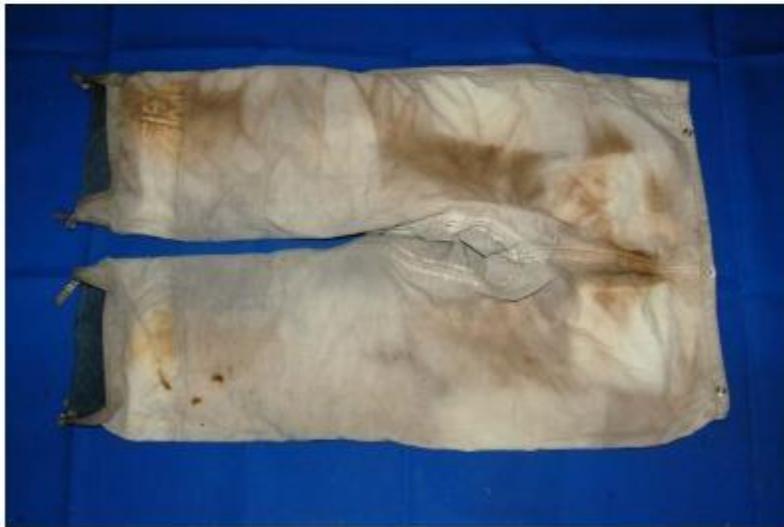
**Protective Pants Liner.** Interior views for the front and back of the lining moisture barrier side are shown in Figures A-47 and A-48. The front view shows only moderate soiling with some light charring at the bottom of the left leg near the hem. However, the back shows charring in several areas including around the seat pockets, upper left inner leg and lower back leg. The char marks noted on the lower right leg coincide with similar marks on the moisture barrier in Figure A-49 and a closer view of the char damage is seen in Figure A-50, including the area where the trim disintegrated. Relatively little to no thermal damage is shown on the innermost layer of the lining as shown in Figures A-51 and A-52. Instead, there is moderate to heavy soiling, particularly in the area of the lower legs. There is mild discoloration and some soiling, particularly near lower left leg. The full protective pants product label and warnings are shown in Figure A-53, indicating compliance with the 2013 edition of NFPA 1971. Information written above the label in indelible ink include "Hand, John 3971 05/14. A close-up of the compliance label indicates that the pants were measured for "Hand."

**Figure A-47. Front of Lieutenant Flynn's Protective Pants Liner  
(Moisture Barrier Side)**

**Figure A-48. Back of Lieutenant Flynn's Protective Pants Liner  
(Moisture Barrier Side)**

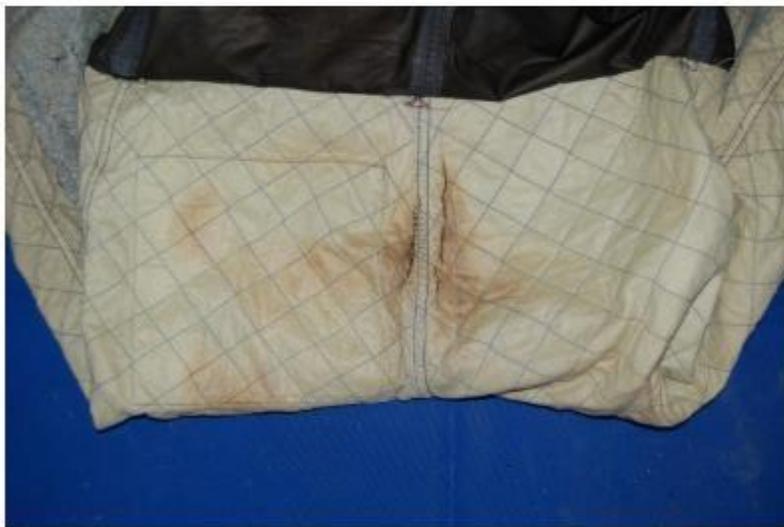
An inspection of the liner interior was performed by inverting the lining through the inspection opening near the fly section of the protective pants pictured in Figure A-55. In this fashion, the moisture barrier film (dark gray) and thermal barrier batting (light yellow) layers of the liner are attached as seen in Figure A-56. The film side of the pants lining is presented in Figure A-57 while the batting or insulation side is shown in Figure A-58. Figures A-59 shows discoloration of the moisture barrier film along the left leg indicating high heat exposure on either side of the knee reinforcement. Figure A-60 shows corresponding charring in the same areas on the thermal barrier batting layer. Figure A-61 provides an interior view of the extra reinforcement material placed at the knee area inside the liner. Figure A-62 show charring in the seat area of the pants primarily between the back pockets.

**Figure A-60 Seat Area of Liner Interior for Lieutenant Flynn's Protective Pants**

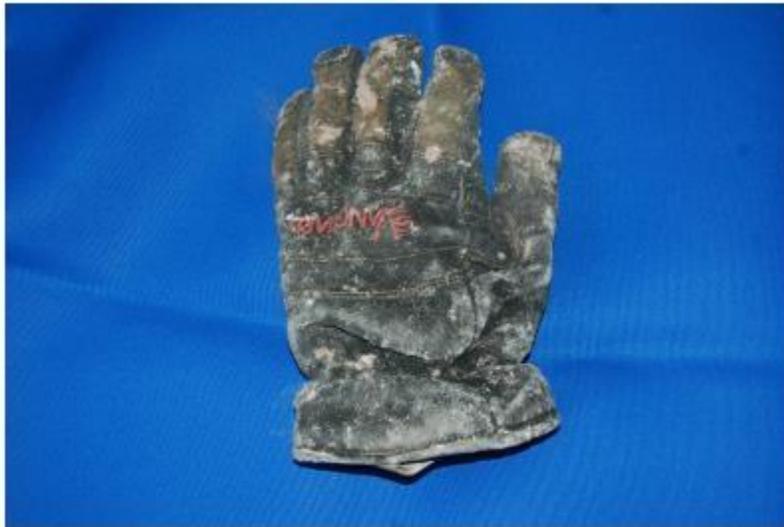
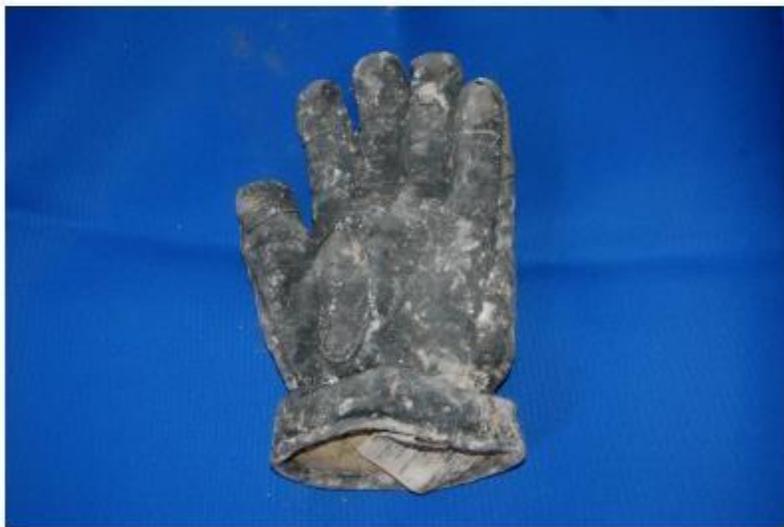
several hours after Lieutenant Flynn had been removed from the structure. The back of the glove is shown in Figure A-61 while the palm side is shown in Figure A-62. The glove is heavily soiled with a white splotchy soiling over both back and palm sides, which was also characteristic of the contamination on some portions of the protective coat and pants. This soiling or contamination extends into the interior of the glove as seen in Figure A-63. This photograph further shows some wear on the glove interior. Labels provided for the glove show its compliance to the 2013 edition of NFPA 1971 (Figure A-64), the care instructions (Figure A-65), and the manufacturing date (Figure A-66).

**Figure A-61. Back Side of Lieutenant Flynn's Protective Left Glove**

**Figure A-62. Palm Side of Lieutenant Flynn's Protective Left Glove**
