## APPENDIX A: HOWARD COUNTY COUNCIL BILL #56-2018

# PLUMTREE BRANCH WATERSHED ASSESSMENT AREA P01

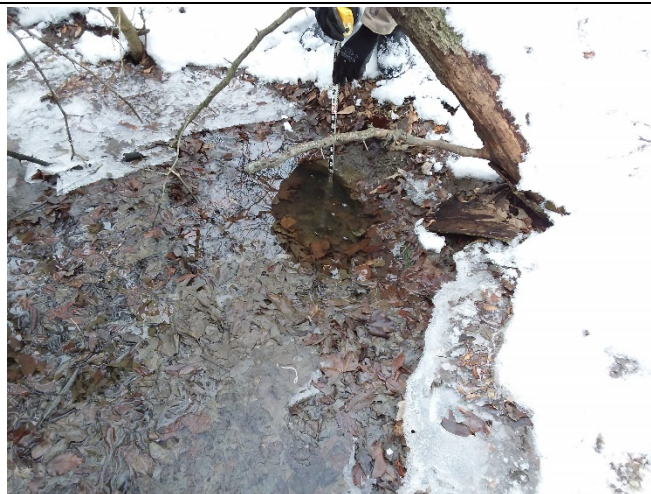
Figure 2: Typical submerged outfall requiring repair.

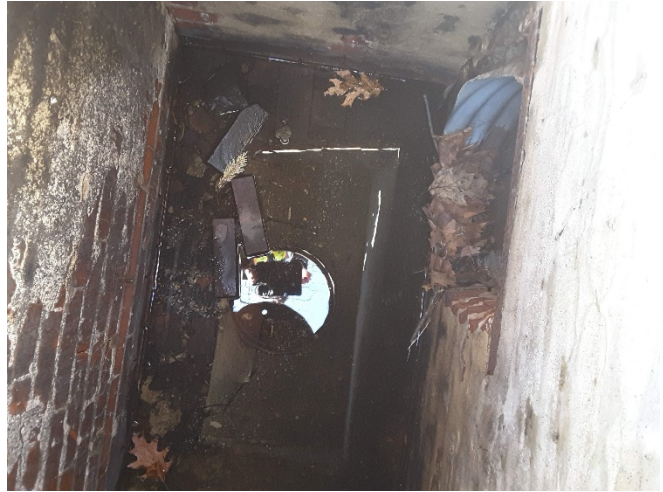
**Figure 2: Inlet at Forest Hill Swim and Tennis Club requiring repair with observed debris.**

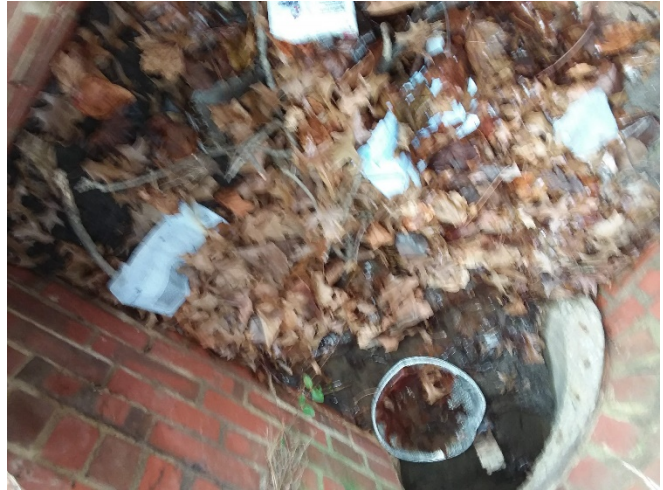
**Figure 2: Inlet along Columbia Road with observed debris.**

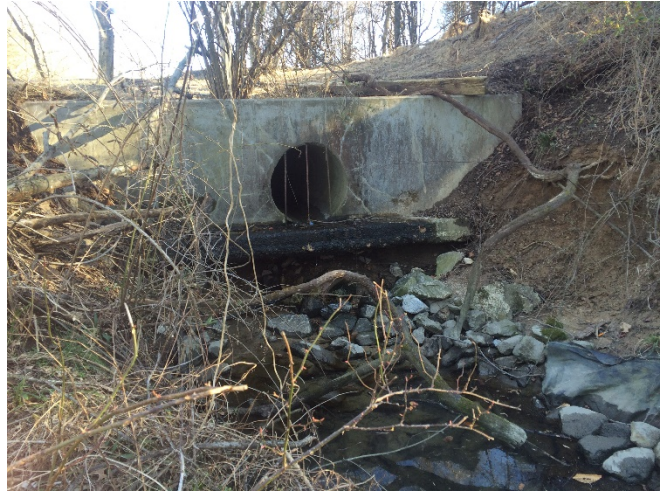
**Figure 2: Outfall requiring repair on the campus of Dunloggin Middle School.**

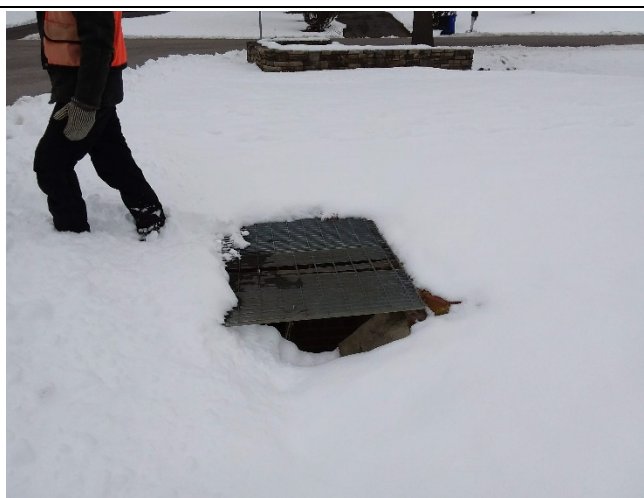
**Figure 3: Typical inlet along MacAlpine Road requiring repair.**

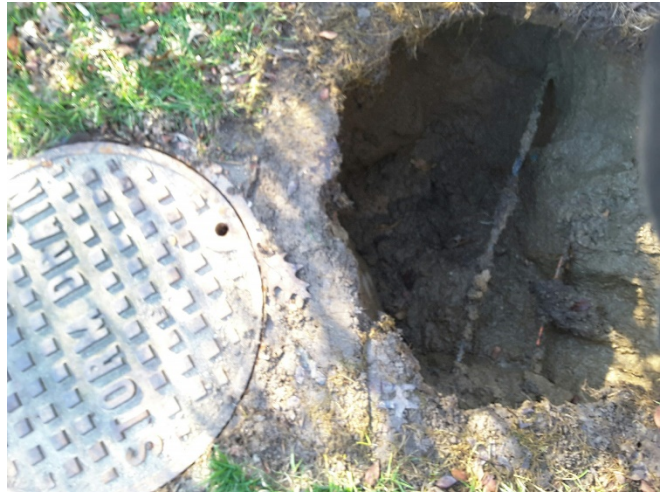
**Figure 2: Utilities exposed adjacent to manhole along Dunloggin Road.**

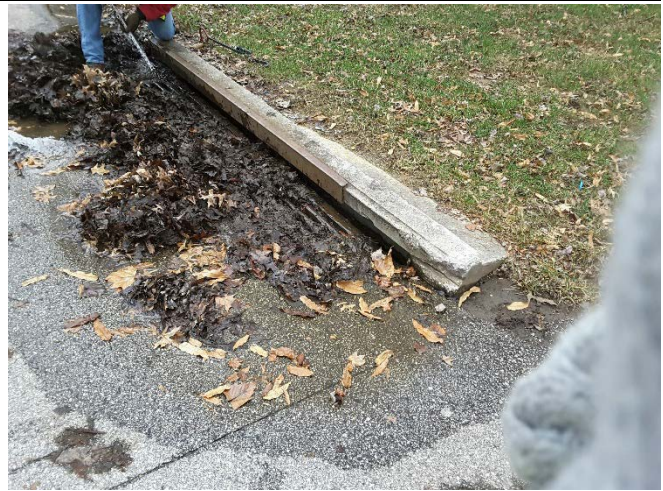
**Figure 2: Typical inlet with observed debris along Dunloggin Road.**

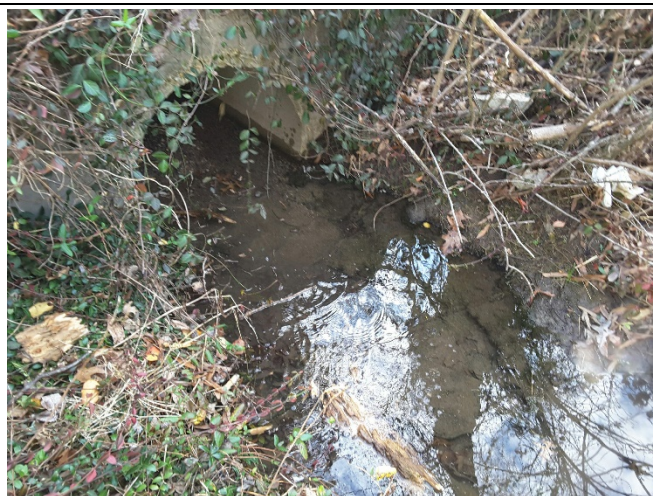
**Figure 2: Typical pipe and outfall with observed debris.**

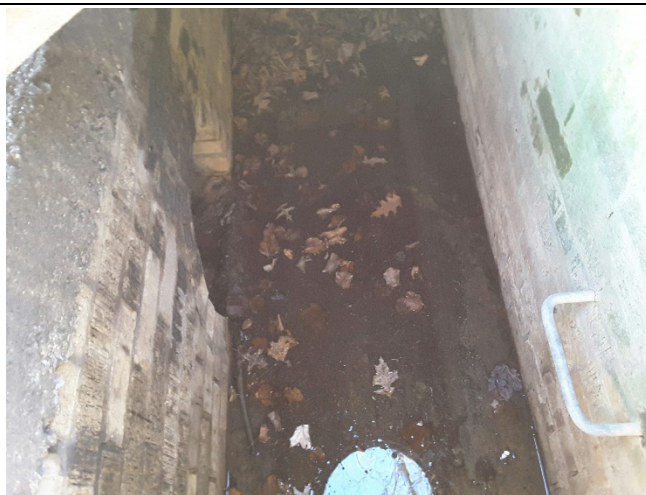
**Figure 3: Typical inlet with observed debris along Plum Spring Lane.**

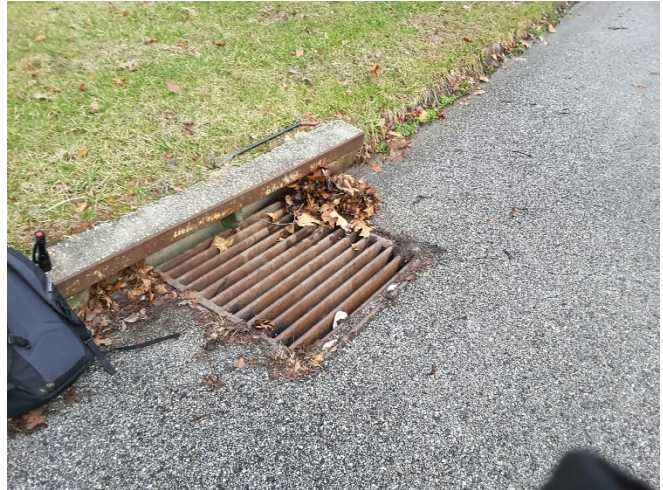
**Figure 1: Inlet along Spring Meadow Drive with observed debris and vegetation.**

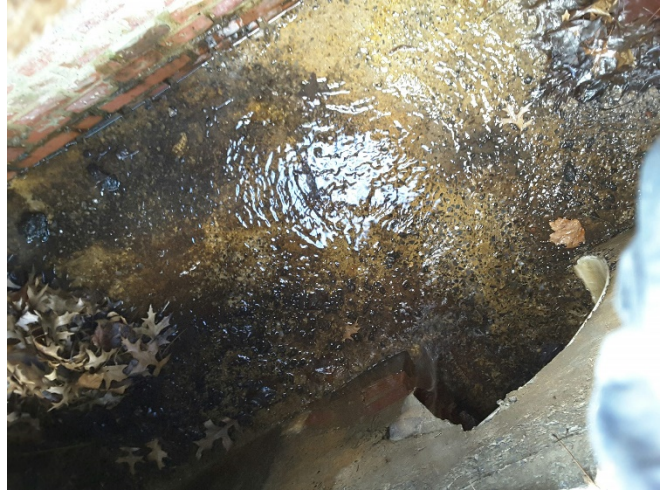
**Figure 2: Typical inlet along Westwood Drive with observed debris.**

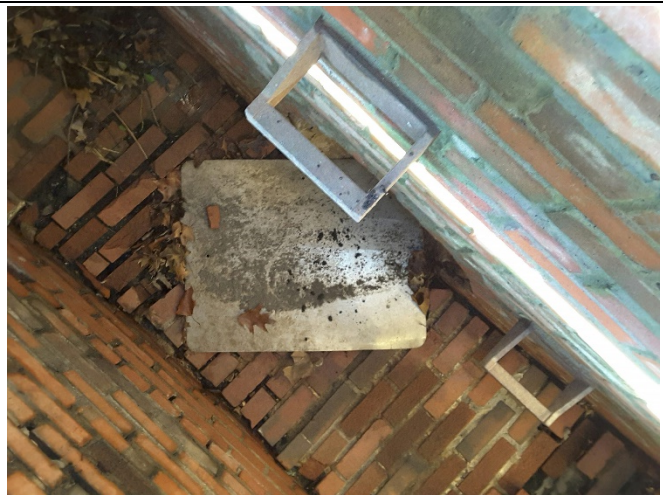
**Figure 2: Typical inlet requiring repair along Nanmark Court.**

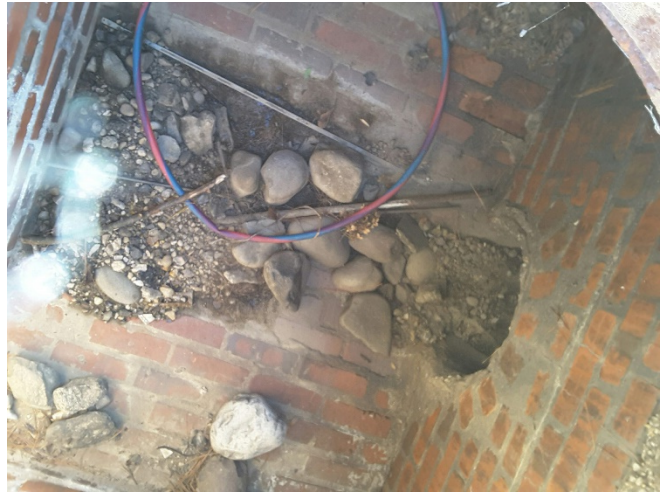
**Figure 2: Typical inlet along Lowlen Court with observed debris.**

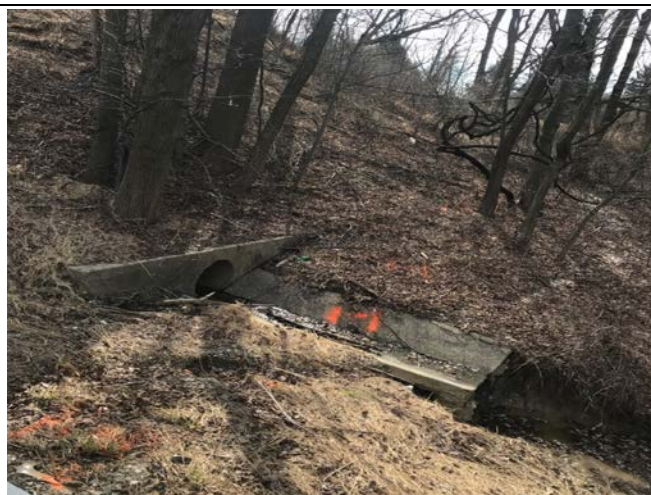
**Figure 4: Severe erosion in the outfall channel downstream of outfall.**

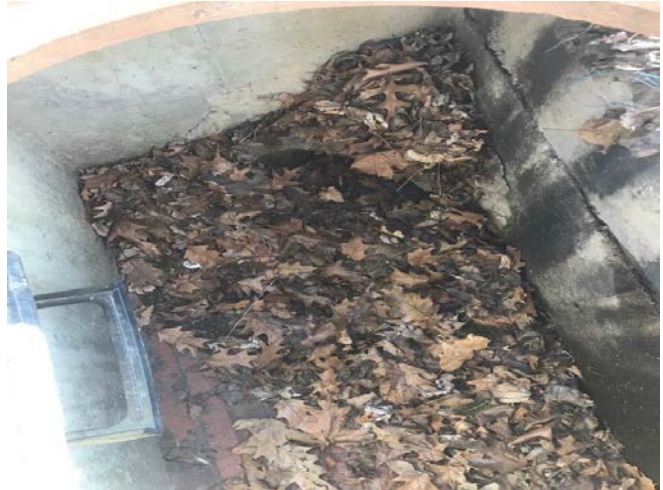
**Figure 2: Cleaning recommended inside inlet.**

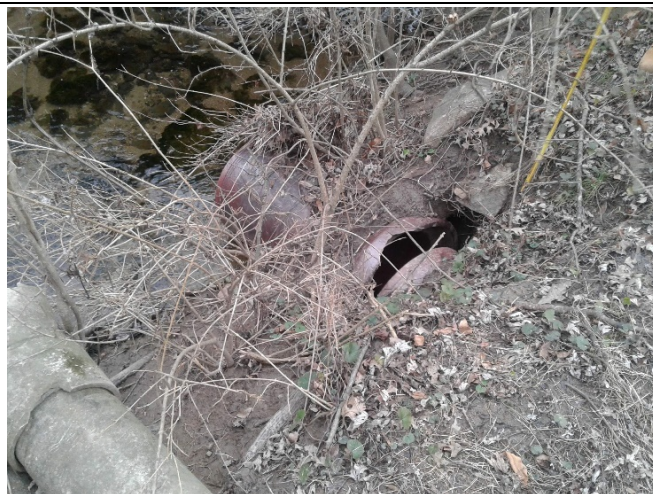
**Figure 4: Outfall is broken at joint.**

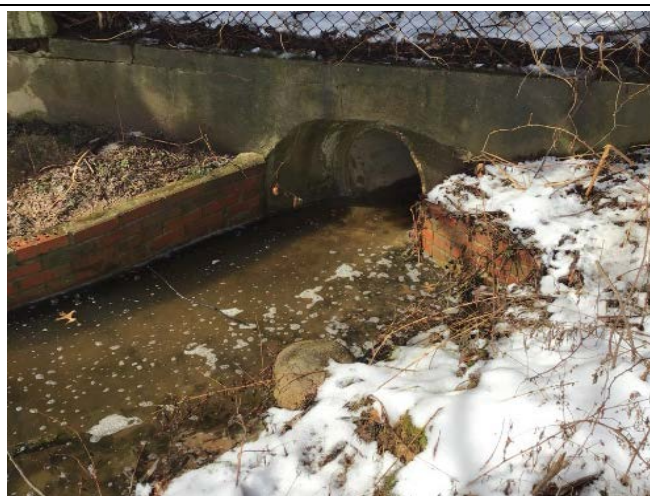
**Figure 2: Outfall at upstream end of channel with standing water observed.**

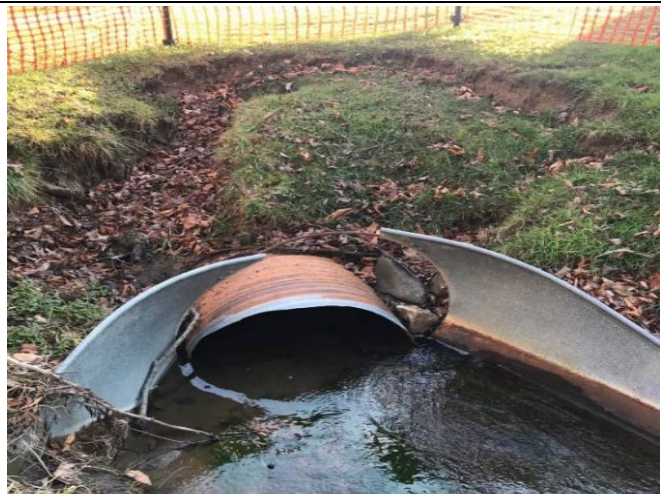
**Figure 4: Disjointed end section at outfall and erosion is in the process of being repaired.**

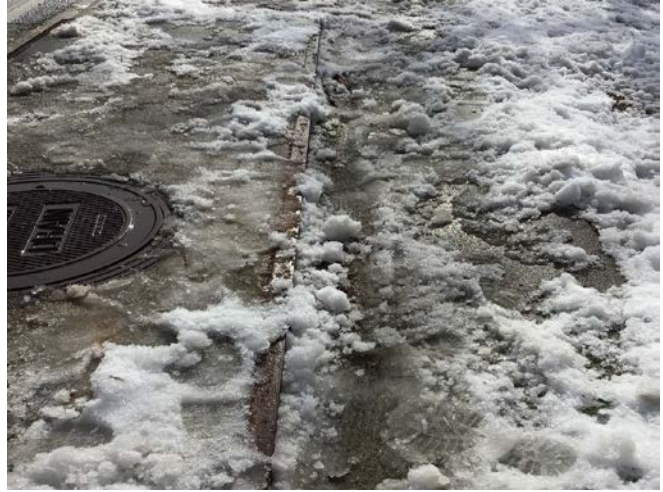
**Figure 2: The back of inlet is raised, causing a safety hazard for pedestrians.**

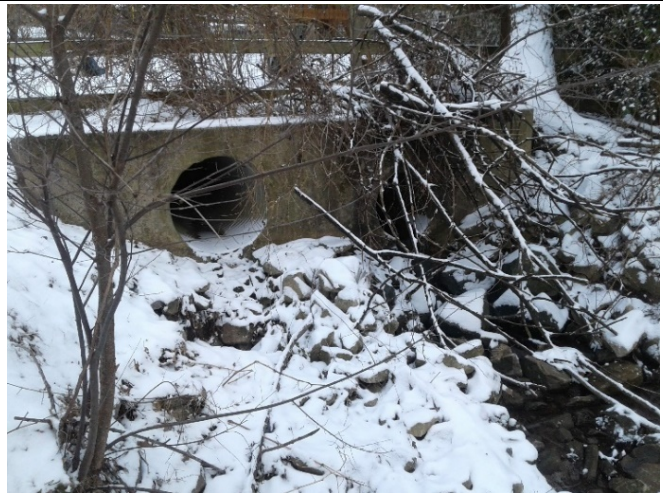
Figure 2: Branches partially blocking outfall.

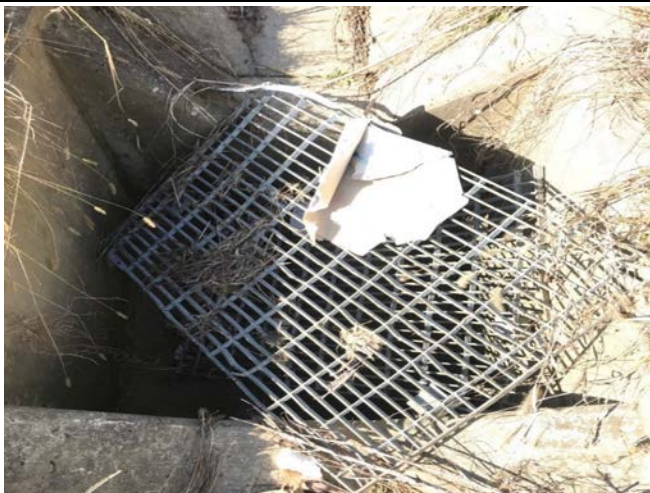
**Figure 2: Grate detached from inlet.**

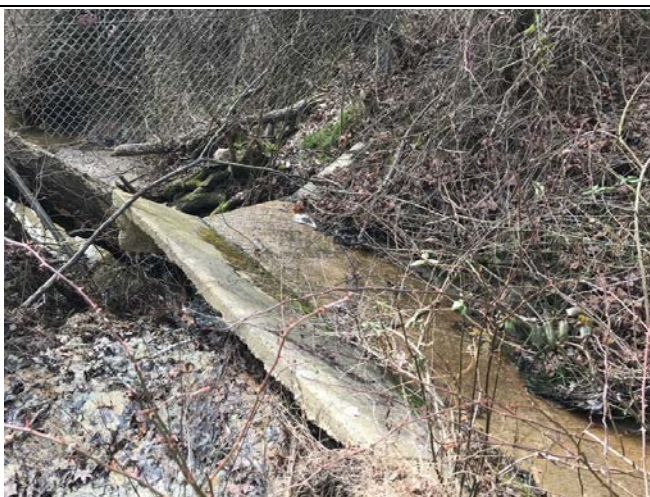
**Figure 4: Erosion surrounding outfall channel, and damage to concrete channel of outfall.**
