Case Study: Ellicott City Flood Event

Case Study-2016 Ellicott City Flood Event

Smith Planning and Design, LLC

4/15/2017

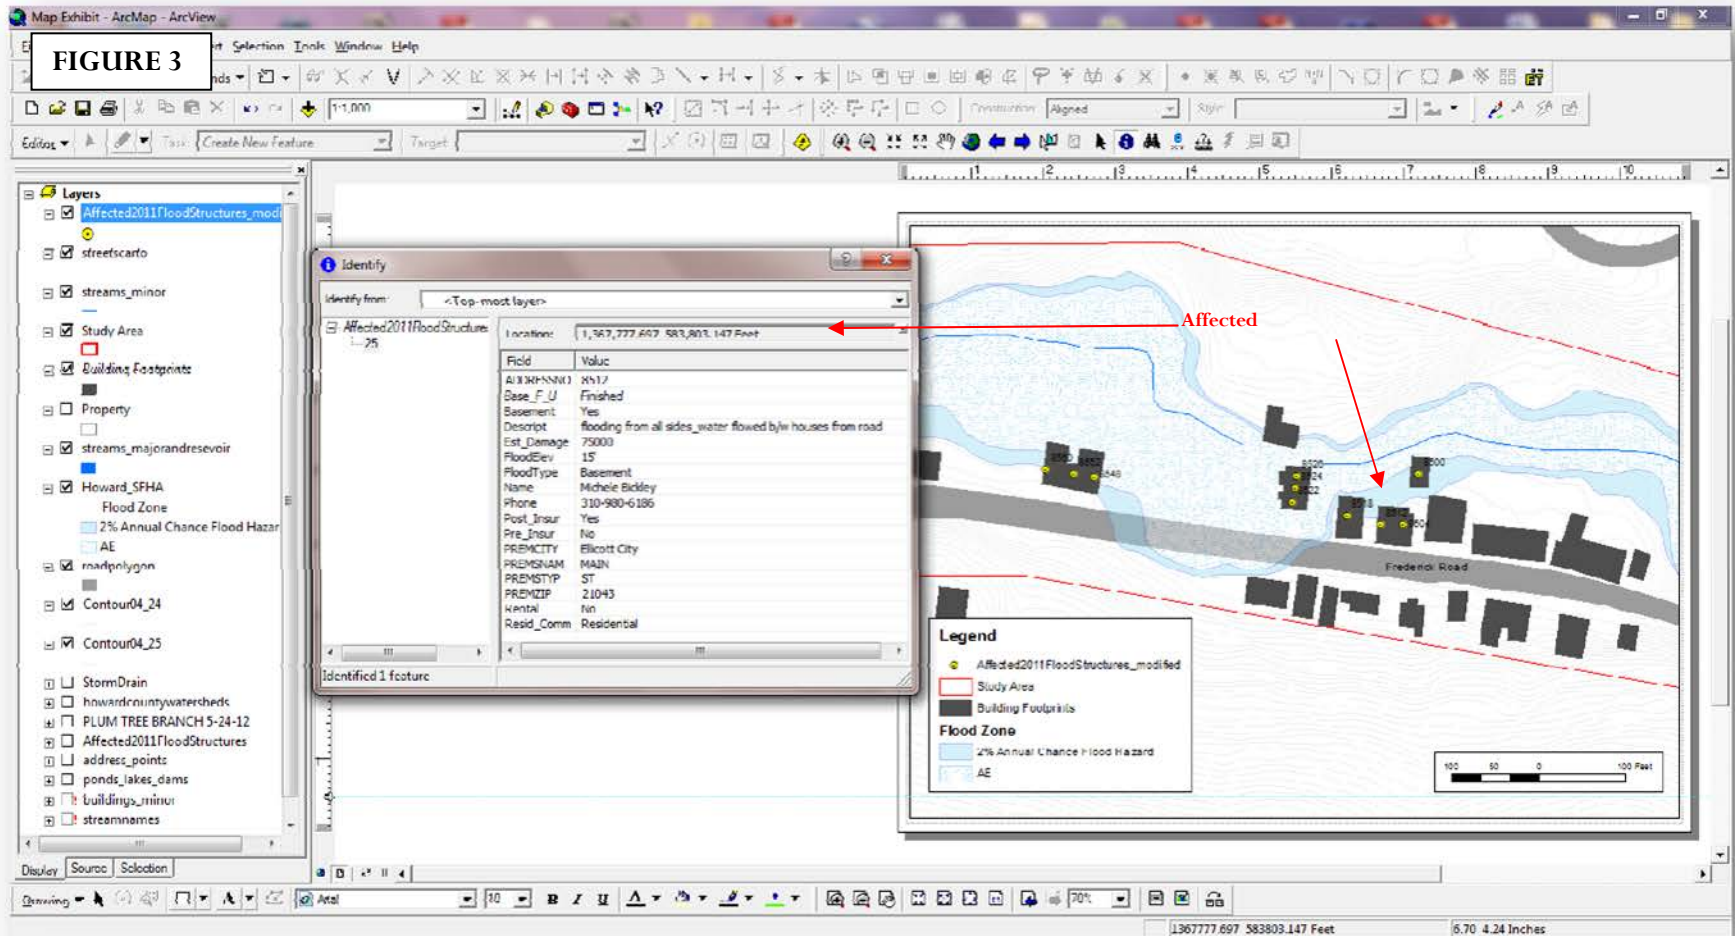
Each data point, shown as yellow dots on the map in Figure 3, has an associated identifier, and may be accessed in ArcGIS as a clickable point. Data captured on the interview form has been incorporated into ArcGIS and appears in a data box for each property associated with an identifier.
