**HOWARD COUNTY
BIOLOGICAL MONITORING
AND ASSESSMENT
SOUTH BRANCH PATAPSCO,
PATAPSCO RIVER LOWER
BRANCH A, and
PATAPSCO RIVER LOWER
BRANCH B
WATERSHEDS 2015**

NPDES Permit Number 00-DP-3318 MD0068322

December 31, 2015
Report

Versar, Inc.
9200 Rumsey Road, Suite 100
Columbia, MD 21045

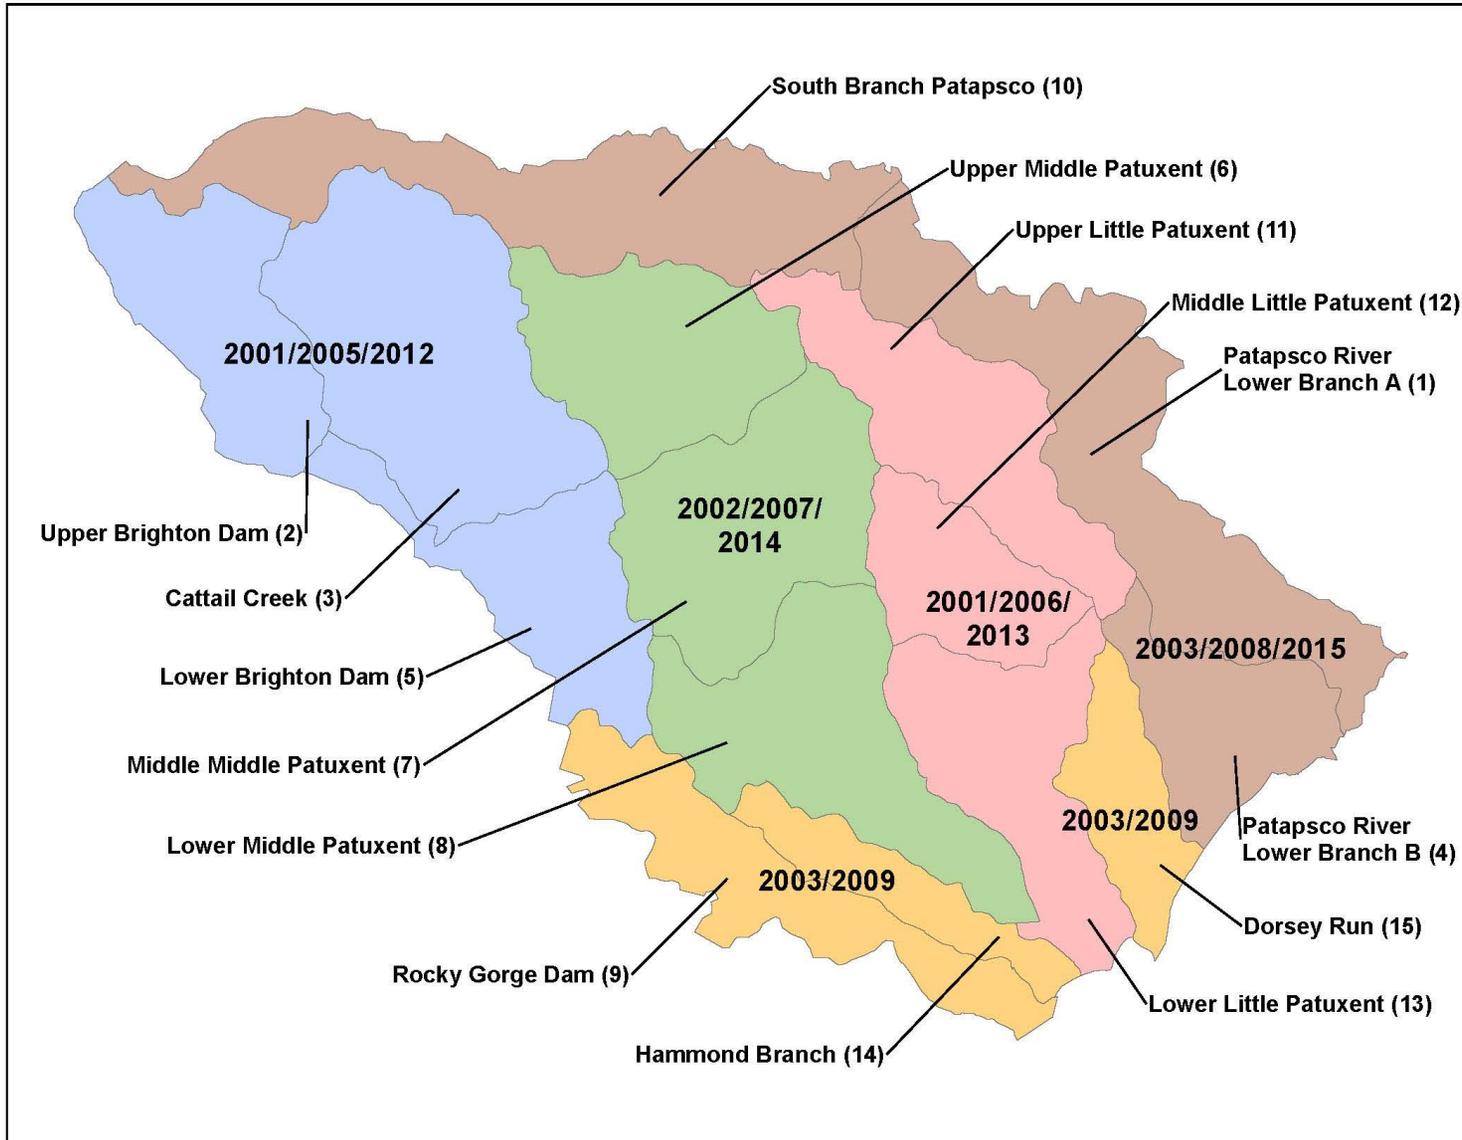
Figure 1-1. Summary of Howard County bioassessment progress (2001-2015)

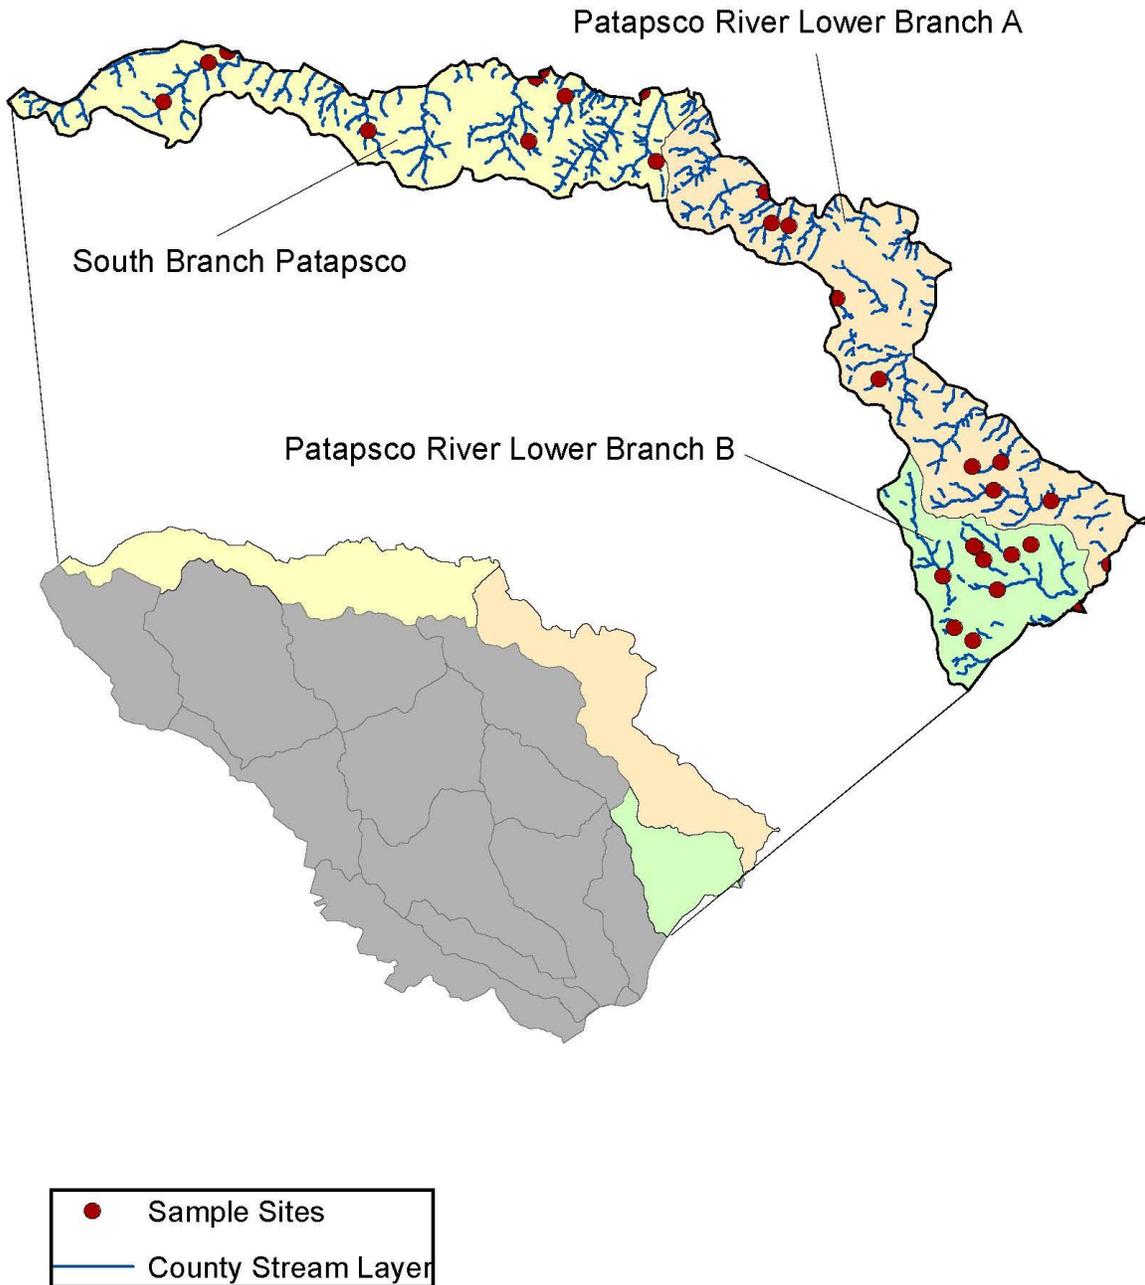
Figure 2-1. Patapsco South Branch, Patapsco River Lower Branch A, and Patapsco River Lower Branch B bioassessment sampling locations

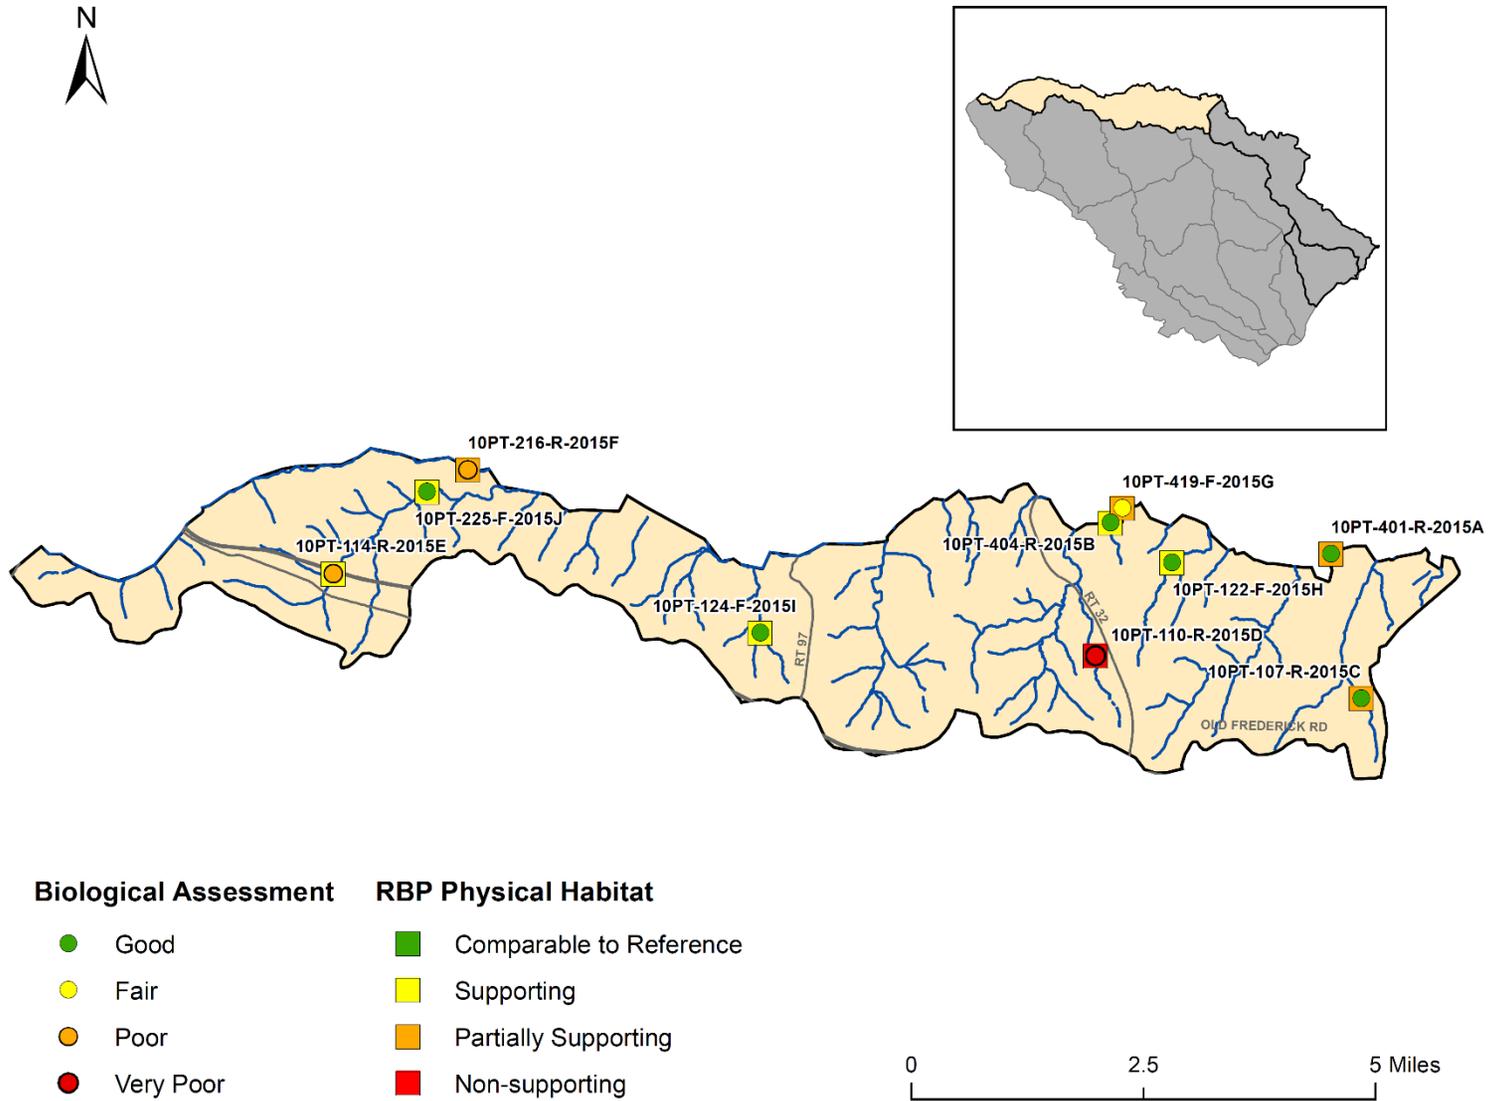
Figure 3-1. South Branch Patapsco sampling results

In 2015, 5 of the 10 sampling sites in the South Branch Patapsco subwatershed were on first-order streams, two were on second-order streams, and three were on fourth order streams. The field QC sample was collected at site 10PT-401-R-2015A. The subwatershed had an average BIBI score of 3.50 and a “Fair” condition rating; scores ranged from 1.33 to 4.67. The average RBP habitat assessment comparability score was 73 or “Partially Supporting,” and scores ranged from 56 (“Non-supporting”) to 80 (“Supporting”). The average PHI score was 65.39 (“Degraded”). The South Branch Patapsco had five stream channels classified as Rosgen type F, four as B, and one as G. Channel substrate at eight of the sites was predominantly gravel. The remaining two sites had sand as the dominant particle size class. Table 3-1 summarizes the results for the South Branch Patapsco subwatershed and Figure 3-1 shows the sites with BIBI and RBP comparability scores on a map.

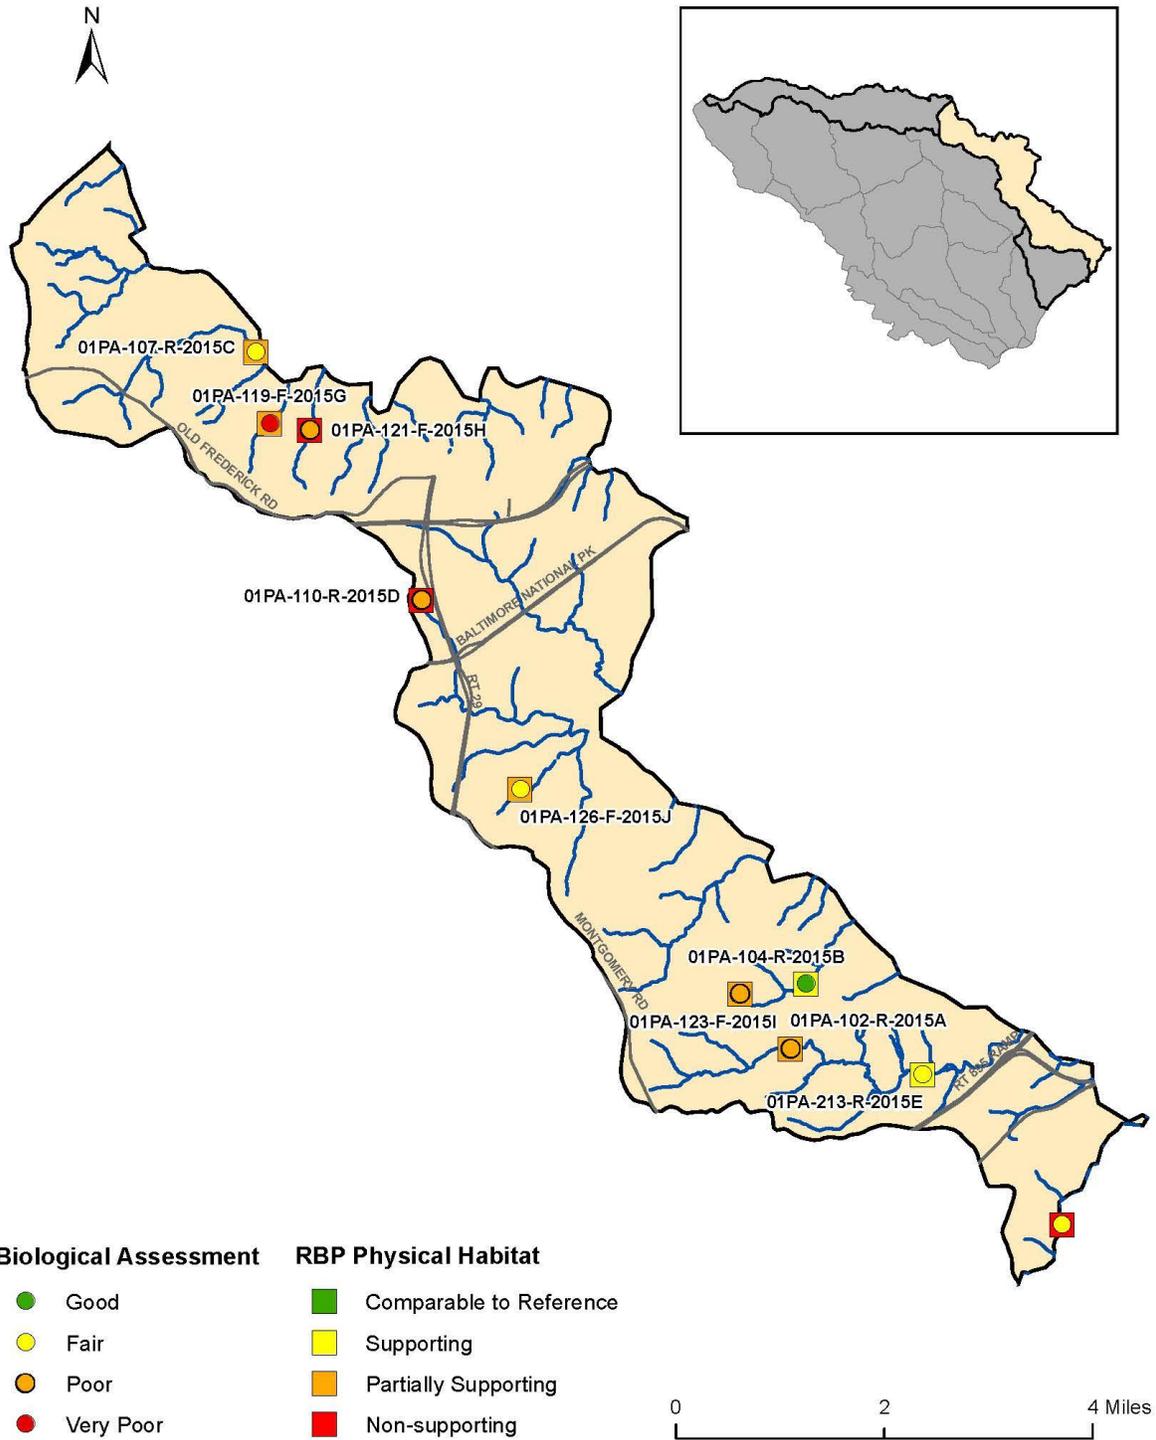
Figure 3-2. Patapsco River Lower Branch A sampling results

In 2015, 8 of the 10 sampling sites in the Patapsco River Lower Branch A were on first-order streams, one was on a second-order, and one was on a third-order stream. The field QC sample was collected at site 01PA-317-R-2015F. The subwatershed had an average BIBI score of 2.90 and a “Poor” condition rating; scores ranged from 1.67 to 4.00. The average RBP habitat assessment comparability score was 68.1 or “Partially Supporting,” and scores ranged from 49 (“Non-Supporting”) to 79 (“Supporting”). The average PHI score was 62.85 (“Degraded”). Seven of the stream channels assessed in the Patapsco River Lower Branch A were classified as Rosgen type F. Two of the remaining channels were classified as C, and one as a type G. Substrates were predominantly gravel at nine of the sites. One site had a sandy substrate. Table 3-2 summarizes the results for the Patapsco River Lower Branch A subwatershed and Figure 3-2 shows the sites with BIBI and RBP comparability scores on a map.

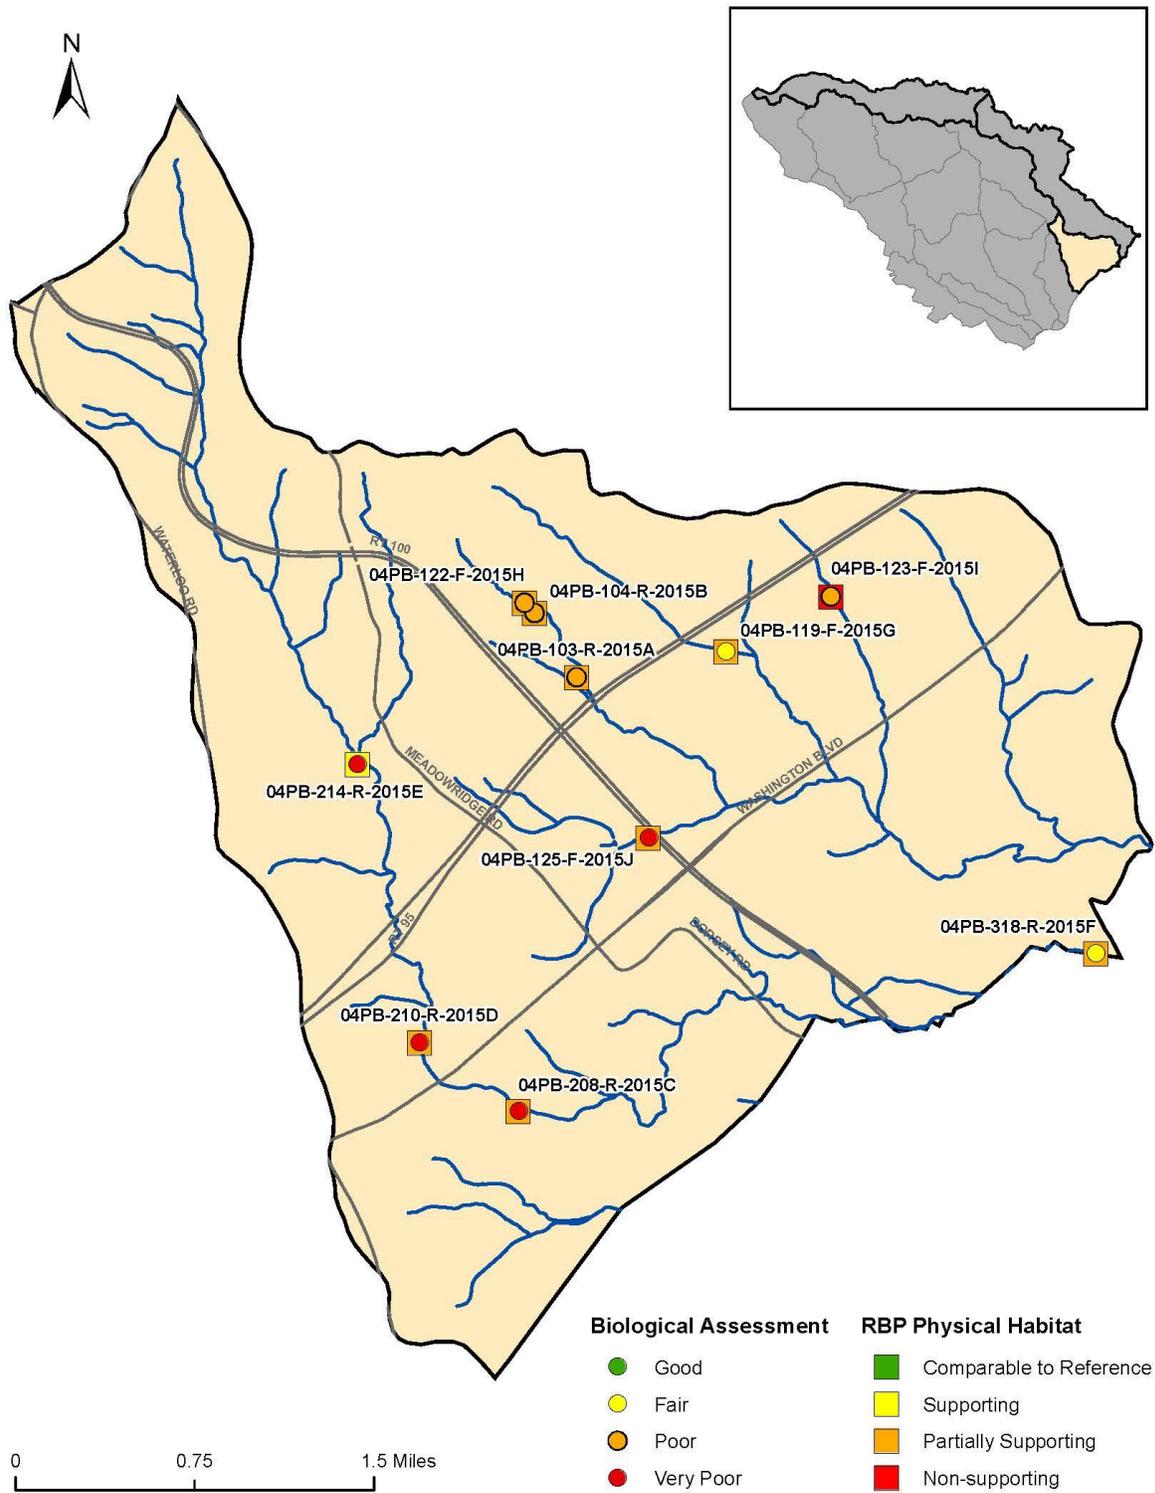
Figure 3-3. Patapsco River Lower Branch B sampling results

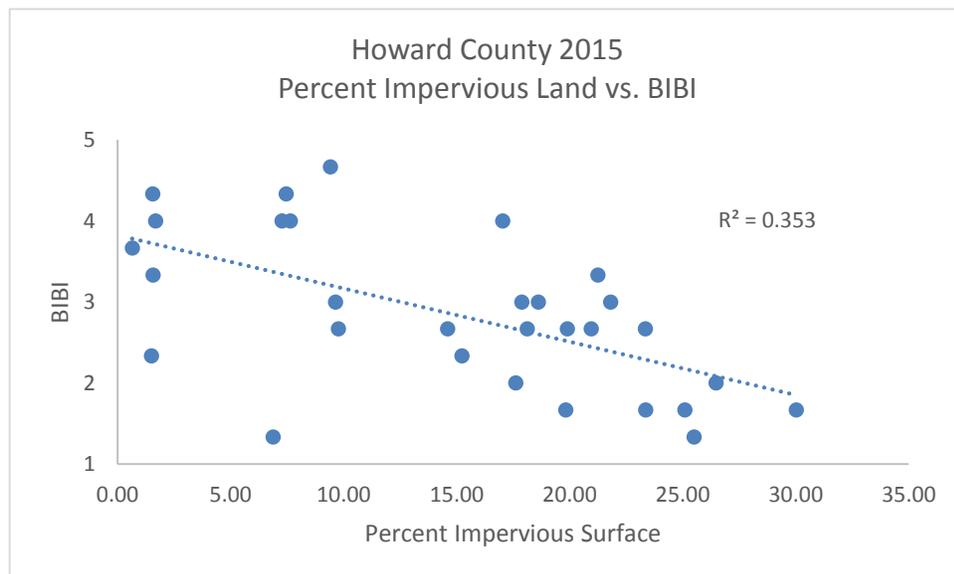
Figure 4-1. Regression relationships between the Benthic Index of Biotic Integrity (BIBI) and impervious surface in upstream catchments during 2015 Howard County Biological Monitoring

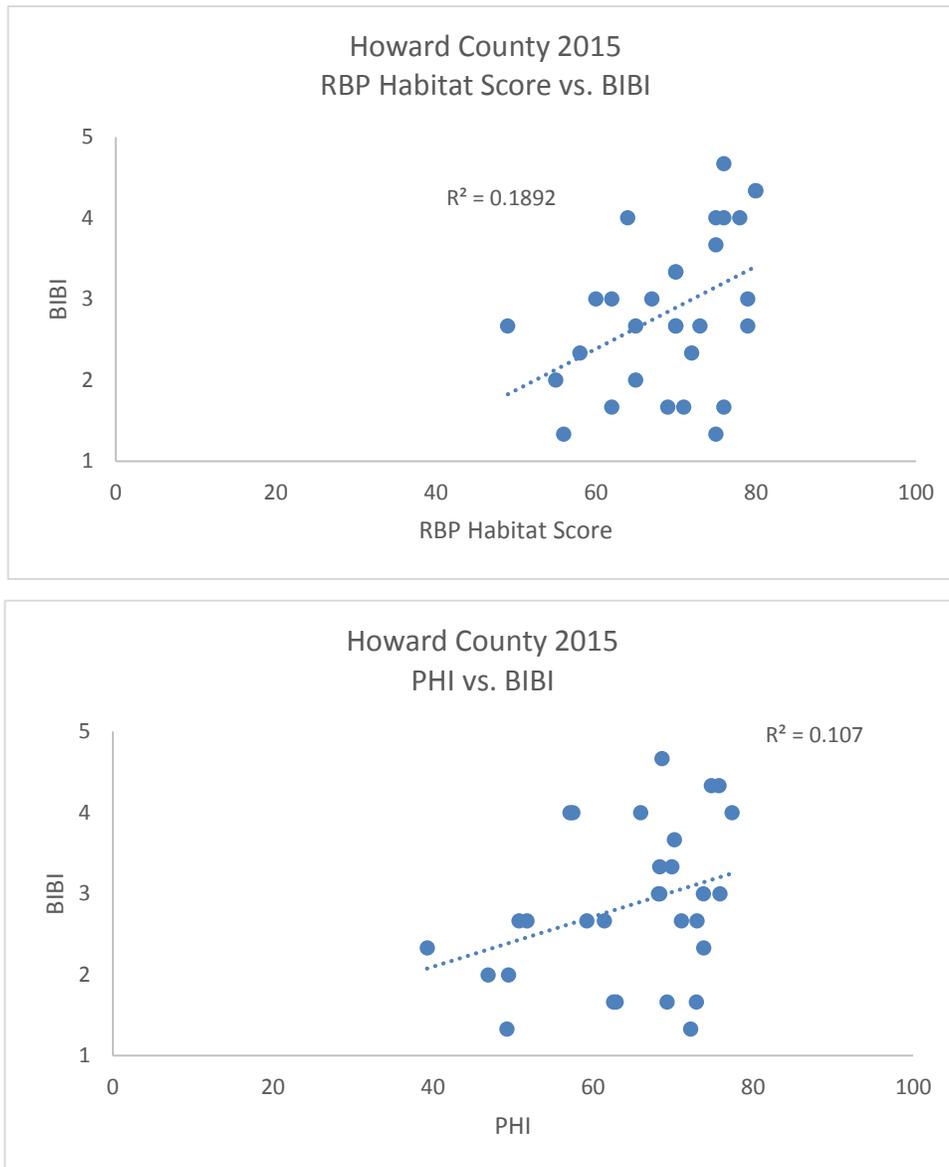
Figure 4-2. Regression relationships between the Benthic Index of Biotic Integrity (BIBI) and both RBP Habitat Assessment Score and Physical Habitat Indicator (PHI) for sites sampled in the 2015 Howard County Biological Monitoring

The relationships between the BIBI and both the RBP habitat assessment score and the PHI score were not significant ($R^2 = 0.19$, $p = .42$, $R^2 = 0.09$, $p = .84$, respectively). As the habitat scores increase, so does the BIBI (see Figure 4-2). This suggests that physical habitat conditions directly affect the biological condition of a stream.

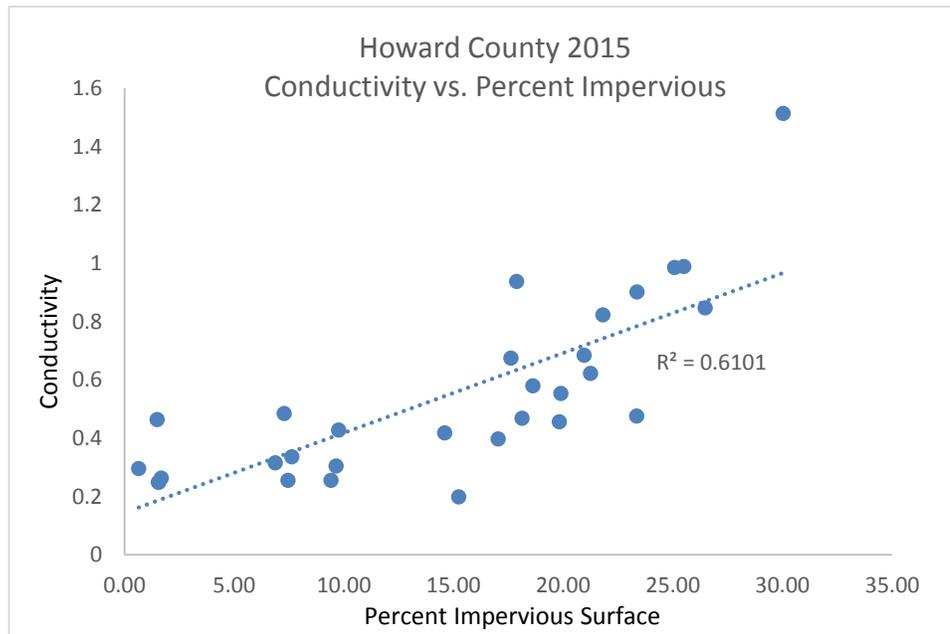
Figure 4-3. Regression relationship between the percent impervious surface and conductivity for sites sampled in the 2015 Howard County Biological Monitoring

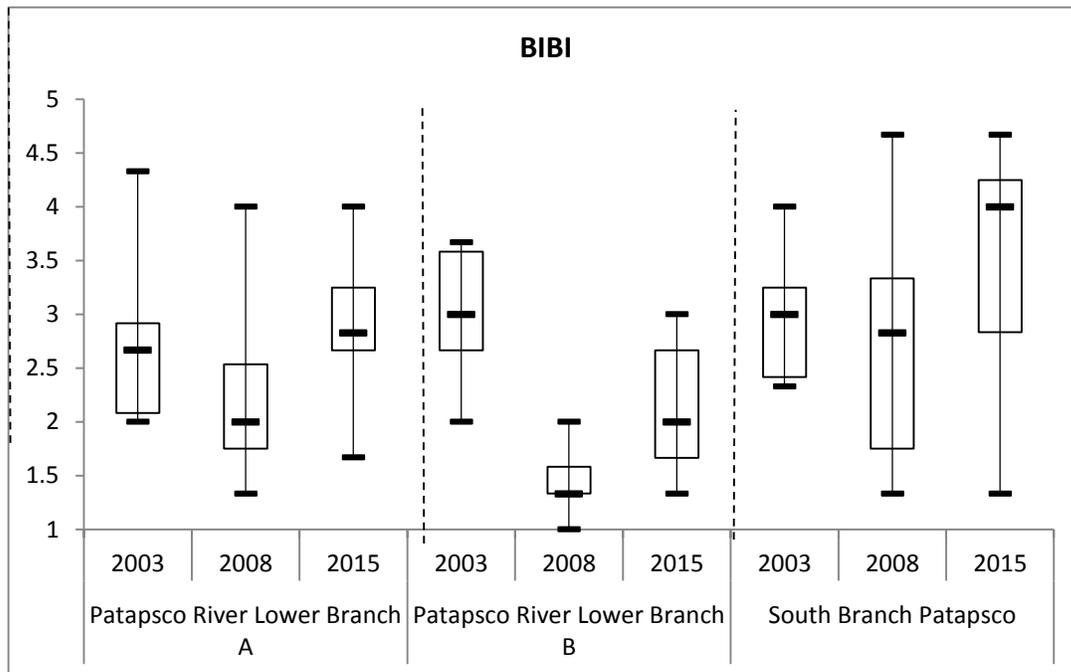
Figure 4-4. Comparison of 2003, 2008, and 2015 BIBI scores

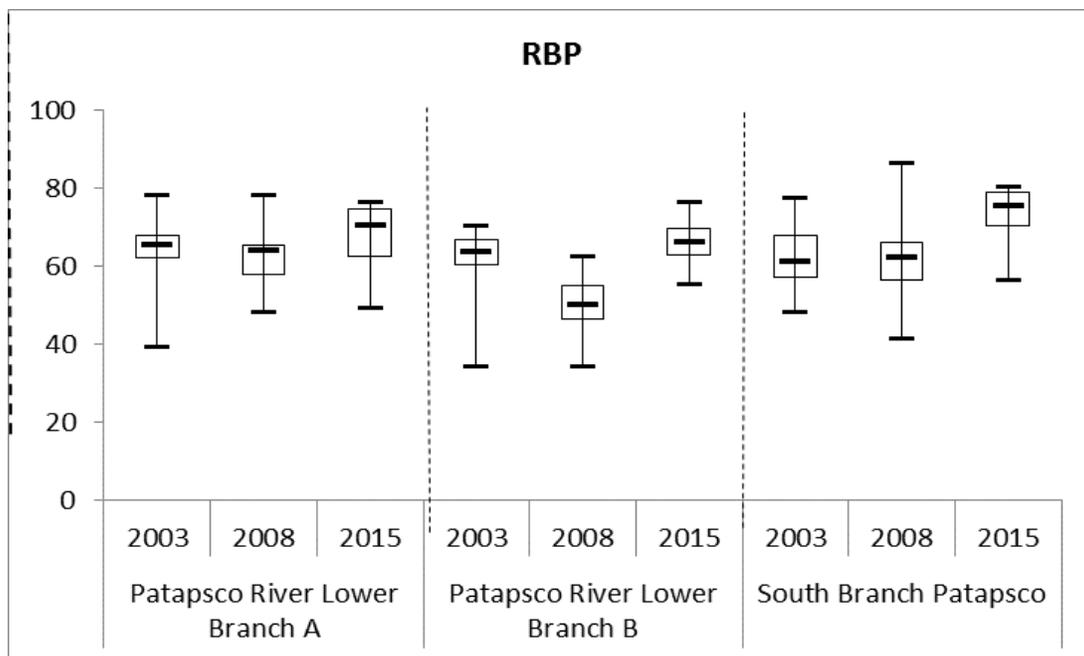
Figure 4-4. Comparison of 2003, 2008, and 2015 RBP scores

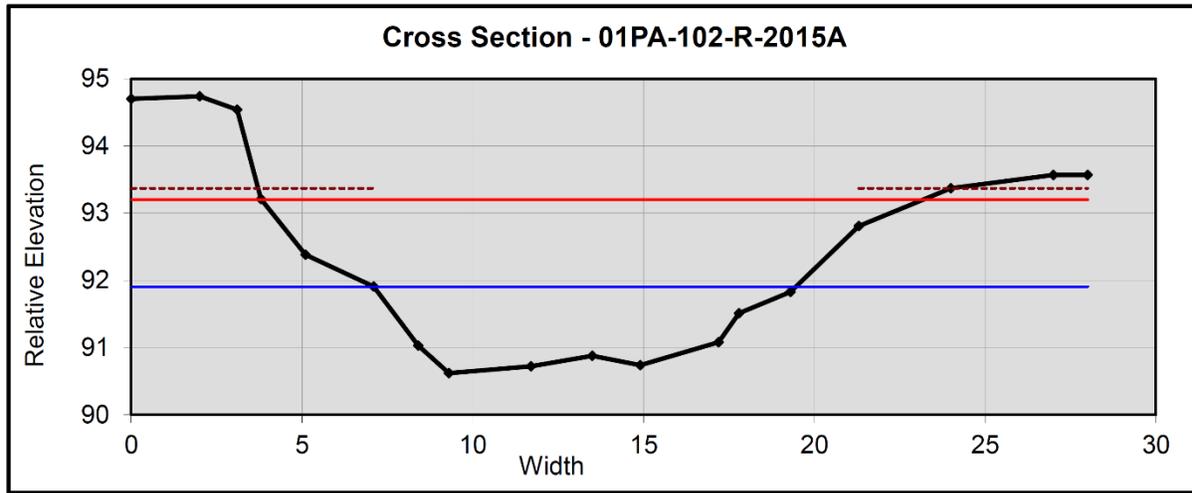
Bankfull Dimensions	
11.1	x-section area (ft.sq.)
12.4	width (ft)
0.9	mean depth (ft)
1.3	max depth (ft)
13.0	wetted perimeter (ft)
0.9	hyd radi (ft)
13.8	width-depth ratio

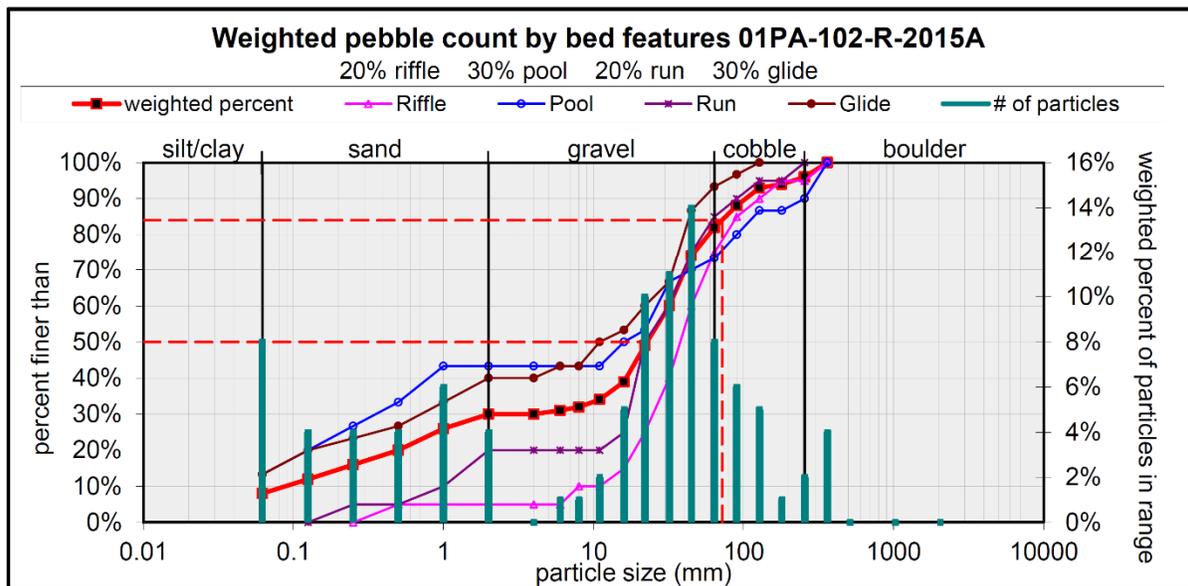
Size (mm)		Size Distribution		Type	
D16	0.25	mean	4.2	silt/clay	8%
D35	12	dispersion	47.6	sand	22%
D50	23	skewness	-0.47	gravel	52%
D65	36			cobble	14%
D84	72			boulder	4%
D95	210

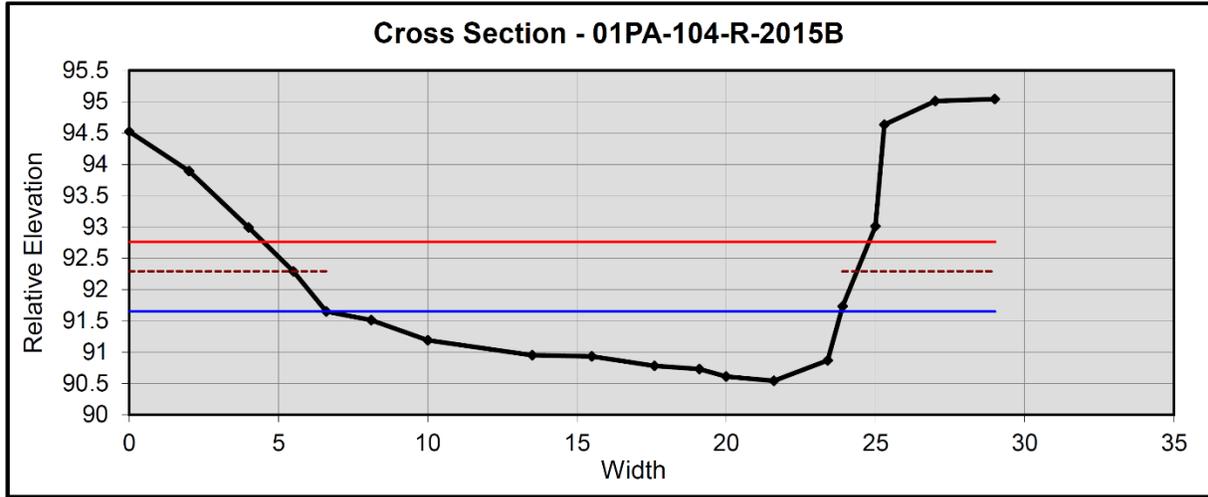
Bankfull Dimensions		Flood Dimensions		Bankfull Flow	
11.6	x-section area (ft.sq.)	20.3	W flood prone area (ft)	3.1	velocity (ft/s)
17.3	width (ft)	1.2	entrenchment ratio	35.8	discharge rate (cfs)
0.7	mean depth (ft)	1.8	low bank height (ft)	1.32	channel slope (%)
1.1	max depth (ft)	1.6	low bank height ratio		
17.8	wetted parimeter (ft)				
0.7	hyd radi (ft)	<u>Flow Resistance</u>		<u>Sinuosity</u>	<u>Channel Type</u>
25.6	width-depth ratio	0.042	Manning's roughness	1.47	F4

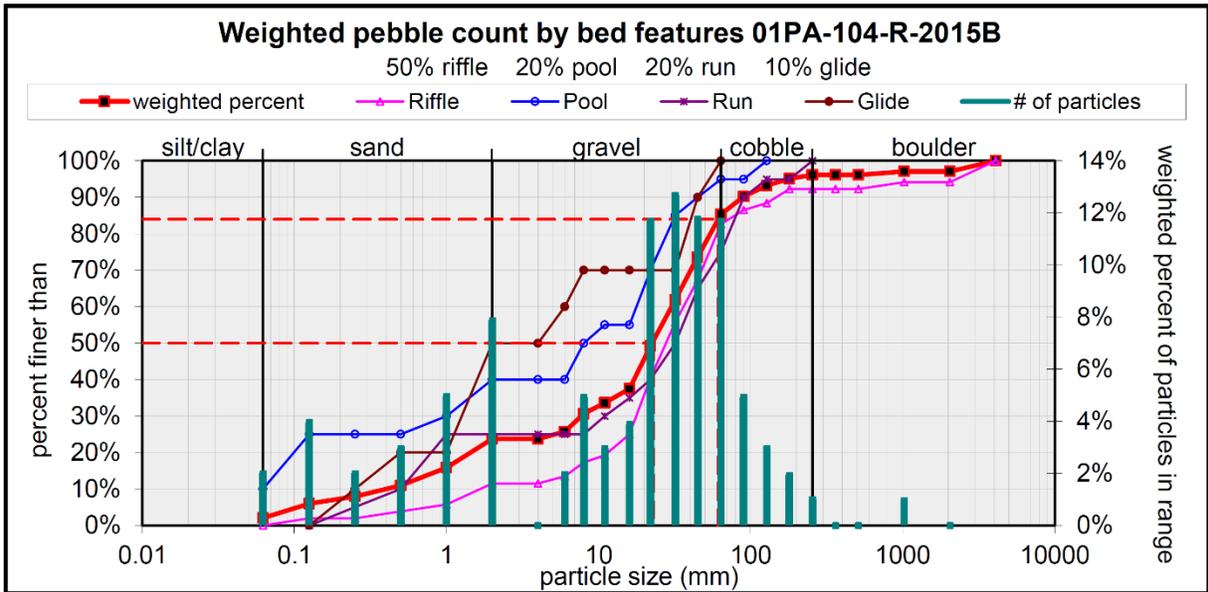
Size (mm)		Size Distribution		Type	
D16	1	mean	7.8	silt/clay	2%
D35	13	dispersion	12.8	sand	22%
D50	23	skewness	-0.35	gravel	62%
D65	35			cobble	11%
D84	61			boulder	4%
D95	180

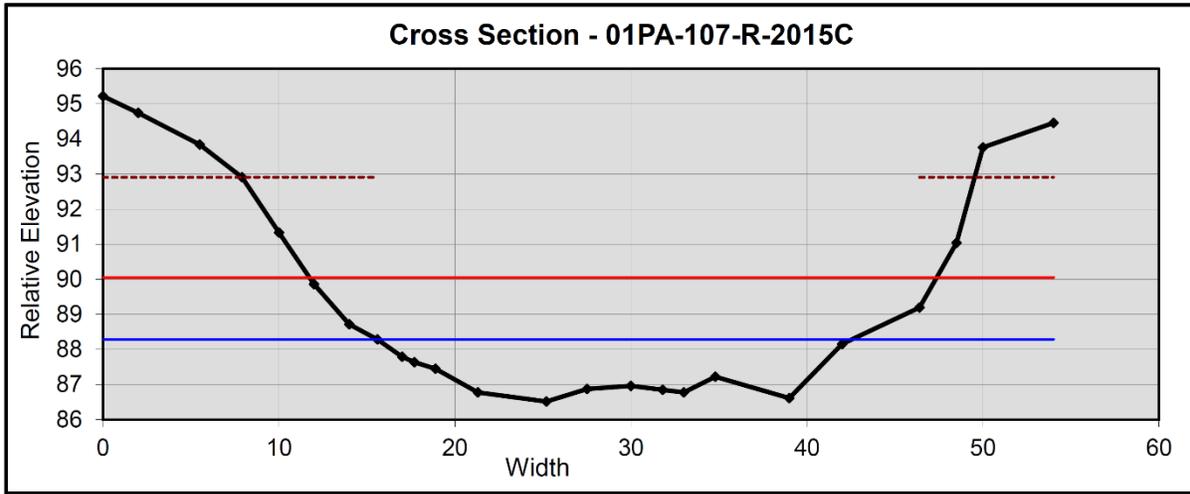
Bankfull Dimensions		Flood Dimensions		Bankfull Flow	
33.1	x-section area (ft.sq.)	35.7	W flood prone area (ft)	3.7	velocity (ft/s)
27.0	width (ft)	1.3	entrenchment ratio	122.9	discharge rate (cfs)
1.2	mean depth (ft)	6.4	low bank height (ft)	1.55	channel slope (%)
1.8	max depth (ft)	3.6	low bank height ratio		
27.7	wetted perimeter (ft)				
1.2	hyd radi (ft)	<u>Flow Resistance</u>		<u>Sinuosity</u>	<u>Channel Type</u>
22.0	width-depth ratio	0.056	Manning's roughness	1.07	F4

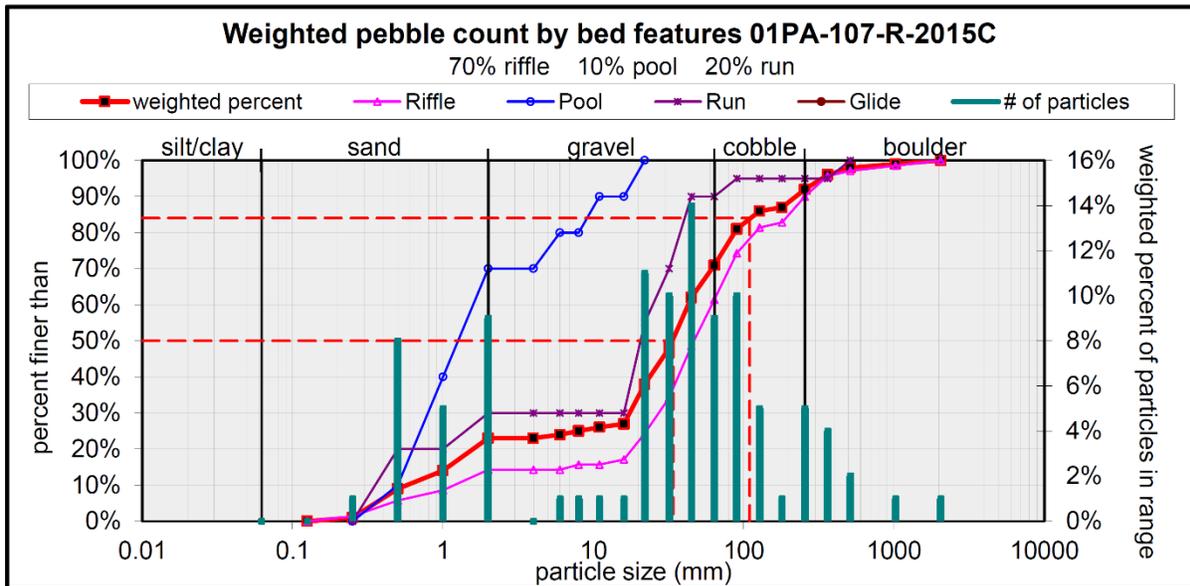
Size (mm)		Size Distribution		Type	
D16	1.2	mean	11.5	silt/clay	0%
D35	20	dispersion	15.8	sand	23%
D50	34	skewness	-0.34	gravel	48%
D65	51			cobble	21%
D84	110			boulder	8%
D95	330
