Northern Little Patuxent River Watershed Assessment

COMMUNITY MEETING NO. 2

December 10, 2015

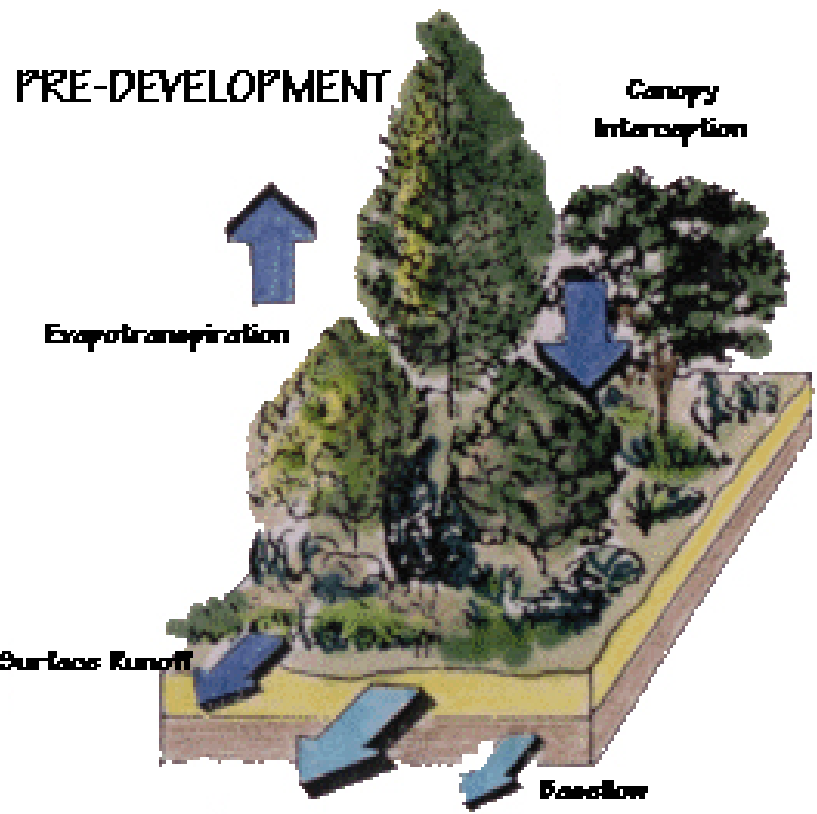
PRE-DEVELOPMENT

WATER BALANCE

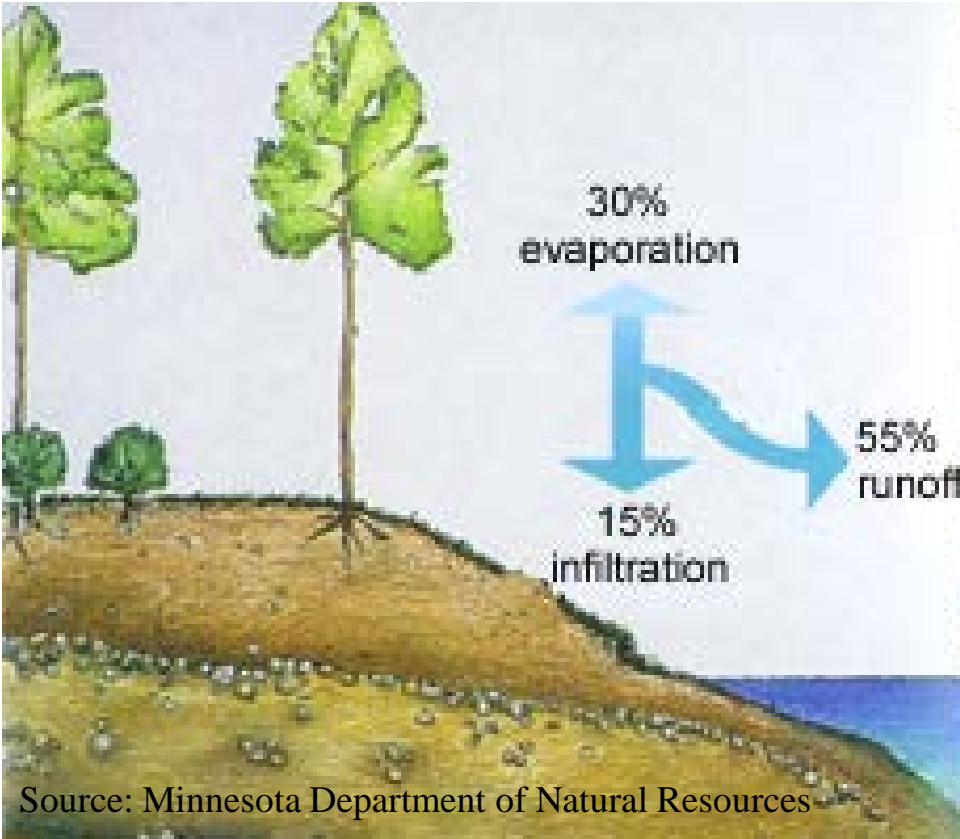
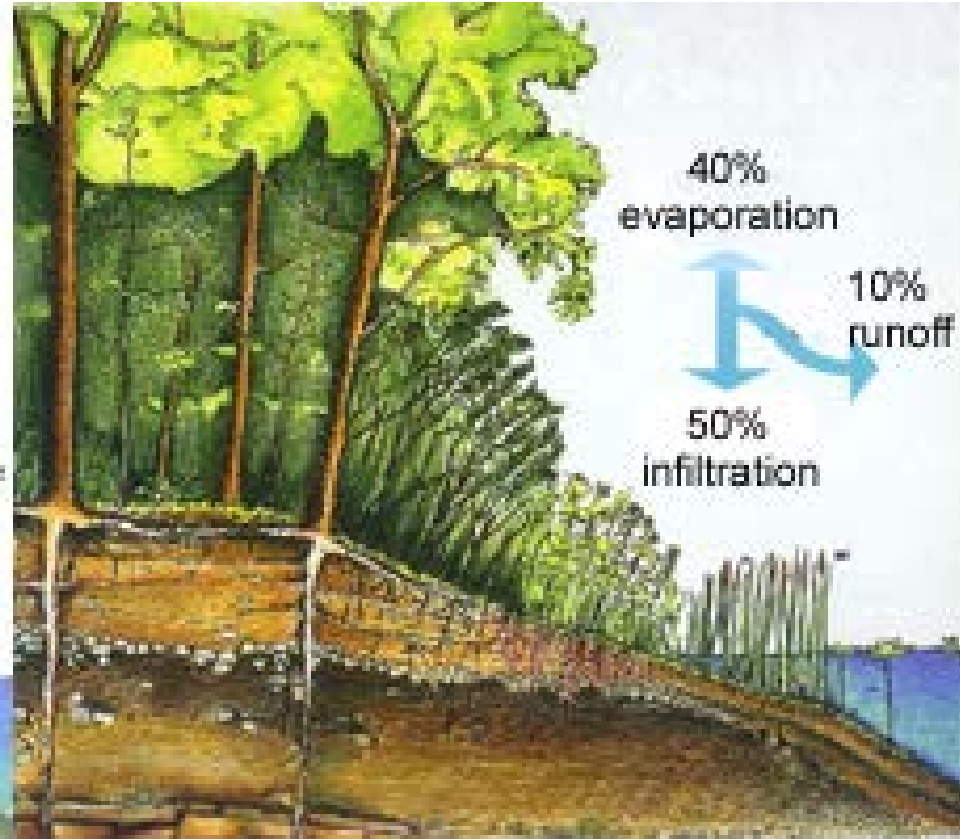
Water quickly runs off a shoreline cleared of natural vegetation, washing nutrients and pesticides into the water. A natural shoreline holds rainfall, which soaks into the soil; less water, soil and chemicals run into the lake or river. Shoreline and aquatic plants anchor shoreline areas, helping to protect them from erosion due to runoff and waves (Source:MN DNR)

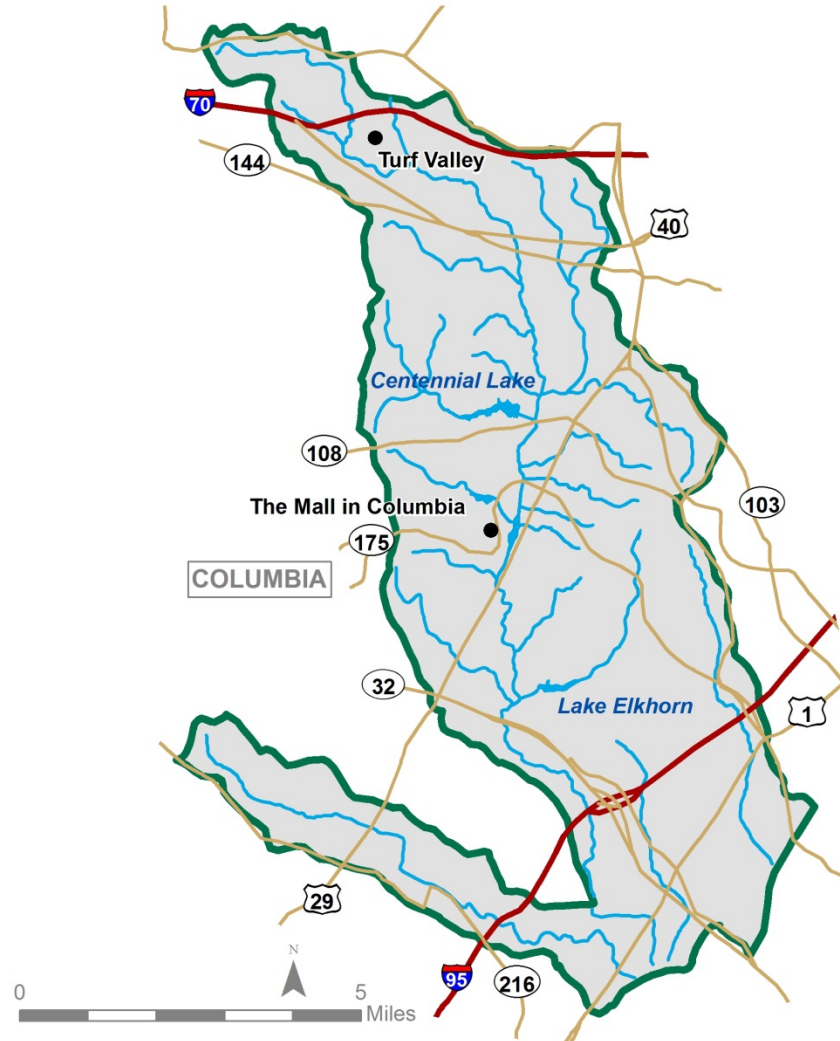
Little Patuxent River Watershed

- 59 square miles
- 37,727 acres
- **9,688 impervious acres**
- 9,043 wooded acres
- 190 miles of streams
- **1,746 stormwater BMPs treating 47 acres of impervious**

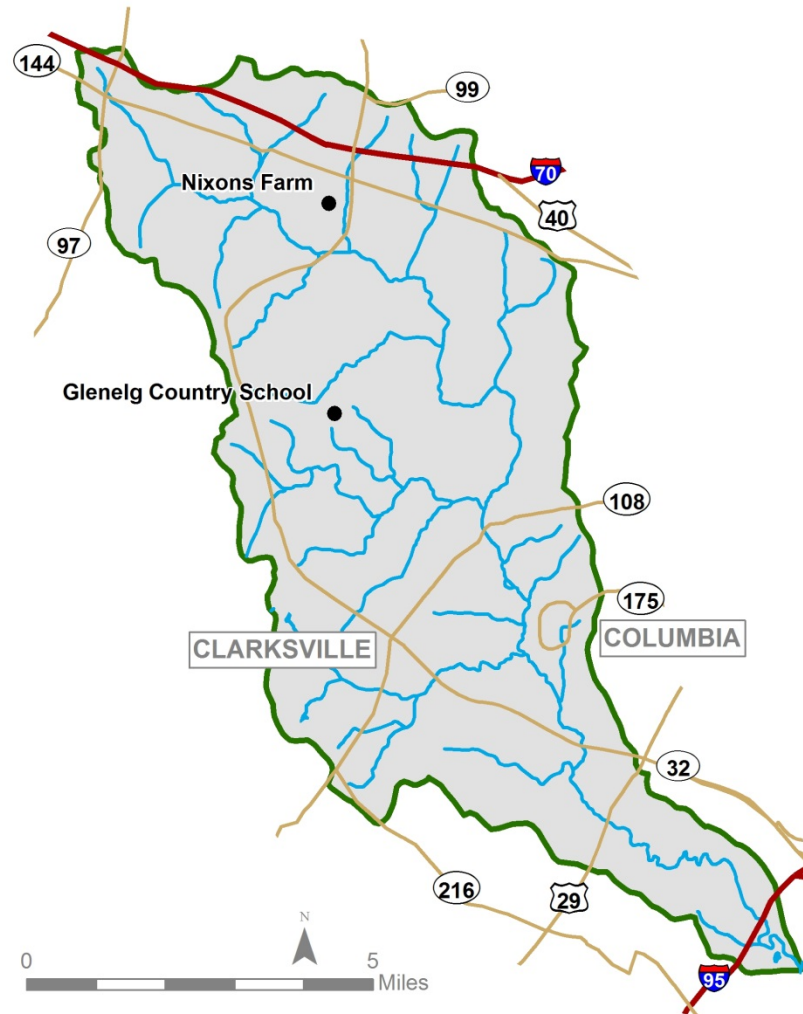
Middle Patuxent River Watershed

- 58 square miles
- 37,074 acres
- **3,675 impervious acres**
- 12,367 wooded acres
- 227 miles of streams
- **593 stormwater BMPs treating 40 acres of impervious**

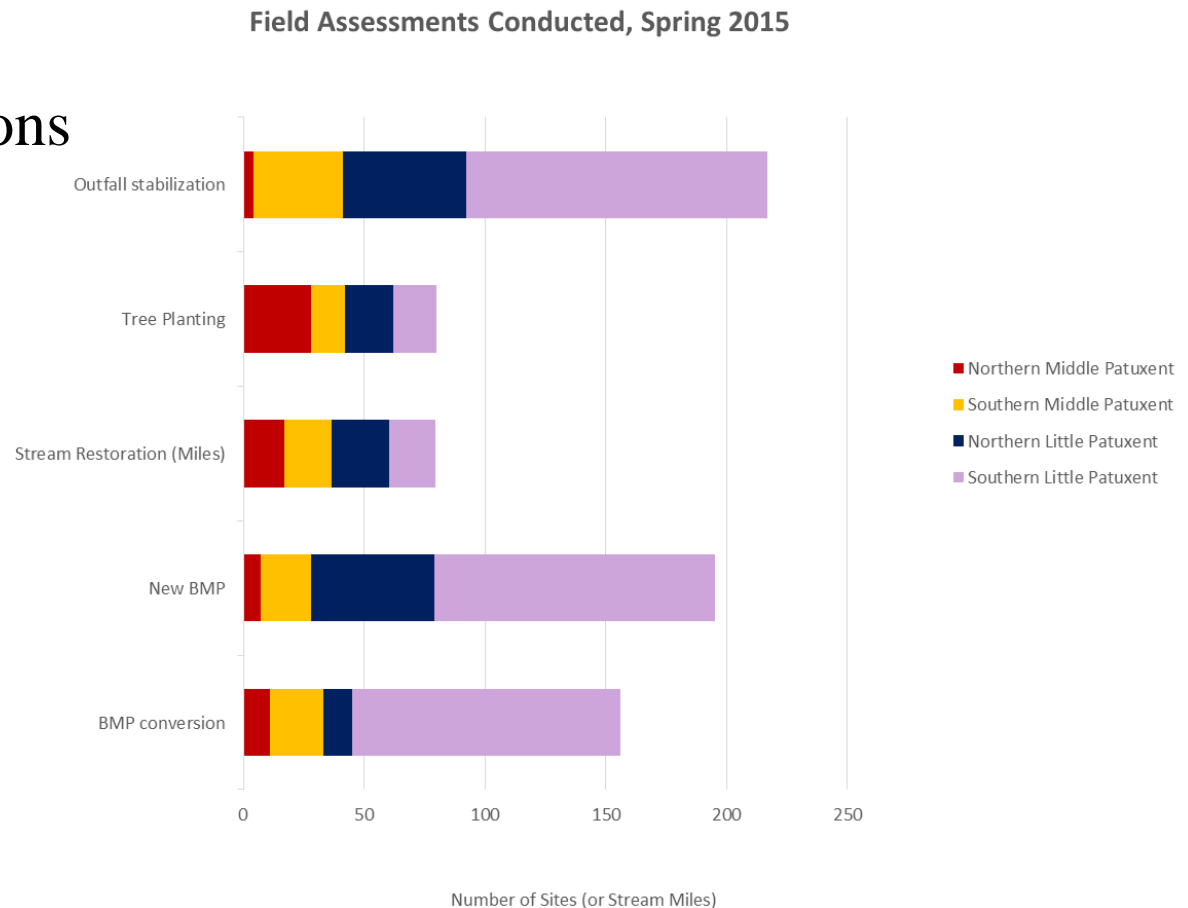
Field Assessment Results – Total

- 217 Outfall stabilizations
- 80 Tree planting sites
- 79.4 Stream miles
- 195 New BMP sites
- 156 BMP conversions

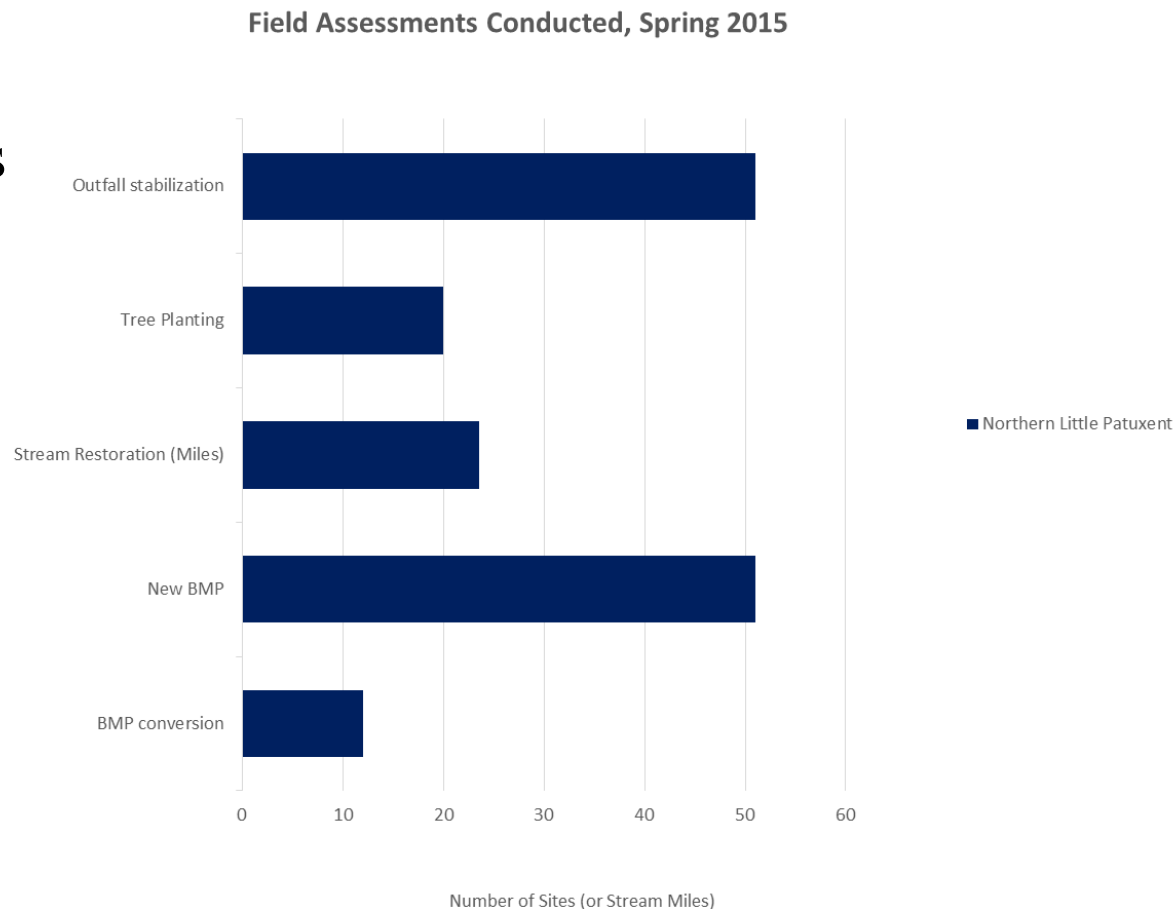
Field Assessment Results – NLP

- 51 outfall stabilizations
- 20 tree planting sites
- 23.6 miles of stream
- 51 new BMP sites
- 12 BMP conversions

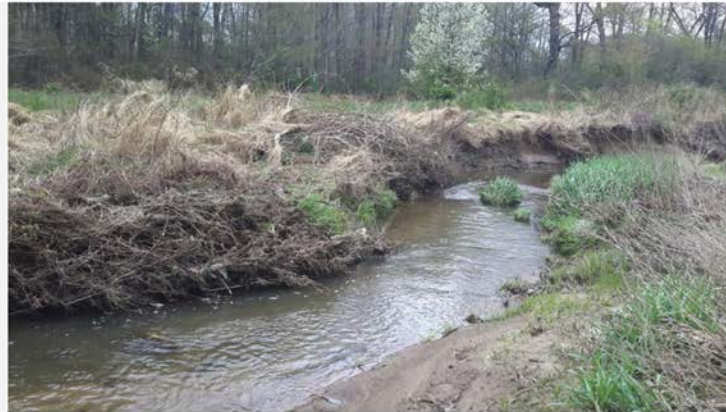
Facing downstream, an average 4 ft. recently eroded bank.

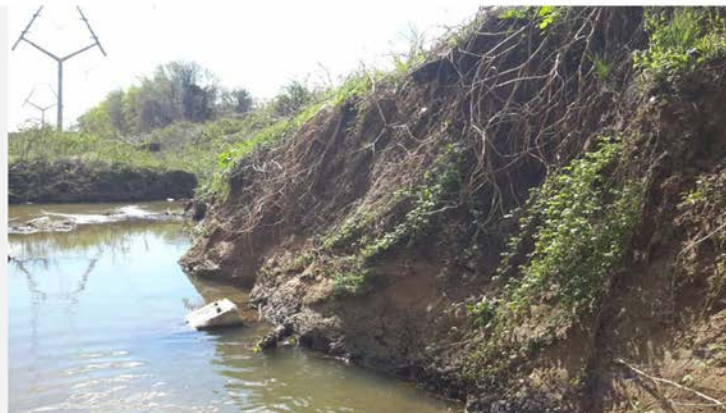
Facing downstream, very high eroded banks cutting into the hillslope near the school.
