Northern Middle Patuxent River Watershed Assessment

COMMUNITY MEETING NO. 2 December 2, 2015

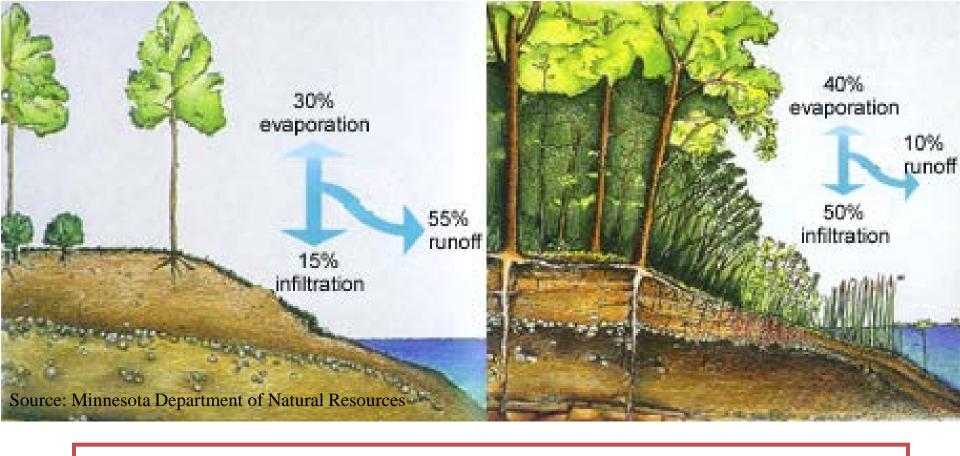
Water quickly runs off a shoreline cleared of natural vegetation, washing nutrients and pesticides into the water. A natural shoreline holds rainfall, which soaks into the soil; less water, soil and chemicals run into the lake or river. Shoreline and aquatic plants anchor shoreline areas, helping to protect them from erosion due to runoff and waves (Source:MN DNR)

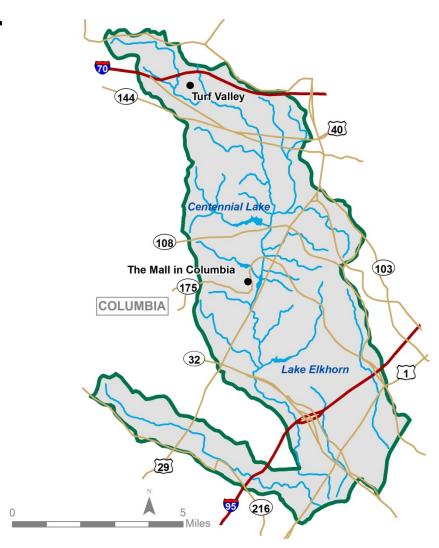
Little Patuxent River

- 59 square miles
- 37,727 acres
- 9,688 impervious acres
- 9,043 wooded acres
- 190 miles of streams
- 1,746 stormwater BMPs treating 47 acres of impervious area

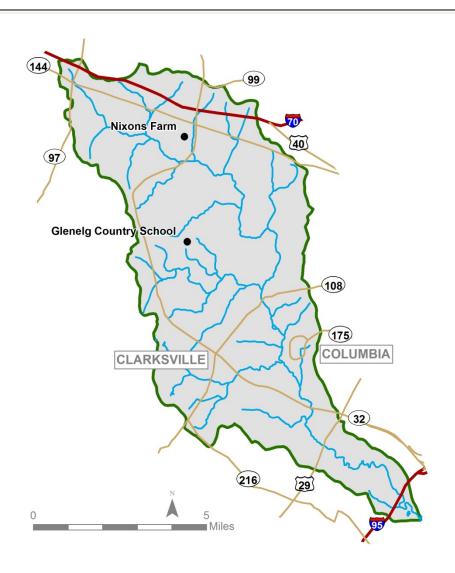
Middle Patuxent River

- 58 square miles
- 37,074 acres
- 3,675 impervious acres
- 12,367 wooded acres
- 227 miles of streams
- 593 stormwater BMPs treating 40 acres of impervious area

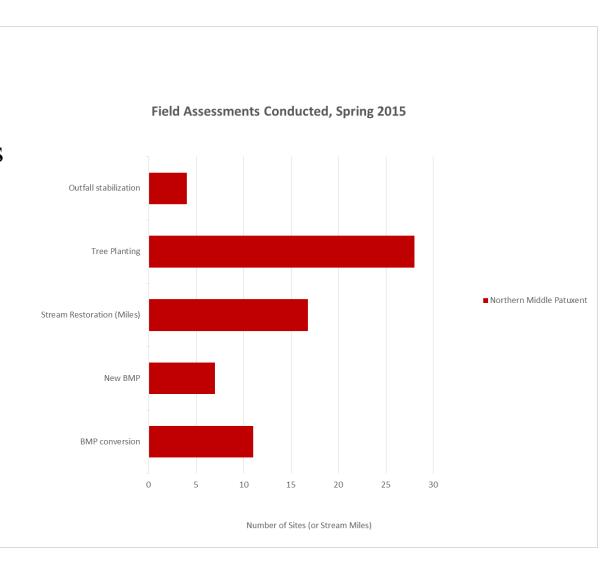
Field Assessment Results - NMP

- 4 outfall stabilizations
- 28 tree planting sites
- 16.8 miles of stream
- 7 new BMP sites
- 11 BMP conversions

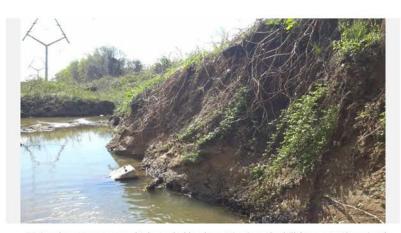
Facing downstream, very high eroded banks cutting into the hillslope near the school.

This project site includes two stream assessment sites: SMP-SR-F336A and SMP-SR-F338A. SMP-SR-F338A is upstream of SMP-SR-F336A on Hammond Branch. A BGE ROW runs the length of the site, with very little overhead cover and shade. SMP-SR-338A is located near Cedar Lane School and Lime Kiln Middle School, while SMP-SR-F336A is near Reservoir High School. The stream has moderate erosion occurring along both the left and right banks ranging from 3 to 5 ft. in bank height for most of the length. The upstream reach (SMP-SR-F338A) has a long section of eroding bank over 9 ft. in height, the right bank has very high eroding banks cutting into the hillslope near the school. The instream habitat within the existing channel scored in the marginal range overall. The epifaunal substrate upstream is poor with less than 20% stable habitat; however, as the stream moves downstream the epifaunal substrate becomes better and consists of 40-70% stable habitat favorable for epifaunal colonization with desirable habitat and some disturbed substrate not ready for colonization yet. Embeddedness throughout the stream is higher at the upstream end and continues to decrease as the stream moves downstream with an average of 25-50% of gravel, cobble, and boulder particles surrounded by fine sediment. The velocity/depth regime of the channel is suboptimal with three velocities present throughout the stream. Severe sediment deposition occurs within the upstream portion of the stream with 50% of the bottom affected and bar formations are occurring along the stream banks. As the stream moves downstream, only 30% of the bottom is affected by sediment deposition. The channel flow status is suboptimal throughout the stream with water filling on average 75% of the available channel and some riffle substrate exposed. Bank stability is moderately unstable on both the left and right side of the stream with 30-60% of the stream banks having some cover and increased erosion during floods. Vegetative protection along the left and right bank is marginal with an average of 70% of the stream bank surface covered. Shading along the existing channel is poor (10%).

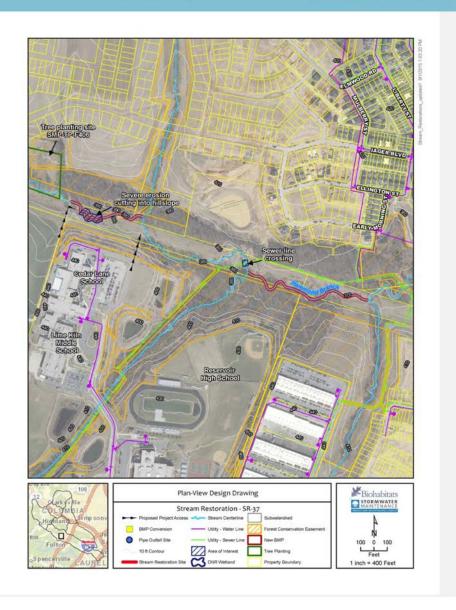
Site ID: SR-37

The objective for this project is to reduce bank erosion and improve instream habitat for aquatic organisms. To improve instream habitat, either the stream invert can be raised or a new floodplain can be graded to reduce bank erosion and promote floodplain reconnection. In addition, grading banks back to a stable angle and stabilizing them with native vegetation to hold soil in place will help reduce bank erosion. Adding woody debris, cobble riffles, pools, and other nature-like habitat structures will reinforce the stream bed and banks, improve the flow diversity and structural complexity of the stream bed, and uplift the instream habitat. The proposed channel restoration work would occur predominately on the existing channel alignment; however, some minor realignment may be necessary where the stream is cutting into the hillslope. Maximizing riparian buffer will increase the shading to reduce the stream temperature and provide needed litter inputs and woody debris. This channel restoration has the potential to reduce the sediment supply, improve habitat, provide opportunities for nutrient uptake, and serve as an outdoor learning laboratory for the surrounding schools. The site can be accessed from the BGE access road and/or the nearby school. There are seven other nearby project recommendations that should be concurrently implemented with this site including five stream restoration sites and two tree planting site. These nearby projects include: SR-33, SR-34, SR-35, SR-36, SR-38, SMP-TP-F405A, and SMP-TP-F406. The outfalls from the area being developed on the reach between here and SR-38 should be modified so that the flow passes to the stream through a channel, not sheet flow so as to limit future headcutting up to the outfall.

Both site assessments are mainly within a BGE ROW and are in close proximity to multiple schools. There are electrical power lines overhead and transmission poles along the stream that can make the site hazardous during construction. A sewer line does cross the stream and runs along a small portion of the stream. Very minimal tree impacts are anticipated due to a lack of overhead cover.
