**CMOM Audit Report**

**January, 2019**

**December, 2019**

**Complaint and Settlement Agreement between Howard County,  
Maryland and the Maryland Department of the Environment  
CO-10-1116**

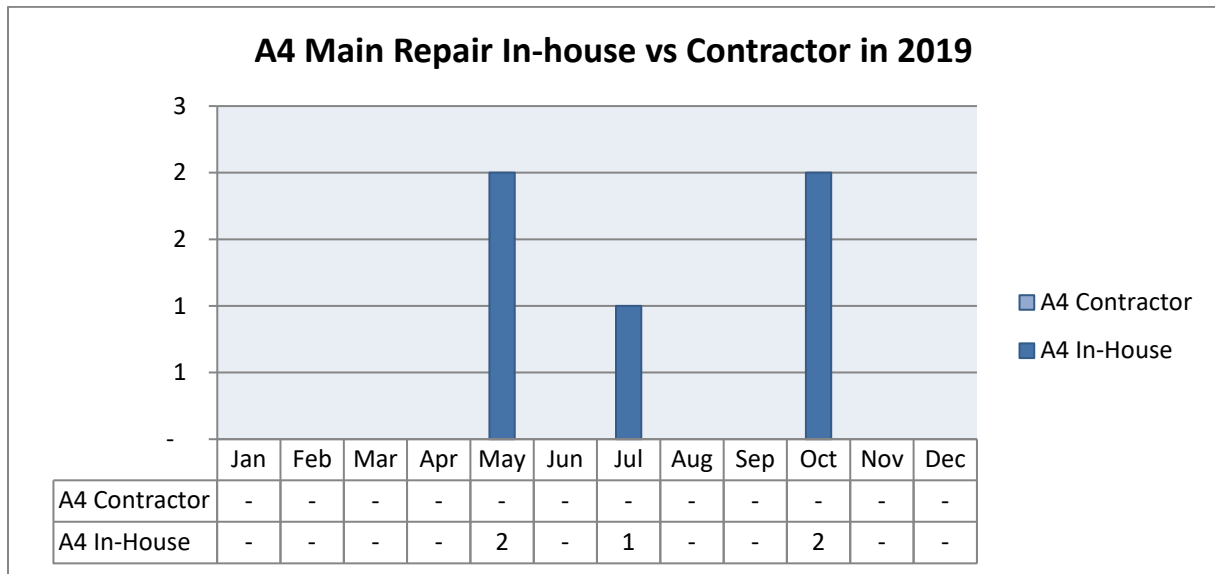
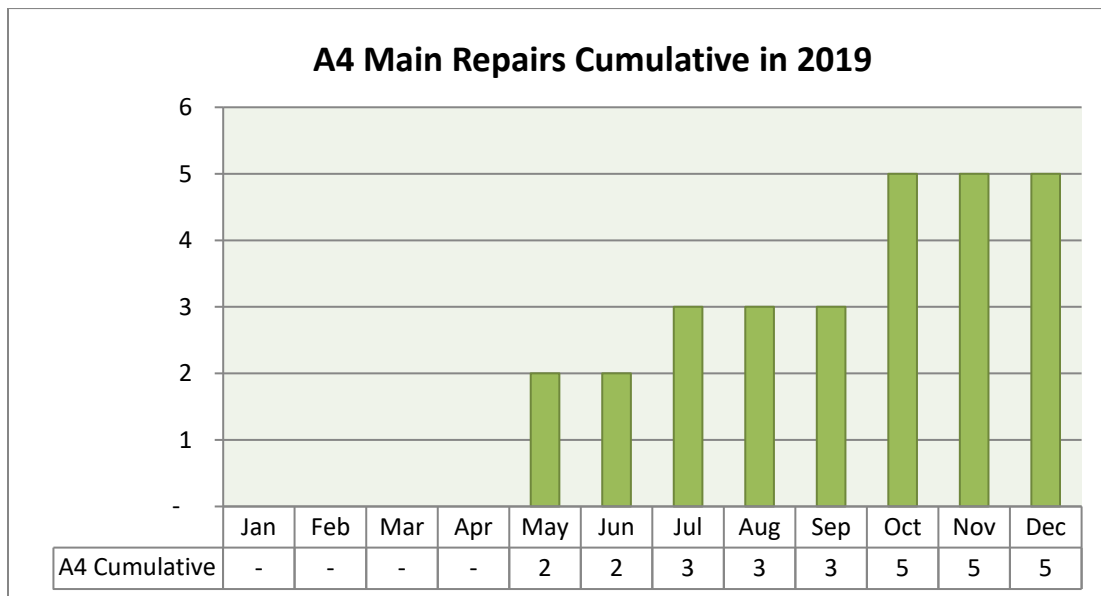
**A4. Sewer Main Repairs**

The County performed the sewer main repair/replacement on an As-Needed basis. Four (4) sewer mains were repaired by County's in-house staff in 2019.

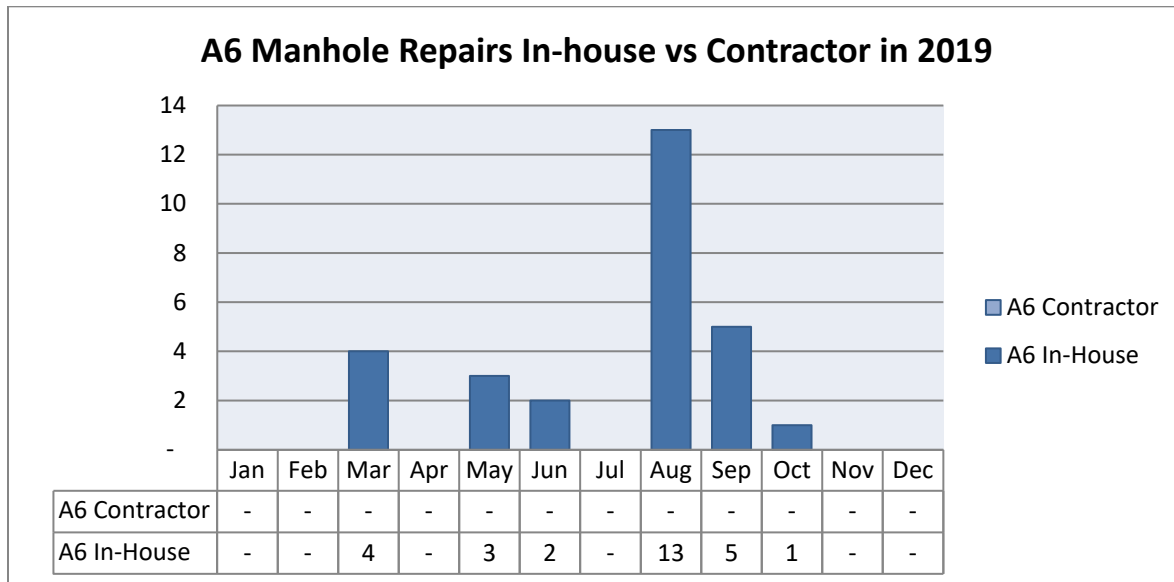
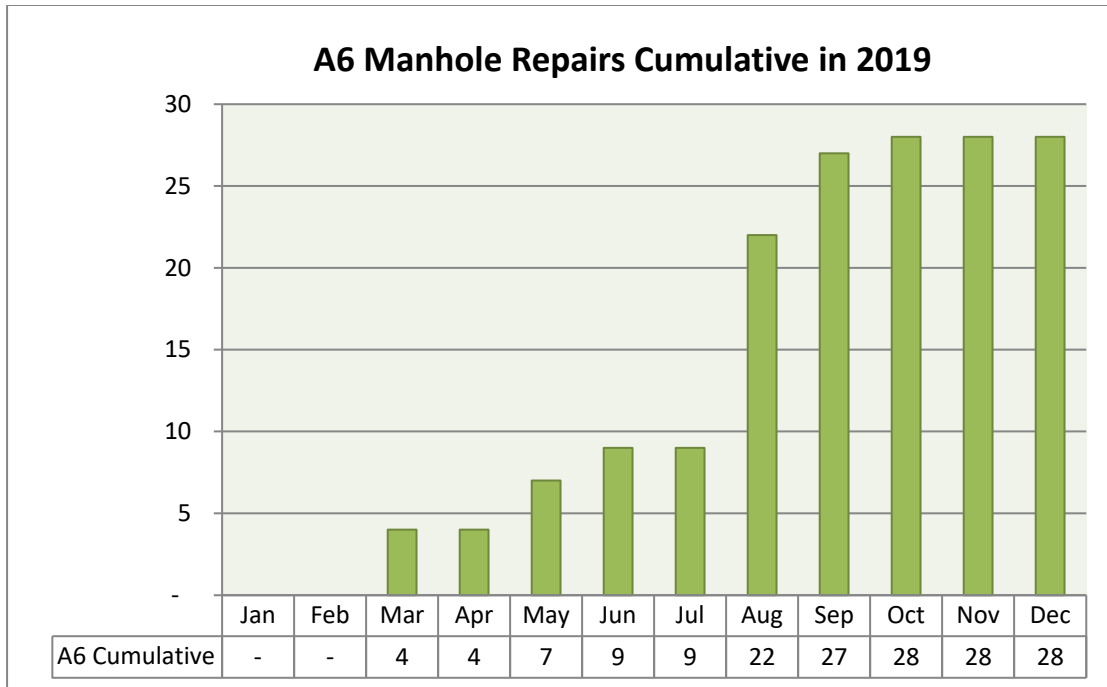
**A6. Manhole Repairs**

The County performed the manhole repair/replacement on an As-Needed basis. Sanitary sewer manholes are repaired by County’s in-house staff and contractors. There were 28 manholes repaired in 2019 by the County’s in-house staff.

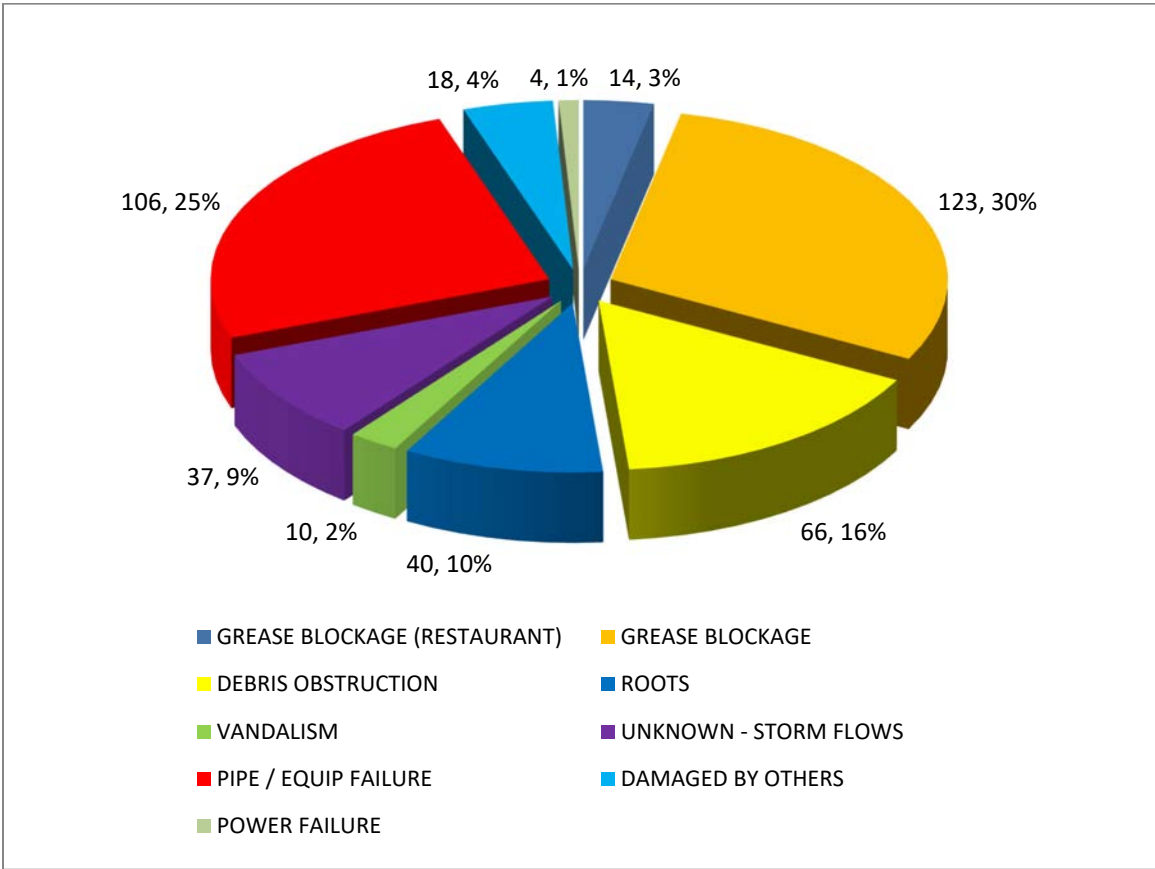
As is shown in the above chart, the top three (3) causes of overflows county-wide are: grease blockage (non FOG, 30%), pipe/equipment failure (25%), and debris obstruction (16%).

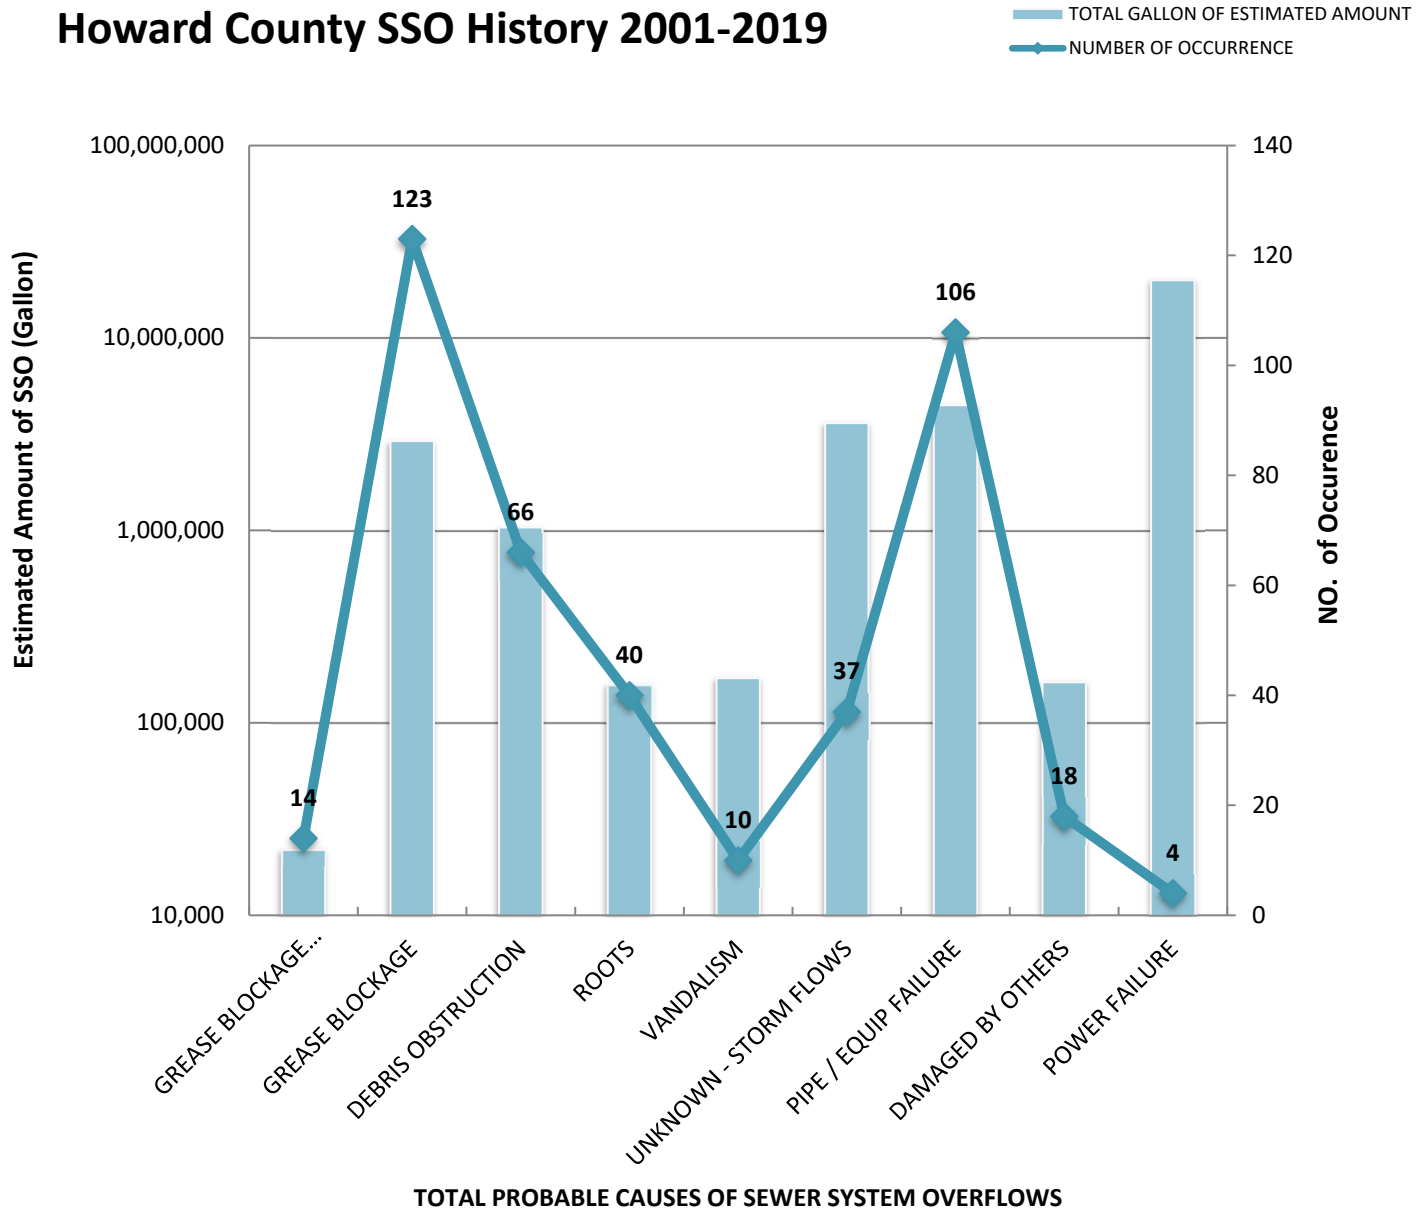
# Howard County SSO History 2001-2019

While taking the estimated overflow amount into consideration, power failure, storms, pipe and equipment failures rank the highest of the total SSO volume contribution. This observation has not changed from 2012.

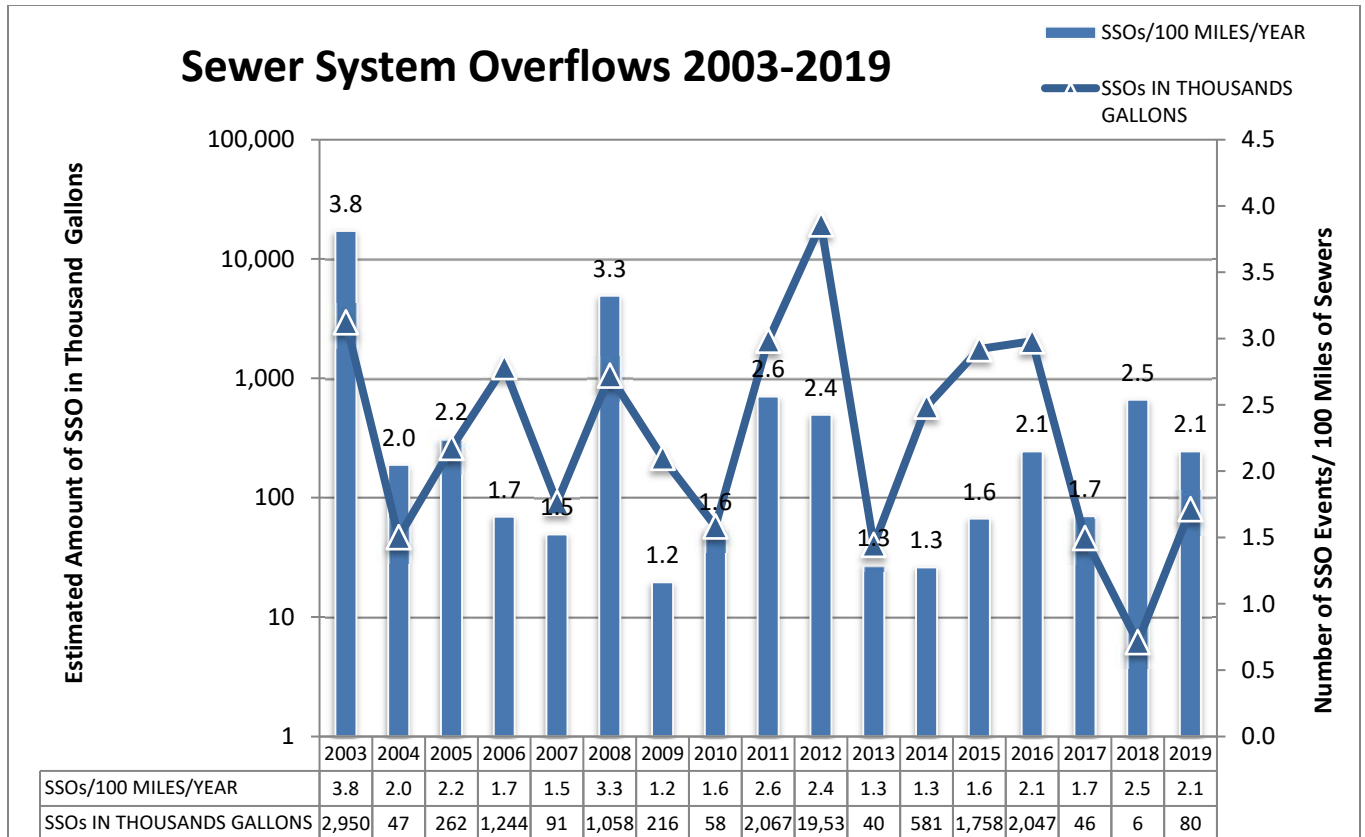
As is shown in the above chart, over the past 17 years from 2003 to 2019, the County has the SSOs/mile/year ranging from 1.2 to 3.8, while the national average posted by EPA in 2004 is 4.5. What's more, the County's overall trend of SSOs/mile/year is downward.

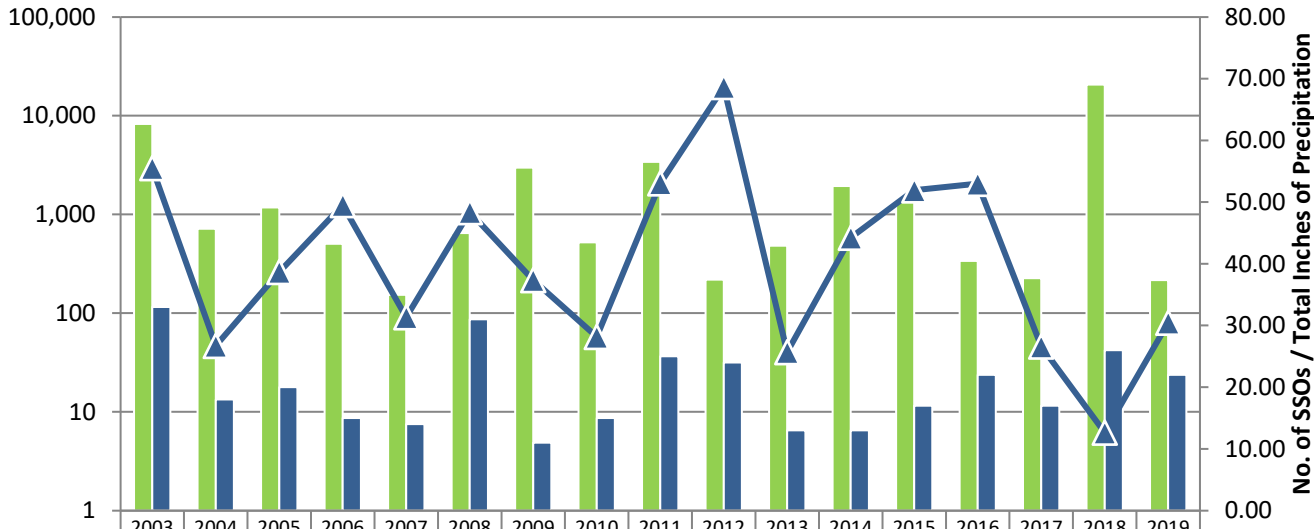
## Sewer System Overflows vs Precipitation 2003-2019

To further investigate the correlation between numbers of SSO occurrence to the total amount, the 17 years' precipitation data is plotted in the below chart. The numbers of SSO occurrence over the years keep a downward trend.
