## APPENDIX A: HOWARD COUNTY COUNCIL BILL #56-2018

# PLUMTREE BRANCH WATERSHED ASSESSMENT AREA P01

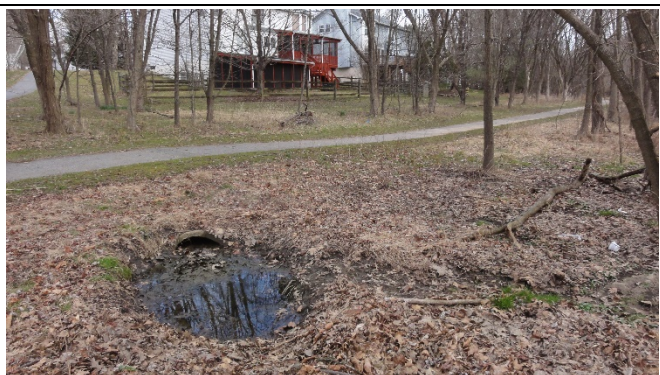
Figure 3: Opportunity to improve existing conveyance system.

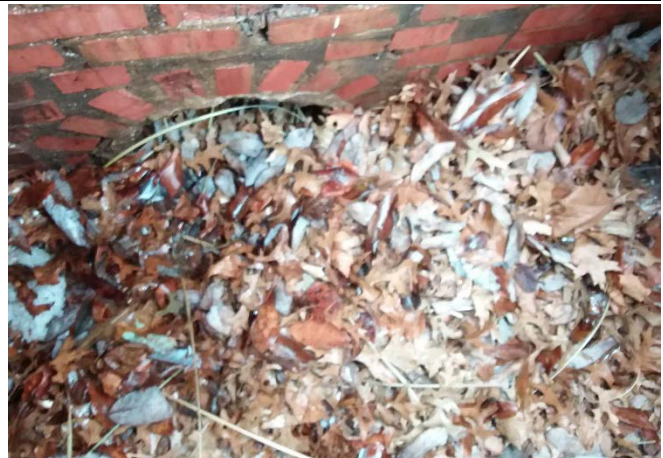
Figure 2: Inlet with observed debris.

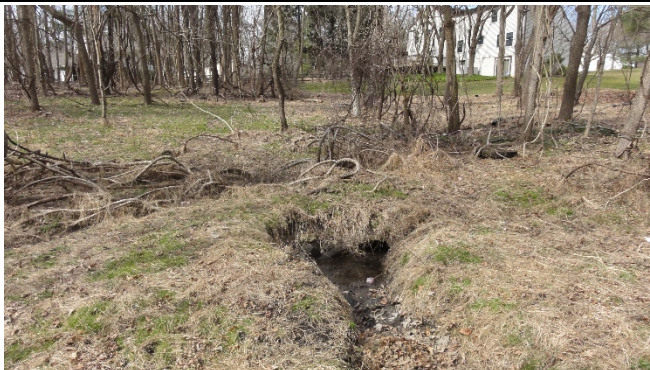
| Type | ID No. | Description & Discussion |
|---|---|---|
| Improve Existing Conveyance System | P02-01 | Existing storm drain system is likely not functioning as intended based on field observations. Field interaction suggests flooding is an issue. Analyze system and, if necessary, improve system with modified infrastructure. |

Figure 3: Opportunity to improve existing conveyance system.

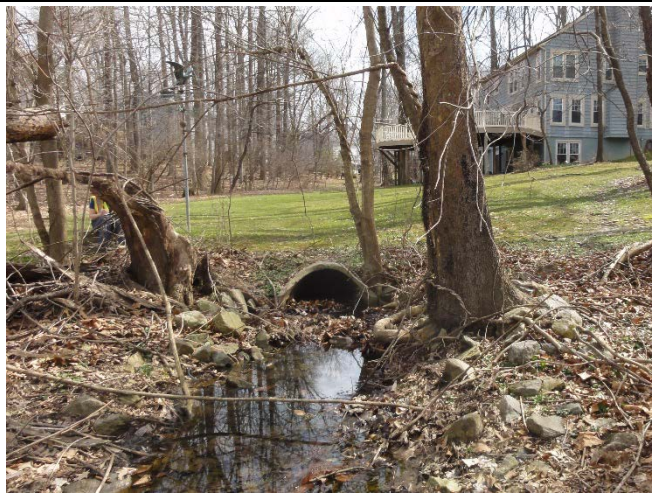
| Type | ID No. | Description & Discussion |
|---|---|---|
| Improve Existing Conveyance System | P03-01 | Existing conveyance system is likely not functioning as intended. Field observations note that conveyance is undefined. Analyze system and, if necessary, improve system with modified infrastructure. |

**Figure 2: Opportunity to improve existing conveyance system.**

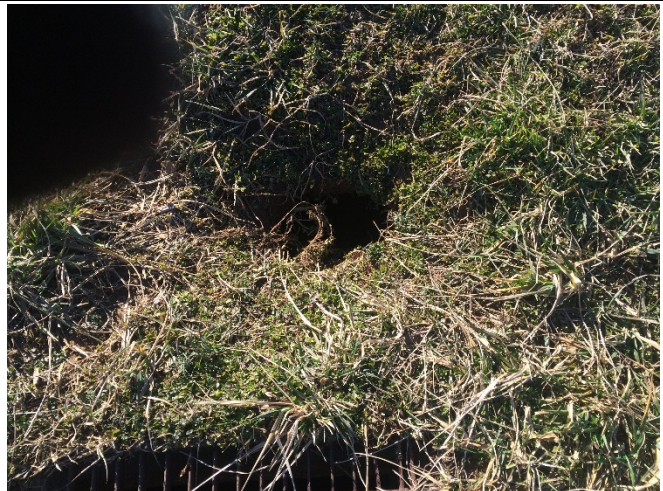
**Figure 2: Sinkhole forming above pipe.**

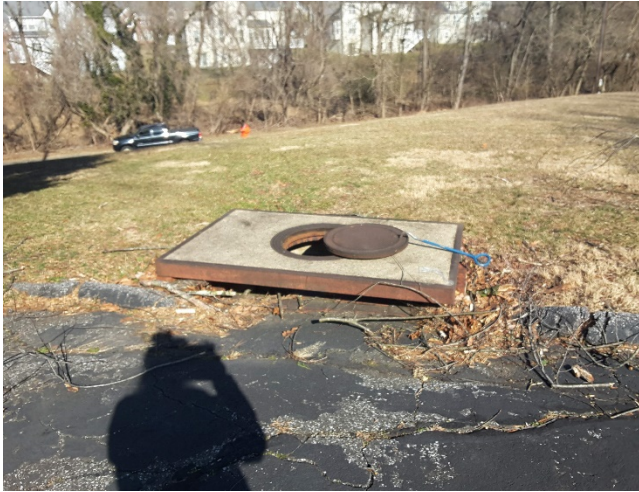
**Figure 1: Inlet at Forest Hill Swim and Tennis Club requiring repair.**

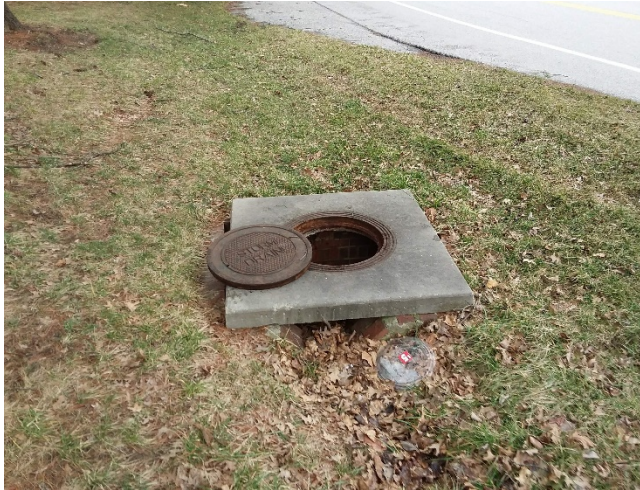
**Figure 1: Typical inlet along Columbia Road.**

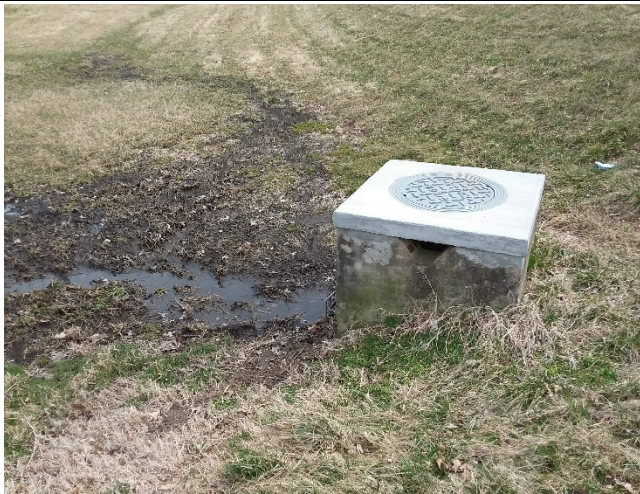
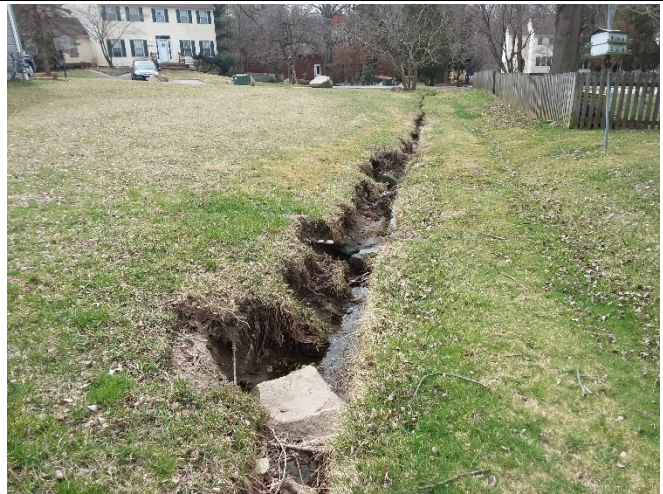
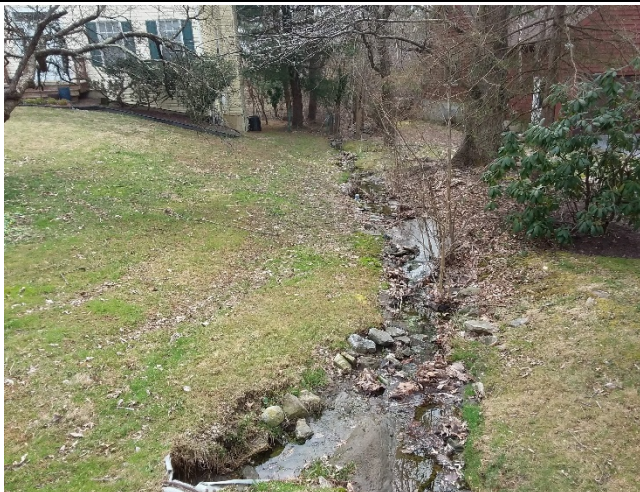
| Type | ID No. | Description & Discussion |
|---|---|---|
| Improve Existing Conveyance System | P08-01 | Existing conveyance system is likely not functioning as intended based on field observations. Field interactions and survey responses suggest that pond's outfall structure is likely not functioning as intended. Analyze system and, if necessary, improve system with modified infrastructure. |

**Figure 1: Opportunity to improve existing conveyance system.**

**Figure 2: Opportunity to improve existing conveyance system.**

**Figure 3: Opportunity to improve existing conveyance system.**

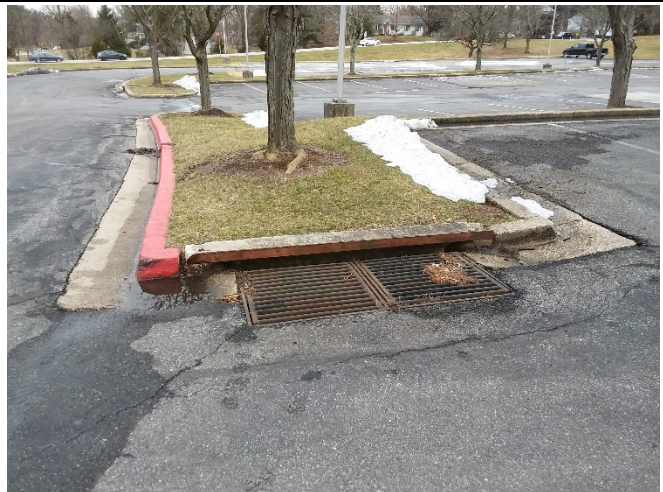
**Figure 4: Typical inlet within The Church of Jesus Christ of Latter-Day Saints parking lot.**

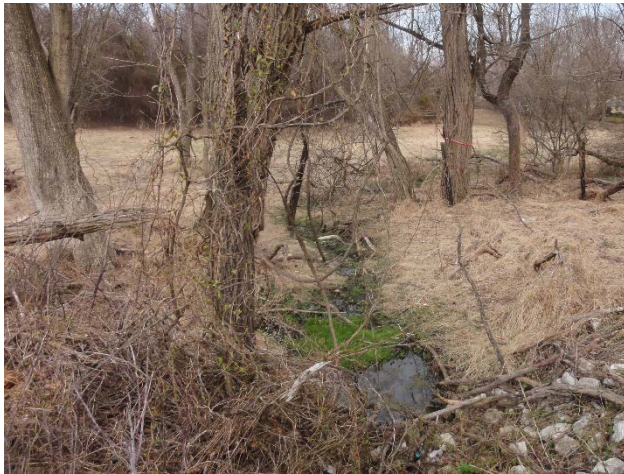
**Figure 1: Opportunity to improve existing conveyance system.**

| Type | ID No. | Description & Discussion |
|---|---|---|
| Conduct More Detailed Analysis of Storm Drain Network | N/A | The major storm drain network(s) within the assessment area is likely not functioning as intended. More detailed analysis is recommended to determine if improving the network with modified infrastructure is necessary. |

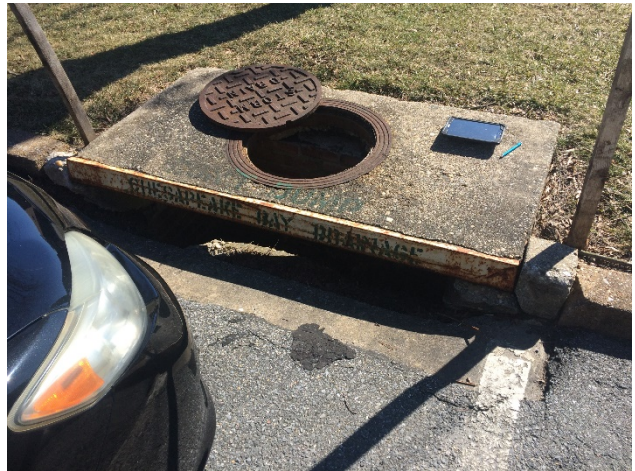
**Figure 2: Typical inlet in front of Northfield Elementary School.**

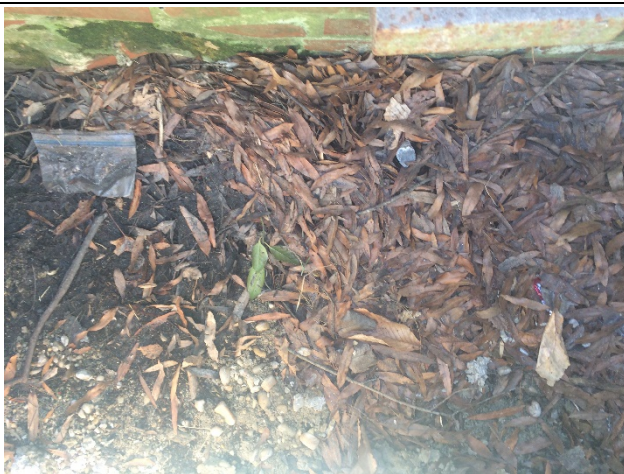
**Figure 3: Typical inlet with observed debris.**

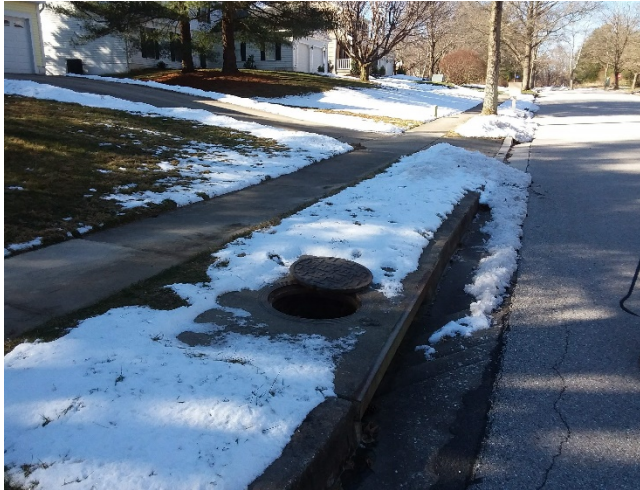
**Figure 1: Typical inlet along Sunlit Passage.**

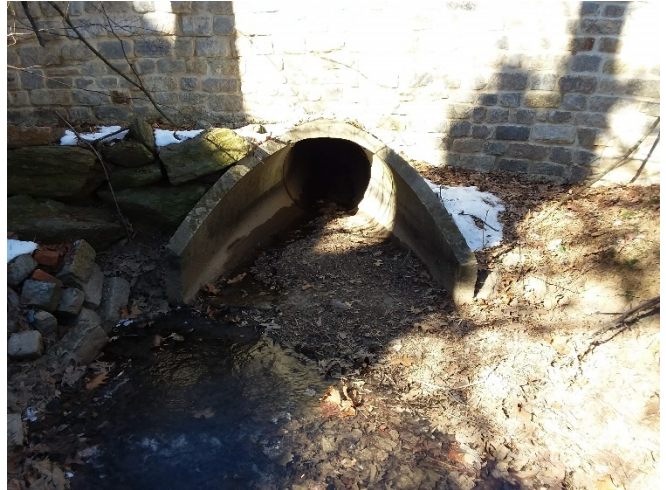
**Figure 2: Typical outfall along Bright Bay Way.**

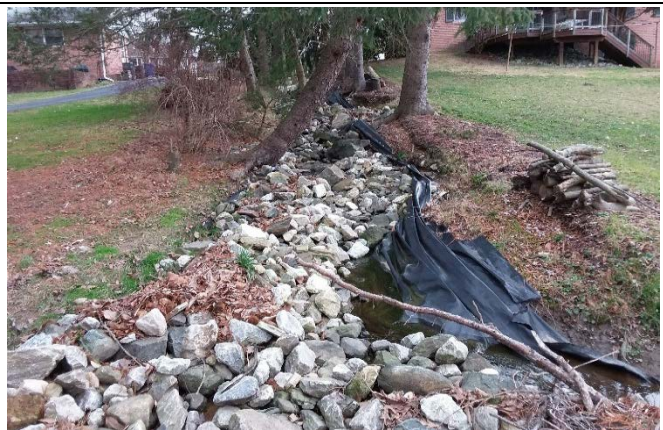
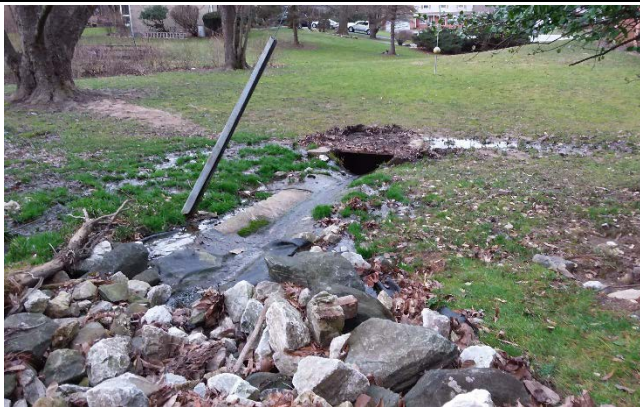
**Figure 1: Opportunity to install new conveyance system.**

**Figure 2: Opportunity to improve existing conveyance system.**

**Figure 3: Opportunity to improve existing conveyance system.**

| Type | ID No. | Description & Discussion |
|---|---|---|
| Conduct More Detailed Analysis of Storm Drain Network | N/A | The major storm drain network(s) within the assessment area is likely not functioning as intended. More detailed analysis is recommended to determine if improving the network with modified infrastructure is necessary. |

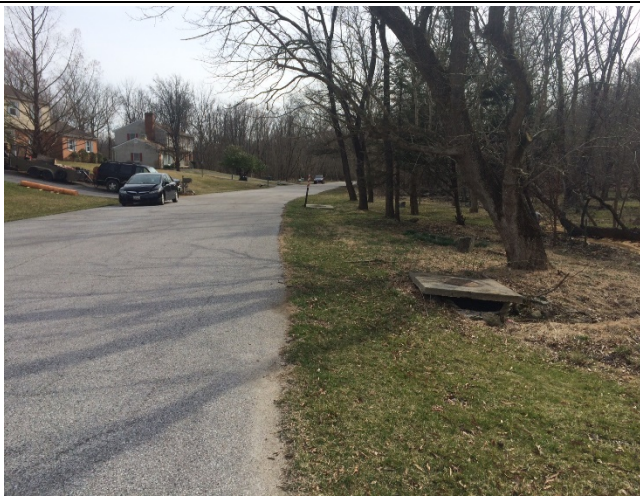
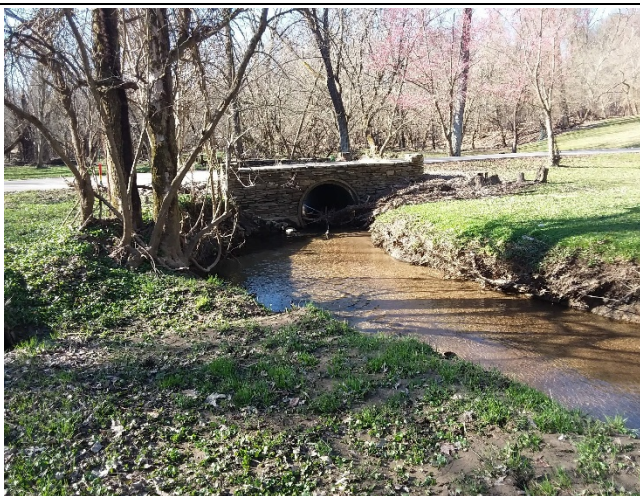
| Improve Existing Conveyance System | P15-04 | Existing conveyance system is likely not functioning as intended. Field observation notes a culvert under a private driveway carrying Plumtree Branch as potentially being a constriction point. Both field observations and survey responses suggest frequent and significant flooding. Analyze system and, if necessary, improve system with modified infrastructure within available open space. |

**Figure 1: Opportunity to improve existing conveyance system.**

**Figure 2: Opportunity to install new conveyance system.**

**Figure 3: Opportunity to improve existing conveyance system.**

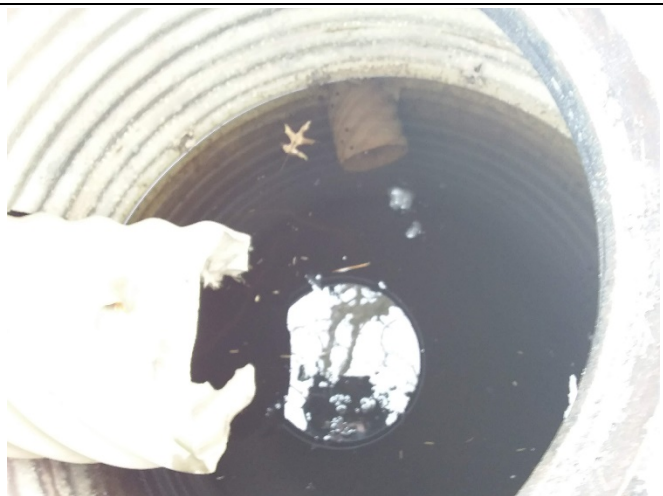
**Figure 4: Pondered water within inlet along Chatham Road requiring further investigation.**

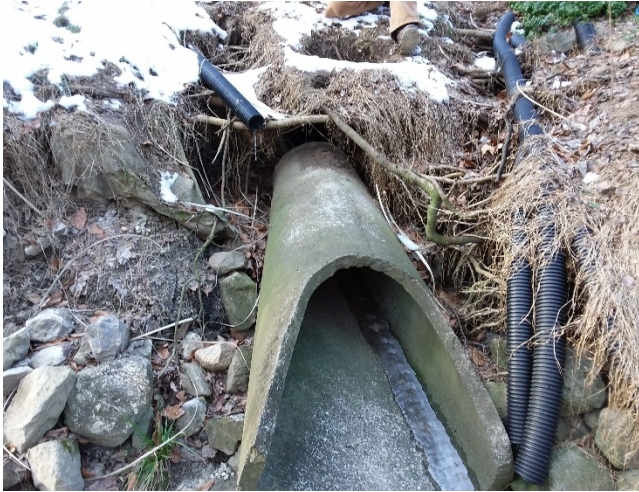
**Figure 1: Outfall with detached end section requiring repair.**

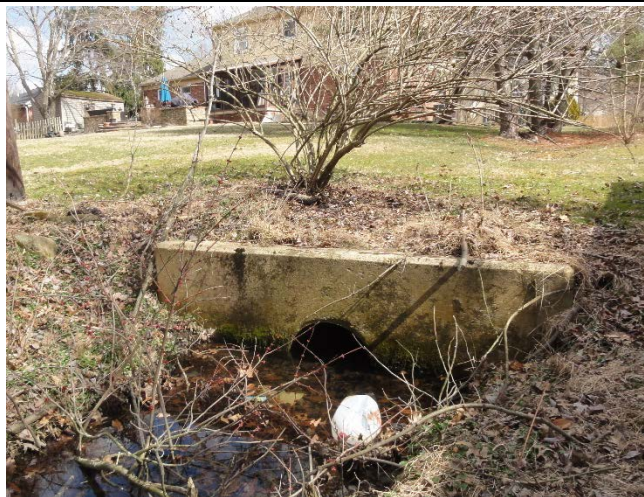
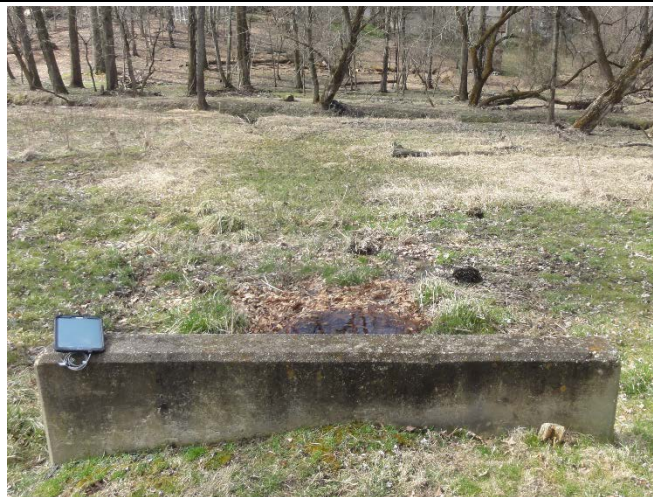
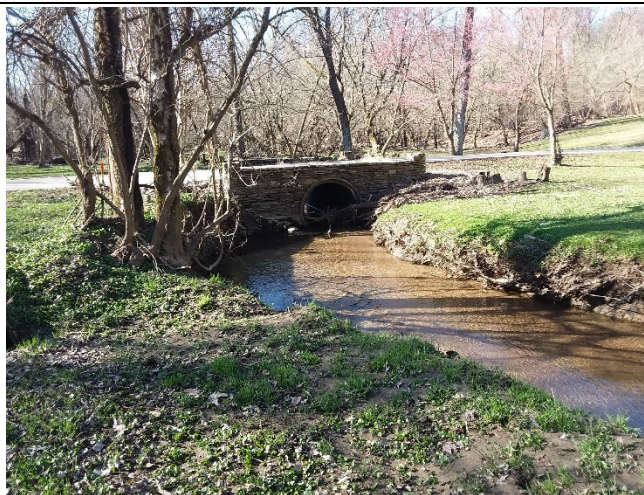
| Type | ID No. | Description & Discussion |
|---|---|---|
| Improve Existing Conveyance System | P17-02 | Existing conveyance system is likely not functioning as intended. Field observations note there is no clear conveyance system between the storm drain outfall downstream to the stream channel; ponded water is visible. Analyze system and, if necessary, improve system with modified infrastructure. |

**Figure 1: Opportunity to improve existing conveyance system.**

**Figure 2: Opportunity to improve existing conveyance system.**

**Figure 3: Opportunity to improve existing conveyance system.**

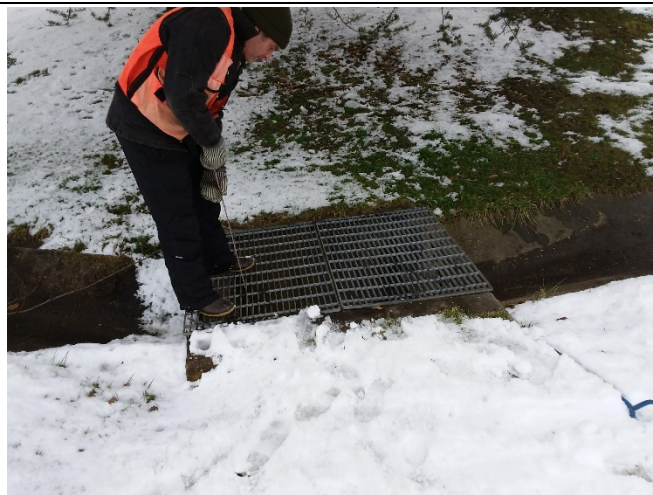
**Figure 4: Typical inlet along Spring Meadow Drive.**

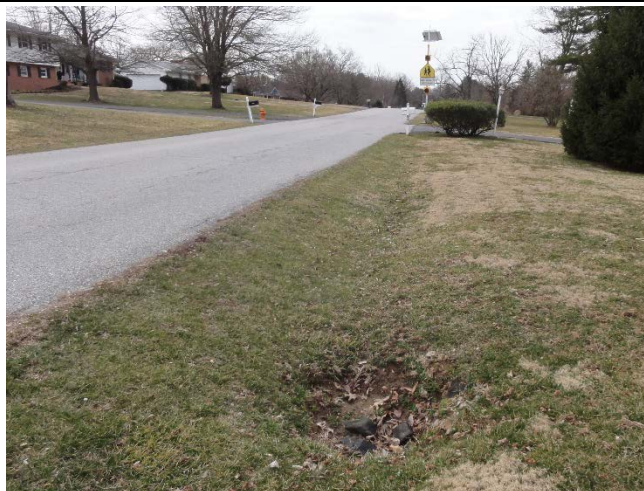
**Figure 1: Opportunity to improve existing conveyance system.**

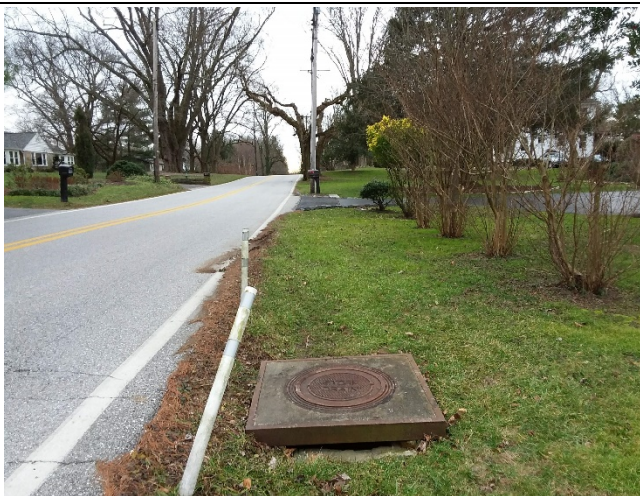
**Figure 1: Opportunity to improve existing conveyance system.**

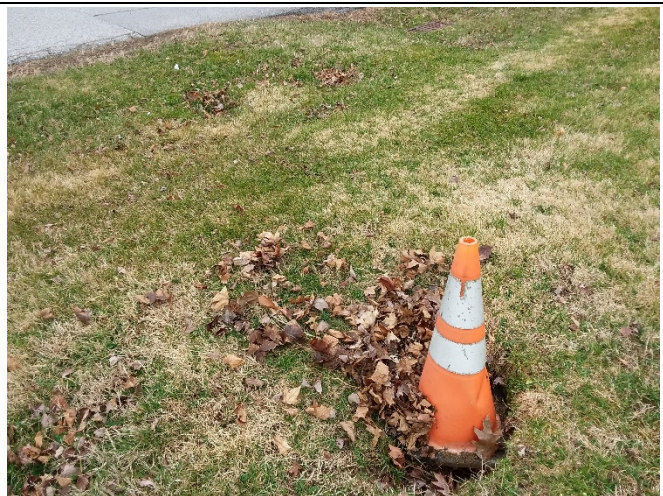
**Figure 2: Sinkhole forming over pipe along Crestleigh Drive.**

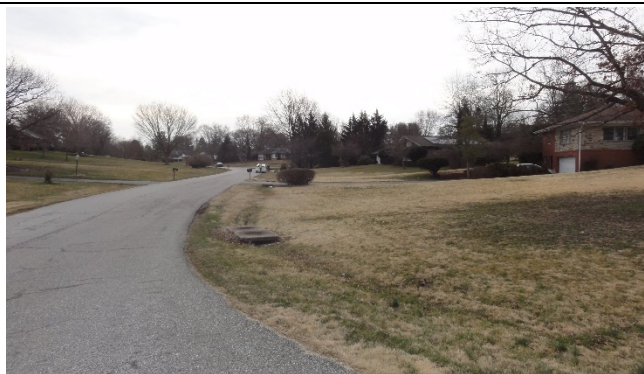
**Figure 3: Opportunity to improve existing conveyance system.**

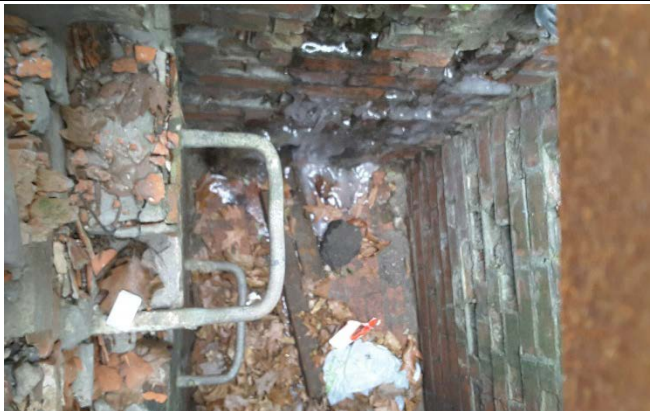
Figure 3: Typical inlet with debris along Baltimore National Pike (U.S. Route 40).

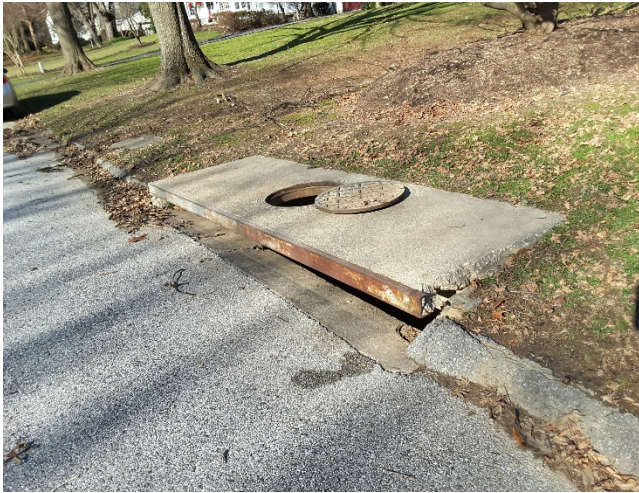
**Figure 1: Damaged inlet along Dunloggin Road.**

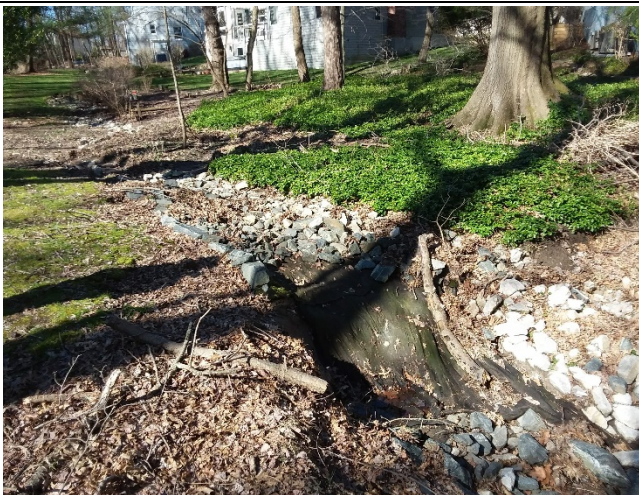
**Figure 3: Opportunity to improve existing conveyance system.**

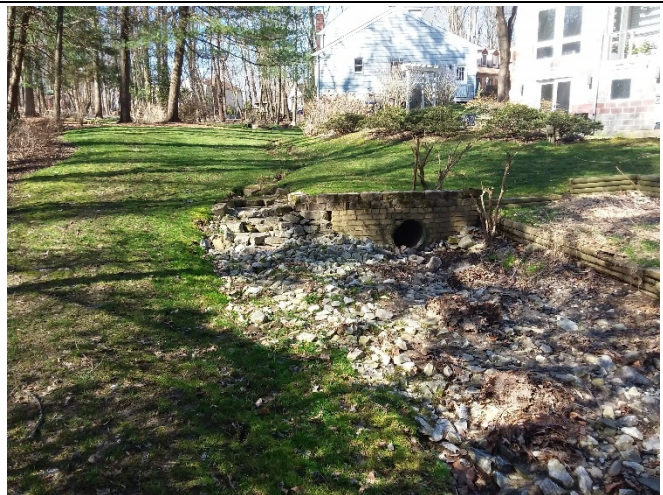
**Figure 4: Opportunity to improve existing conveyance system.**

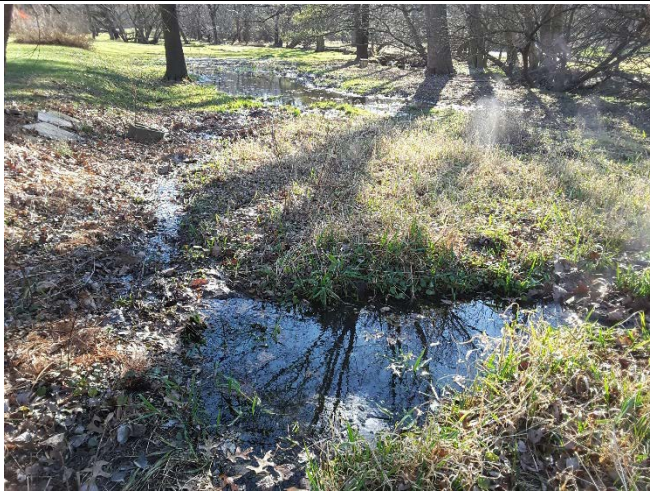
**Figure 1: Opportunity to improve existing conveyance system.**

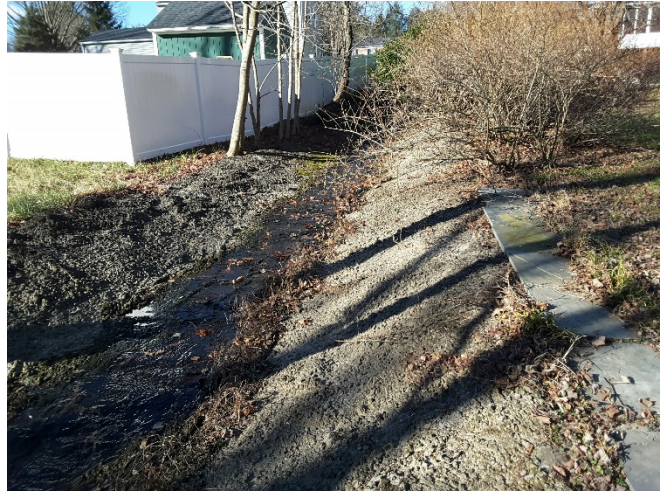
**Figure 2: Concrete swale conveying stormwater to Plumtree Branch.**

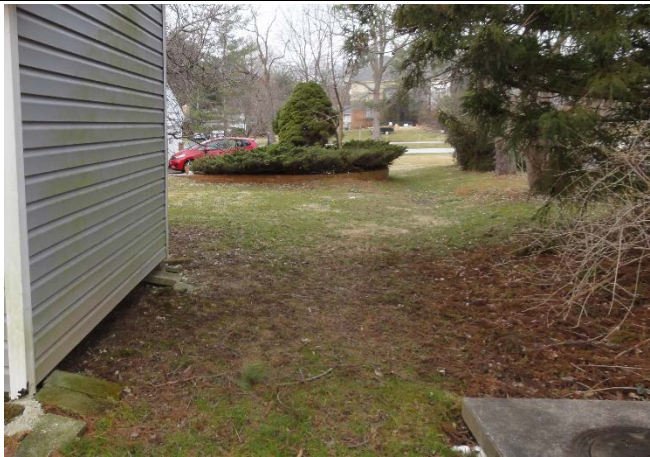
**Figure 1: Opportunity to improve existing conveyance system.**

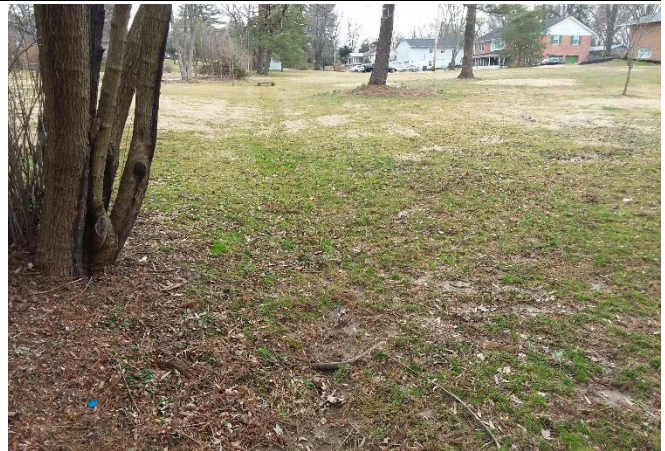
**Figure 2: Opportunity to improve existing conveyance system.**

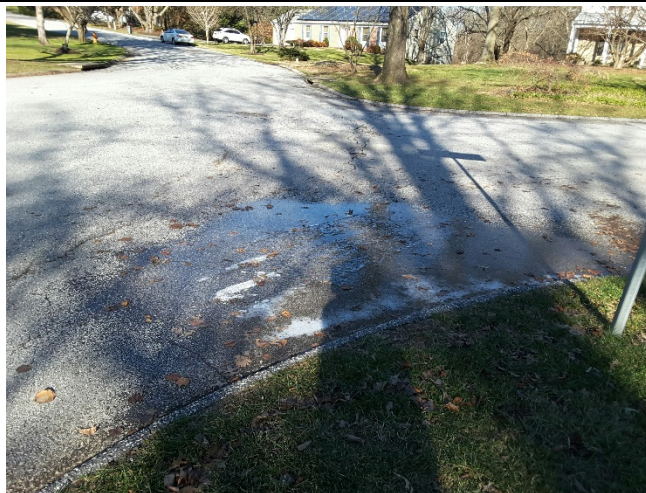
**Figure 1: Opportunity to improve existing conveyance system.**

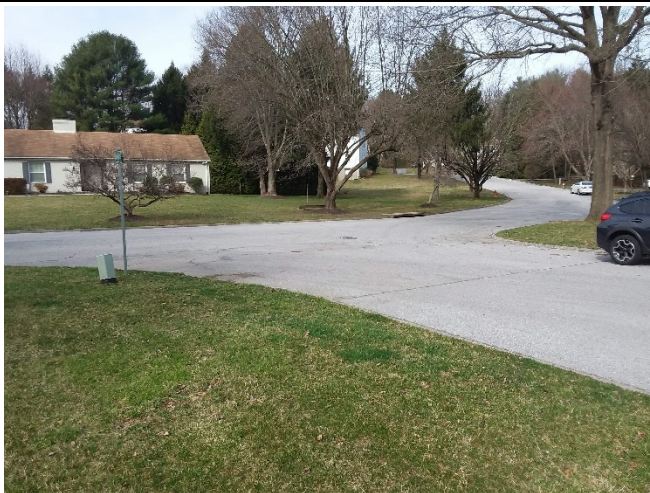
**Figure 2: Opportunity to improve existing conveyance system.**

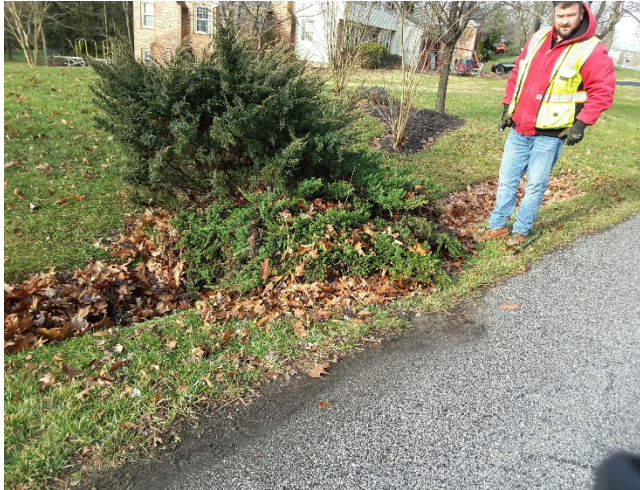
**Figure 1: Inlet along Spring Meadow Drive with observed debris and vegetation.**

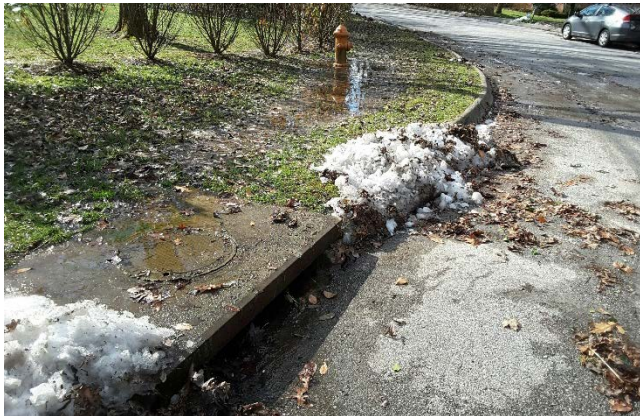
**Figure 1: Opportunity to improve existing conveyance system along Underoak Drive.**

| Type | ID No. | Description & Discussion |
|---|---|---|
| Conduct More Detailed Analysis of Storm Drain Network | N/A | The major storm drain network(s) within the assessment area is likely not functioning as intended. More detailed analysis is recommended to determine if improving the network with modified infrastructure is necessary. |

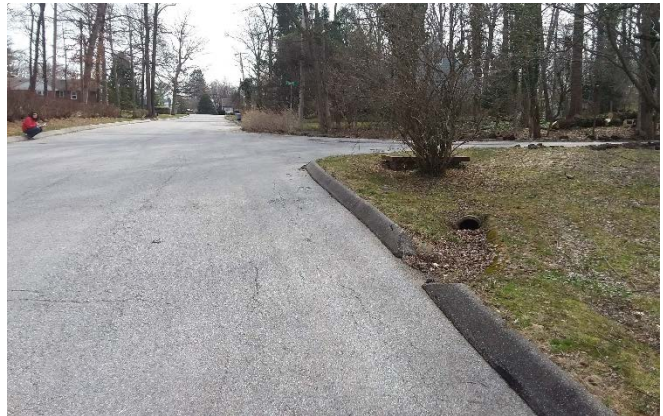
**Figure 2: Opportunity to improve existing conveyance system along Underoak Drive.**

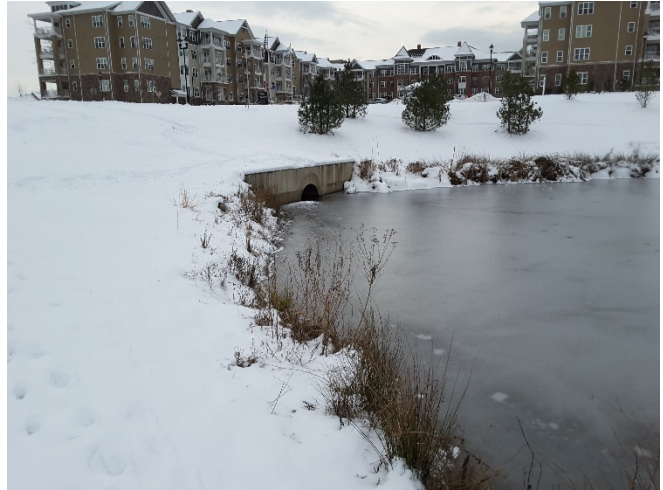
**Figure 2: Typical stormwater facility outfall within The Lutheran Village at Miller's Grant development.**

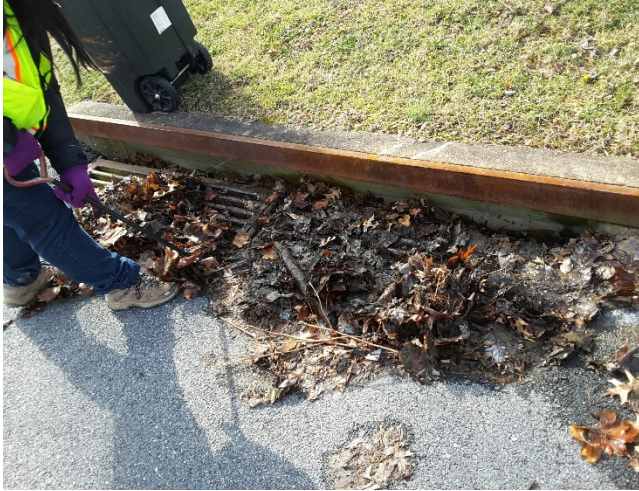
**Figure 1: Typical inlet along Westwood Drive with observed debris.**

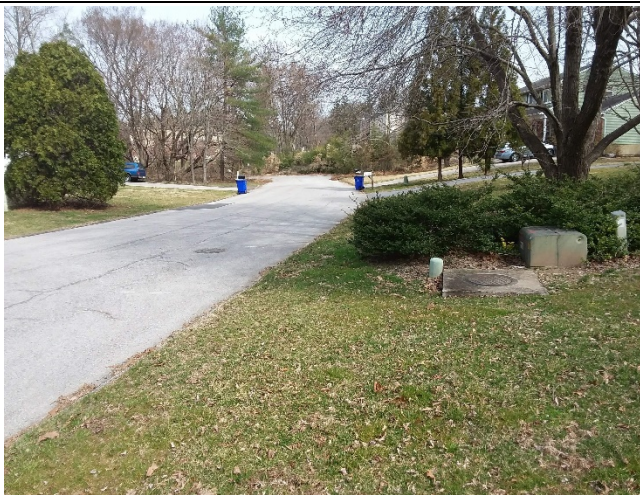
| Type | ID No. | Description & Discussion |
|---|---|---|
| Improve Existing Conveyance System | P35-01 | Existing storm drain system is not likely functioning as intended. Field observation notes system seems to have limited capture efficiency. Survey responses and field observation indicate roadway experiences flooding frequently. Analyze system and, if necessary, improve system with modified infrastructure. |

**Figure 1: Opportunity to improve existing conveyance system along Acadia Drive.**

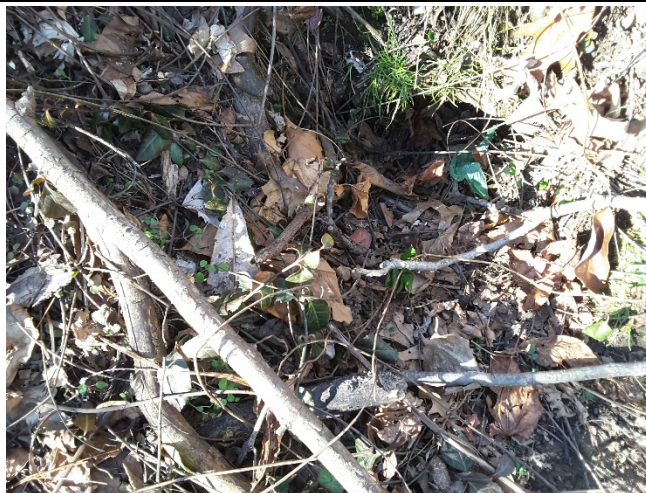
**Figure 1: Outfall requiring repair.**

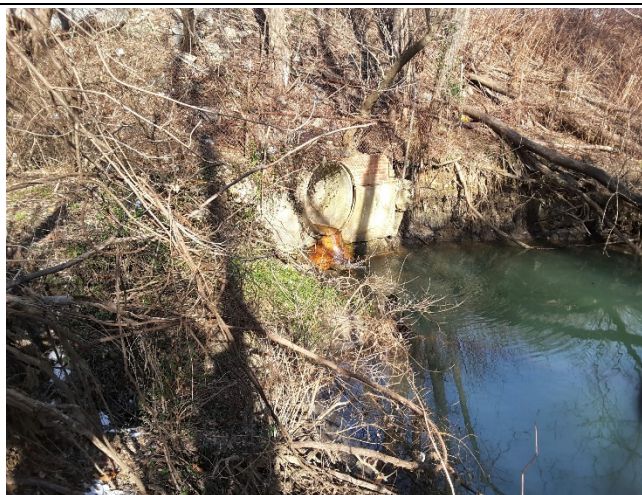
Figure 1: Outfall requiring repair.

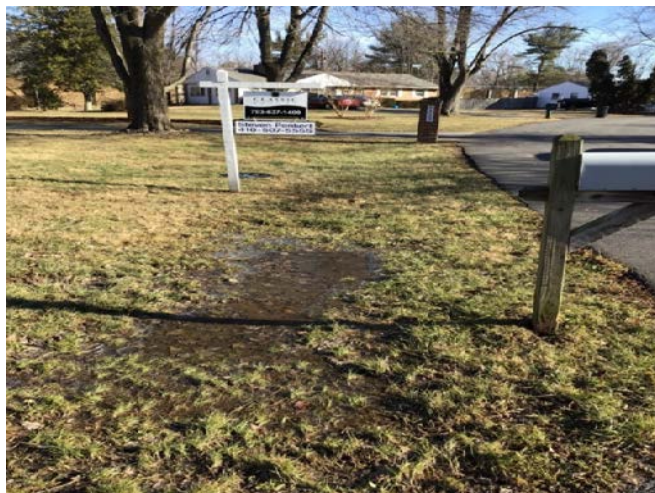
| Type | ID No. | Description & Discussion |
|---|---|---|
| Improve Existing Conveyance System | P39-001 | Field observations and survey response suggest that roadway runoff ponds on properties in this area. Improve conveyance through roadside ditches by regrading and installing driveway culverts. |

**Figure 1: Standing water in roadside ditch along Millbrook Rd.**

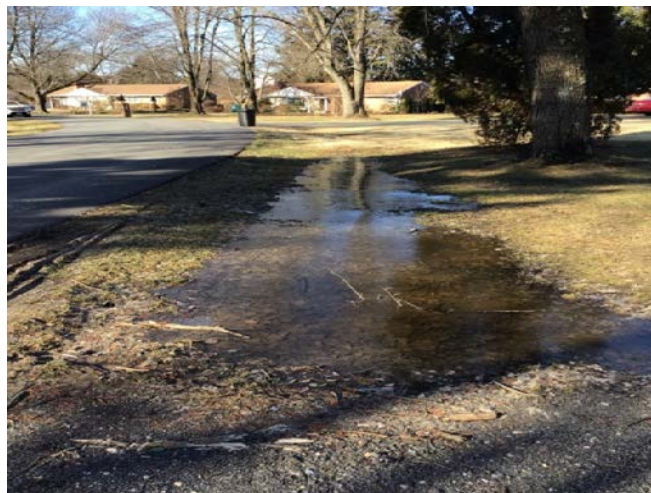
**Figure 2: Standing water in roadside ditch along Millbrook Rd.**

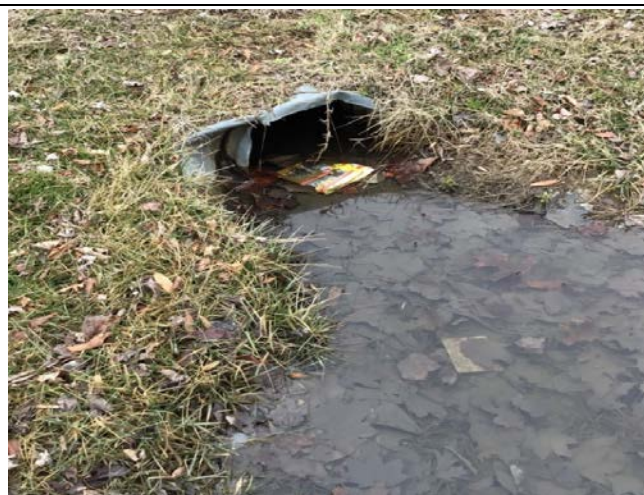
**Figure 3: Outfall is deformed and deteriorating.**

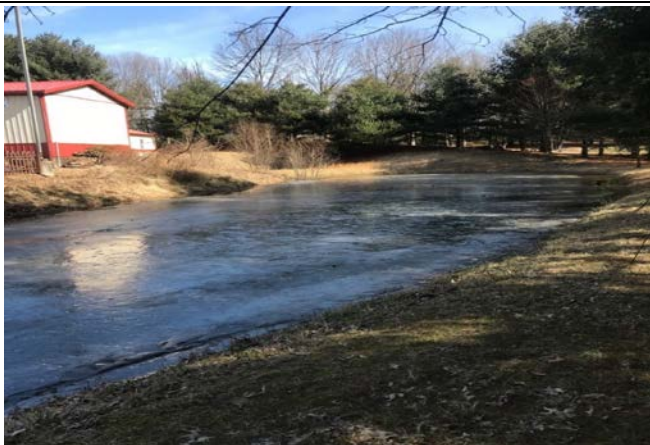
Figure 1: Infiltration facility is filled with standing water.

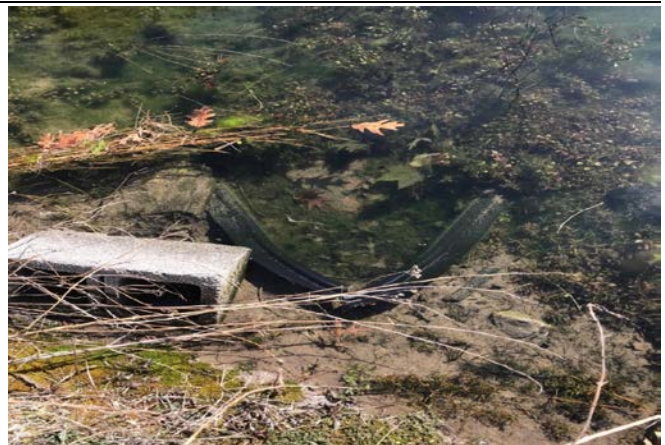
Figure 1: Inflow to facility is submerged and filled with sediment.

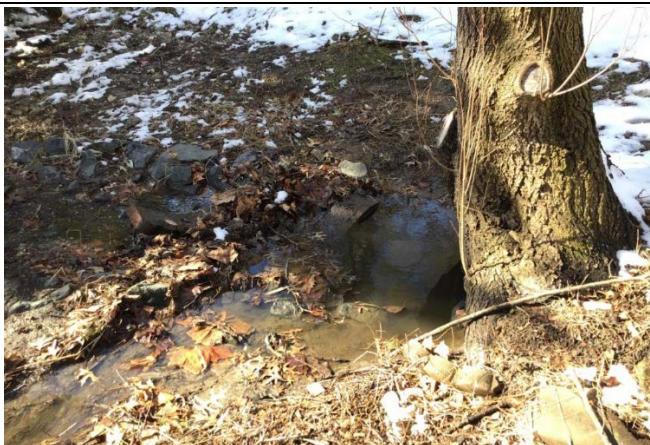
Figure 2: Storm drain outfall approximate location.

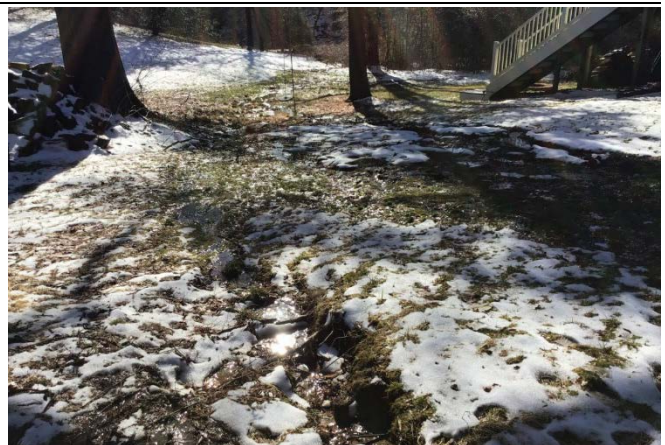
Figure 3: Eroded storm drain outfall channel through homeowner's yard.

| Type | ID No. | Description & Discussion |
|---|---|---|
| Improve Existing Conveyance System | P40-003 | Existing conveyance system is likely not functioning as intended. Improve conveyance from storm drain system outfall to downstream channel. |

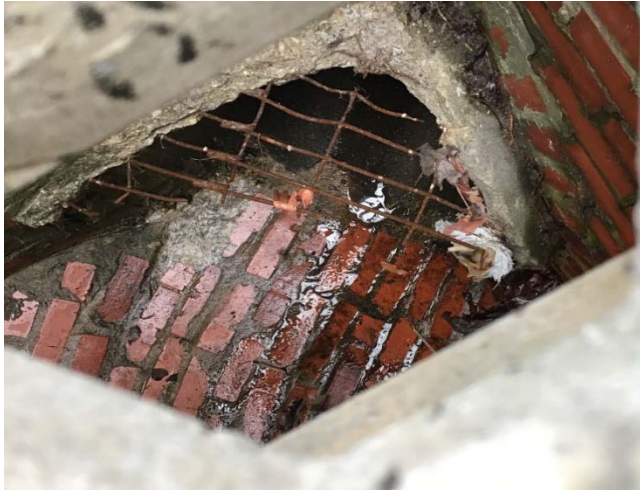
**Figure 1: Exposed rebar in pipe.**

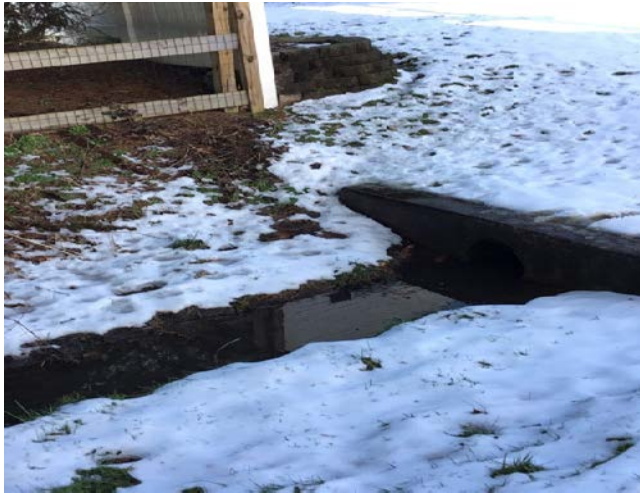
| Improve Existing Conveyance System | P42-002 | Existing conveyance system is likely not functioning as intended. Field observations and survey responses suggest that channel does not maintain positive flow. Improve conveyance between storm drain outfall and storm drain system to minimize flooding of private property. |

**Figure 1: Storm drain outfall channel with standing water.**

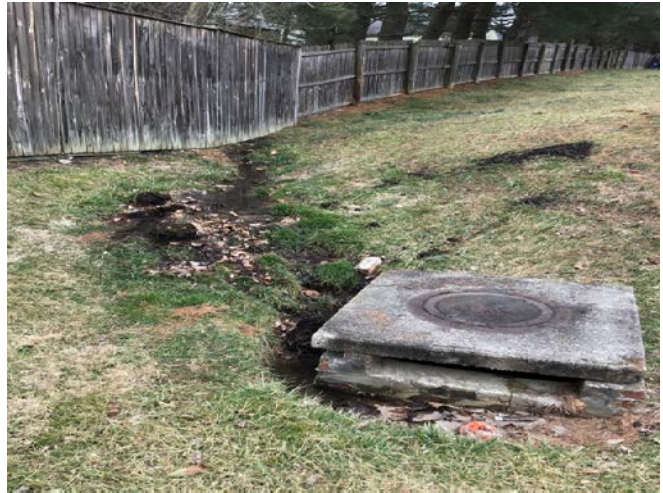
**Figure 2: Downstream end of outfall channel leading to inlet.**

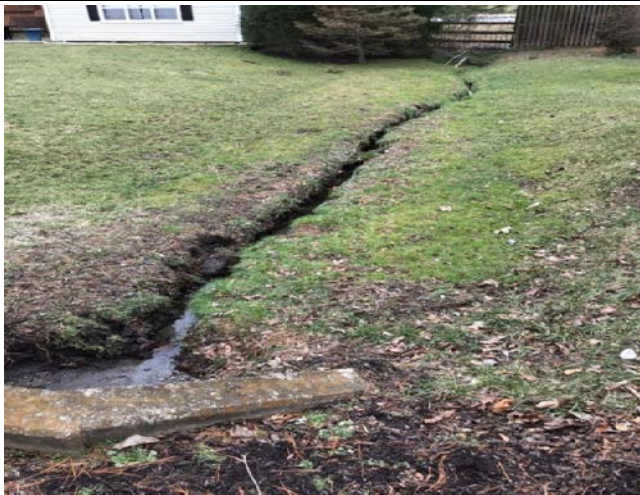
**Figure 3: Eroded Outfall Channel.**

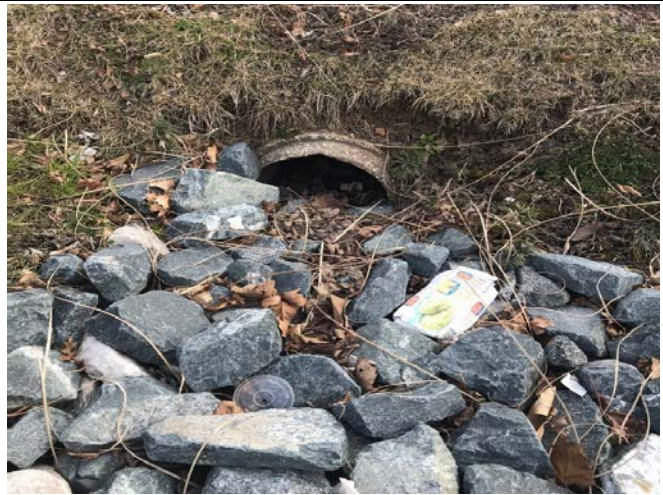
**Figure 4: Outfall partially full with sediment.**

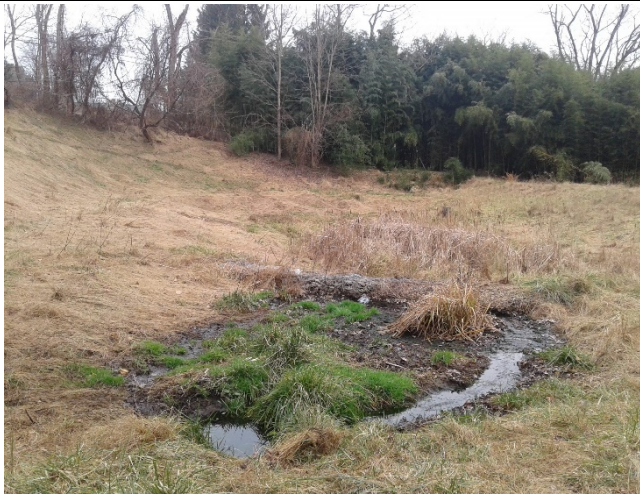
**Figure 1: Pond forebay filled with sediment.**

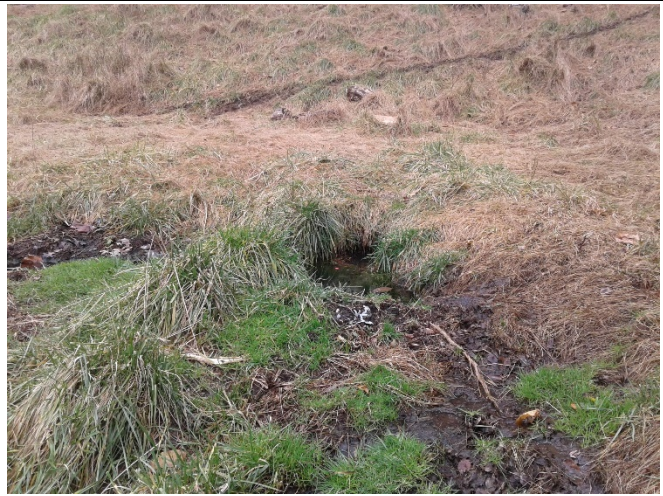
**Figure 2: Pond inflow submerged and overgrown.**

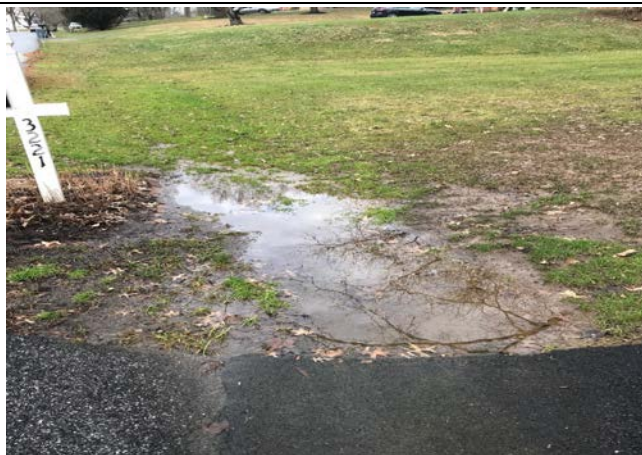
**Figure 1: Standing water adjacent to driveway on Hearthstone Rd.**

| Type | ID No. | Description & Discussion |
|---|---|---|
| Improve Existing Conveyance System | P45-003 | Field observations suggest that existing conveyance system is likely not functioning as intended. Improve conveyance through roadside ditches by regrading and installing driveway culverts. |

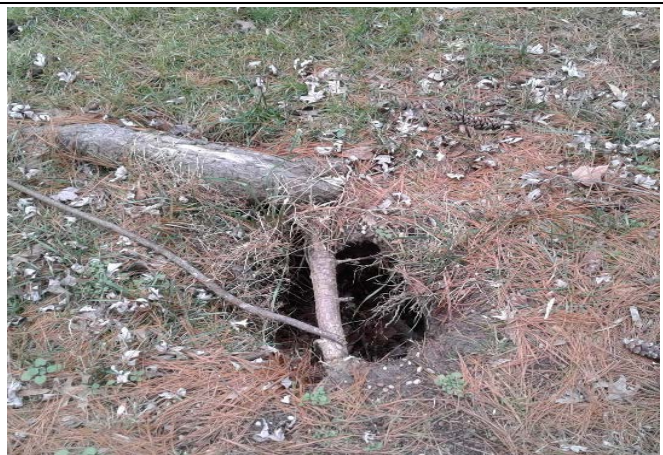
**Figure 2: Sinkhole above assumed location of pipe behind houses on Greenway Dr.**

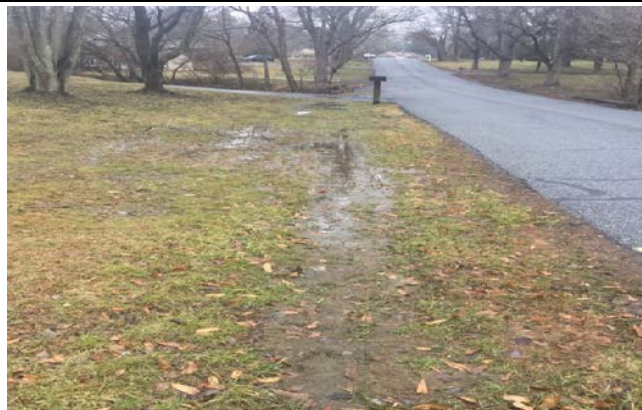
**Figure 3: Standing water in ditch along Brookmede Rd.**

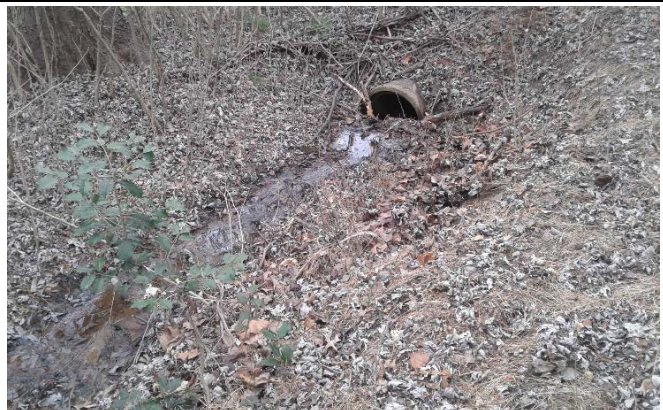
**Figure 4: Channel leading up to pipe is filled with sediment and debris.**

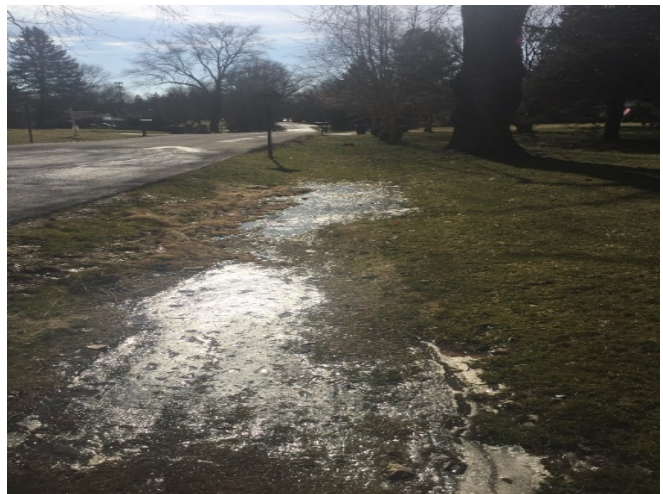
Figure 2: Standing water and erosion in roadside ditch along Greenway Dr.
