## APPENDIX A: HOWARD COUNTY COUNCIL BILL #56-2018

# PLUMTREE BRANCH WATERSHED ASSESSMENT AREA P01

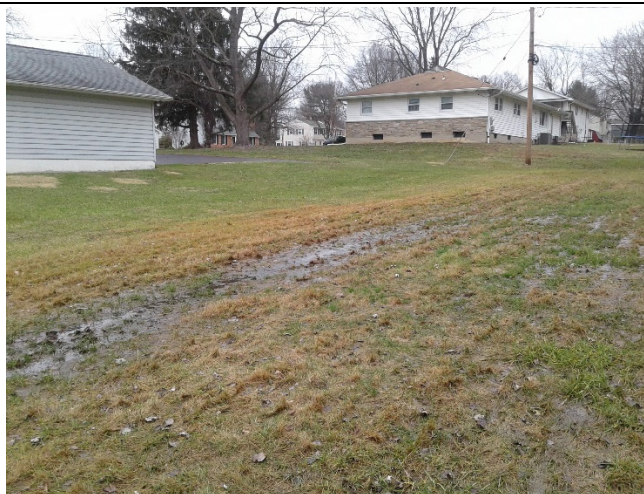
**Figure 3: Standing water between houses along Joey Dr.**

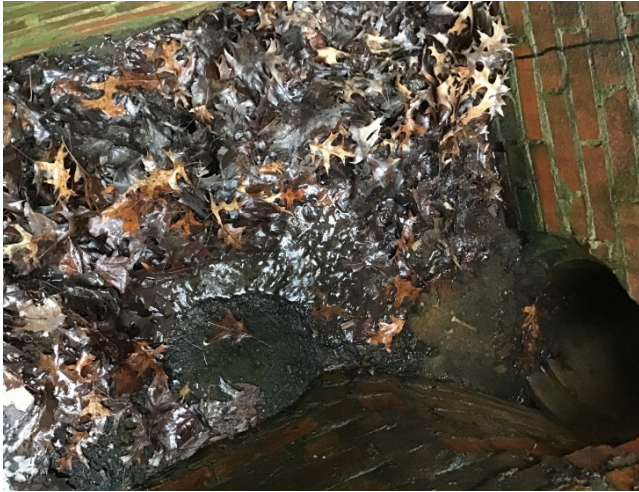
**Figure 1: Inlet filled with sediment and debris.**

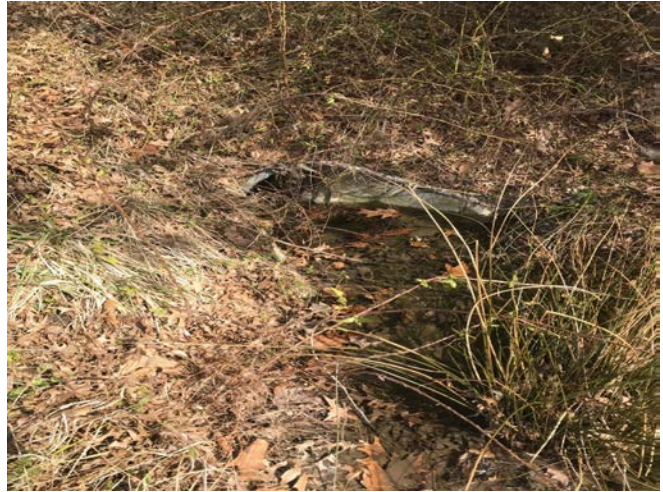
**Figure 2: Outfall partially submerged.**

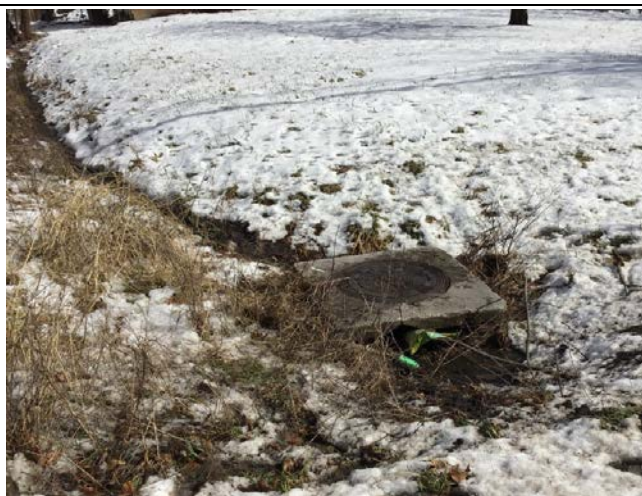
**Figure 1: Stormdrain outfall channel with standing water leading to existing inlet.**

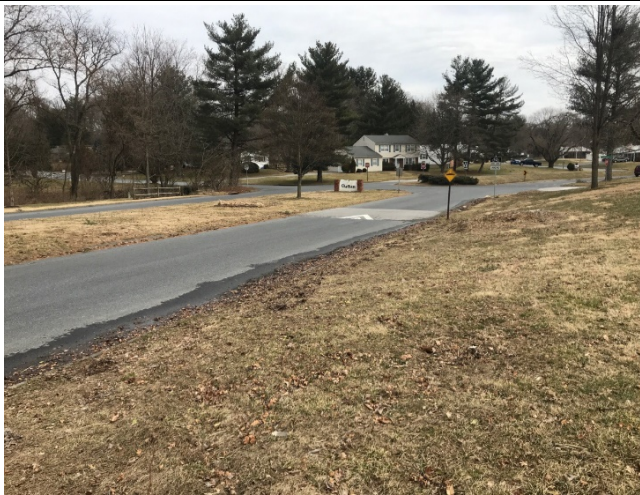
**Figure 1: Intersection of Michaels Way and Ramblewood Rd. several survey responses were made of flooding at this intersection.**

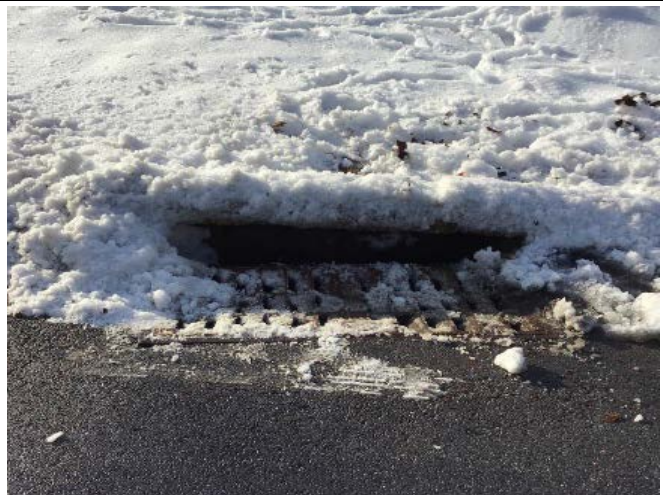
**Figure 2: Uneven asphalt in front of inlet at intersection of Michaels Way and Ramblewood Rd.**

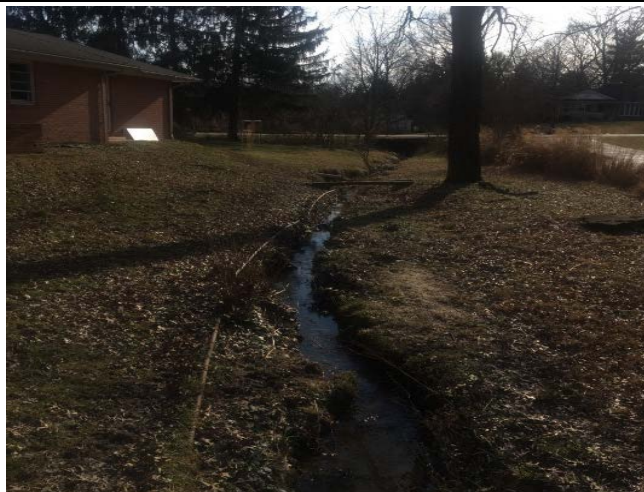
**Figure 3: Stream channel upstream of pipe network that is potentially inefficient.**

| Type | ID No. | Description & Discussion |
|---|---|---|
| Improve Existing Conveyance System | P50-004 | This stormdrain system was likely installed prior to current design standards and could benefit from additional analysis for drainage improvement. Field observations and storm drain analysis suggests pipe is potentially inefficient. |

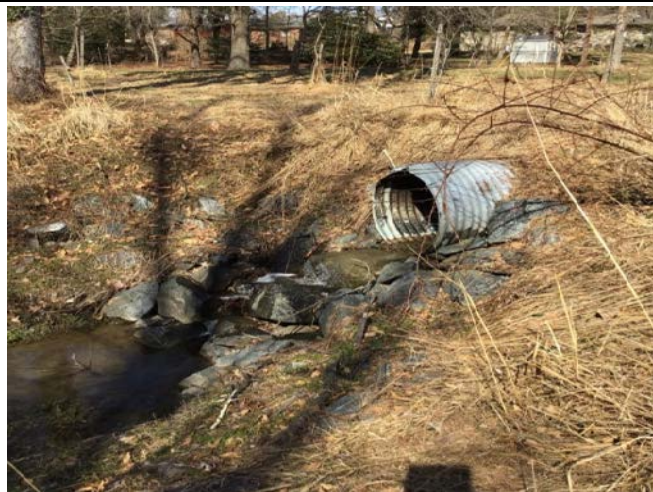
**Figure 4: Outfall of storm drain network that is potentially inefficient.**

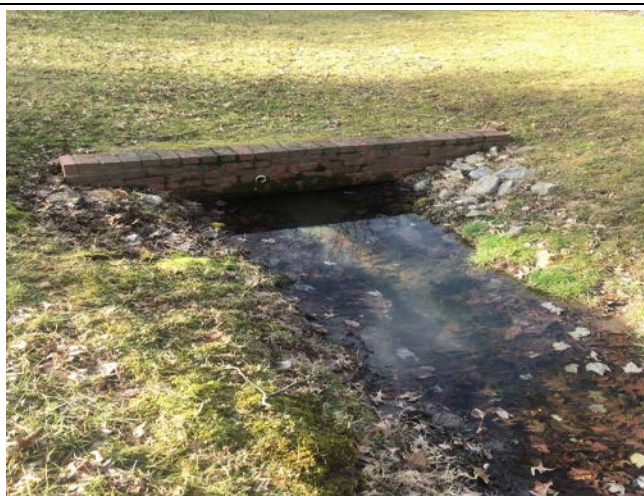
**Figure 5: Outfall and downstream channel submerged in standing water.**

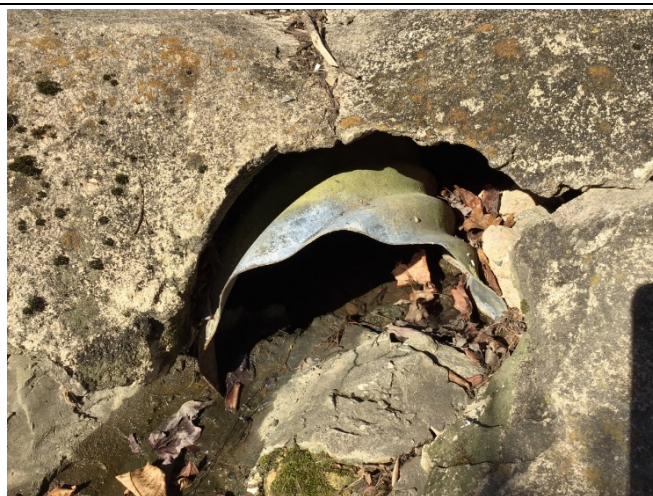
**Figure 6: Outfall is deformed and partially buried.**

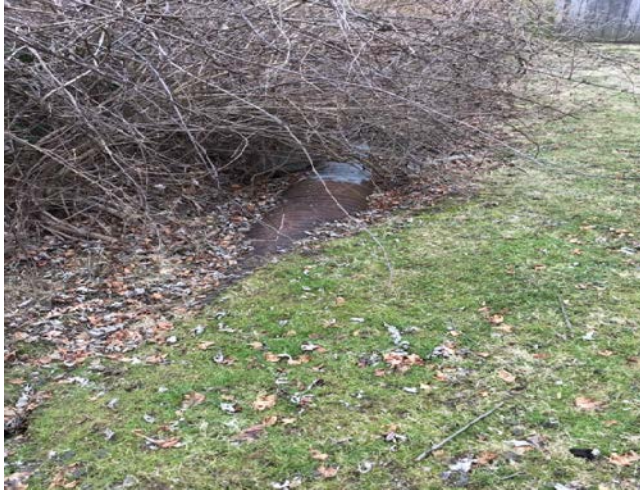
**Figure 1: Storm drain top exposed.**

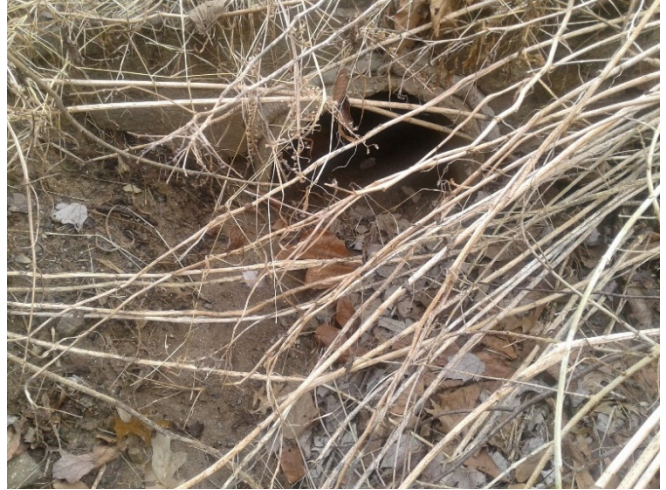
**Figure 2: Storm drain partially filled with sediment.**

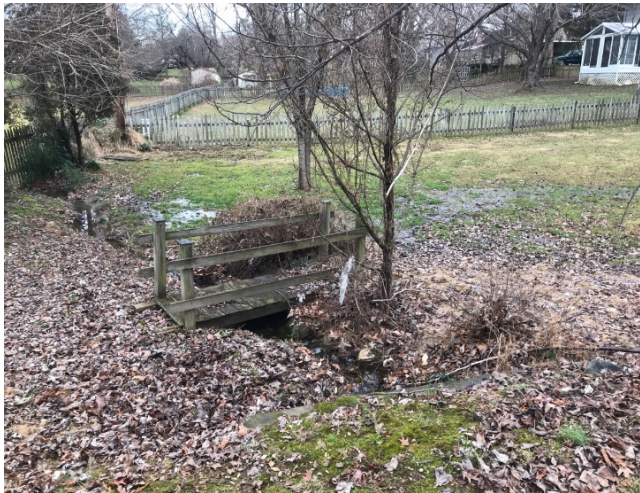
**Figure 1: Channel running through back yard at 3134 Hearthstone Rd.**

| Type | ID No. | Description & Discussion |
|---|---|---|
| Improve Existing Conveyance System/ESD Practice | P52-002 | Field observations and survey responses suggest that flooding is significant in this area. Stream restoration should be considered in order to channelize flow away from private properties. ESD facilities to be considered in areas with drainage issues where ample space is available. |

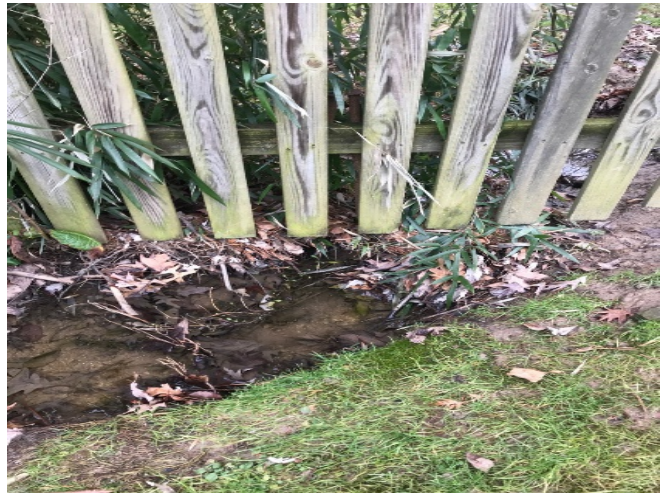
**Figure 2: Standing water and sediment buildup under fence between 3134 Hearthstone Rd. and 9522 Joey Dr.**

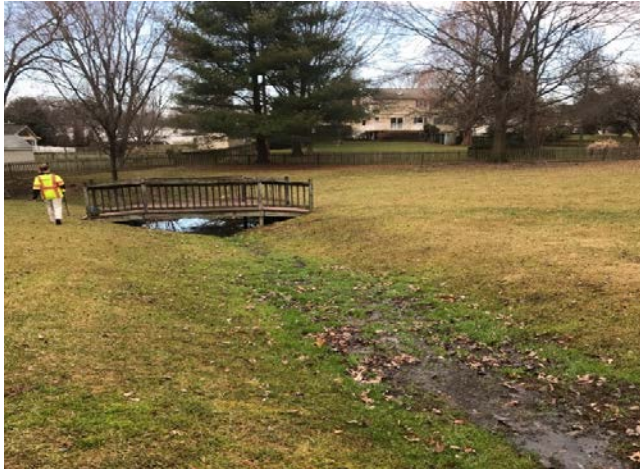
**Figure 3: Eroded channel running behind house at 9522 Joey Dr.**

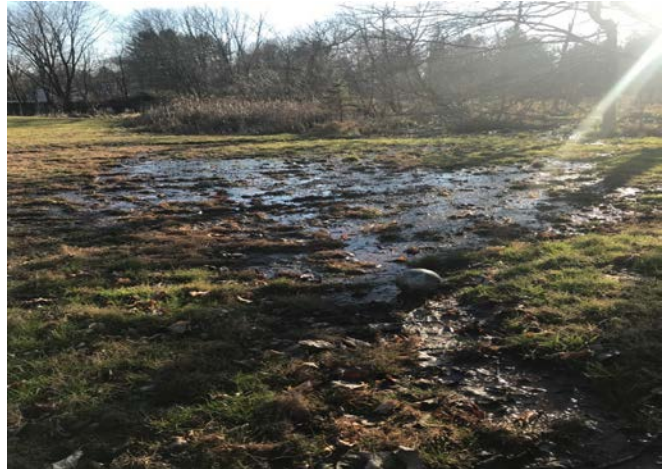
**Figure 4: Water ponds behind houses along Joey Dr. before entering Plumtree Branch.**

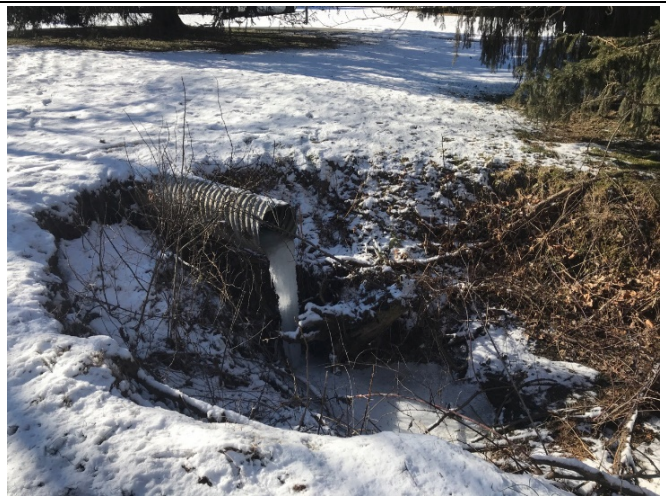
**Figure 6: Outfall with highly eroded outfall channel.**

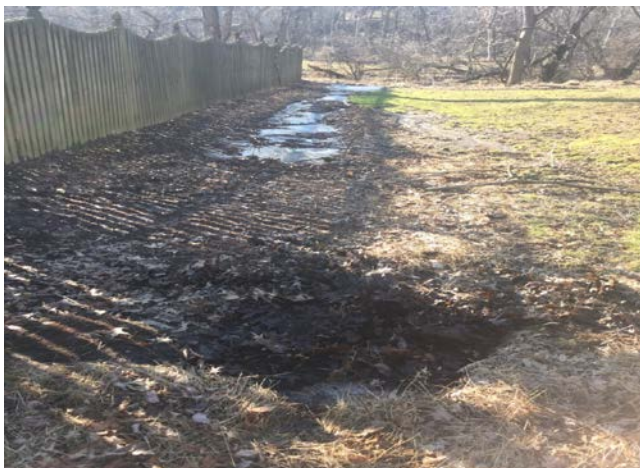
**Figure 7: Outfall and outfall channel is buried in sediment and debris.**

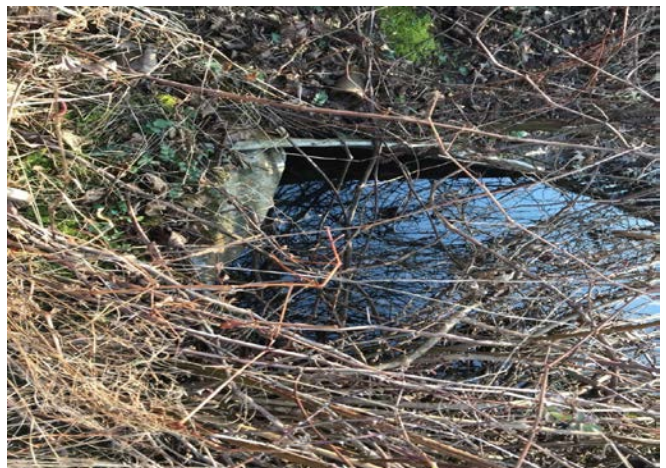
**Figure 8: Outfall is partially submerged and overgrown with vegetation.**

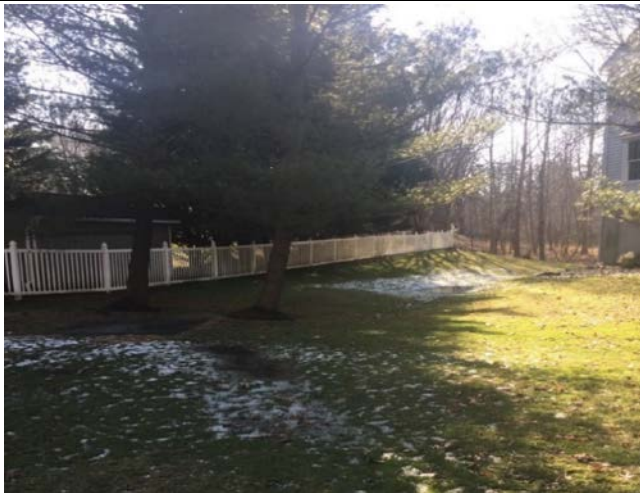
**Figure 1: Ponding water beside home at 9543 Michaels Way.**

| Type | ID No. | Description & Discussion |
|---|---|---|
| Improve Existing Conveyance System | P53-001 | Field observations and survey responses suggest that ponding water is an issue in this area. Add a yard inlet connecting to existing storm drain network or regrade the yard to better convey flow towards the stream. |

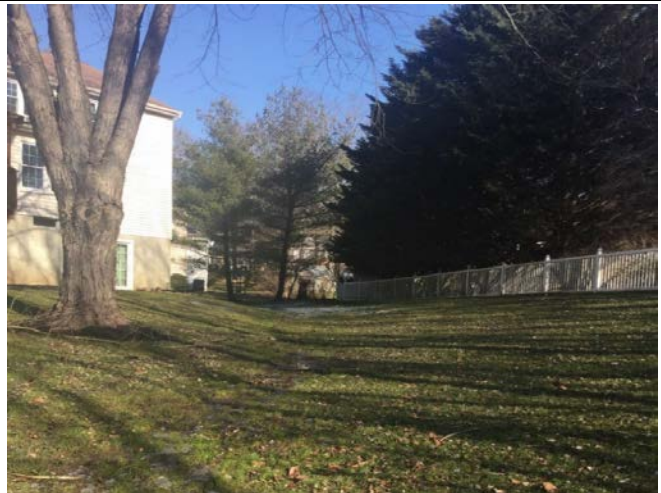
**Figure 2: Ponding water behind home at 9543 Michaels Way.**

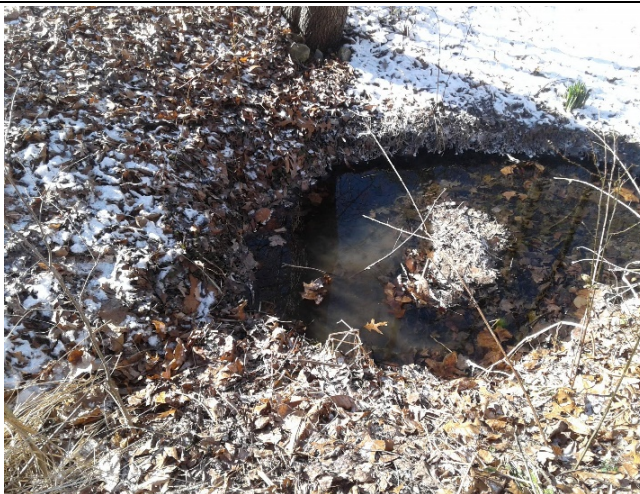
**Figure 3: Outfall is submerged and buried.**

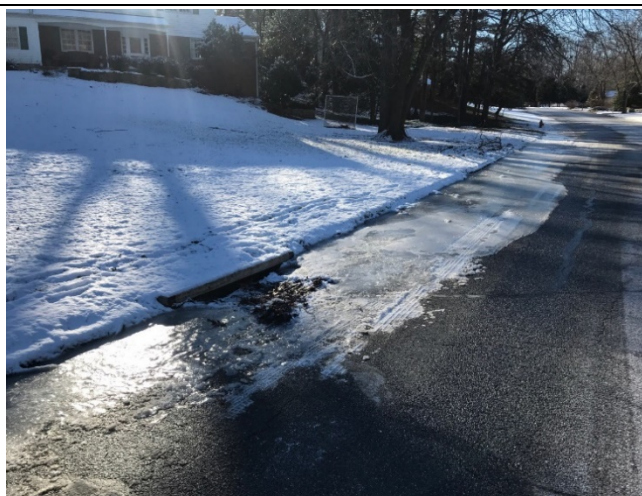
**Figure 1: Ice buildup behind inlet at Michaels Way and Longview Dr.**

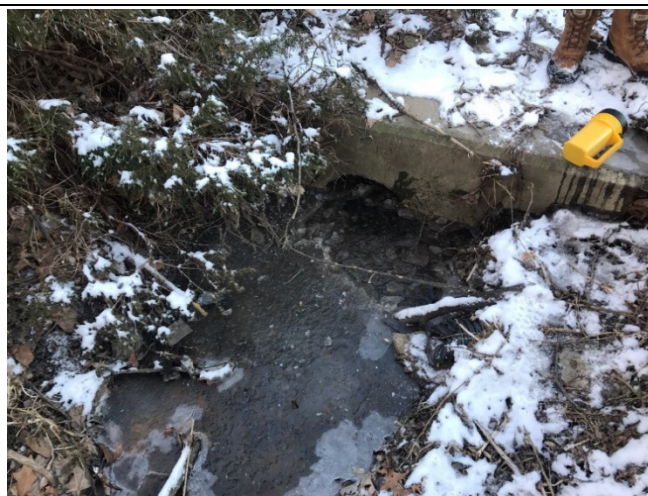
**Figure 2: Outfall partially submerged due to sediment and debris buildup.**

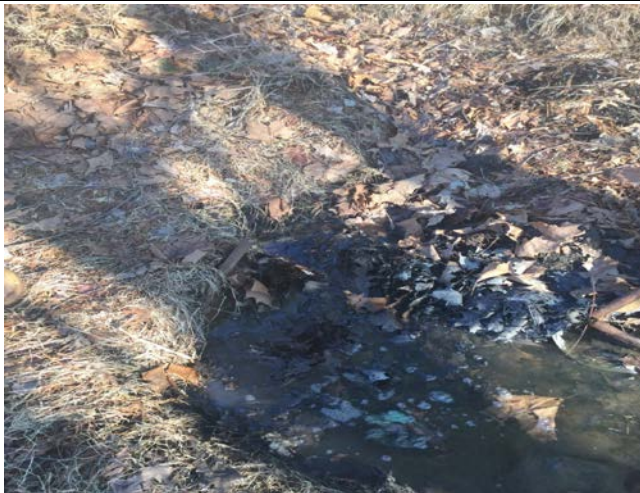
**Figure 1: Storm drain outfall is damaged and partially buried.**

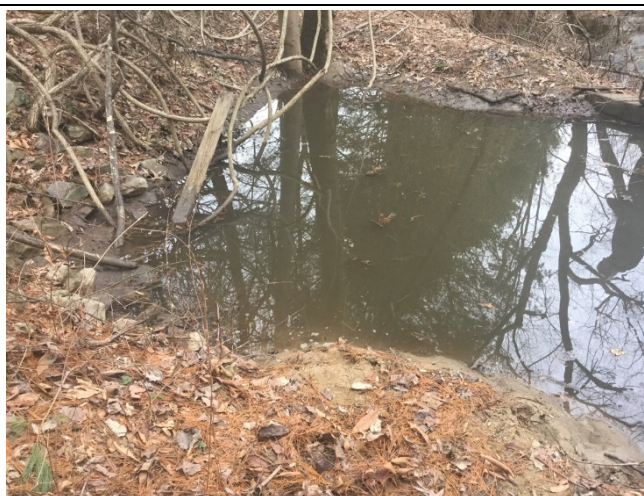
**Figure 1: Outfall into pond unable to be located. Forebay is inundated with water.**

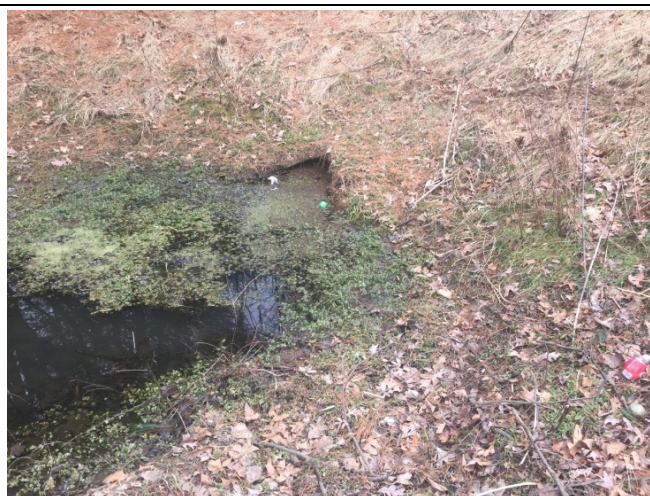
**Figure 2: Outfall into pond backfilled with water.**

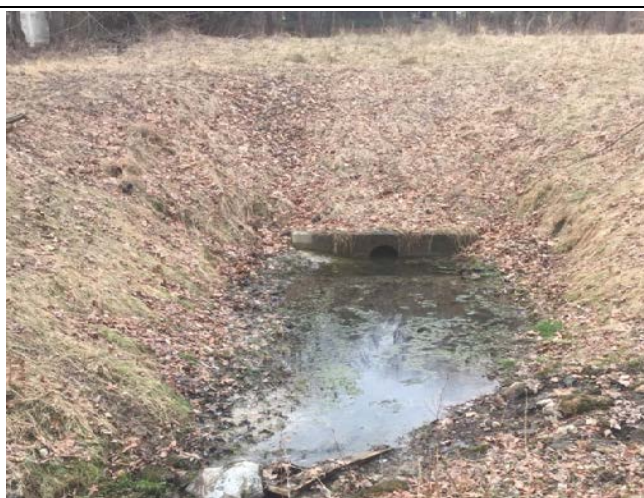
**Figure 3: Water in outfall channel is backing up into outfall pipe.**

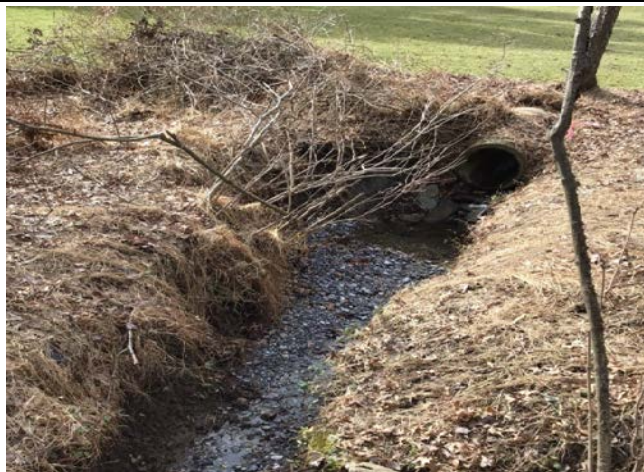
**Figure 1: Unstable outfall and disjointed pipe section at outfall.**

| Type | ID No. | Description & Discussion |
|---|---|---|
| Improve Existing Conveyance System | P57-001 | Field observations and interactions suggest that this storm drain and outfall is not functioning as intended. Clean pipe of gravel and repair/replace disjointed pipe section at the outfall. Investigate need for outfall channel stabilization. |

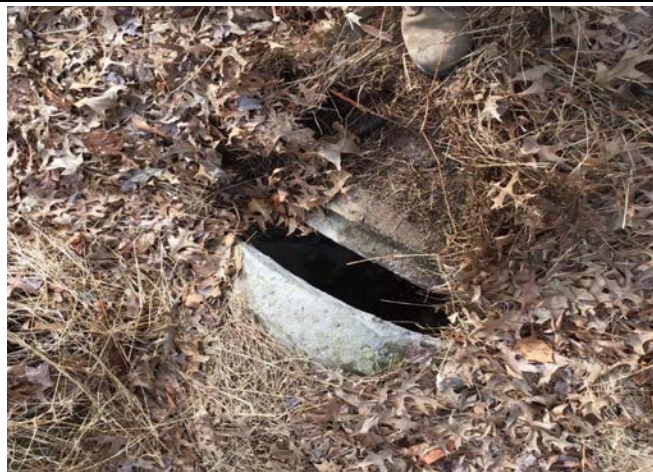
**Figure 2: Disjointed pipe at outfall.**

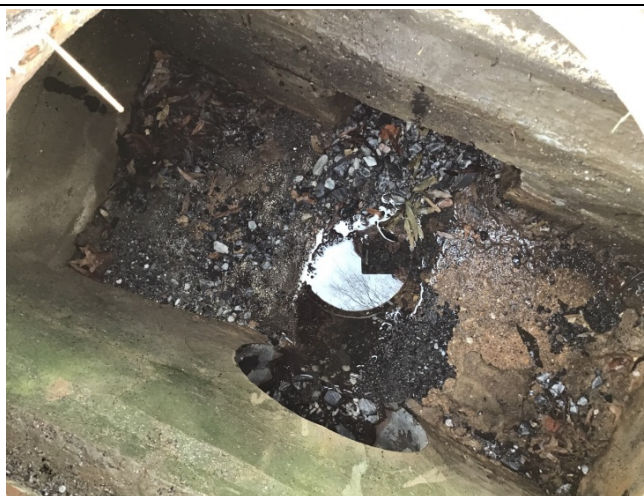
**Figure 3: Gravel inside inlet.**

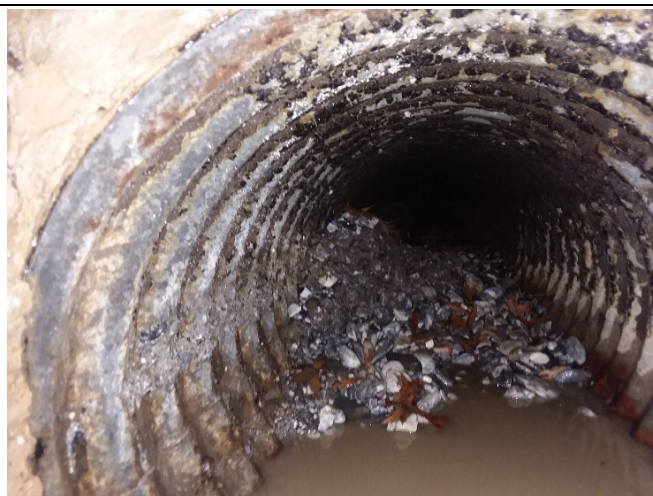
**Figure 4: Gravel blocking flow within pipe.**

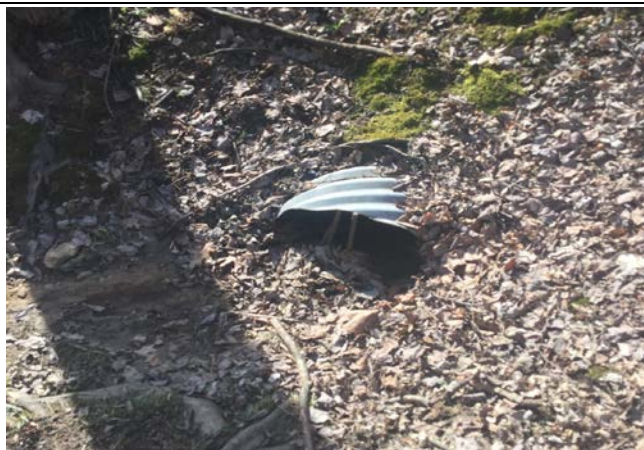
**Figure 5: Outfall is deformed and partially buried.**

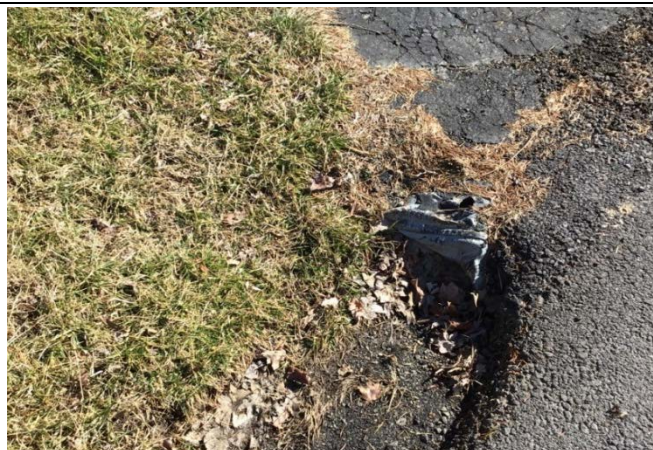
**Figure 6: Outfall and associated pipe is damaged.**

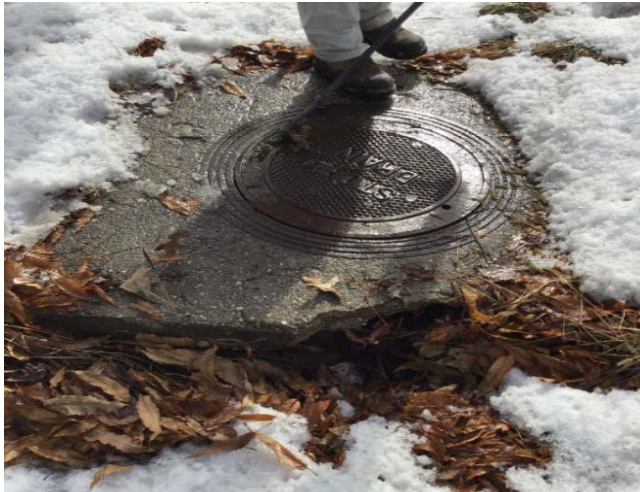
**Figure 1: Damaged concrete at inlet.**

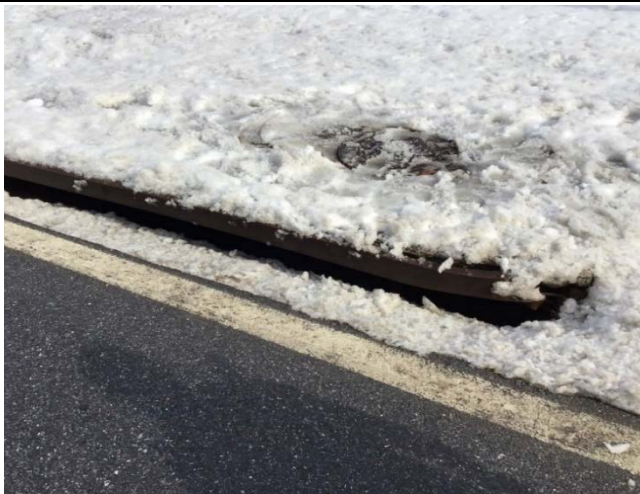
**Figure 3: Damage on the front right side of inlet.**

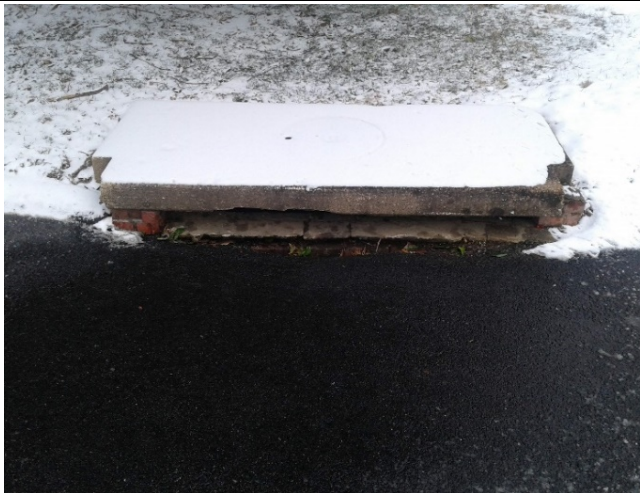
Figure 1: Damage along inlet opening.

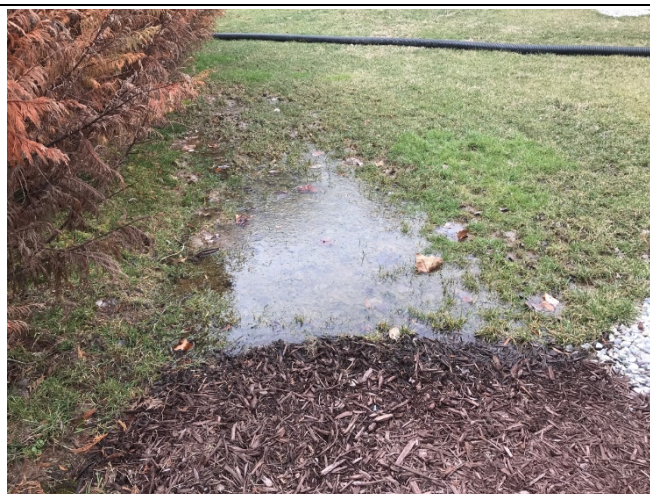
**Figure 2:** Localized ponding in area between houses.

| Type | ID No. | Description & Discussion |
|---|---|---|
| Improve Existing Conveyance System | P60-001 | Field observations and survey response suggest ponding water is an issue in this area. Possibly cut opening into back of existing inlet to allow flow to enter from back side. |

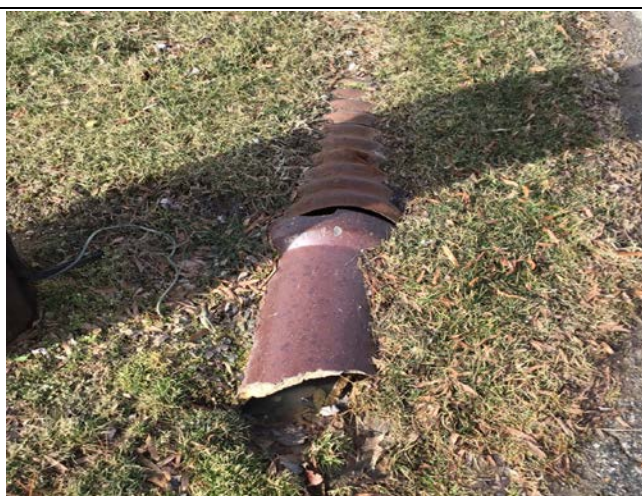
**Figure 3:** Pipe is disjointed and upstream end could not be located.

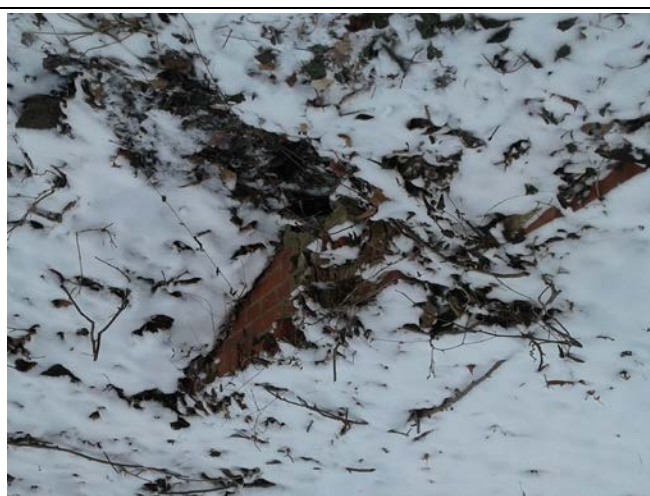
**Figure 4:** Outfall is collapsed.

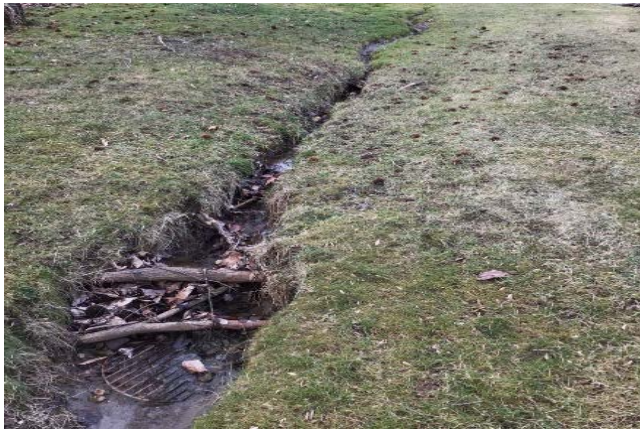
**Figure 1: Outfall channel running behind back yard at 2802 Leaf Shade Drive is severely eroded.**

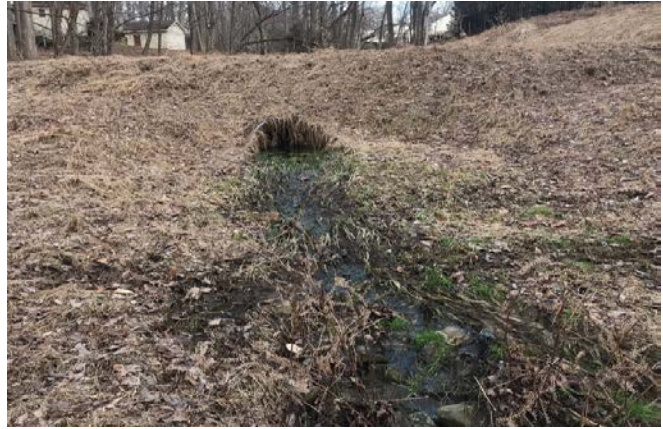
**Figure 2: Outfall is partially blocked.**

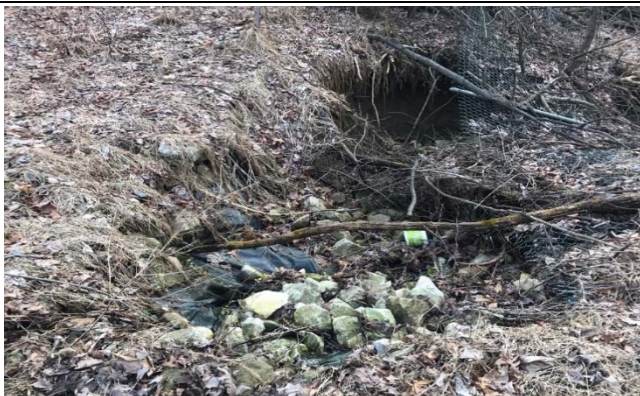
**Figure 3: Significant erosion and debris in outfall channel.**

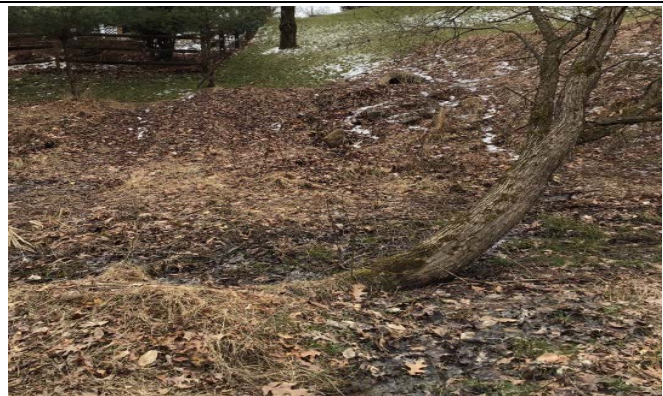
**Figure 4: Buildup of sediment and debris at pond inflow.**

| Type | ID No. | Description & Discussion |
|---|---|---|
| Detention Practice | P61-003 | Field observations suggest that conveyance into this SWM Pond is not functioning as intended due to buildup of sediment and debris at the inflow. Improve existing conveyance by cleaning inflow pipe and clearing pond of sediment and debris. |

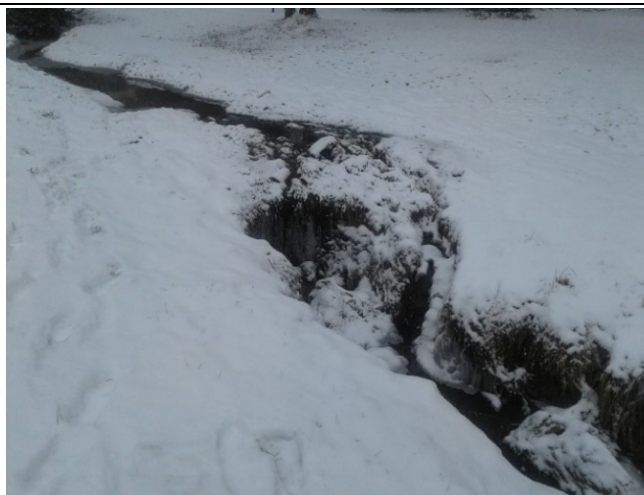
**Figure 1: Significant erosion in outfall channel.**

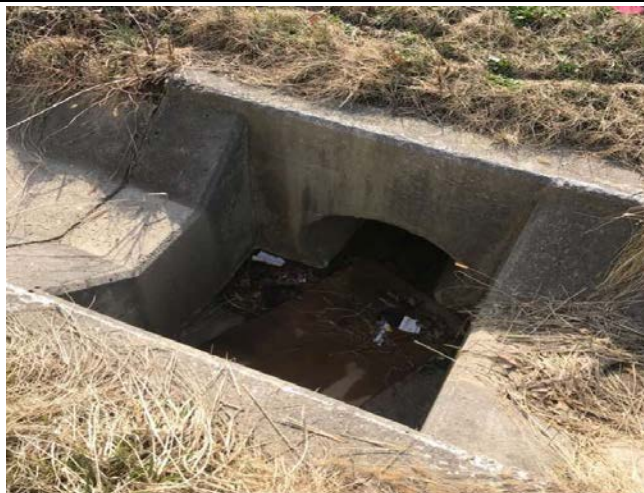
**Figure 1: Grate missing from inlet.**

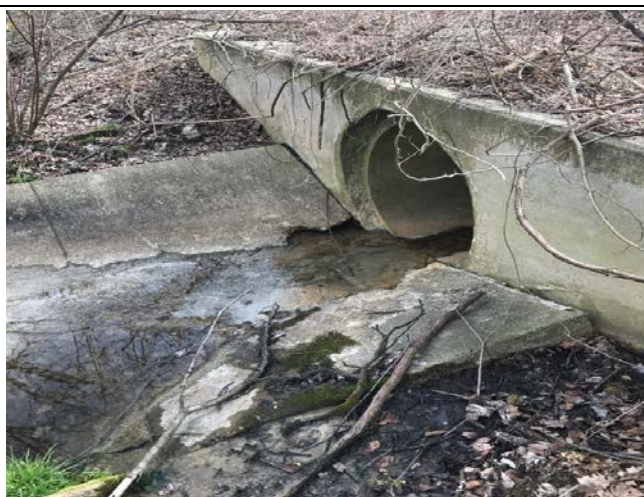
**Figure 3: Erosion surrounding outfall channel of outfall.**
