Appendix B – Photography Inventory

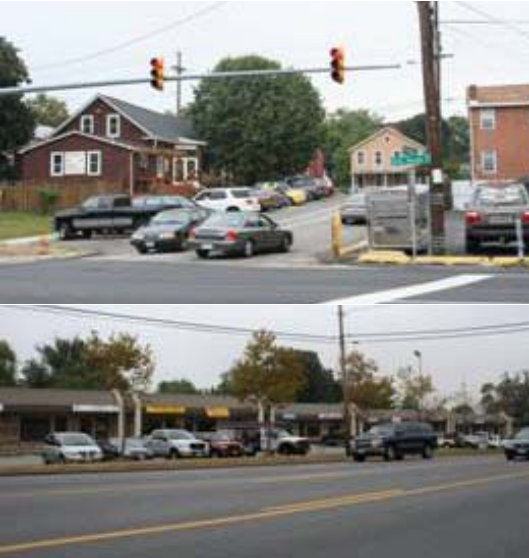
| Element | Existing Conditions, Issues, & Opportunities | Photos |
|--|--|--|
| <p align="center">US 1 Land Uses</p> | <ul style="list-style-type: none"> • Land uses along US 1 include the following: <ul style="list-style-type: none"> ○ Residential Communities ○ Hotels/motels (new and established) ○ Business offices and business parks ○ Commercial/Retail Strips ○ Small Businesses ○ Rock Quarry ○ Heavy Industrial ○ Light Industrial ○ Undeveloped Land • The variety of land uses and their site design challenge safe accommodation for pedestrians and bicycles. • Alternative routes for pedestrians, bicycles, vehicles, and trucks should be developed to ease the demand on US 1. | |

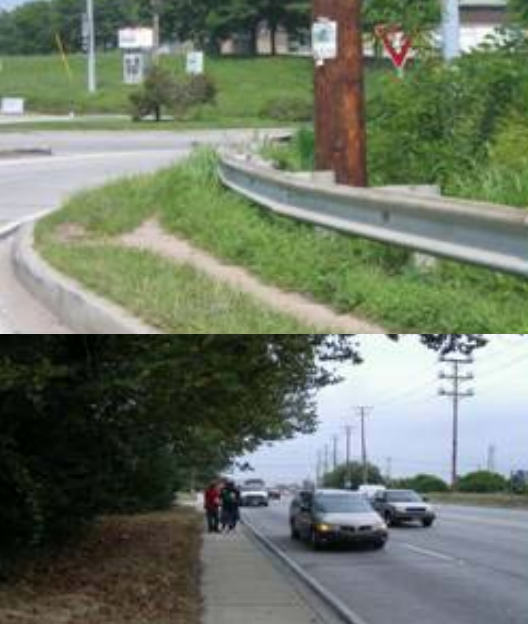
| Element | Existing Conditions, Issues, & Opportunities | Photos |
|--|--|--|
| <p align="center">Sidewalks and Pedestrian Facilities</p> | <ul style="list-style-type: none"> • Sidewalks are provided sporadically along US 1. Some sidewalks are located adjacent to the travel way and others are set back a few feet from the roadway. • Some transit stops and intersections with heavy pedestrian traffic do not yet have sidewalk connections to local generators (employers and retail) although many are planned. • Worn pedestrian paths indicate the need and the opportunity for sidewalks in areas with high pedestrian traffic. | |

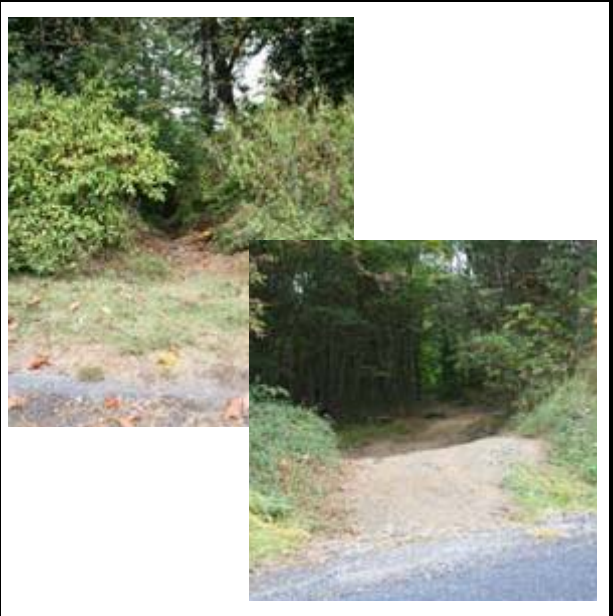
| Element | Existing Conditions, Issues, & Opportunities | Photos |
|---|--|--|
| <p>Informal Pedestrian and Bicycle Connections</p> | <ul style="list-style-type: none"> • Residents are using their own shortcuts to create connections through some areas. • Pedestrian connections are missing between many existing residential communities along US 1. • Alternatives to US 1 for parallel pedestrian and bicycle pathways travel are desirable. | |

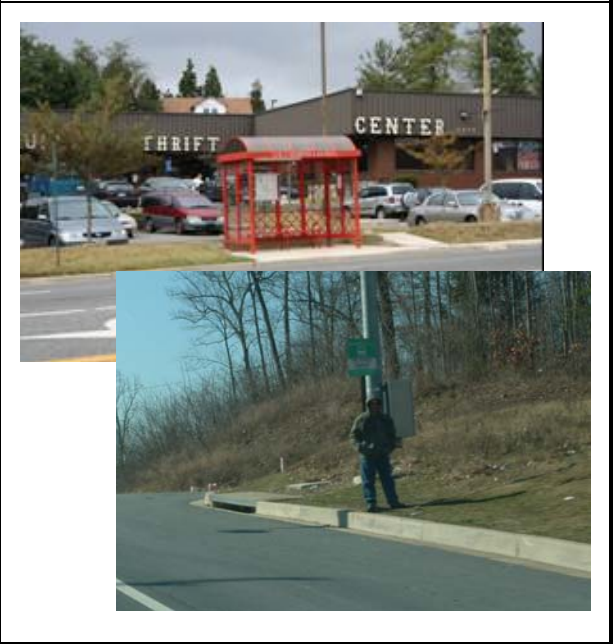
| Element | Existing Conditions, Issues, & Opportunities | Photos |
|---|--|--|
| <p>Transit Stops</p> | <ul style="list-style-type: none"> • MTA and Howard County provide transit service along US 1. <ul style="list-style-type: none"> ○ MTA Route #320 ○ Howard Transit Purple Route ○ Howard Transit Red Express • US 1 Corridor Revitalization Study recommended increased transit service. • Currently, pedestrian shelters are provided at high volume transit stops; lower volume stops are indicated by a posted sign. • All transit stops should have sidewalk connections to nearby employment and retail centers. | |

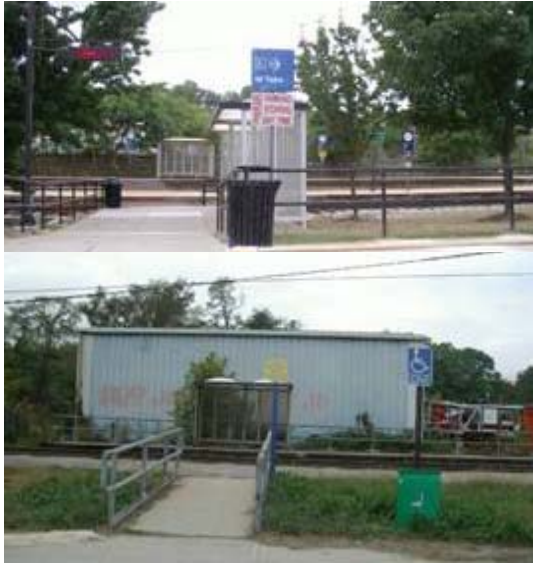
| Element | Existing Conditions, Issues, & Opportunities | Photos |
|---|---|--|
| <p>MARC Camden Line</p> | <ul style="list-style-type: none"> • MARC Camden Line has three stops in the vicinity of US 1; they are the: <ul style="list-style-type: none"> ○ Savage Station ○ Dorsey Station ○ Jessup Station (potential to be closed) • The Savage and Dorsey stations are currently served by Howard Transit bus routes. | |

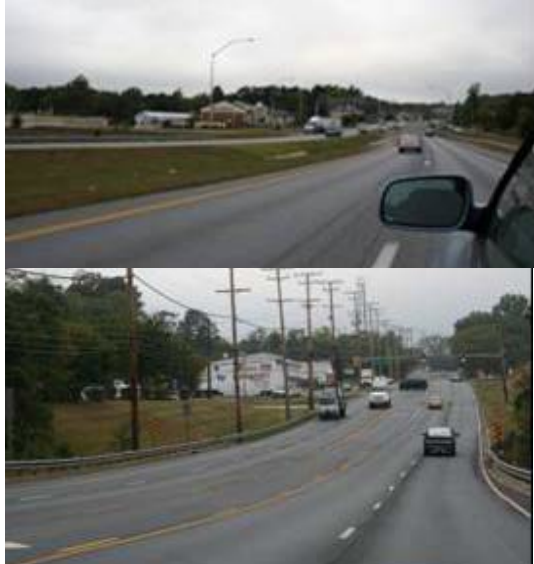
| Element | Existing Conditions, Issues, & Opportunities | Photos |
|---|---|--|
| <p>US 1 Cross Sections</p> | <ul style="list-style-type: none"> • US 1 has three different cross sections over the stretch of the 10 mile study corridor; they are: <ul style="list-style-type: none"> ○ Divided four-lane cross section ○ Four-lane cross section with two-way center left-turn lane ○ Undivided Four-lane Cross Section • The inconsistent cross section makes it difficult to develop a sense of place along portions of the corridor. • The width of the roadway makes it difficult and, in some cases, unsafe for pedestrians and bicycles to cross at uncontrolled intersections. • Sections of US 1 lack access management elements such as central medians. The lack of access management increases the number of vehicle conflicts on US 1. | |

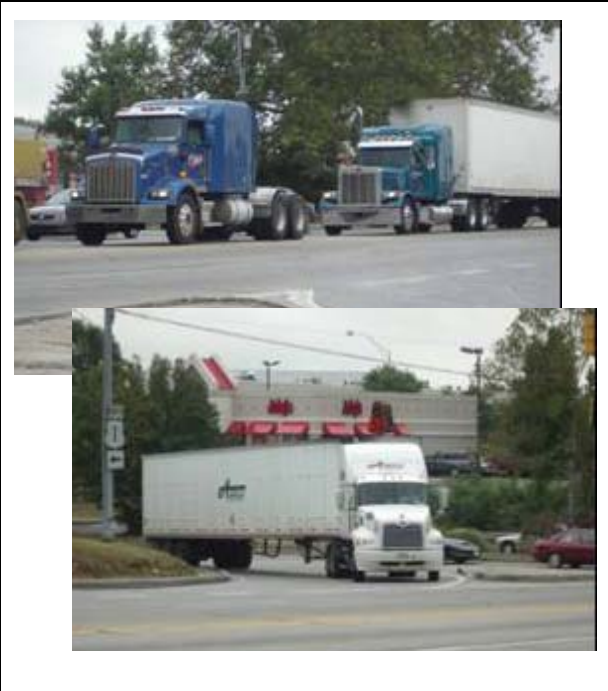
| Element | Existing Conditions, Issues, & Opportunities | Photos |
|---|---|--|
| <p style="text-align: center;">Truck Traffic</p> | <ul style="list-style-type: none"> • A high percentage of truck traffic is present along US 1 because of the heavy industrial uses in the area. • Geometric elements of the intersection such as channelizing islands, curb radii, and lane widths are designed to accommodate truck traffic. • Intersections along US 1 are designed primarily to accommodate vehicle and truck traffic; therefore the size of the intersections makes it difficult to safely and effectively accommodate pedestrians and bicyclists. | |

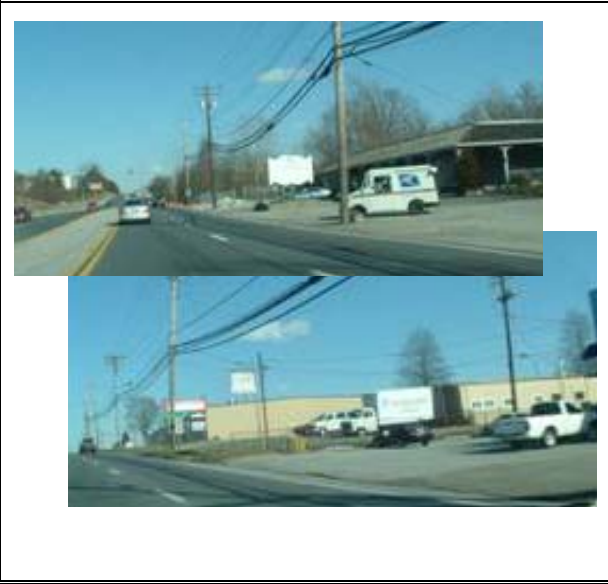
| Element | Existing Conditions, Issues, & Opportunities | Photos |
|---|---|--|
| <p style="text-align: center;">Driveway Access</p> | <ul style="list-style-type: none"> • Areas with high concentrations of driveway openings are: <ul style="list-style-type: none"> ○ Elkridge area ○ South of MD 100 to just past MD 175 • Many driveways extend the full length of roadway frontage challenging both aesthetics and safety • Combining driveways and providing side street access will permit traffic control, roadside pedestrian and bicycle facilities, and landscaping at the street edge. | |

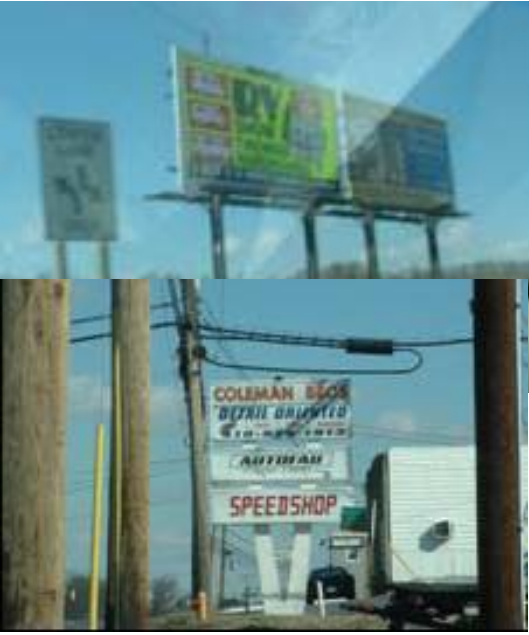
| Element | Existing Conditions, Issues, & Opportunities | Photos |
|---|---|--|
| <p>Signage and Utility poles</p> | <ul style="list-style-type: none"> • Highway scale signage dominates the roadway for both on site businesses and off site advertising. • A major feature of the street edge is the utility pole, often not buffered visually or physically. | |

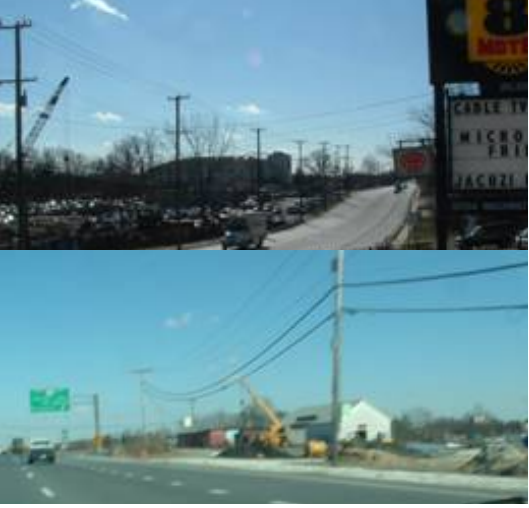
| Element | Existing Conditions, Issues, & Opportunities | Photos |
|---|---|--|
| <p>Street Edge</p> | <ul style="list-style-type: none"> • Highly visible industrial uses define the street edge • Edges are not defined by buildings or landscape treatment • Architecture is non discript | |

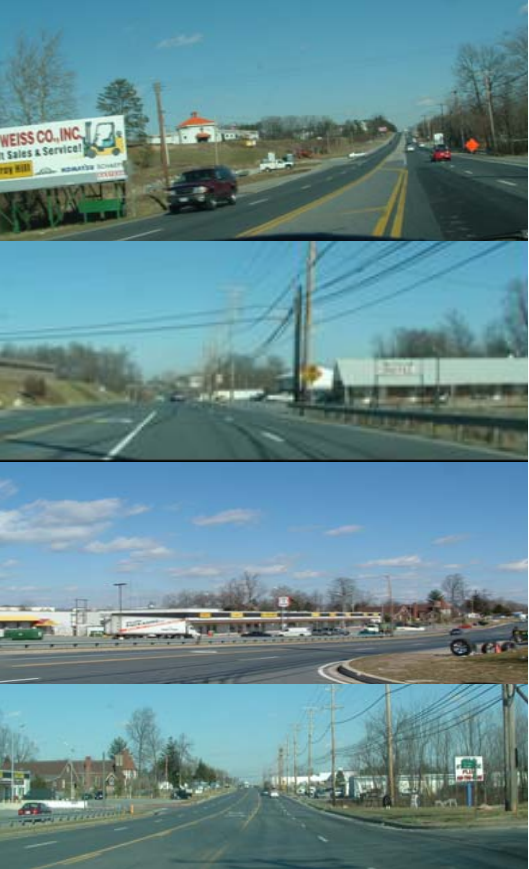
| Element | Existing Conditions, Issues, & Opportunities | Photos |
|---|--|---|
| <p data-bbox="170 639 457 667">Built Environment</p> | <ul data-bbox="562 532 1184 748" style="list-style-type: none">• Architecture is non distinct• Building setback varies from property to property• Function-oriented highway infrastructure | <p>The 'Photos' column contains four images stacked vertically. The top image shows a highway with a 'WEISS CO., INC.' billboard on the left. The second image is a view from a vehicle on a highway with utility poles. The third image shows a large commercial building with a parking lot. The bottom image shows a highway with utility poles and a building in the distance.</p> |
