CMOM Audit Report No. 7

January, 2017

December, 2017

**Complaint and Settlement Agreement between Howard County,
Maryland and the Maryland Department of the Environment
CO-10-1116**

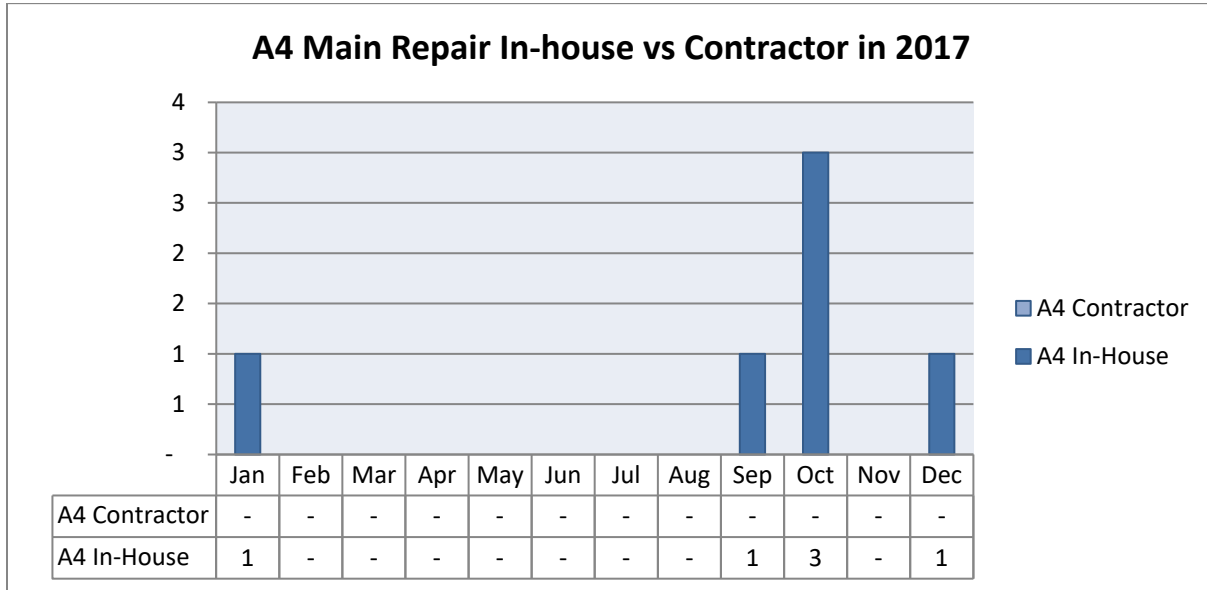
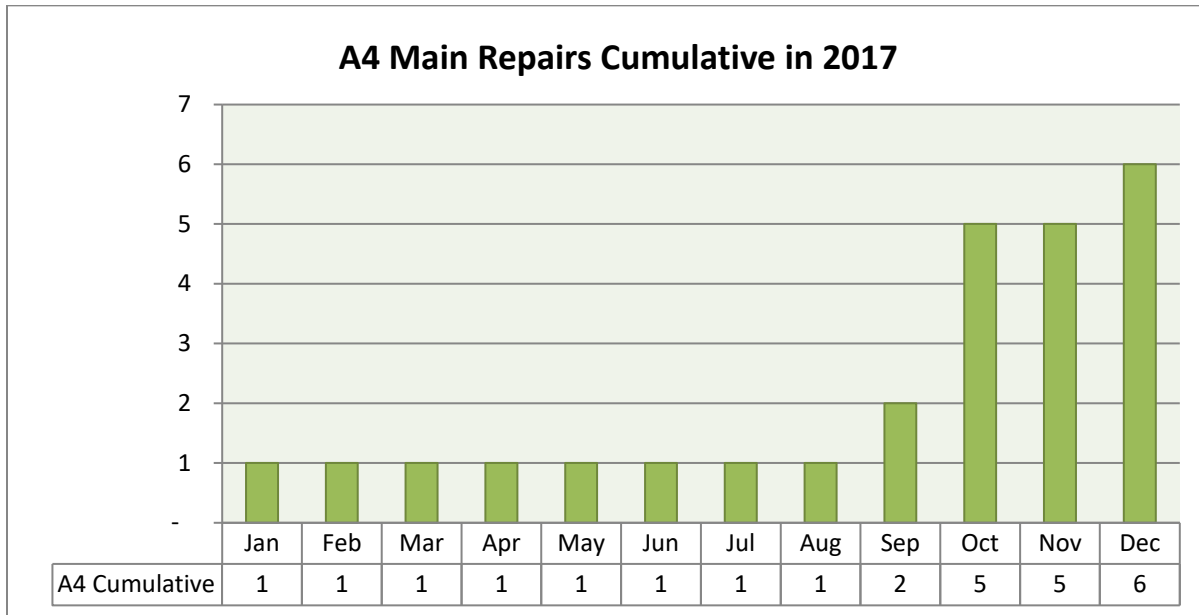
A4. Sewer Main Repairs

The County performed the sewer main repair/replacement on an As-Needed basis. Six (6) sewer mains were repaired by County's in-house staff in 2017, totaled 1,455 ft.

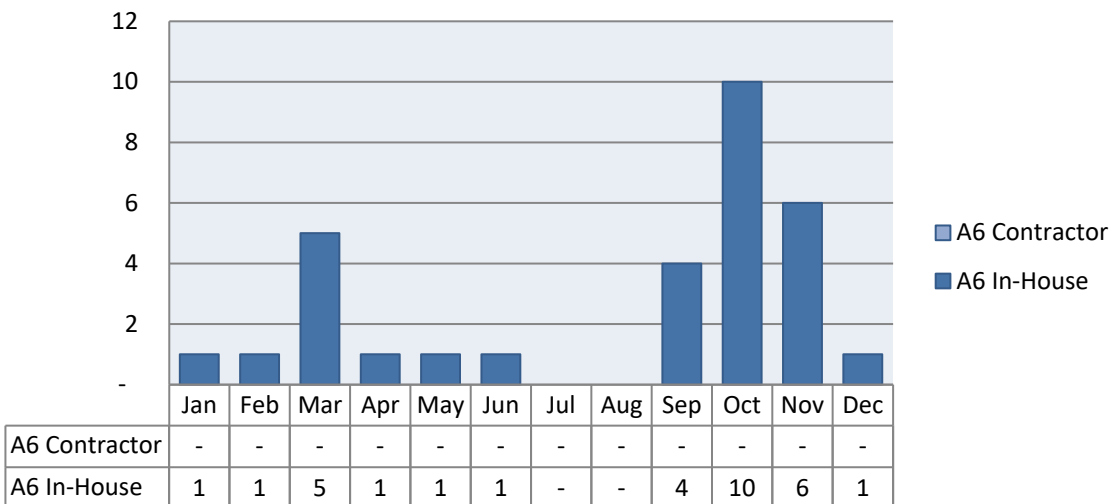
A6 Manhole Repairs In-house vs Contractor in 2017

The County performed the manhole repair/replacement on an As-Needed basis. Sanitary sewer manholes are repaired by County's in-house staff and contractors. There were 31 manholes repaired in 2017 by the County's in-house staff.

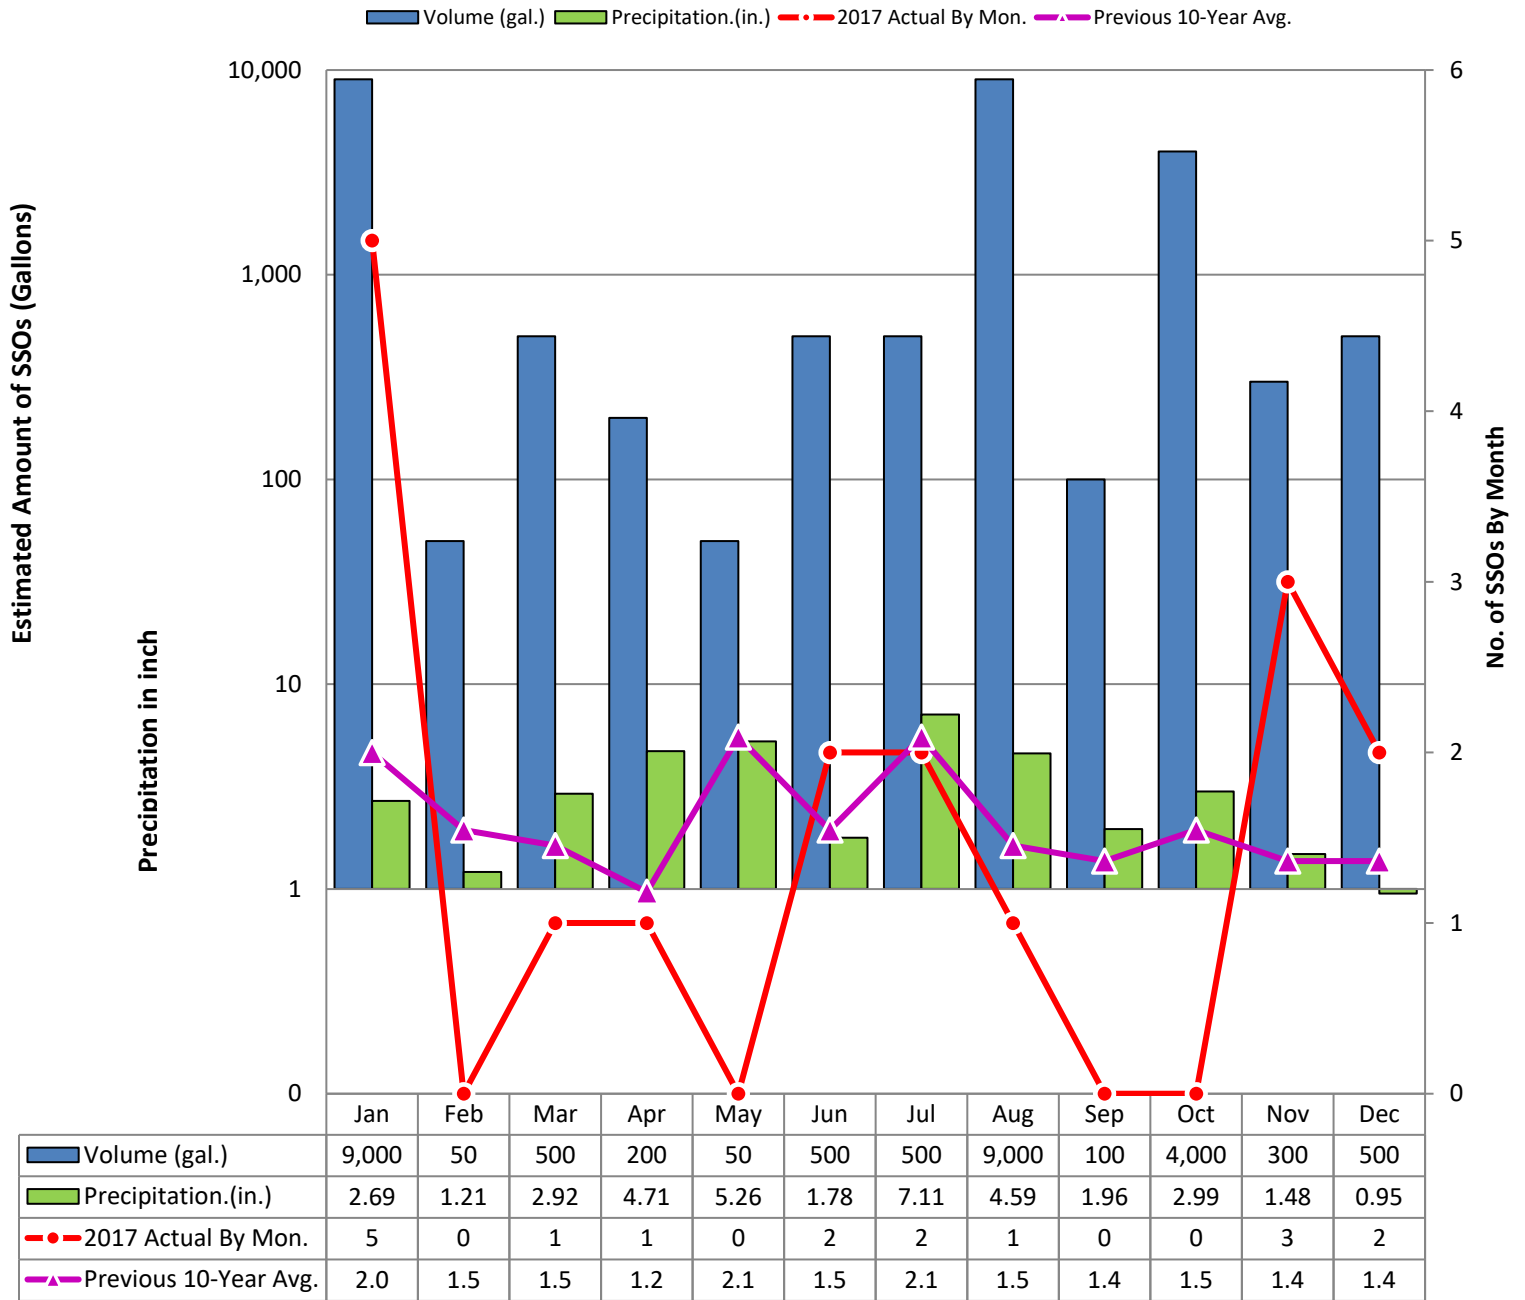
Howard County SSO vs Precipitation in 2017

The County’s SSO’s have been plotted by month in the above chart. As is shown in the chart, most months’ SSO occurrence numbers in 2017 were all below the previous 10-year average. There was no SSO occurred during February, May, September and October. You can also see the number of SSO occurrence in each month still correlates the amount of precipitation. The more it rained, the more SSO occurred.

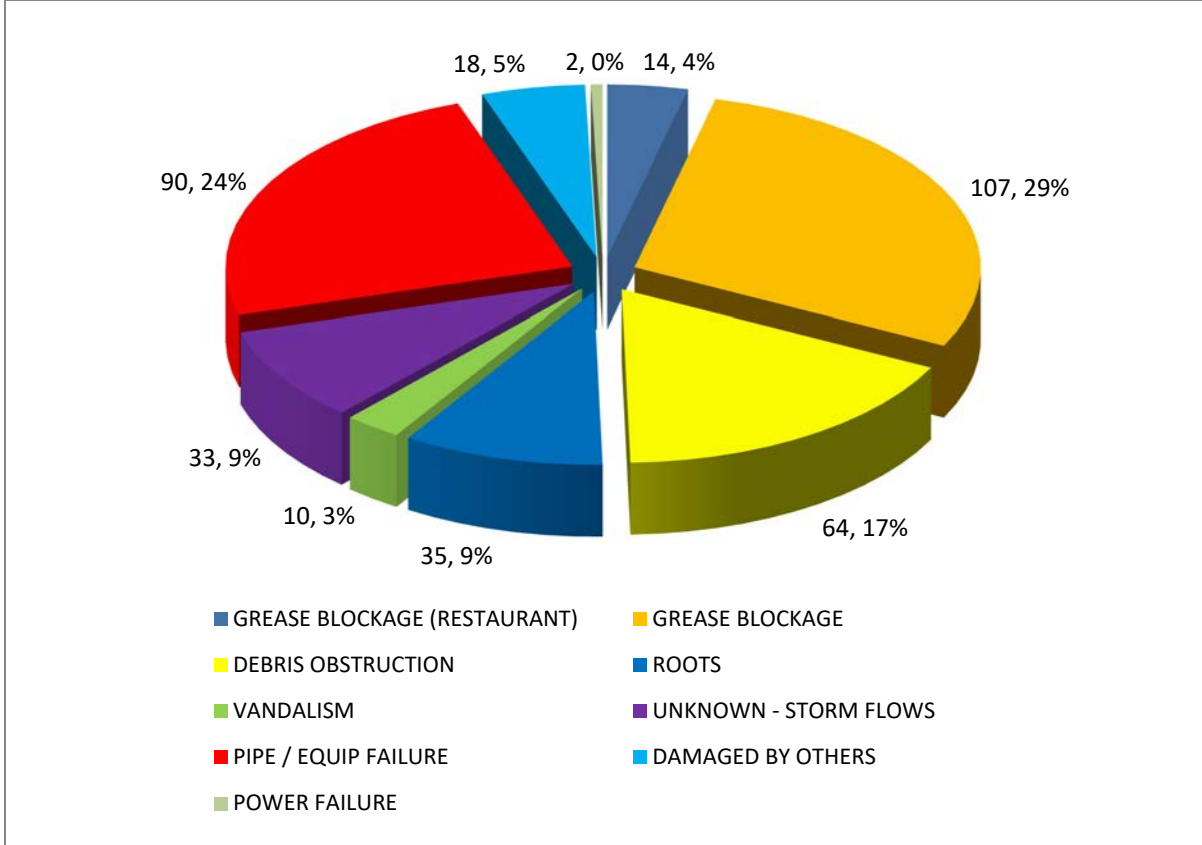
As is shown in the above chart, the top three (3) causes of overflows county-wide are: grease blockage (non FOG, 29%), pipe/equipment failure (24%), and debris obstruction (17%).

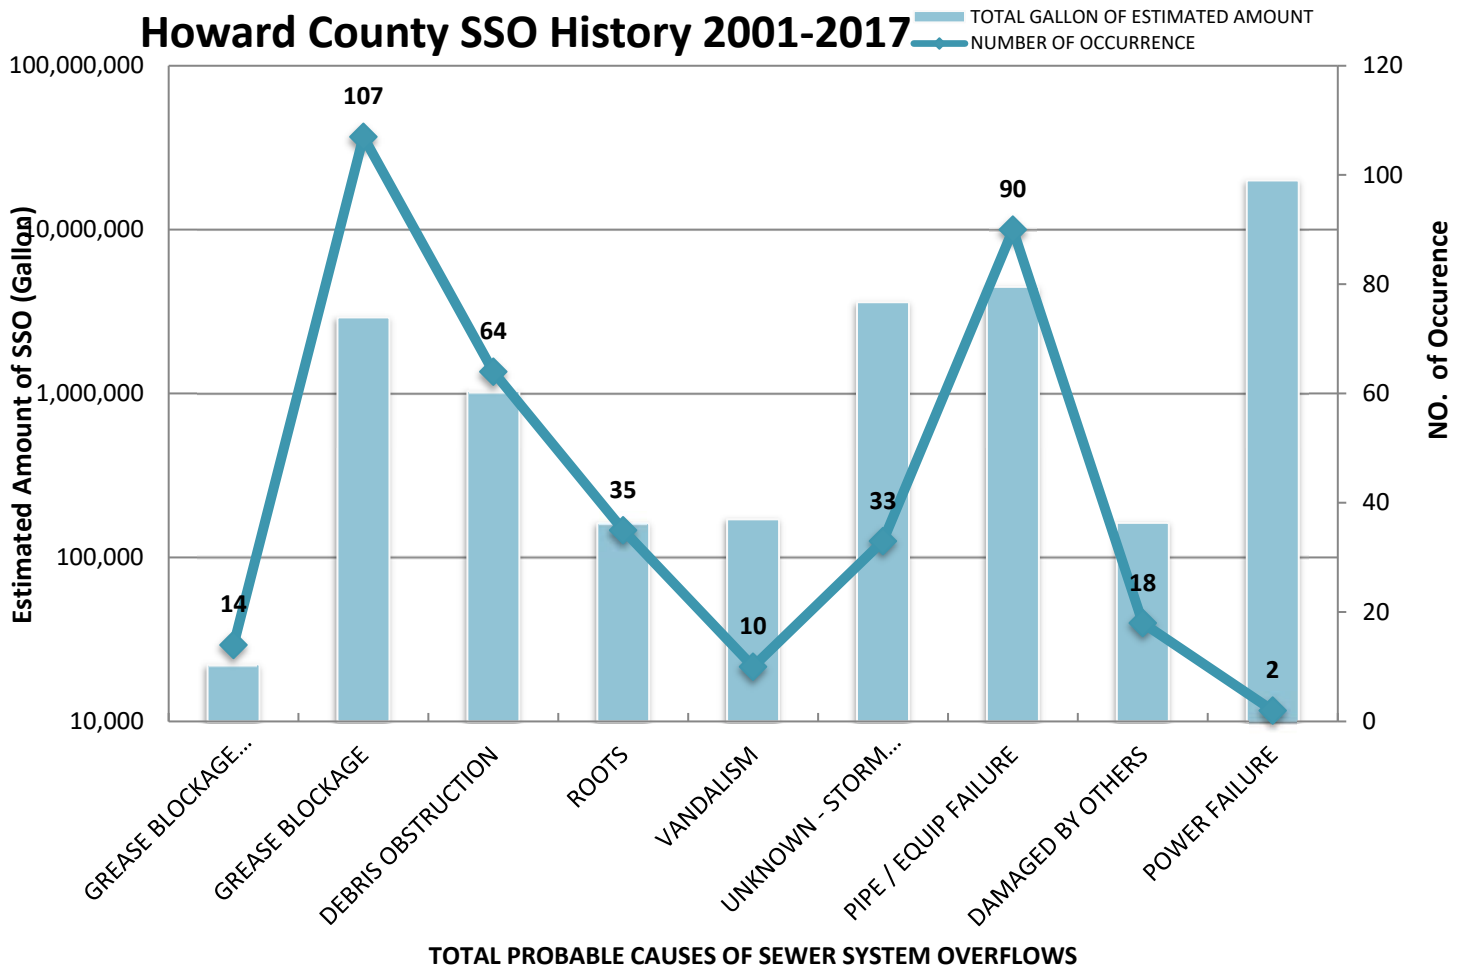
While taking the estimated overflow amount into consideration, power failure, storms, pipe and equipment failures rank the highest of the total SSO volume contribution. This observation has not changed from 2012.

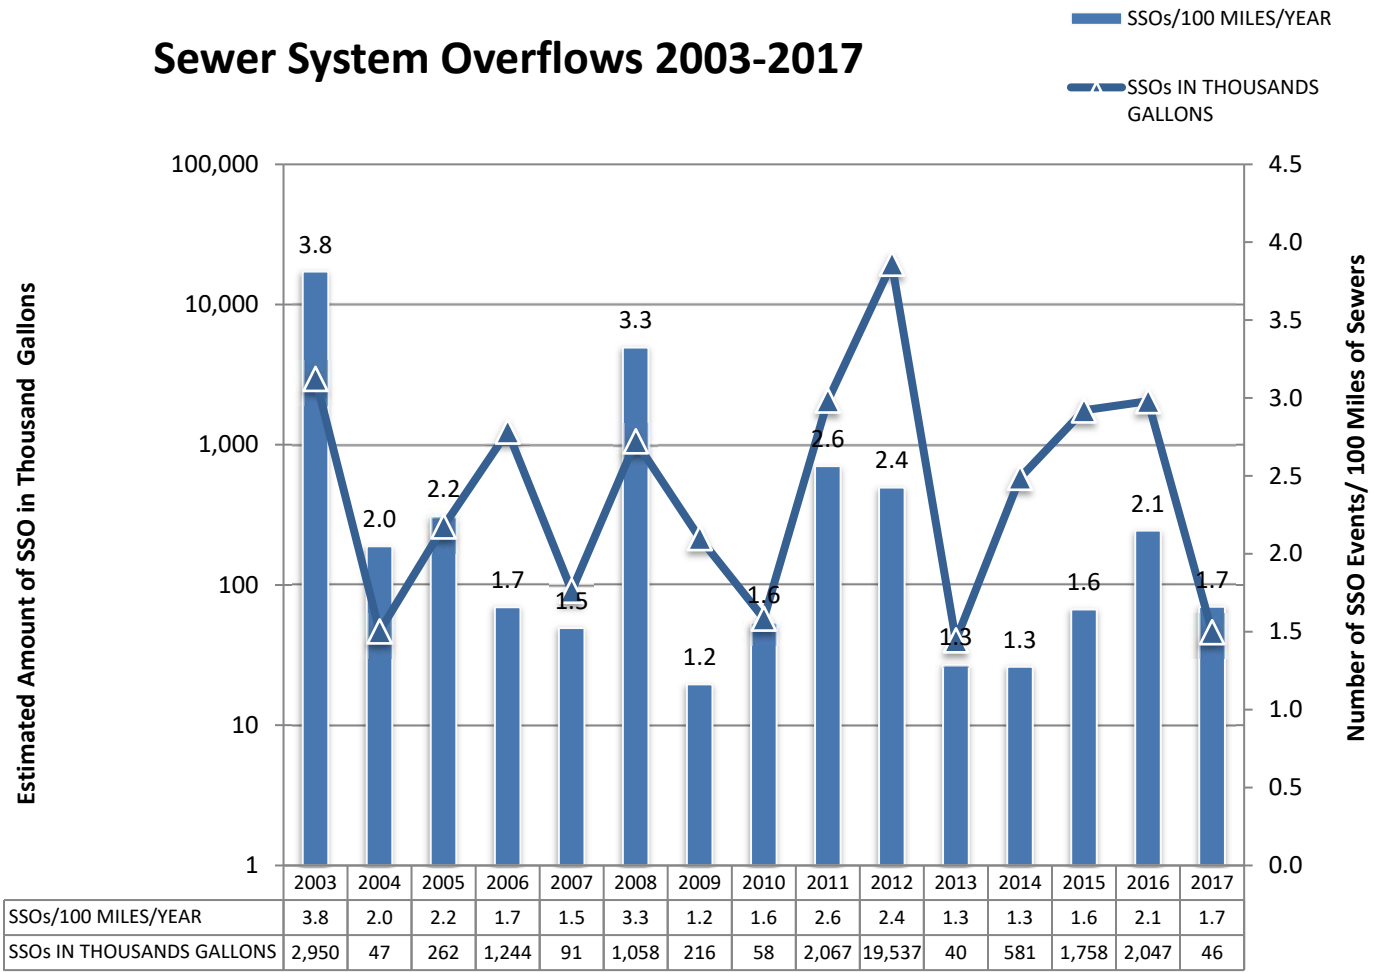
Sewer System Overflows 2003-2017

As is shown in the above chart, over the past 12 years from 2003 to 2017, the County has the SSOs/mile/year ranging from 1.2 to 3.8, while the national average posted by EPA in 2004 is 4.5. What's more, the County's overall trend of SSOs/mile/year is downward.
