## **CMOM Audit Report**

Complaint and Settlement Agreement between Howard County, Maryland and the Maryland Department of the Environment CO-10-1116

This Self-Audit Report is a requirement of "Paragraph C, CMOM Audit" of the Complaint and Settlement Agreement. One year after the commencement of implementation of the approved CMOM Program, and annually thereafter until termination of this Agreement, the County shall conduct a performance assessment audit to evaluate the CMOM Program and submit a report to MDE certifying and describing:

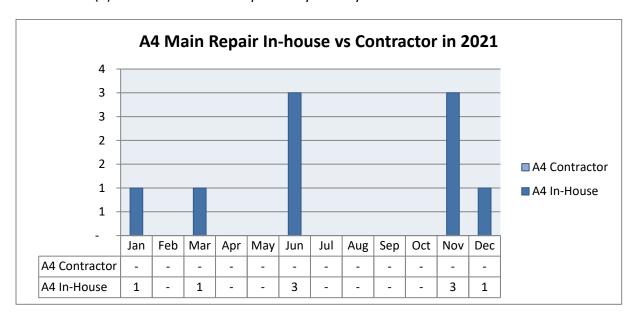
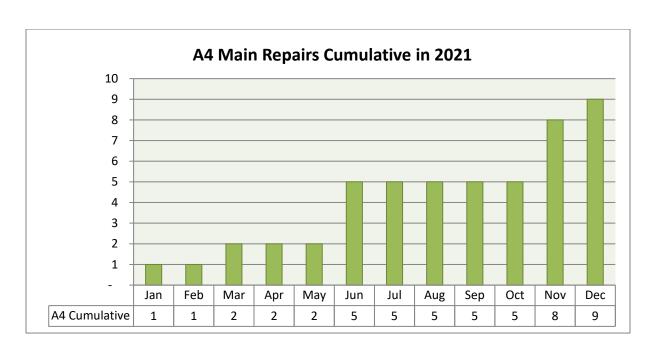
#### A4. Sewer Main Repairs

The County performed the sewer main repair/replacement on an As-Needed basis. Five (5) sewer mains were repaired by County's in-house staff in 2021.

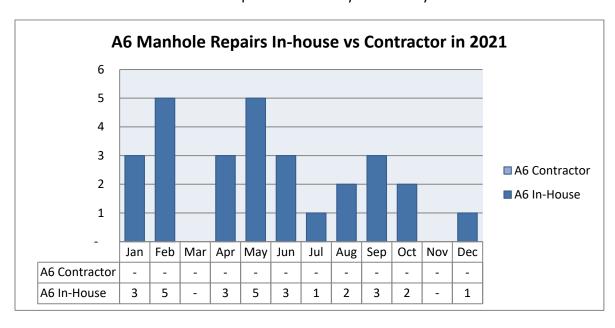
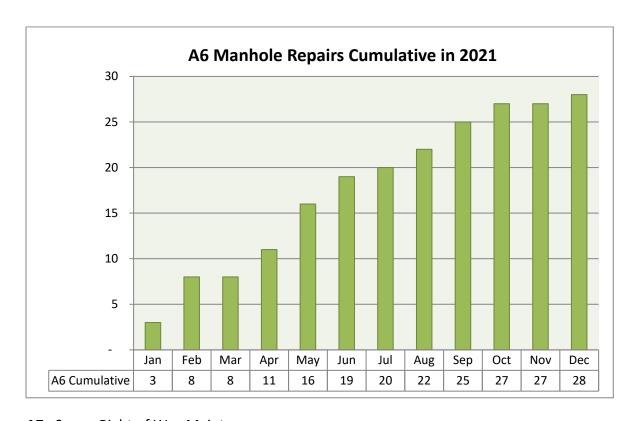
#### A6. Manhole Repairs

The County performed the manhole repair/replacement on an As-Needed basis. Sanitary sewer manholes are repaired by County's in-house staff and contractors. There were 28 manholes repaired in 2021 by the County's in-house staff.

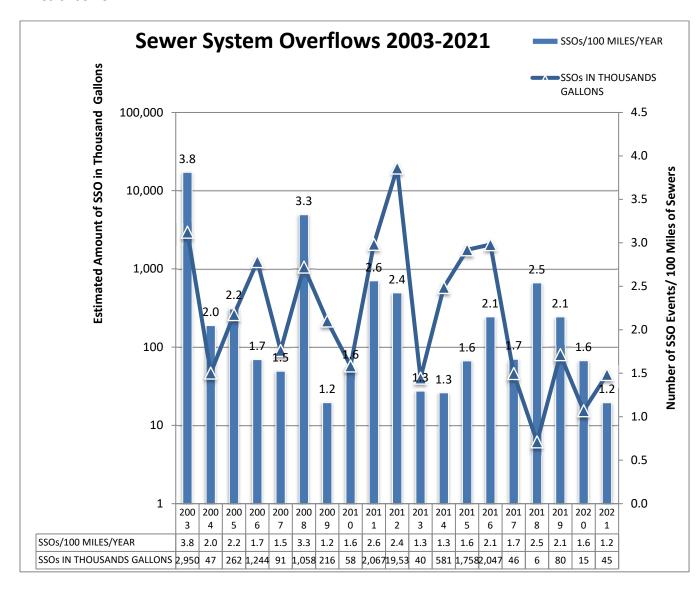
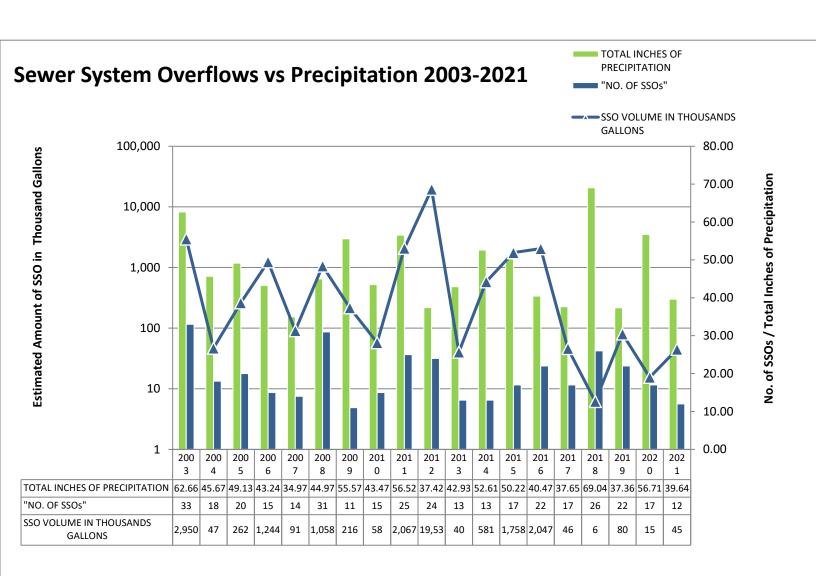
Since 2003, Howard County maintains a far below national average for the number of sewer overflow occurrence. The national average for SSO is 4.5 per 100 miles of sewer, based on a 2004 EPA report to Congress. The County's average for 2021 is 1.2 per 100 miles of sewer.

The County's SSO's have been plotted by month in the above chart. As is shown in the chart, most months' SSO occurrence numbers in 2021 were all below the previous 10-year average. There was no SSO occurred during March, July, and August.

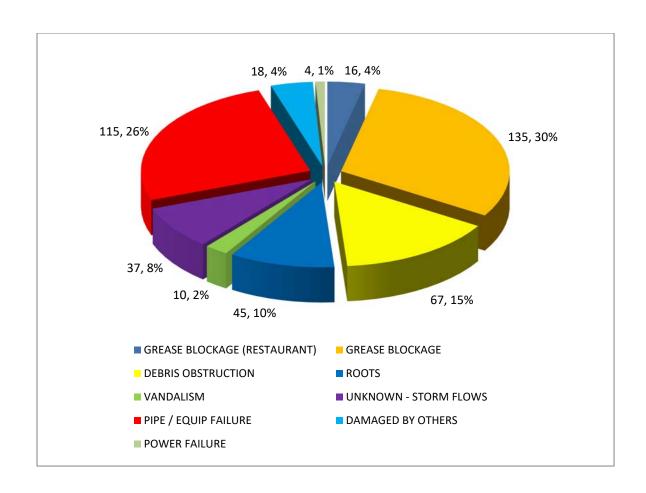
As is shown in the above chart, the top three (3) causes of overflows county-wise are: grease blockage (non FOG, 30%), pipe/equipment failure (26%), and debris obstruction (15%).

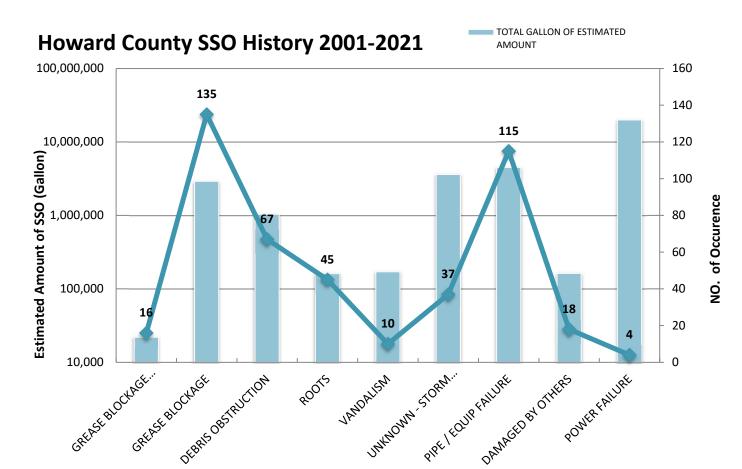
TOTAL PROBABLE CAUSES OF SEWER SYSTEM OVERFLOWS

While taking the estimated overflow amount into consideration, power failure, storms, pipe and equipment failures rank the highest of the total SSO volume contribution. This observation has not changed from 2012.

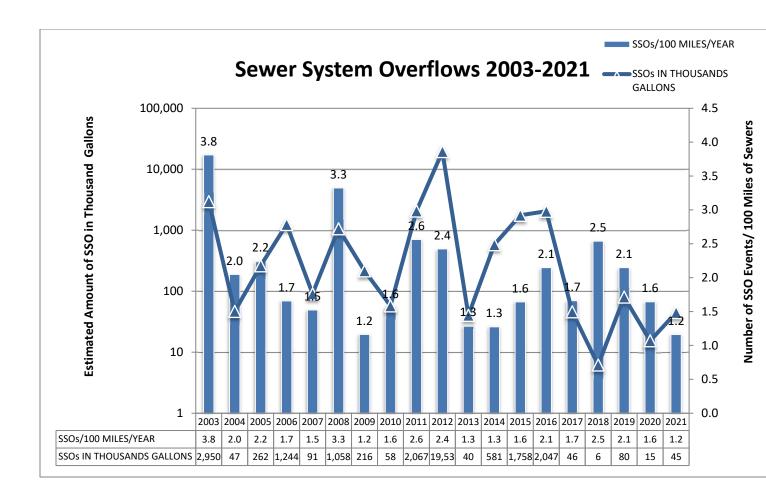
As is shown in the above chart, over the past 17 years from 2003 to 2021, the County has the SSOs/mile/year ranging from 1.2 to 3.8, while the national average posted by EPA in 2004 is 4.5. What's more, the County's overall trend of SSOs/mile/year is downward.

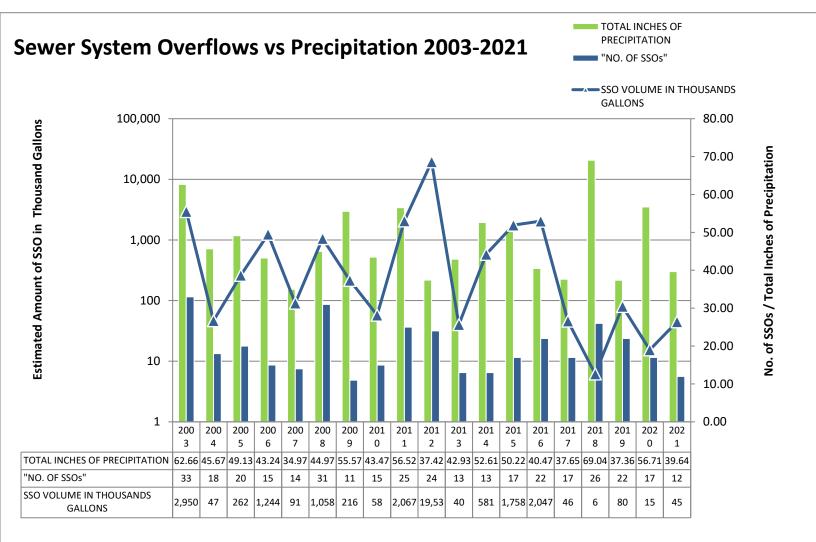
To further investigate the correlation between numbers of SSO occurrence to the total amount, the 17 years' precipitation data is plotted in the below chart. The numbers of SSO occurrence over the years keep a downward trend.
