CMOM Audit Report No. 4

January, 2014

**Complaint and Settlement Agreement between Howard County,
Maryland and the Maryland Department of the Environment
CO-10-1116**

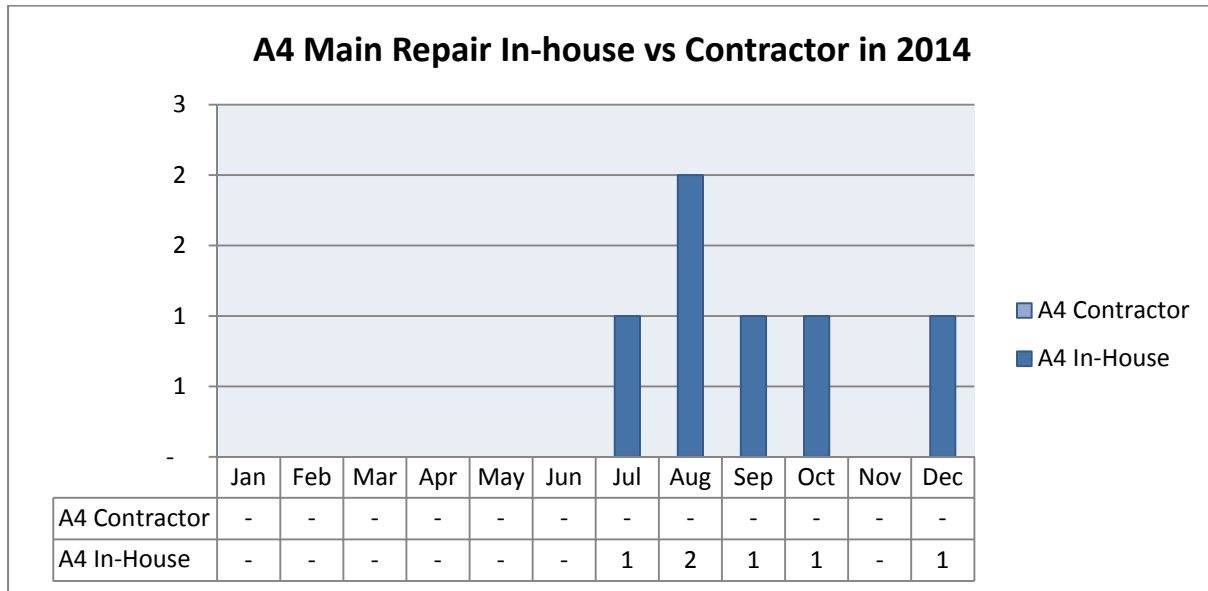
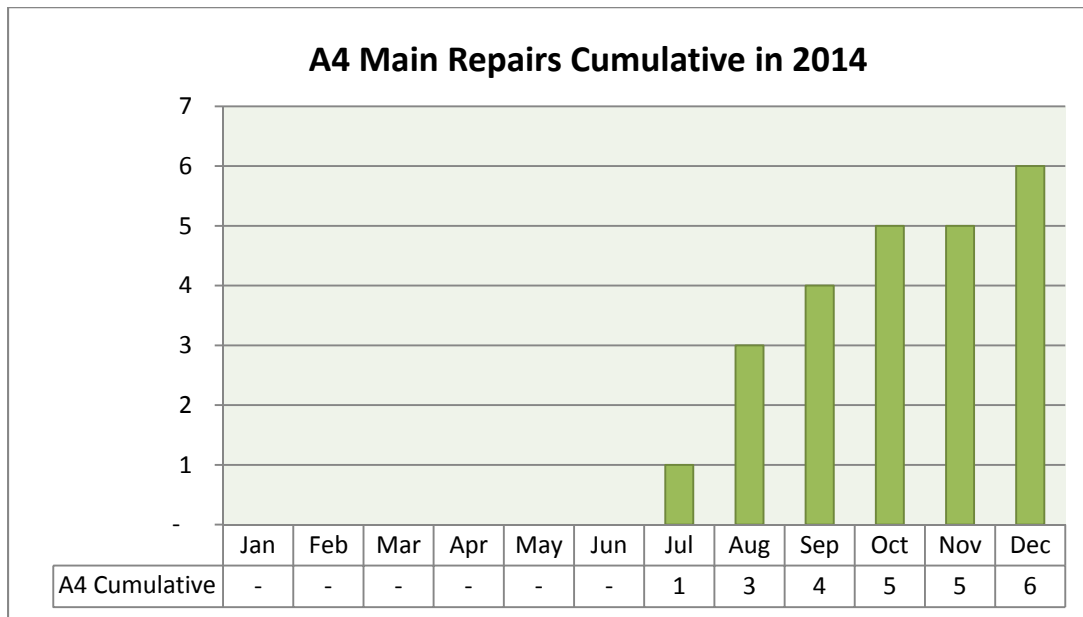
The County performed the sewer main repair/replacement on an As-Needed basis. Six (6) sewer mains were repaired by County's in-house staff in 2014, totaled 621 ft.

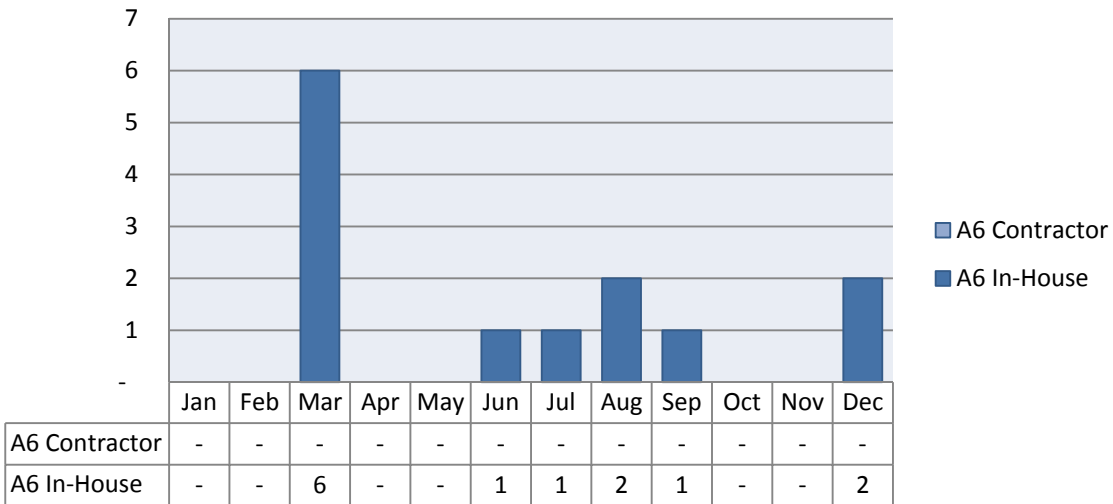
A6 Manhole Repairs In-house vs Contractor in 2014

The County performed the manhole repair/replacement on an As-Needed basis. Sanitary sewer manholes are repaired by County's in-house staff and contractors. There were 13 manholes repaired in 2014 by the County's in-house staff.

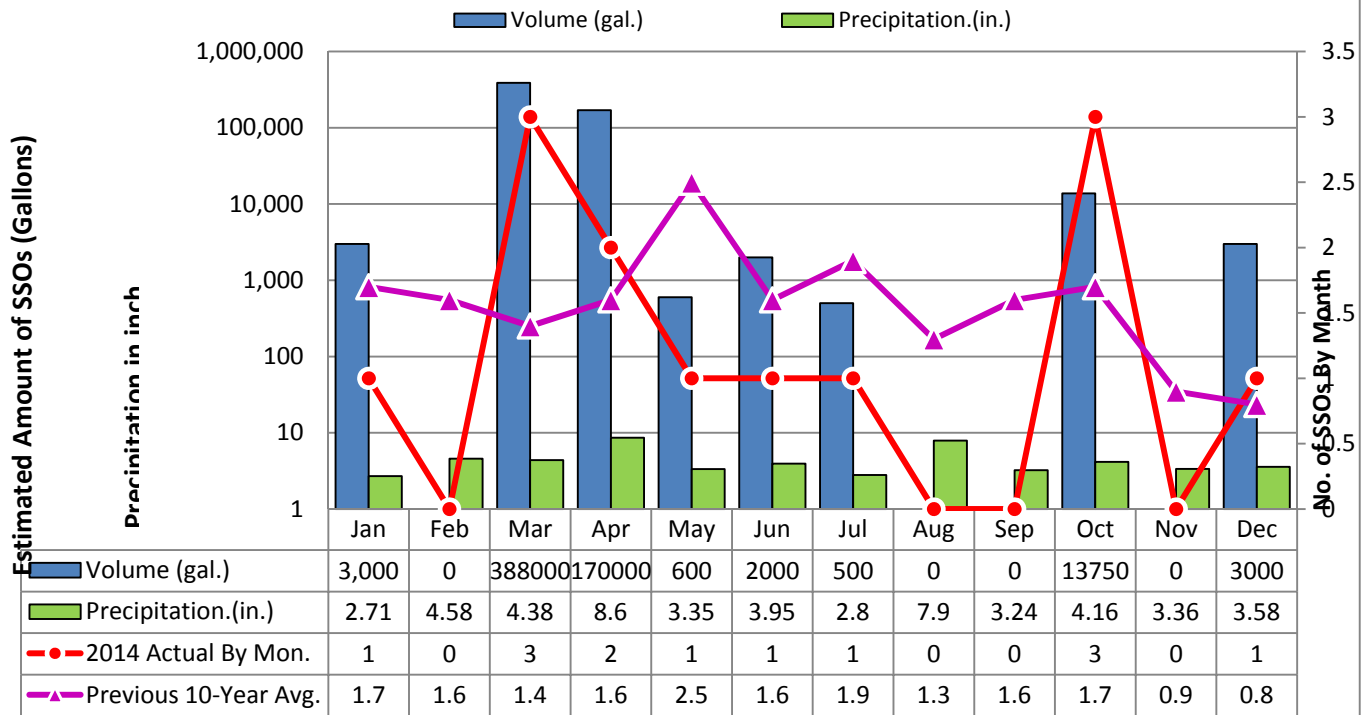
Howard County SSO vs Precipitation in 2014

The County’s SSO’s have been plotted by month in the above chart. As is shown in the chart, most months’ SSO occurrence numbers in 2014 were all below the previous 10-year average. There was no SSO occurred during February, August, September and November. You can also see the number of SSO occurrence in each month still correlates the amount of precipitation. The more it rained, the more SSO occurred.

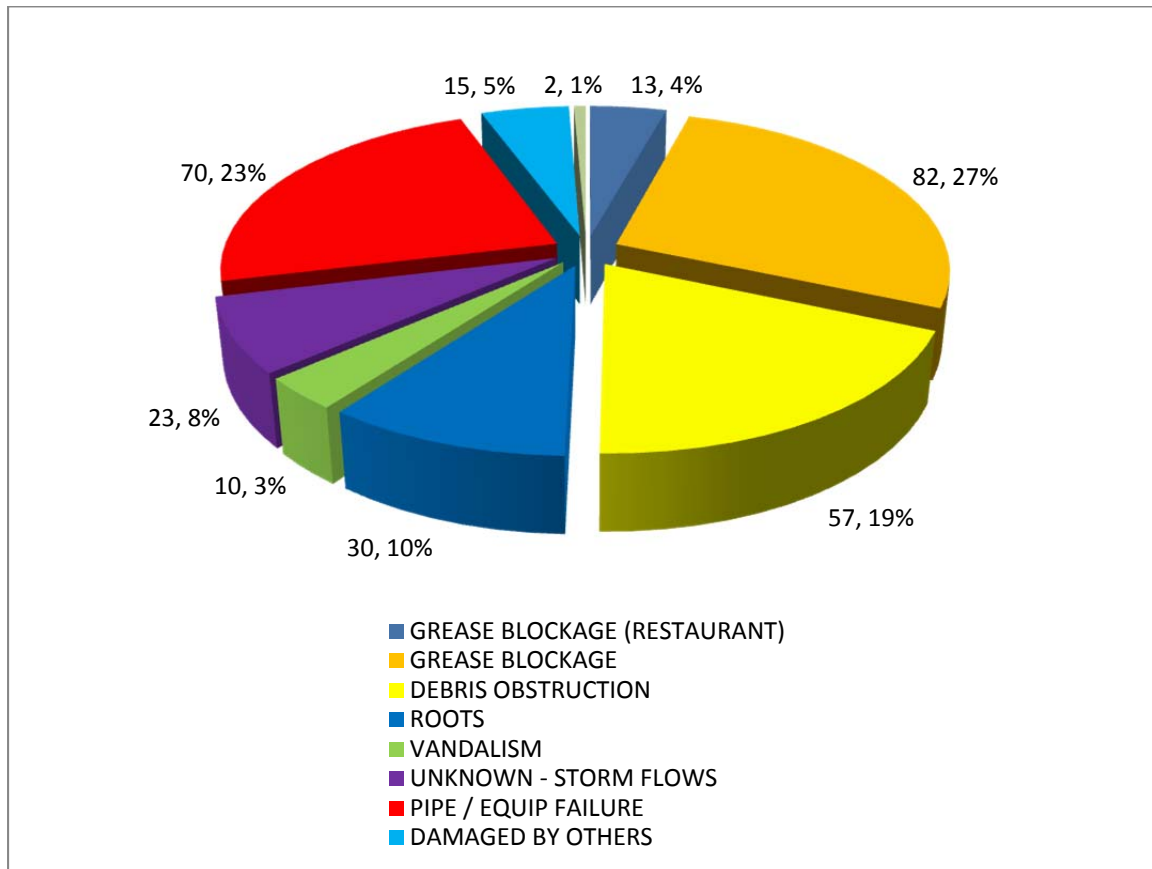
As is shown in the above chart, the top three (3) causes of overflows county-wide are: grease blockage (non FOG, 27%), pipe/equipment failure (23%), and debris obstruction (19%).

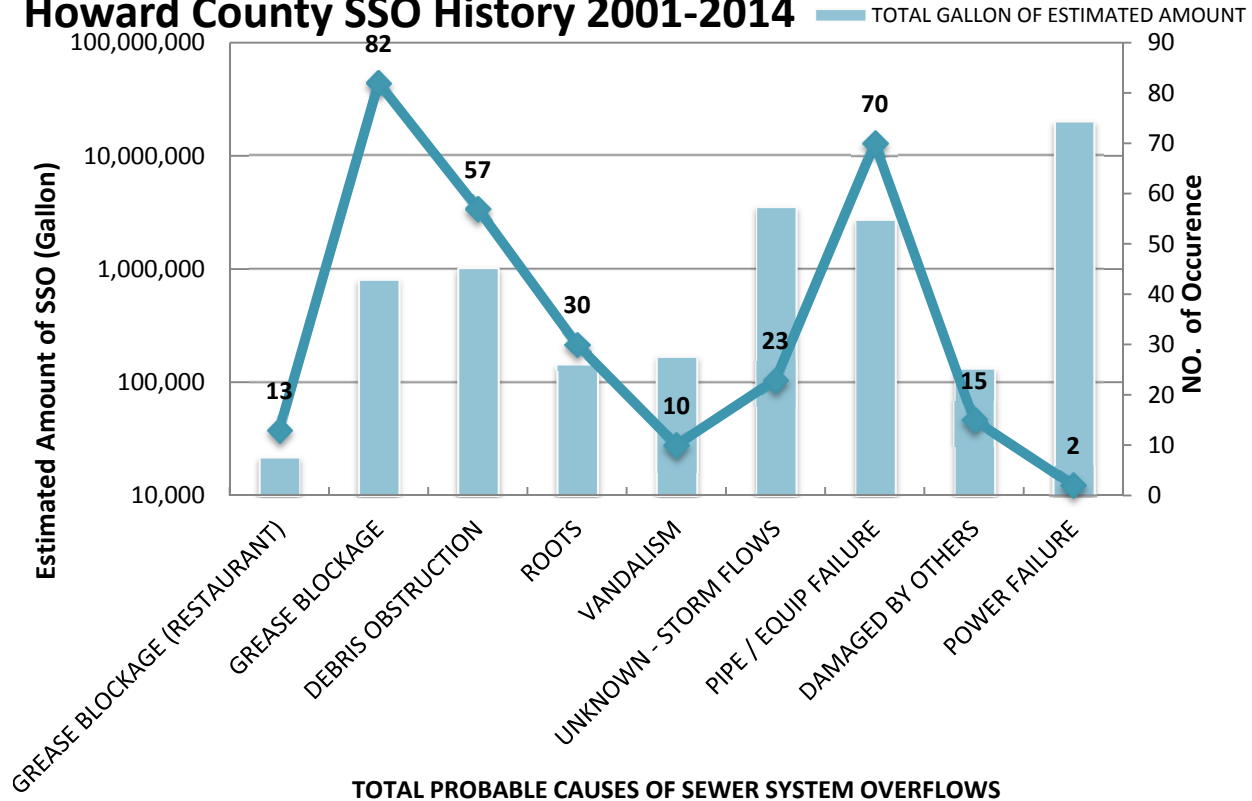
Howard County SSO History 2001-2014

While taking the estimated overflow amount into consideration, power failure, storms, pipe and equipment failures rank the highest of the total SSO volume contribution. This observation has not changed from 2012.

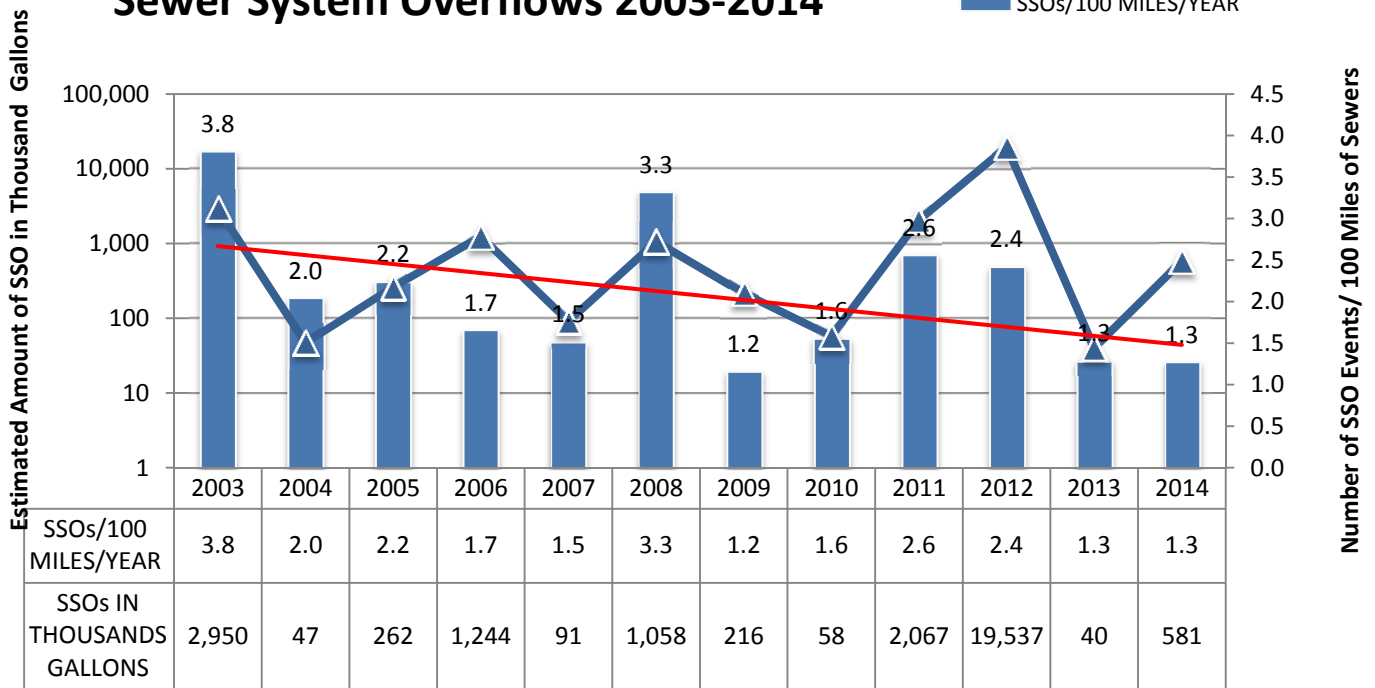
Sewer System Overflows 2003-2014

As is shown in the above chart, over the past 12 years from 2003 to 2014, the County has the SSOs/mile/year ranging from 1.2 to 3.8, while the national average posted by EPA in 2004 is 4.5. What's more, the County's overall trend of SSOs/mile/year is downward. The SSOs/mile/year for 2013 is 1.3, which is the second lowest number among the past 11 years.

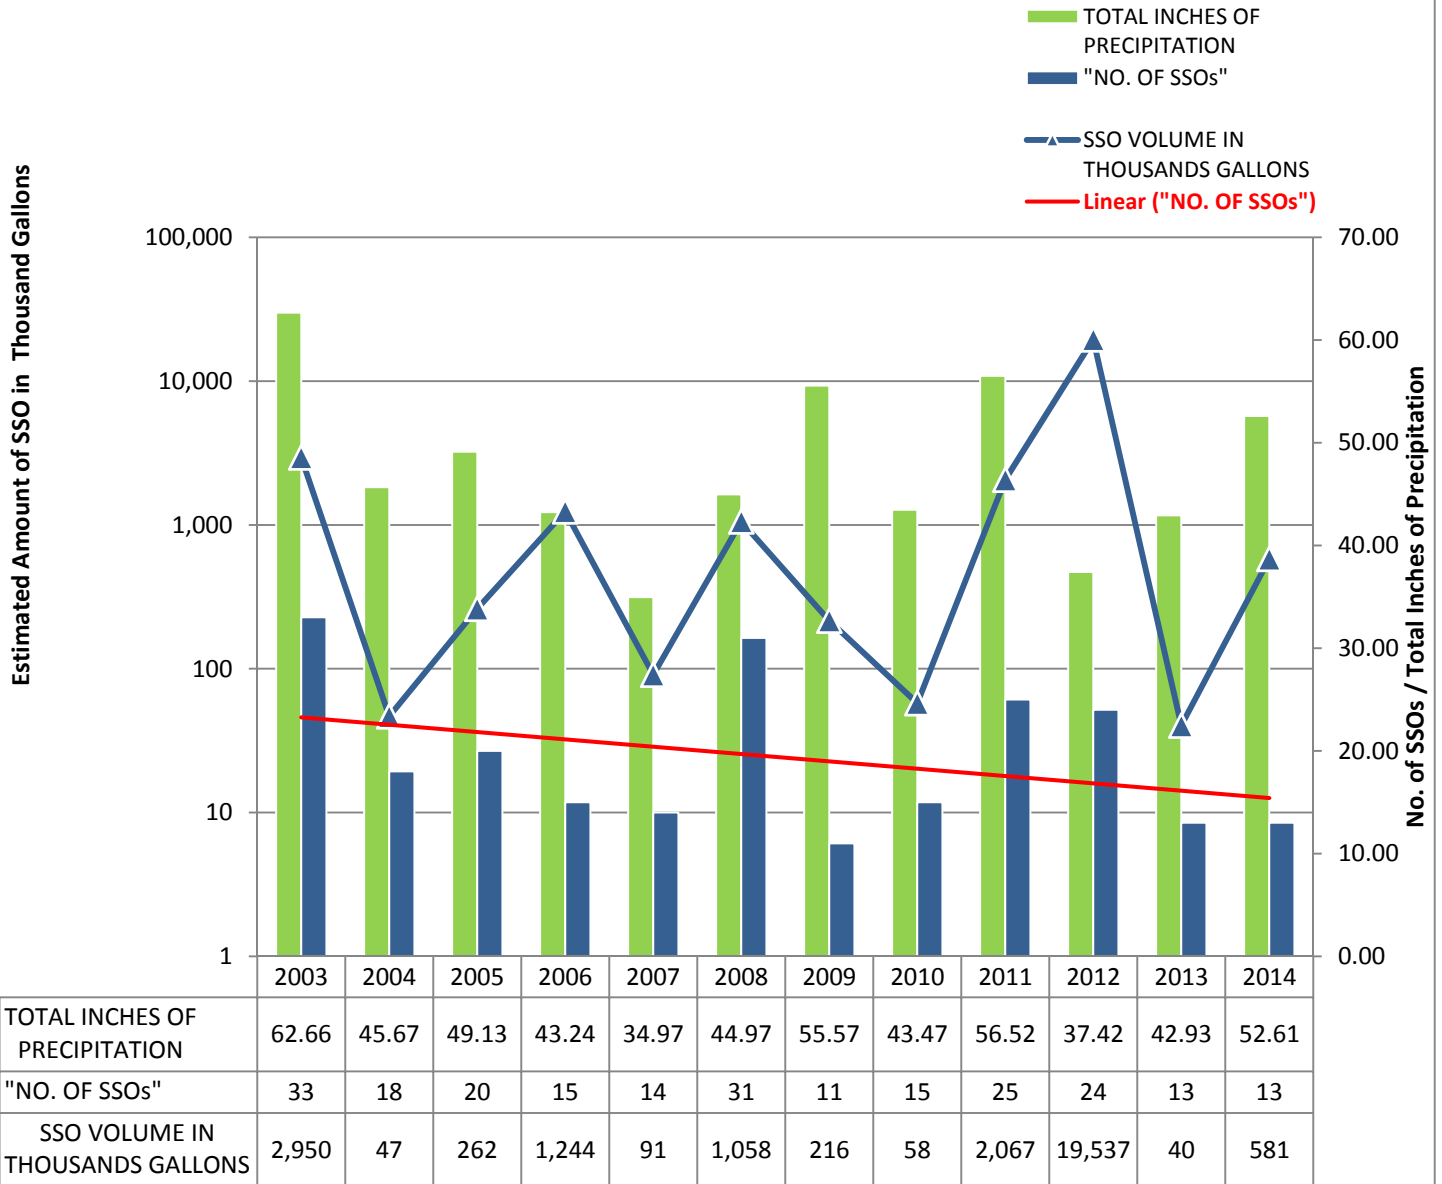
Sewer System Overflows vs Precipitation 2003-2013

To further investigate the correlation between numbers of SSO occurrence to the total amount, the 11 years' precipitation data is plotted in the below chart. The numbers of SSO occurrence over the years keep a downward trend, despite the fact that the total overflow amount in 2012 was severely affected by the by-pass incident that happened during Hurricane Sandy at LPWRP.
