# **NONSTRUCTURAL FLOOD PROOFING STUDY FOR ELLICOTT CITY, MD**

**U.S. Army Corps of Engineers, Baltimore District  
2 Hopkins Plaza  
Baltimore, Maryland 21201**

**FINAL  
FEBRUARY 2018**

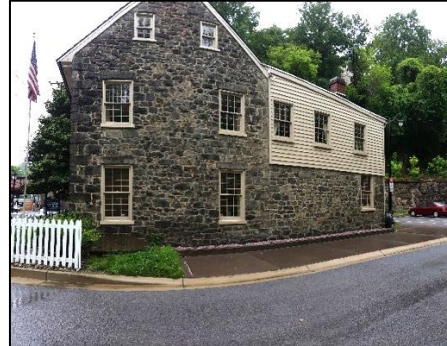
2. East elevation, showing basement access at left

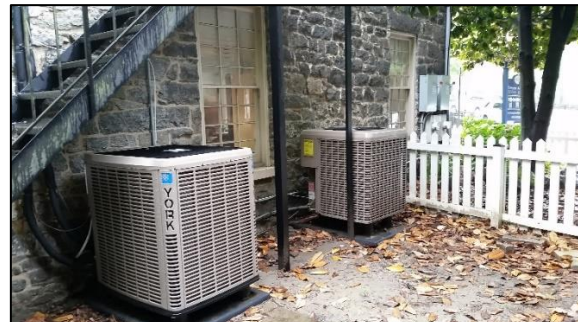
4. Exterior equipment on west elevation

- g. **Elevate mechanical and electrical equipment:**
  - i. Relocate two wall-mounted electrical panels in basement to the first floor.
  - ii. Elevate two existing exterior electrical meters approximately 1ft. to match adjacent panel elevation.

- iii. Elevate two at-grade HVAC units in place on a single steel platform, approximately 1.9 ft. height.

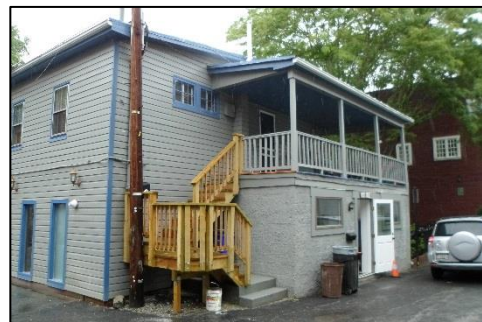
4. Small CMU addition on south elevation

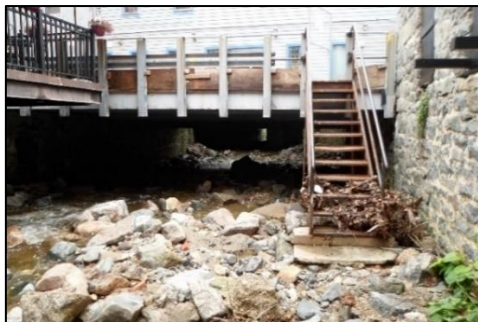
3. Metal access stair reducing stream conveyance

In addition to considerations relating to the structure itself, it is recommended for structures located directly over the stream to ***minimize impedance to water conveyance beneath the structure***. Although the first floor framing of this building was replaced with a cast-in-place slab system with built-in reinforced beam sections, the original structural steel framing below the building is still in place. Additionally, there is a steel staircase (which may not be owned by the subject property) adjacent to the building which provides access from the adjacent vehicle bridge down to the stream level below. This staircase is behind a locked gate and is not accessible to the public. These two building and site features themselves inhibit the flow of water in the stream channel immediately beneath the structure and can also catch debris which would cause further blockage. In the case of the steel staircase, it is

recommended to provide a mechanism by which the stair can be raised out of the channel, and lowered only when access is needed.

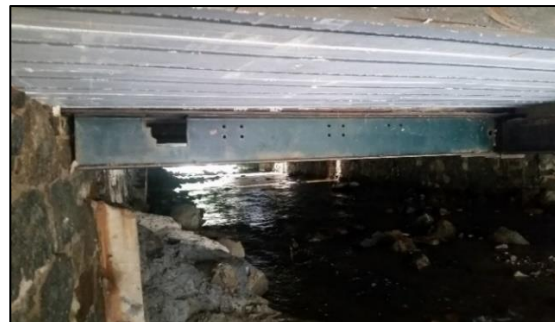
4. Extraneous steel framing below first floor slab

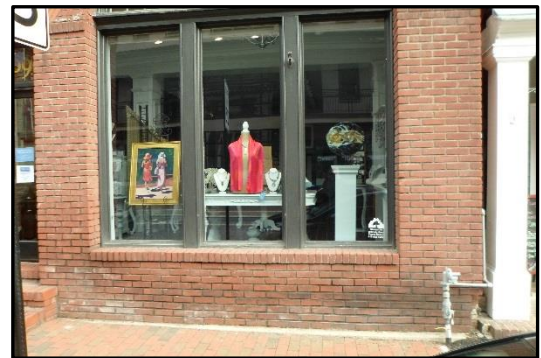
3. Store Front Window

The gallery owner was present during the site visit and commented on the impacts of the July 2016 flood event. The large front windows and glass door were broken during the flood and the first floor was inundated with flood depths greater than 5 ft.

- ii. Replacement of existing windows with flood proof structural windows
    - 1. Three panels, estimated 4 ft. by 6 ft. each.
- b. ***Door openings:*** Flood proof all first floor doorways.

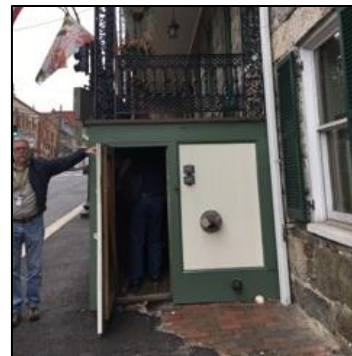
2. Entrance to crawlspace beneath porch

During, the 2016 flood event, a vehicle being carried by flood waters slammed into the porch, causing significant damage and worsening the flood risk in the remainder of the building. A major concern is that fast moving debris could damage the foundation of the structure if the porch area is not fortified. A recommended retrofit in order to minimize future damage to the porch is to *install bollards or a debris barrier wall* along the south elevation for additional protection. The bollards could be installed behind the porch wall to preserve the historic aesthetic.

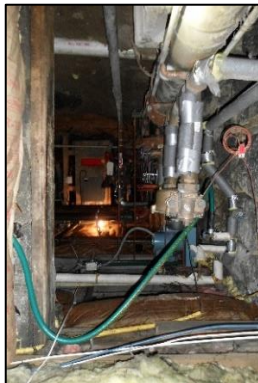
3. Equipment in crawlspace

The property owner was available on the site visit and mentioned that, while water did not enter the first floor, it did enter the utility space in the crawl space. The owner also mentioned that the front porch sustained damages due to fast moving debris.

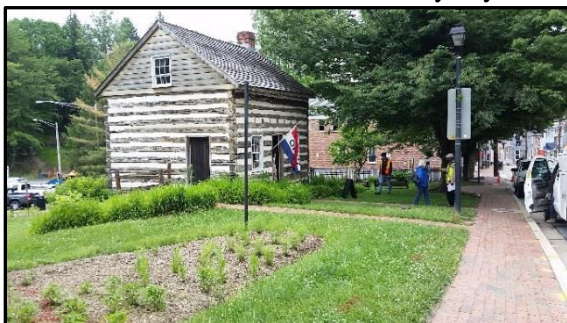
3. West Elevation, Side Entryway and Potential Debris Blockage Area

The building is located downhill of a major intersection and on the exterior of a major roadway bend, making it susceptible to debris damages traveling down Main Street. It is recommended that a ***constructed barrier that blends into the surrounding environment*** (i.e. a planter box or outdoor seating) be implemented in the south west corner of the building in the grass landscaped area. This barrier would provide impact protection from debris and potentially divert high water flows away from the building.

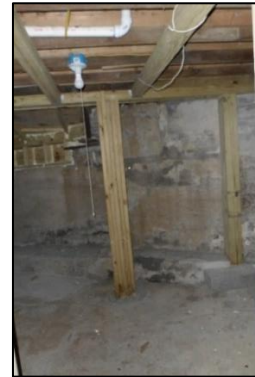
4. Basement with supplemental wood framing

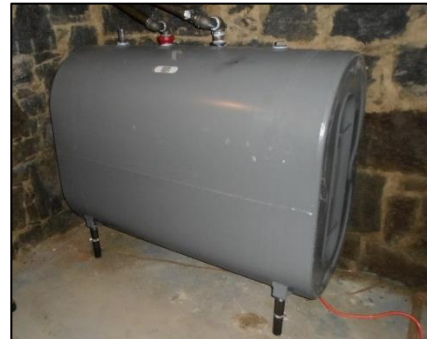
4. Typical mechanical equipment in basement

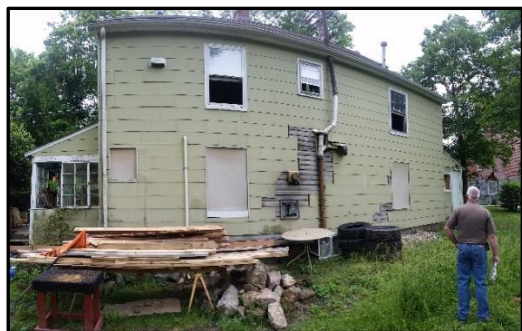
3. North elevation

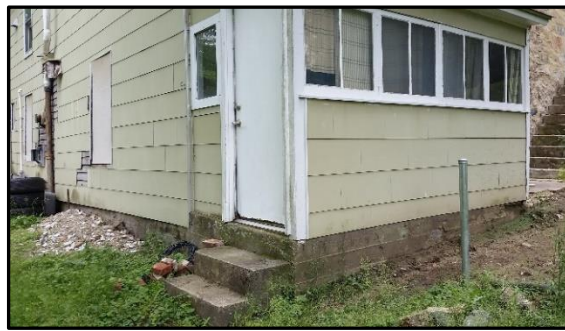
4. Northwest corner

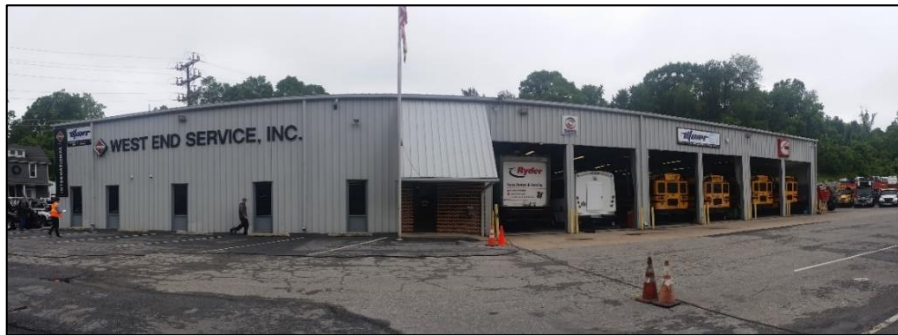
1. South elevation

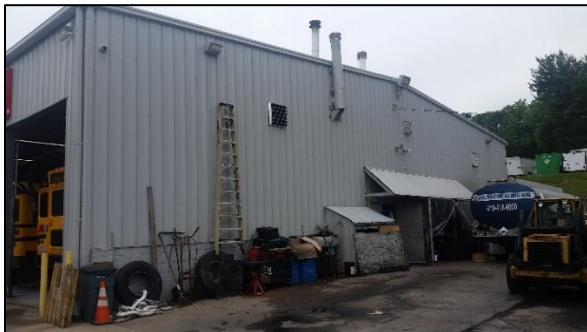
2. East elevation

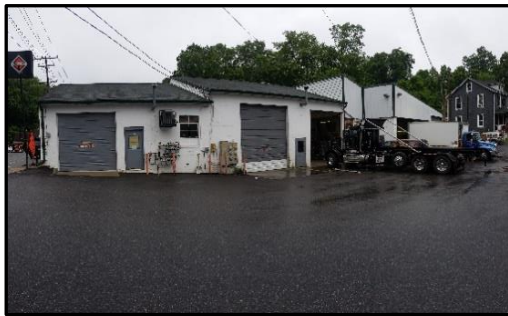
1. East Elevation

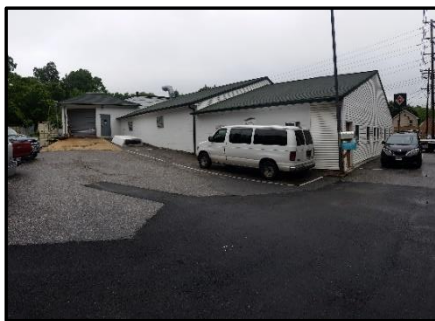
3. West Elevation, Raised on higher ground

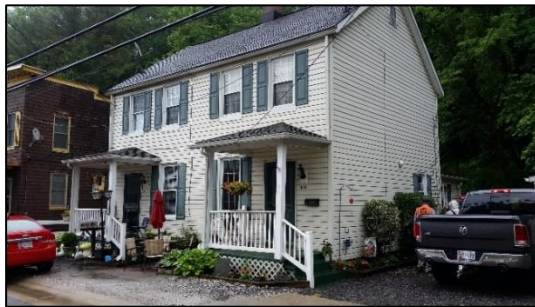
1. North elevation

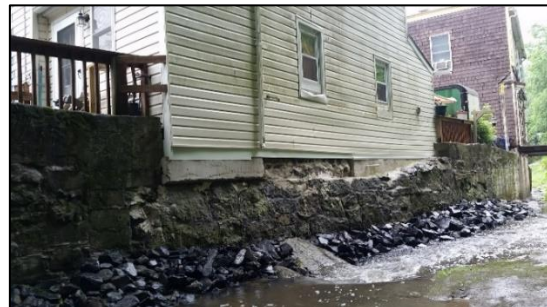
2. South elevation, stream adjacent to structure

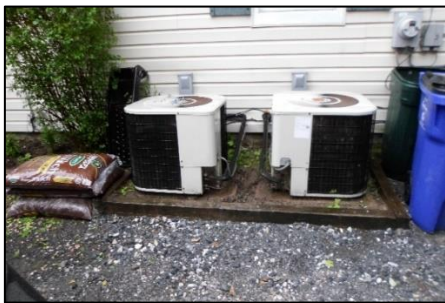
3. Exterior mechanical units on west elevation

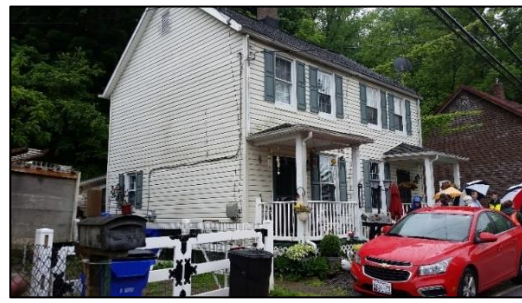
4. North and east elevations from northeast corner
