## Valley Mede Storm Drainage

## Inspection Report April 20, 2017 FINAL

**Re:** Valley Mede Storm Drain Investigation

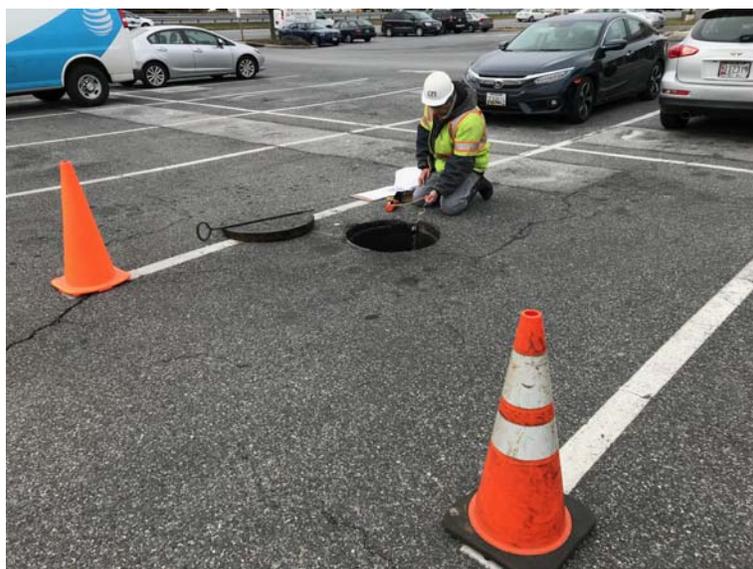
1. One additional manhole was found that is not picked up in the County's existing GIS. The manhole is located in the St. John's Plaza and is identified in CPJ overview map as MANHOLE #2.

004.manhole 2

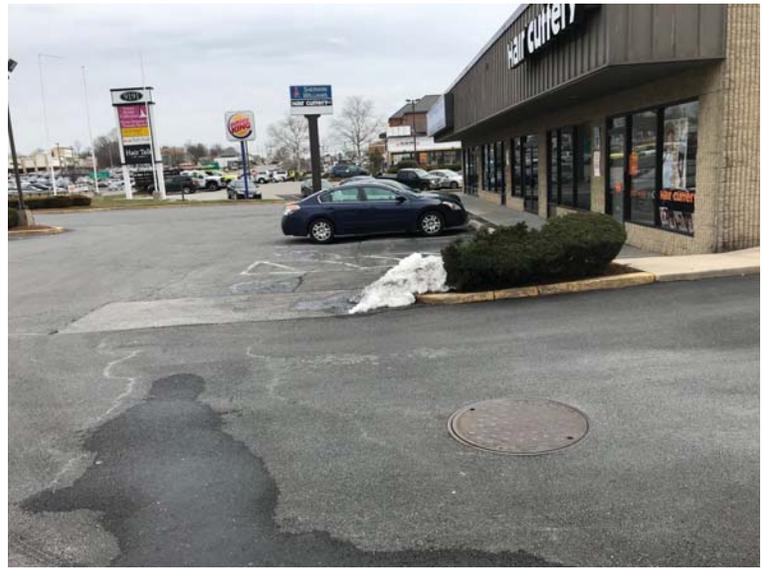
2. The Manhole identified on the overview map as MANHOLE #5 was cracked and unable to be opened by CPJ staff. Howard County Public Works was alerted prior to the inspection and was able to open the manhole, with property owner permission, so it would be accessible if needed, however the manhole was not replaced.

014.surface at manhole 5

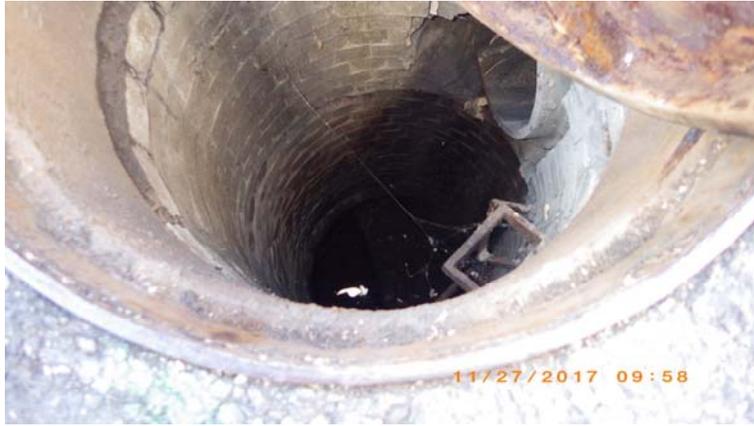
1. A single branch approximately 3" in a diameter and 8' in length created a small backwater at MANHOLE 1. The inspection crew was unable to remove or break the branch. CPJ crews returned on April 19, 2018 and removed the branch and debris from this location.
2. Debris and invert corrosion was noted at the infall from INLET C.
3. A previously unidentified 15" CMP pipe infall at MANHOLE 2 was discovered but appears to be abandoned and grouted full.

019.manhole 1

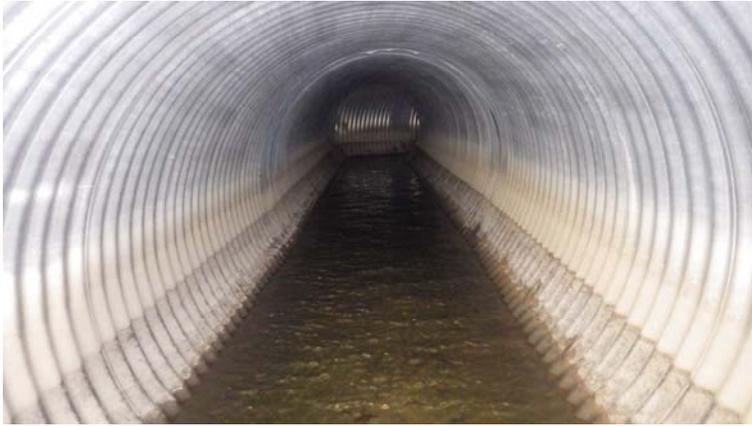
025.entry 1.station 0+00 to 0+94

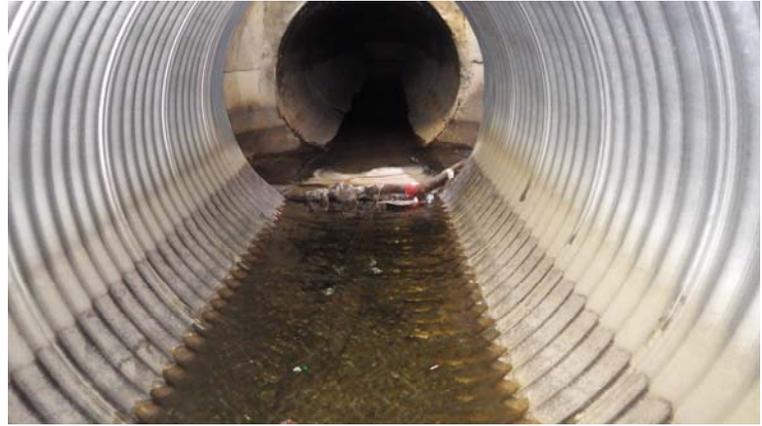
026.entry 1.station 1+19.manhole 6

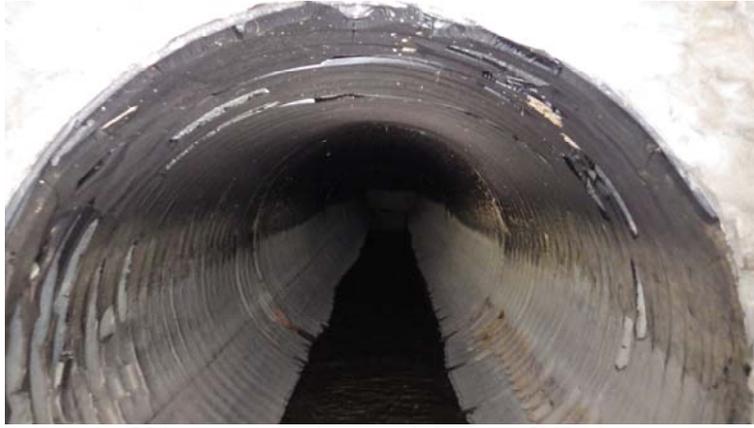
031.entry 1.station 1+19.84 inch CMP pipe

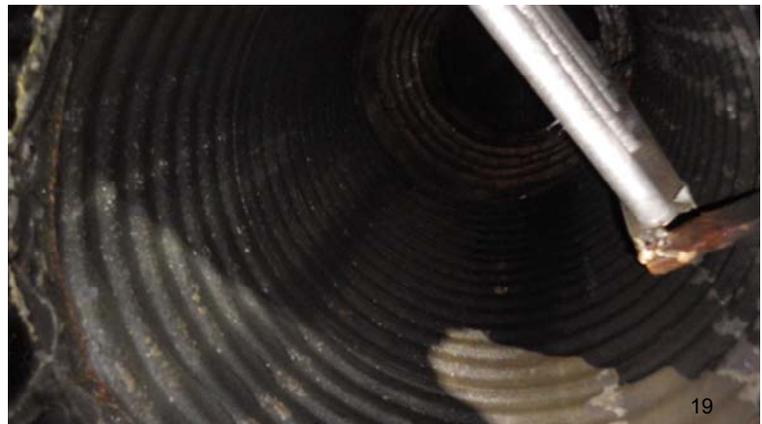
036.entry 1.station 2+91.manhole

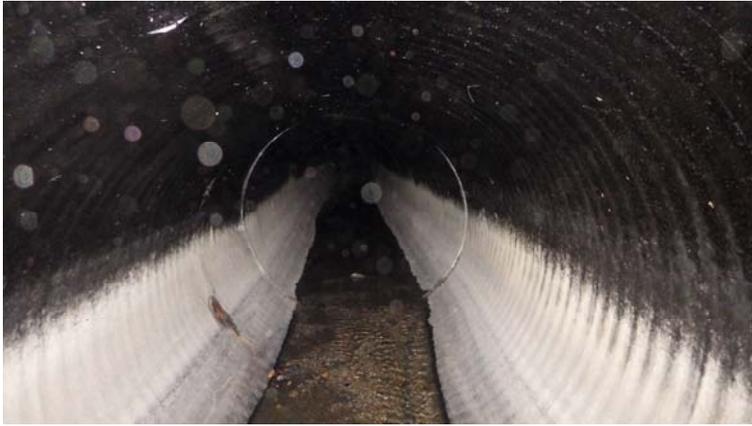
037.entry 1.station 3+00.overview

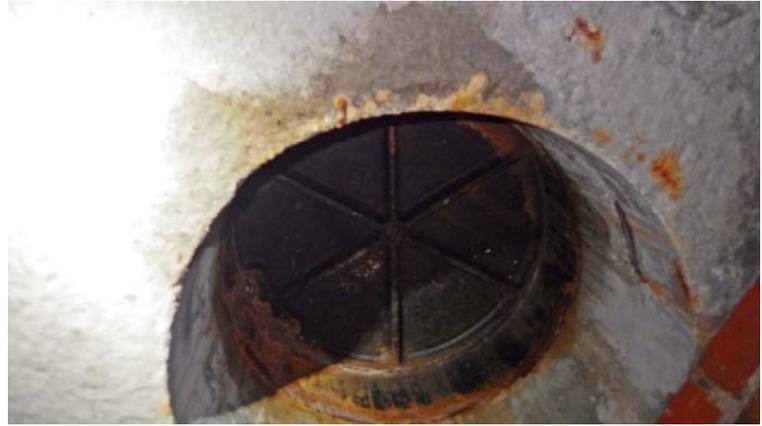
044.entry 1.station 4+26 manhole

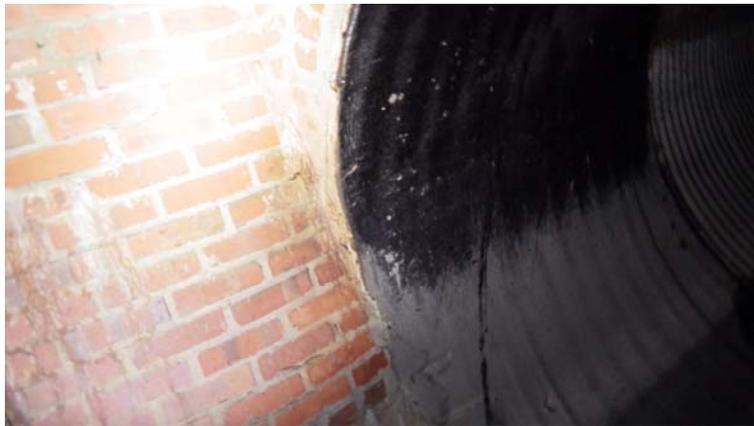
045.entry 1.station 4+26 masonry manhole structure

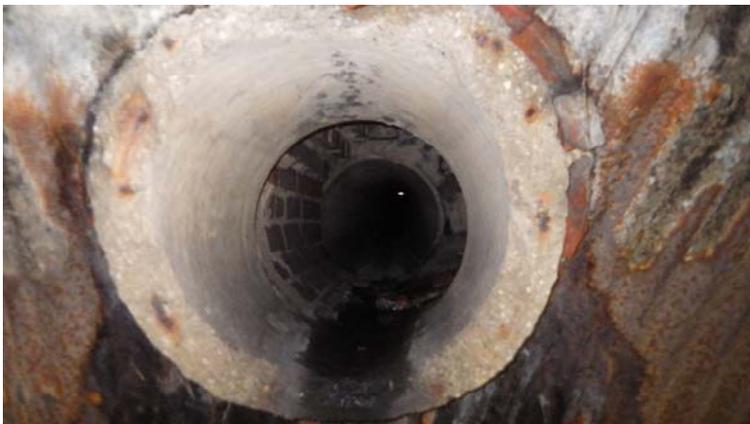
053.entry 1.station 4+43.15 inch RCP inlet

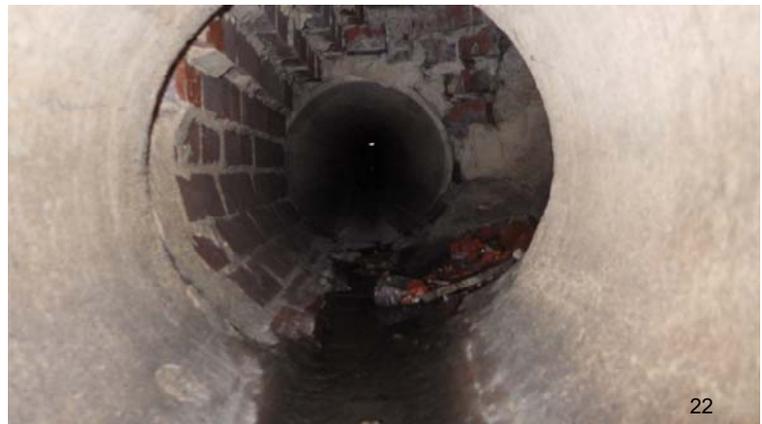
054.entry 1.station 4+43.15 inch RCP inlet

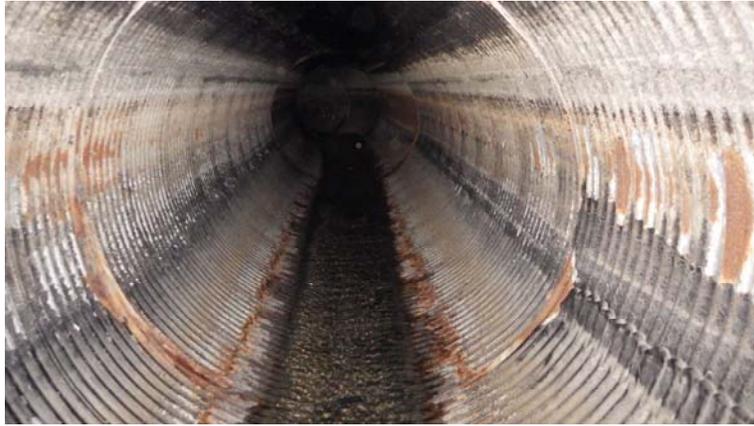
055.entry 1.station 6+00.overview

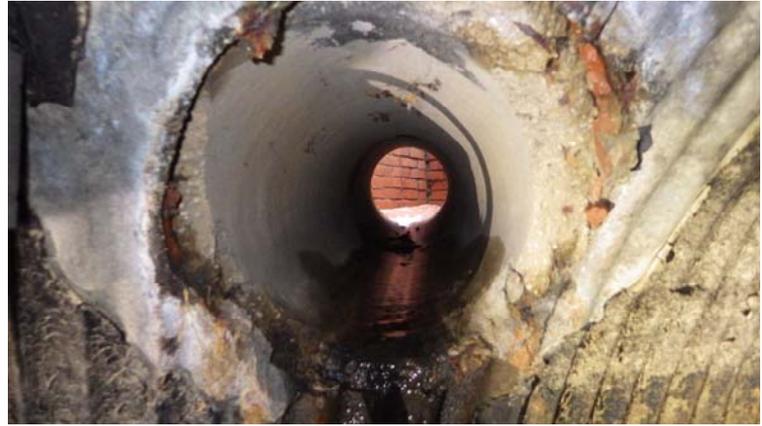
056.entry 1.station 6+68.15 inch RCP inlet

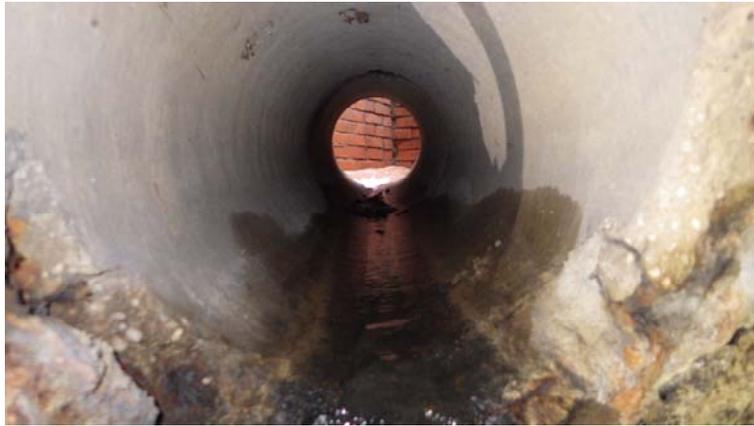
057.entry 1.station 6+68.15 inch RCP inlet

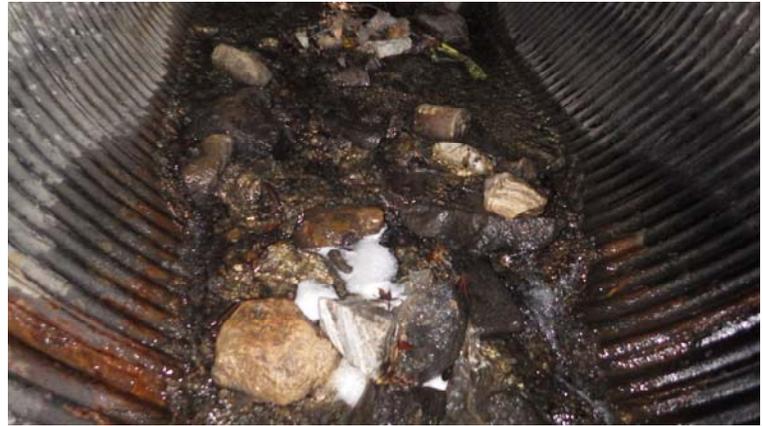
058.entry 1.station 7+00.rocks debris

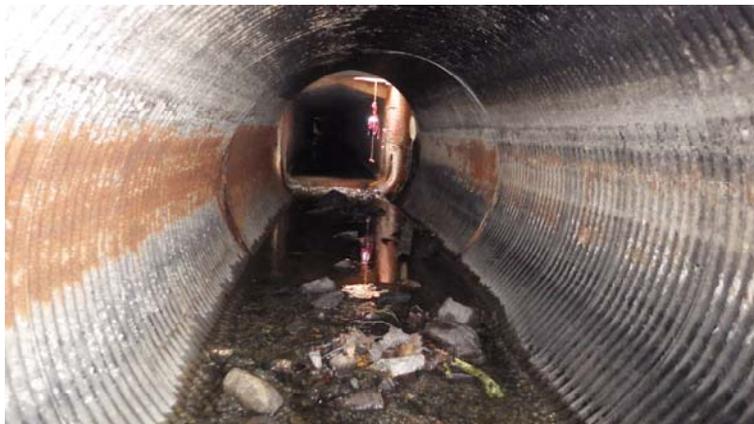
059.entry 1.station 7+00.rocks debris

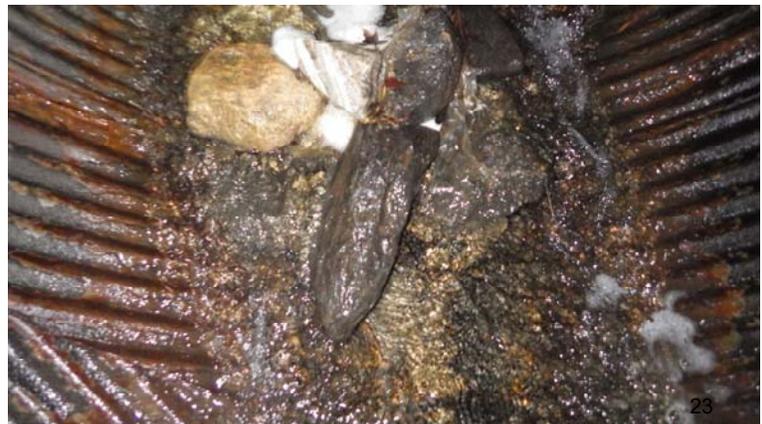
060.entry 1.station 7+00.rocks debris

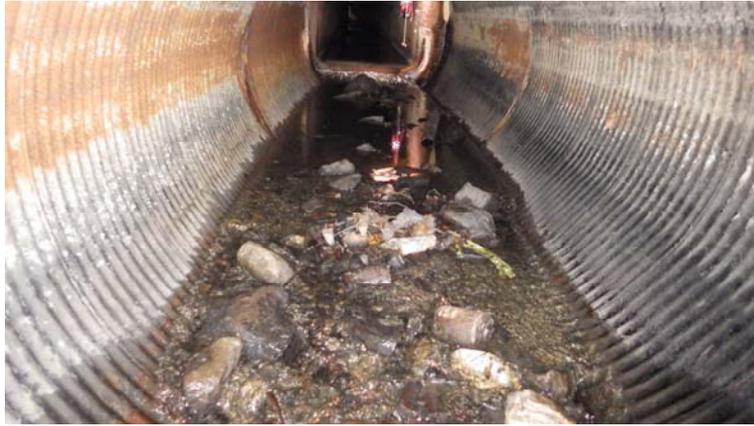
061.entry 1.station 7+00.rocks debris

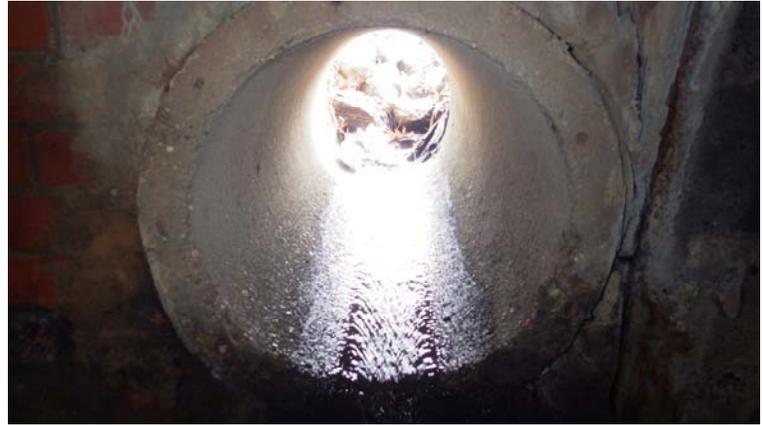
062.entry 1.station 7+12.15 inch RCP inlet

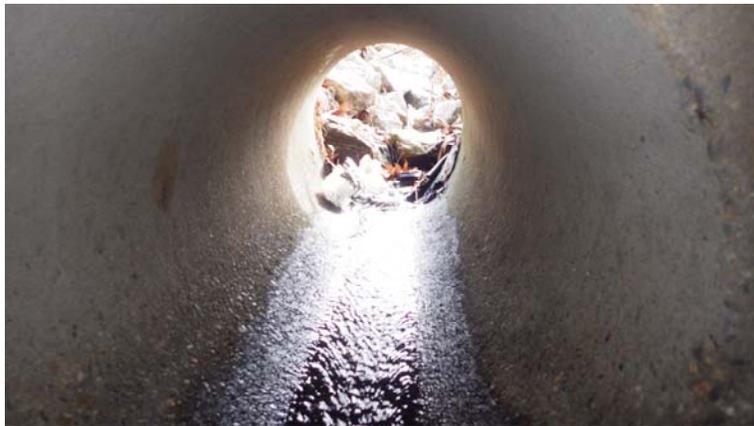
063.entry 1.station 7+12.15 inch RCP inlet

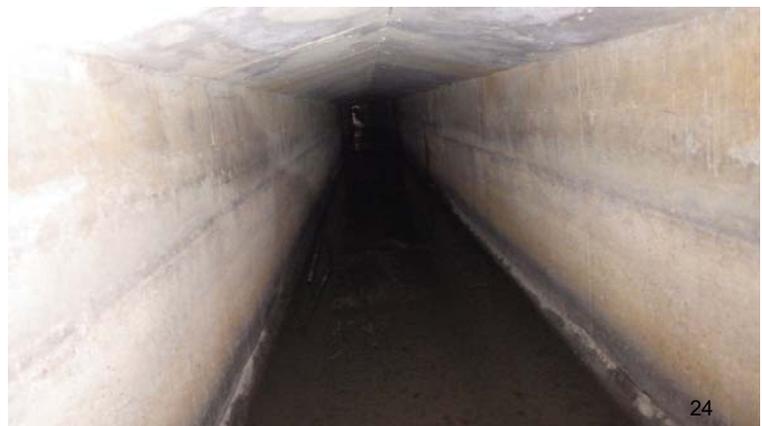
066.entry 1.station 7+17.6 x 6 box culvert

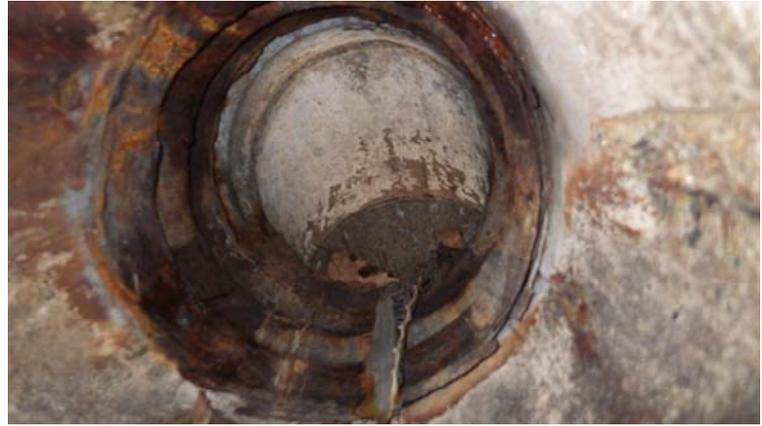
068.entry 1.station 7+75.10 CMP inlet at 1200

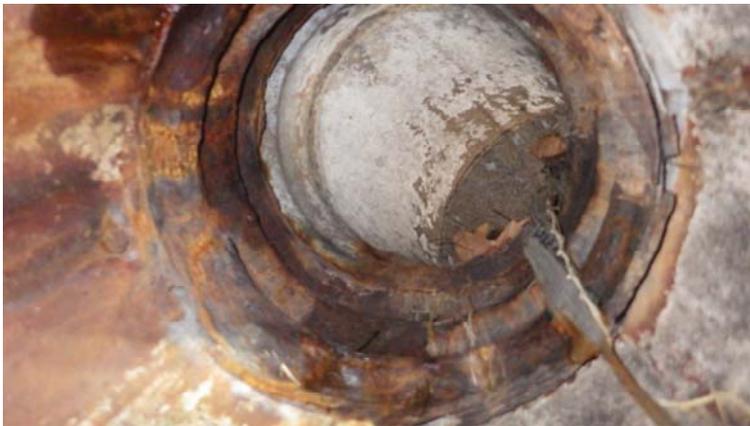
069.entry 1.station 7+75.10 CMP inlet at 1200

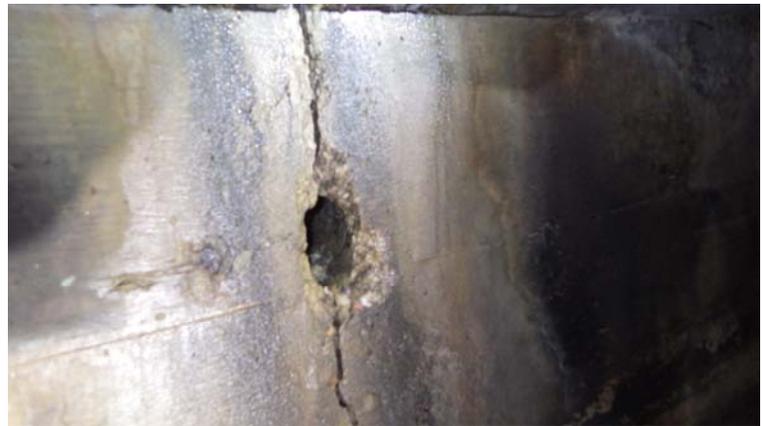
070.entry 1.station 7+77.hole

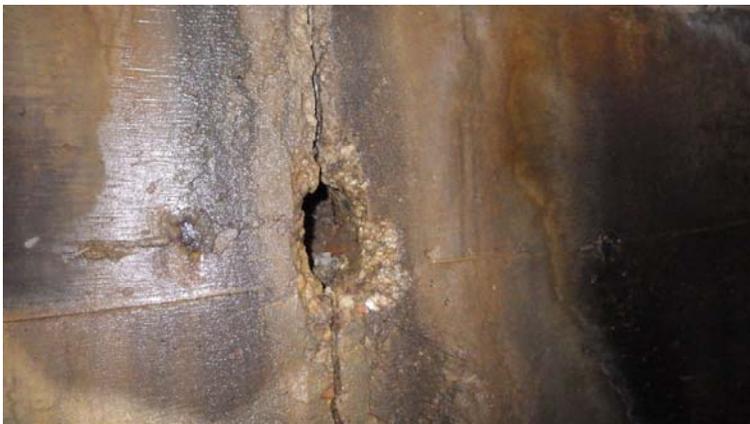
071.entry 1.station 7+77.hole

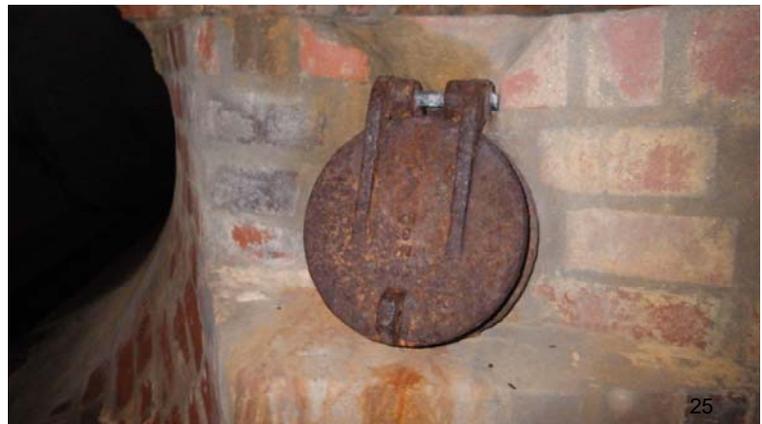
072.entry 1.station 8+44.manhole 3 unknown inlet

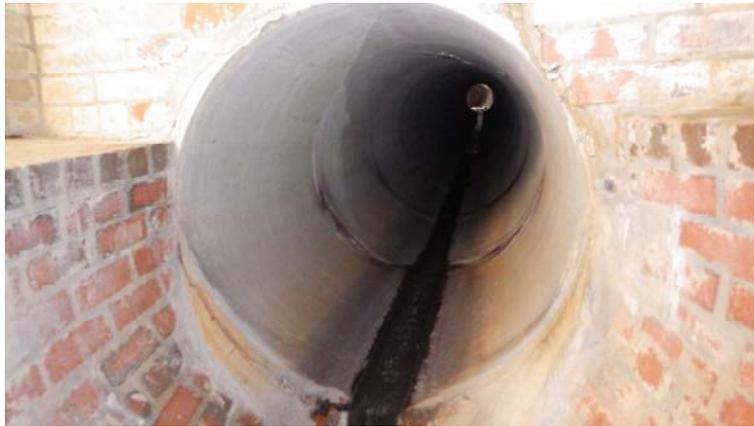
073.entry 1.station 8+44.manhole 3 42 inch RCP inlet

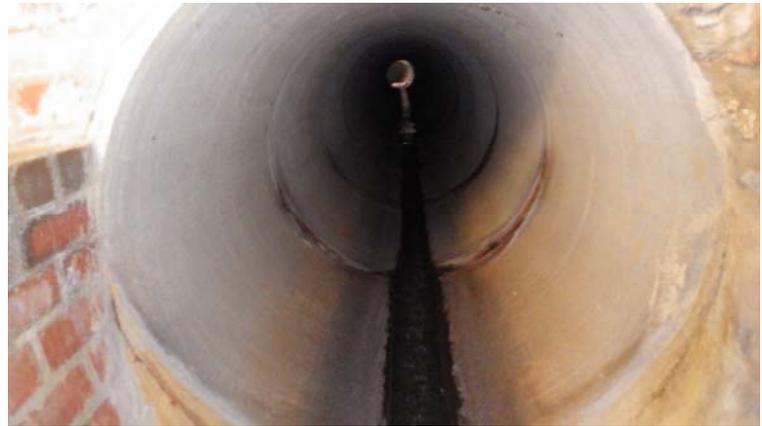
074.entry 1.station 8+44.manhole 3 42 inch RCP inlet

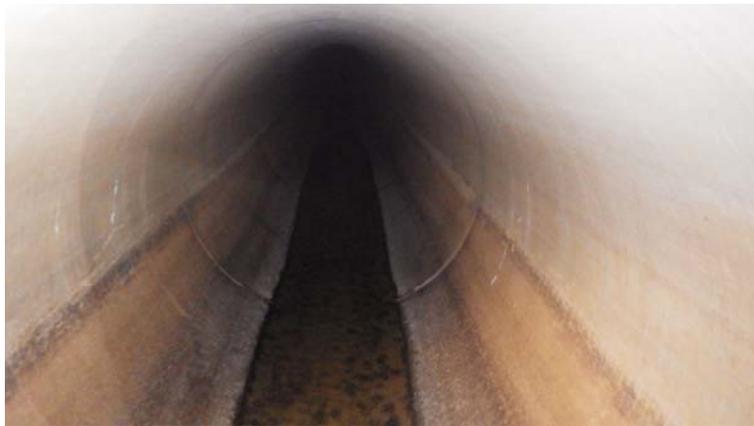
075.entry 1.station 8+44.manhole 3 60 inch RCP inlet

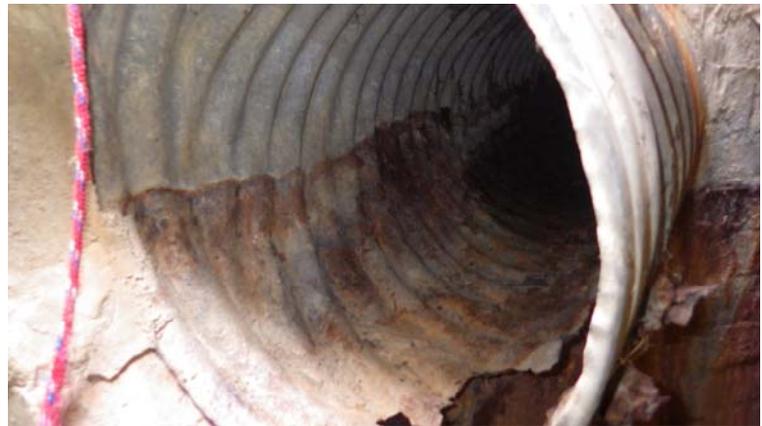
076.entry 1.station 8+44.manhole 3 21inch CMP inlet

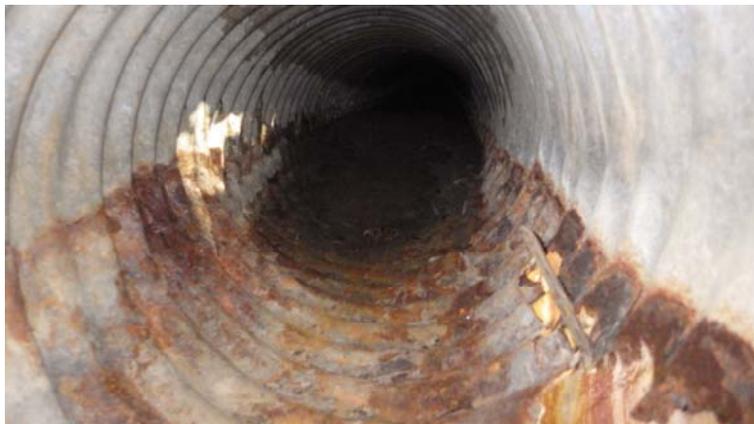
077.entry 1.station 8+44.manhole 3 21inch CMP inlet

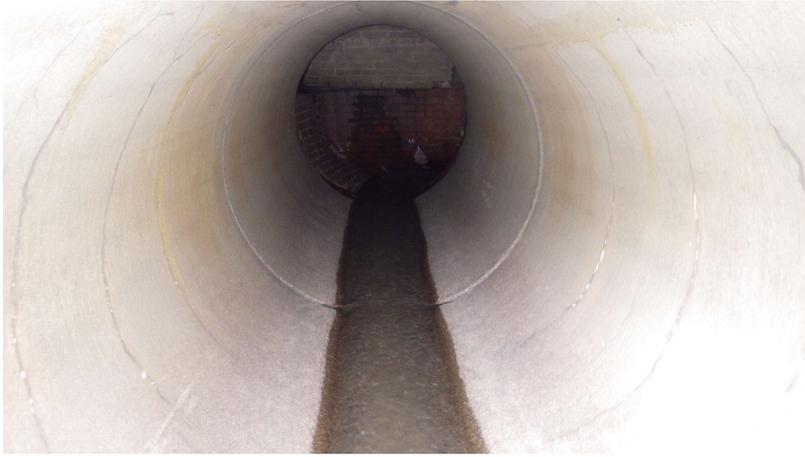
079.entry 2.60 inch RCP

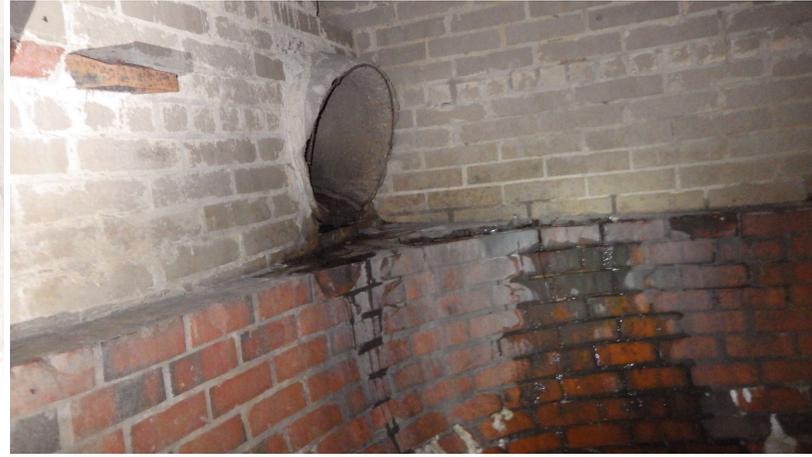
080.entry 2.21 inch RCP inlet

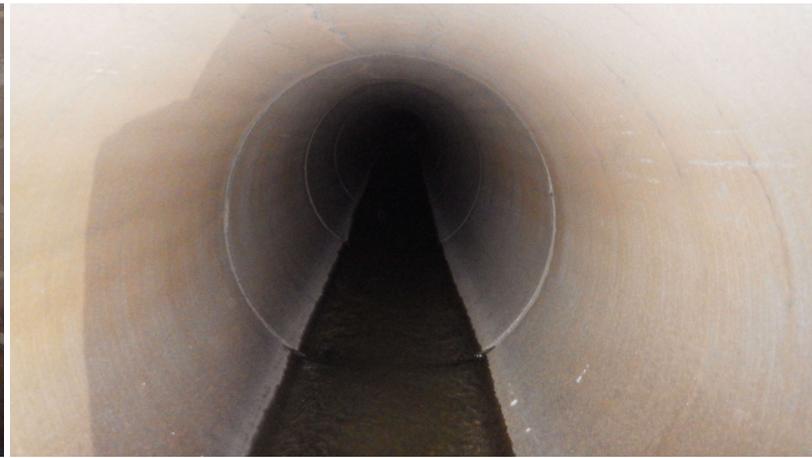
082.entry 2.station 0+00

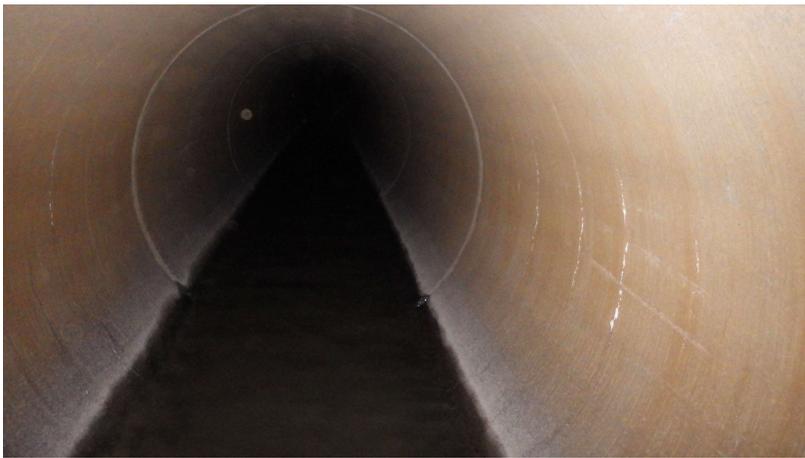
083.entry 2.station 0+40.calcification

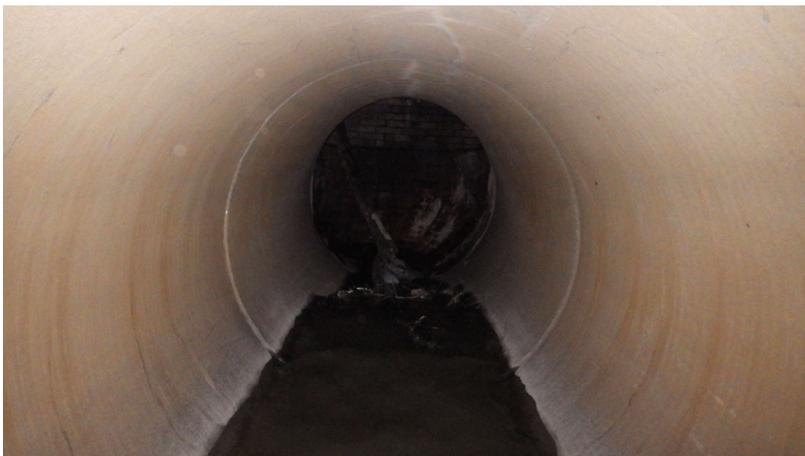
Station	Notes	Photo	Description
0+00	Crew entered at headwall, Station 0+00 beginning at the junction a shown in photo 082.	079	Just outside of Entry 3 looking downstream to the 60" RCP culvert.
0+80	MINOR BLOCKAGE, Depth of flow upstream of blockage is 7", see photo 085.	080	A 21" RCP pipe coming in from the left at the pipe junction. The pipe has some wearing and reinforcement is exposed.
0+90 LEFT TURN	Left turn occurred at Station 0+90, see photo 086.	081	Close up of exposed reinforcement on 21" RCP.
0+98	MINOR INFILTRATION and BLOCKAGE, See photos 087-094	082	Station 0+00 looking downstream into 60" RCP culvert.
2+04	MINOR INFILTRATION and SPALLING, see photos 099-101	083	Station 0+40, minor calcification on the wall.
3+00	MINOR SPALLING AND CALCIFICATION, see photo 103	084	Photo at Station 0+50 looking downstream into 60" RCP culvert.
3+37	Right turn occurred at Station 3+37, see photo 26.	085	Photo at Station 0+80 looking downstream at blockage consisting of a log, trash and other minor debris.

085.entry 2.station 0+80.log trash debris

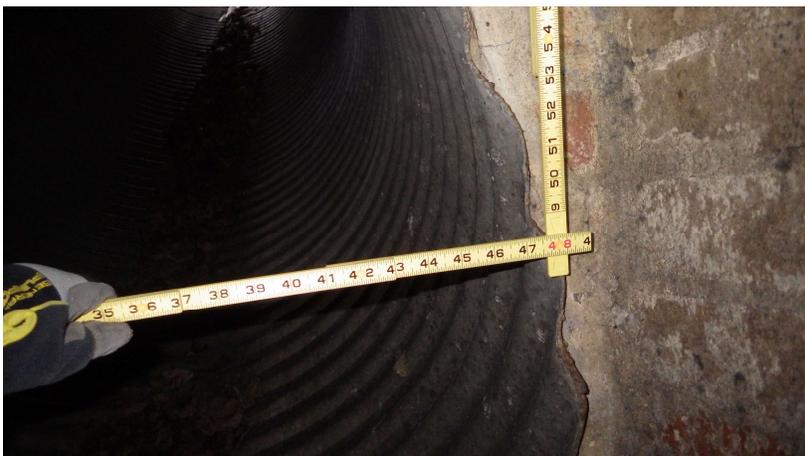
090.entry 2.station 0+98.manhole junction

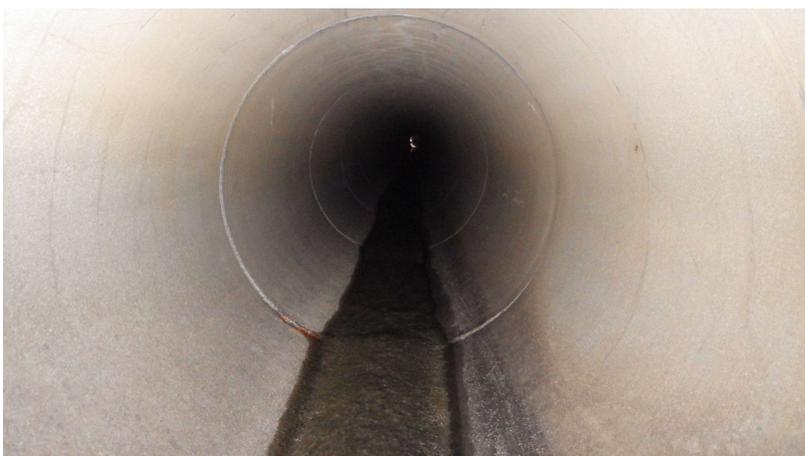
095.entry 2.station 1+00

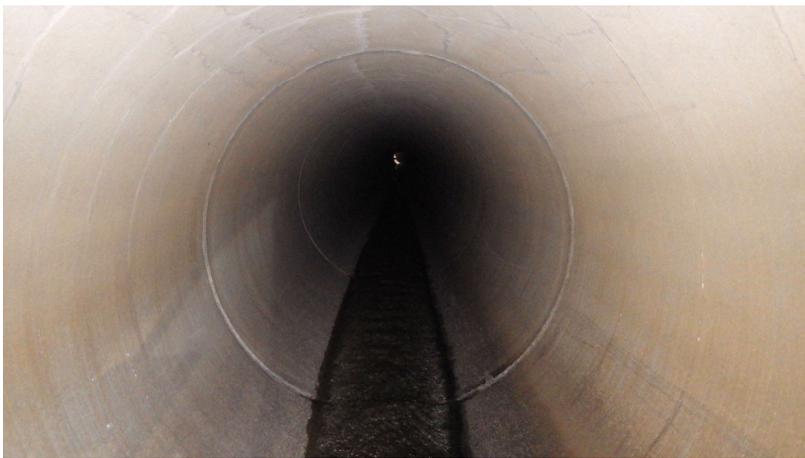
097.entry 2.station 1+50

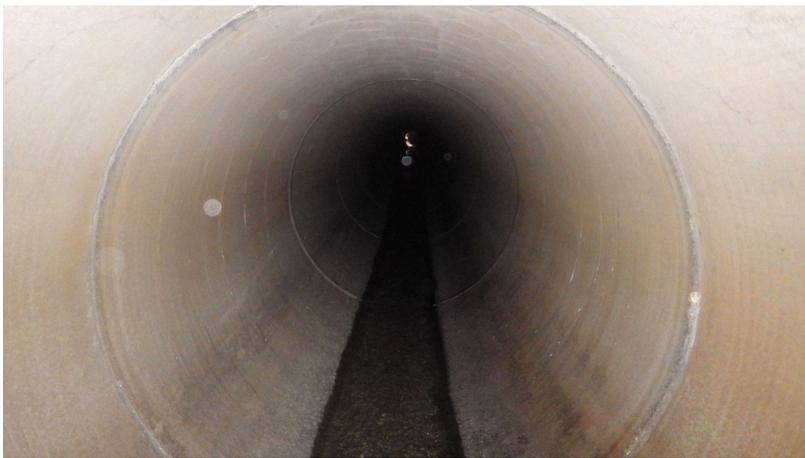
098.entry 2.station 1+50.joint

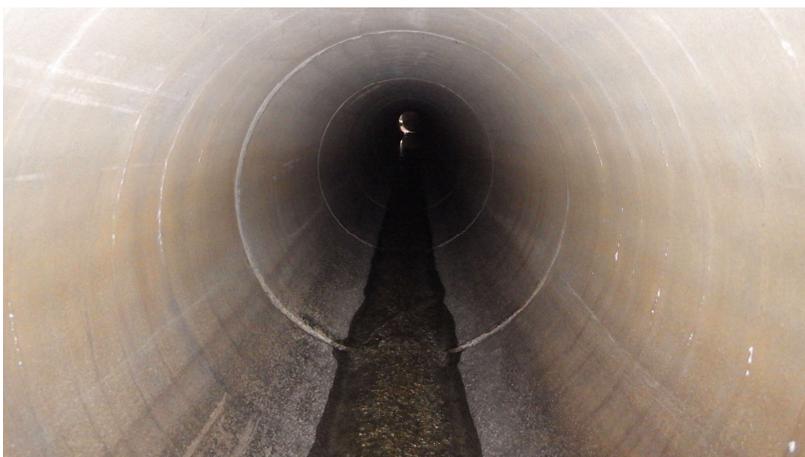
100.entry 2.station 2+04

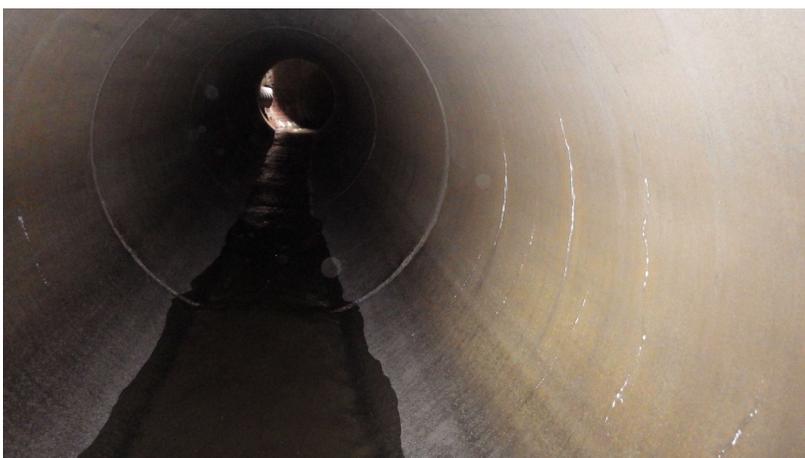
102.entry 2.station 2+50

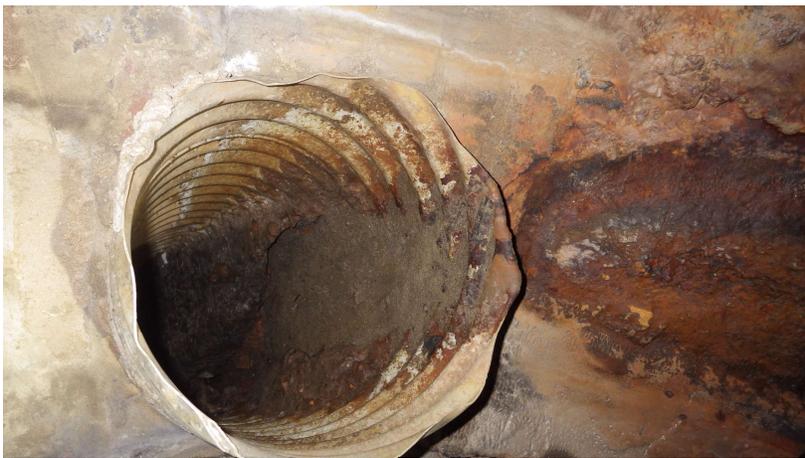
104.entry 2.station 3+37.manhole junction

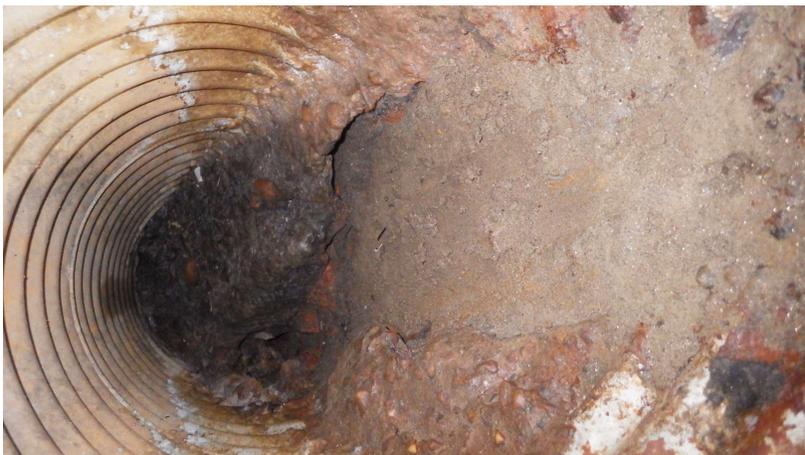
105.entry 2.station 3+41.1.5 inch CMP sediment

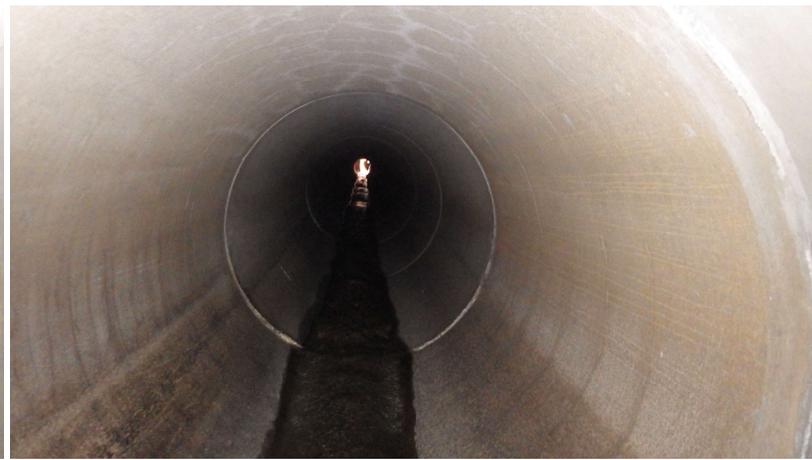
110.entry 2.station 3+50

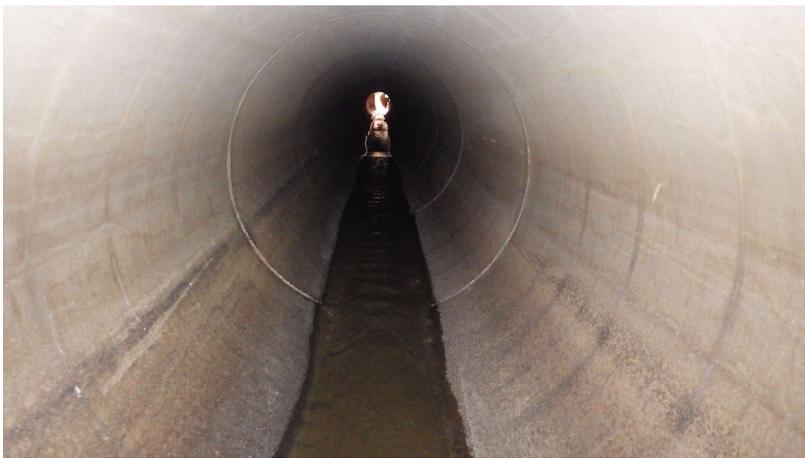
111.entry 2.station 4+00

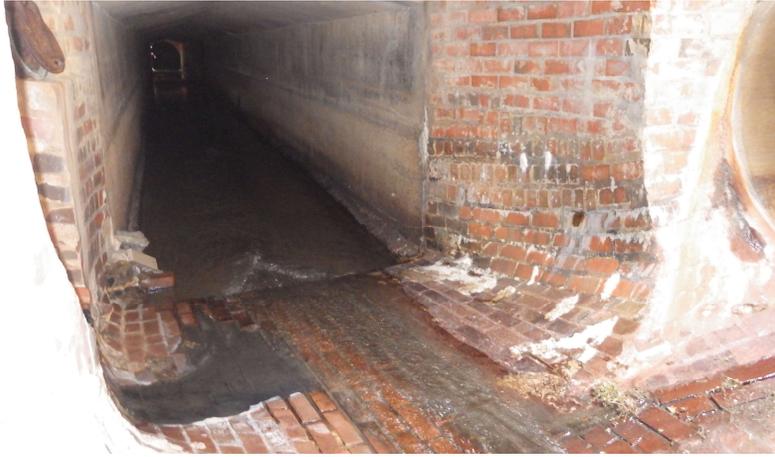
115.entry 2.station 5+34.6 x 6 box culvert

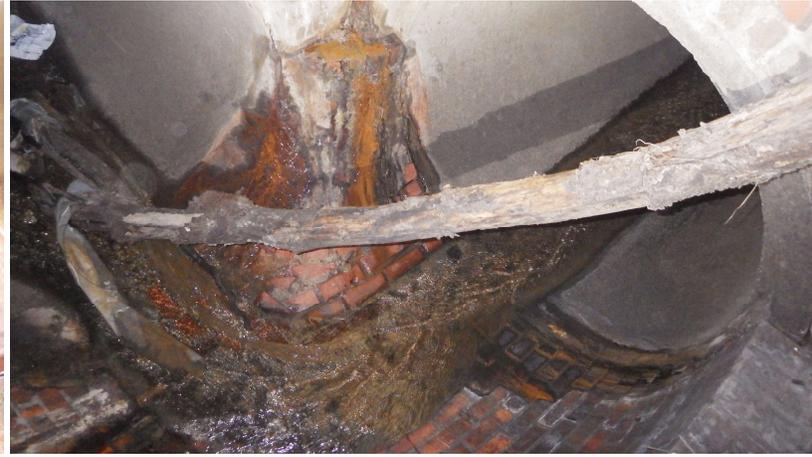
116.entry 2.station 0+90.overview before removal

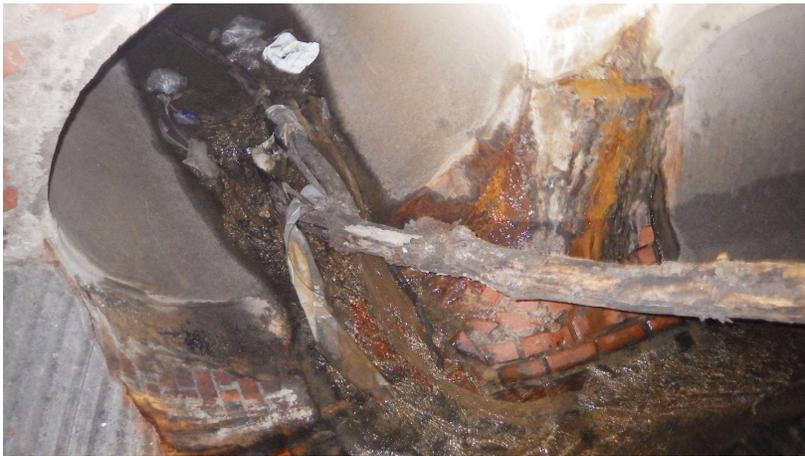
117.entry 2.station 0+90.lower portion before removal

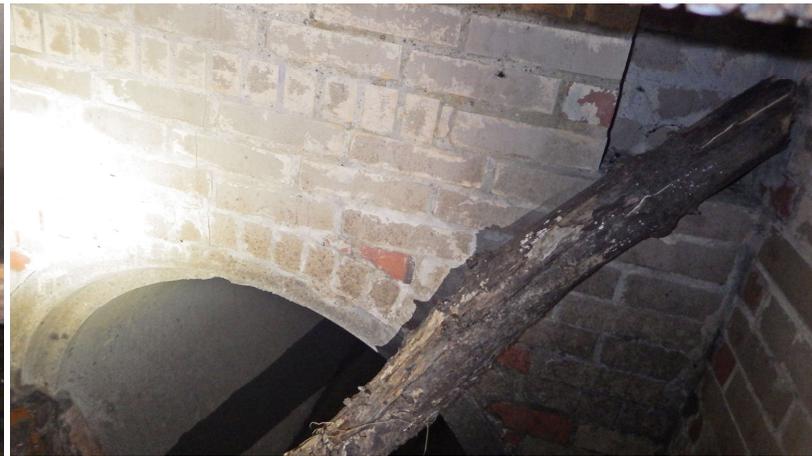
118.entry 2.station 0+90.upper portion before removal

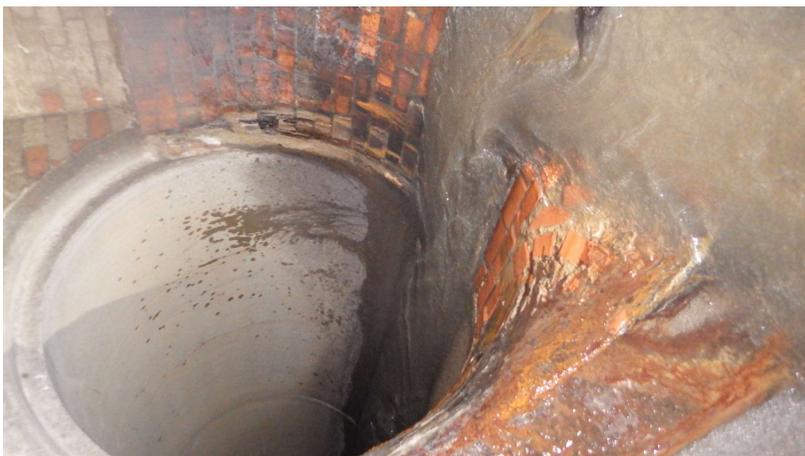
119.entry 2.station 0+90.overview after removal

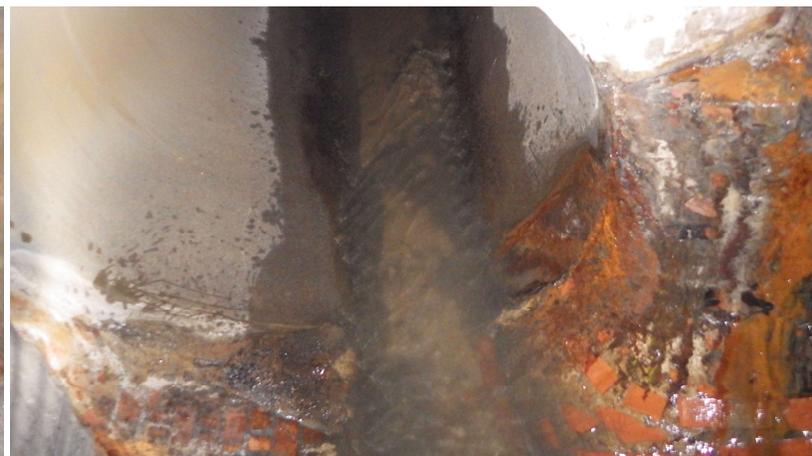
120.entry 2.station 0+90.lower portion after removal

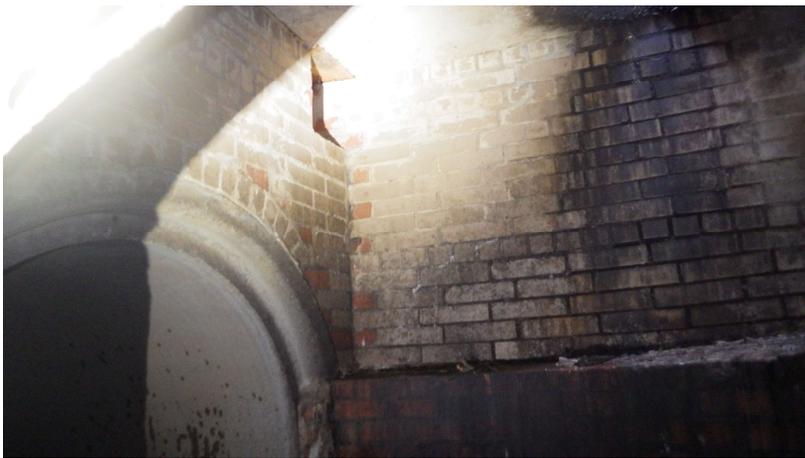
121.entry 2.station 0+90.upper portion after removal
