# ELLICOTT CITY RETAINING WALLS INSPECTION REPORT

## STREAM WALLS

## HISTORIC ELLICOTT CITY, MARYLAND

MAY 2016

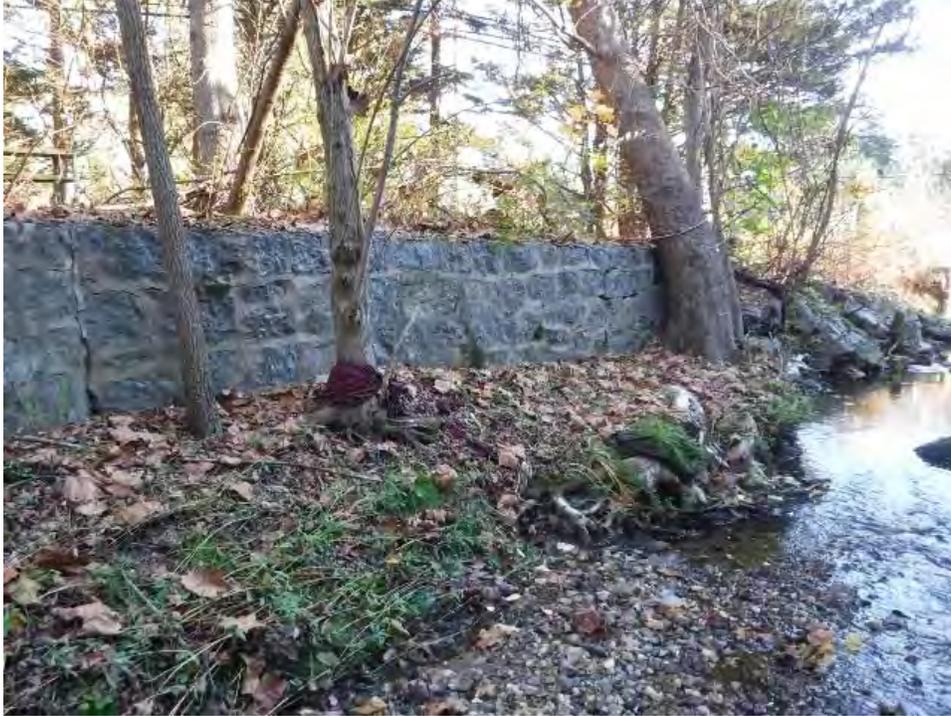
*Photo 5 – Failed Portion of Wall at East End of Section 1.*

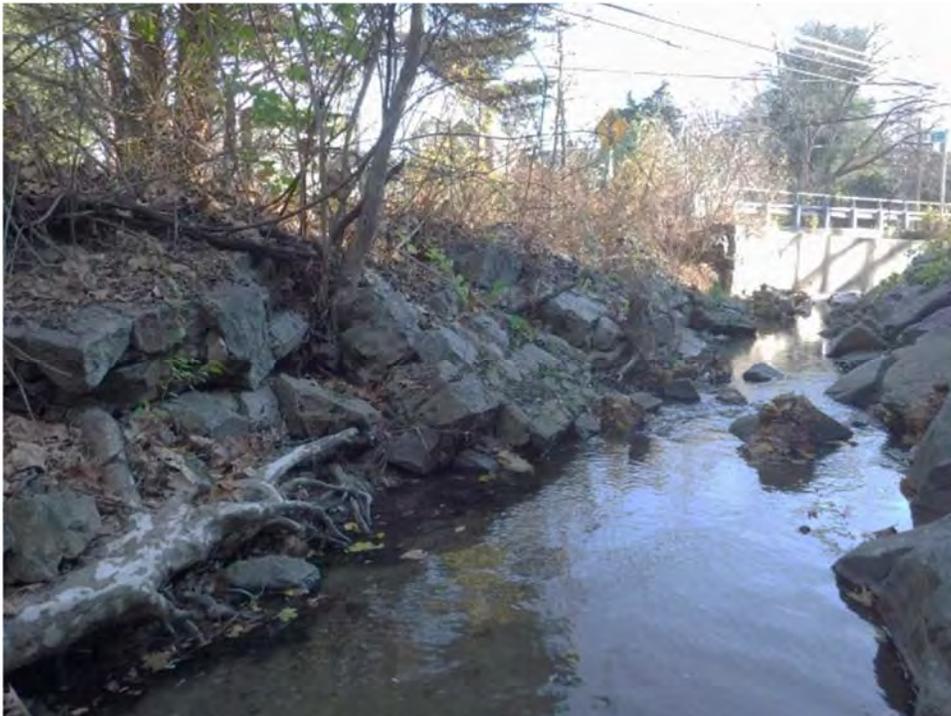
*Photo 6 – Failed Portion of Wall at East End of Section 1, Looking Northeast.*

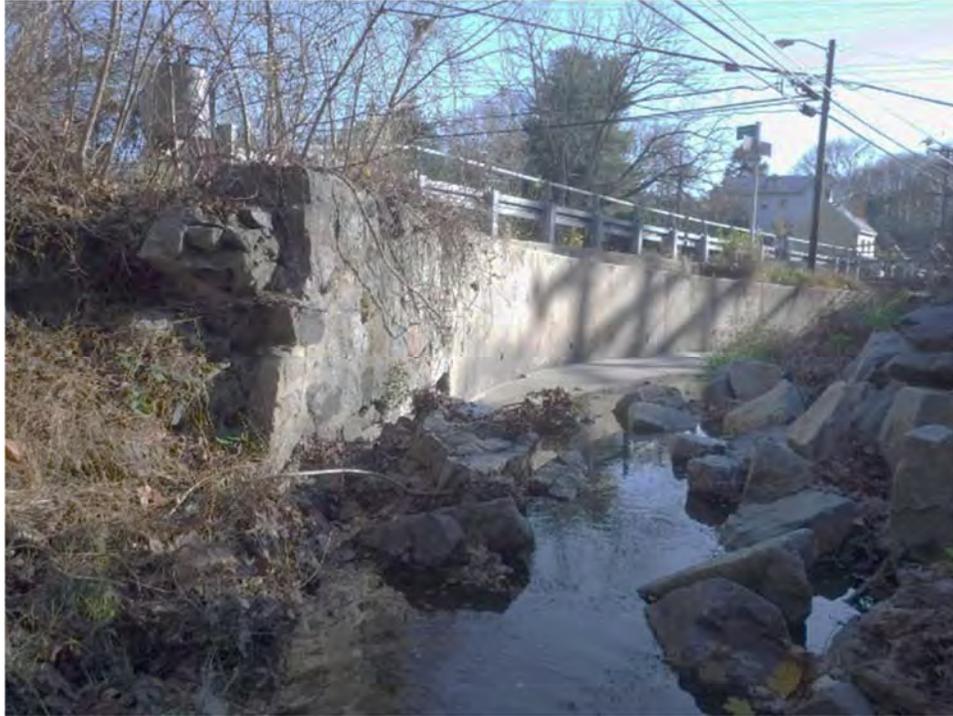
Section 2 extends from 200' to 497' from the west end of the wall. The western 15' of Section 2 is comprised of stone masonry, which is failing at the west end and exhibits missing mortar and small voids up to 2'-0" deep along the bottom 2'-0" height (see Photos 7 and 8). There is an area of missing stones at the base of the wall at 213' from the west end, measuring 2'-6" wide x 1'-6" high. Starting at 215' from the west end, the wall is comprised of concrete. There are full-height x 1/16" wide cracks spaced at approximately 6'-0" throughout the concrete (see Photos 9 and 10). There is a pedestrian bridge over the wall located at 286' from the west end of the wall. At 306' from the west end of the wall, there is a vertical wall joint which is open up to 1" wide with missing joint material (see Photo 11). At the east end of Section 2, there are two pipe culverts through the retaining wall, and a vehicular bridge over the wall (see Photo 12). To the east of the vehicular bridge, there is erosion along the back face of the wall at the east end of Section 2 (see Photo 13).

*Photo 7 – Section 2, Looking Northeast.  
Note Failing Stone Masonry at West End.*

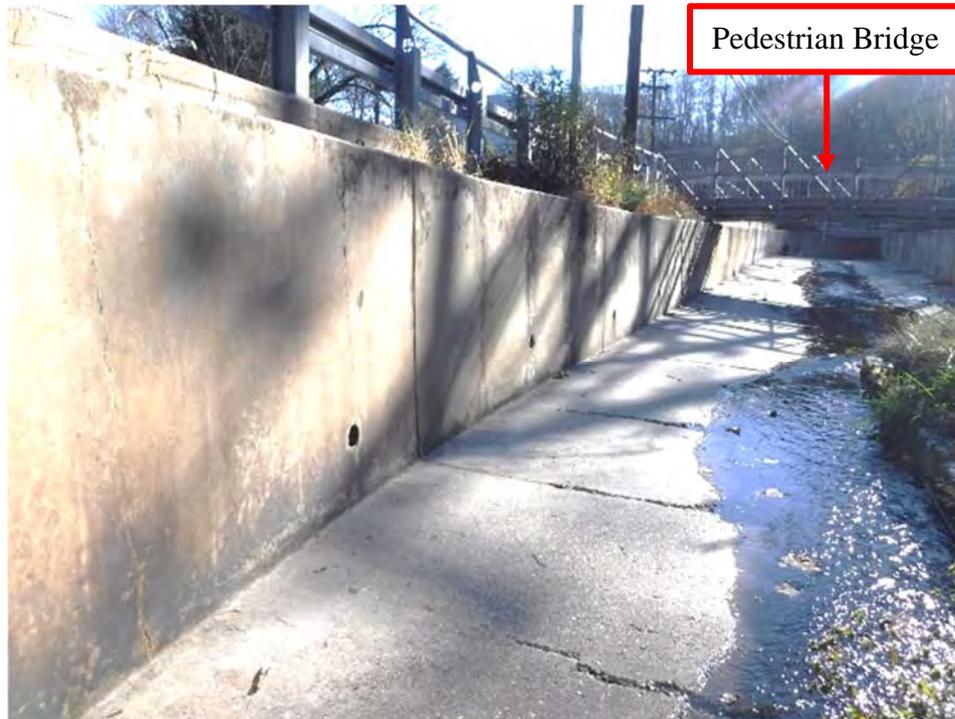
*Photo 9 – Section 2, Looking Northeast.*

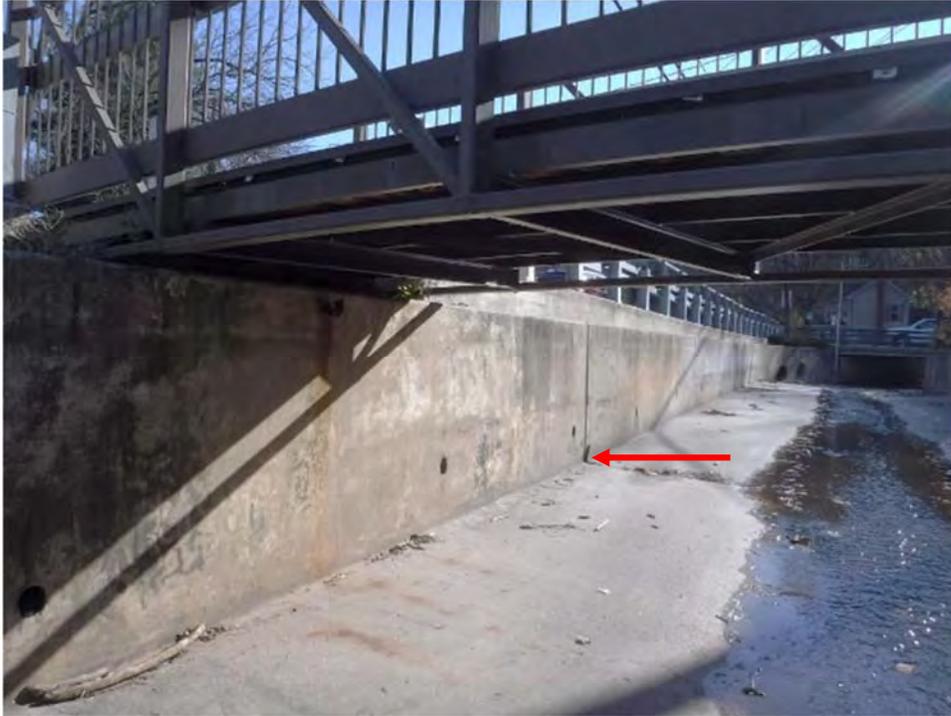
*Photo 11 – Section 2, Looking Northeast.  
Note Wall Joint with Missing Material.*

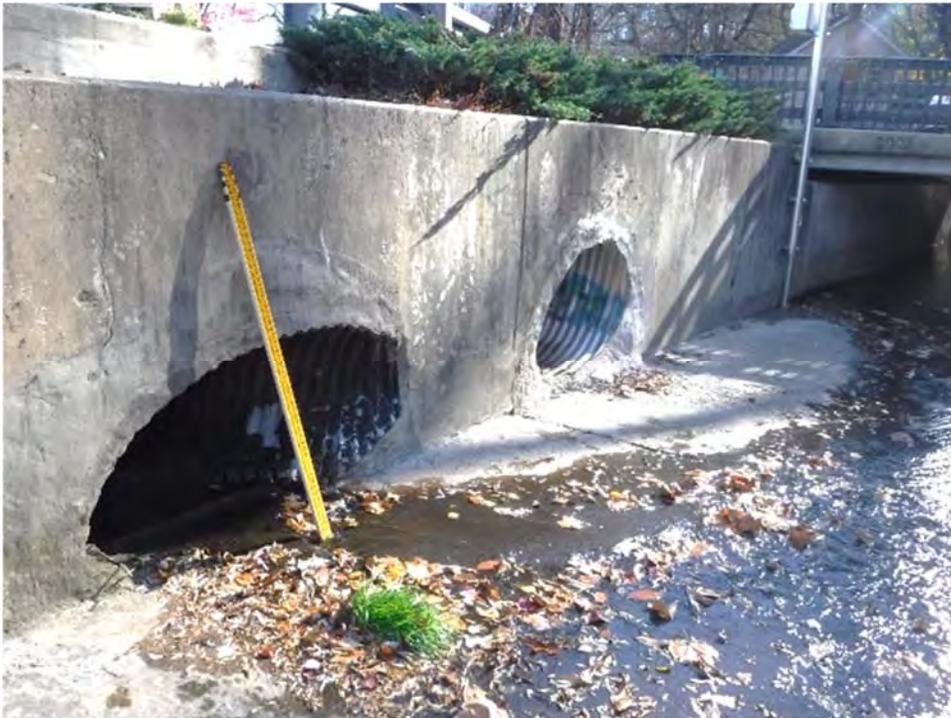
*Photo 12 – Culverts and Vehicular Bridge at East End of Section 2,  
Looking Northeast.*

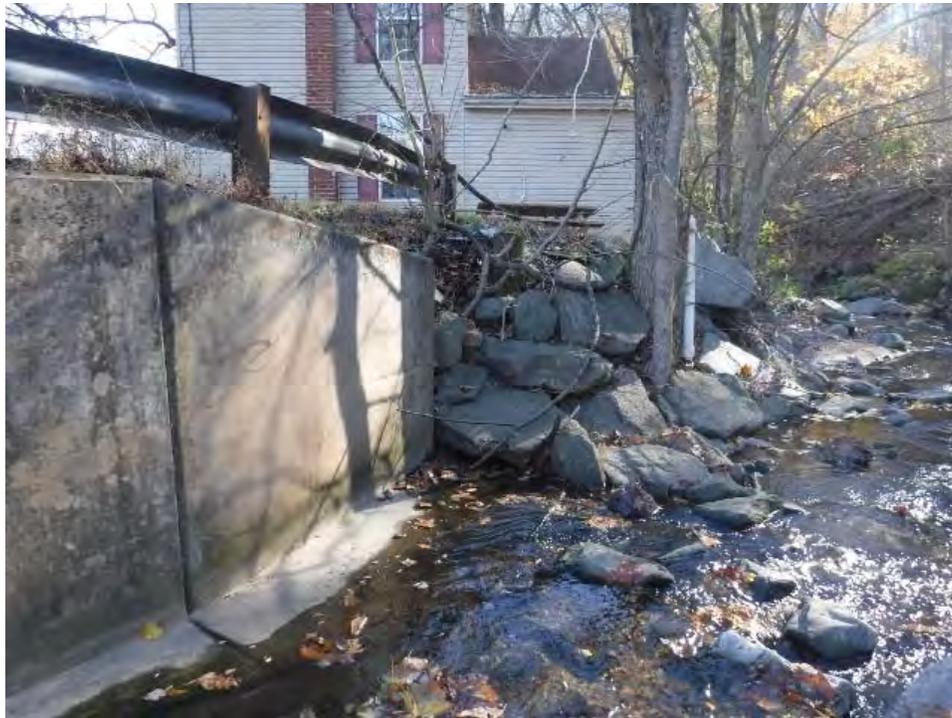
Section 4 extends from 497' to 675' from the west end of the wall. The western 63' of Section 4 is comprised of natural stone and the foundation of a private property (see Photos 14 and 15). Starting at 560' from the west end, the wall is comprised of stone masonry. The stone masonry exhibits missing mortar throughout the joints, with large trees growing along the top of the wall (see Photos 16 and 17). At 582' from the west end, the wall has failed for a 93' length, with embankment erosion (see Photo 18). Within this area, at the eastern 32' of Section 4, the retaining wall supports a timber deck. The stones in this area are loose and displaced, with voids up to 1'-0" deep (see Photo 19).

*Photo 14 – Start of Section 4 (Natural Stone), Looking East.*

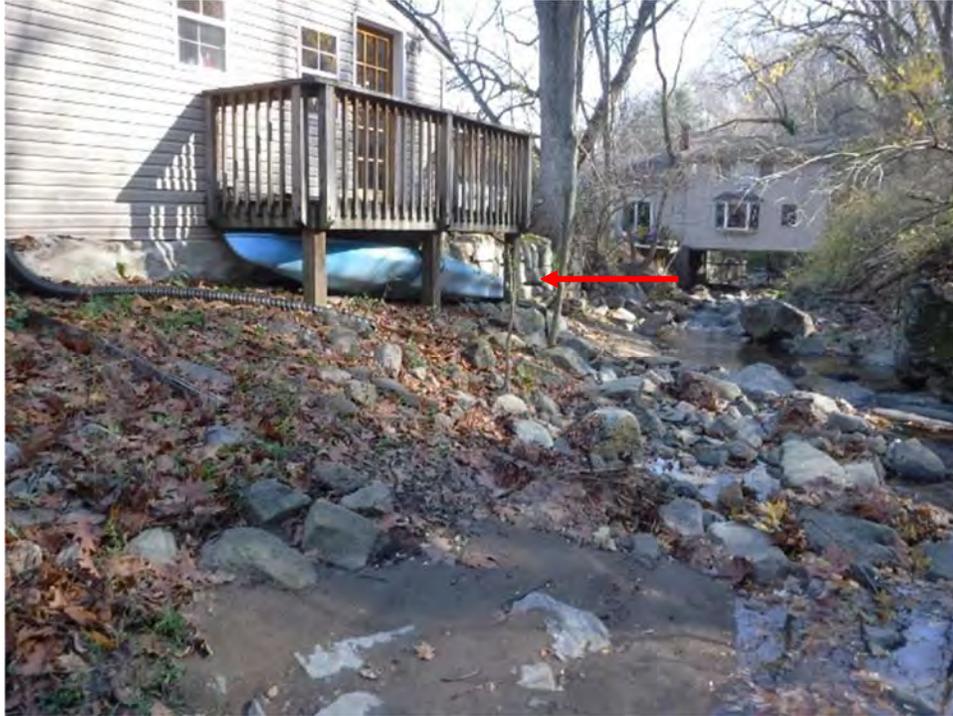
*Photo 15 – Section 4, Looking East.  
Note Start of Stone Masonry Wall, East of House.*

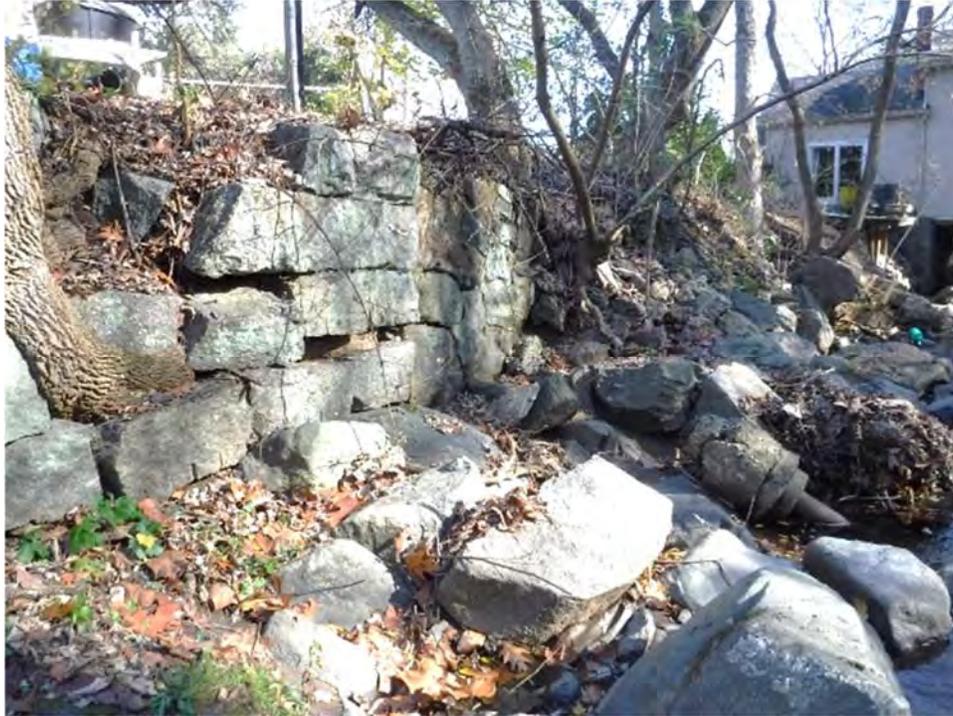
*Photo 17 – Section 4 with Mature Tree Growth, Looking Northeast.*

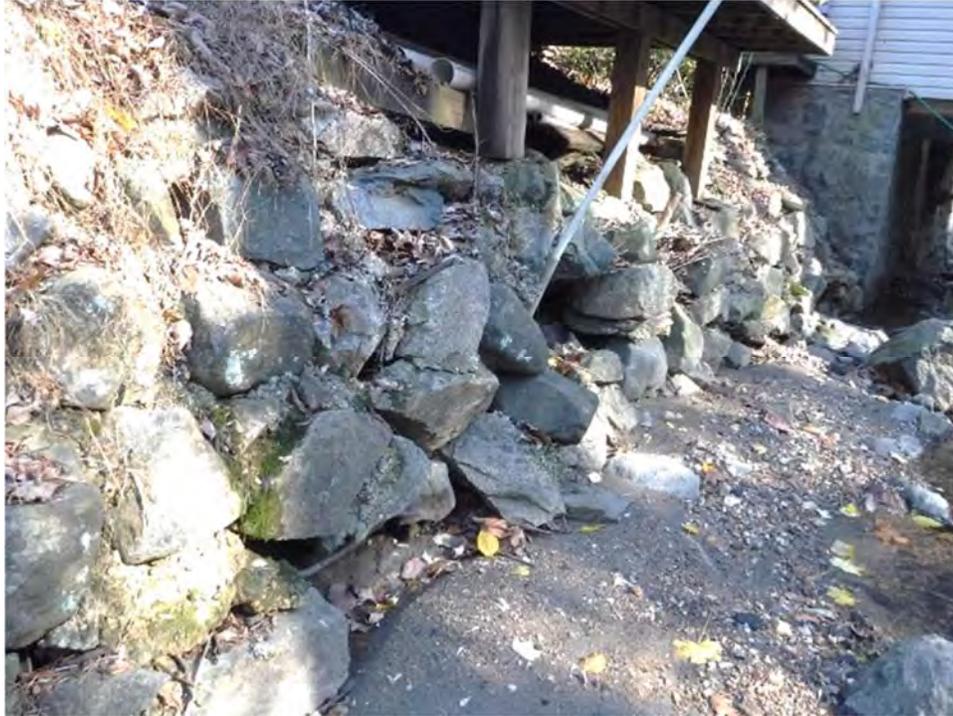
*Photo 19 – Displaced Stones and Voids beneath Timber Deck at East End of Section 4, Looking East.*

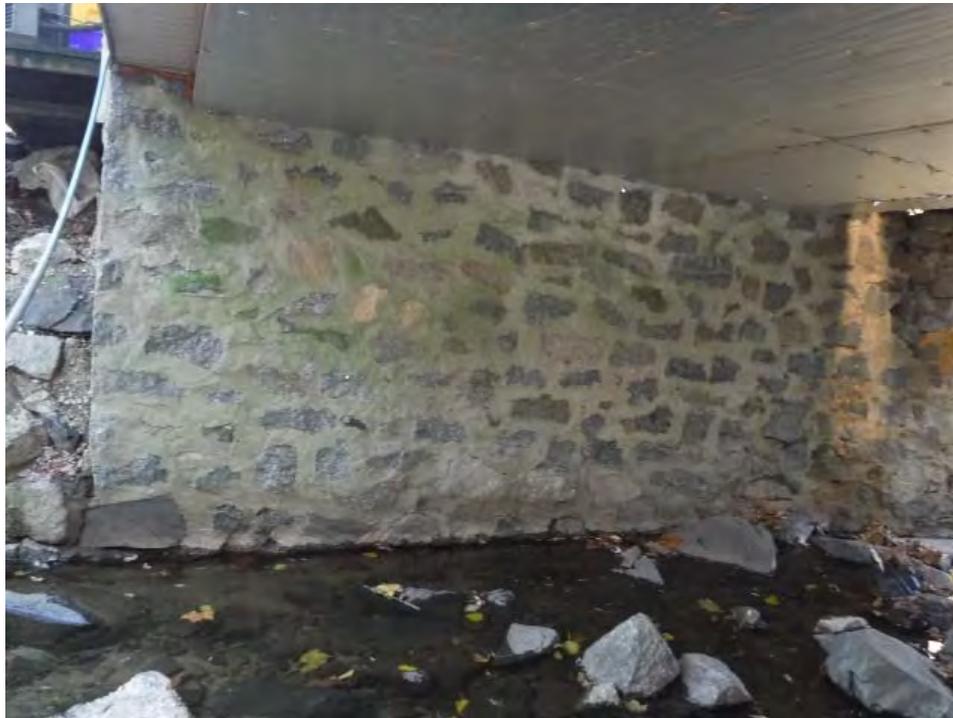
Section 5 extends from 675' to 738' from the west end of the wall. The western 21' of Section 5 consists of a house foundation comprised of stone masonry (see Photo 20). The mortar joints are typically in good condition, except at the top east corner, where there is a 3'-6" high x 3'-0" wide area of missing mortar and loose stones above a utility pipe penetration (see Photo 21). Starting

*Photo 20 – Section 5 House Foundation, Looking North.*

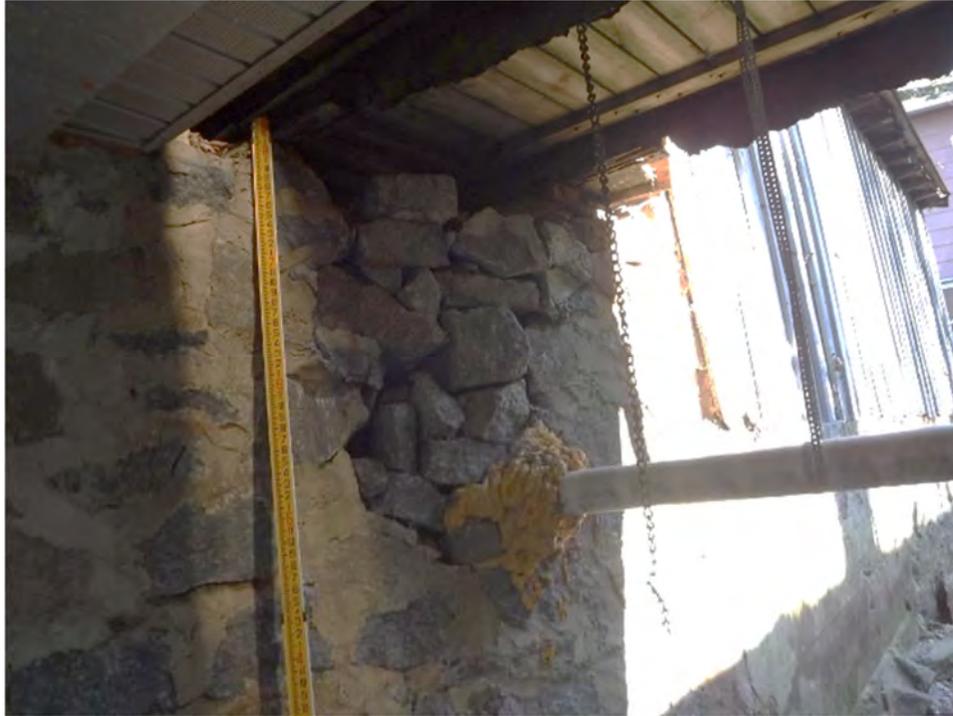
*Photo 21 – Section 5 with Missing Mortar and Loose Stones at Top East Corner of Wall beneath House.*

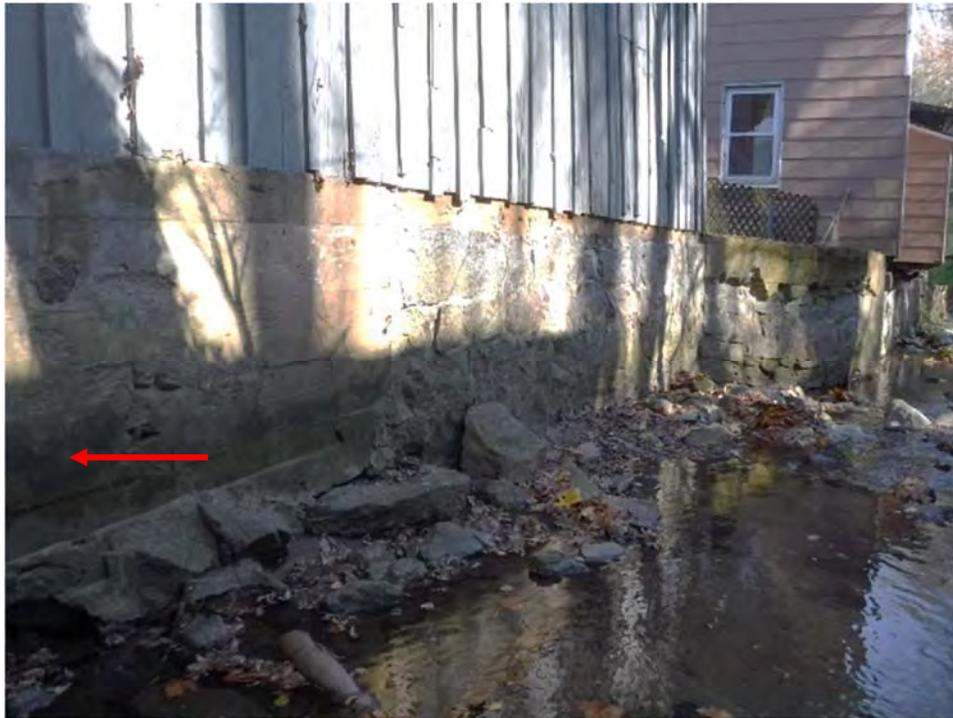
at 696' from the west end, the retaining wall is comprised of concrete blocks for an 11' length (see Photo 22). The concrete wall exhibits voids and undermining along the base, 5'-0" long x 1'-6" high x 8" deep (see Photo 23). The retaining wall is comprised of stone masonry from 707' to 738' from the west end, which exhibits minor random mortar loss in the joints. There is a concrete cap at the top of the wall within the eastern 12' length of Section 5, which is deteriorated within the lower 6" height (see Photo 24). There is an area of missing stones at the base at the east end of Section 5, measuring 2'-0" long x 1'-0" high x 8" deep.

*Photo 22 – Section 5, Looking Northeast.  
Note Concrete Block Portion.*

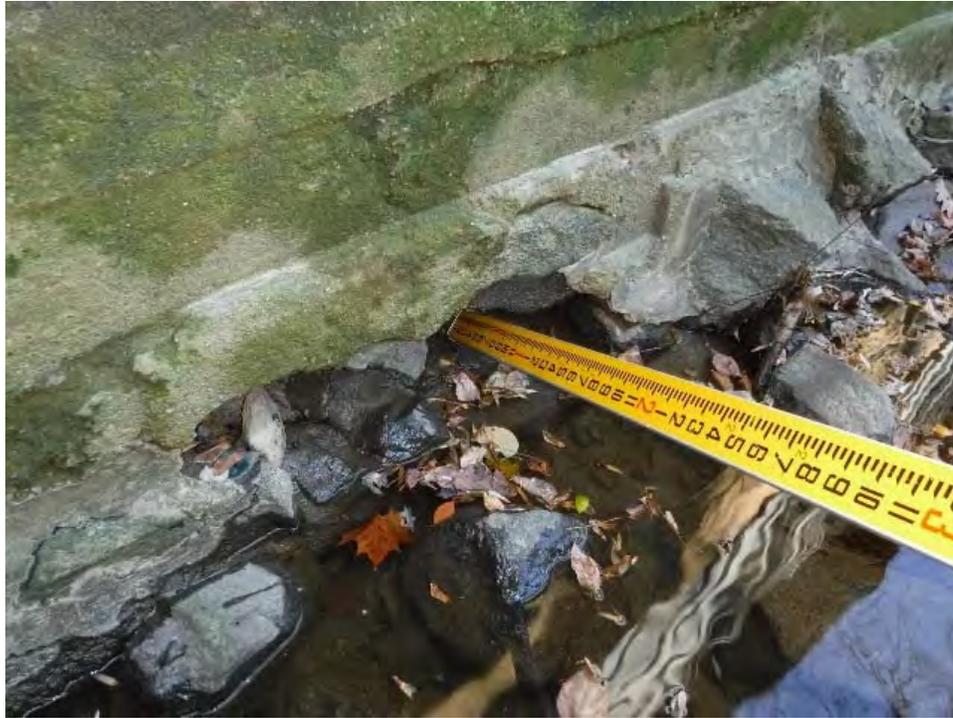
*Photo 23 – Undermining along Concrete Block Portion of Section 5.*

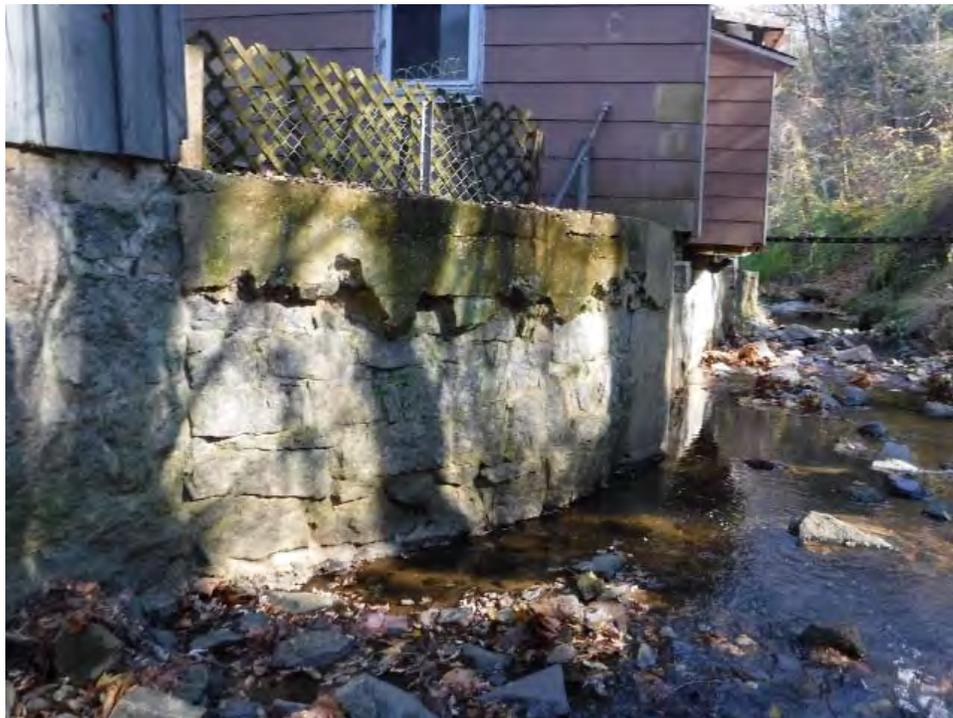
*Photo 24 – Stone Masonry Portion of Section 5 with Missing Mortar and Deteriorated Concrete Cap, Looking Northeast.*

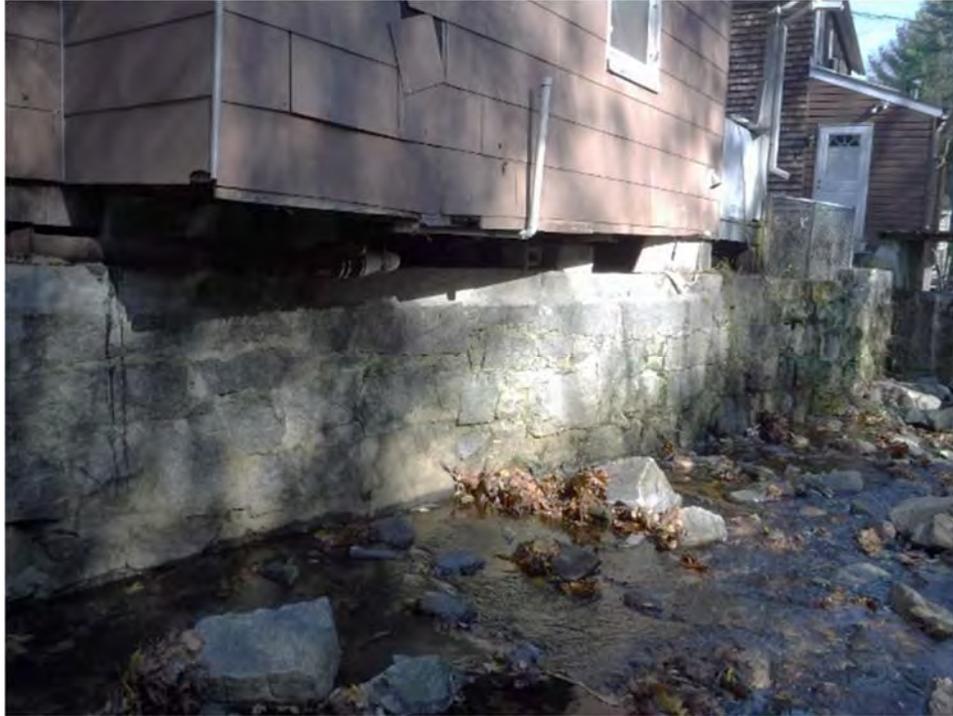
Section 6 extends from 738' to 843' from the west end of the wall (see Photo 25). The stone masonry retaining wall has missing mortar, vegetation growth, and water leakage through the joints (see Photo 26). At 789' from the west end of the wall, there is a pedestrian bridge which spans the retaining wall. At 803' from the west end, there is a 4'-0" wide x 2'-0" high area of loose and displaced stones at the base of the wall, and the wall is undermined 10'-0" long x 7" high x 1'-0" deep (see Photos 27 and 28).

*Photo 25 – Section 6, Looking Northeast.*

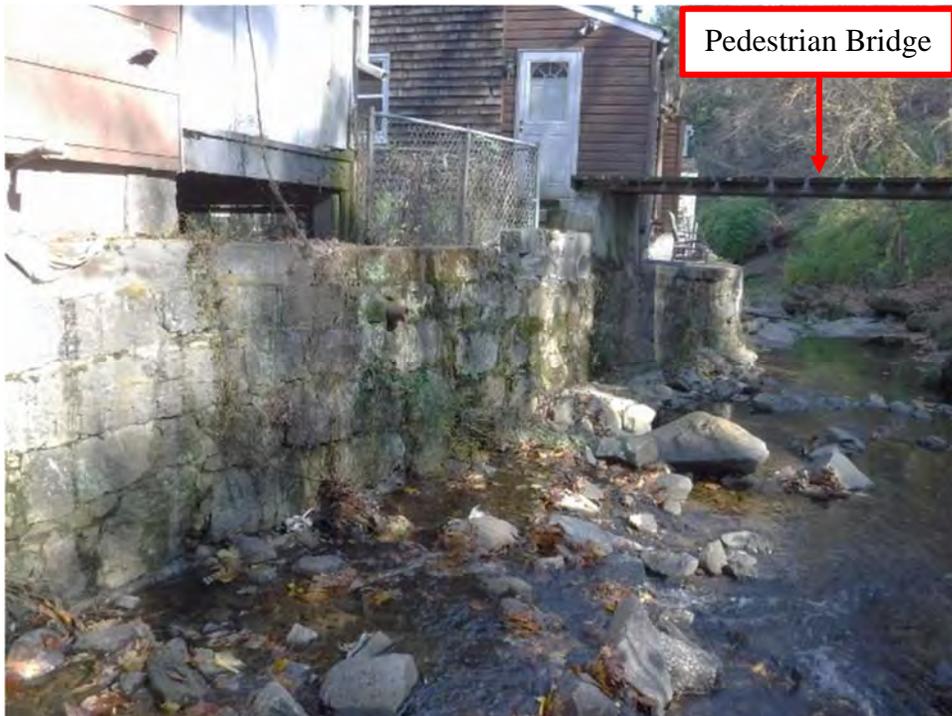
*Photo 26 – Section 6, Looking Northeast.*  
*Note Vegetation Growth.*

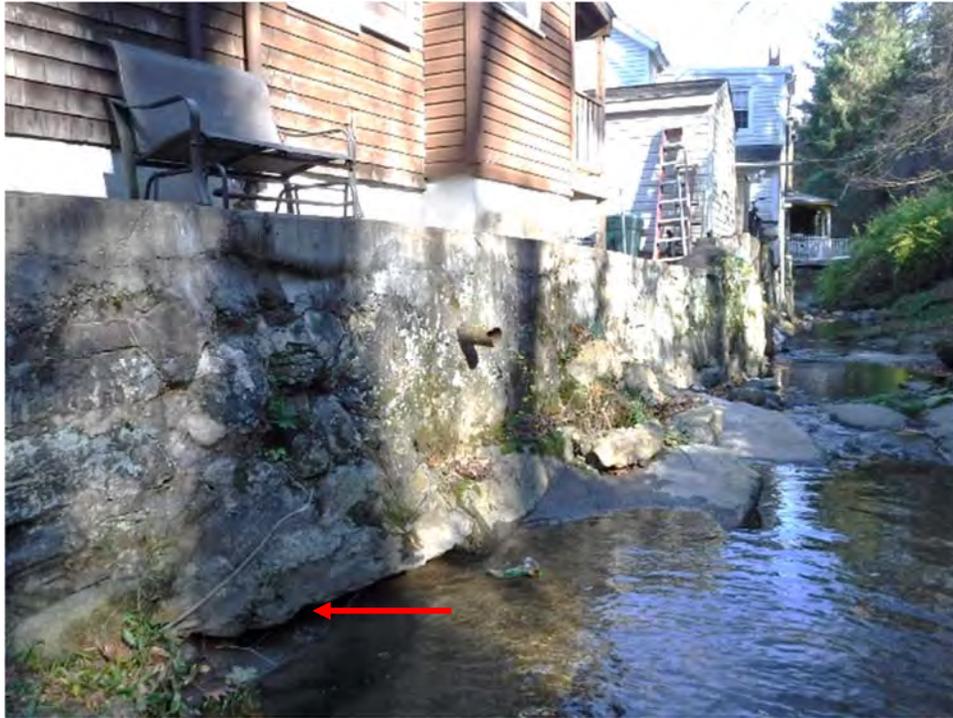
*Photo 27 – Section 6, East of Pedestrian Bridge, Looking Northeast.  
Note Area of Undermining.*

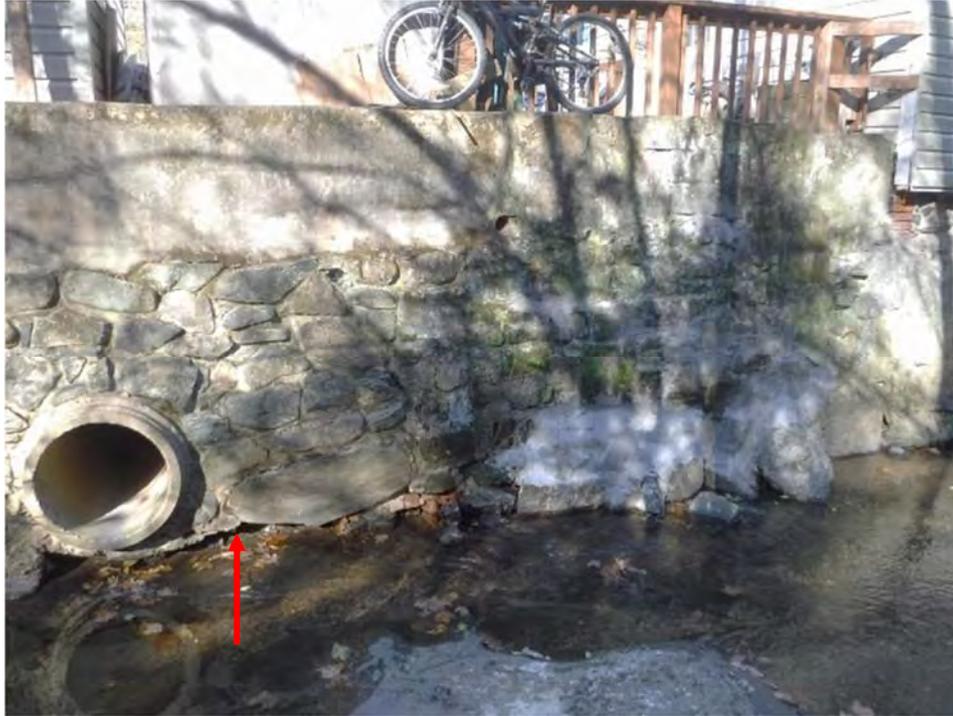
Section 7 extends from 843' to 956' from the west end of the wall (see Photo 29). The stone masonry retaining wall has random missing mortar and small voids, typically worst within the lower 1'-6" height of the wall. At 850' from the west end, the wall is undermined 10'-0" long x 1'-0" high x 9" deep (see Photo 29). At 869' from the west end, beneath a house, the wall is undermined 15'-0" long x 1'-6" high x 1'-6" deep (see Photos 30 and 31). Above the undermined area, the stones appear to be bulging, specifically at mid-height, up to 6" (see Photo 32). Starting at 908' from the west end, the wall is comprised of concrete. At the interface with this concrete portion, the stone masonry portion is offset horizontally to the south up to 3½" at the lower 5'-0" of the wall (see Photo 33). The concrete portion of the wall has minor scaling on the lower 1'-0".

*Photo 29 – Section 7, Looking North.  
Note Undermining.*

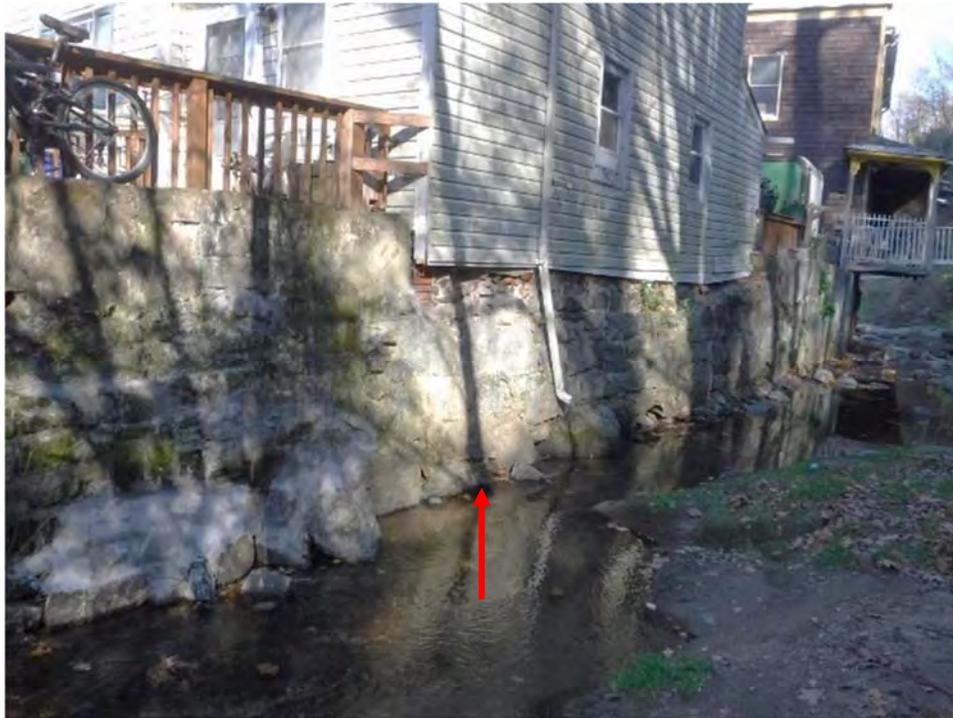
*Photo 30 – Section 7, Looking Northeast.  
Note Undermining.*

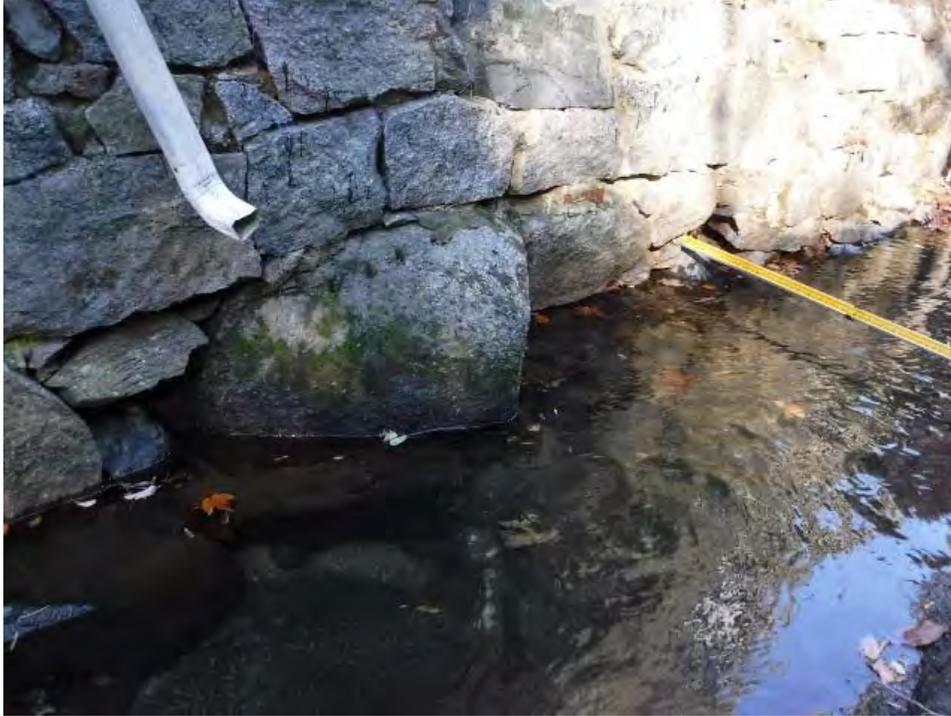
*Photo 31 – Undermining Beneath House in Section 7, Looking Northeast.  
Note Missing Mortar.*

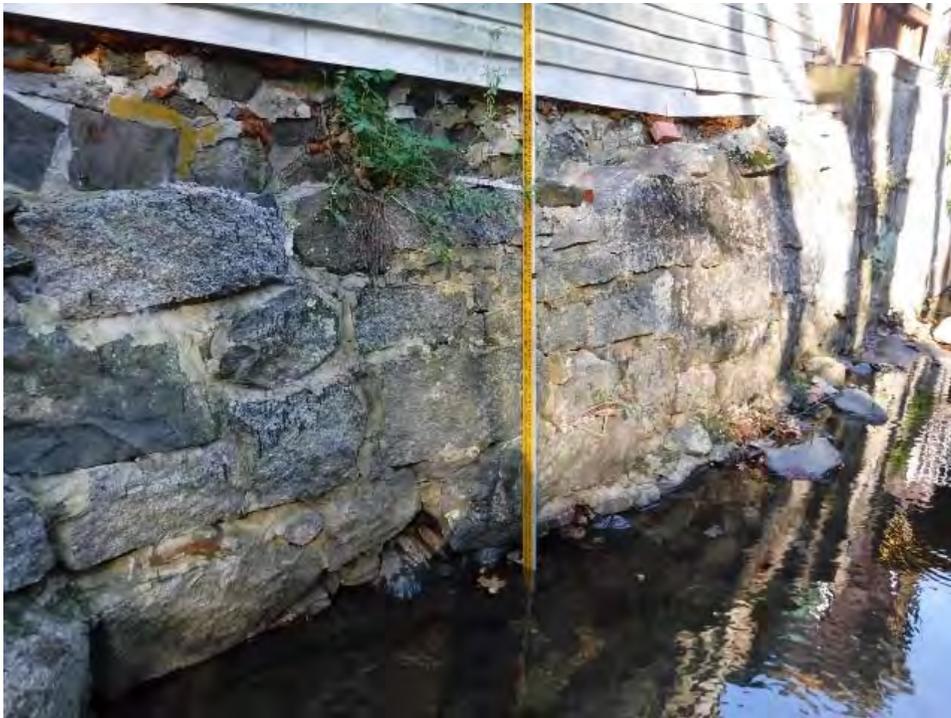
*Photo 32 – Bulging Beneath House in Section 7, Looking Northeast.*

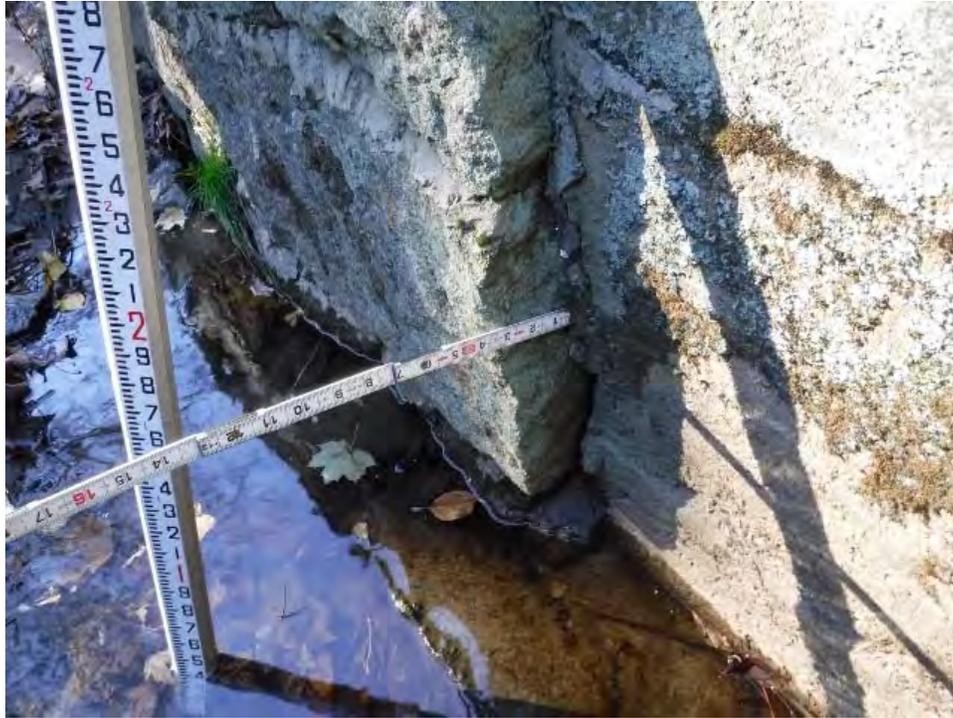
*Photo 33 – Horizontal Offset Between Stone Masonry and Concrete Portions, at East End of Section 7, Looking Northwest.*

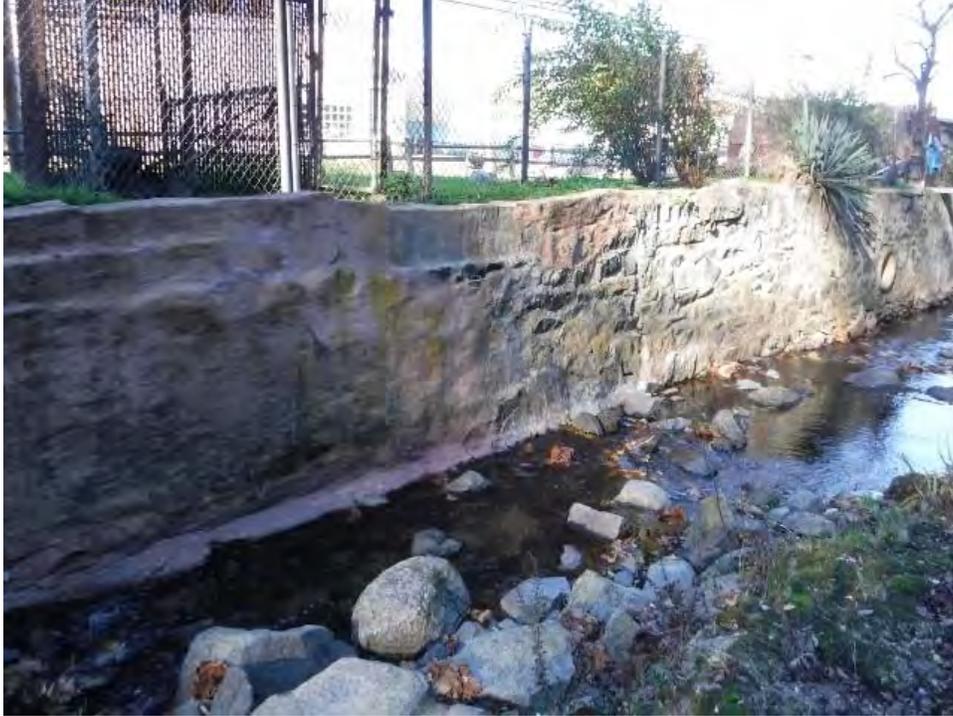
Section 8 extends from 956' to 1,078' from the west end of the wall (see Photos 34-37). The stone masonry retaining wall typically has random areas of missing mortar and small voids, random areas of pneumatically applied mortar (PAM), and joints that can be probed to 8" deep (see Photo 38). Starting 1,032' from the west end, at the location of a pedestrian bridge, the wall is undermined for a 30'-0" length x 1'-0" high x 1'-0" deep (see Photo 39). Between 1,054' and 1,134' from the west end of the wall, the stone masonry joints exhibit missing mortar, exposed fill and vegetation growth, and can be probed to 1'-0" deep (see Photo 40). Between 1,079' and 1,099' from the west end, the wall is leaning toward the stream channel up to 9" (see Photo 41). At 1,110' from the west end, there is a 3'-0" long x 8" wide vertical fracture with active water leakage near the base of the wall (see Photo 42). At the east end of Section 8, there is a missing stone at the base, 1'-6" high x 3'-0" wide x 2'-0" deep (see Photo 43).

*Photo 35 – Section 8, Looking Northeast.*

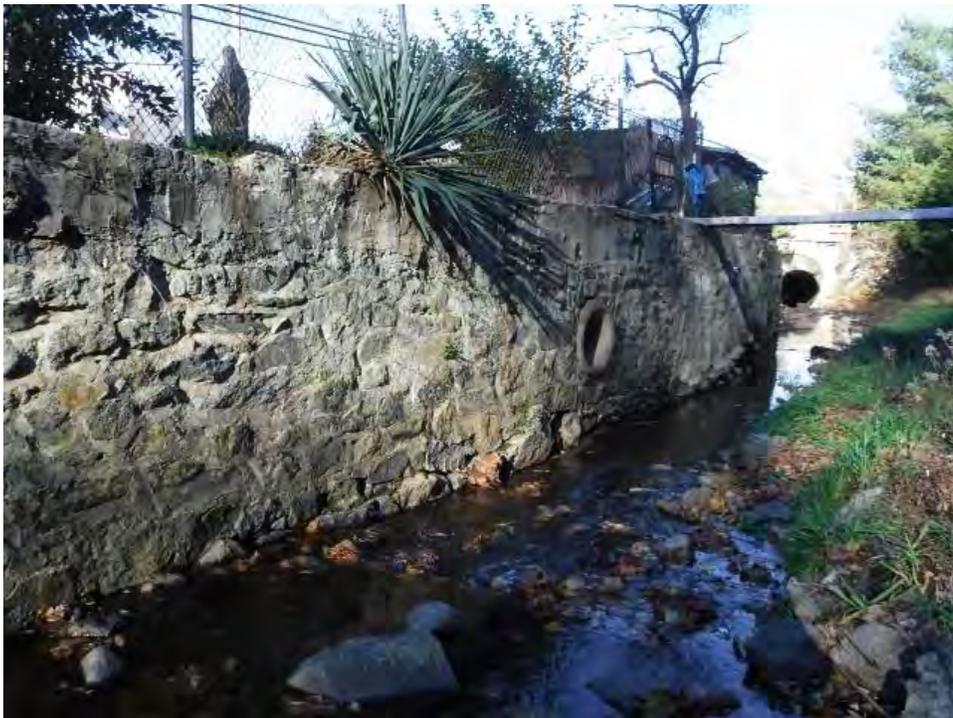
*Photo 36 – Section 8, Looking Northeast.*

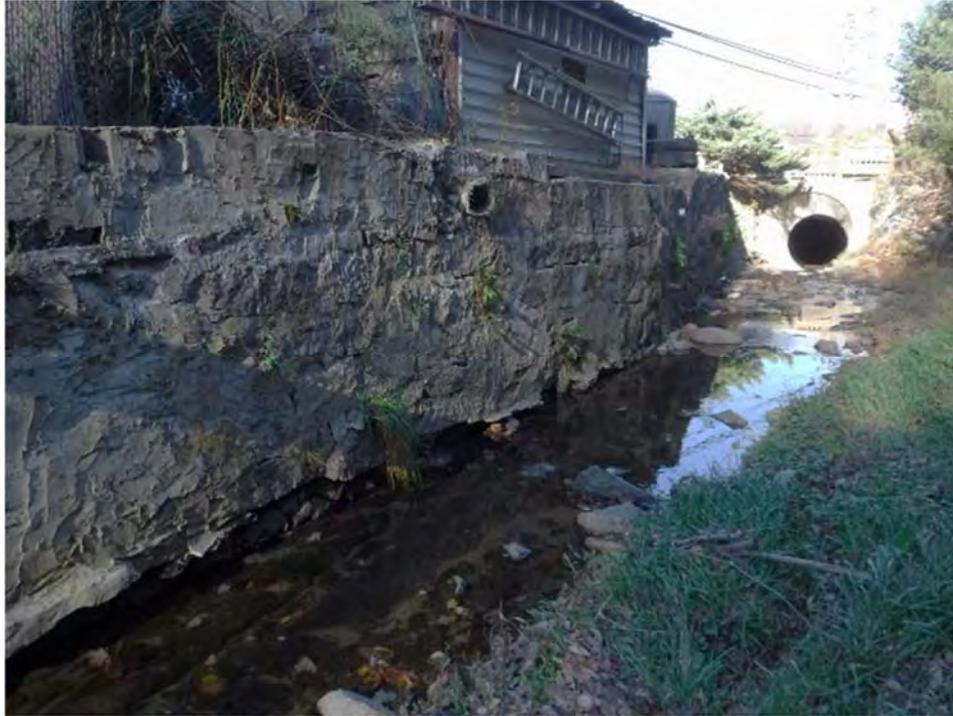
*Photo 37 – East End of Section 8, Looking Northeast.*

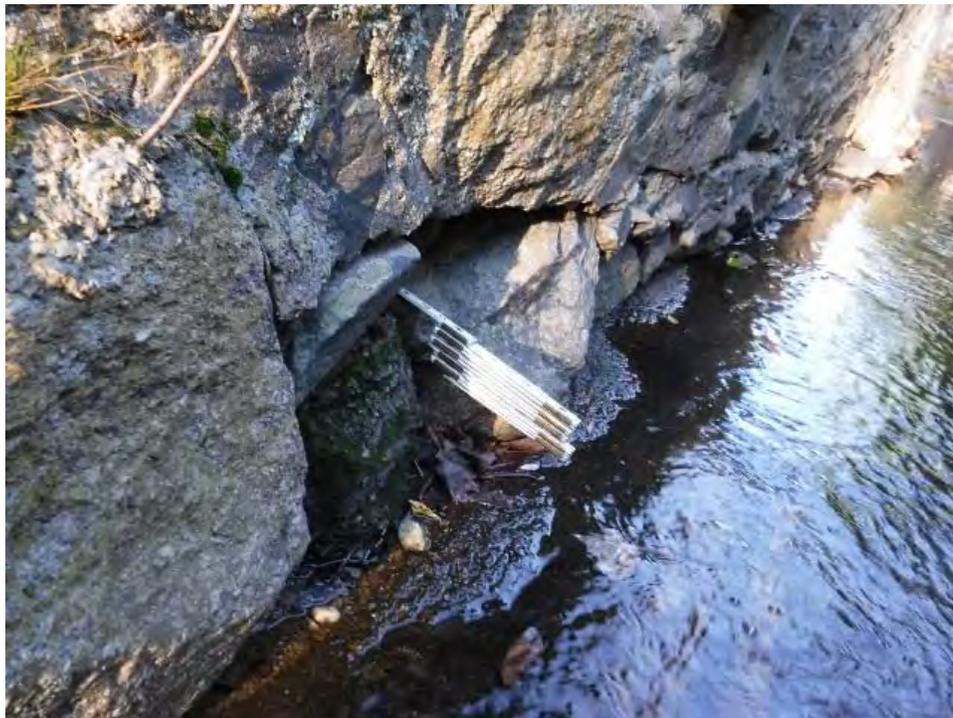
*Photo 38 – Typical Missing Mortar and Voids in Section 8, Looking Northeast.*

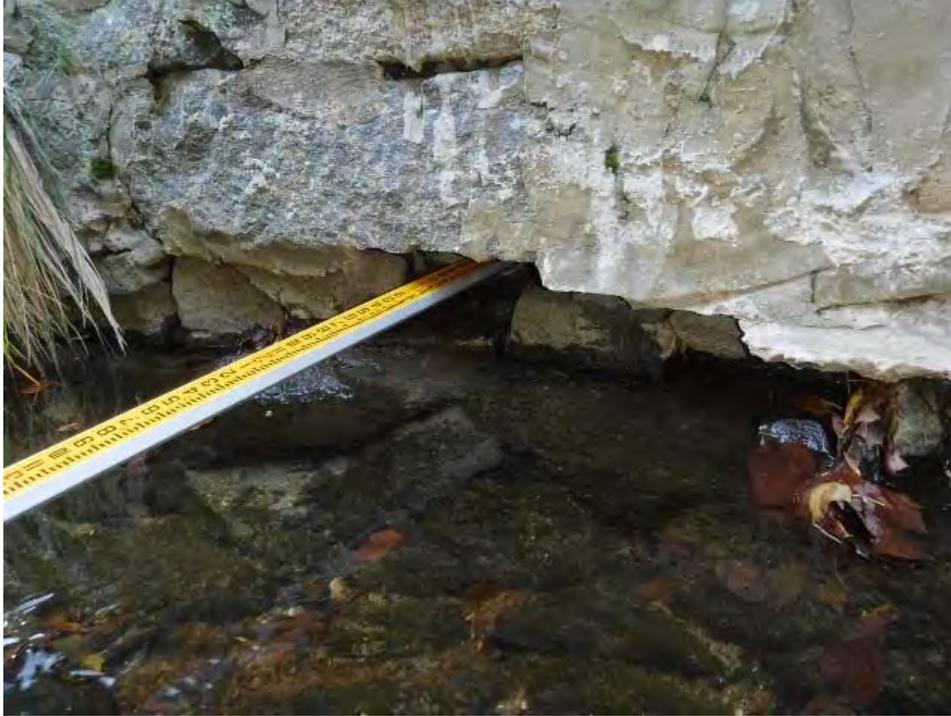
*Photo 39 – Undermining Beneath Pedestrian Bridge in Section 8.*

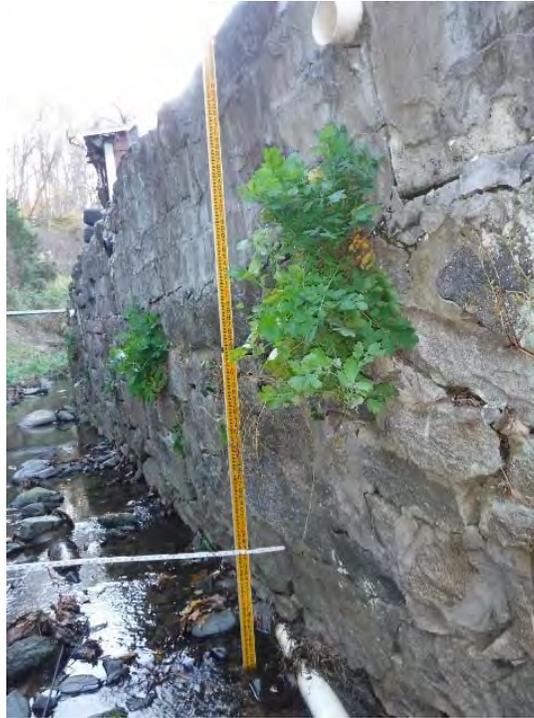
*Photo 41 – Leaning Portion of Section 8, Looking West.*

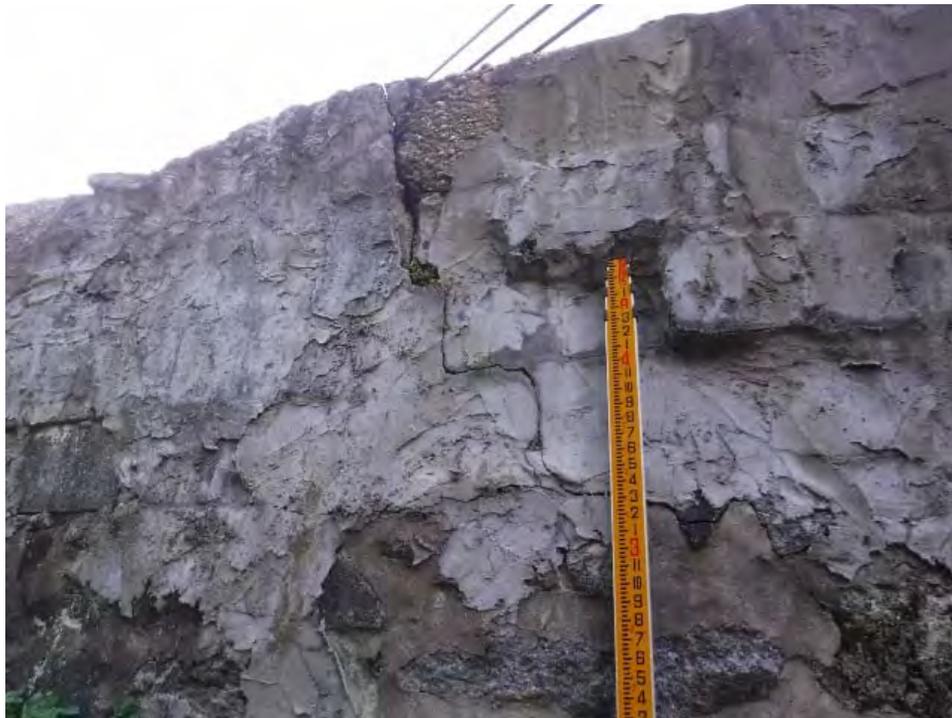
*Photo 42 – Fracture at 24' from East End of Section 8, Above Area of Water Leakage.*

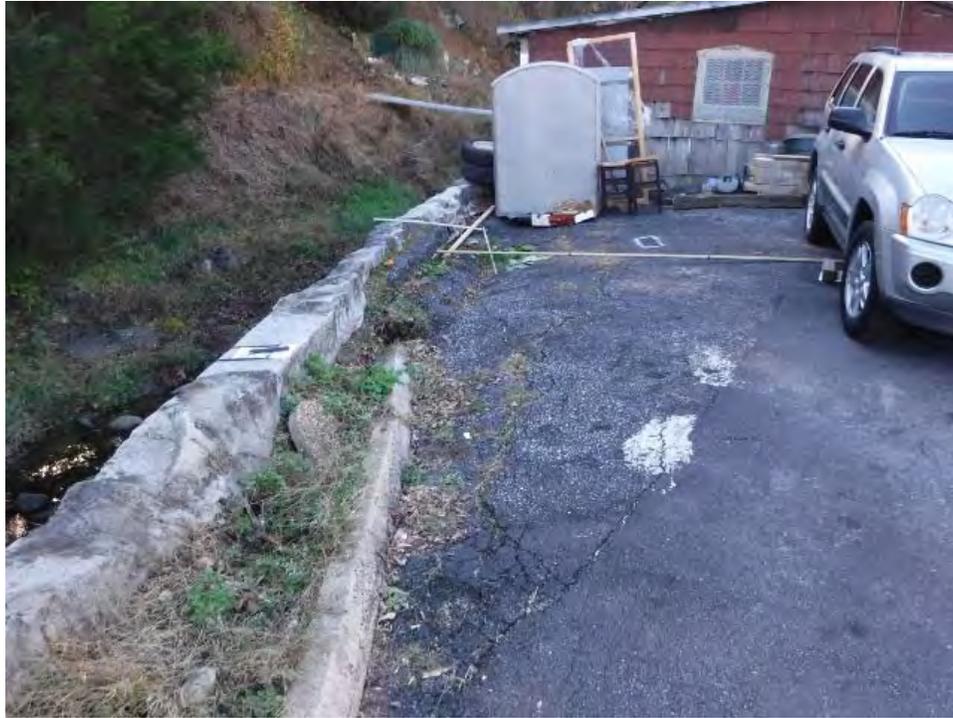
At the east end of Retaining Wall 1A, there is a private driveway behind the wall. The asphalt pavement exhibits cracking and settlement in a 33'-0" long x 13'-0" wide area (see Photos 44 and 45). At 1,090' from the west end, there is a sinkhole behind the wall, measuring 3'-2" long x 3'-2" wide x 9" deep (see Photo 46). Between 1,079' and 1,099' from the west end of the wall (bulging portion), there is a gap between the pavement and the wall, between 5" and 9" wide, which can be probed to 1'-8" deep (see Photo 47). There are also several 1'-0" diameter x up to 2'-0" deep sinkholes along the backside of the wall (see Photo 48).

*Photo 45 – Settlement in Pavement above East End of Section 8, Looking West.*
