# ELLICOTT CITY RETAINING WALLS INSPECTION REPORT

## STREAM WALLS

## HISTORIC ELLICOTT CITY, MARYLAND

MAY 2016

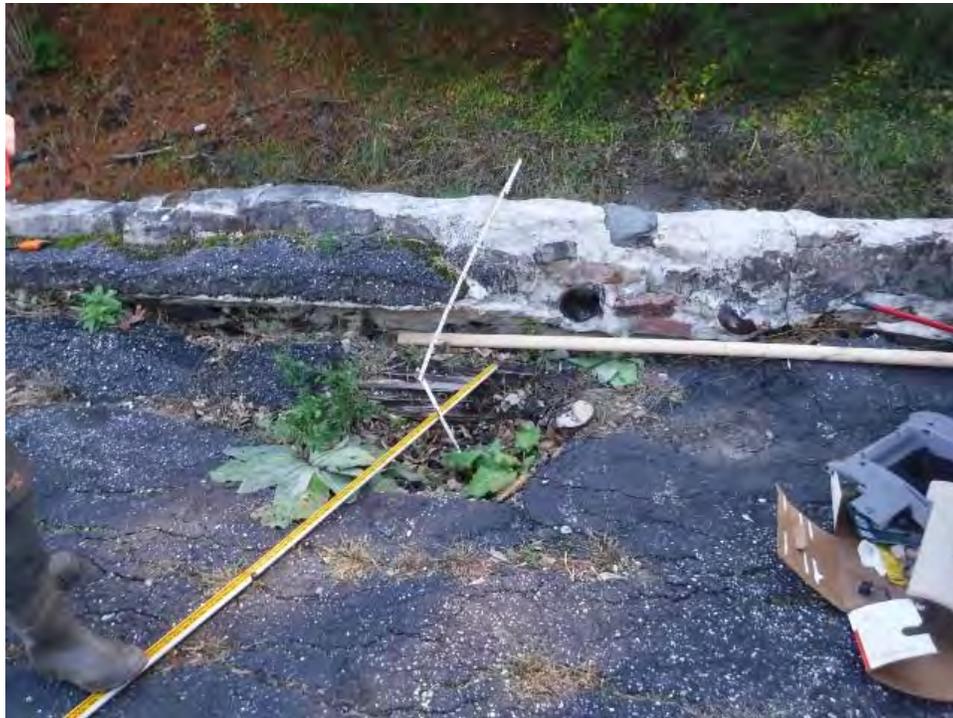
At the east end of Retaining Wall 1A, there is a private driveway behind the wall. The asphalt pavement exhibits cracking and settlement in a 33'-0" long x 13'-0" wide area (see Photos 44 and 45). At 1,090' from the west end, there is a sinkhole behind the wall, measuring 3'-2" long x 3'-2" wide x 9" deep (see Photo 46). Between 1,079' and 1,099' from the west end of the wall (bulging portion), there is a gap between the pavement and the wall, between 5" and 9" wide, which can be probed to 1'-8" deep (see Photo 47). There are also several 1'-0" diameter x up to 2'-0" deep sinkholes along the backside of the wall (see Photo 48).

*Photo 46 – Sinkhole at 44' from the East End of Section 8, Looking South.*

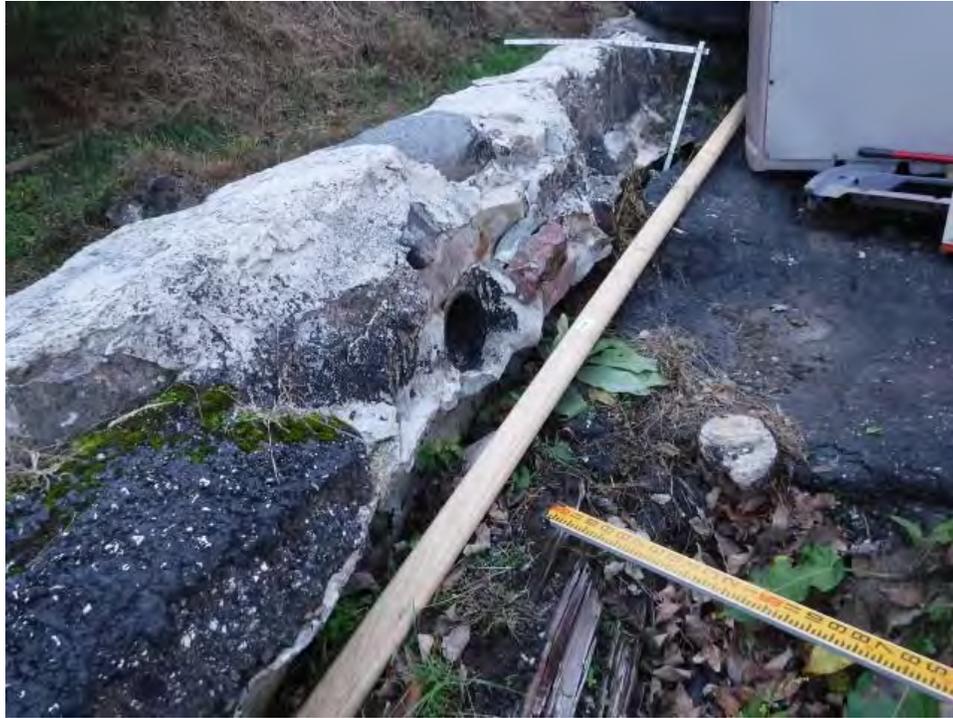
*Photo 47 – Gap between Pavement and Section 8, Looking West.*

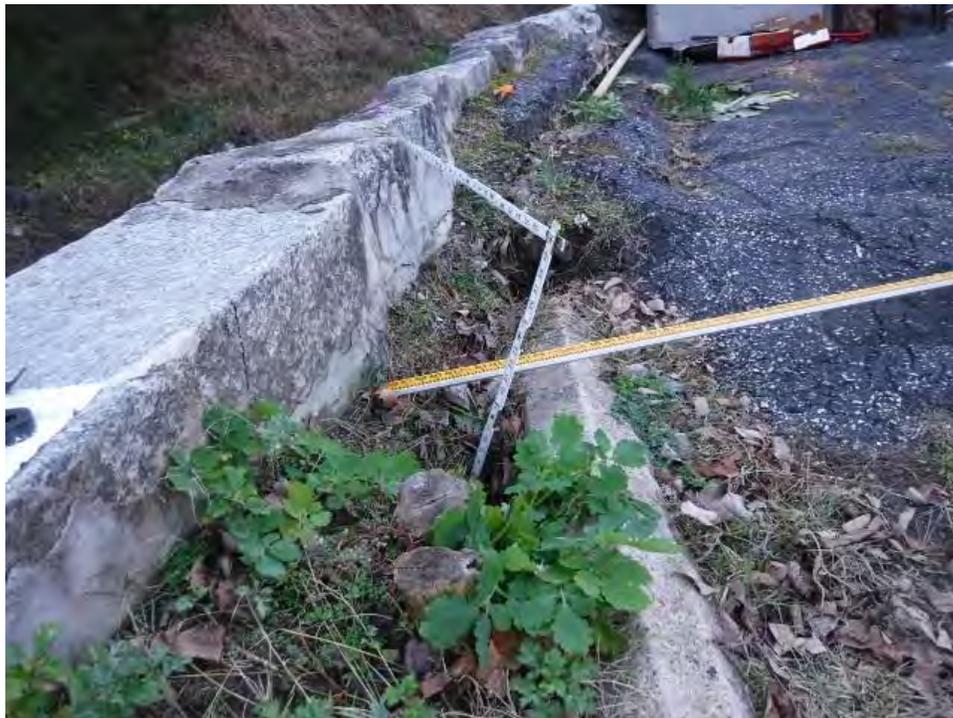
*Photo 48 – Sinkholes along Backside of Section 8, Looking West.*

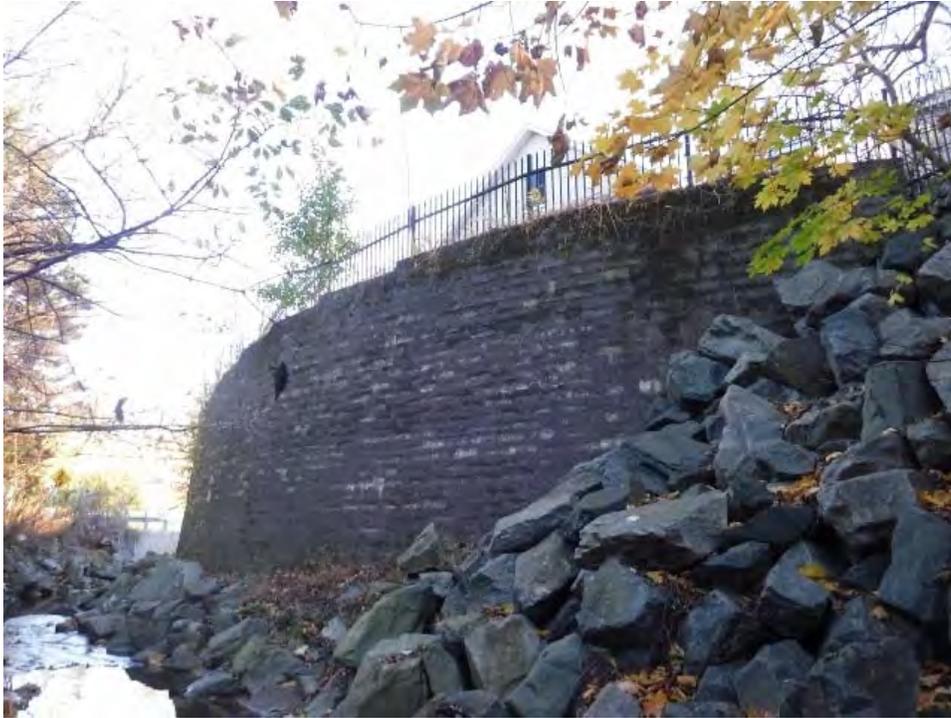
Overall, the wall is in fair condition. Section 1 (western 163') is comprised of brick. The brick wall has vegetation growth throughout and large riprap along the wall (see Photos 1 and 2).

*Photo 1 – Section 1 at West End, Looking Southeast.*

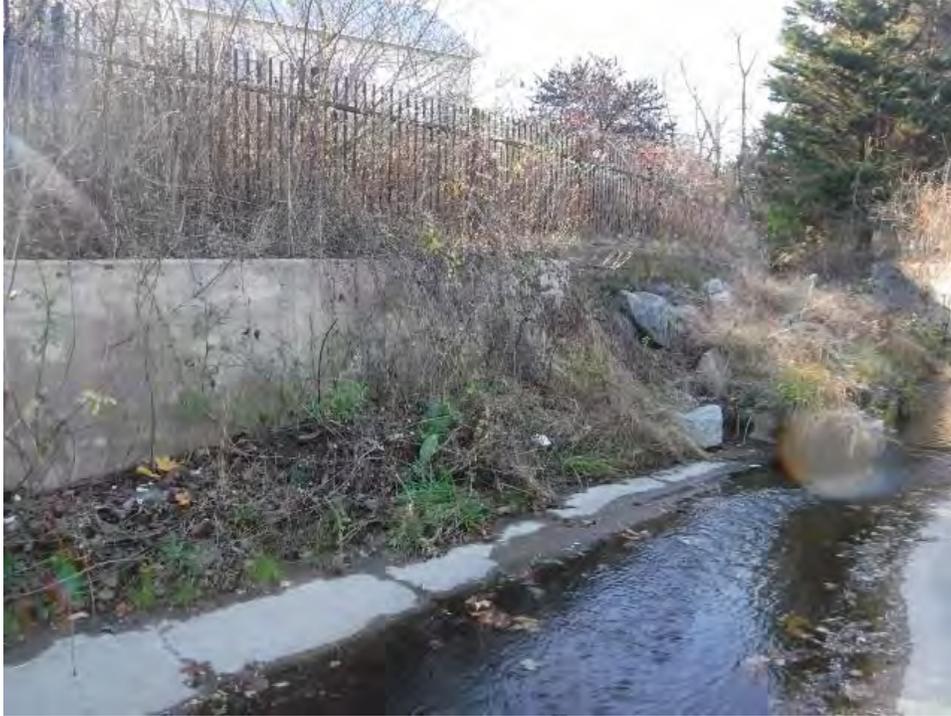
*Photo 3 – West End of Section 2, Looking Southwest.  
Note Vegetation Growth and Natural Stone.*

**VEGETATION REMOVAL** (Designated as "V") - This item includes the removal of vegetation growth, including mature trees, from the vicinity of the retaining walls. These repairs should be completed as funds become available; however, vegetation will continue to impact the retaining walls until removed.

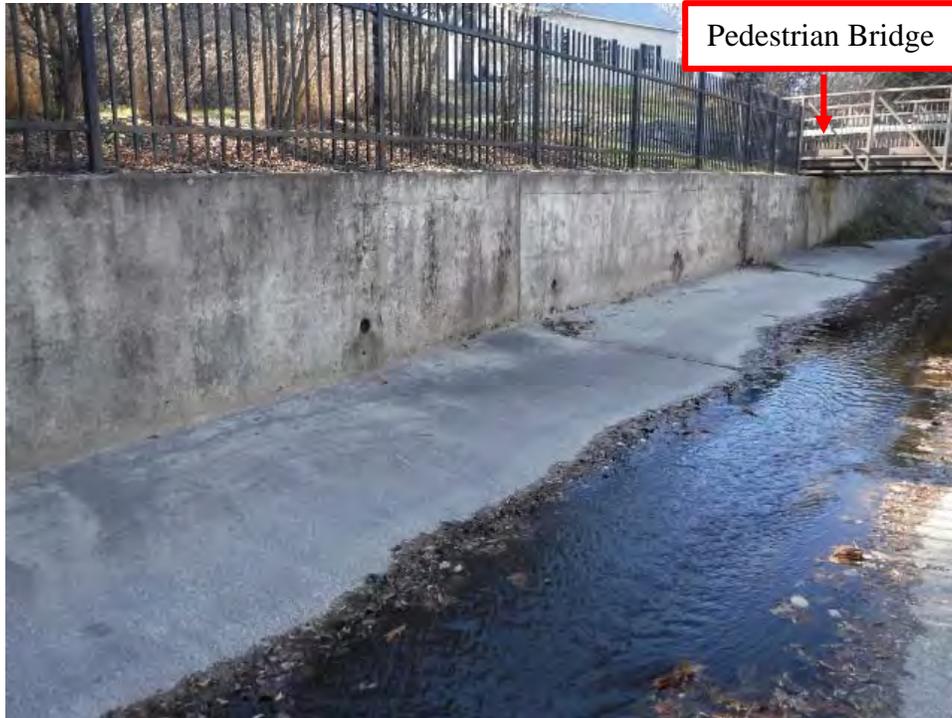
*Photo 4 – Section 2, Looking Southwest towards Pedestrian Bridge.*

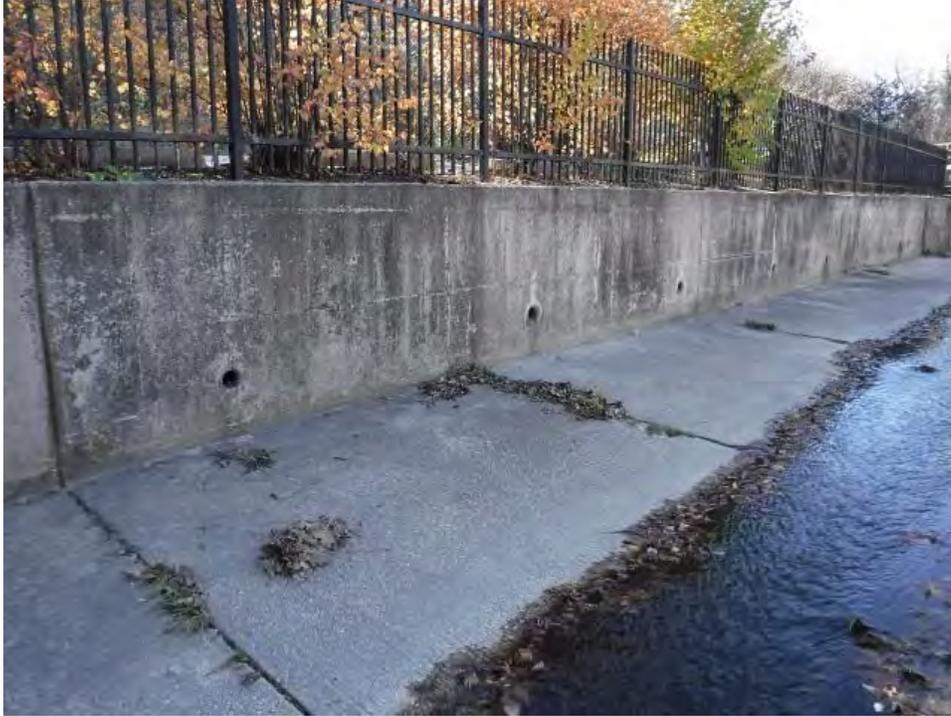
*Photo 5 – Section 2, Looking Southwest*

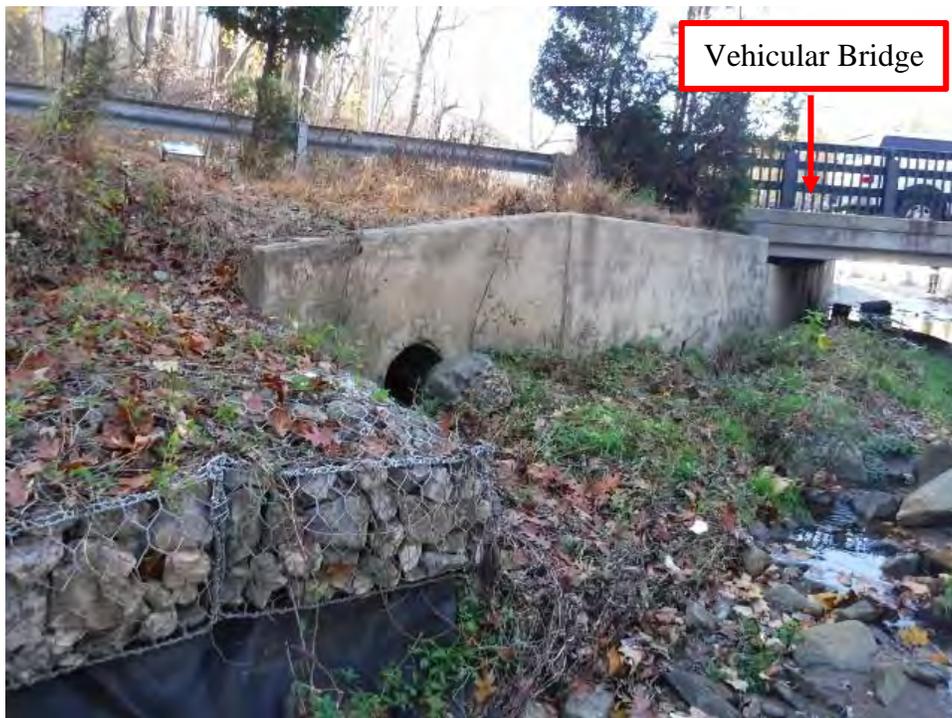
Section 3 extends from 400' to 578' from the west end of the wall. The retaining wall is missing in this portion (see Photo 6).

*Photo 6 – East End of Section 2, Looking Southwest.  
Note Missing Retaining Wall in Section 3 to East.*

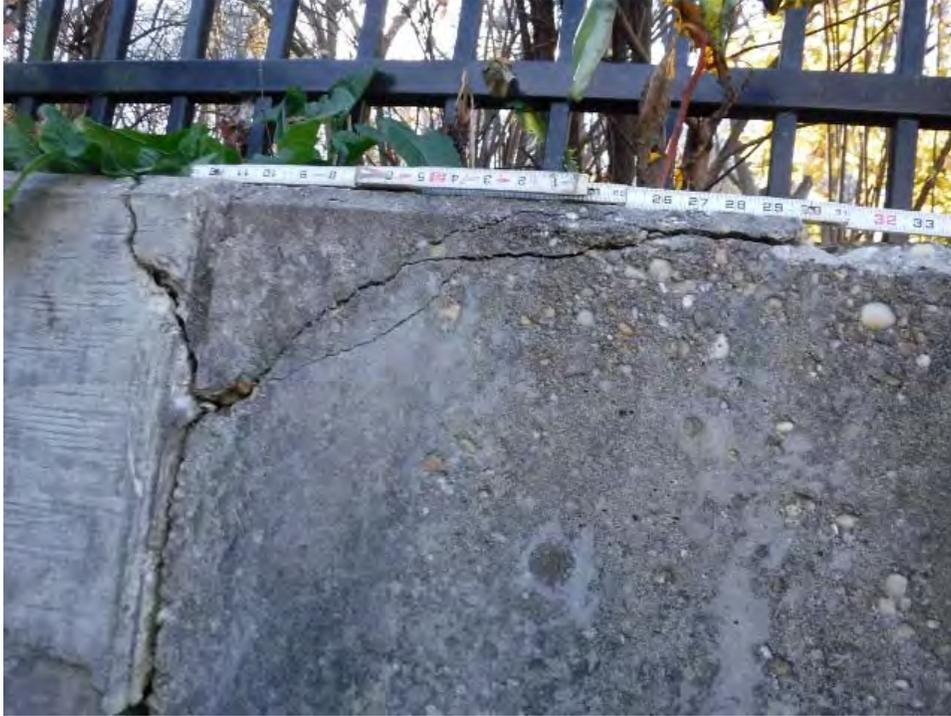
Section 2 extends from 163' to 400' from the west end of the wall. This portion of the wall is comprised of concrete. There are typically hairline vertical cracks extending from the drain pipes. There is a pedestrian bridge over the wall at 183' from the west end. Adjacent to west side of the pedestrian bridge, there is vegetation growth and riprap in front of the concrete retaining wall (see Photo 3). There is a vehicular bridge over the wall at 322' from the west end (see Photo 6). At the first wall joint west of the vehicular bridge, the top of the wall has a 1'-7" wide x 6" high area of delamination (see Photo 7).

*Photo 7 – Section 2, Cracking and Delamination at Top of Wall at 1<sup>st</sup> Joint West of Vehicular Bridge.*

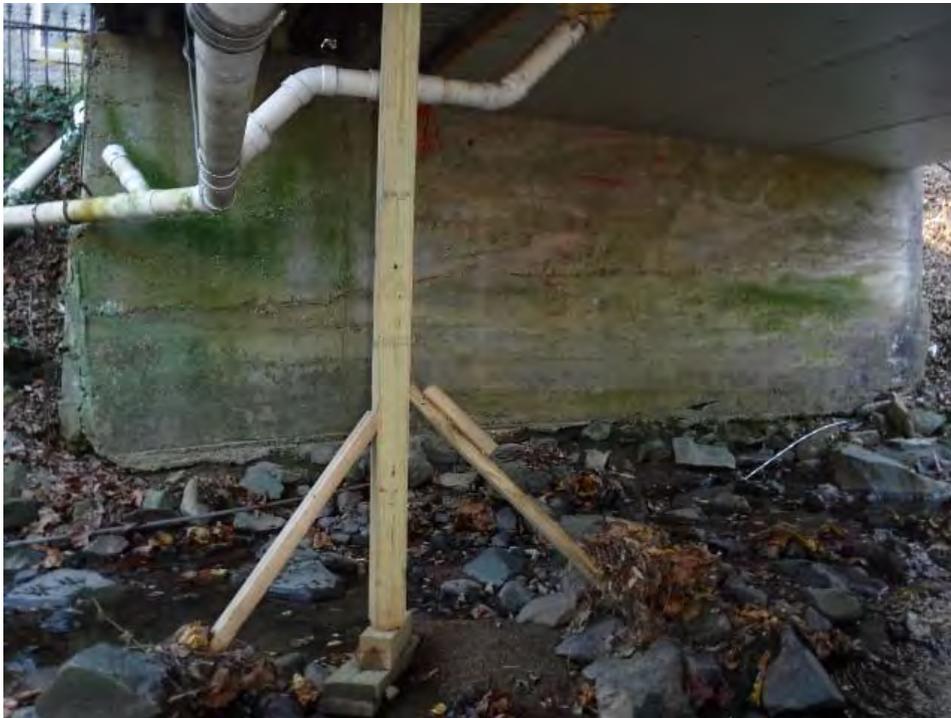
Section 4 extends from 578' to 603' from the west end of the wall. This section consists of a 20' wide concrete abutment for a house which spans the stream channel (see Photo 8). There is undermining at the west end of the abutment, 1'-4" long x 3" high x 5" deep (see Photo 9). Behind the west end, there is an erosion hole 3'-0" long x 1'-4" high x 2'-0" deep, causing undermining of the abutment wingwall (see Photo 10). There is a fracture and undermining at the east end of the abutment, 1'-0" wide x 9" high x 8" deep (see Photo 11).

*Photo 8 – Section 4, House Abutment, Looking South.*

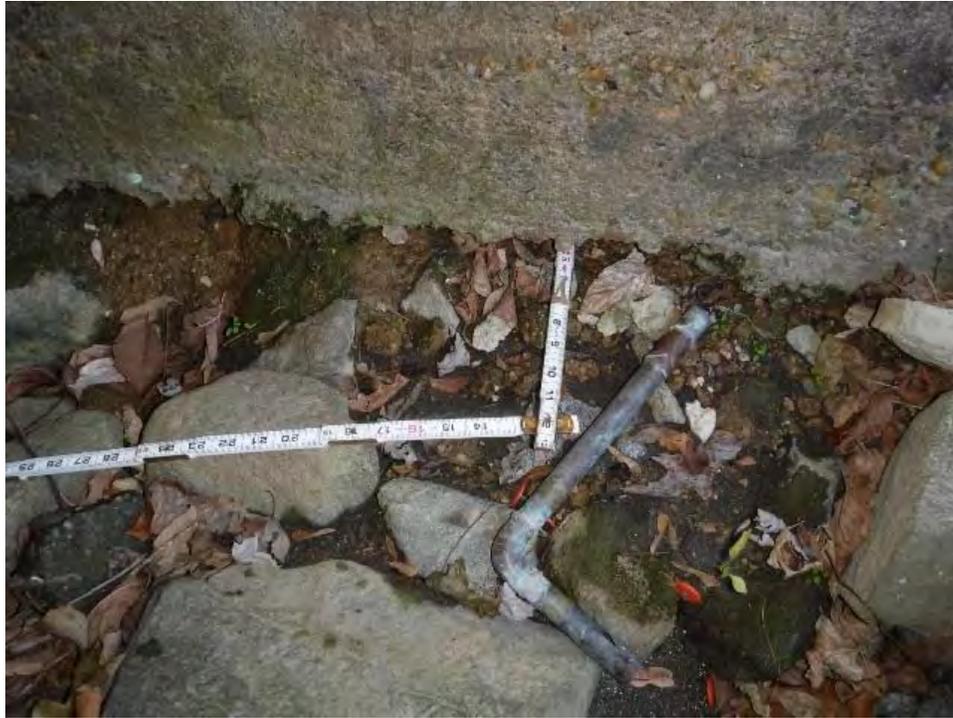
*Photo 9 – Undermining at West End of Section 4 House Abutment.*

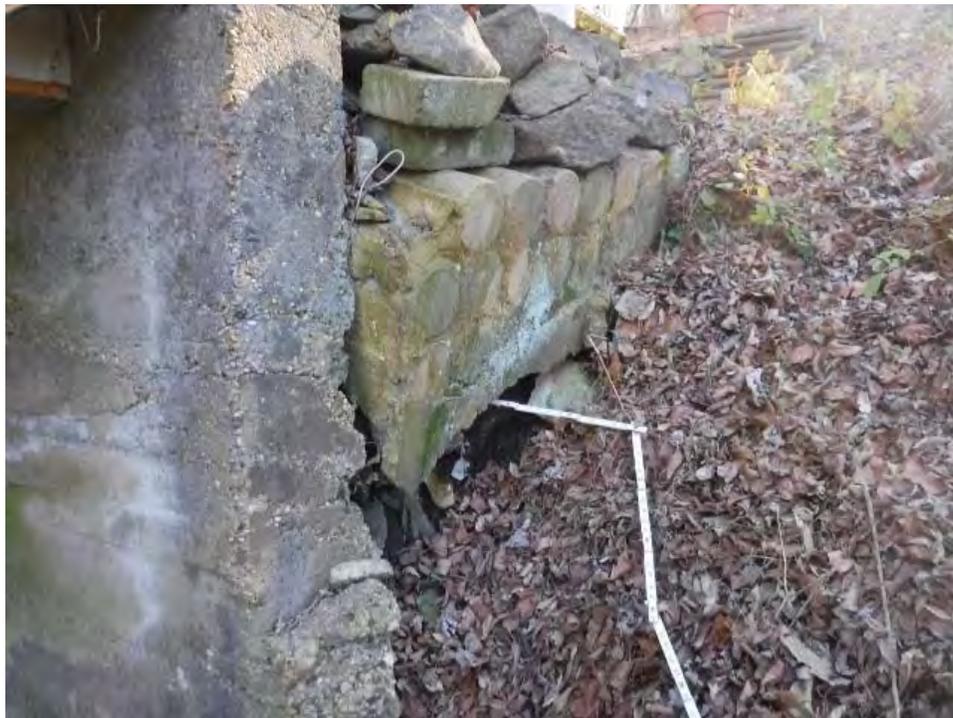
*Photo 10 – Undermining at Southwest Wingwall of House Abutment in Section 4, Looking Southeast.*

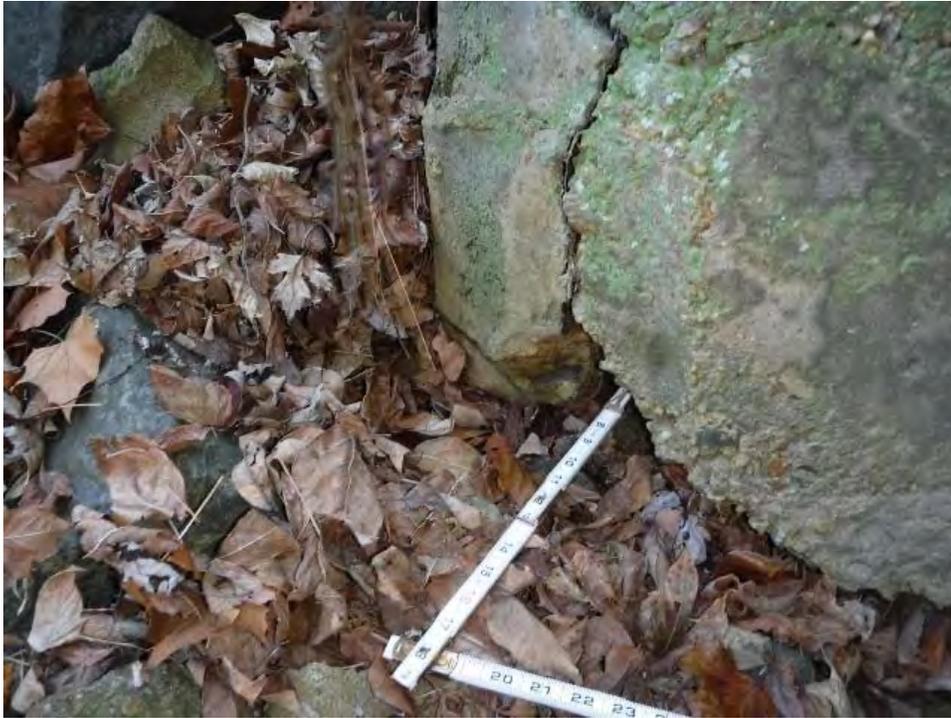
*Photo 11 – Fracture and Undermining at Lower East Corner of Section 4 House Abutment.*

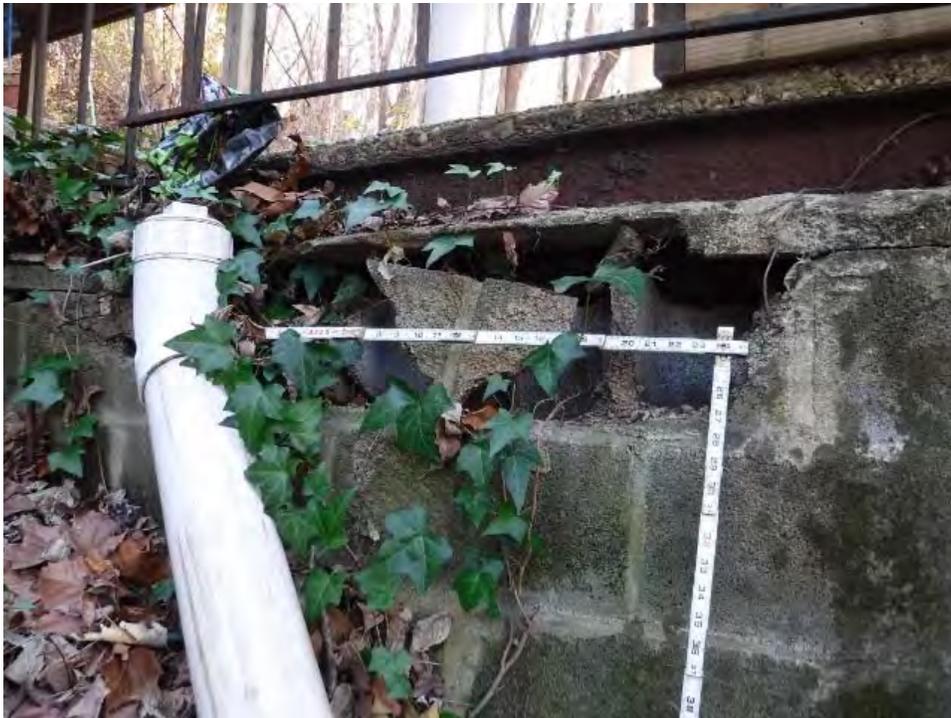
Section 5 extends from 603' to 630' from the west end of the wall and runs behind several private properties. The wall is comprised of concrete blocks from 603' to 609' from the west end. There is a broken block at the top of the wall with a void 3'-0" long x 10" high (see Photo 12). To the east of the concrete block, the wall is comprised of stone masonry which is covered with vegetation growth (see Photo 13). The joints have missing mortar and the wall leans slightly toward the stream channel. Along the bottom of the wall, there is a 21'-0" long x 1'-2" high gap due to missing stones which exhibits undermining up to 1'-0" deep. The soil behind the top of the wall is soft in this area.

*Photo 12 – Broken Concrete Block at Top of Wall in Section 5.*

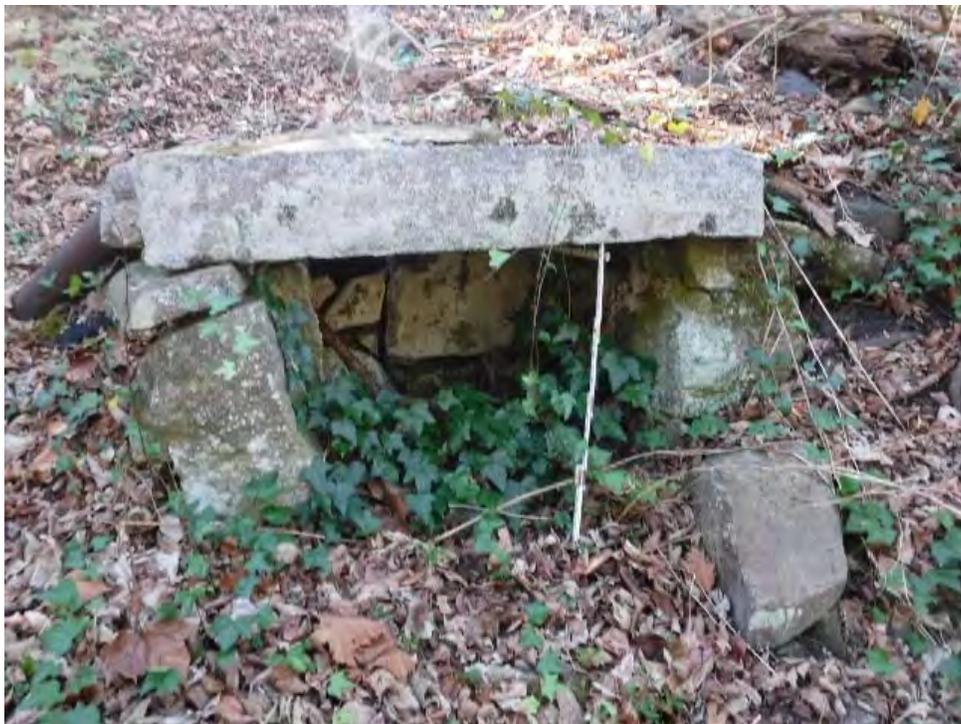
Section 6 extends from 630' to 702' from the west end of the wall. The retaining wall is mostly missing in this portion. There is an old spring house remaining (see Photo 14), and a collapsed portion of wall adjacent to a pedestrian bridge (see Photo 15).

*Photo 14 – Abandoned Spring House in Section 6,  
52' West of the Pedestrian Bridge.*

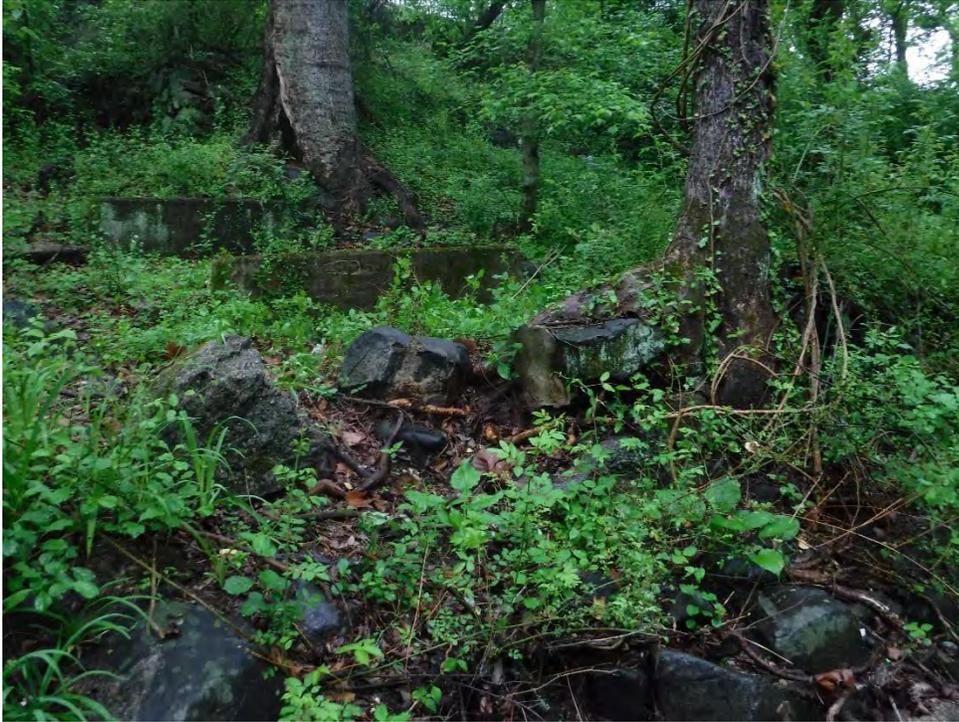
*Photo 1 – Concrete Walls in Section 1, Looking North.*

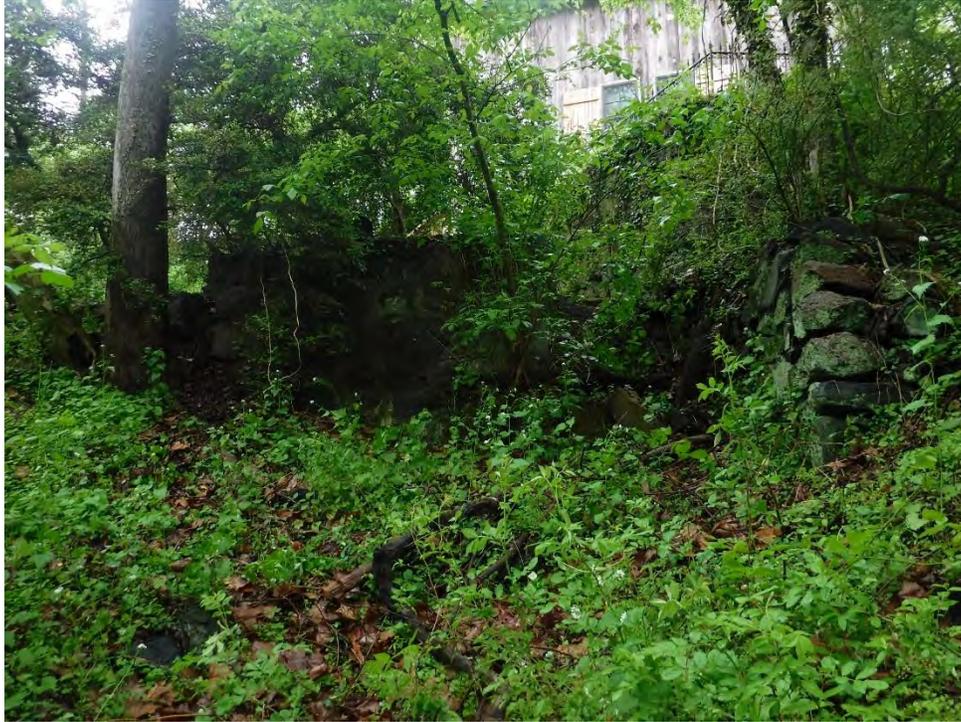
*Photo 3 – Stone Masonry Wall in Section 1, Looking North.*

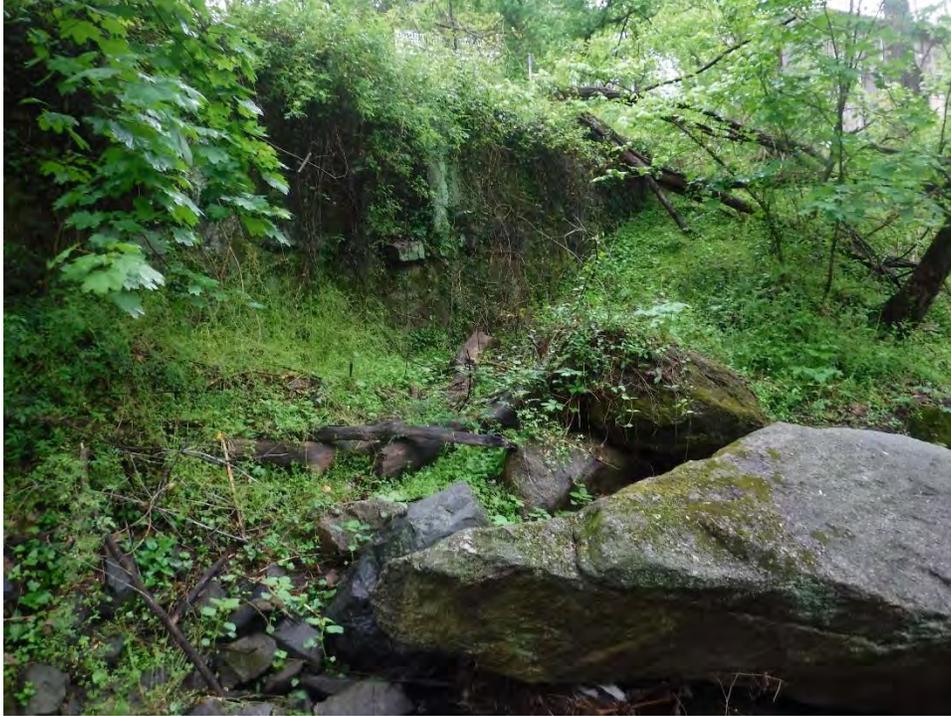
*Photo 5 – East End of Section 2, Looking Northeast.  
Note Heavy Vegetation Growth*

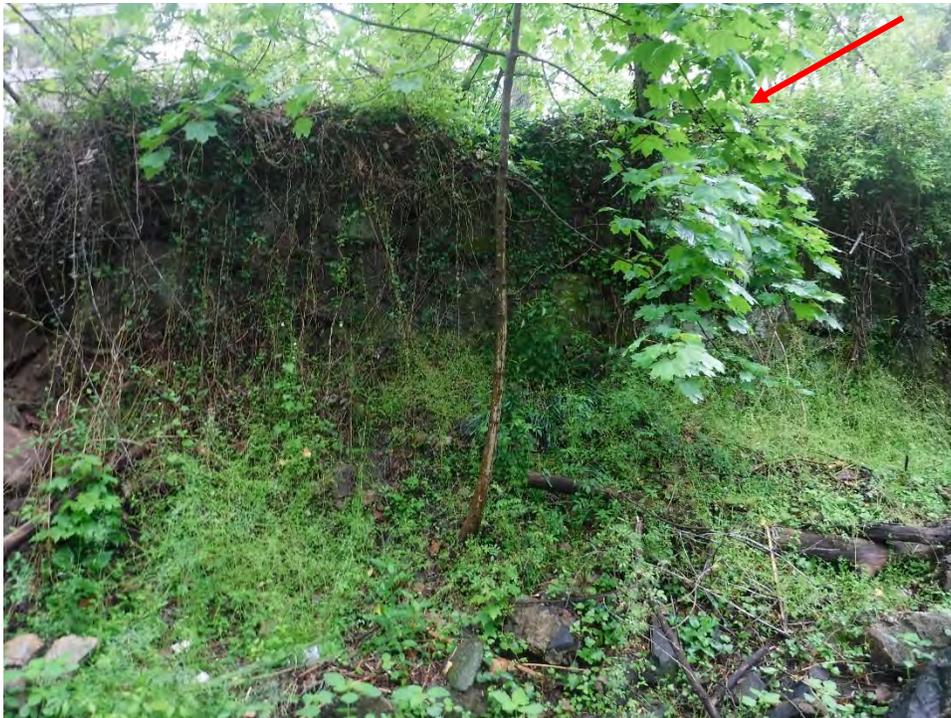
*Photo 6 – Heavy Vegetation and Tree Growth in Section 2, Looking North.*

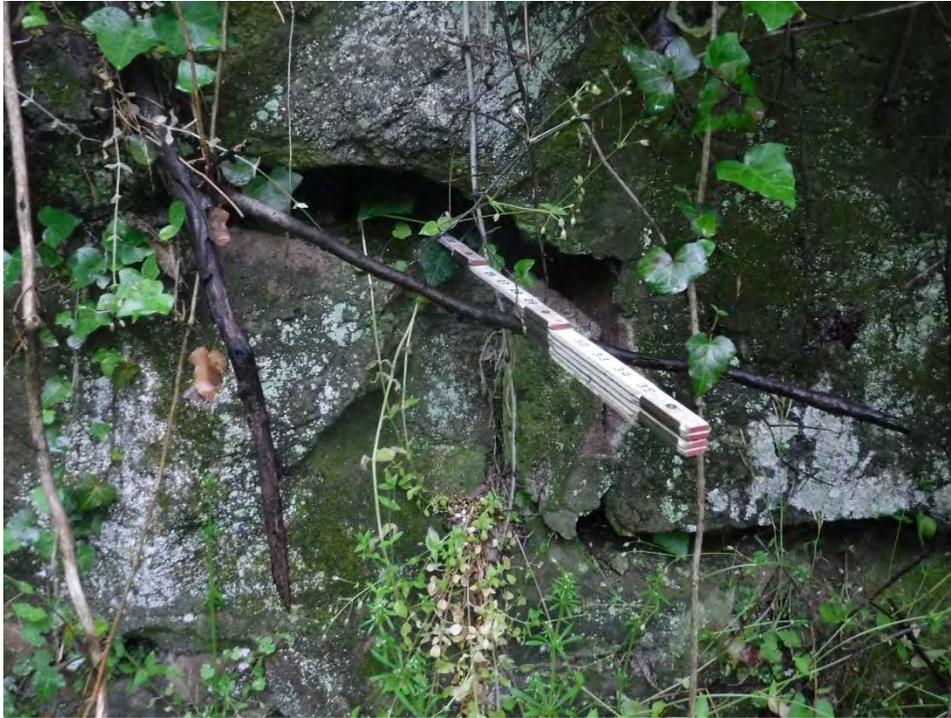
*Photo 7 – Typical Missing Mortar and Small Voids in Section 2.*

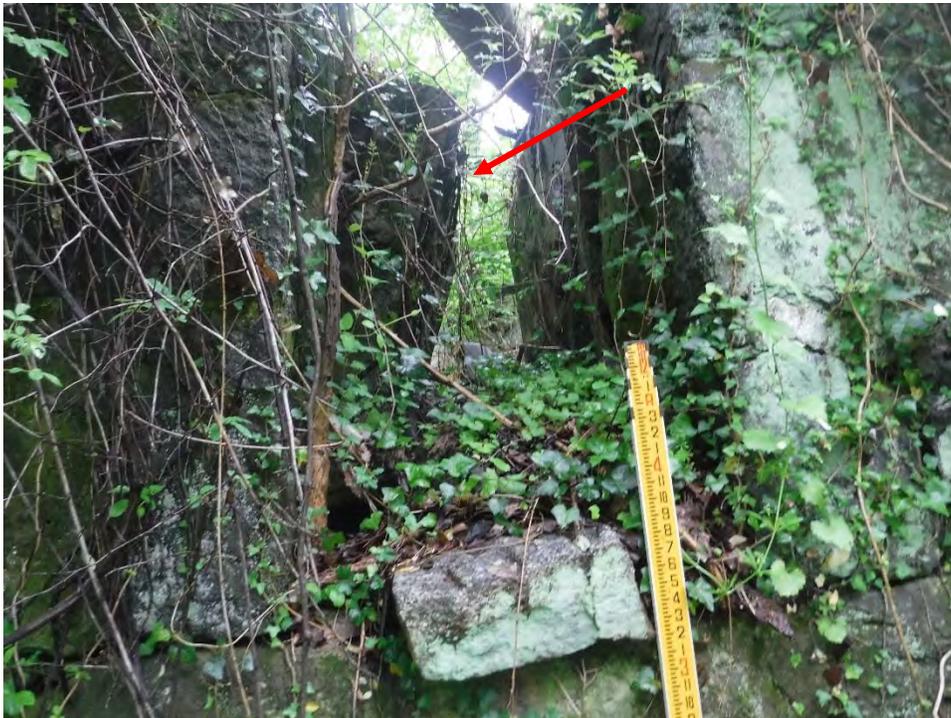
*Photo 8 – West Wall of Drainage Channel Leaning to the East and Loose/Displaced Stones at East End of Section 2, Looking North.*

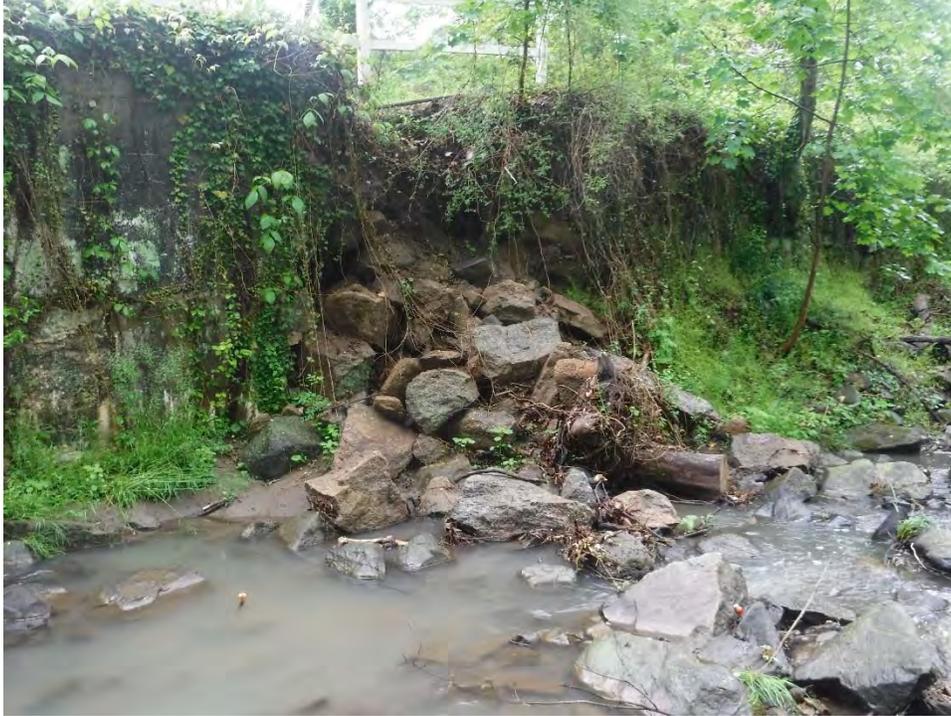
*Photo 9 – Failed Portion of Wall in East Half of Section 2.*

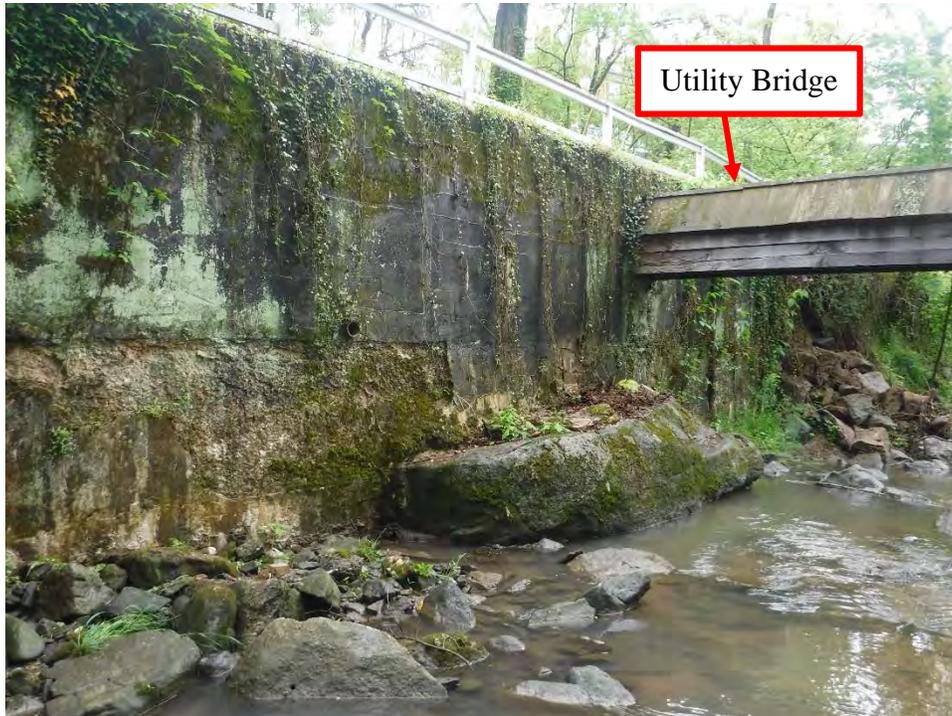
*Photo 10 – Section 2, Looking Northeast. Note Shallow Spalls in Concrete.*

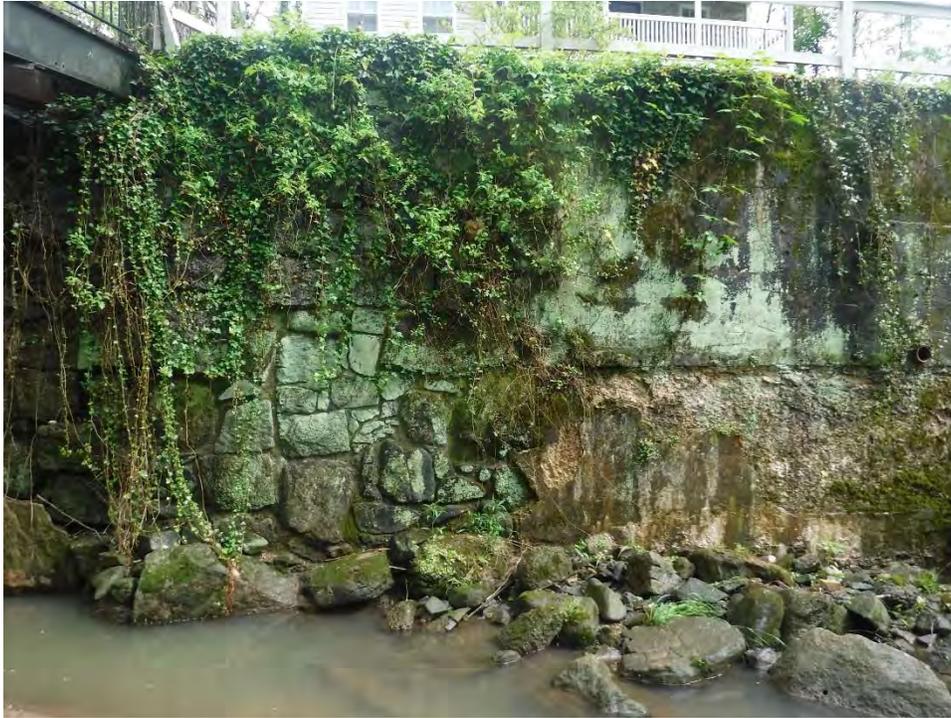
*Photo 11 – Section 2, Looking Northeast. Note Shallow Spalls in Concrete.*

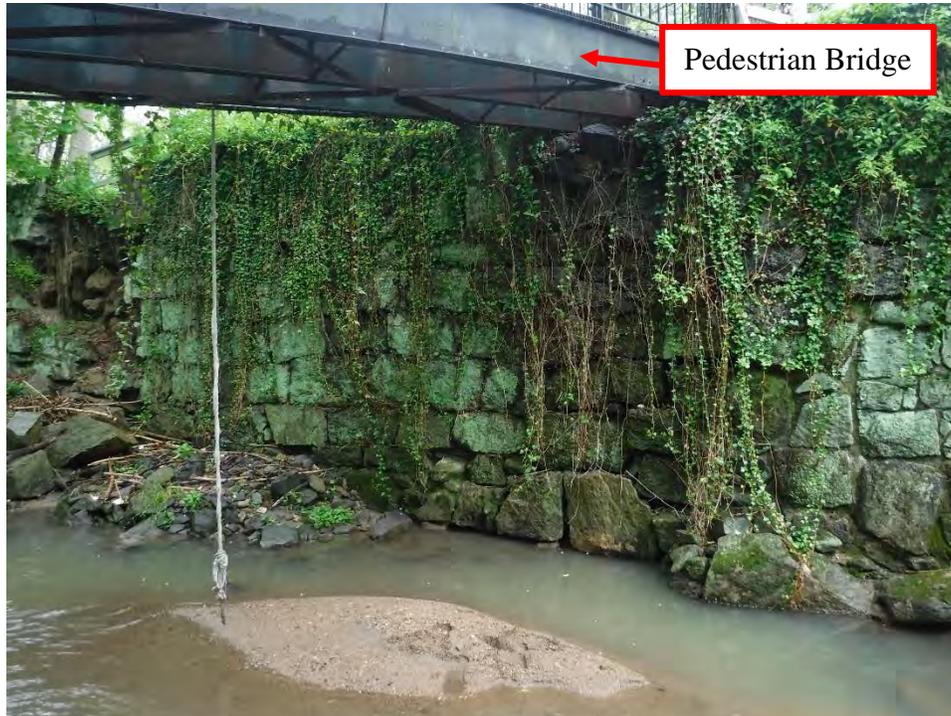
*Photo 12 – Undermining of Wall under Pedestrian Bridge and Typical Missing Mortar and Small Voids in Section 2, Looking Northwest.*

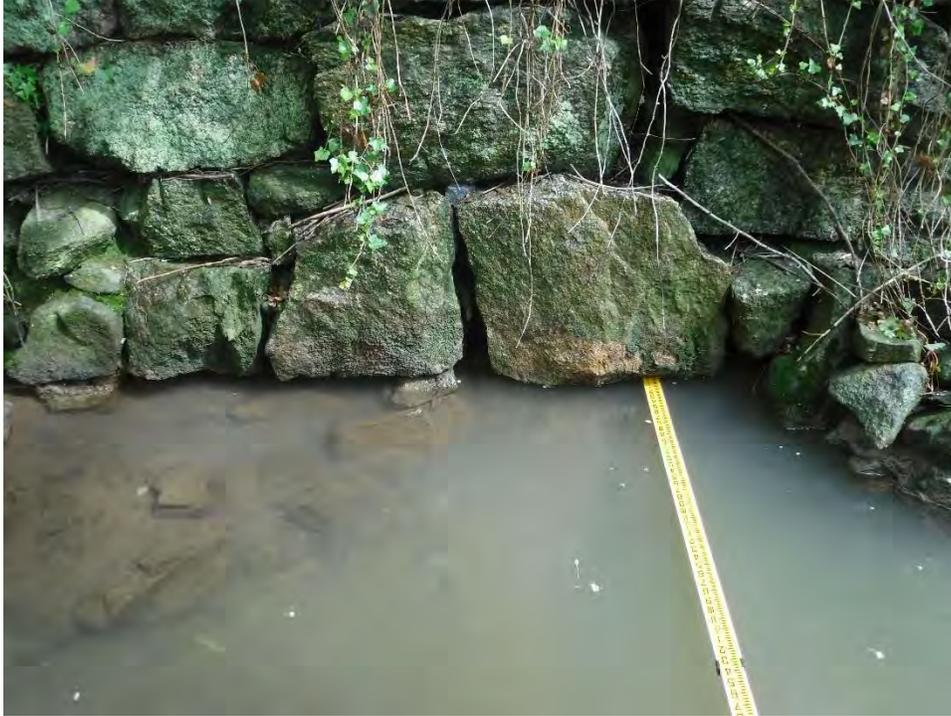
*Photo 13 – Undermining of Wall under Pedestrian Bridge in Section 2, Looking North.*

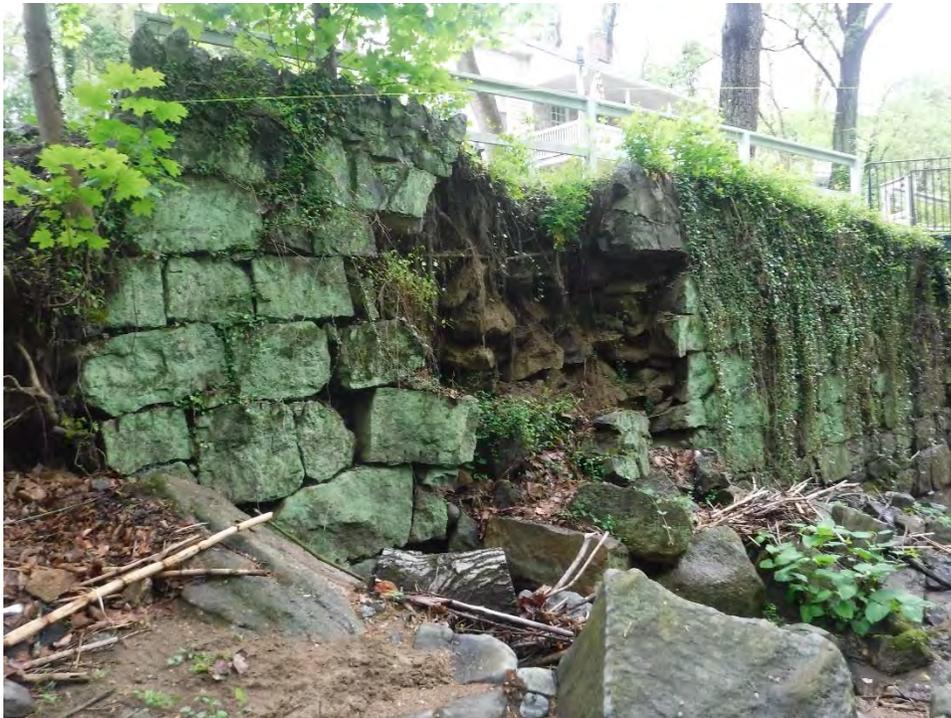
*Photo 14 – Failed Wall and Missing Mortar at West End of Section 2.*

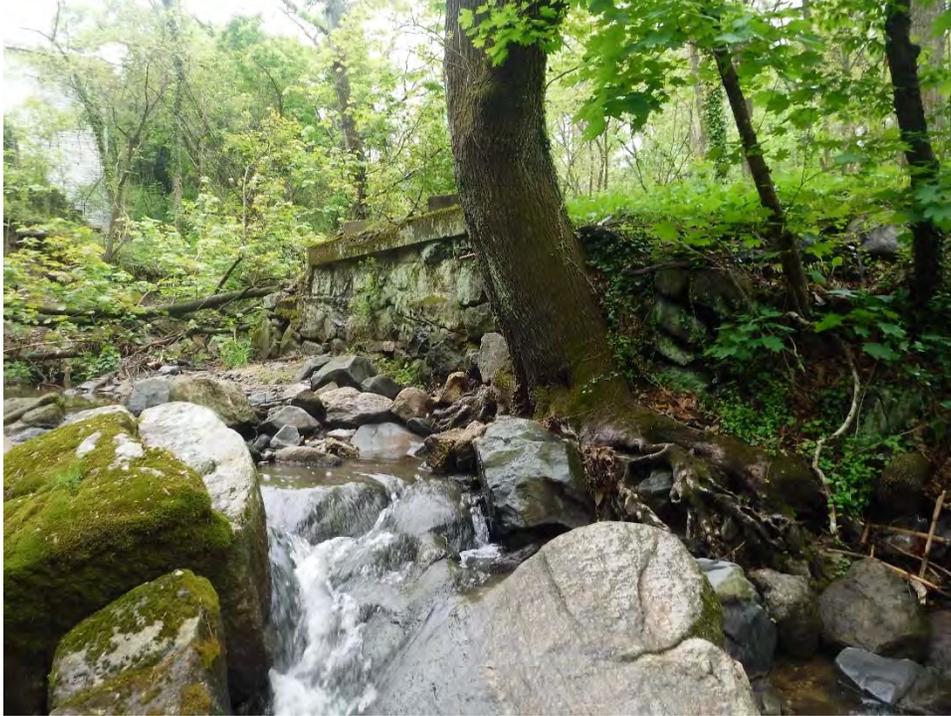
*Photo 15 – Buried/Failed Wall and Large Tree in Section 3, Looking Northwest.*

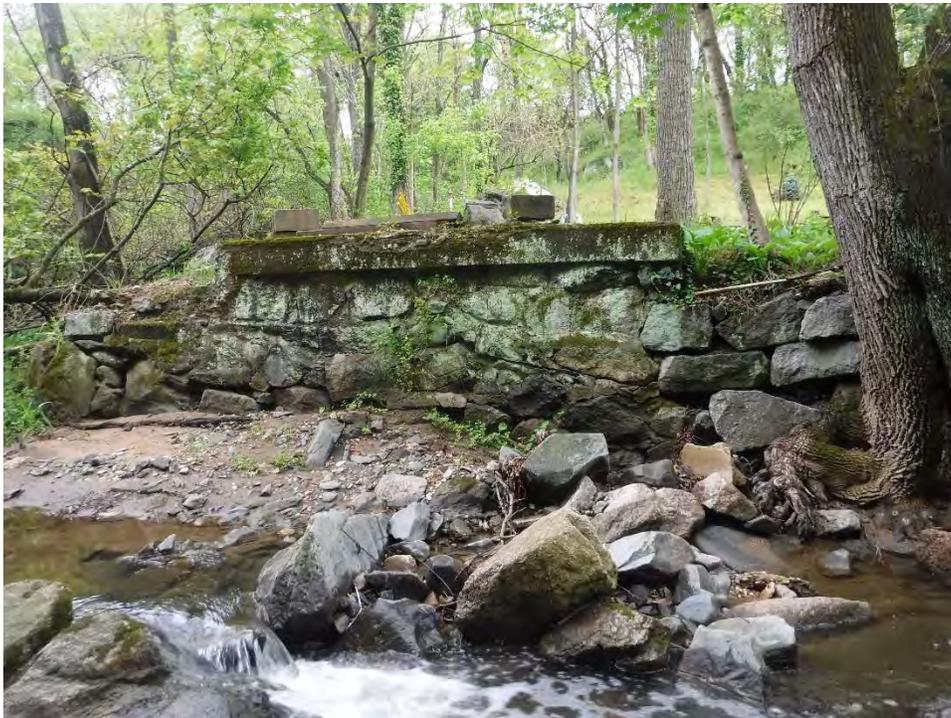
0" long stone masonry wall with a concrete cap starting 36' from the east end of the section, with approximately 30% of the mortar missing, mostly along the bottom 1'-0" (see Photo 16). At the east end of the wall, there is a 2'-6" diameter tree, a full height x 4'-0" wide area with no mortar remaining, and small voids, displaced stones, and open joints that can be probed up to 1'-6" deep (see Photo 17).

*Photo 16 – Missing Mortar and Small Voids in Section 3.*

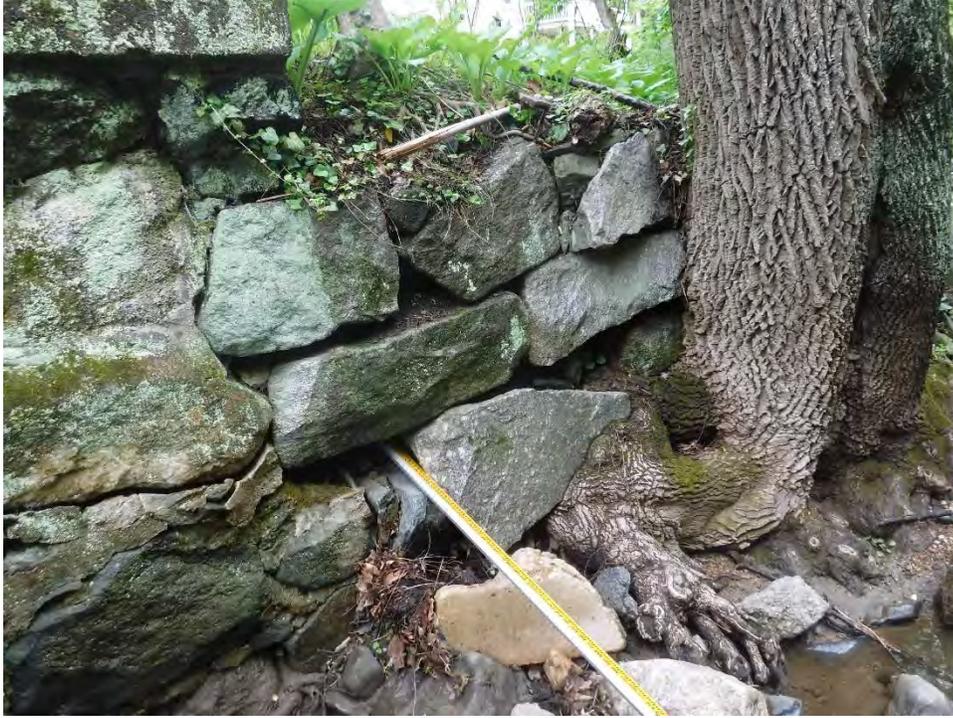
*Photo 17 – Missing Mortar, Small Voids, and Displaced Stones at East End of Wall in Section 3.*
