# ELLICOTT CITY RETAINING WALLS INSPECTION REPORT

## STREAM WALLS

## HISTORIC ELLICOTT CITY, MARYLAND

MAY 2016

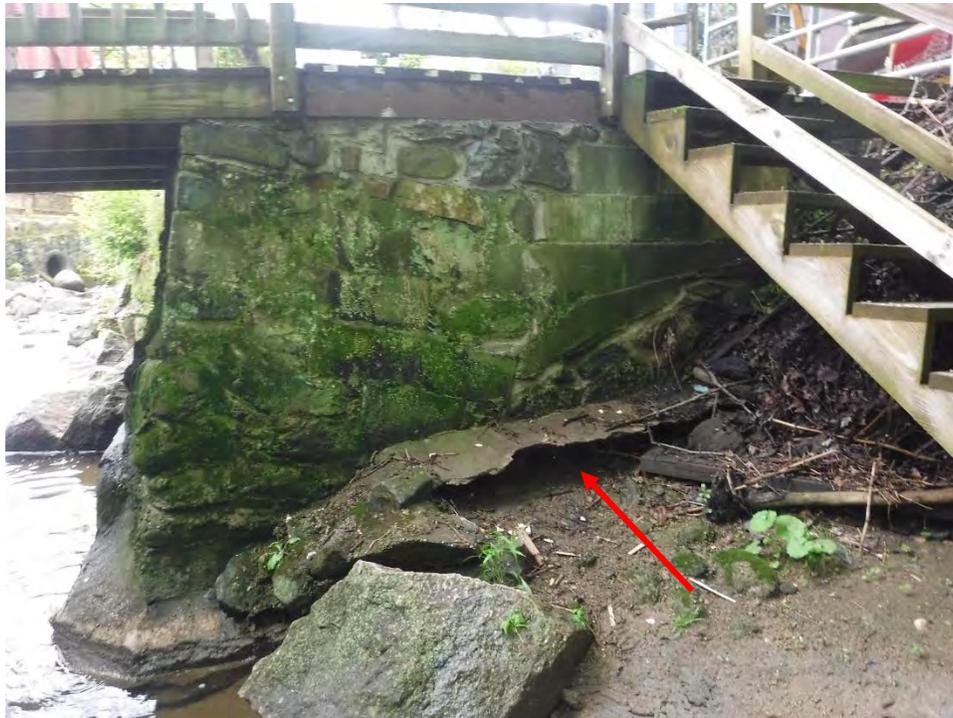
Section 4 extends from 795' to 902' from the east end and is comprised of mostly stone masonry (see Photos 18 through 22). There is typically missing mortar, random loose/displaced stones, and joints that can be probed up to 2'-0" deep along the top and bottom 2'-0". There is heavy vegetation growth along the top of the wall. At the east end of the section, there is a 4'-0" long x 1'-0" high x 1'-0" deep area of undermining (see Photo 18). Starting 31'-0" from the east end of the section, there is a full height x 10'-0" wide area of displaced stones (see Photo 23). There is a 8'-0" long x 3'-0" high area of stones along the bottom of the wall that are displaced up to 6" to the south, in the center of Section 4 (see Photo 24). Starting 35'-0" from the west end of the section, there is a full height x 18'-0" wide area with 90% of the mortar missing, small voids, and joints that can be probed up to 1'-6" deep (see Photo 21). Near the west end of the section, there is a 4'-0" long x 1'-0" high x 1'-0" deep area of undermining (see Photo 25).

*Photo 18 – East End of Section 4, Looking West. Note Undermining.*

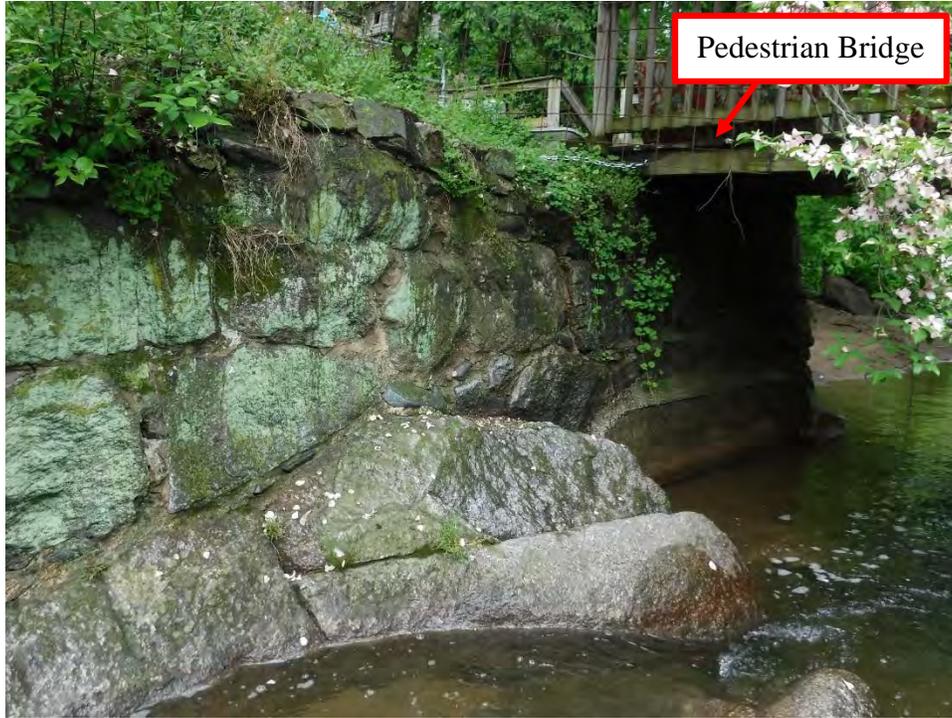
*Photo 19 – Vegetation Growth along Top of Section 4, Looking Northeast.*

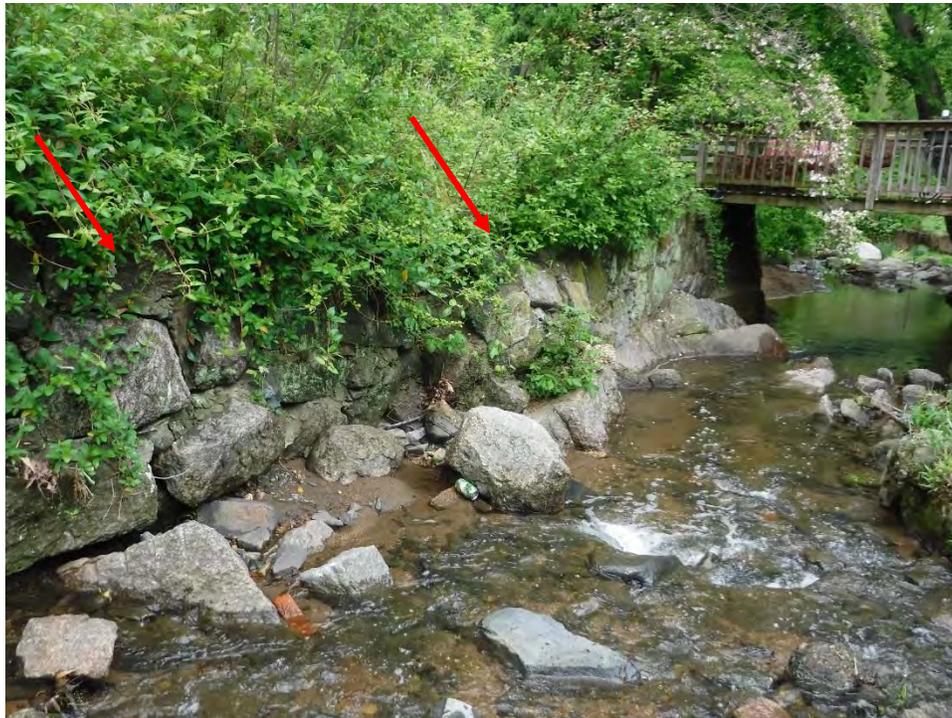
*Photo 20 – Areas of Bulging and Displaced Stones in Section 4, Looking Northeast.*

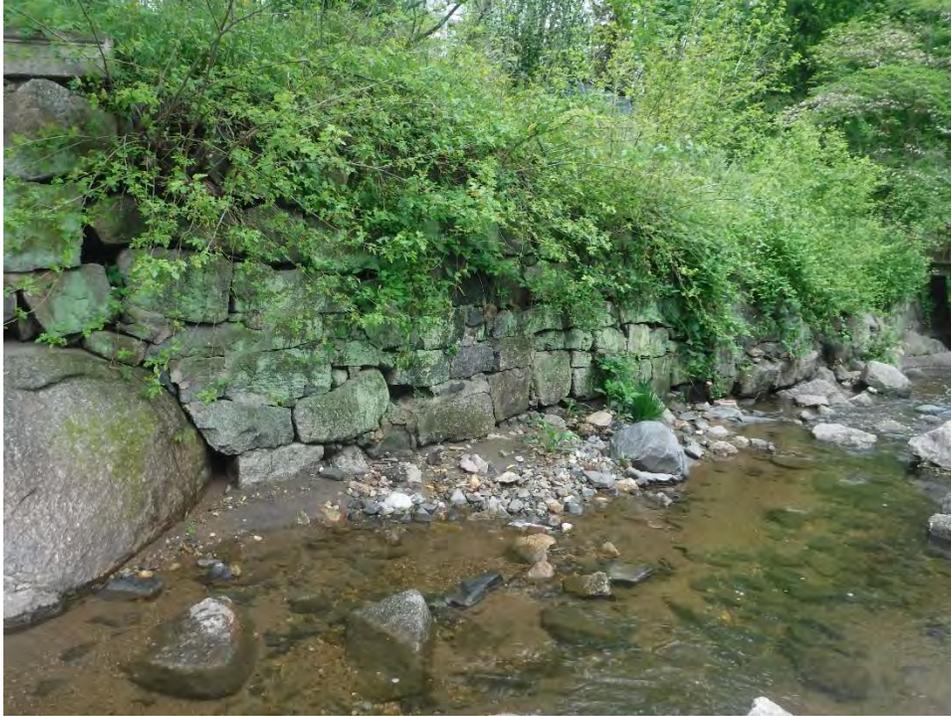
*Photo 21 – Missing Mortar and Vegetation Growth in Section 4,  
Looking Northeast.*

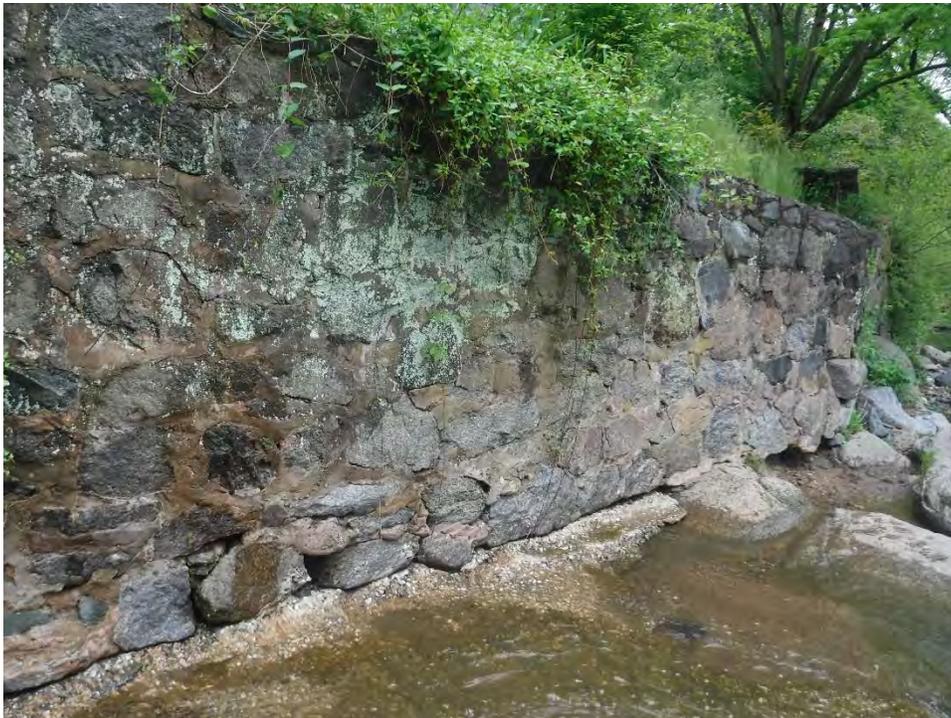
*Photo 22 – Missing Mortar along the Bottom of Section 4, Looking Northeast.*

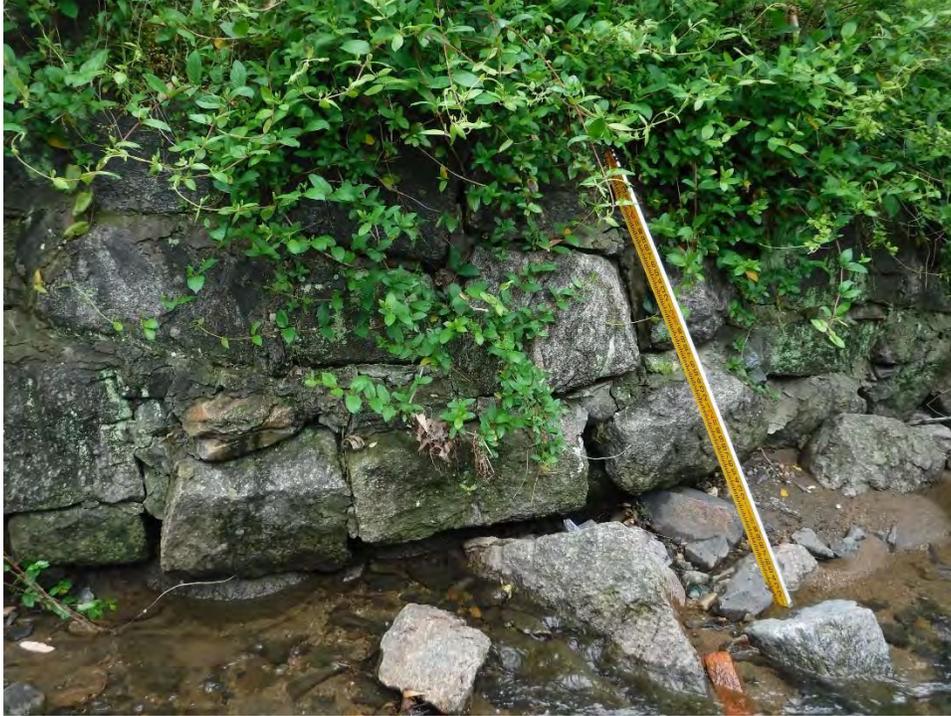
*Photo 23 –Displaced Stones in Section 4, Looking Northeast.*

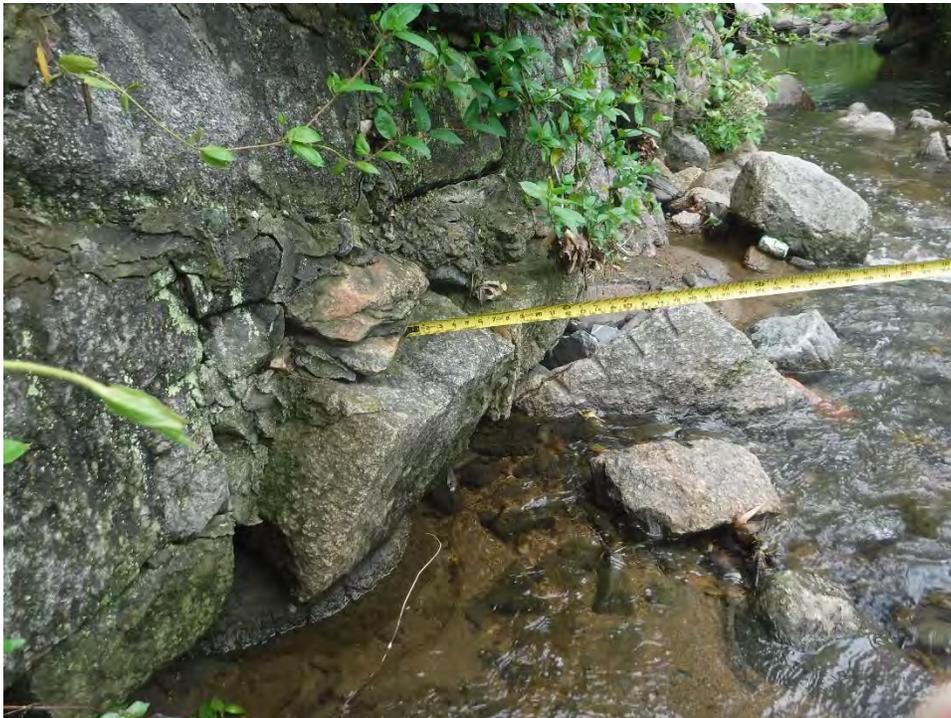
*Photo 24 –Displaced Stones at Base of Wall near Center of Section 4, Looking Northeast.*

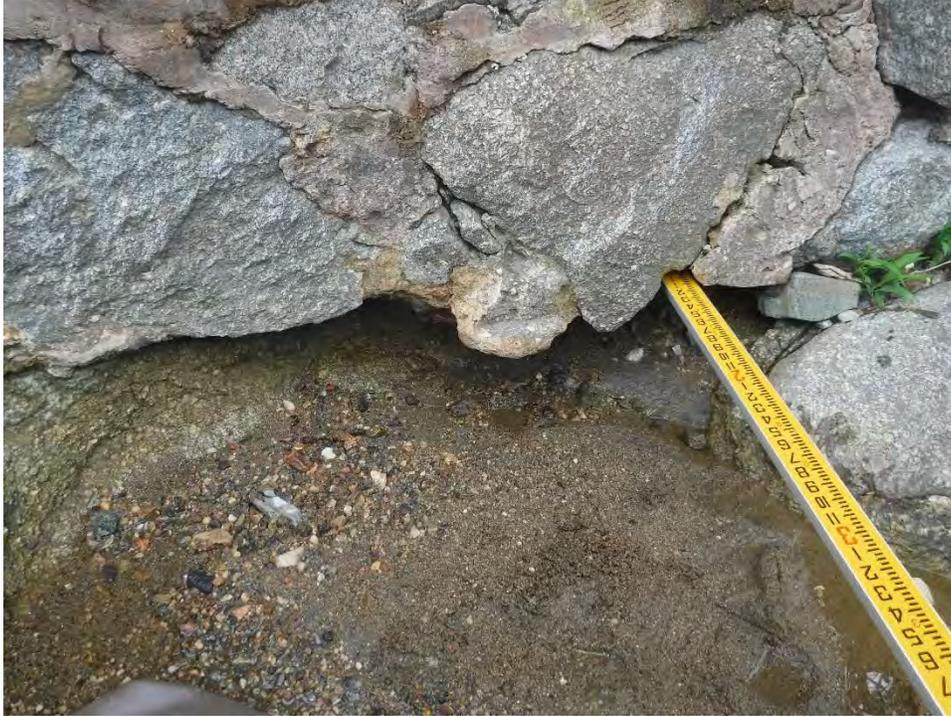
*Photo 25 – Undermining near West End of Section 4, Looking North.*

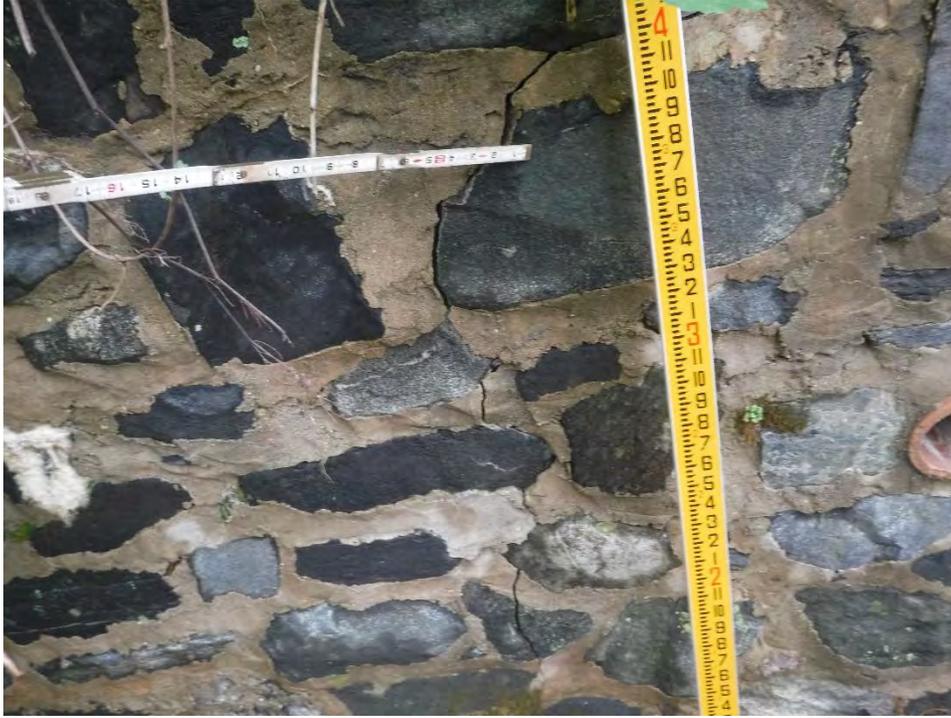
*Photo 29 – Crack in Stone Masonry Wall in Section 5, Looking North.*

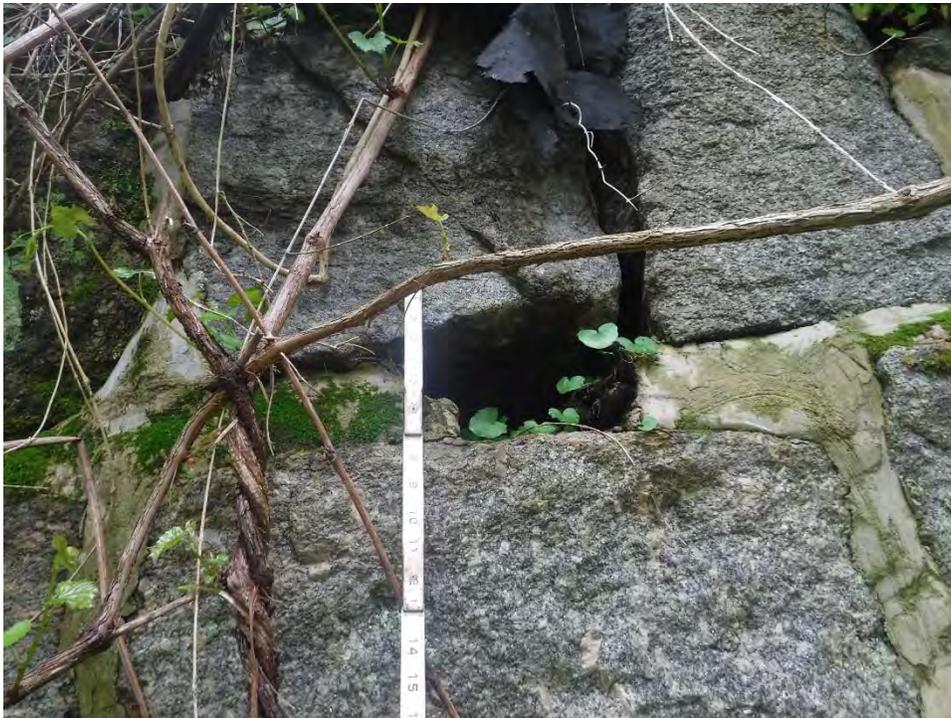
Section 5 extends from 902' to 1,145' from the east end. There is a 78' long stone masonry wall at the west end, with vegetation/bamboo growing along the top (see Photos 26 through 28). In the east half of the wall, there is hairline map cracking throughout the mortar with random areas of moderate efflorescence. There is a vertical full height x ¼" wide crack near the center of the stone masonry wall (see Photo 29). In the west half of the wall, there is minor to moderate scaling, up to 2" deep, along the concrete footing. Starting 27'-0" from the west end, there is an 11'-0" long x 1'-0" high area of loose stones along the top of the wall. There is a 10" long x 6" high x up to 1'-6" deep void in the top west end of the stone masonry wall (see Photo 30).

*Photo 30 – Void at West End of the Stone Masonry Wall in Section 5, Looking East.*

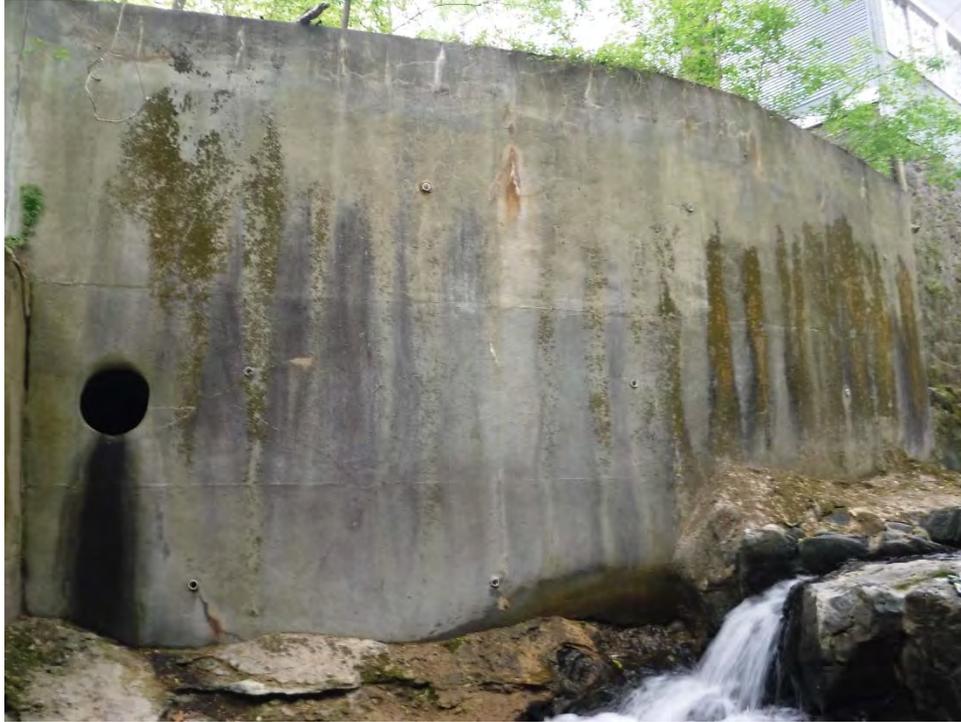
Overall, the wall is in fair condition. Section 1 (eastern 35') is comprised of reinforced concrete and has hairline map cracking with minor efflorescence in random areas and along the top 1'-0" (see Photo 1).

*Photo 1 – Section 1, Looking Southwest.*

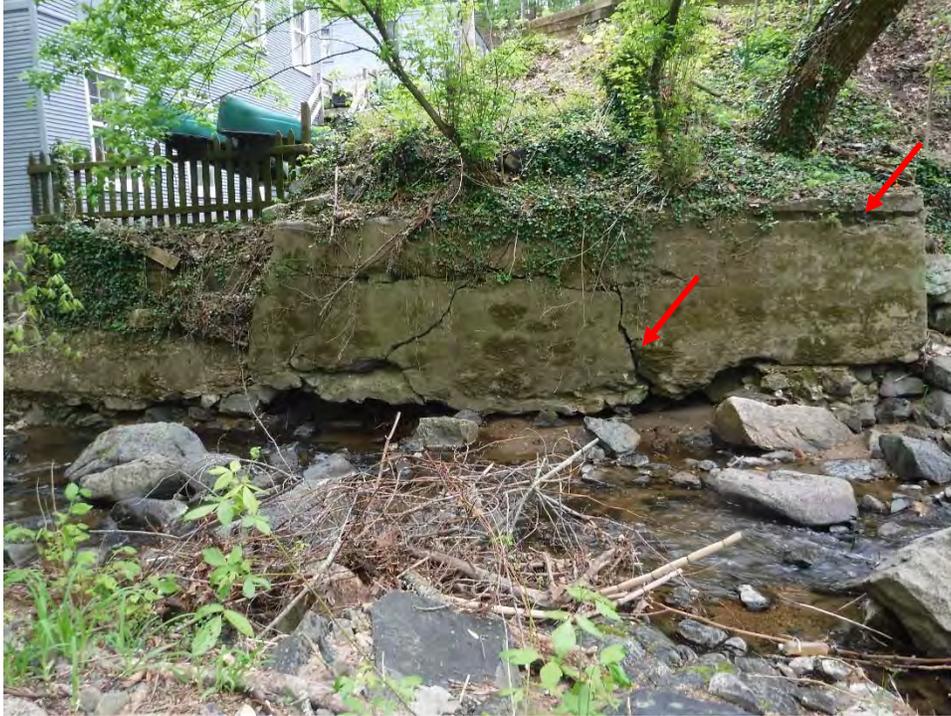
Section 3 extends from 75' to 107' from the east end of the wall and is mostly comprised of concrete covered stone masonry (see Photo 5). The east 10'-0" of Section 3 is comprised of timber in the top half and concrete covered stone masonry in the bottom half. The concrete is typically spalled up to 4" deep throughout 70% of the area. This section is undermined 10'-0" long x 2'-0" high x up to 1'-0" deep with several large stones missing (see Photo 6). There is a 9'-0" long x 2'-0" high area of failed timber wall starting 1'-0" from the east end (see Photo 7).

In the center third of Section 3, there are diagonal and horizontal fractures, up to 2" wide, with small spalls. In the west 22'-0", there are small trees and vegetation growth along the top, a 6'-0" long x 6" high x 6" deep spall at mid-height and a 5'-6" long x 5" high x 4" deep spall near the top west end (see Photo 5). Along the bottom, there is a 2'-6" long x 2'-0" high x up to 10" deep void at the west end, a 6'-6" long x 1'-6" high x up to 1'-6" deep void located 3'-6" from the west end, and an 8'-0" long x 1'-6" high x up to 2'-8" deep void located 14'-0" from the west end (see Photo 8). Behind the west end of the wall, there is a full height x 1'-6" wide area of missing and loose stones with voids that can be probed up to 2'-6" deep.

*Photo 5 – Section 3, Looking South.  
Note Fractures at Center of Wall and Random Spalls.*

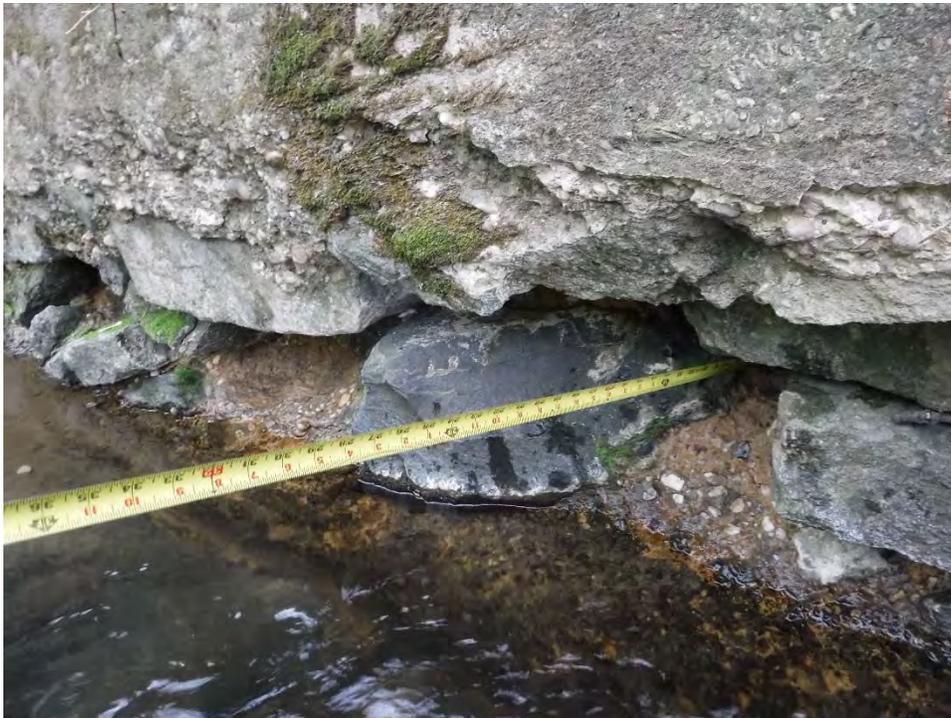
*Photo 6 – Undermining at East End of Section 3, Looking Southeast.*

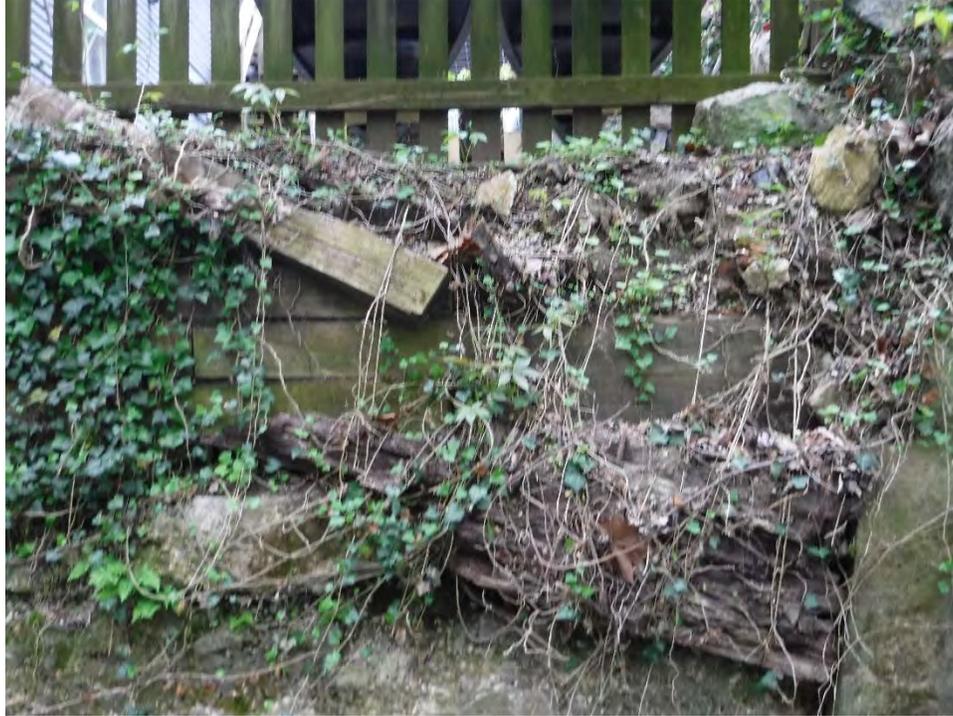
*Photo 7 – Failed Portion of Timber Wall at East End of Section 3,  
Looking South.*

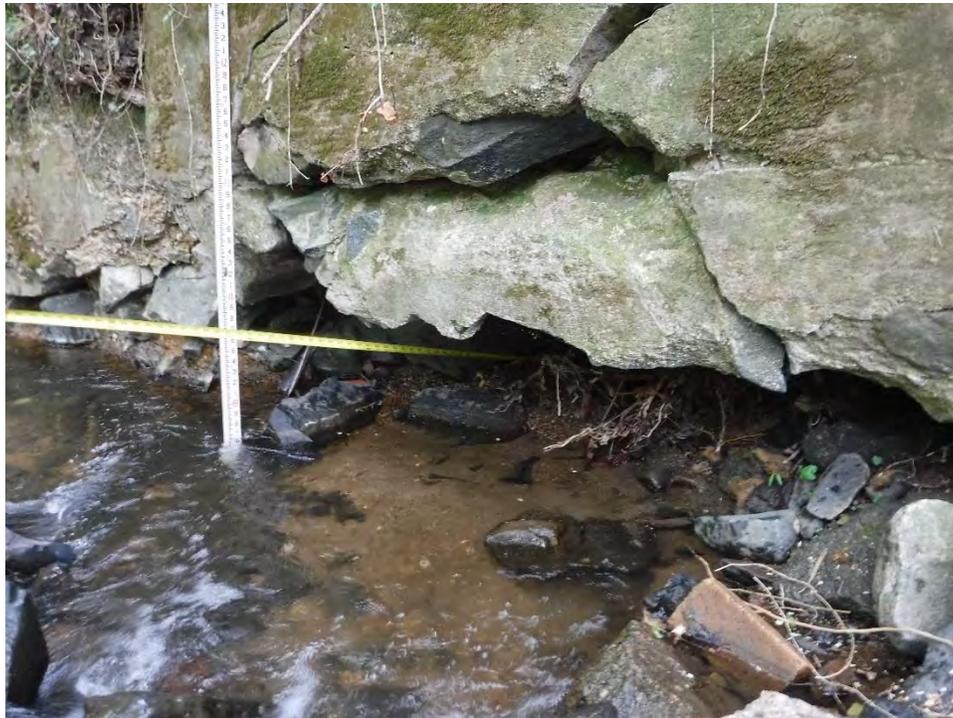
*Photo 8 – Typical Voids along Base of Section 3 Stone Masonry,  
Looking Southeast.*

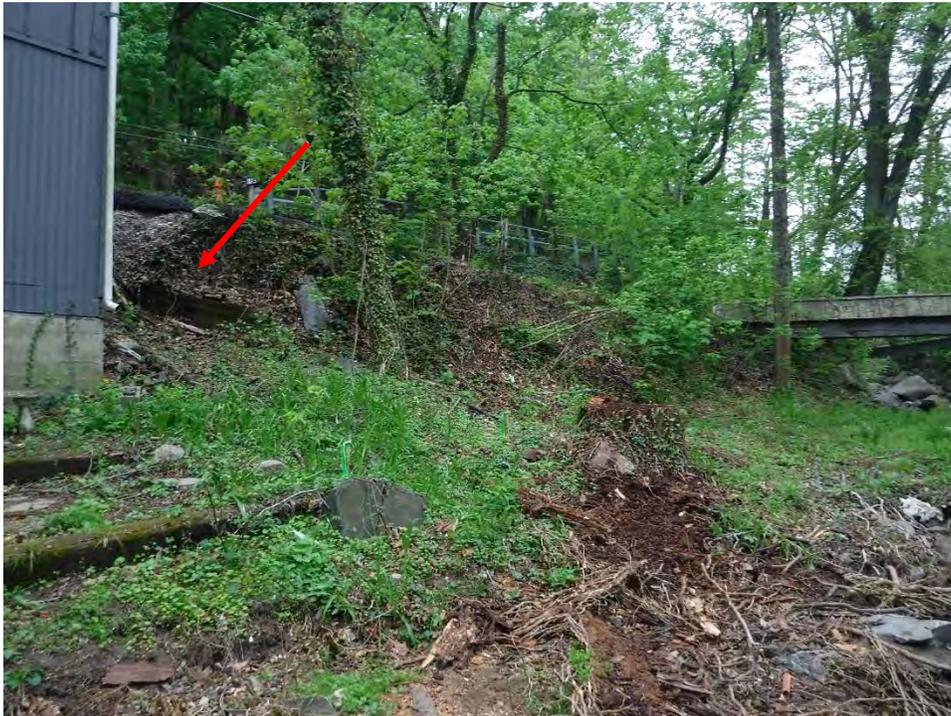
*Photo 10 – Section 4, Looking Southwest.  
Note Failed Timber Wall*

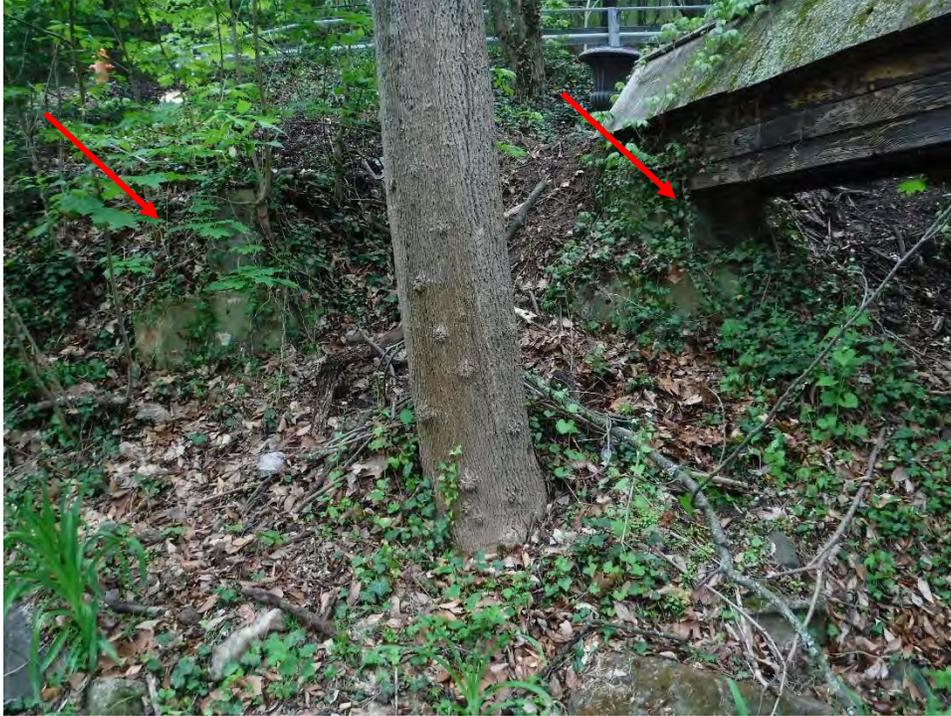
*Photo 11 – Concrete Abutments in Section 4, Looking South.*

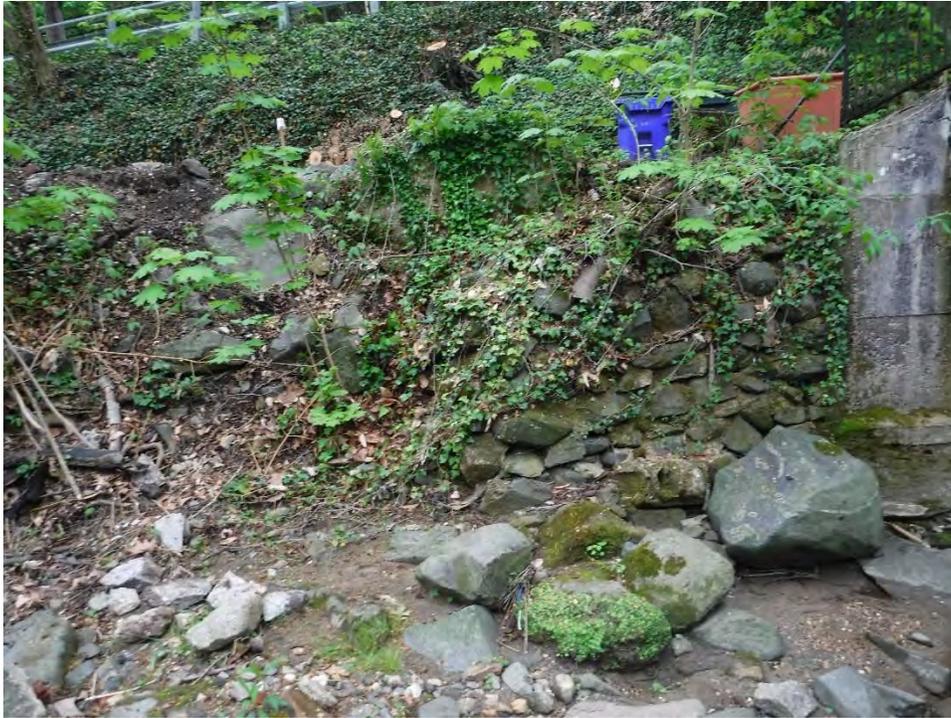
Section 4 extends from 107' to 241' from the east end of the wall. The eastern 128' of Section 4 is comprised of natural stone, the foundation of a private property, and two small concrete abutments; one abandoned, and the other supporting a utility pipe (see Photos 9 through 12). The 10'-0" long timber wall to the west of the private property, located approximately 40' from the streambed, has failed (see Photo 10). The west 6'-0" of Section 4 is comprised of stone masonry, with up to 50% of the mortar missing and random small missing stones, with joints that can be probed up to 10" deep (see Photo 13). The top 2'-6" is failing with minor tree and vegetation growth.

*Photo 13 – West End of Section 4 with Missing Mortar and Random Small Missing Stones, Looking South.*

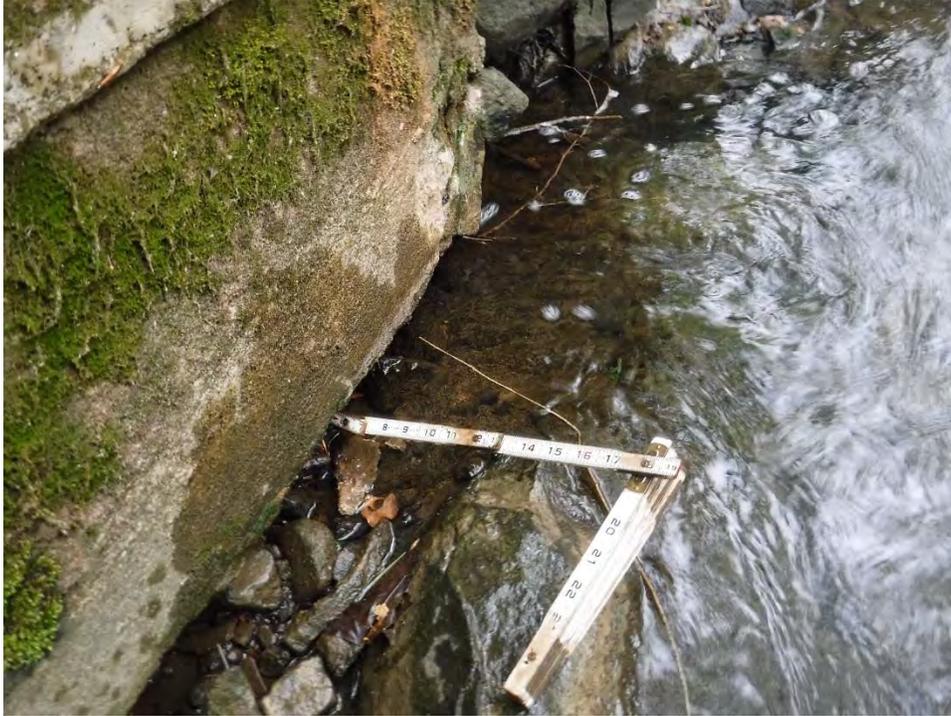
Section 5 extends from 241' to 353' from the east end. The eastern 8' of Section 5 is a concrete abutment for a pedestrian bridge (see Photo 14). There is minor scaling throughout, full length x 4" high x up to 7" deep undermining (see Photo 15), and a 10'-0" diameter x 4'-0" deep scour hole in front of the bridge abutment. Just west of the abutment is a 60' long section of natural stone/boulders along the bank (see Photo 16). The western 44' of Section 5 is comprised of stone masonry with approximately 25% of the mortar missing, moss and vegetation growth throughout, and a few random shifted stones near the top (see Photos 17 through 19). The bottom 5'-0" consists of a 2'-0" wide concrete bump-out with undermining along the full length x 1'-0" high x up to 1'-2" deep. There is a 5'-6" long x 2'-3" high x up to 1'-5" deep spall with exposed corroded reinforcement located 8'-0" from the east end and a 5'-0" long x 1'-2" high x up to 1'-2" deep spall located 12'-0" from the west end (see Photo 20).

*Photo 15 – Undermining along Concrete Portion of Section 5, Looking West.*

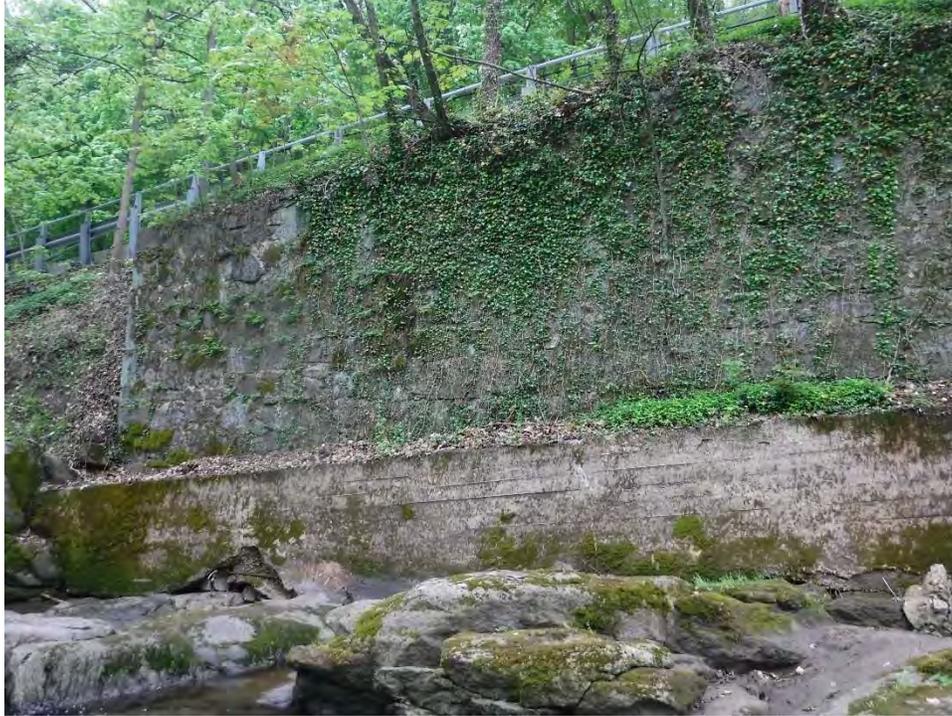
*Photo 17 – Section 5 with Vegetation Growth, Looking South.*

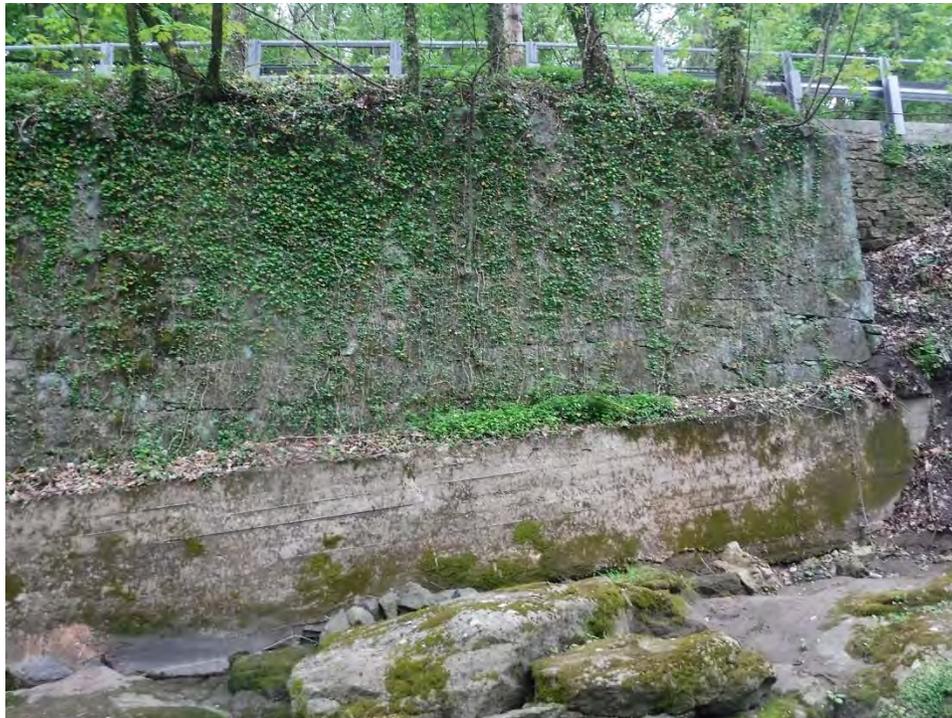
*Photo 18 – Section 5 with Vegetation Growth, Looking South.*

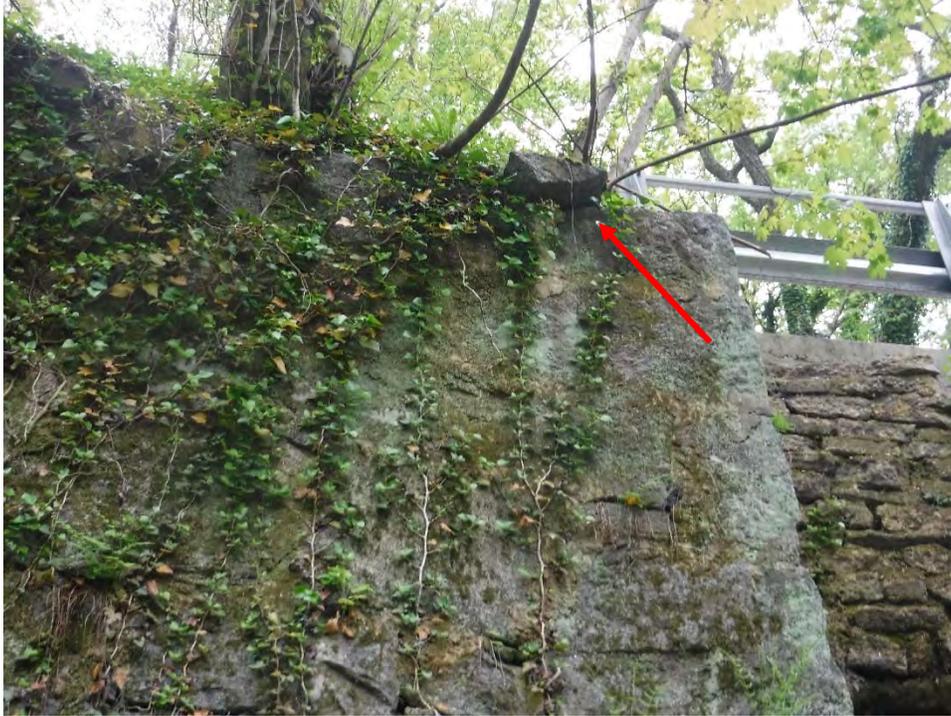
*Photo 19 – Shifted Stones near Top West End of Section 5, Looking South.*

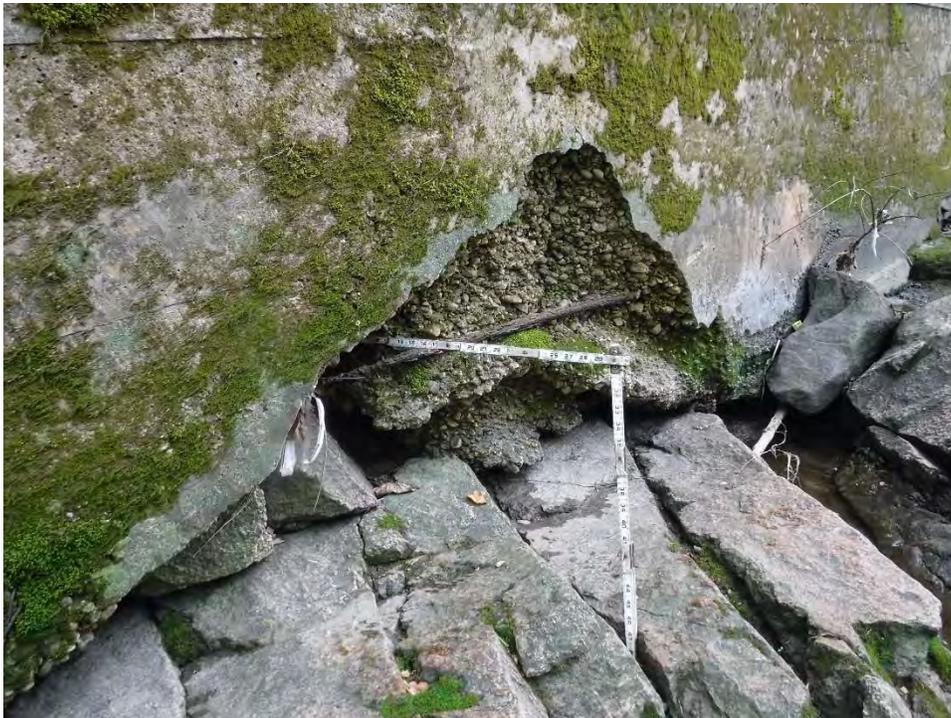
*Photo 20 – Spall in Section 5, 8' from the East End, Looking Southwest.*

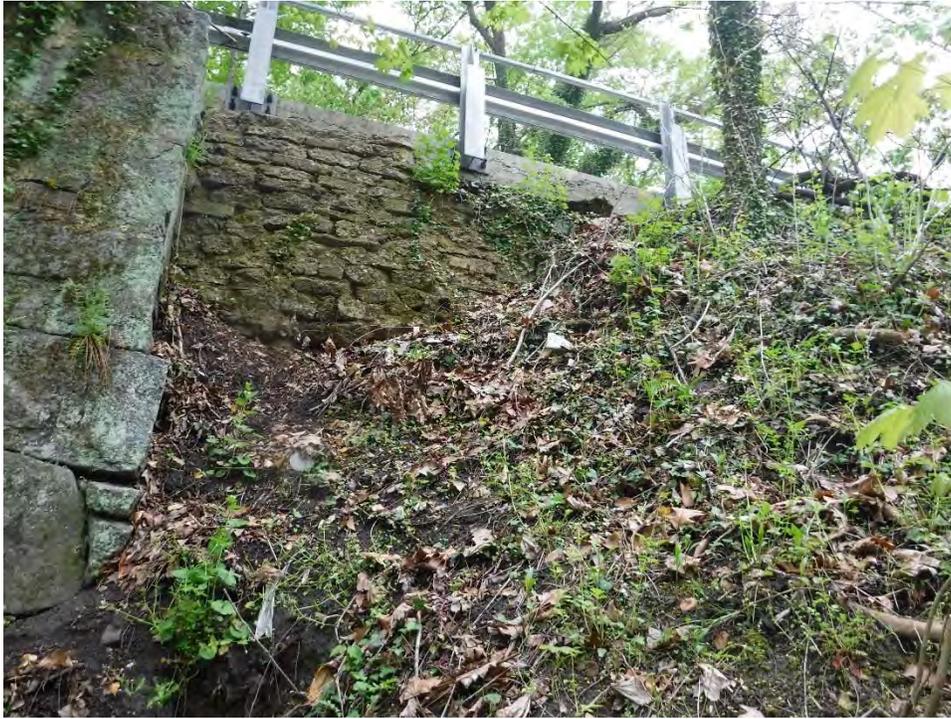
Section 6 extends from 353' to 532' from the east end of the wall. The eastern 9' of Section 6 is comprised of a stone masonry retaining wall near the top of the bank (see Photo 21). Just below the stone wall, there are two deteriorated and abandoned concrete structures (see Photo 22). The remaining 170' of Section 6 is comprised of a natural stream bank.

*Photo 21 – Stone Masonry Wall at Top East Corner of Section 6*

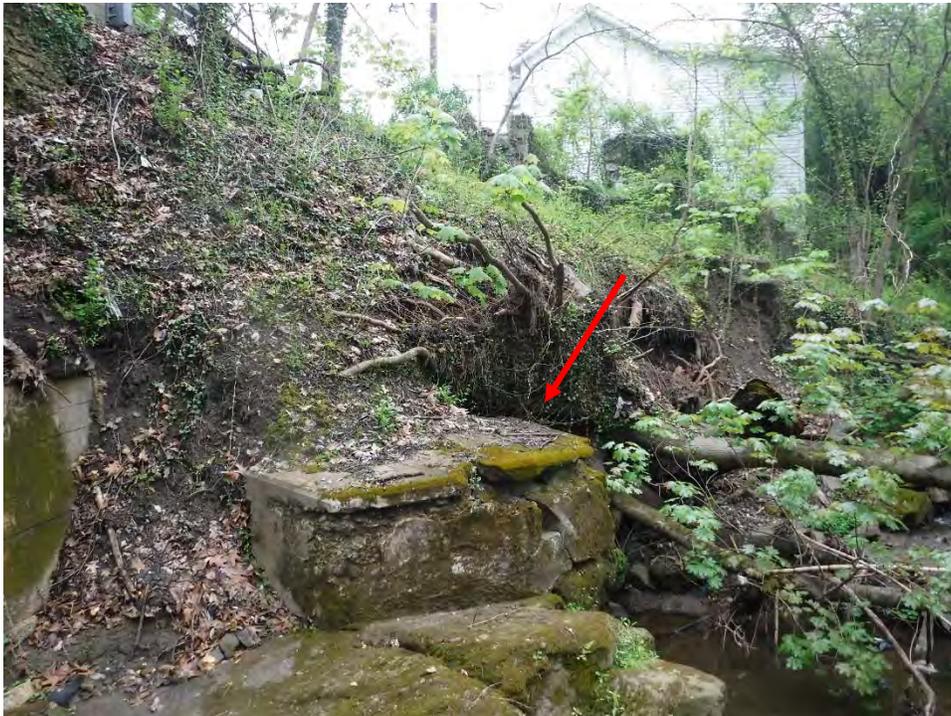
*Photo 22 – Abandoned Abutment at East End of Section 6, Looking West.*

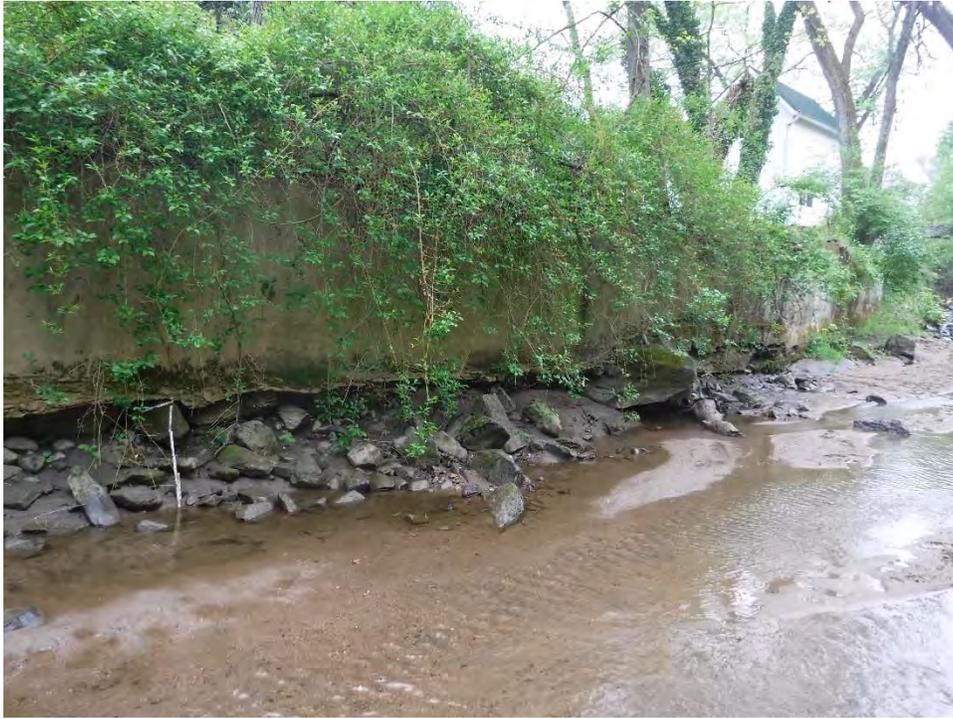
Section 7 extends from 532' to 801' from the east end of the wall (see Photos 23 through 25). The eastern 84' of Section 7 is comprised of concrete and typically has random areas of minor scaling with vegetation growth throughout the top of the wall. There is a 32'-0" long x 2'-3" high x up to 1'-10" deep undermined area starting from the east end (see Photo 26). Just west of the concrete wall, there is a 15' long concrete block wall with a 3" wide x full height vertical fracture (see Photo 27).

*Photo 23 – Section 7, Looking Southwest.*

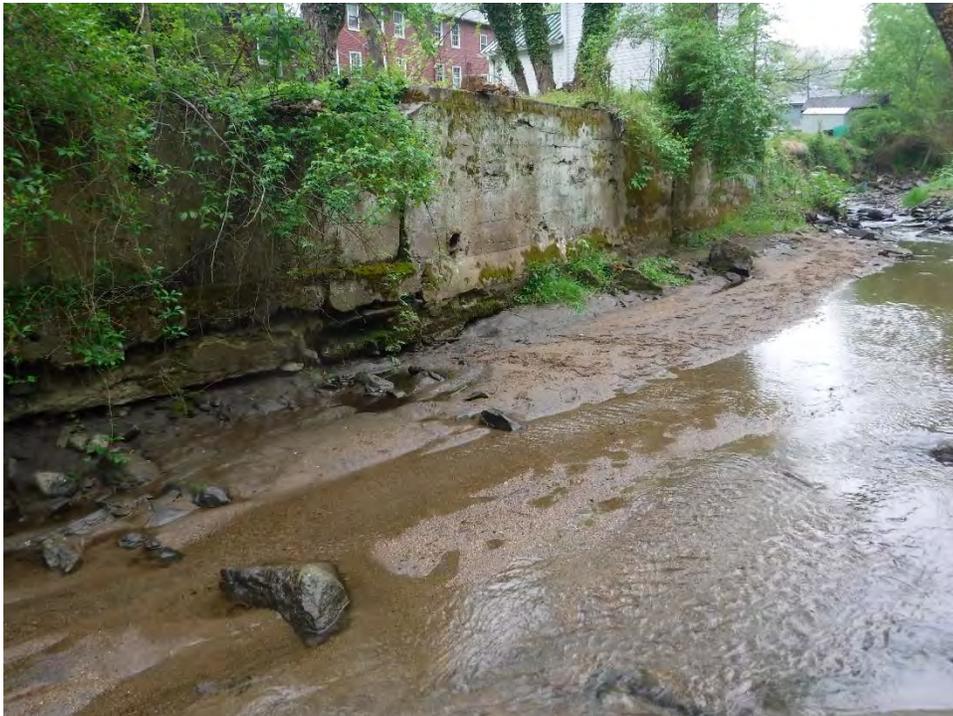
*Photo 24 – Section 7, Looking Southwest.*

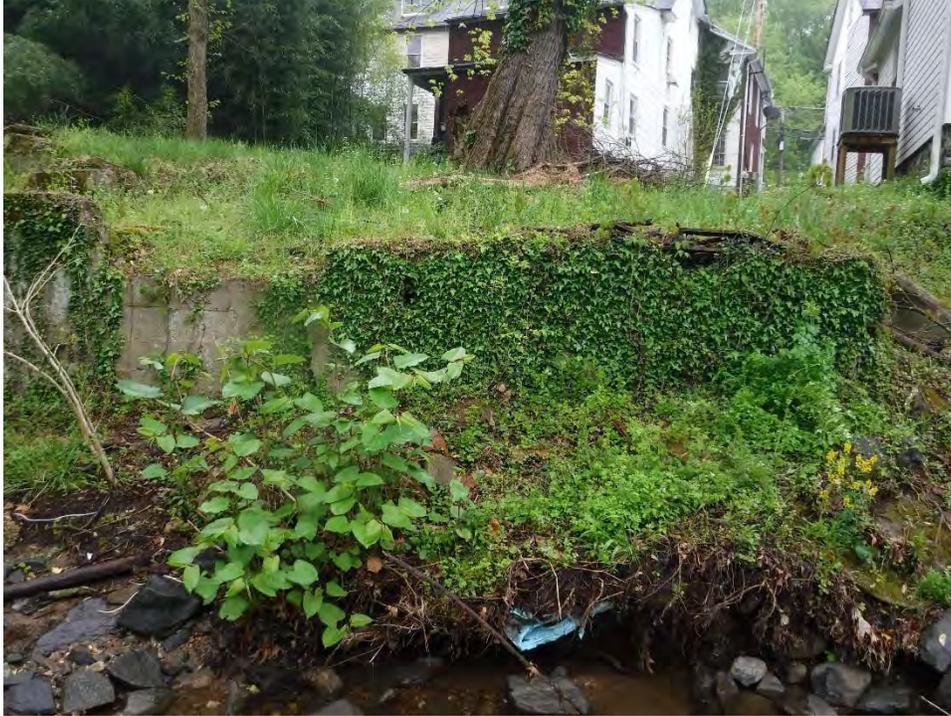
*Photo 25 – Section 7, Looking South.*

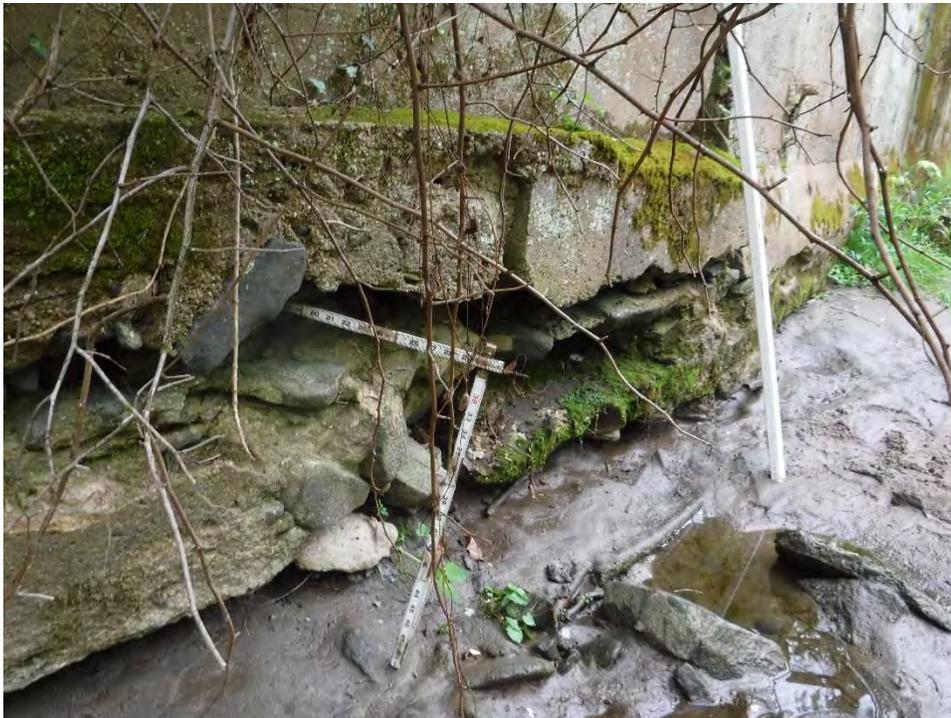
*Photo 26 – Undermining at East End of Section 7, Looking Southwest.*

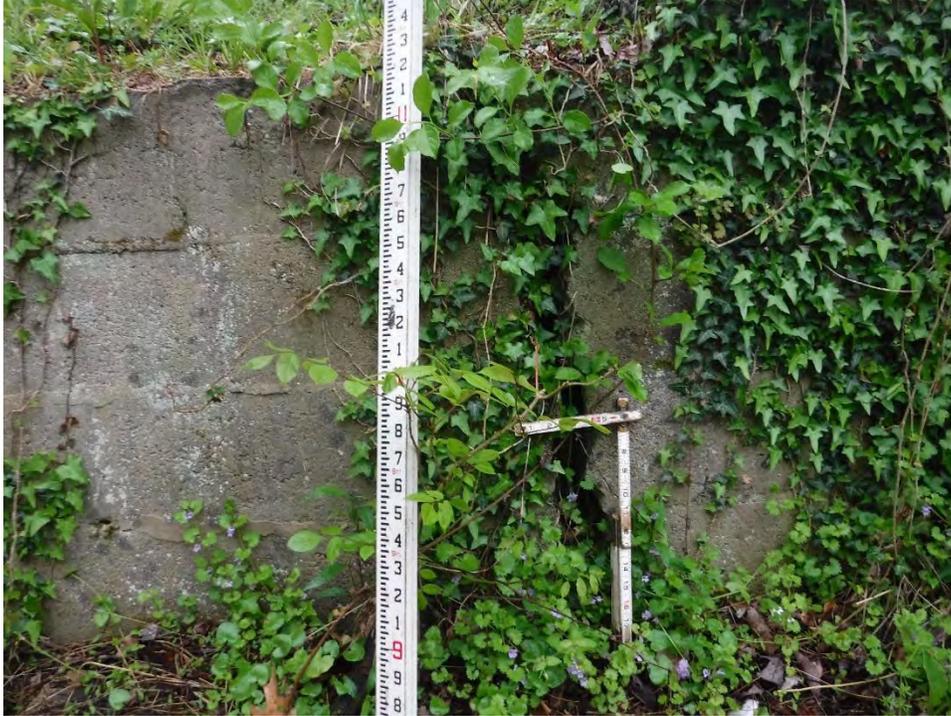
*Photo 27 – Vertical Fracture near West End of Section 7.*
