# ELLICOTT CITY RETAINING WALLS INSPECTION REPORT

## STREAM WALLS

## HISTORIC ELLICOTT CITY, MARYLAND

MAY 2016

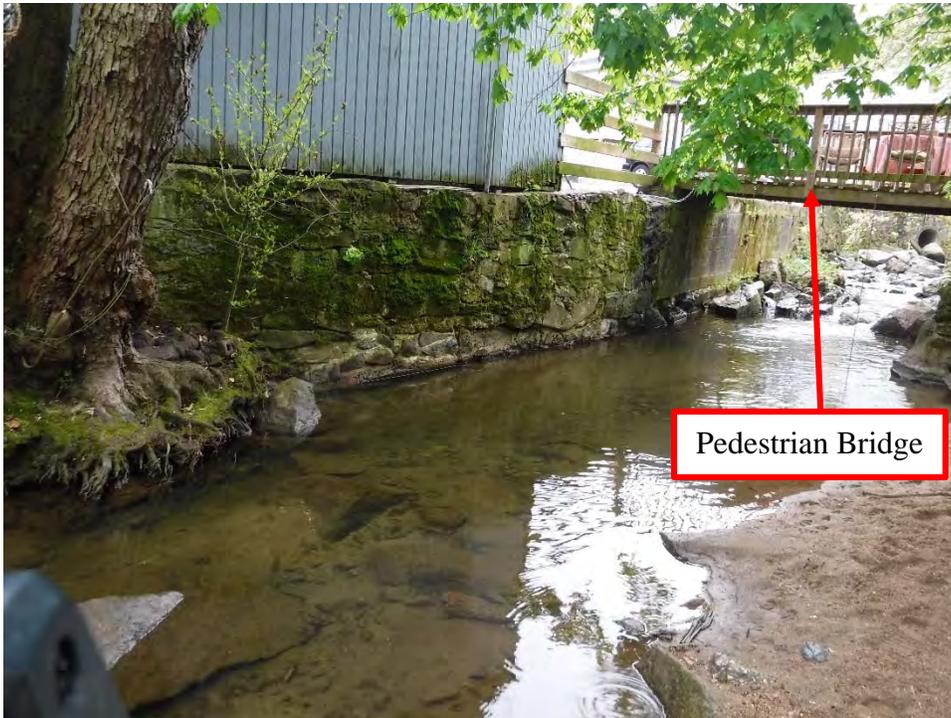
Section 8 extends from 801' to 900' from the east end and is comprised of a mixture of stone masonry and concrete blocks (see Photos 28 through 31). The eastern 26' of Section 8 is stone masonry with approximately 10% of the mortar missing, mostly along the bottom 2'-0" (see Photo 28). Beneath the pedestrian bridge, starting 26' from the east end, there is an 8'-0" long x 2'-0" high area of missing mortar and random small missing stones at the bottom (see Photo 29). Also, located 26' through 61' from the east end of the section, there are several open joints between the concrete blocks, up to ¼" wide x up to 7" deep with up to ¾" horizontal offset (see Photo 29). Located 61' from the east end of the section, there is a full height x 5'-0" wide area with no mortar remaining and random small missing stones (see Photo 31). The western 38' of Section 8 typically has missing mortar and stones along the bottom 1'-0", which can be probed up to 2'-2" deep (see Photos 31 and 32) with approximately 10% of the mortar missing, random small missing stones, and minor moss growth.

*Photo 28 – Section 8, Looking Southwest.*

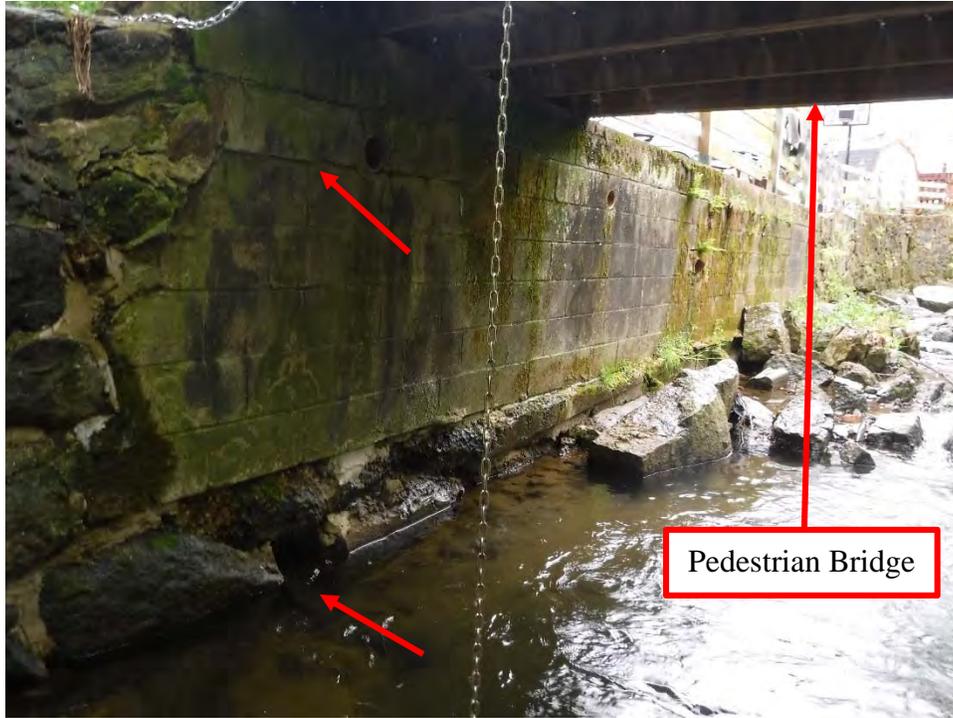
*Photo 29 – Section 8, Looking Southwest. Note Open and Offset Joint at Top of Wall and Missing Stones and Mortar at Bottom of Wall.*

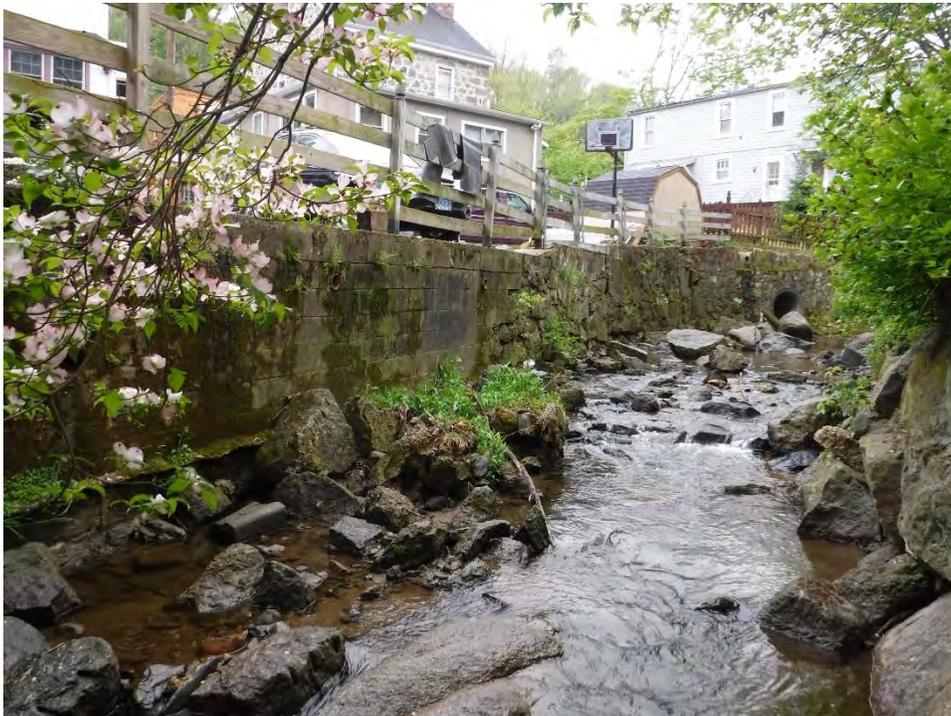
*Photo 30 – Section 8, Looking Southwest.*

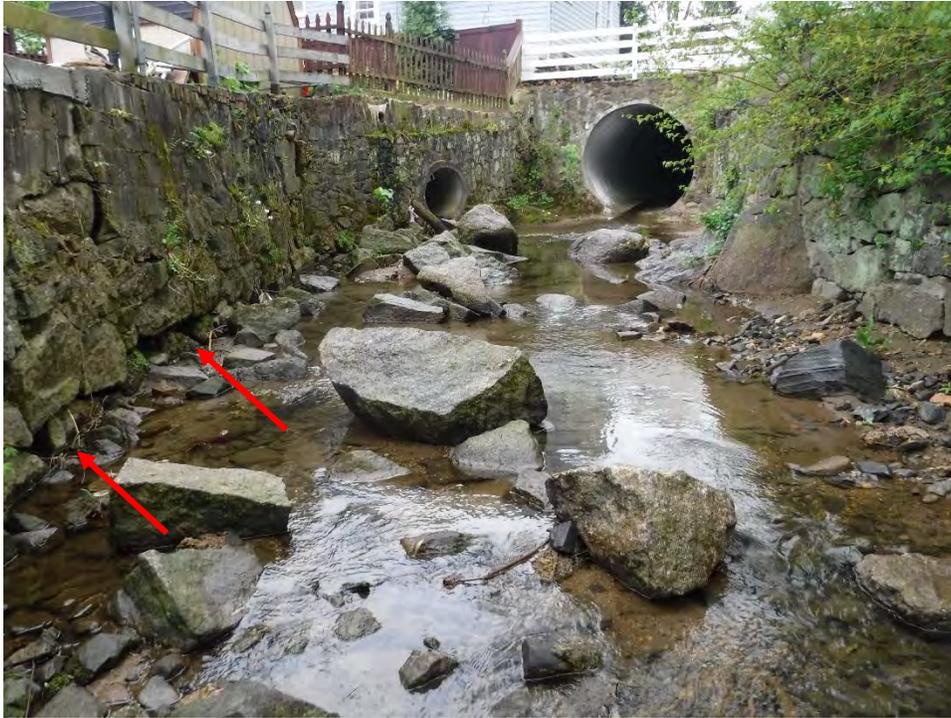
*Photo 31 – Section 8, Looking Southwest.  
Note Missing Mortar/Stones along the Base.*

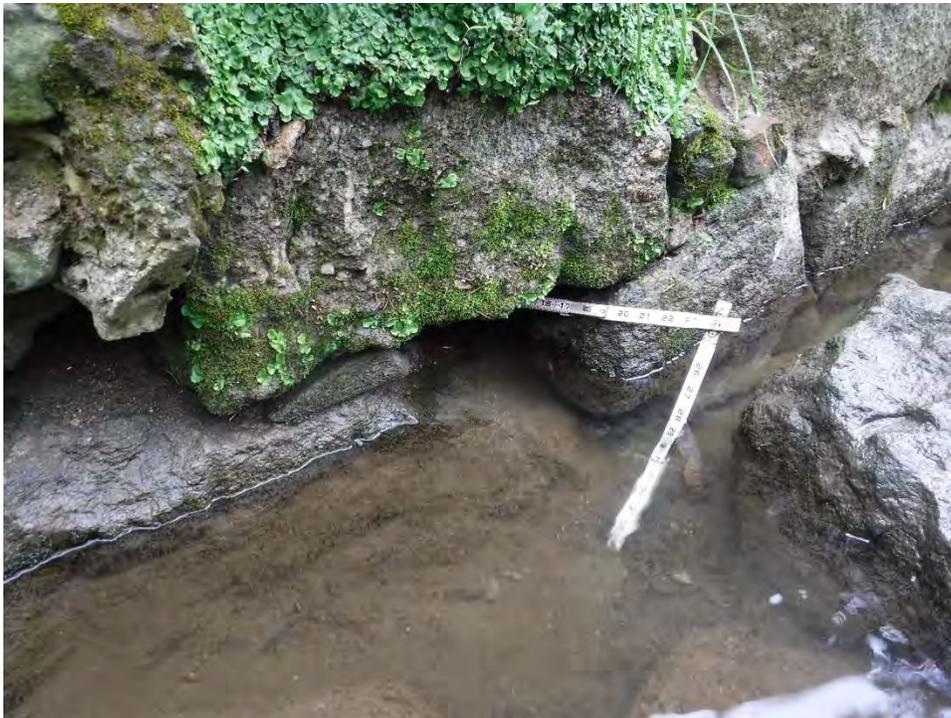
*Photo 32 – Missing Stones/Mortar along the Base of Section 8.*

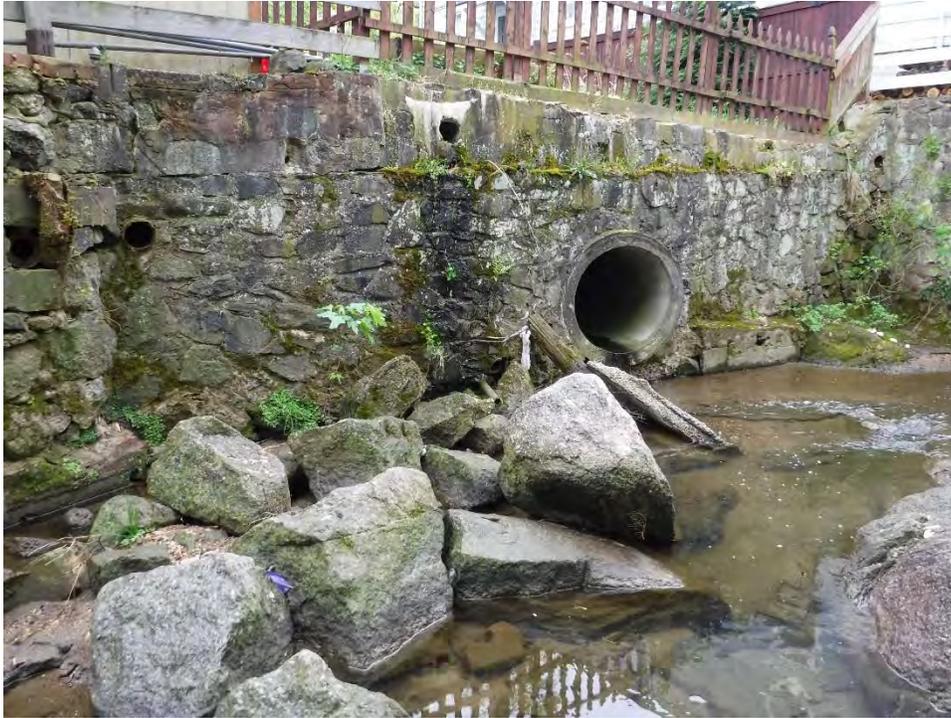
Section 9 extends from 900' to 930' from the east end and is comprised of a mixture of stone masonry and concrete blocks (see Photo 33). There is approximately 10% of the mortar missing, random small missing stones, and minor vegetation growth along the horizontal joint at the top of the wall. There is a 3'-6" long x 1'-0" high x up to 3'-10" deep void area under the 3'-0" diameter concrete pipe outfall (see Photo 34). At the west end, there is a 6'-0" high x up to 5'-0" wide area with no mortar remaining and random small missing stones below a small drain pipe.

*Photo 33 – Section 9, Looking Southwest.*

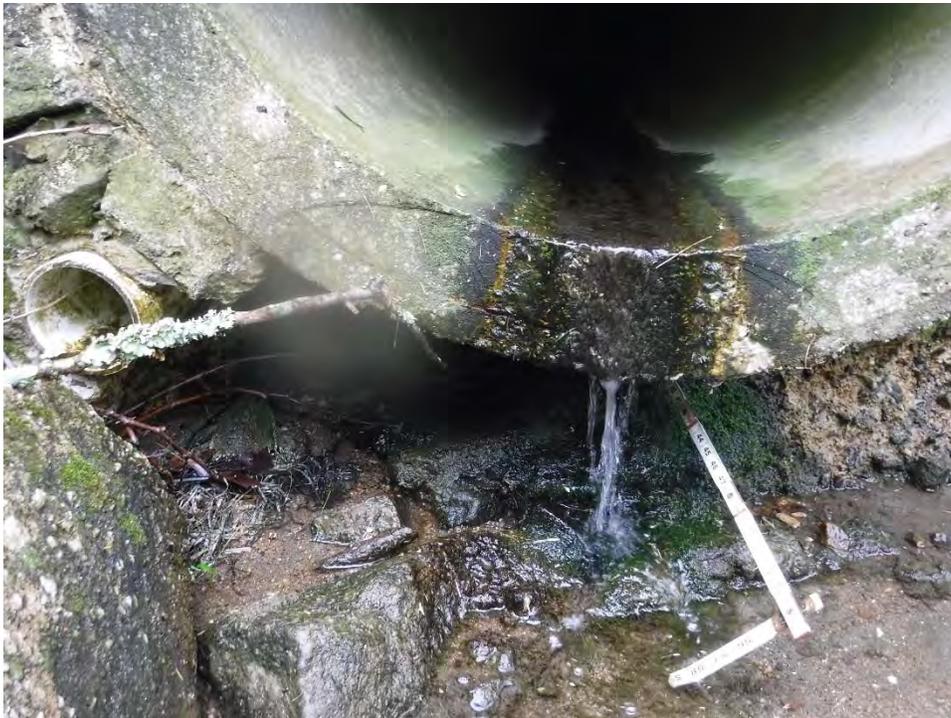
*Photo 34 – Section 9, Void Under Pipe Outfall, Looking Southwest.*

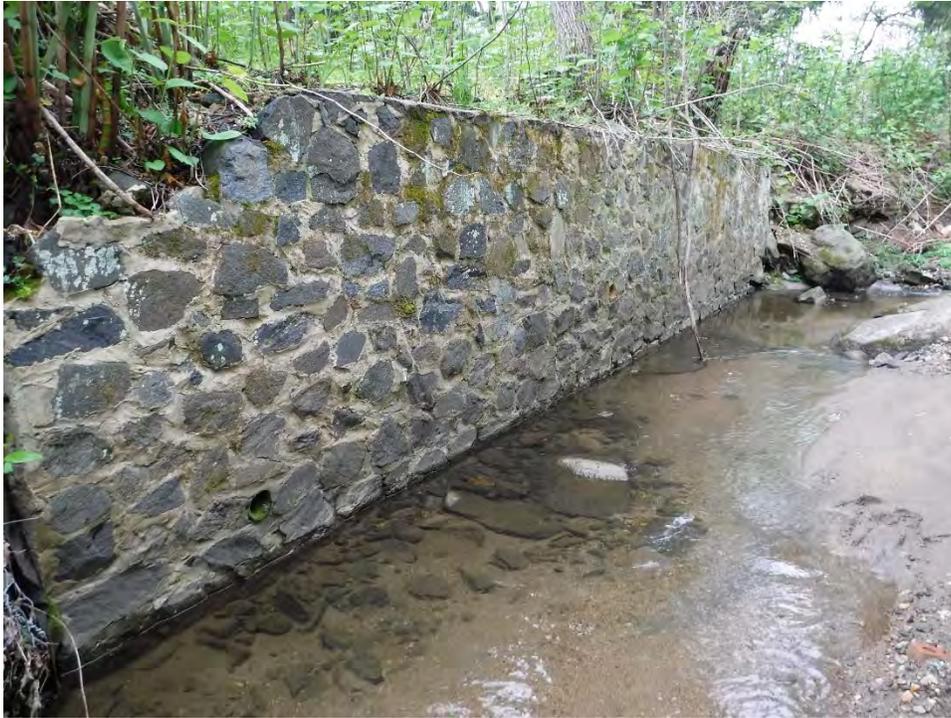
Section 10 extends from 930' to 1,152' from the east end (see Photo 35). There is a 45' long stone masonry wall starting 162' from the east end of Section 10, with missing mortar along the bottom 1'-0". There is a 4'-0" long x 1'-0" high area of missing stones at the top east end of the wall. At the west end of the wall, there is 3'-0" diameter tree growing on top of the wall causing a full height x 3'-0" wide area of failure with a 1" wide vertical fracture that can be probed up to 1'-0" deep and a 4'-0" long x 2'-0" high x 1'-7" deep void area at the bottom (see Photo 36). The western 15' of Section 10 consists of stacked stone and concrete debris with no mortar (see Photo 36).

*Photo 35 – Section 10, Looking Southwest.*

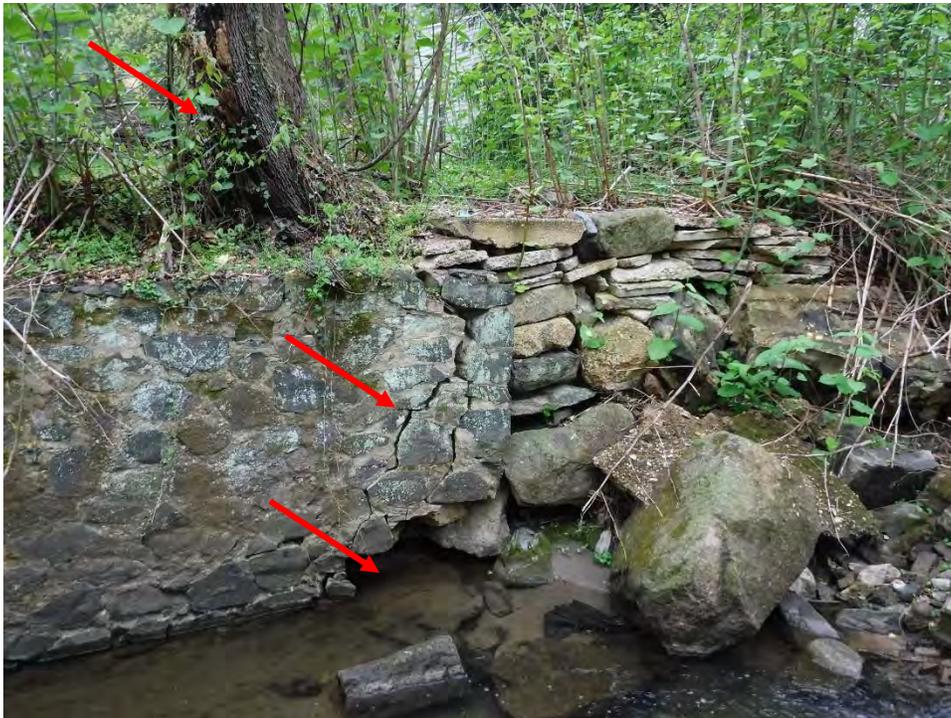
*Photo 36 – Undermining, Fracture, Large Tree Growth and Loose Stacked Stones at West End of Section 10, Looking South.*

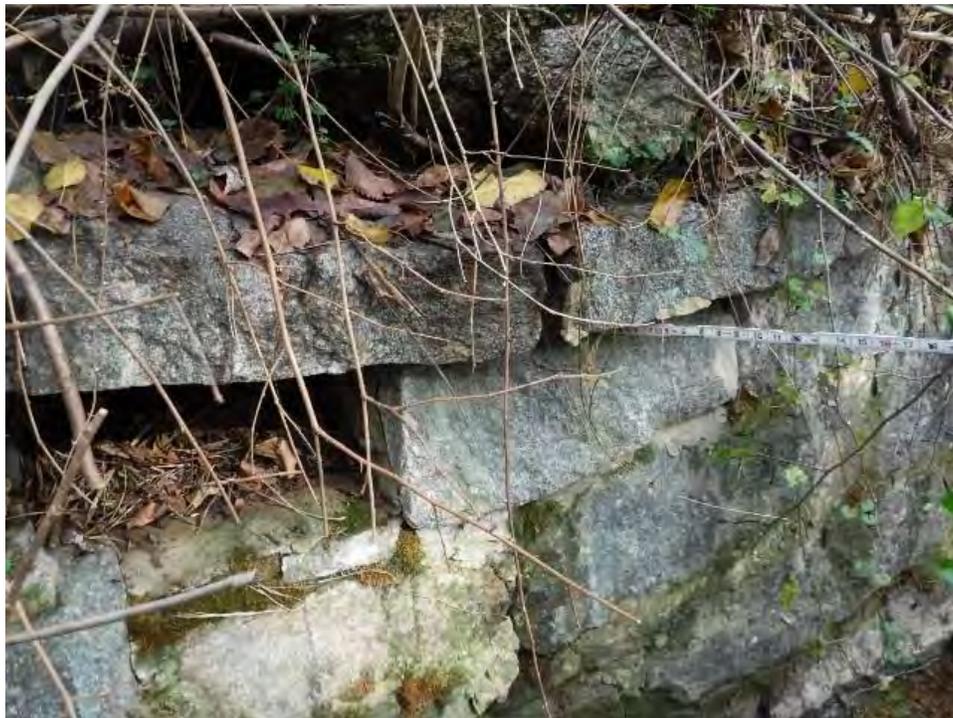
*Photo 6 – Stone Movement and Void at Top of Wall, 4' from West End of Wall.*

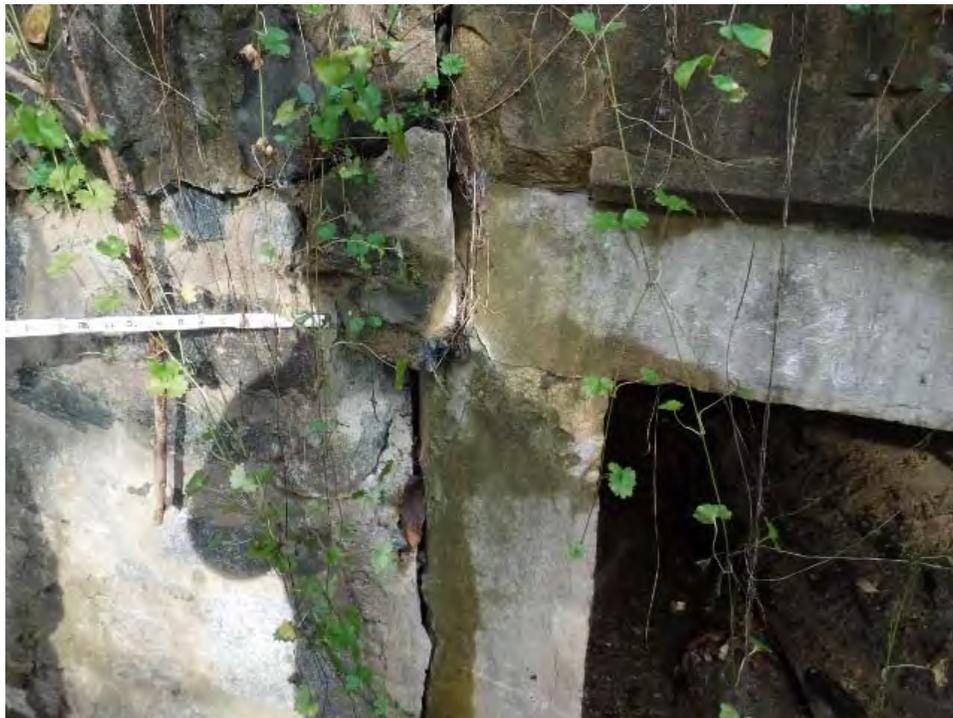
Section 1 (western 22') stone masonry exhibits missing mortar throughout the joints, with penetration into fill up to 2'-0" deep. The soil along the top backside of the wall is soft with minor depressions, which may be evidence of sinkholes. At the west end of the wall, there is a 15'-0" long area of embankment erosion up to 5'-0" high, with exposed tree root systems and evidence of wall failure (see Photo 5). Starting 4' from the west end of the wall, there is a 1'-6" high x 13'-0" long section at the top of the wall which is leaning south, toward the stream channel, up to 5" (see Photo 6). There is a void measuring 1'-4" high x 2'-6" wide in this area, with penetration up to 2'-0" deep (see Photo 6). At the east end of Section 1, there is a concrete culvert at the base of the retaining wall (see Photo 7). There is a void at the top west corner of the culvert, measuring 1'-0" high x 5" wide x 9" deep (see Photo 8).

*Photo 8 – Void at Top West Corner of Concrete Culvert in Section 1.*

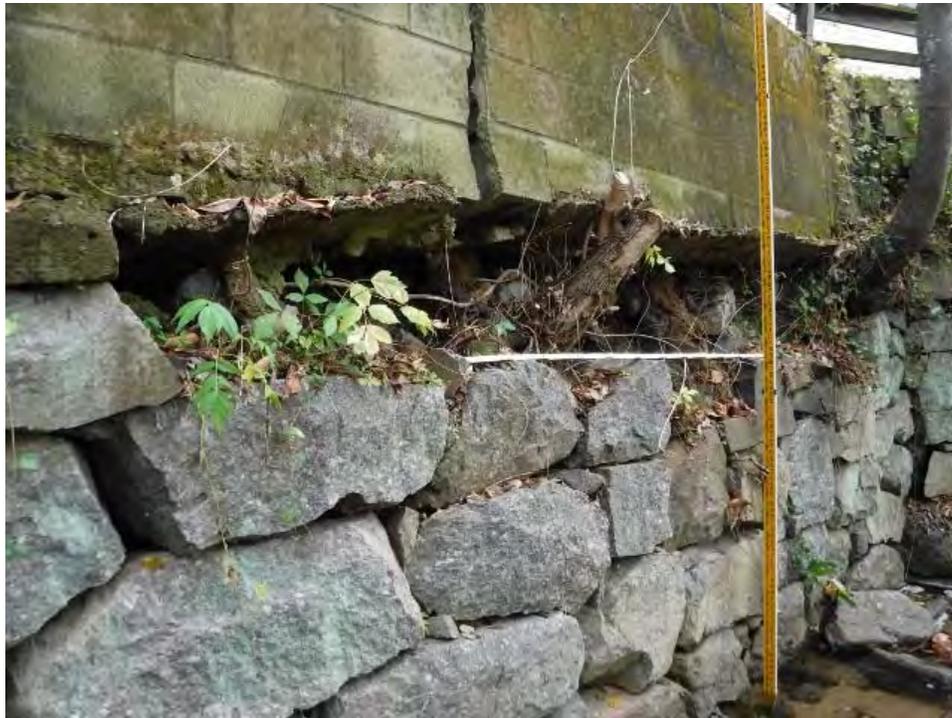
Section 2 extends from 22' to 52' from the west end. There are random missing small stones throughout, as well as missing medium sized stones along the base of the wall, with voids up to 2'-0" deep. There is vegetation growth in the voids (see Photo 9). The concrete portion of the wall (top 4') is leaning to the north, away from the stream channel, up to 2.5" at the west end and 6" at the east end. The concrete is fractured full-height x 2" wide at 39' from the west end of the wall (see Photo 9). Starting 38' from the west end of the wall, there is a void between the concrete portion and stone masonry portion of the wall, measuring 2'-4" high x 12'-0" long x 1'-5" deep with exposed root systems (see Photo 10).

*Photo 10 – Void beneath Concrete Portion in Section 2, Looking Northeast.*

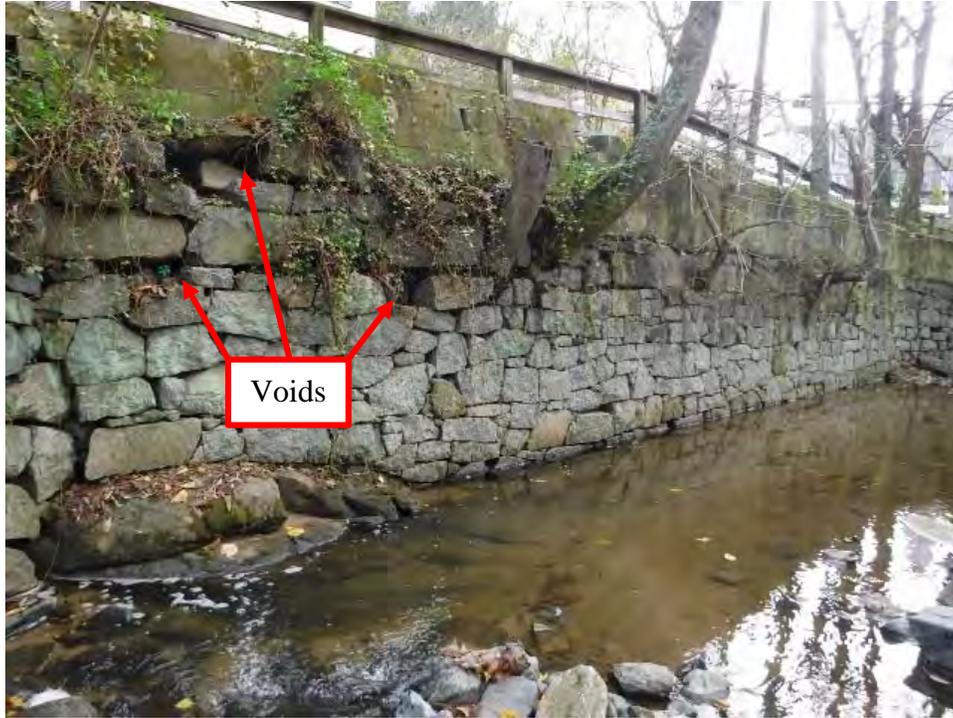
*Photo 11 – Elevation of Section 3, Looking East.  
Note Missing Mortar, Voids, and Vegetation Growth.*

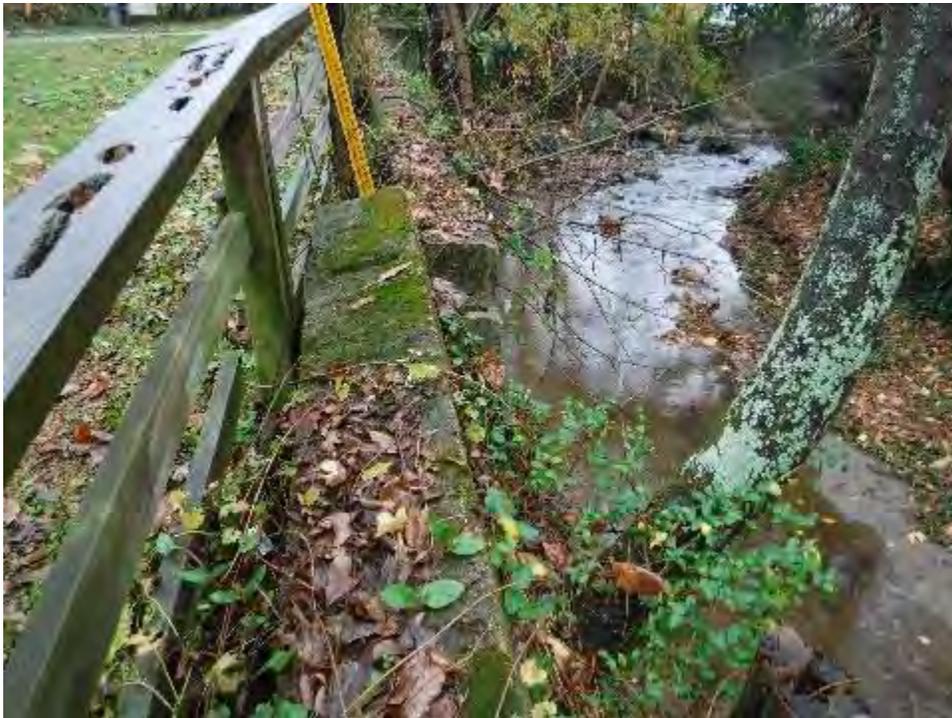
*Photo 12 – Top of Wall Leaning to North in Section 3, Looking East.*

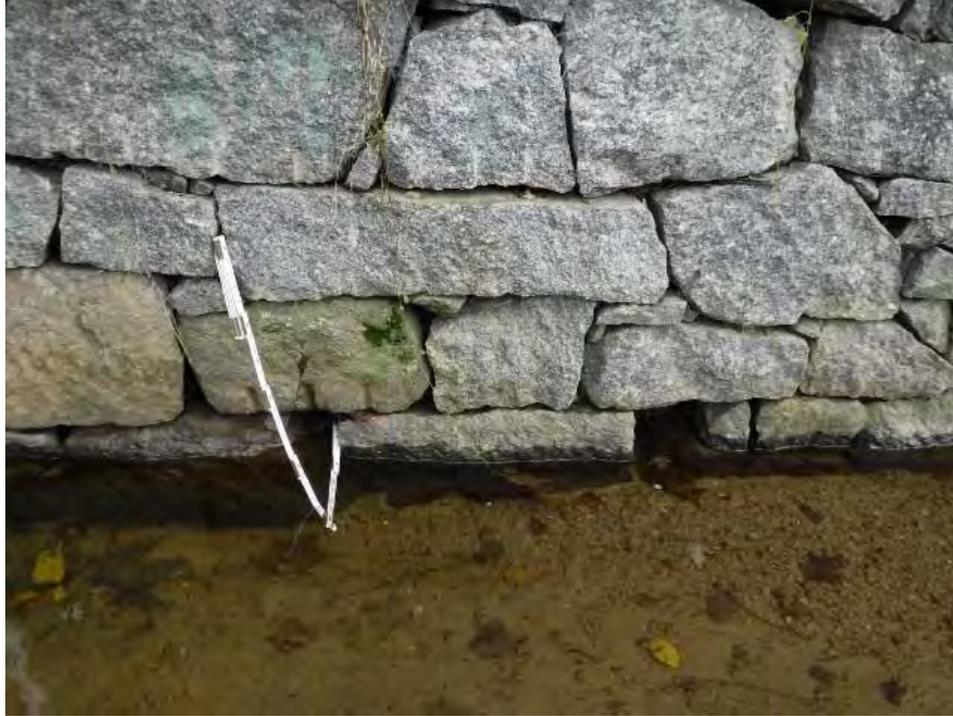
Section 3 extends from 52' to 112' from the west end of the wall. There are three voids in the wall within the western 6' length of Section 3, measuring up to 1'-5" high x 2'-6" wide x 2'-0" deep with exposed fill (see Photo 11). The top of the wall (concrete portion) is leaning up to 1'-0" towards the north within the western 20' length of Section 3 (see Photo 12). There are random small voids along the base of the wall throughout Section 3, with penetration up to 1'-8" deep (see Photo 13).

*Photo 13 – Typical Voids along Base of Section 3.*

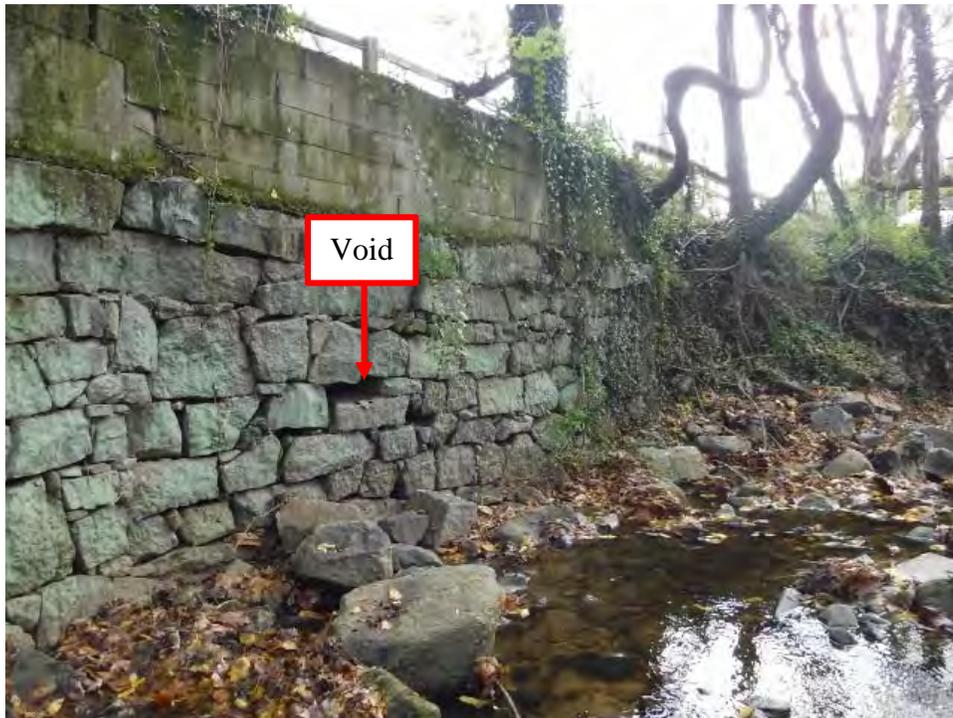
Section 4 extends from 112' to 121' from the west end of the wall. There is minor cracking in the concrete portion of the wall. There is a void located 117' from the west end of the wall, at mid-height of the wall, measuring 10" high x 1'-8" wide x 1'-9" deep (see Photo 14). Within the eastern 4' length of Section 4, the top stones of the masonry portion are pushed out 4" toward the stream channel (see Photo 15).

*Photo 14 – Elevation of Section 4, Looking East.  
Note Missing Mortar and Void.*

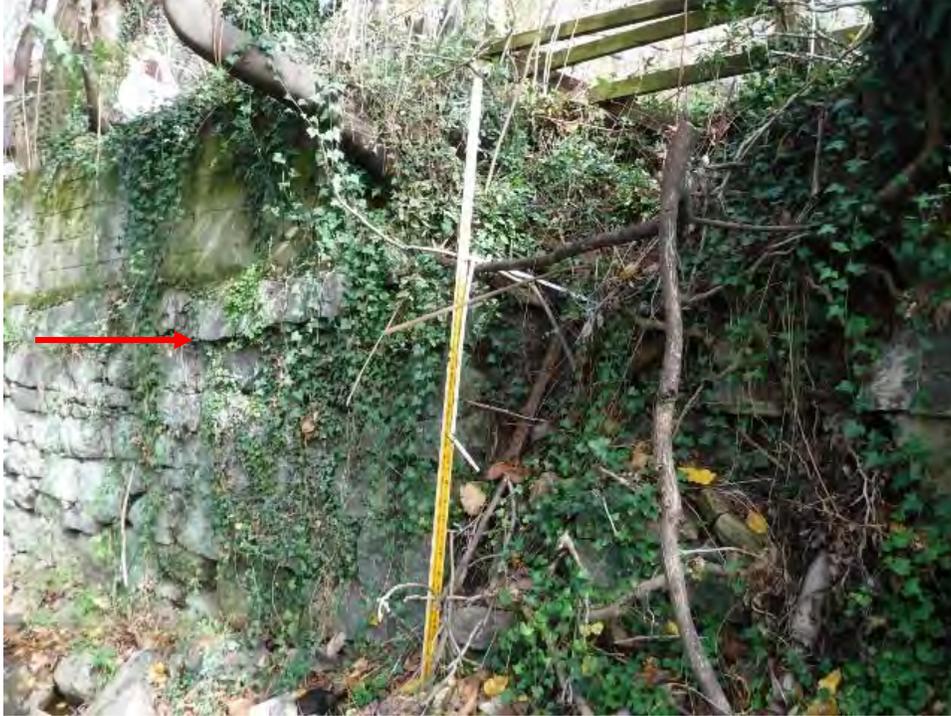
*Photo 15 – Misaligned Stones at West End of Section 4, Looking North.*

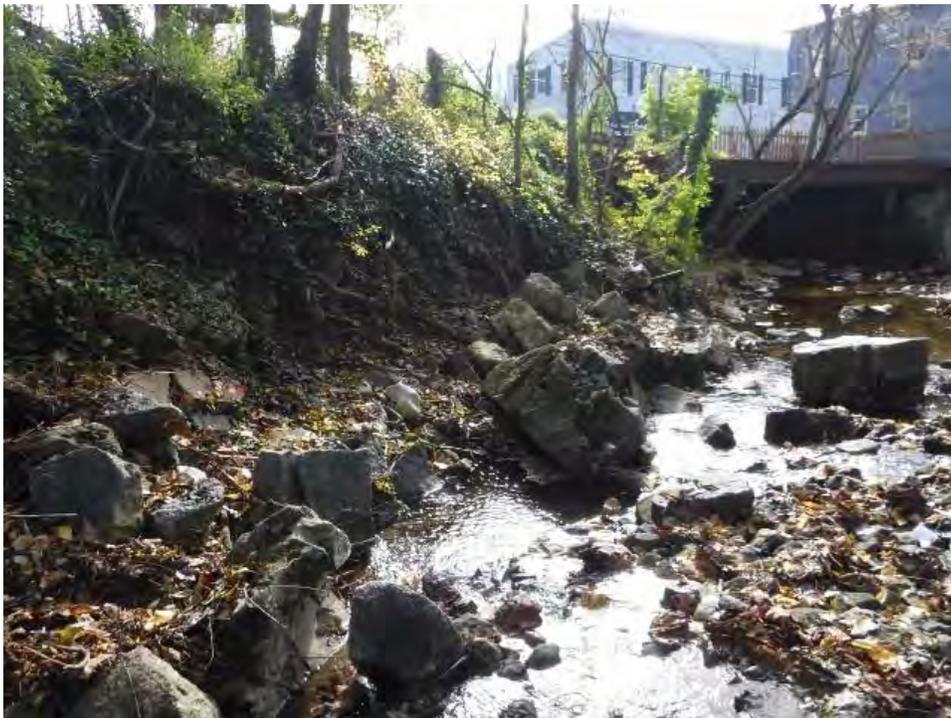
*Photo 16 – Failed Portion of Wall in Section 5, Looking East.*

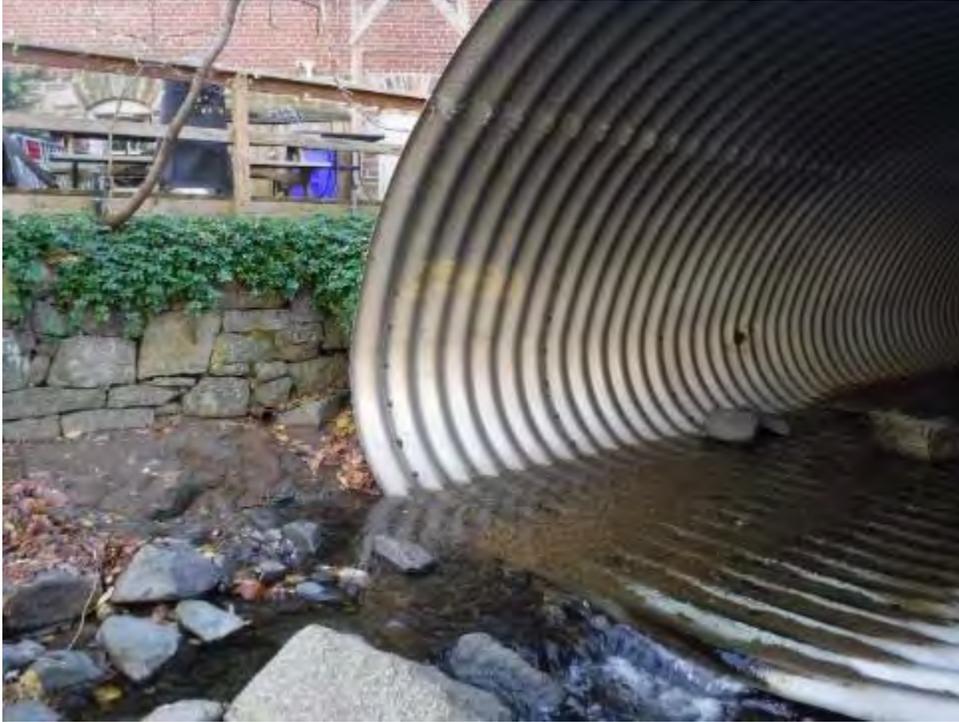
Overall, the retaining wall is in fair condition. Section 1 (western 23') is comprised of stone masonry. At the west end, there is a large corrugated metal pipe culvert which sits in front of the retaining wall (see Photo 1). There is missing mortar throughout the masonry joints and vegetation growth along the top of the wall (see Photo 2).

*Photo 1 – West End of Section 1, Looking South.*

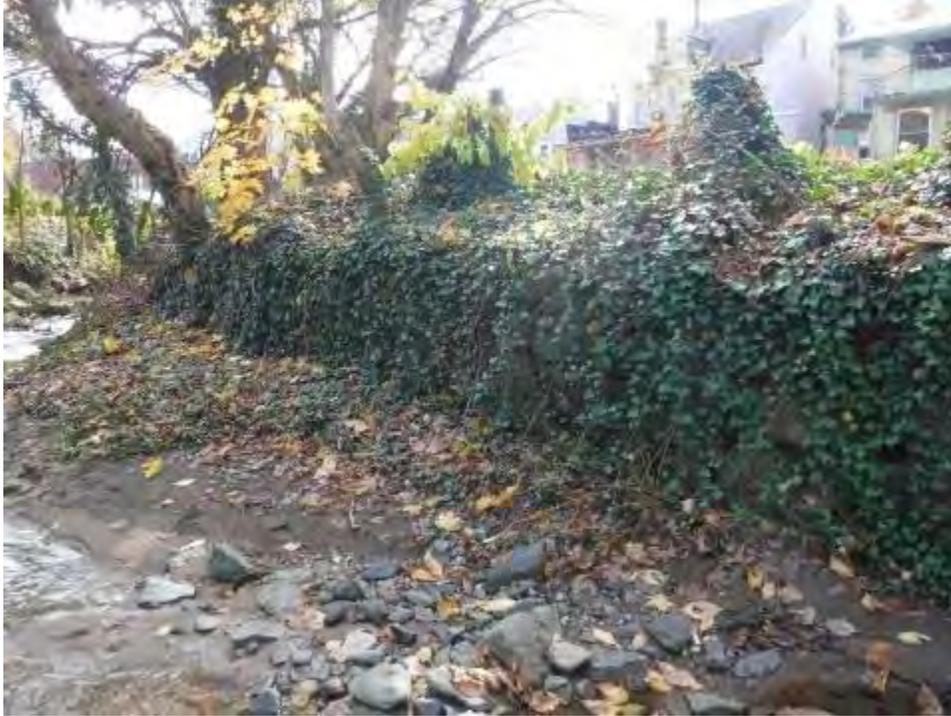
*Photo 5 – Section 2, Looking East.  
Note Vegetation Growth.*

Vegetation growth including mature trees is impacting the wall. The trees and vegetation should be removed immediately. The failed portions of wall should be rebuilt, providing proper drainage. The masonry joints should be re-pointed with mortar throughout the wall.

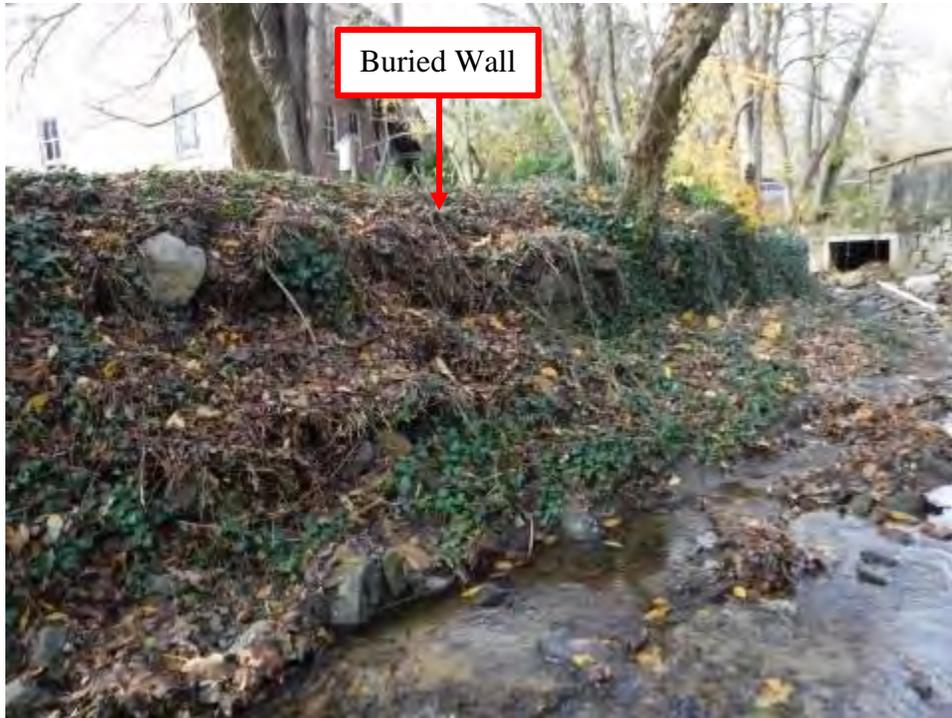
Section 3 extends from 53' to 103' from the west end of the wall. There is missing mortar in the joints and vegetation growth along the top of the wall (see Photo 5). A 17'-0" length of the wall near the east end is buried under soil and vegetation (see Photo 6).

*Photo 6 – Section 3, Looking West.  
Note Buried Portion of Wall.*

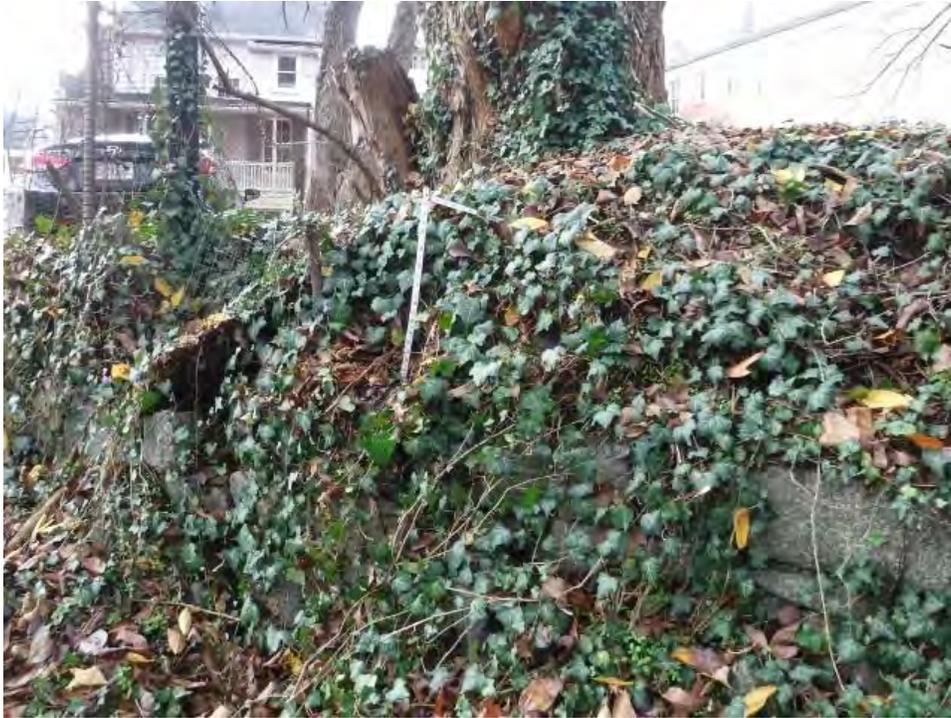
Section 4 extends from 103' to 135' from the west end of the wall. There is a large tree growing at the top of the wall at the west end of Section 4, and the wall exhibits missing stones within a 3'-0" wide area below the tree (see Photo 7). At 3' from the east end of Section 4, the wall is fractured full height x 10" wide with exposed fill (see Photo 8).

*Photo 7 – Section 4, Large Tree and Missing Stones at Top of Wall.*

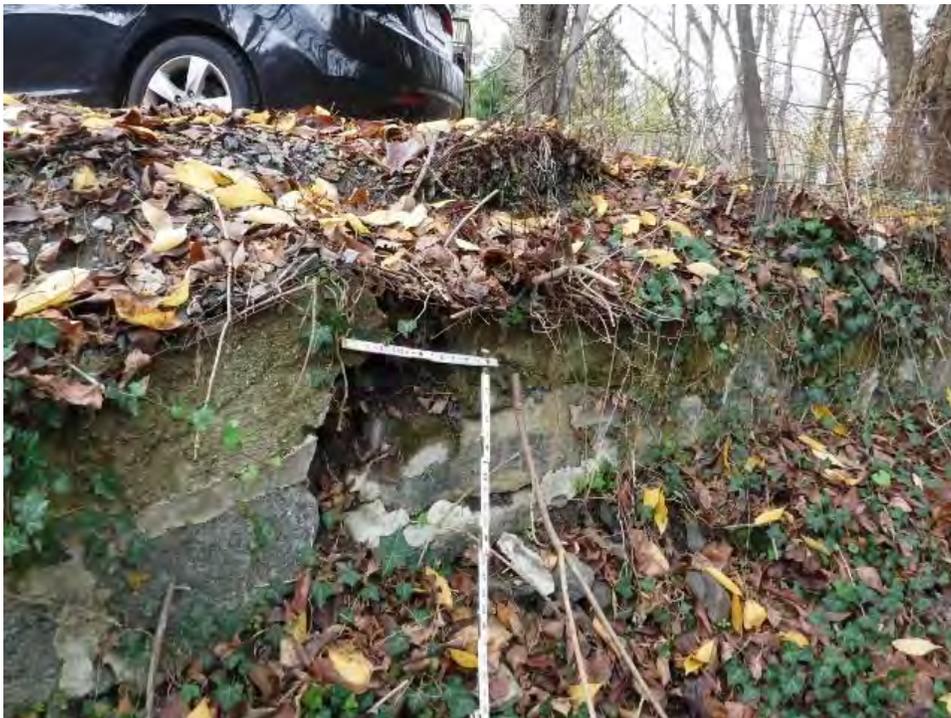
*Photo 8 – Fracture at East End of Section 4, Looking Southwest.*

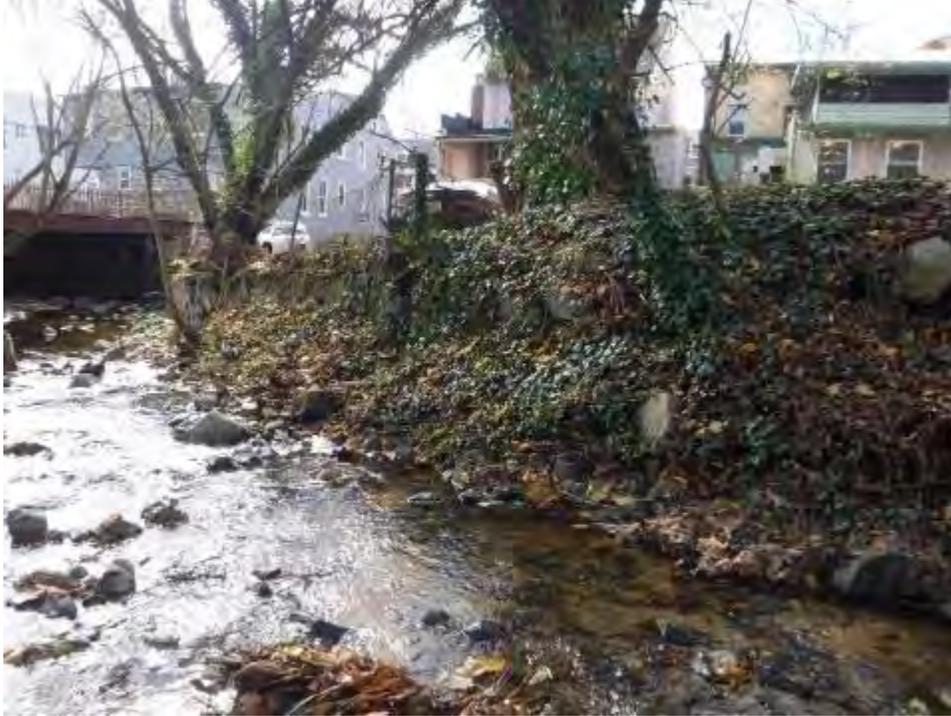
*Photo 9 – Sections 4 and 5, Looking East.*

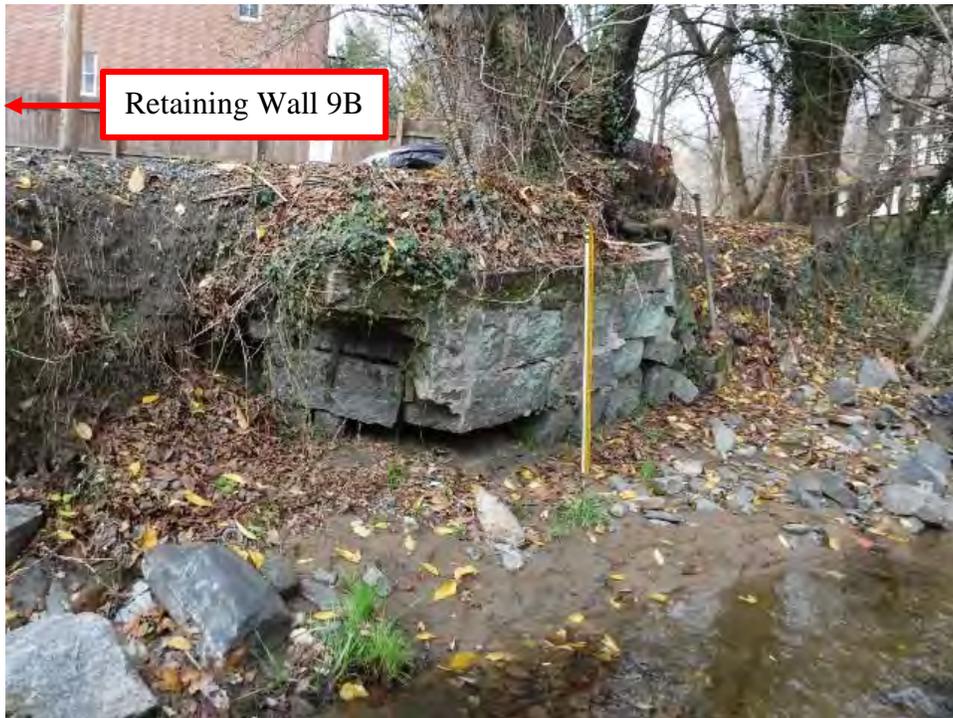
Section 5 (eastern 18') exhibits loose and bulging stones. At the east end, portions of the wall have collapsed and the banks are eroded leading up to Retaining Wall 9B (see Photo 10).

*Photo 10 – Section 5 Remnants of Wall with Surrounding Erosion at East End, Looking Southwest.*

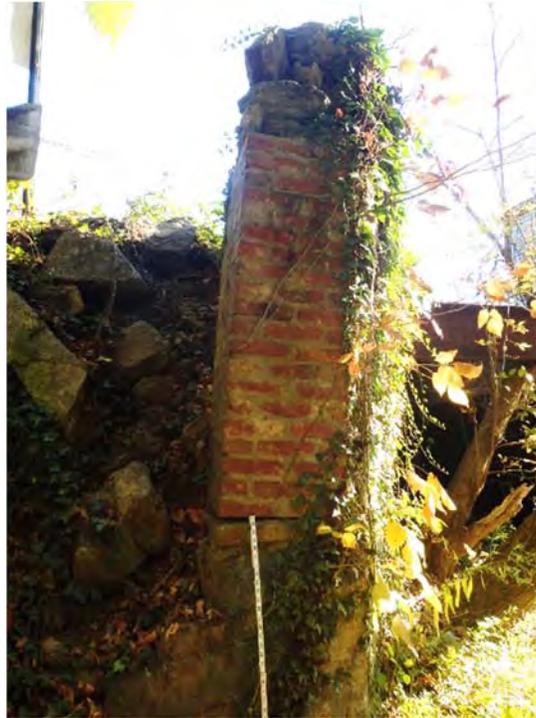
*Photo 3 – West End Leaning Toward Channel,  
Looking East.*

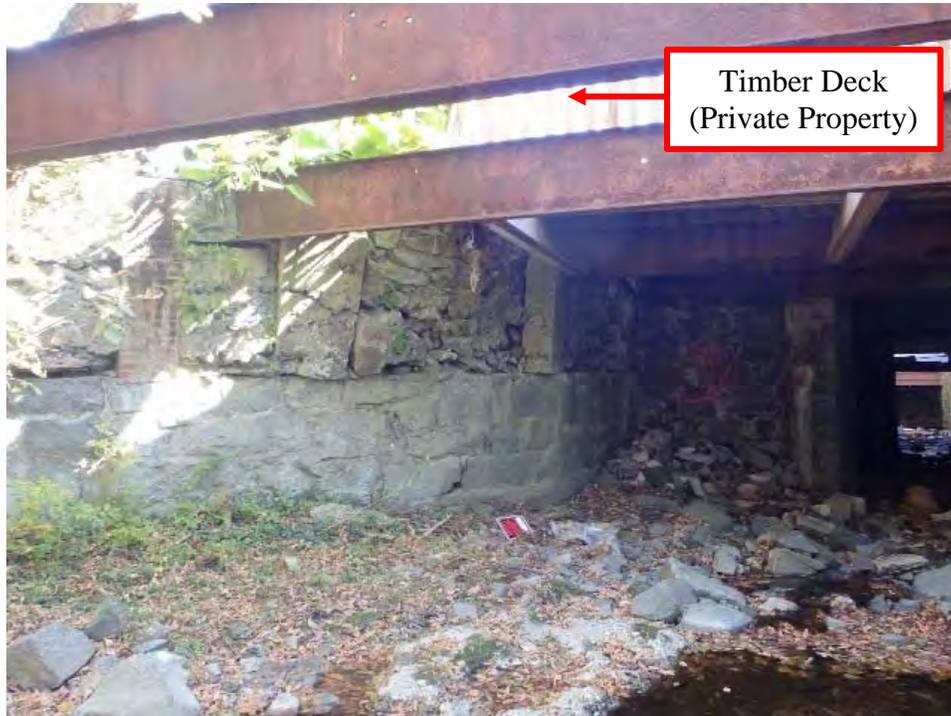
*Photo 4 – Portion below Timber Deck, Looking Northeast.*

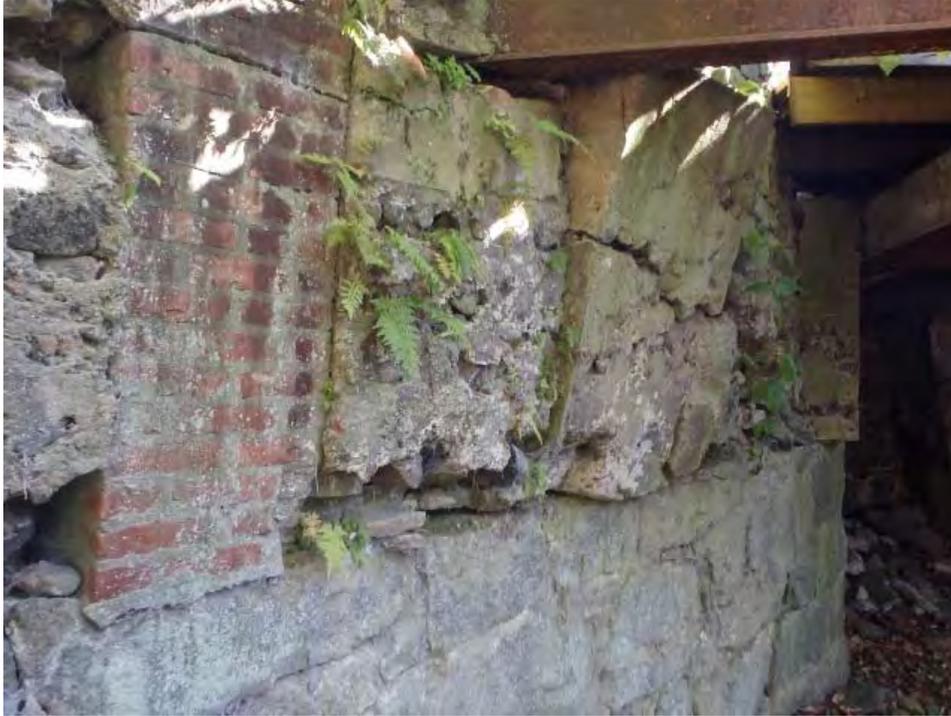
*Photo 5 – Bulged Area below Timber Deck, Looking Northeast.*

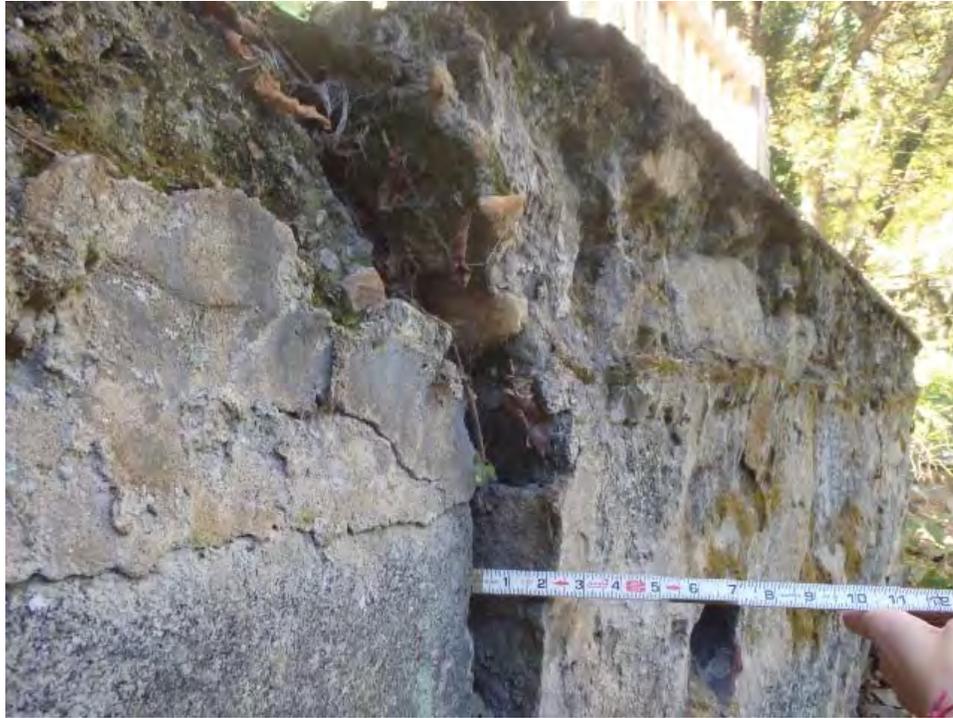
*Photo 5 – Fracture at 12' from West End, Looking West.*

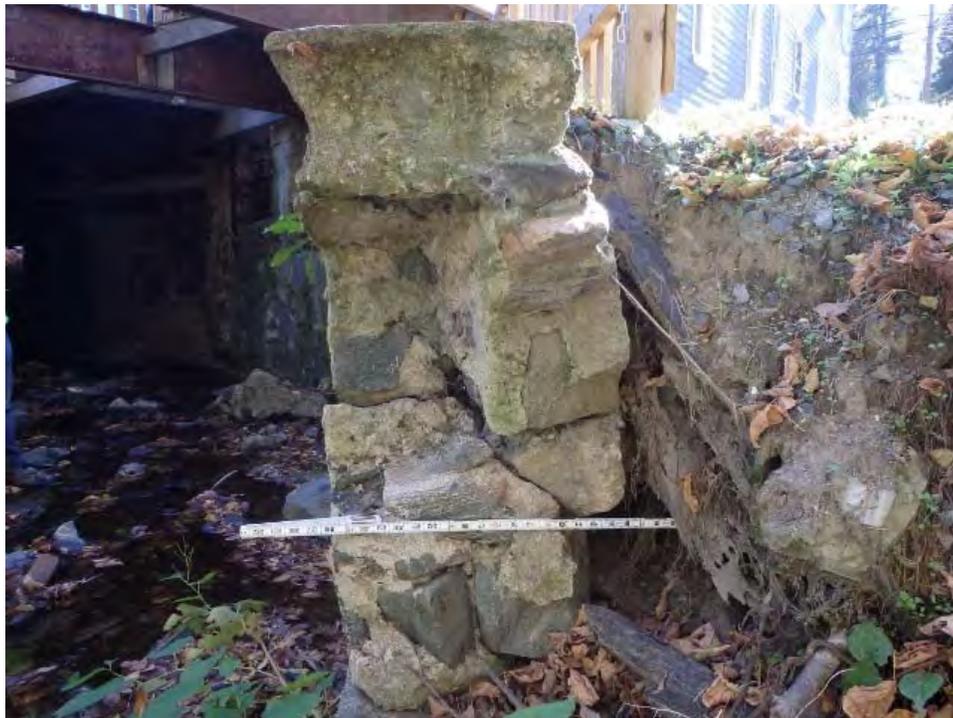
*Photo 6 – Full-Depth Fracture at West End, Looking East.  
Note Erosion at End of Wall.*
