# ELLICOTT CITY RETAINING WALLS INSPECTION REPORT

## STREAM WALLS

## HISTORIC ELLICOTT CITY, MARYLAND

MAY 2016

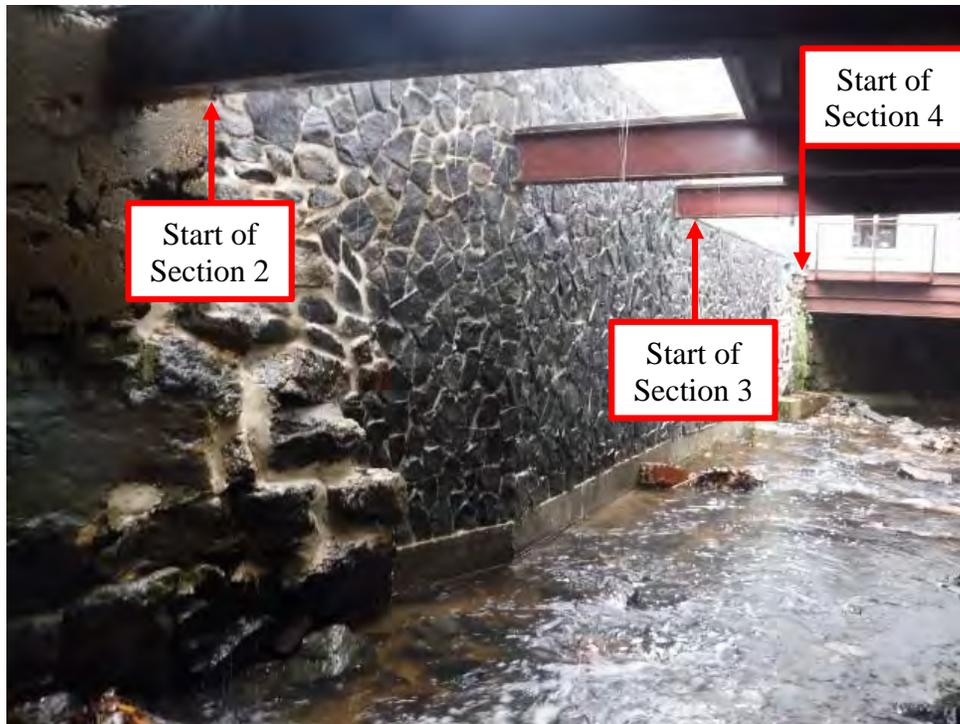
*Photo 2 – Elevation of Sections 2 and 3, Looking Northeast. Note Steel I-Beams Supporting Deck in Section 2 (beneath 8320 Main Street).*

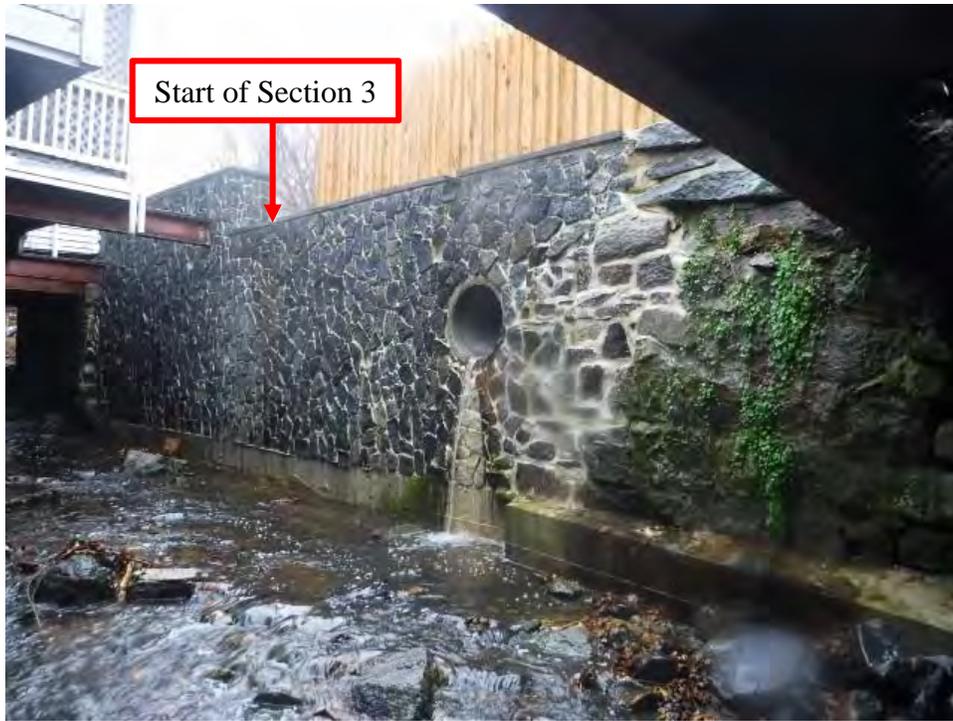
*Photo 3 – Elevation of Sections 2 and 3, Looking Northwest.  
Note Vegetation Growth at East End.*

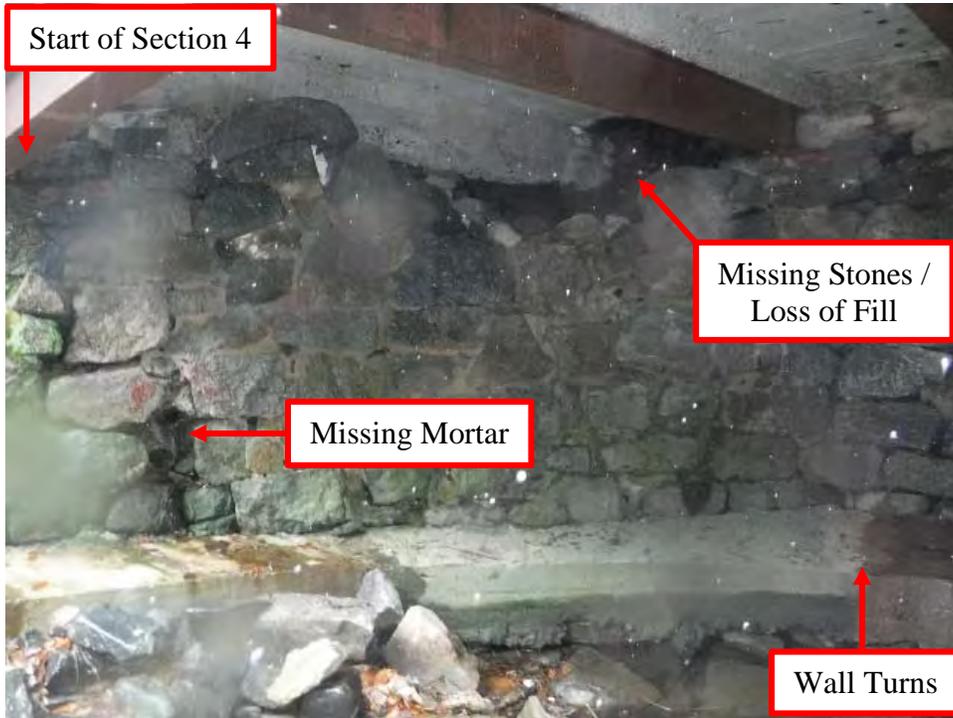
*Photo 4 – Elevation of Section 4 (beneath 8308 Main Street),  
Looking Northeast.*

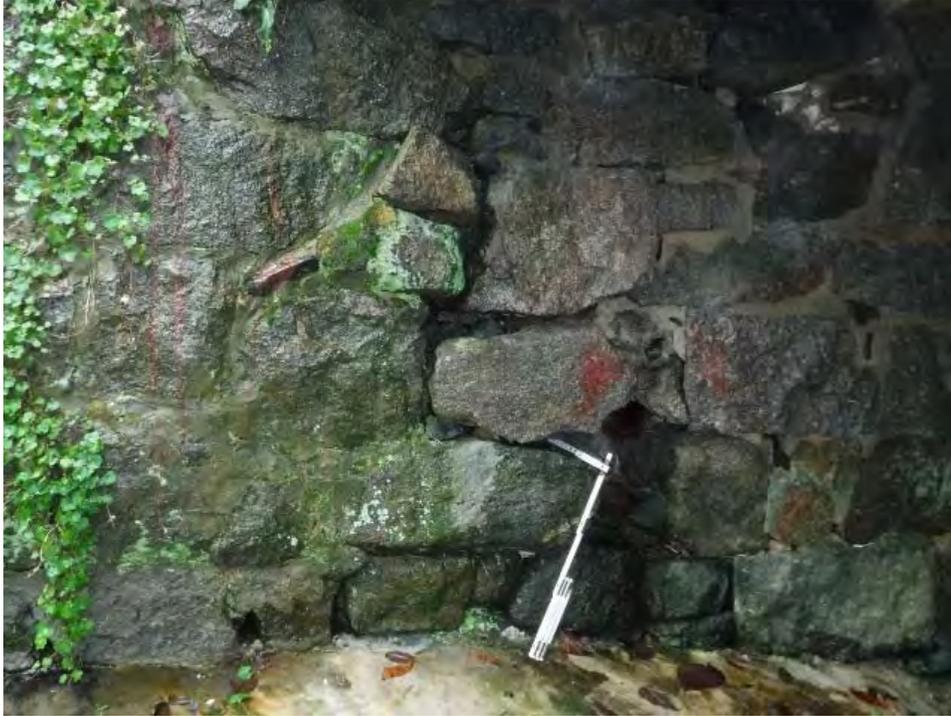
*Photo 5 – Missing Mortar at West End of Section 4.*

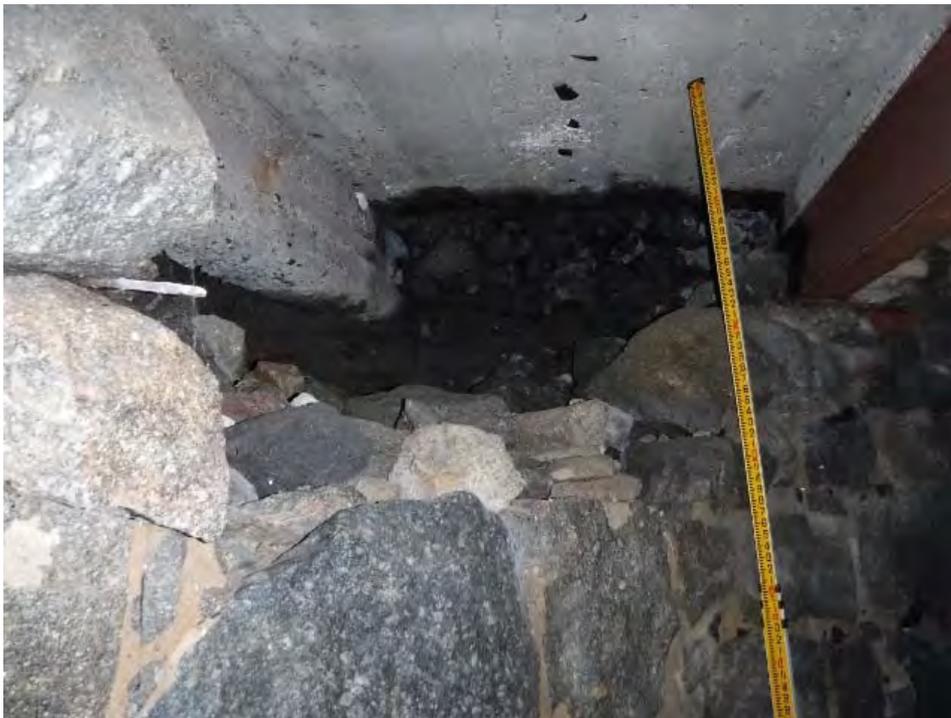
*Photo 6 – Missing Stones and Loss of Fill at Top of Wall, 6'-0" from West End of Section 4.*

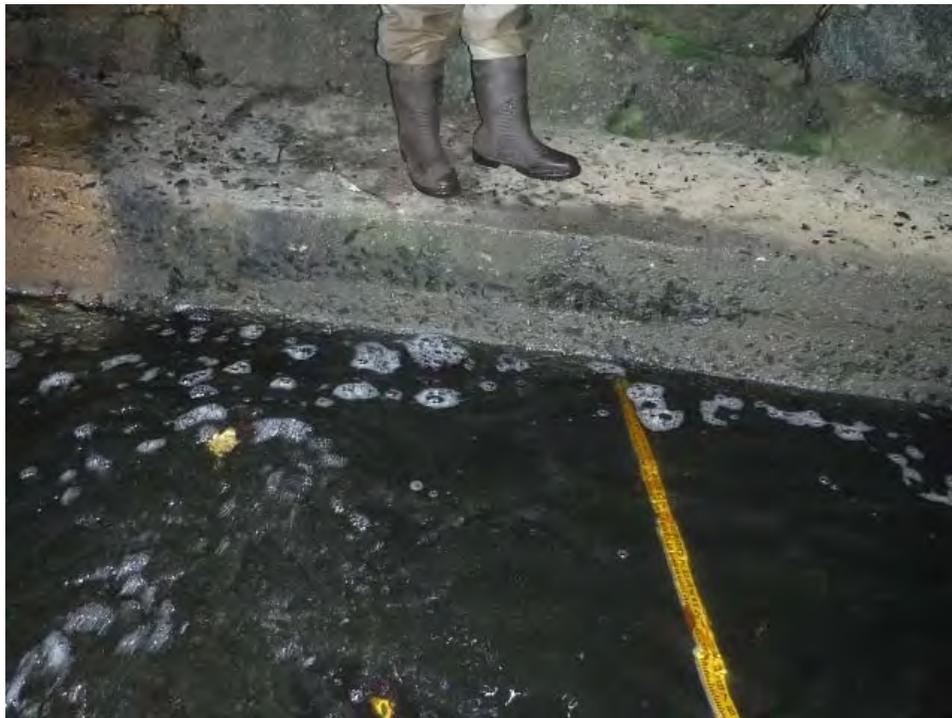
*Photo 8 – Undermined Concrete Footing in Section 4, Looking Northeast.*

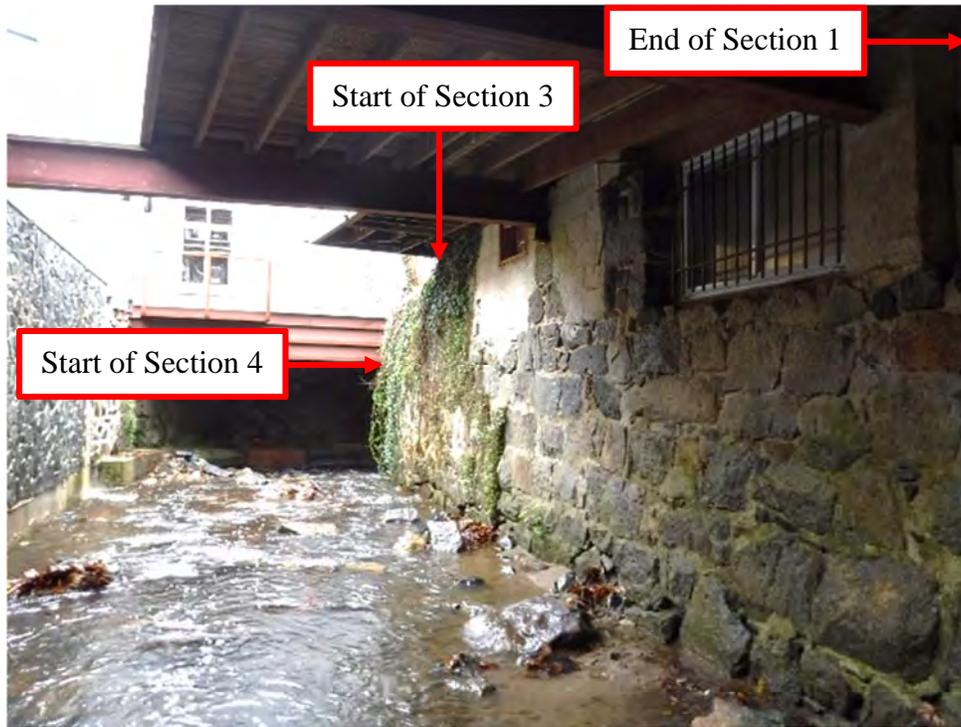
*Photo 3 – Elevation of Section 2 (beneath 8320 Main Street), Looking East.*

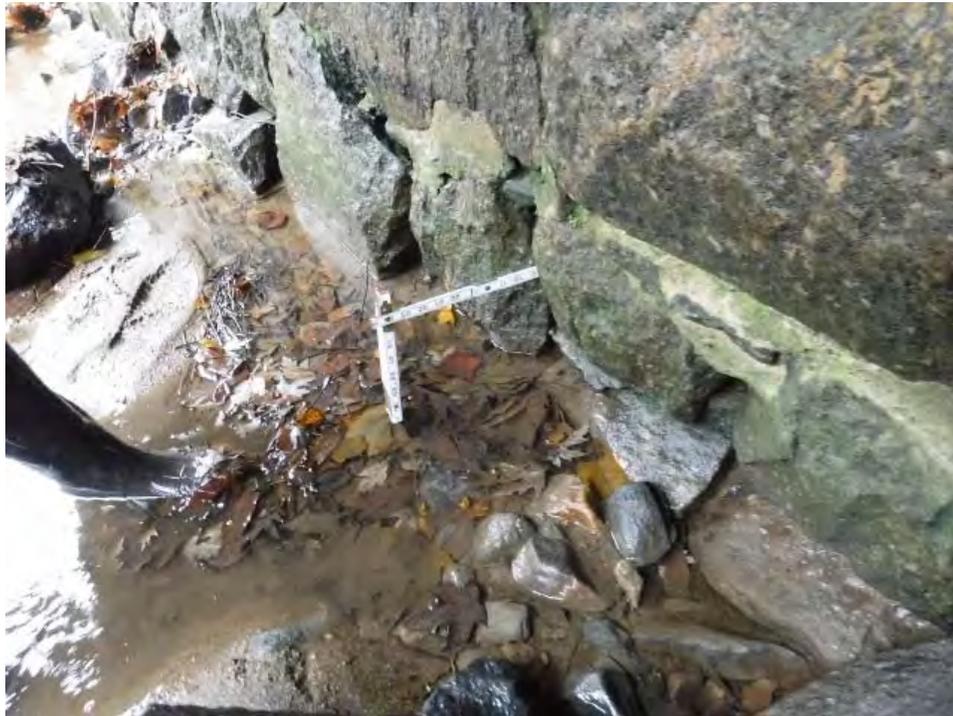
*Photo 4 – Typical Missing Mortar and Penetration into Joints in Section 2.*

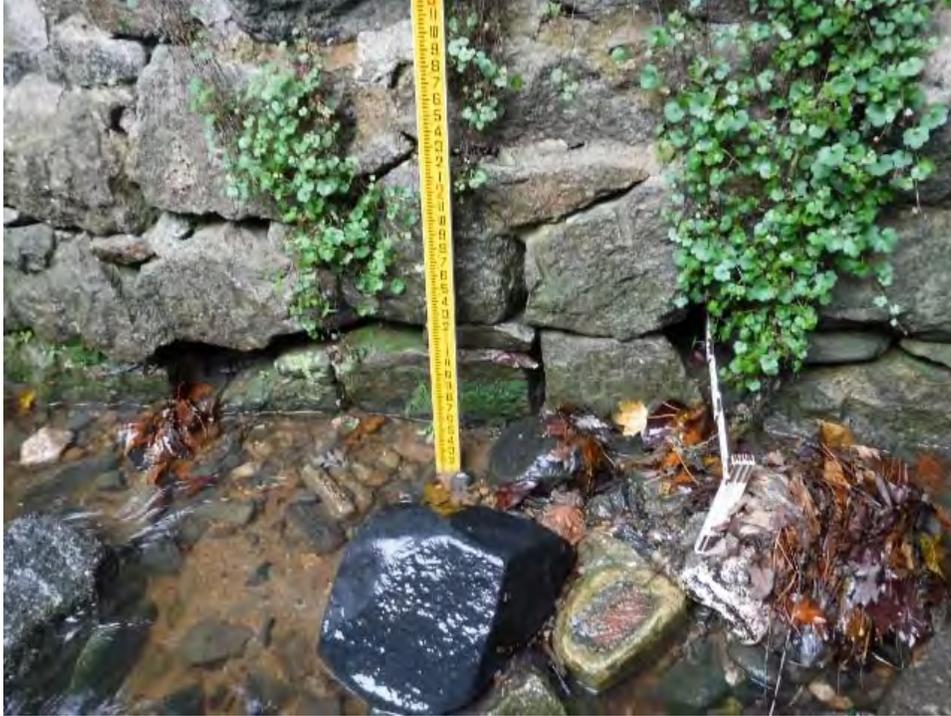
*Photo 5 – Missing Stones at Base of Wall in Section 2.*

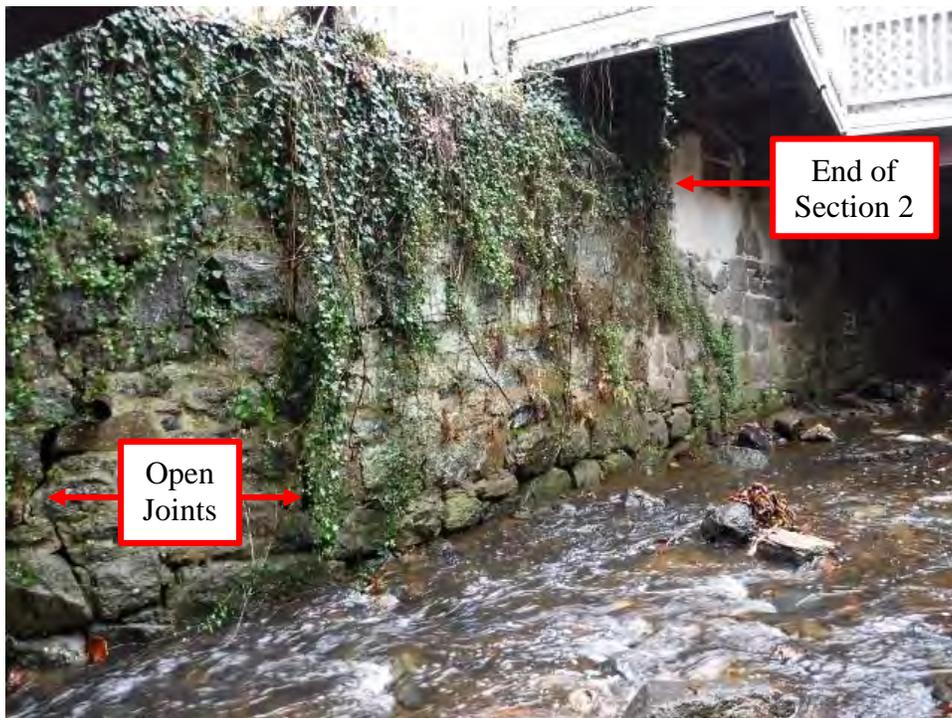
*Photo 6 – Elevation of Section 3 (beneath 8320 Main Street), with Missing Mortar and Vegetation Growth, Looking Southwest.*

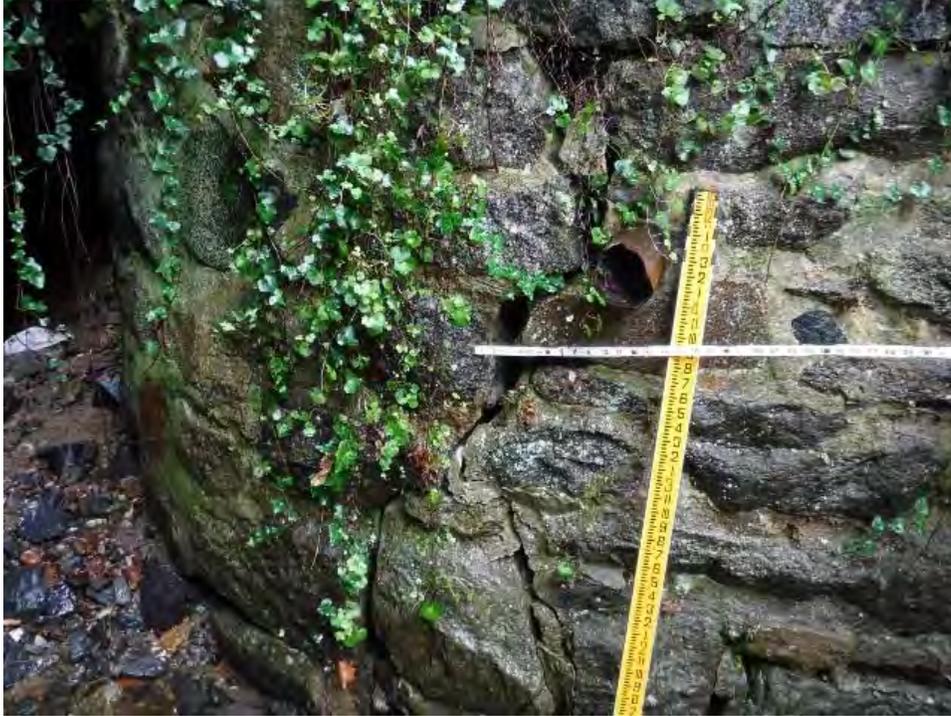
*Photo 7 – Masonry Joint Open to 4" Wide in Section 3, Looking Southeast.*

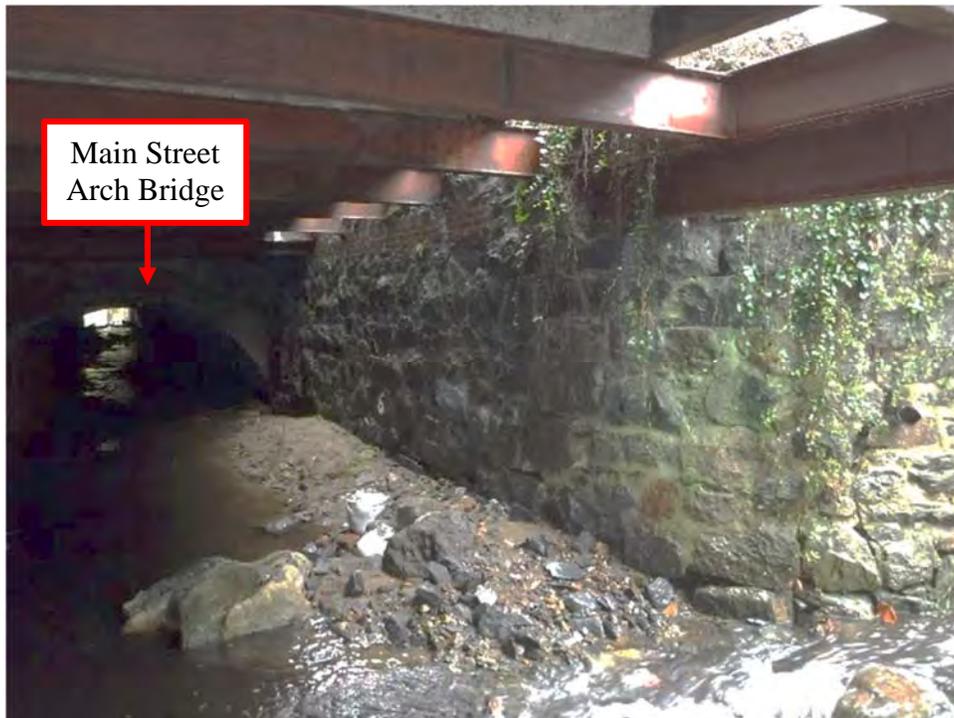
*Photo 8 – Elevation of Section 4 (beneath 8320 Main Street), Looking South.*

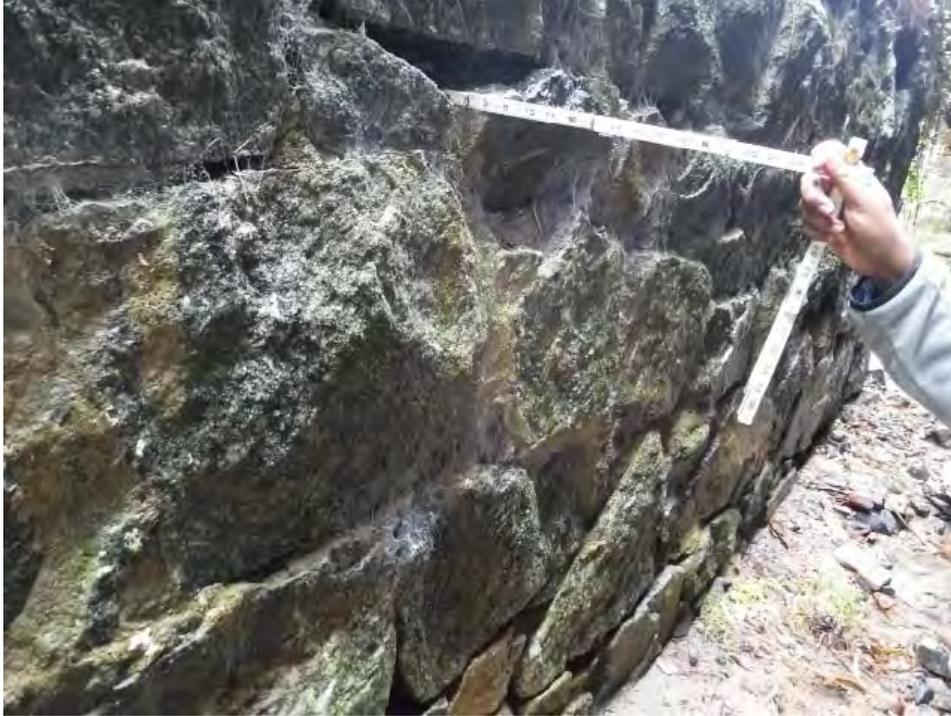
*Photo 9 – Typical Missing Mortar within Section 4.*

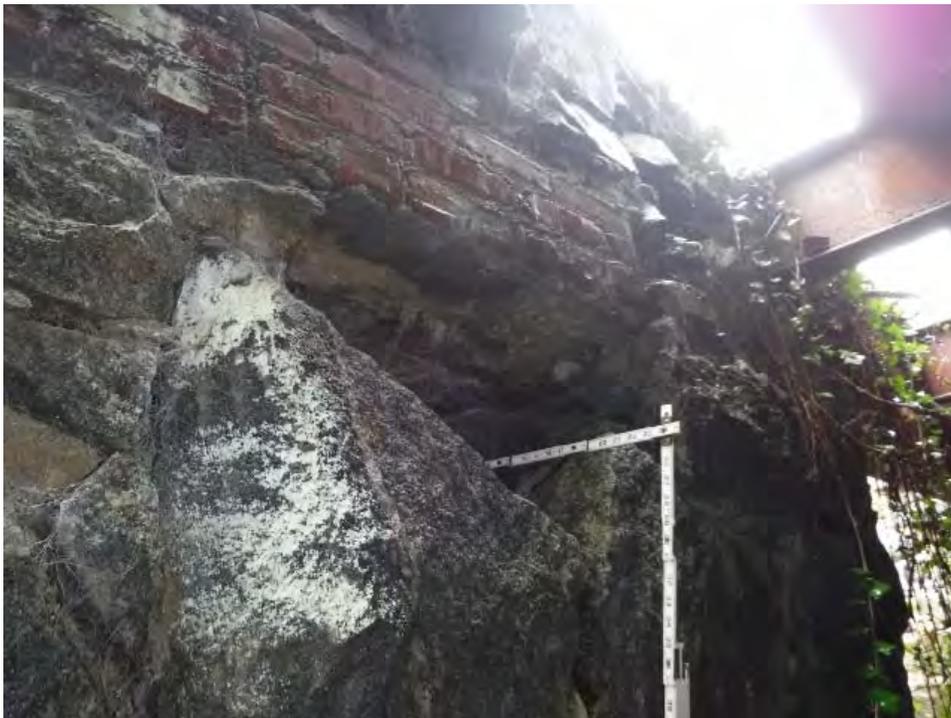
*Photo 10 – Missing Stone at Top of Wall in Section 4, 74' from West End of Wall.*

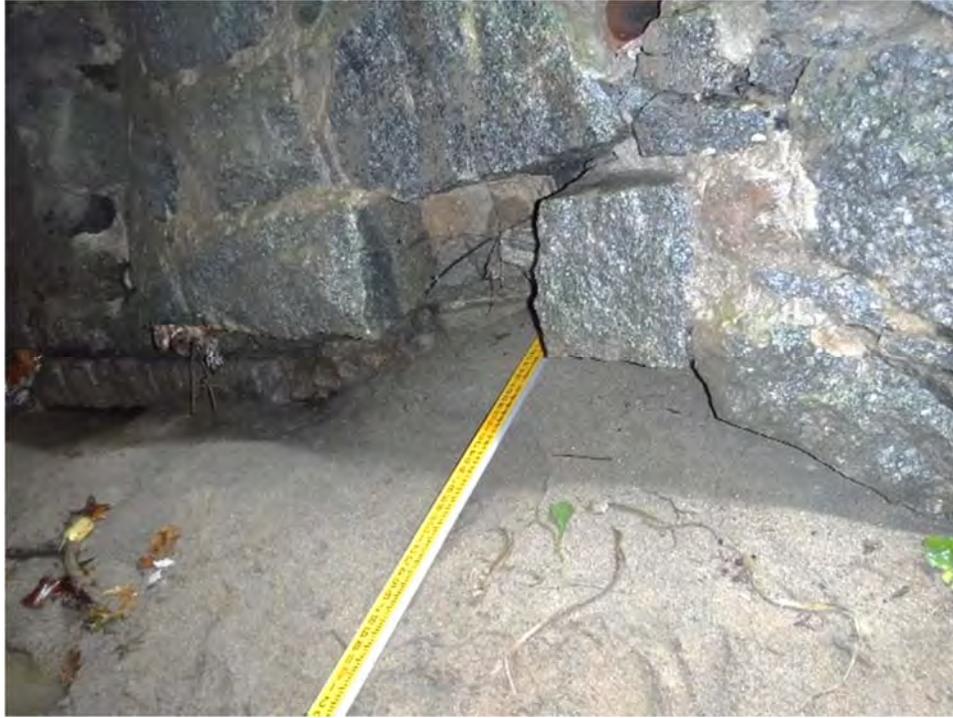
*Photo 11 – Typical Missing Stones along Base of Section 4, 5'-0" from the East End.*

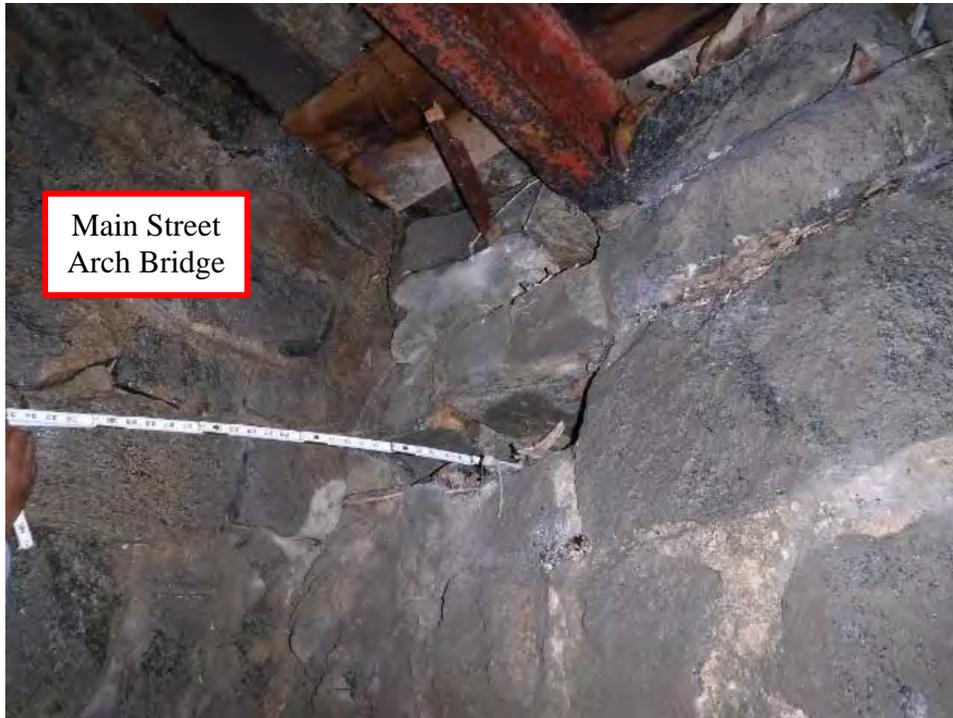
*Photo 12 – Missing Stone at Top of Wall at East End of Section 4.*

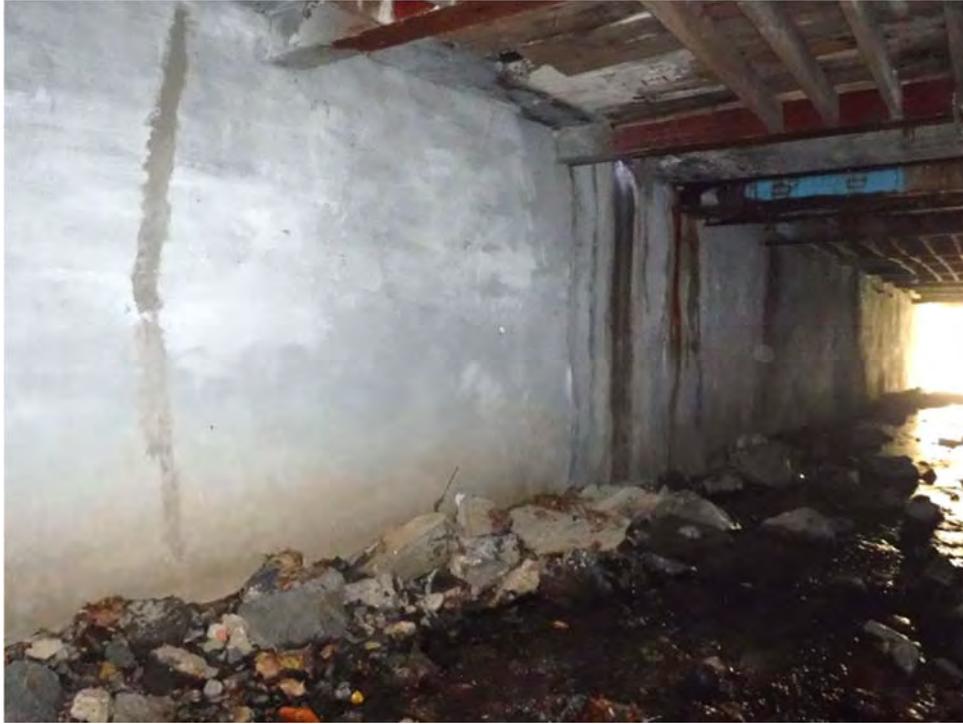
*Photo 3 – Wall Elevation, Looking Southeast.*

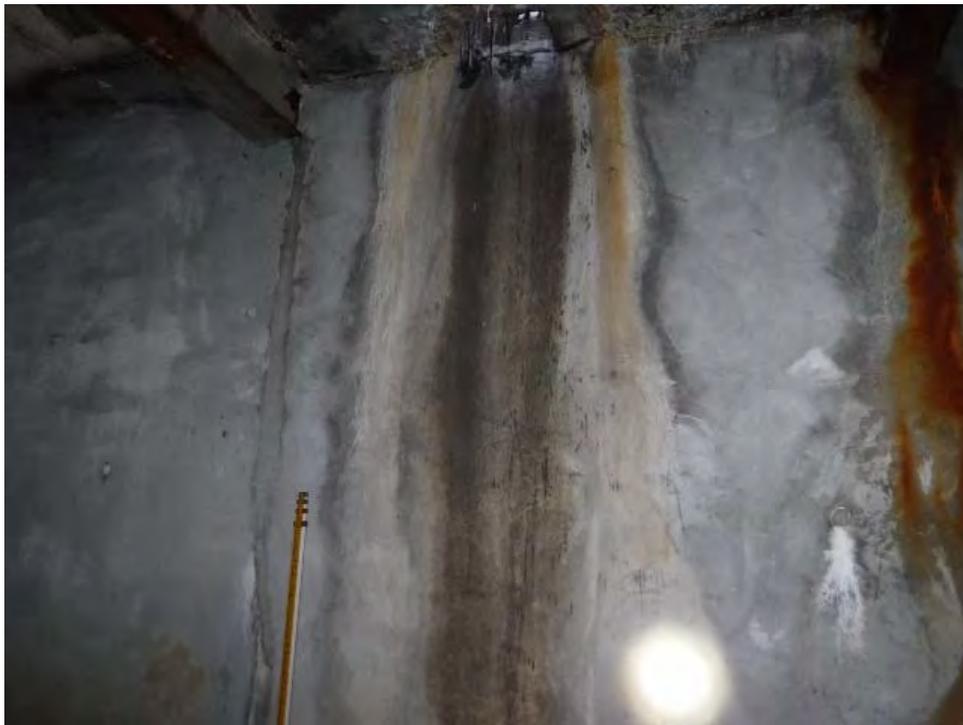
*Photo 4 – Moderate Efflorescence below Drain Pipe, 68' from North End of Wall.*

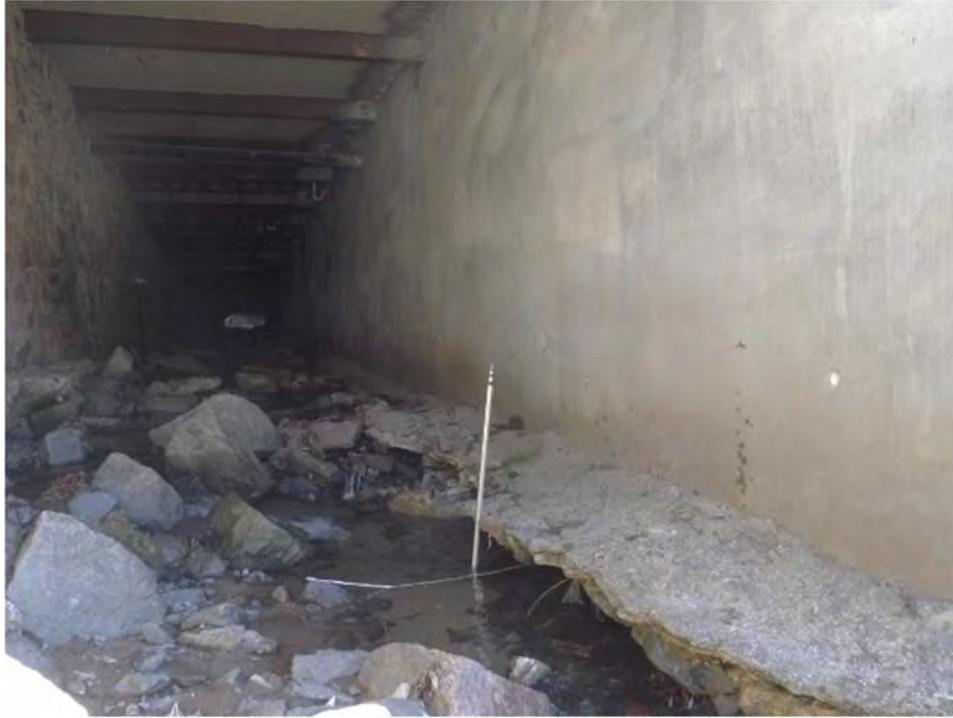
*Photo 5 – Undermined Concrete Overpour Starting 169' from West End of Wall, Looking Northeast.*

The undermining of the concrete overpour at the south end of the wall should be monitored for encroachment on the concrete retaining wall. No repairs are recommended at this time.

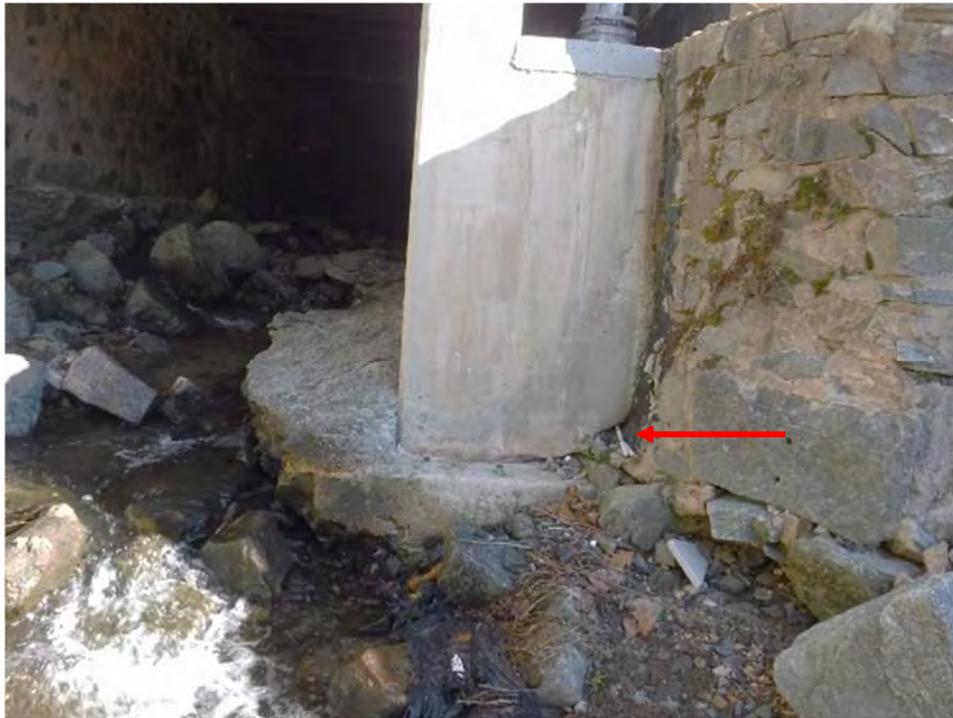
Overall, the retaining wall is in good condition. There are several full height vertical hairline cracks with minor efflorescence, typically located at the drains (see Photo 1). At the north end of the wall, there is a concrete bump-out located 1'-6" above the ground line, measuring 3'-6" high x 3'-0" wide x 4'-6" long (see Photo 2). At 68' from the north end of the wall, there is moderate efflorescence extending 5'-0" wide x full-height of the wall, below a drain pipe (see Photo 4). At 131' from the north end of the wall, there is a 58'-0" long x 3'-0" wide concrete overpour along the ground line. The overpour is undermined 20'-0" long x 1'-9" high x 3'-0" deep at the south end (see Photo 5). The undermining does not extend below the front face of the retaining wall. At the south end of the wall, on the south face, there is a small void at the back corner measuring 3" high x 5" wide x 6" deep (see Photo 6).

*Photo 6 – Void at South End of Wall, Looking North.*

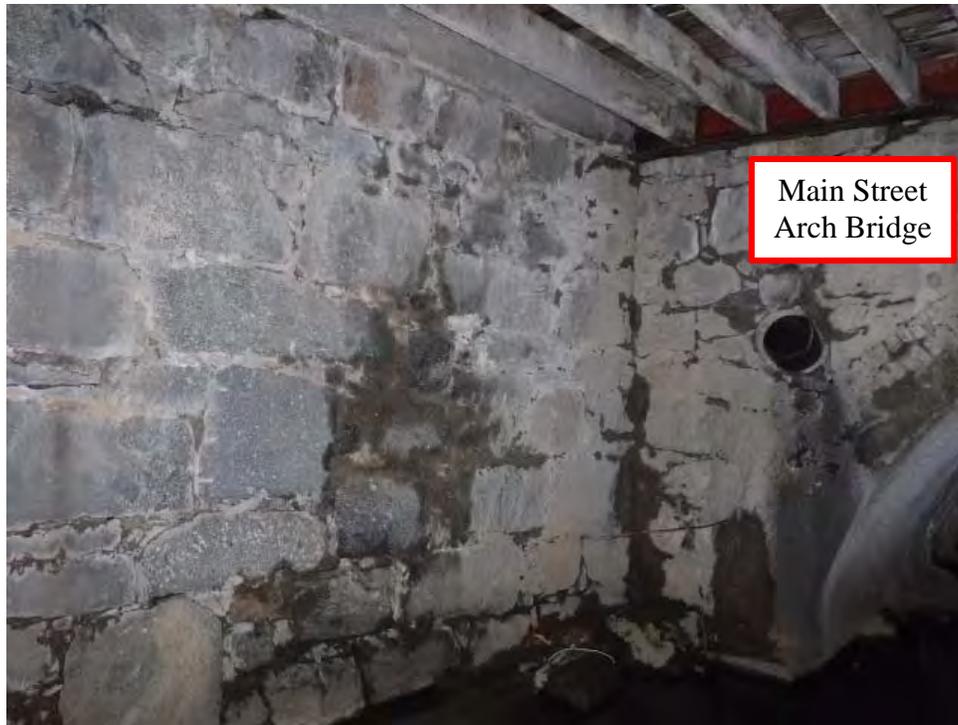
*Photo 1 – Elevation at North End, Looking Northwest.*

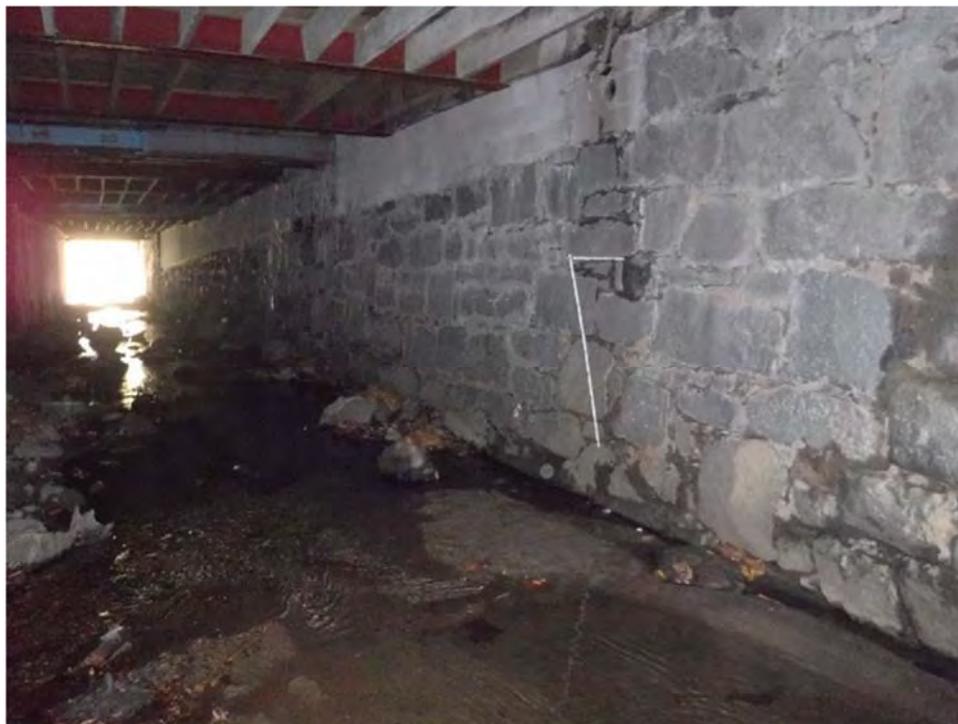
*Photo 2 – Wall Elevation, Looking Southwest.*

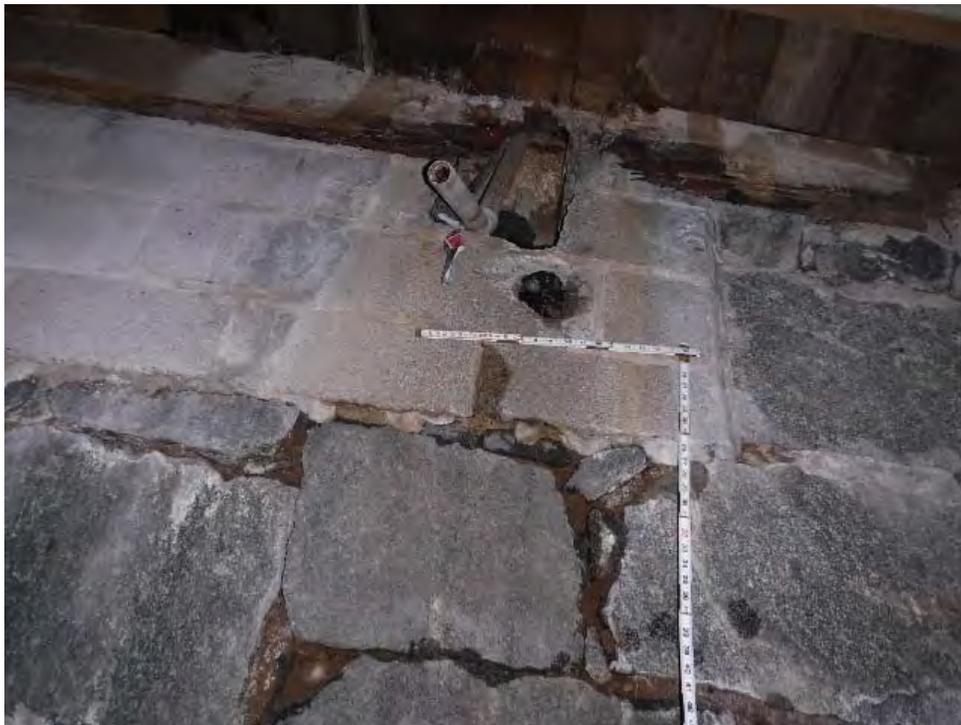
*Photo 4 – Pipe Access at Top of Wall, 17' from North End.*

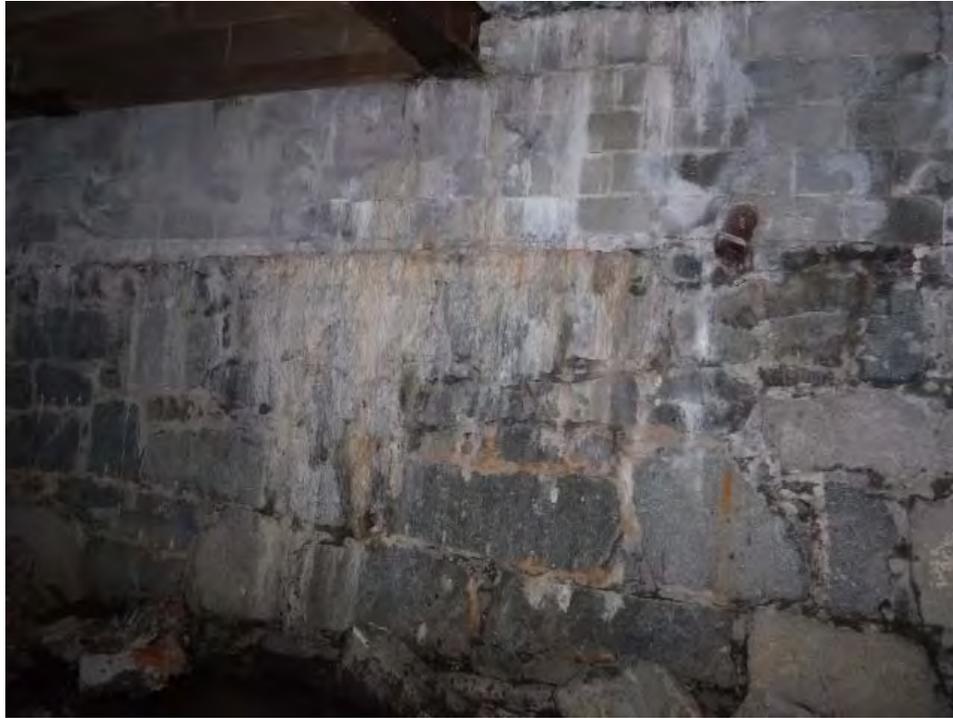
*Photo 5 – Heavy Efflorescence Located 46' from North End, Looking Southwest.*

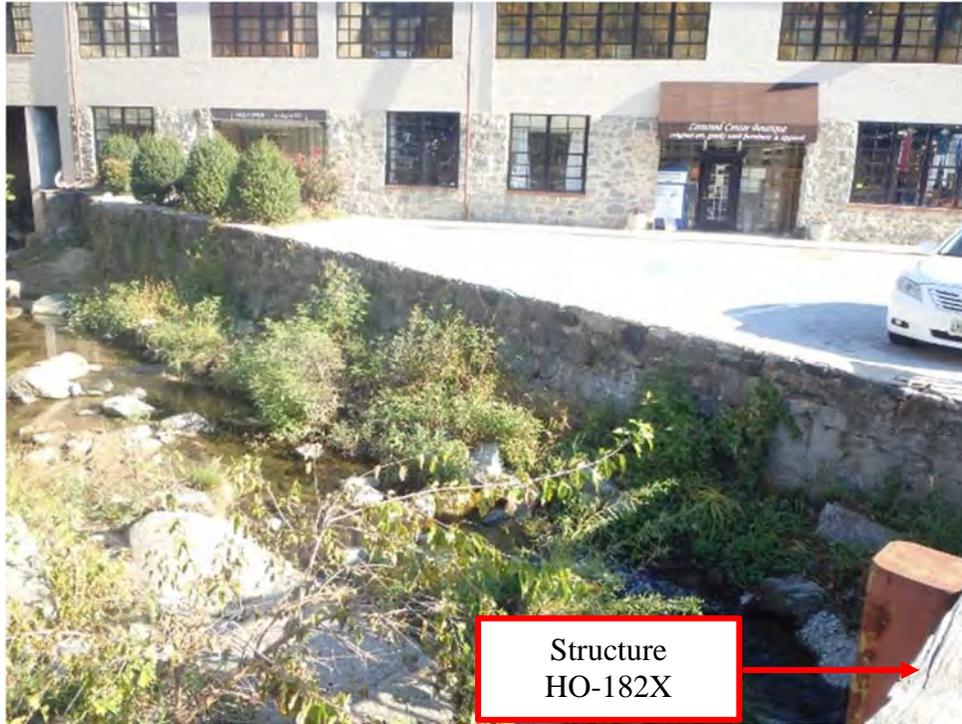
*Photo 1 – Elevation of Section 1, Looking Northwest.  
Note Vegetation Growth.*

The vegetation growth should be removed from the vicinity of the retaining wall. The masonry joints should be repointed throughout the wall where the mortar has deteriorated. Stones should be placed at the locations of voids with exposed fill. The west end of the retaining wall at the location of undermining (Section 1) and the undermining of the concrete overpour footing in Section 2 should be filled with grout.

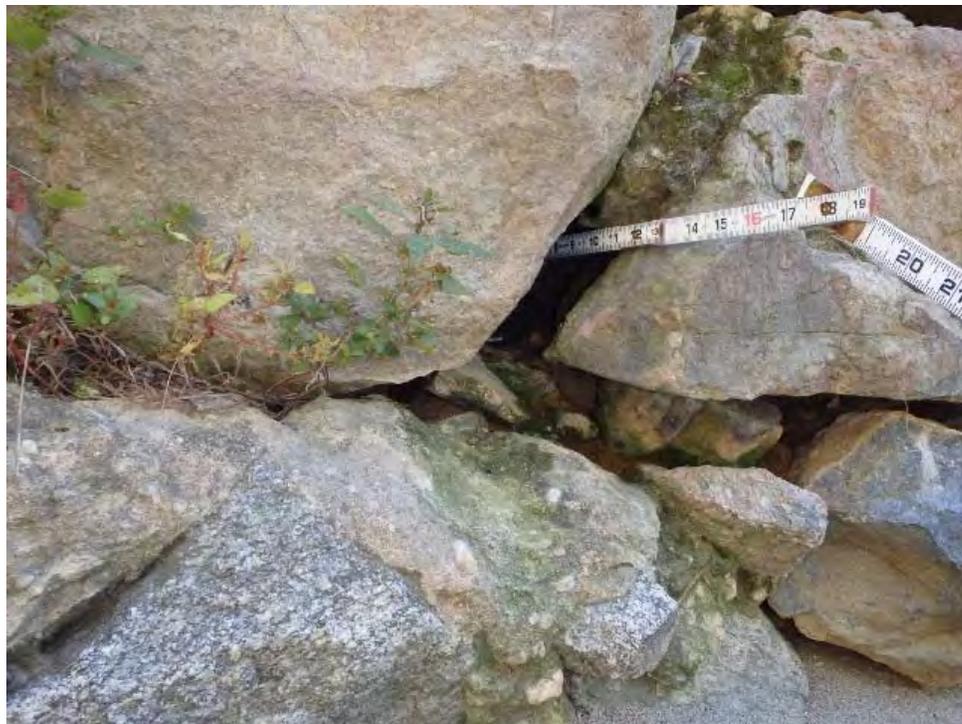
*Photo 2 – Typical Loss of Mortar and Small Stones within Section 1.*

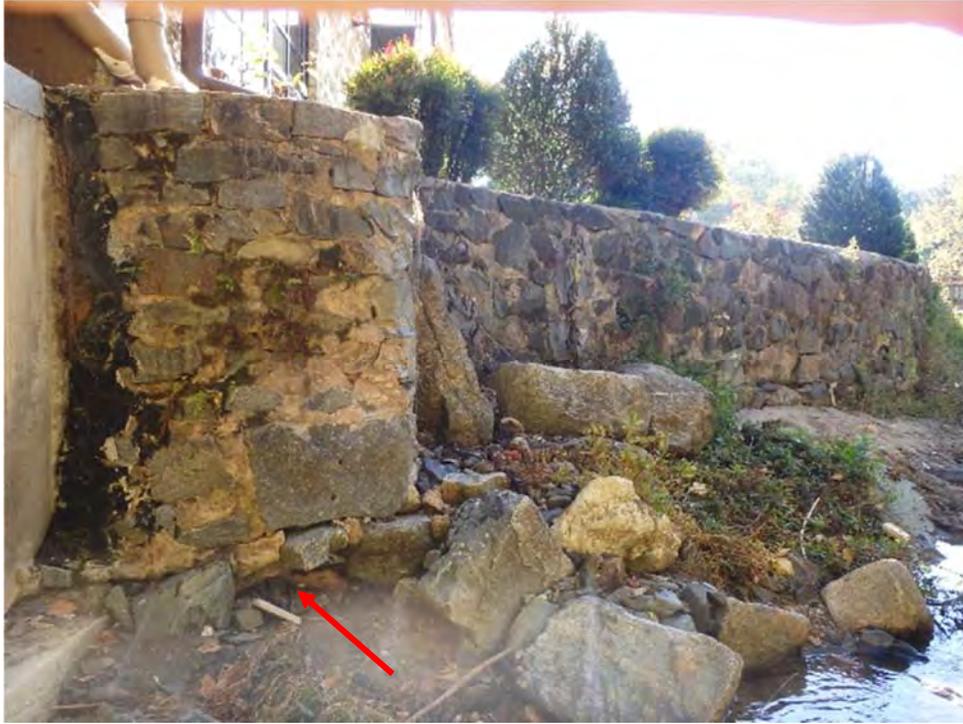
*Photo 3 – Undermining at West End of Wall, Looking East.*

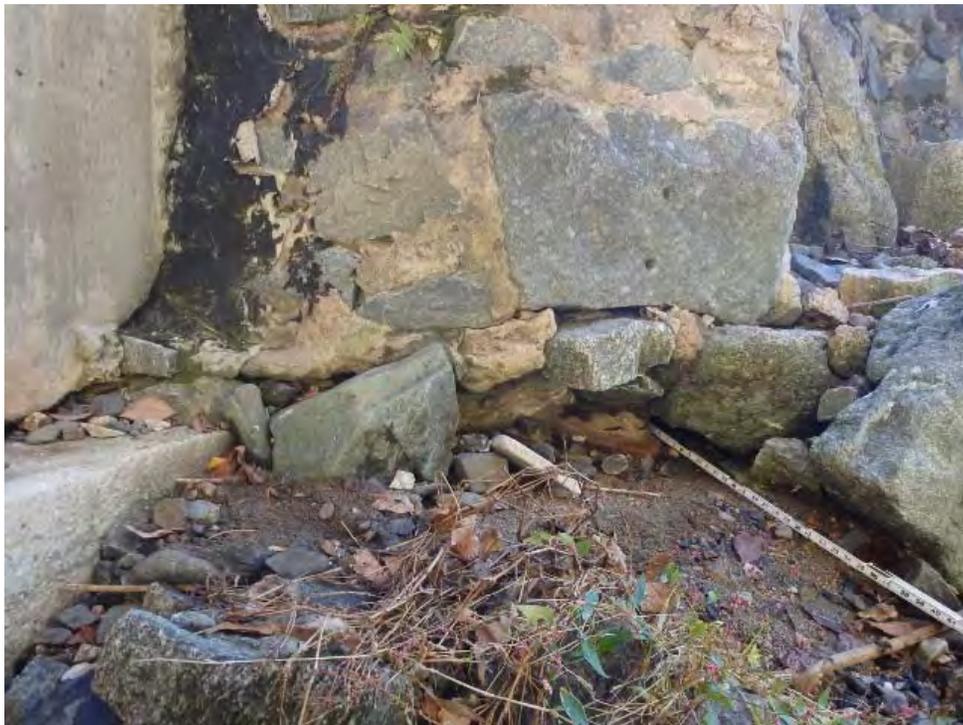
*Photo 4 – Undermining at West End of Wall, Looking North.*

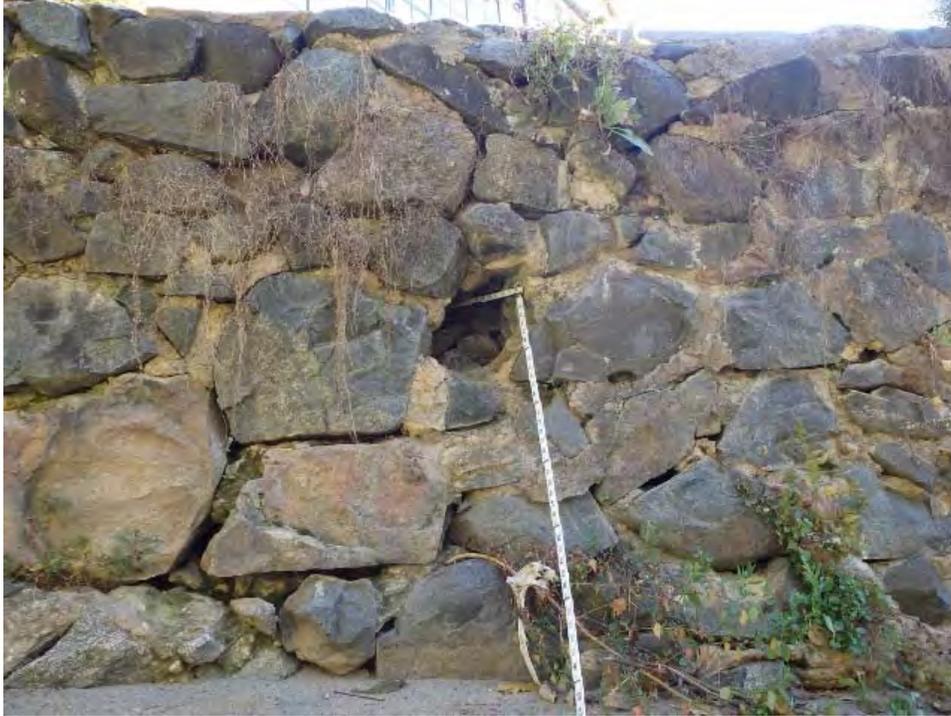
*Photo 5 – Void Located 26' from West End of Wall.*

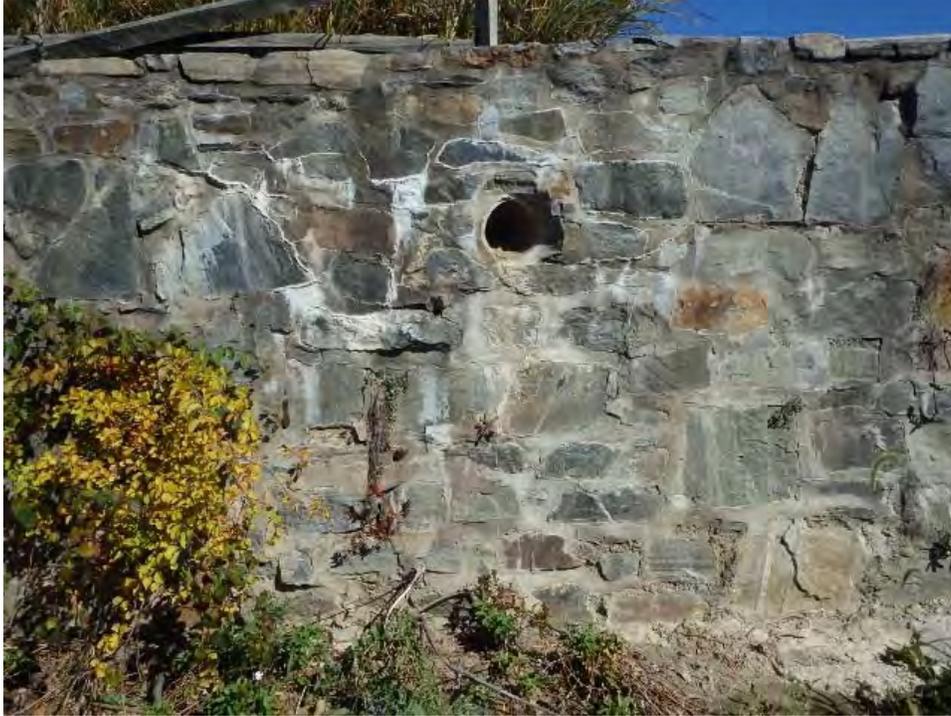
*Photo 7 – Moderate Efflorescence Surrounding Drain in Section 2.  
Note Minor Random Missing Mortar in Joints.*

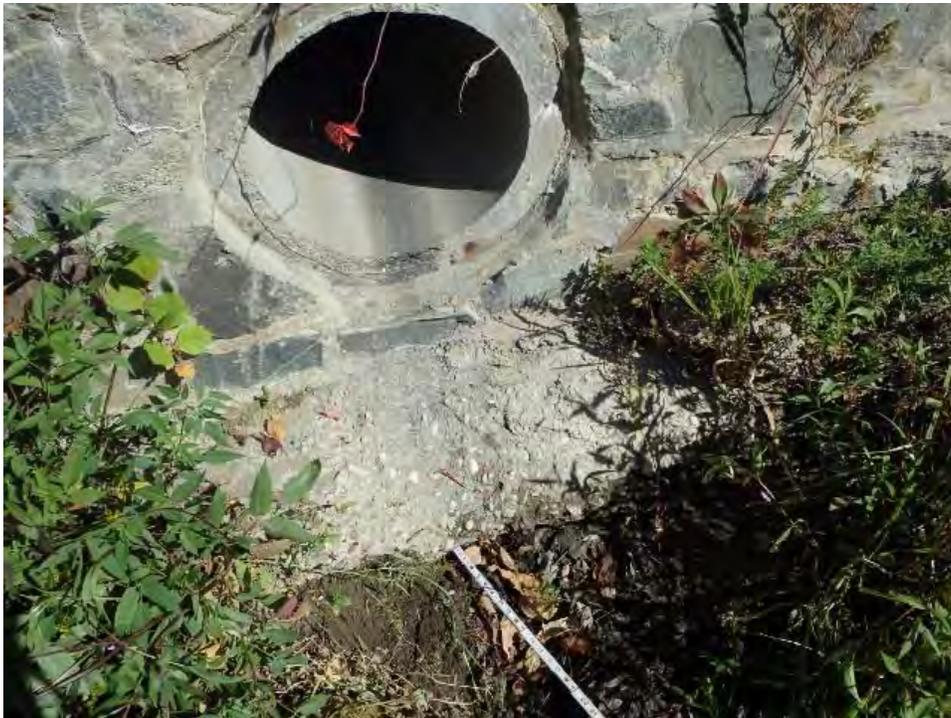
*Photo 8 – Exposed and Undermined Footing below Drain Pipe in Section 2.*

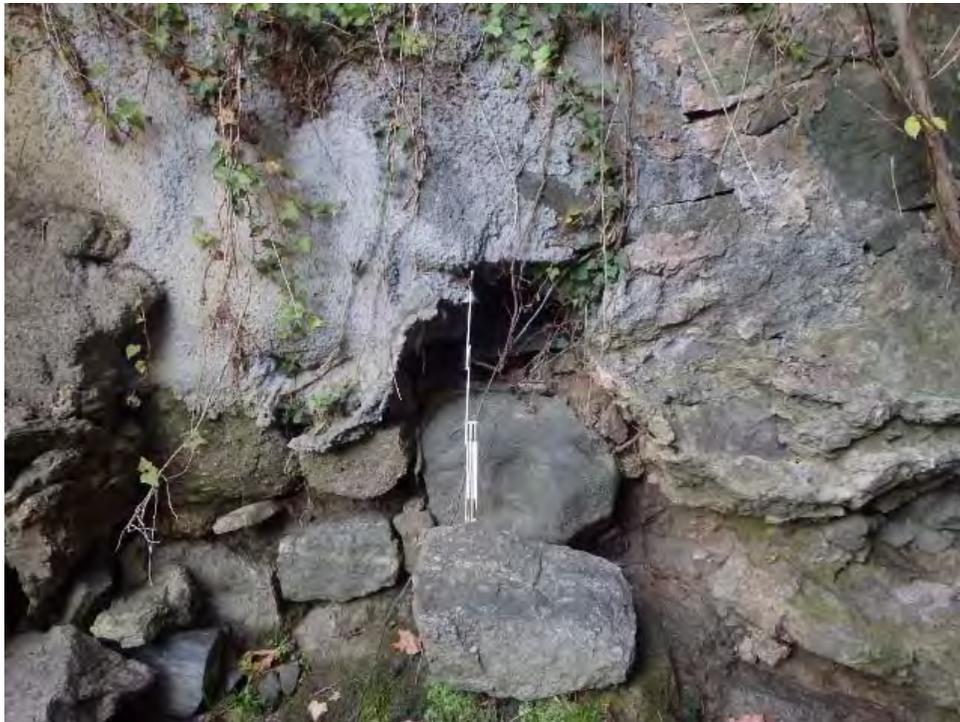
*Photo 2 – Void below P.A.M. Coating at 5' from West End of Wall.*

The vegetation growth in the vicinity of the wall should be removed immediately. The voids along the base of the wall in Section 1 should be filled. The area of bulging stones and failed coating at the east end of Section 2 should be repaired.
