# ELLICOTT CITY RETAINING WALLS INSPECTION REPORT

## STREAM WALLS

## HISTORIC ELLICOTT CITY, MARYLAND

MAY 2016

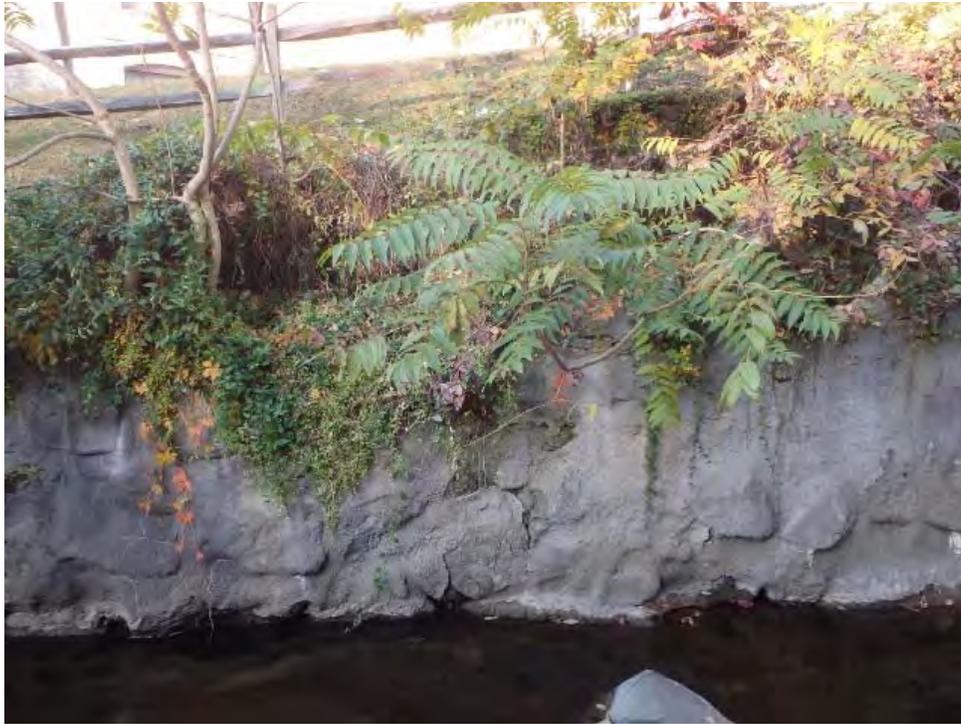
*Photo 3 – Typical P.A.M. Coating throughout Section 1 and Vegetation Growth along Top of Wall.*

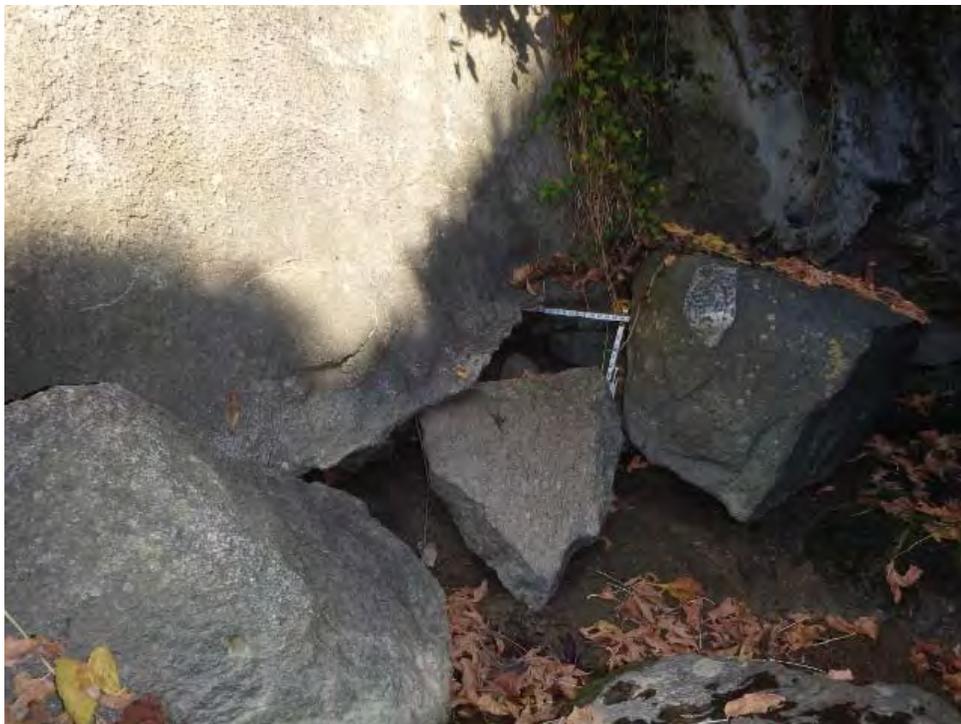
*Photo 4 – Void below P.A.M. Coating Probed to 2'-0" Deep, 9' from West End of Wall.*

The vegetation growth in the vicinity of the wall should be removed immediately. The voids along the base of the wall in Section 1 should be filled. The area of bulging stones and failed coating at the east end of Section 2 should be repaired.

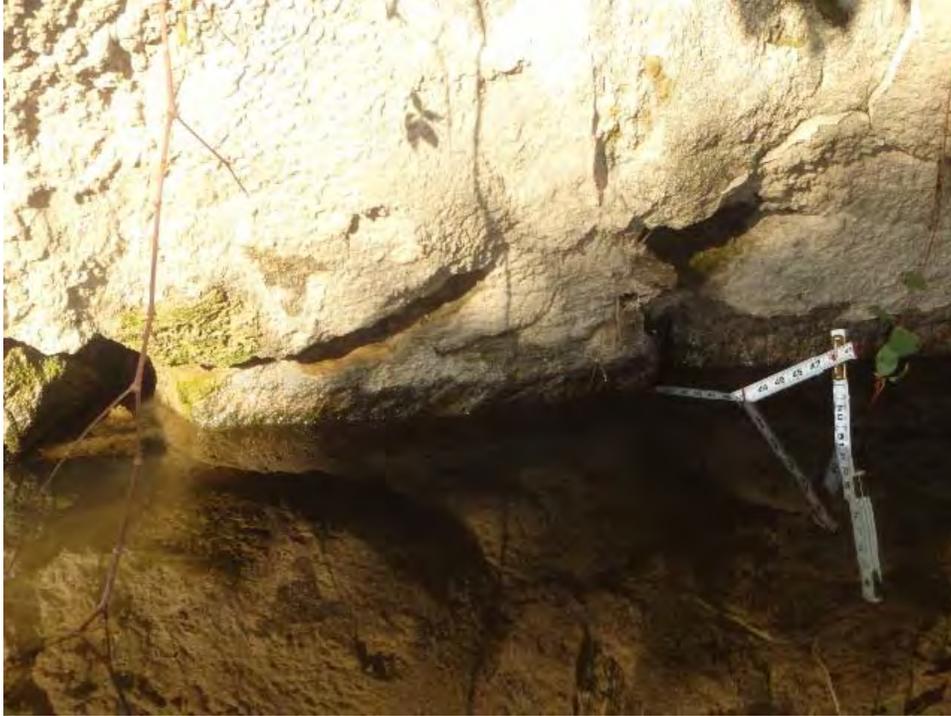
*Photo 5 – Void below P.A.M. Coating Probed to 3'-0" Deep, 26' from West End of Wall.*

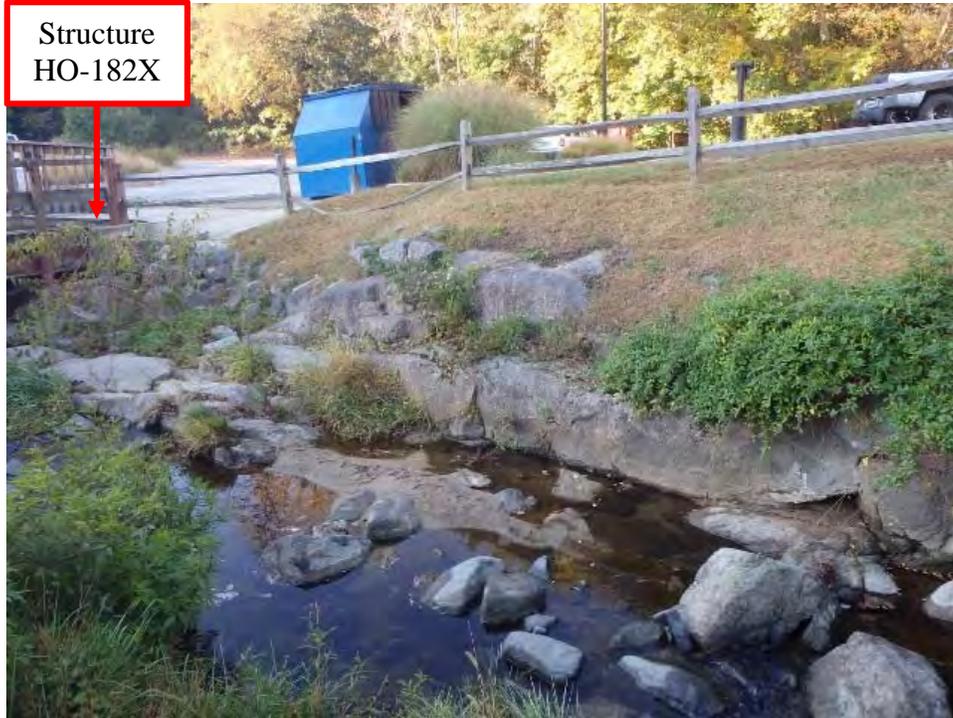
Overall, the retaining wall is in fair condition. There is vegetation growth in front of the wall throughout the length. Within Section 1 (western 107'), the stone masonry wall has been covered by a pneumatically-applied mortar (P.A.M.) coating, which typically ends 1'-0" above the ground line (see Photos 1 and 3). Starting 9' from the west end of the wall, there is missing mortar, random missing small stones, and vegetation growth throughout the top 9'-0" height of the wall (see Photo 1). At 5' from the west end of the wall, there is a void at the base of the wall measuring 2'-6" high x 2'-0" wide x 2'-4" deep (see Photo 2). Starting 9' from the west end of the wall, there are voids beneath the P.A.M. coating for a 5'-0" length, which could be probed 2'-0" deep to fill (see Photos 3 and 4). Starting 26' from the west end of the wall, there are voids beneath the P.A.M. coating for a 30'-0" length, which could be probed up to 3'-0" deep to fill (see Photo 5). The east end of Section 1 (adjacent to Structure HO-182X) is comprised of natural stone (see Photo 6).

*Photo 6 – Natural Stone at East End of Section 1, Looking Southeast.*

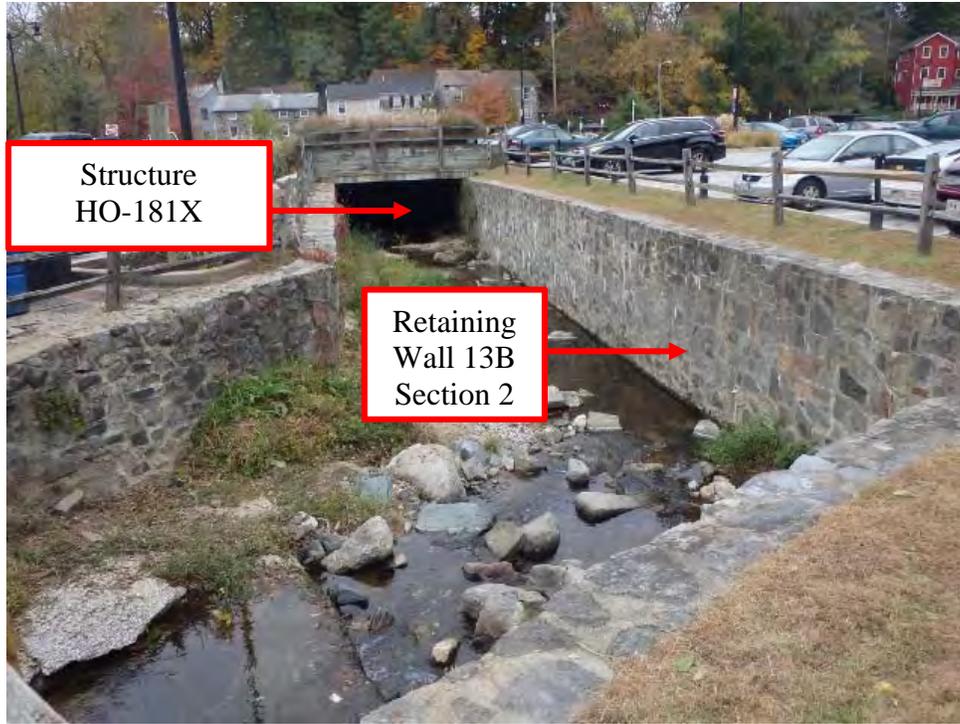
*Photo 7 – Elevation of Section 2, Looking East.*

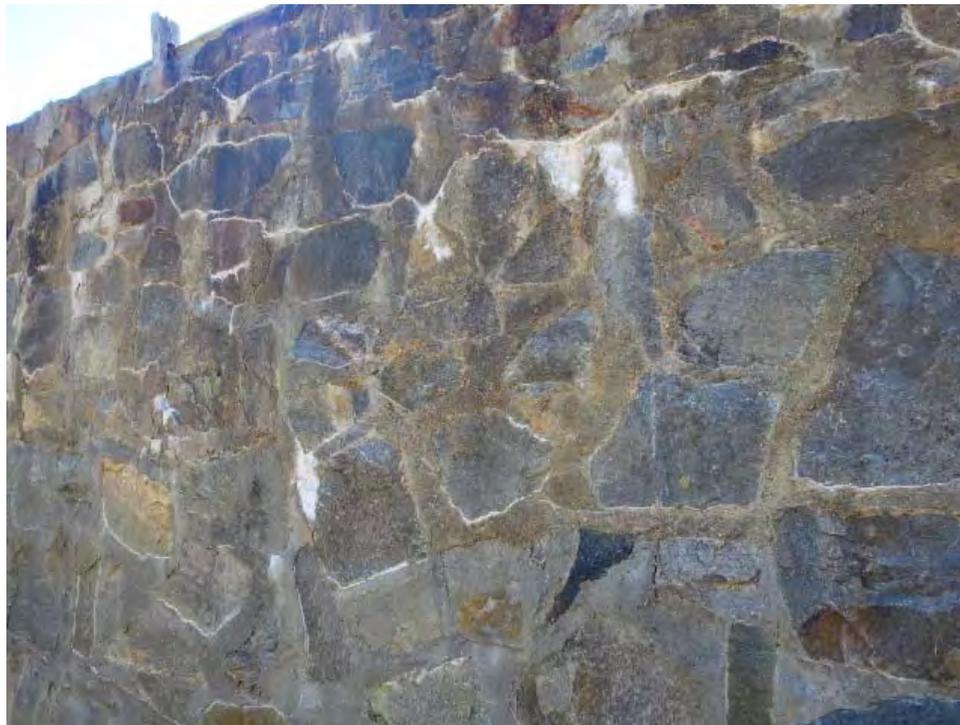
Section 2 extends from 120' to 226' from the west end of the wall. The stone masonry exhibits light efflorescence in the mortar joints (see Photo 8). At the east end of Section 2, there is a full-height x 7'-0" wide area of missing mortar, missing small stones, and vegetation growth. There is minor bulge in this area. Pneumatically-applied mortar has been placed over the stone masonry in this area; however, it is failing (see Photo 9).

*Photo 8 – Typical Light Efflorescence in Mortar Joints in Section 2.*

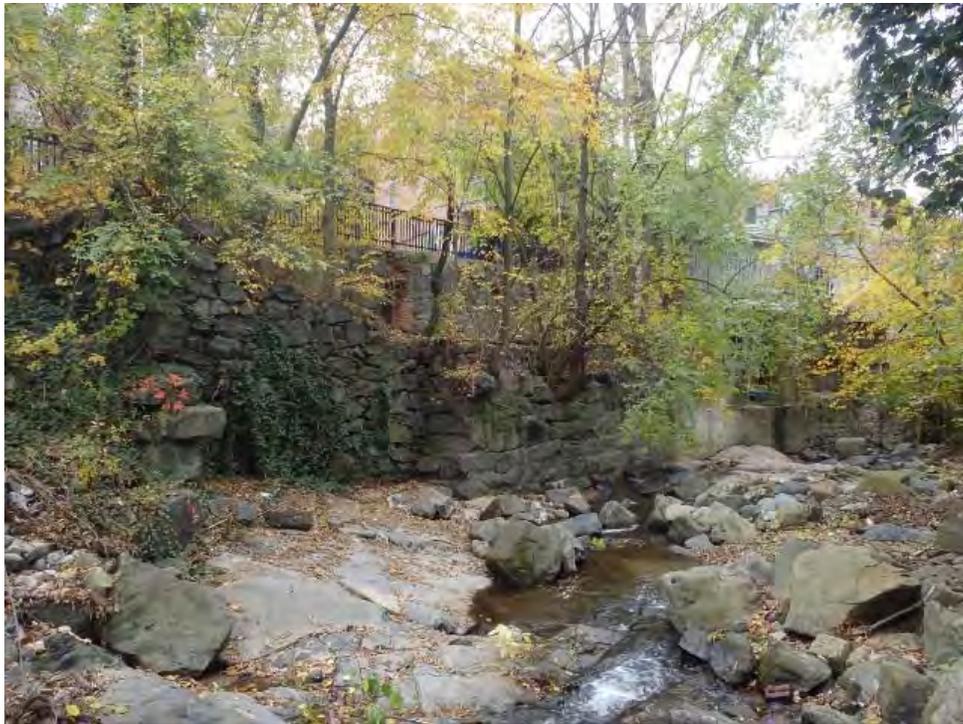
Section 2 extends from 88' to 145' from the west end of the wall and is comprised of large stones with missing mortar and voids which could be probed to 3'-0" deep (see Photos 2 and 3). There are several large trees growing along the top of the wall, which are impacting the wall (see Photo 4). There is vegetation growth through the open joints throughout Section 2.

*Photo 2 – Elevation of Section 2, Looking Northeast.*

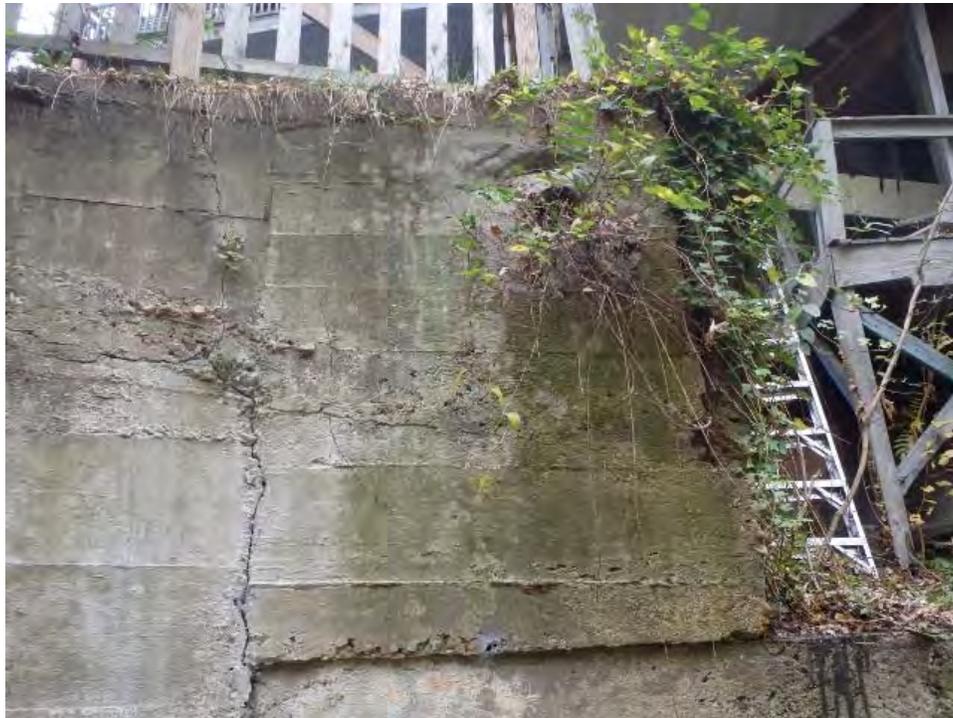
Section 3 extends from 145' to 185' from the west end of the wall and is comprised of concrete (see Photo 5). The wall has a full-height fracture at 157' from the west end, which was open to ¼" wide (see Photo 5). There is a large tree (~2'-0" diameter trunk) located behind the wall, in line with this fracture, that could be impacting the wall. The bottom of the wall was undermined for a 10'-0" length x 6" high and could be probed up to 1 foot deep (see Photo 5). The top right corner of the wall (5'-0" high x 4'-0" wide) has fractured and is leaning up to 4 inches towards the channel (see Photos 5 and 6). The portion of the wall perpendicular to this corner (running north-south towards house) was leaning to the east. This portion of the wall supports a timber house column at the corner of the house. The column was out of plumb, although measurements were not taken due to lack of access (see Photos 7 and 8). The presence of erosion behind the wall was not investigated. This area was noted in a Critical Findings Memo to Howard County on October 30, 2015.

*Photo 6 – Top Corner Fractured and Leaning in Section 3, Looking North.*

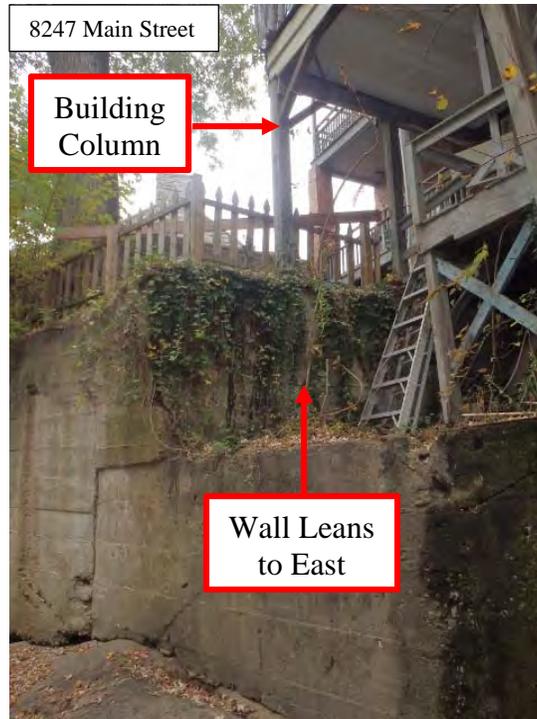
*Photo 7 – Building Column Bearing on Retaining Wall; Out of Plumb, Looking Northwest.*

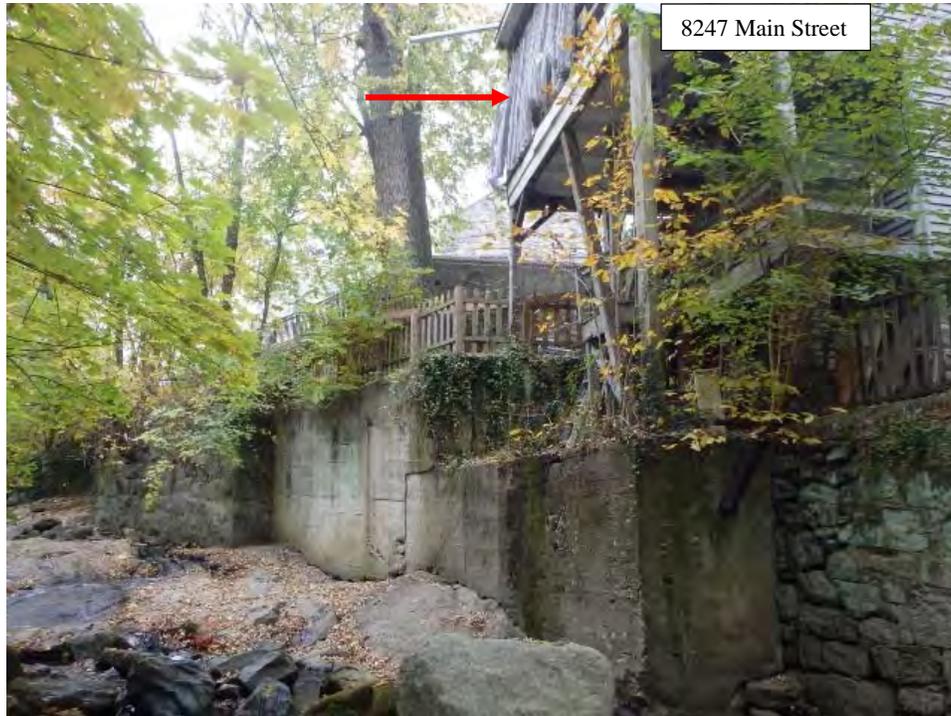
*Photo 8 – View of Cantilevered Portion of Building over Section 3, Looking West.*

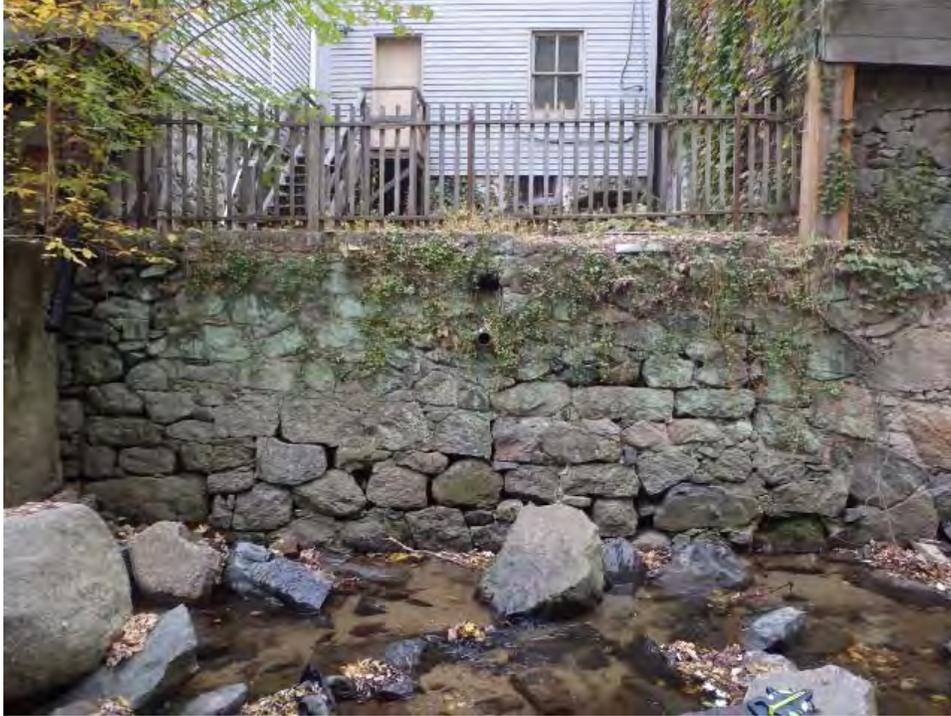
Section 4 extends from 185' to 281' from the west end of the wall and is comprised of stone masonry which has missing mortar and voids which could be probed to 2'-0" deep, and vegetation growth (see Photo 9). There is a 1'-0" high x 1'-0" wide void above a drain pipe near the top of the wall at the west end (see Photo 10). There is a 10'-0" wide stone masonry wall which has been constructed on top of the original wall, under a cantilevered portion of a house (see Photo 11). The base of the original retaining wall exhibited a 10'-0" long x 2'-0" high void with undermining that could be probed 2'-0" deep to fill (see Photo 11). Starting at 223' from the west end of the wall,

*Photo 9 – Section 4 West Half Elevation, Looking North.  
Note Missing Mortar, Voids, and Vegetation Growth.*

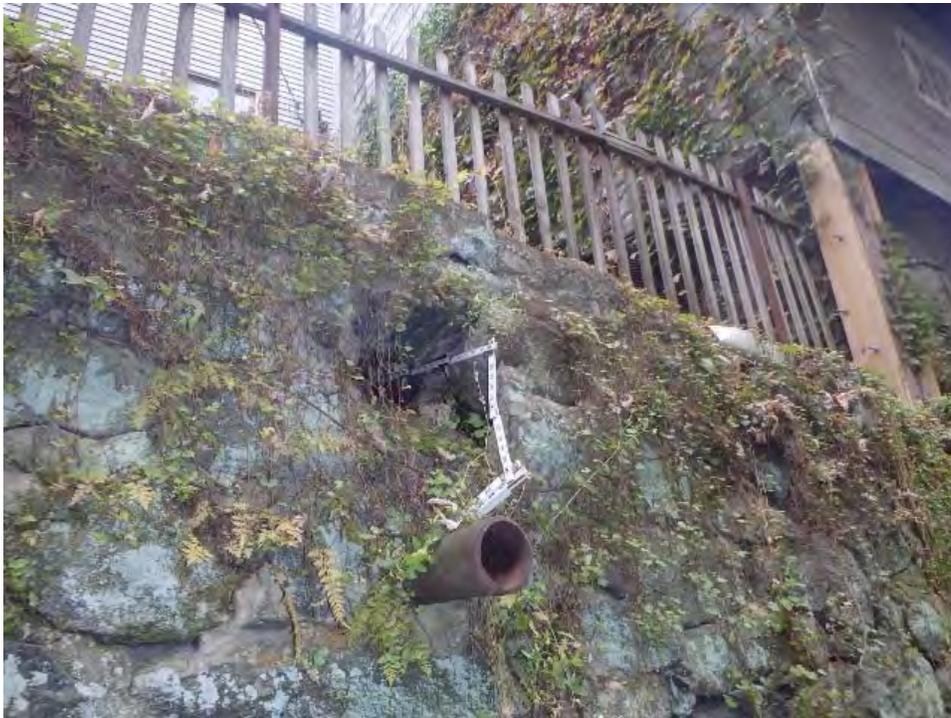
*Photo 10 – Void above Drain Pipe in Section 4, Looking Northeast.*

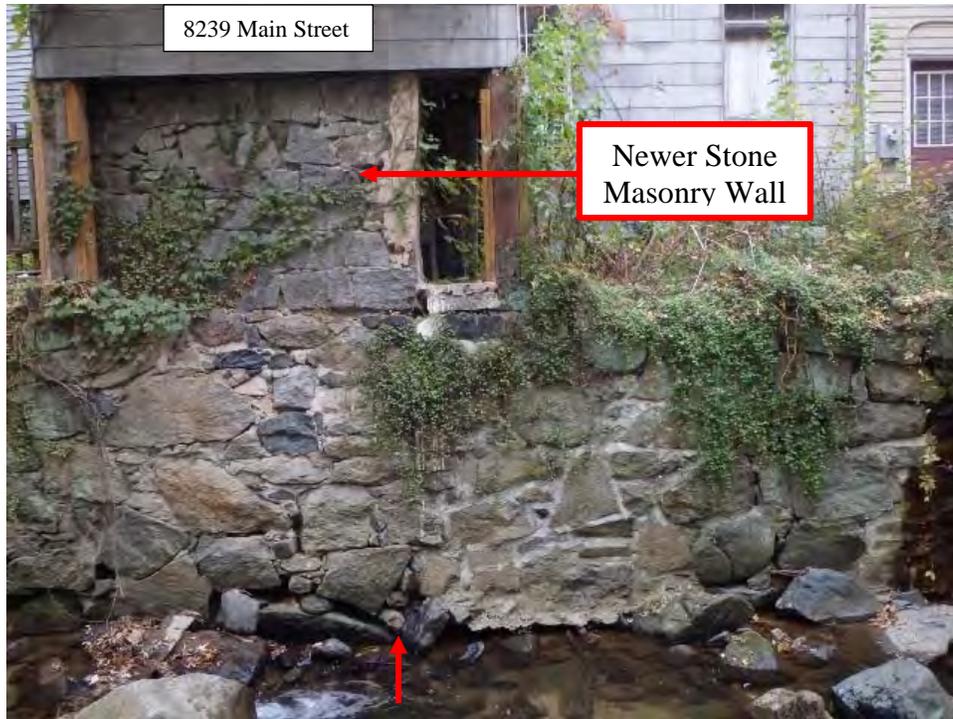
*Photo 11 – Section 4 Elevation, Looking North.  
Note Voids and Undermining along Base.*

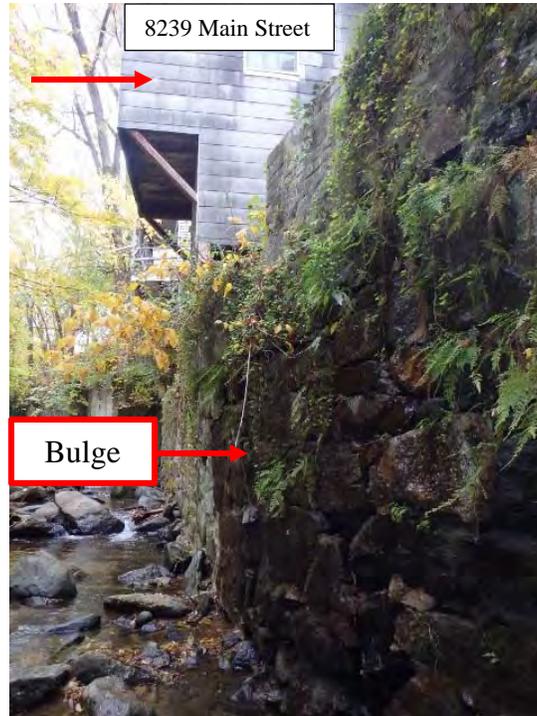
there is a 10'-0" wide area of bulging with up to 4" of horizontal displacement (see Photo 12). The bulging was worse at the top of the wall. The presence of sink holes or erosion behind the retaining wall was not investigated due to lack of access. There was vegetation growth with root systems at the top of the wall and randomly throughout the mortar joints. This area was noted in a Critical Findings Memo to Howard County on October 30, 2015. At 233' from the west end, there is a 10'-0" wide portion of the wall which exhibited active water leakage through the open joints (see Photo 13). The voids at the joints could be probed up to 5'-0" deep to fill. There is a brick wall bearing on top of the stone masonry wall, and a building column which bears on this brick wall at the west corner of the building (see Photo 13). The back face of the building bears on the stone masonry wall in the eastern half of the property (see Photo 13). At the east end of Section 4, the back face of a building bears on the stone masonry wall (see Photo 14). There were typically voids probed 2'-6" deep to fill with vegetation growth. There is a large void (missing stones) at the base of the wall at 263' from the west end, measuring 2'-0" high x 3'-0" wide x 2'-6" deep (see Photo 14).

*Photo 12 – View of Cantilevered Portion of Building over Section 4,  
Looking West. Note Bulging Wall.*

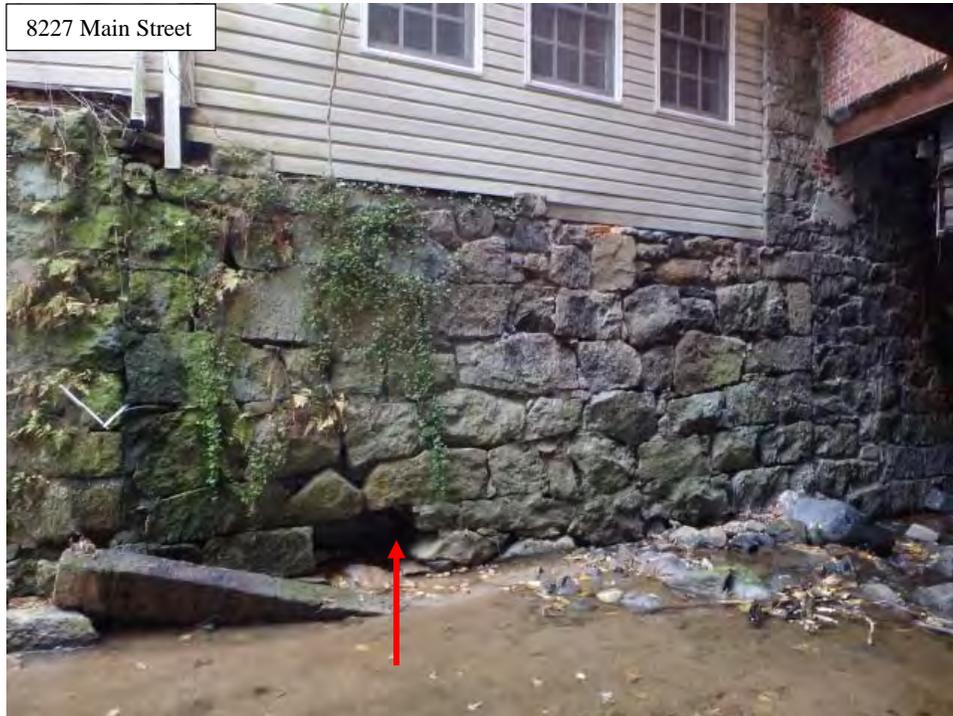
*Photo 14 – Section 4 Elevation at East End, Looking Northeast.  
Note Missing Mortar, Voids, and Vegetation Growth.*

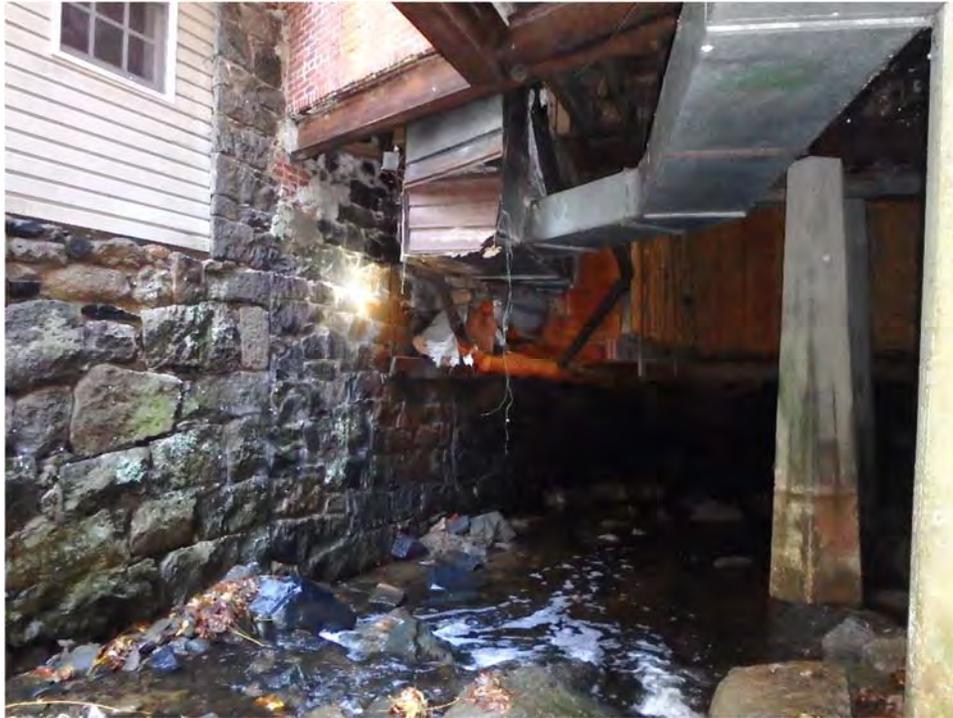
*Photo 15 – Elevation at West End of Section 5, Looking Northeast.*

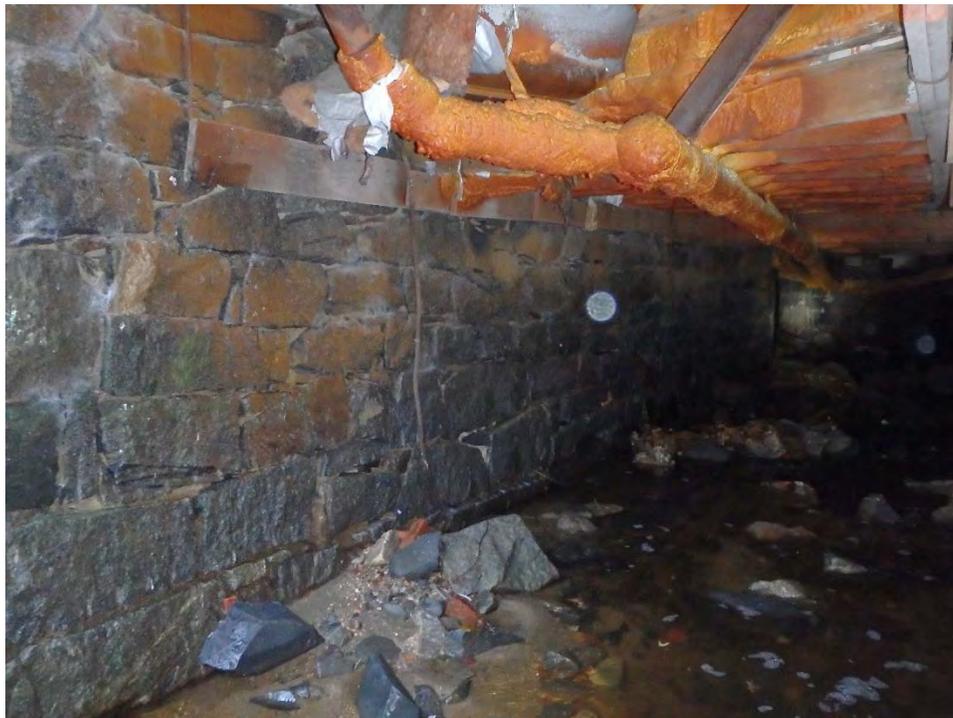
Section 5 extends from 281' to 342' from the west end of the wall and is comprised of stone masonry (see Photos 15-18). There is missing mortar throughout 50% of the joints, which could be probed to 1'-6" deep (see Photo 16). The bottom of the wall at the west end has a 7'-0" long x 5" high x 1'-0" deep area of undermining (see Photo 19).

*Photo 16 – Elevation of West Half of Section 5, Looking Northeast.  
Note Missing Mortar.*

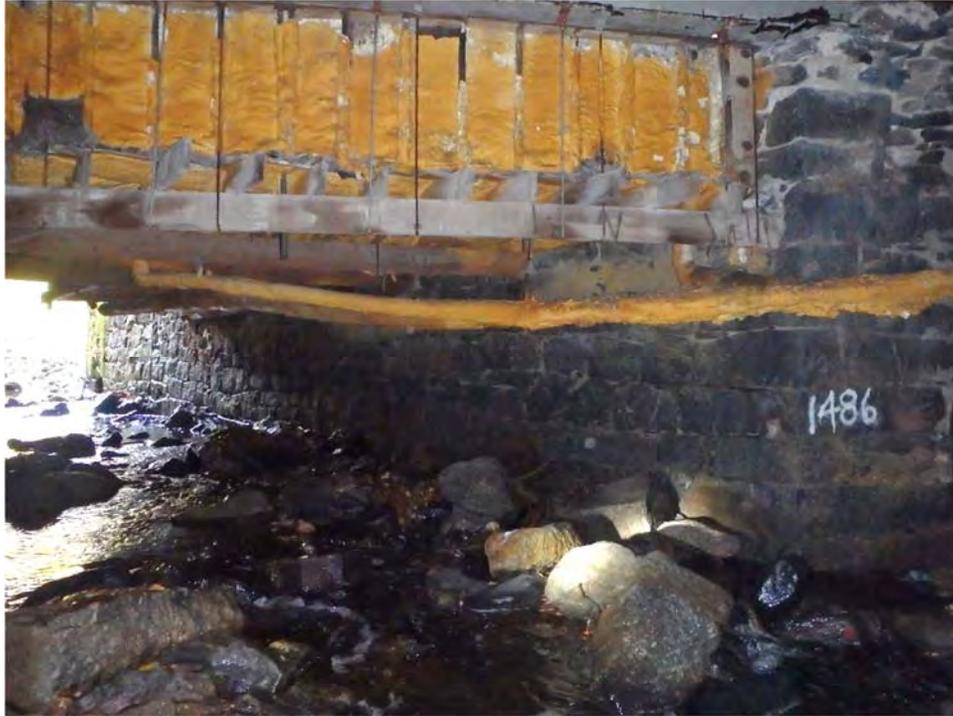
*Photo 17 – Elevation of East Half of Section 5, Looking Northwest.*

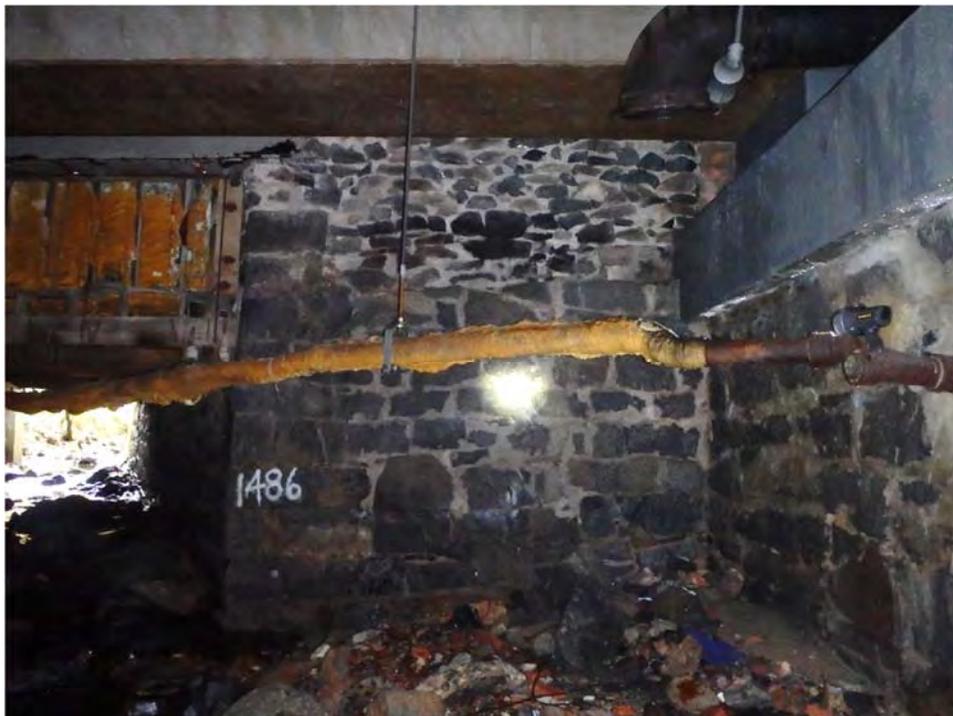
*Photo 18 – Elevation at East End of Section 5, Looking West.*

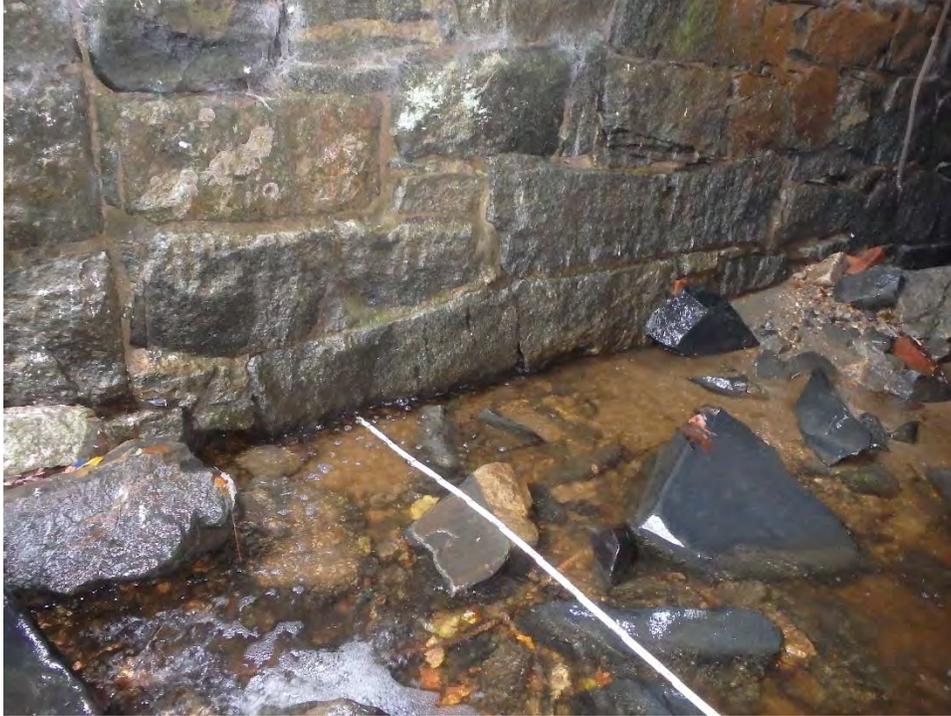
*Photo 19 – Undermining at West End of Section 5.*

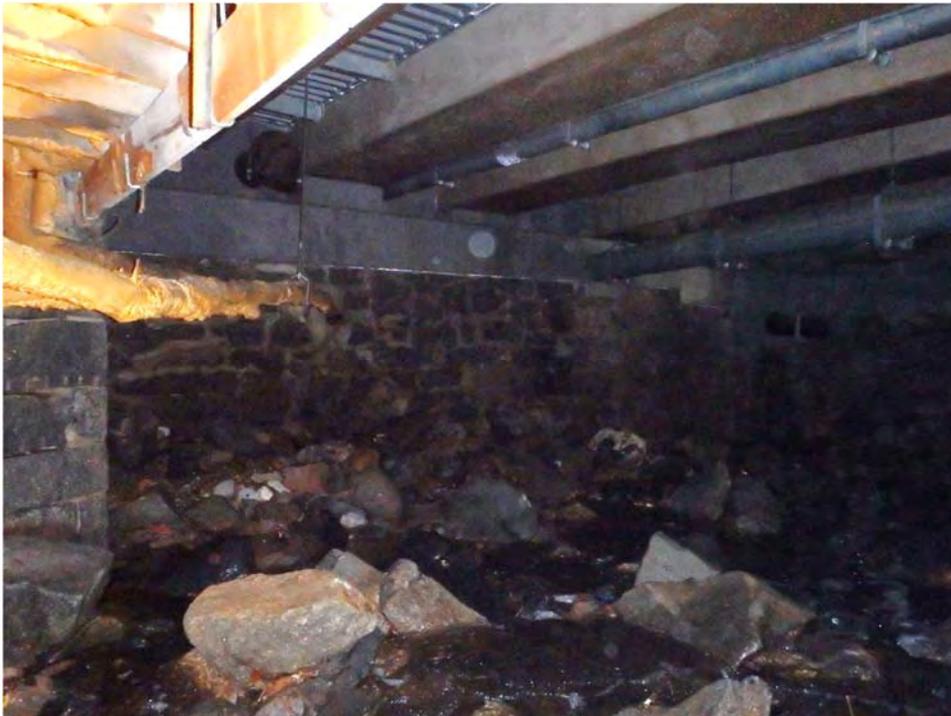
*Photo 20 – Elevation at West End of Section 6, Looking Northeast.*

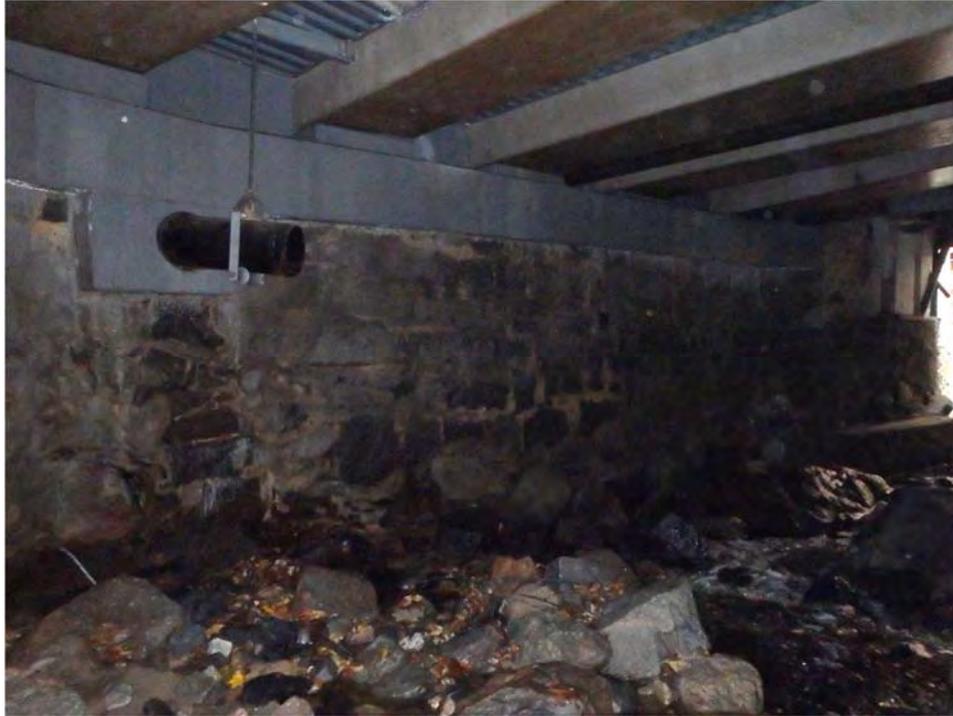
*Photo 21 – Elevation of West Half of Section 6, Looking Northeast.*

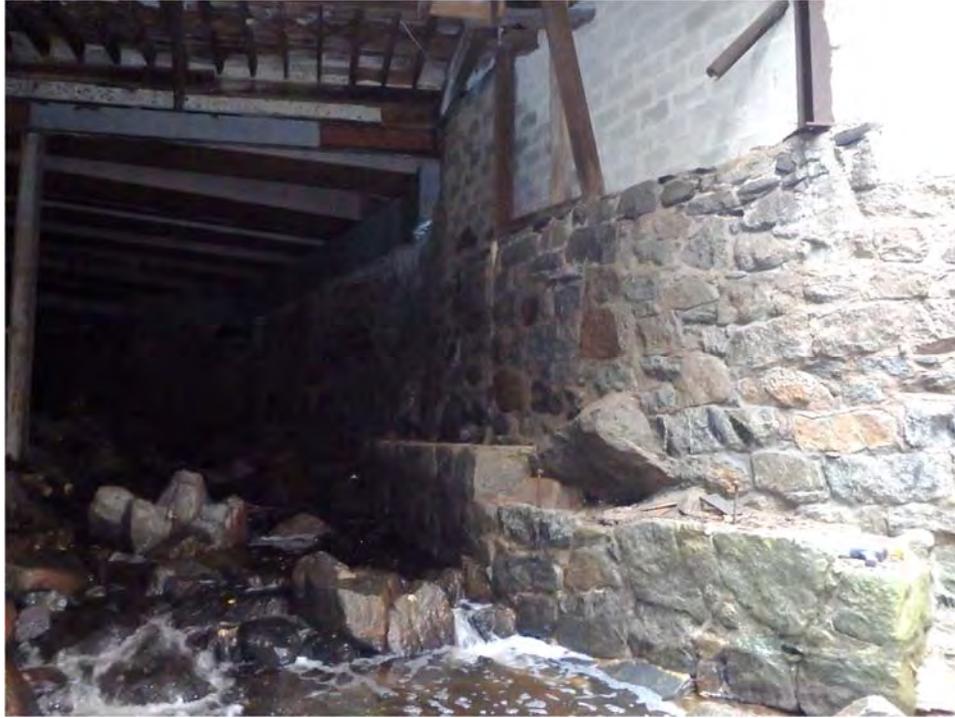
*Photo 23 – Elevation at East End of Section 6, Looking Northwest.*

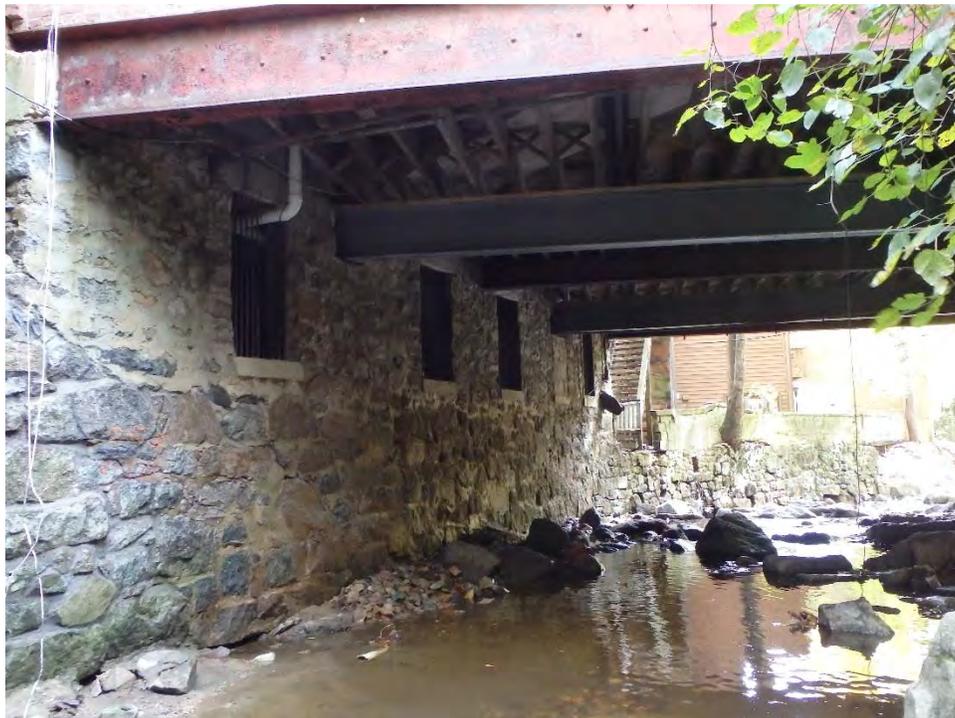
*Photo 24 – Elevation of West Half of Section 7, Looking Northeast.*

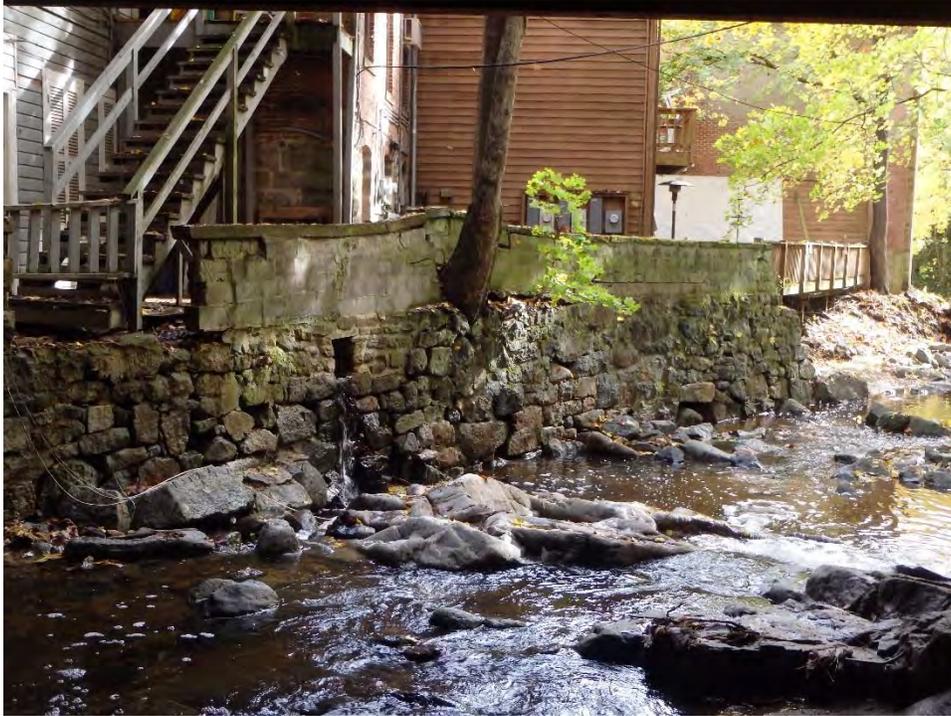
*Photo 25 – Elevation of East Half of Section 7, Looking Northeast.*

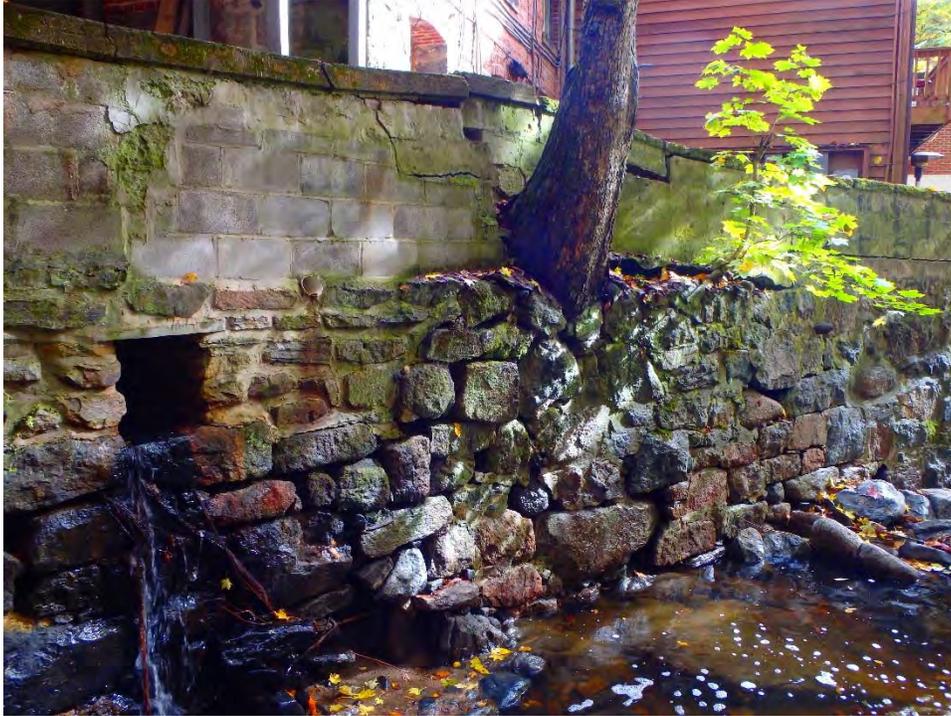
Section 7 extends from 461' to 567' from the west end of the wall and is comprised of stone masonry and concrete block (see Photos 24-26). There is missing mortar and small voids up to 1'-0' x 1'-0" which can be probed to 2'-0" deep throughout the east half of Section 7 (see Photo 27). Approximately 30' from the east end, there is a large 2'-0" diameter tree growing at the top of the wall causing the lower stone wall to bulge and the top concrete wall to fail (see Photo 27). There is a 3'-0" wide x 1'-6" high x 2'-6" deep void and a 5'-0" wide x 3'-0" high x 4'-0" deep void along the bottom of the wall near the east end (see Photo 28). At the east end of the retaining wall, the stones are loose and shifted (see Photo 26).

*Photo 27 – Large Tree Growth, Failing Concrete Wall, Voids and Missing Mortar in the East Half of Section 7, Looking Northeast.*

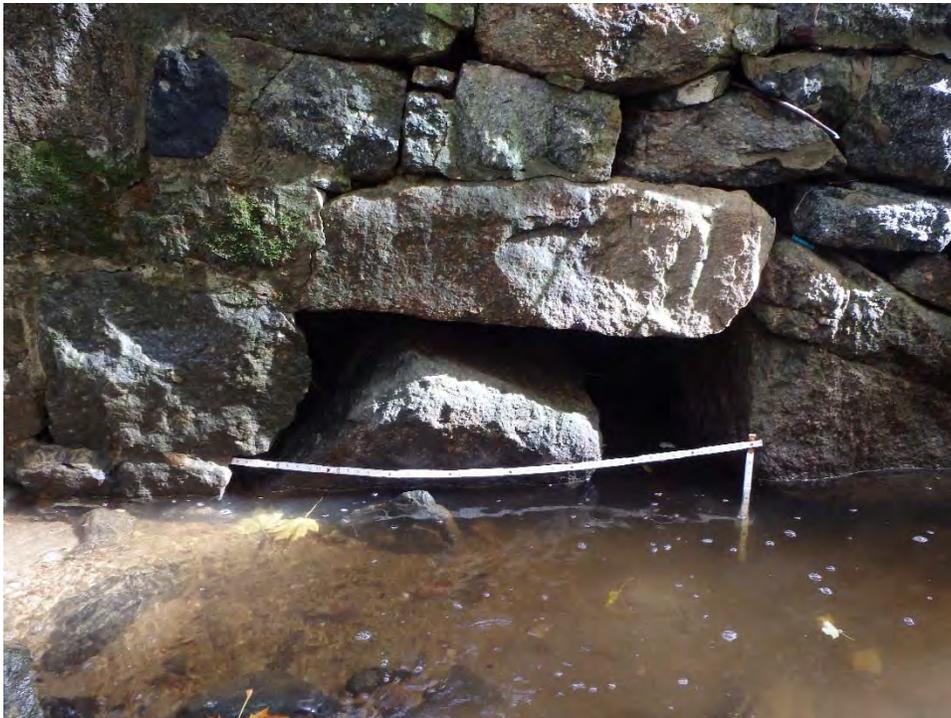
*Photo 28 – 5'-0" Long x 3'-0" High Void at Base of Wall Near East End of Section 7.*

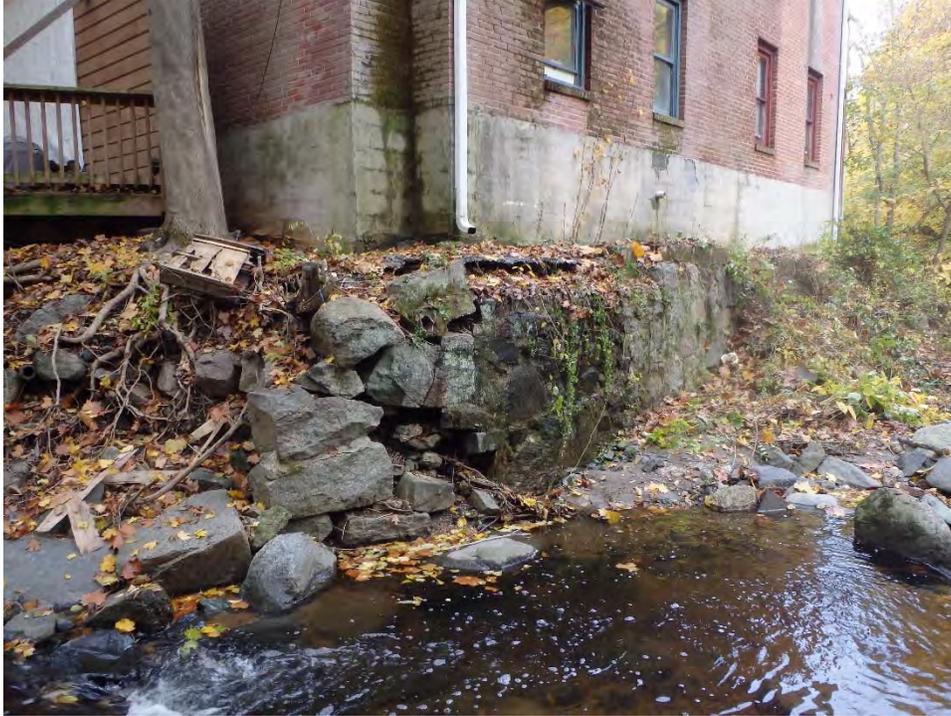
*Photo 29 – Elevation at West End of Section 8, Looking Northeast.*

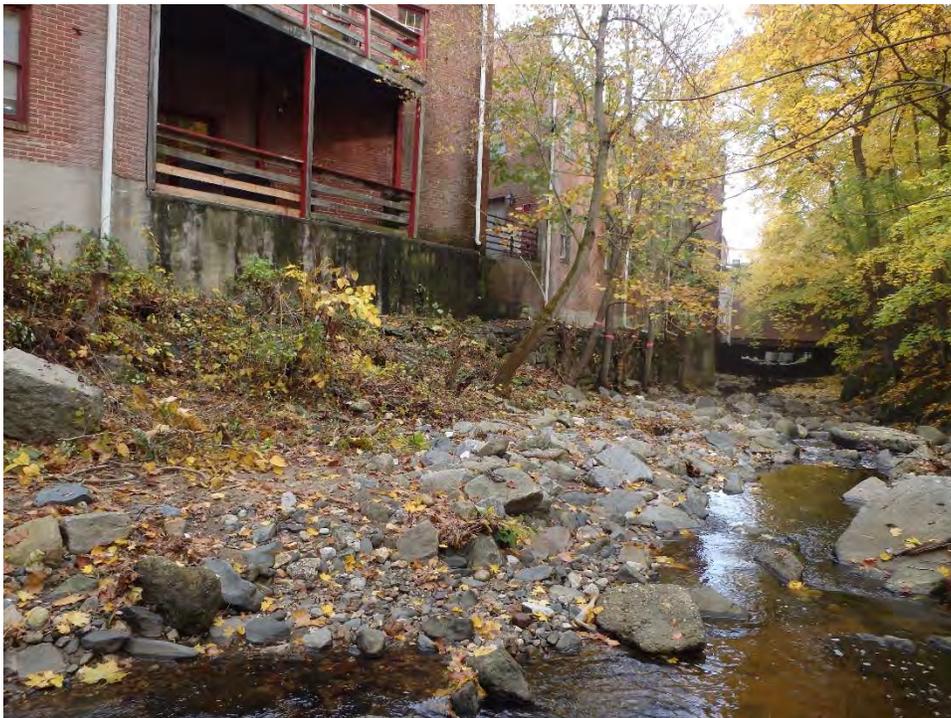
*Photo 30 – Elevation of West Half of Section 8, Looking Northeast.*

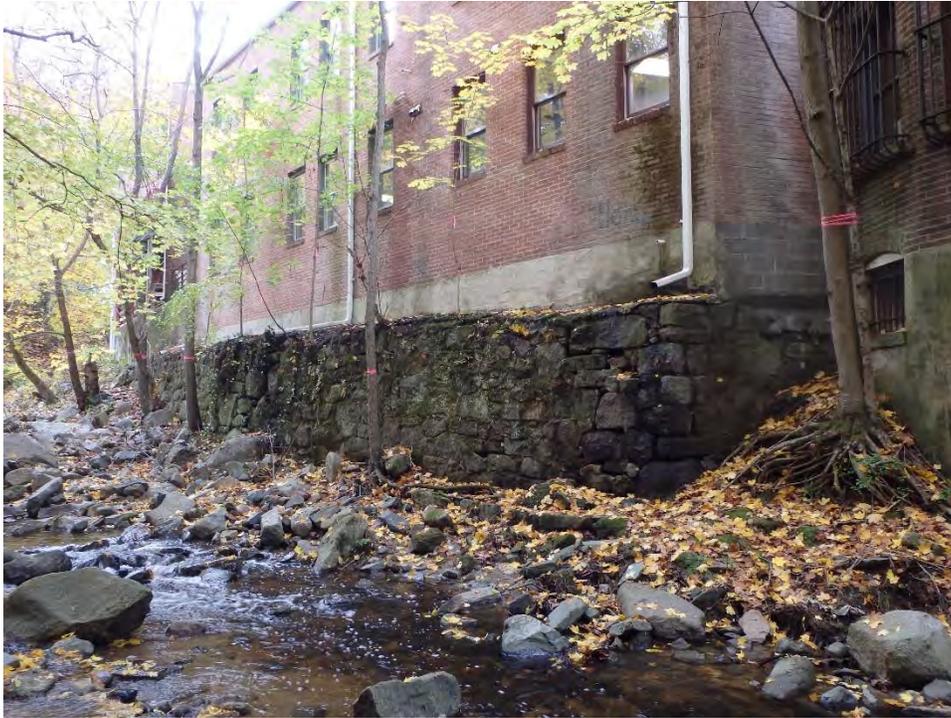
*Photo 31 – Elevation of East Half of Section 8, Looking Northwest.*

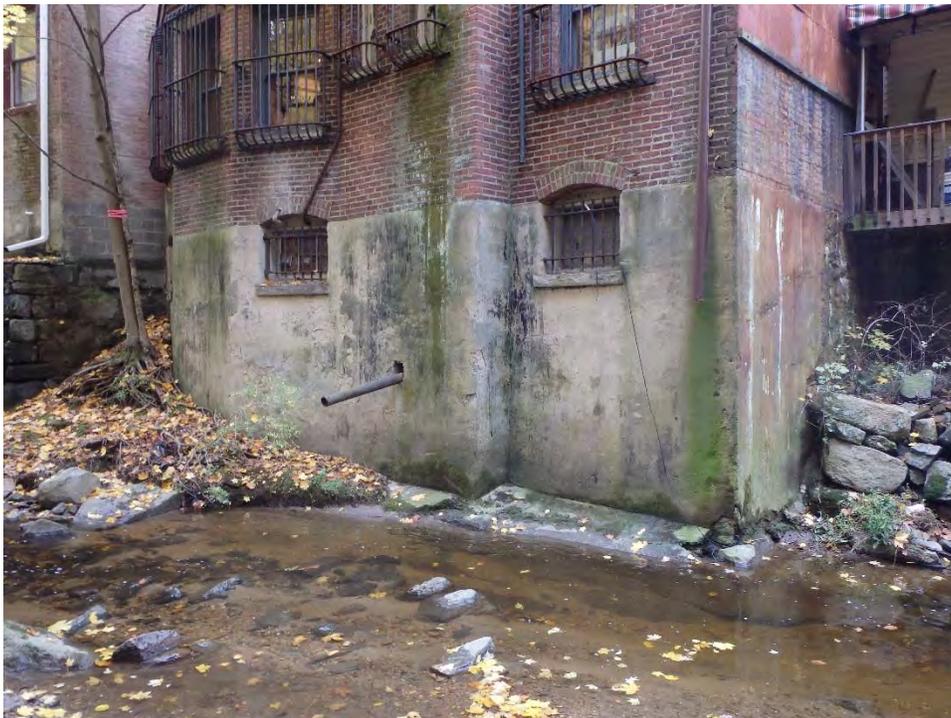
*Photo 32 – Elevation at East End of Section 8, Looking Northwest.*
