# ELLICOTT CITY RETAINING WALLS INSPECTION REPORT

## STREAM WALLS

## HISTORIC ELLICOTT CITY, MARYLAND

MAY 2016

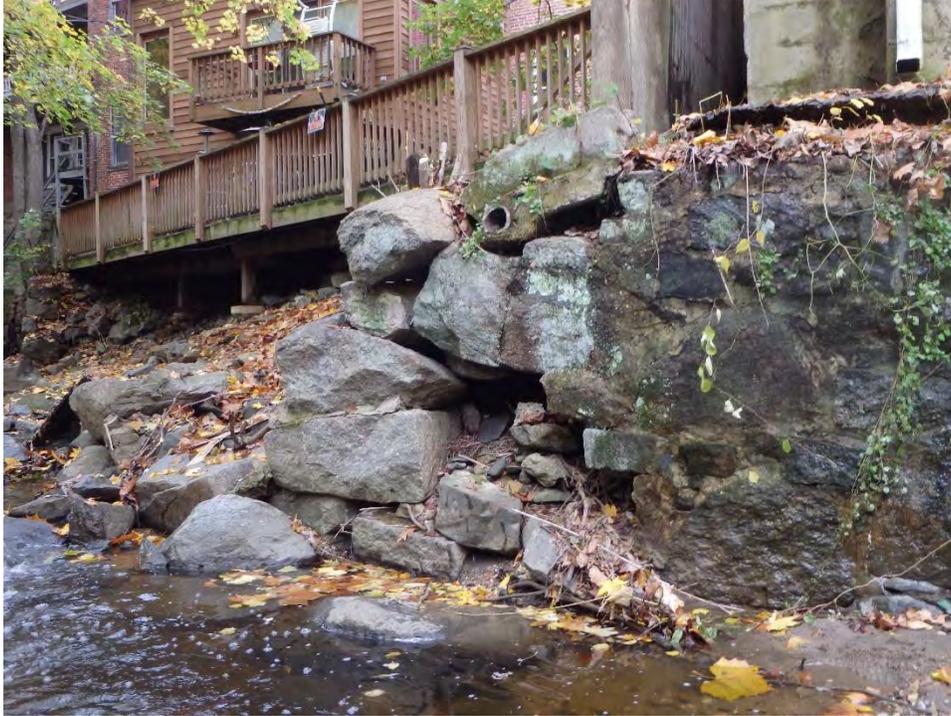
*Photo 33 – Collapsed West End of Section 8, Looking Northwest.*

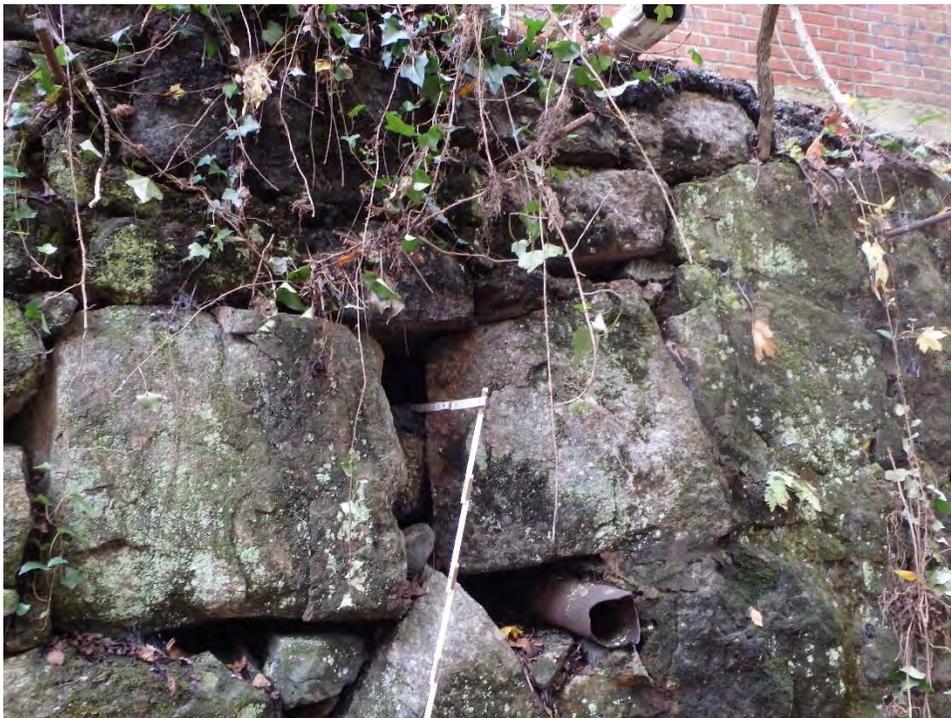
6" deep (see Photo 34). At the east end of the stone wall, 35' from the east end of Section 8, there is an area of loose stones and loss of mortar which can be probed to 2'-0" deep (see Photo 35).

*Photo 34 – Void and Missing Joint Material at Mid-length in Section 8.*

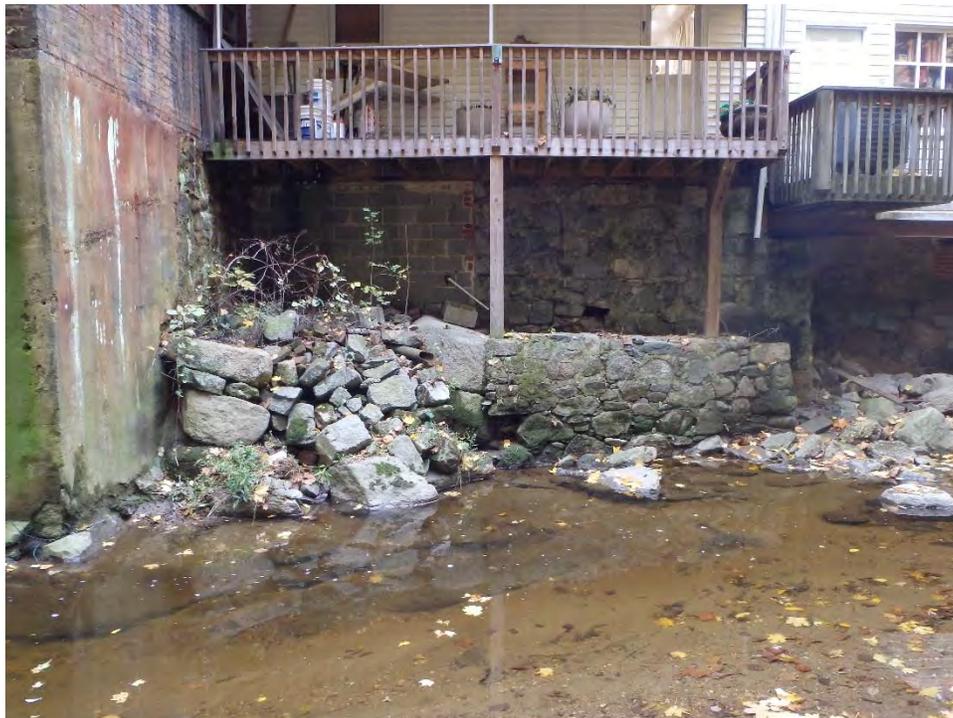
*Photo 36 – Elevation at West End of Section 9, Looking North.  
Note Void under the First Deck Post from the West*

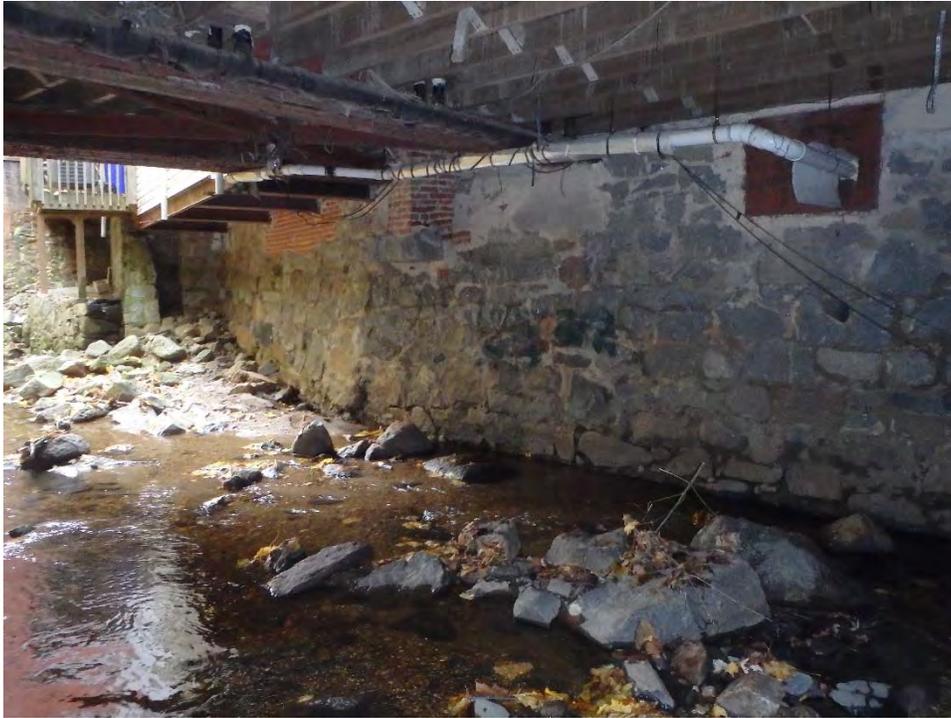
*Photo 37 – Elevation of West Half of Section 9, Looking Northwest.  
Note Missing Mortar along Base of Wall.*

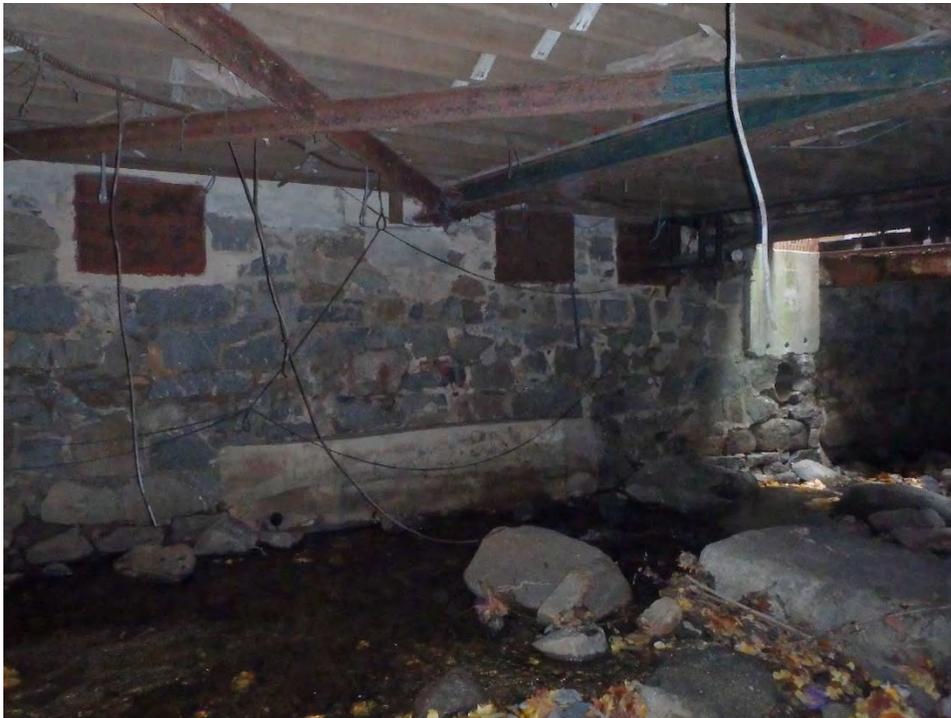
*Photo 38 – Elevation of East Half of Section 9, Looking Northeast.  
Note Missing Mortar along Base of Wall.*

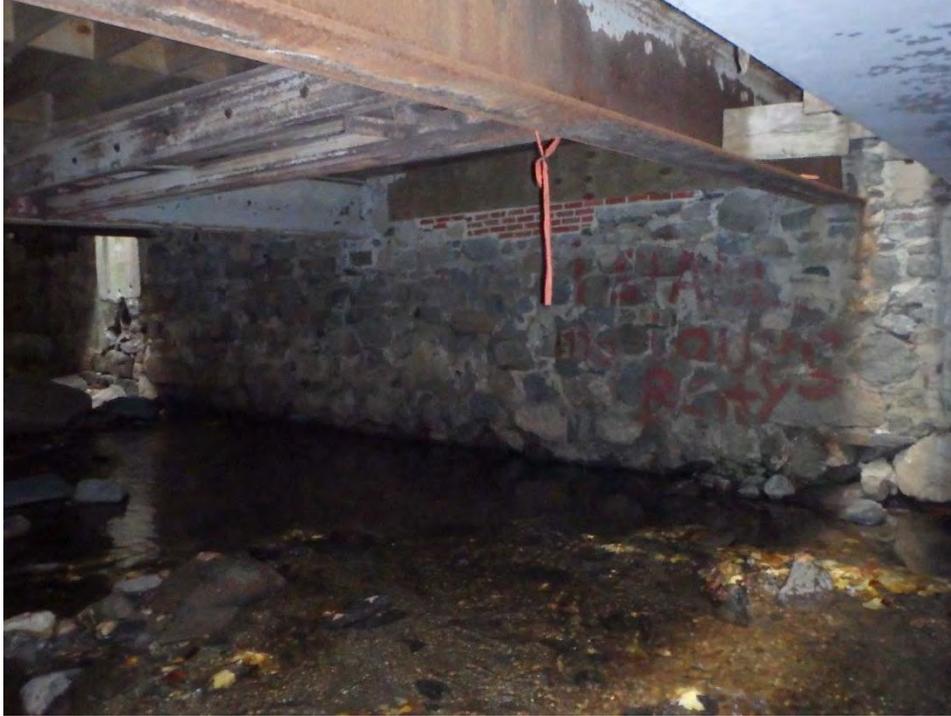
*Photo 39 – Elevation at East End of Section 9, Looking Northwest.  
Note Voids along Base of Wall.*

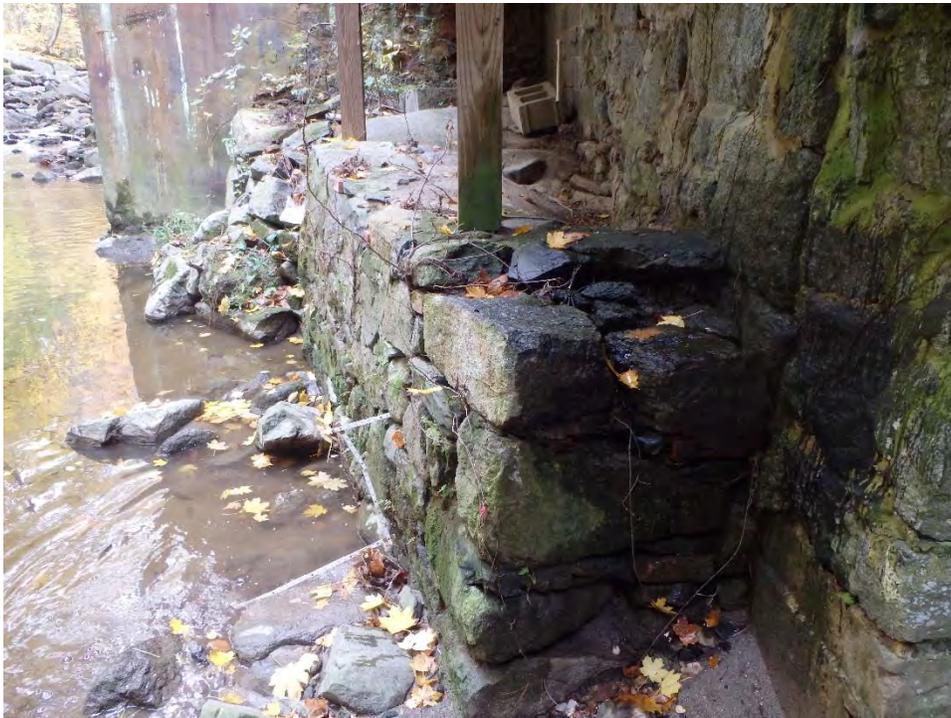
*Photo 40 – Voids and Loose Stones in Section 9, 20' From West End.*

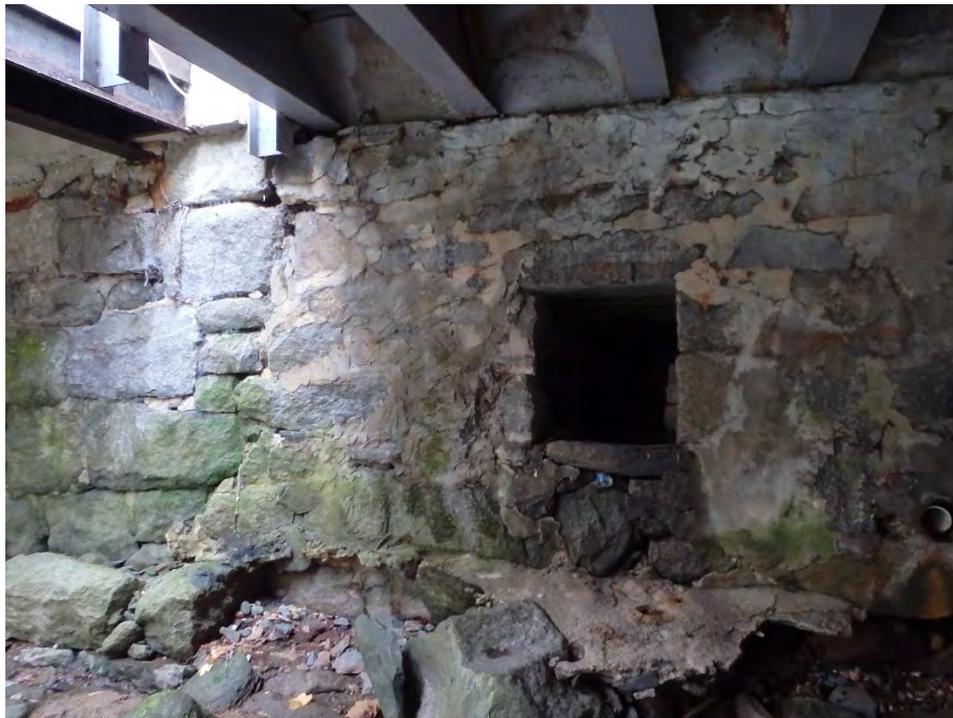
*Photo 46 – Opening in Wall in Section 10, Just East of 8081 Main Street.*

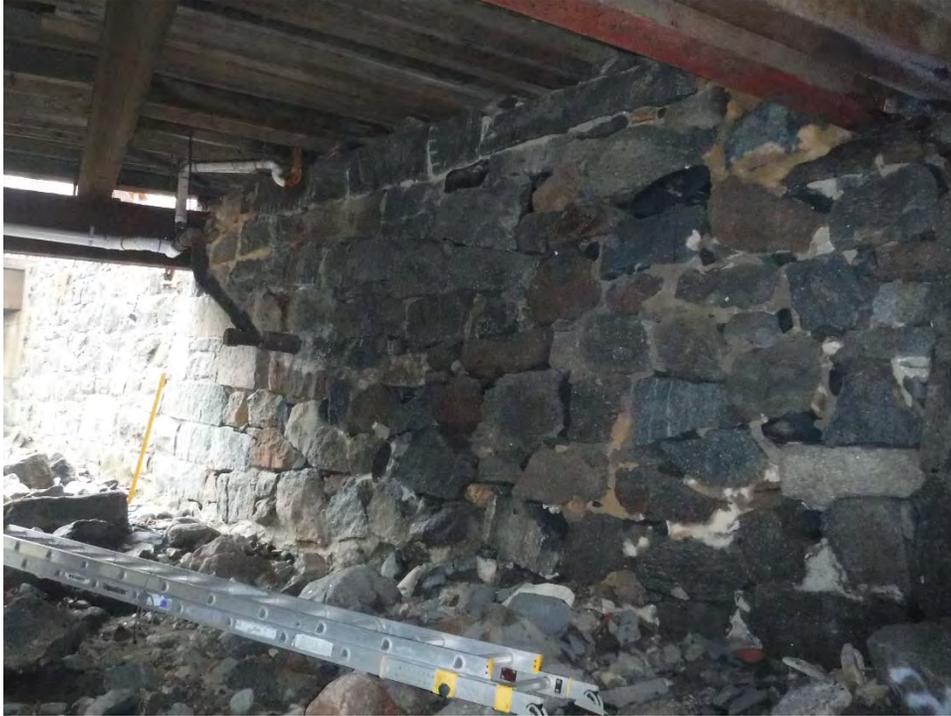
*Photo 47 – Elevation at West End of Section 11, Looking Northwest.  
Note Bulging and Missing Mortar Throughout*

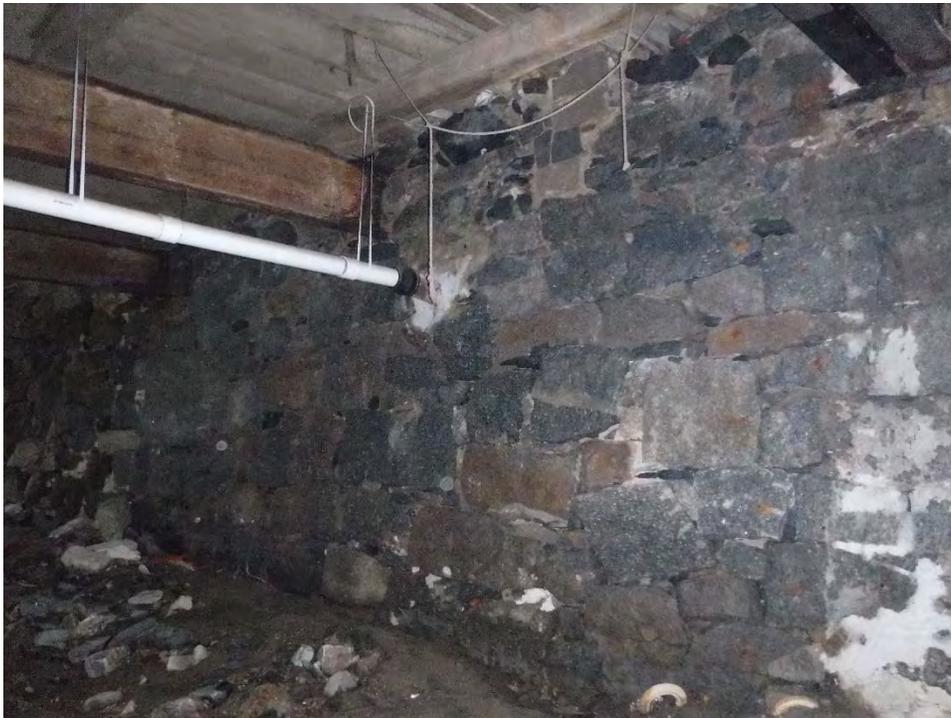
*Photo 48 – Elevation of Middle of Section 11, Looking Northwest.  
Note Missing Mortar Throughout*

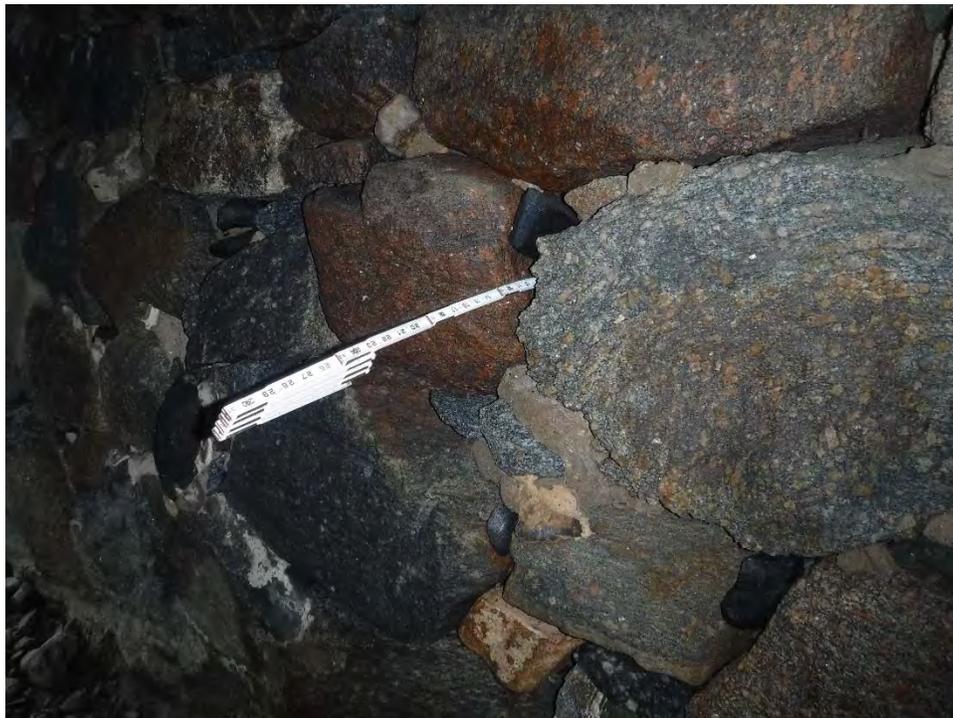
Section 12 extends from 1,157' to 1,233' from the west end and is comprised mostly of stone masonry (see Photos 47-49). There is missing mortar and small voids throughout 60% of the joints, which can be probed up to 2'-0" deep, in the west 52'-0" (see Photo 50). The remaining mortar is loose and deteriorated. There is a 14'-0" wide x 8'-0" high area of stones that are bulging outward to the south up to 6" at the base of the wall, starting 10'-0" from the west end of the section. The bottom of the wall at the east end has a 4'-0" long x 2" high x 6" deep area of undermining in the southeast corner (see Photo 51).

*Photo 50 – Typical Missing Mortar and Small Voids in Section 11.*

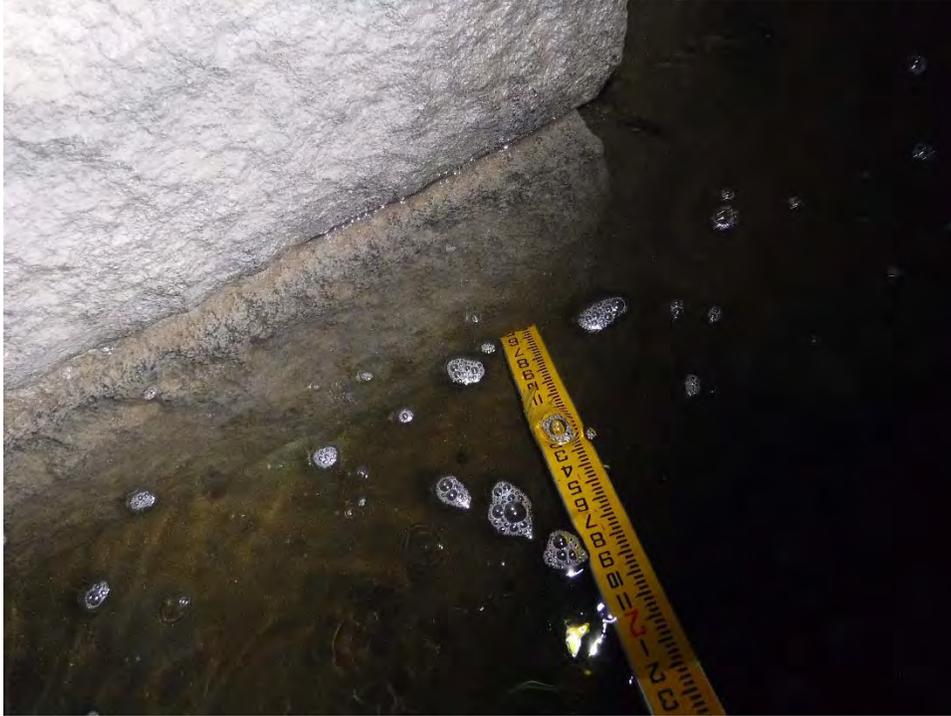
*Photo 51 – Undermining at East End of Section 11.*

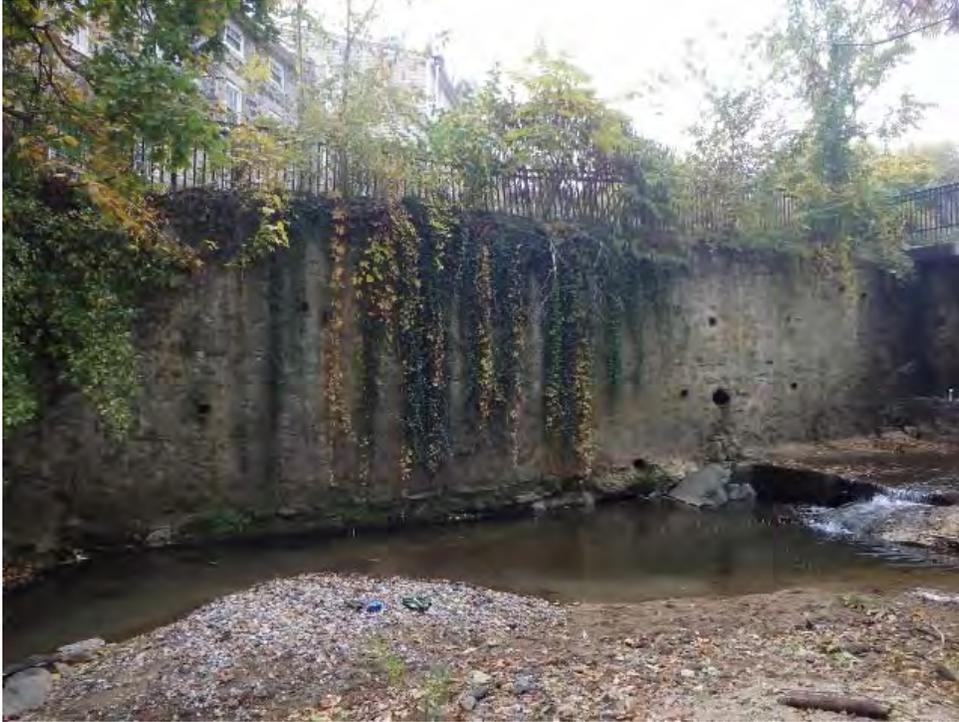
Overall, the wall is in fair condition. The western 53' length (Section 1) is comprised of stone masonry and the top 2'-0" has missing mortar, tree roots, and moss growth throughout the joints (see Photos 1-2). There is a 2'-6" high x 4'-0" wide area of loose stones around a drain pipe at the top west corner of the wall (see Photo 3). Approximately 20' from the west end, there is a 3'-0" wide x 4'-0" high area of missing mortar which could be probed to 10" deep. The bottom of the wall, starting 19' from the west end, has a 34' long x up to 2'-0" high area of undermining up to 4'-0" deep (see Photo 4). This area was noted in a Critical Findings Memo to Howard County on October 30, 2015. Grout bags have been installed and the undermined area has been filled with grout since this inspection based off of the Critical Findings Memo (see Photo 5).

*Photo 1 – Elevation of Section 1, Looking Southwest.*

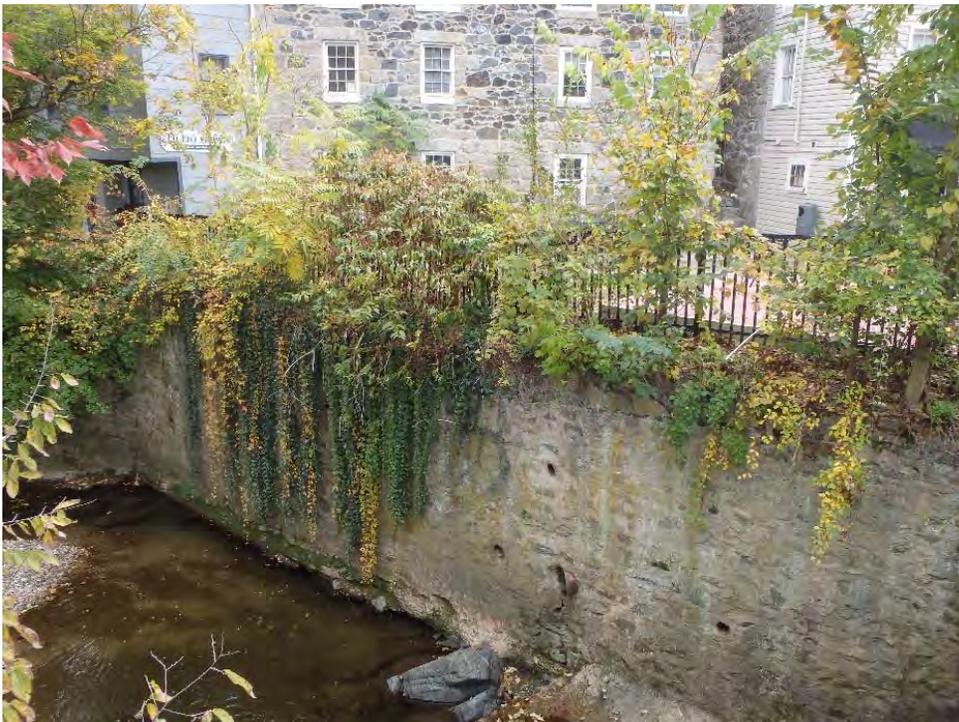
*Photo 2 – Elevation of Section 1, Looking Southeast.*

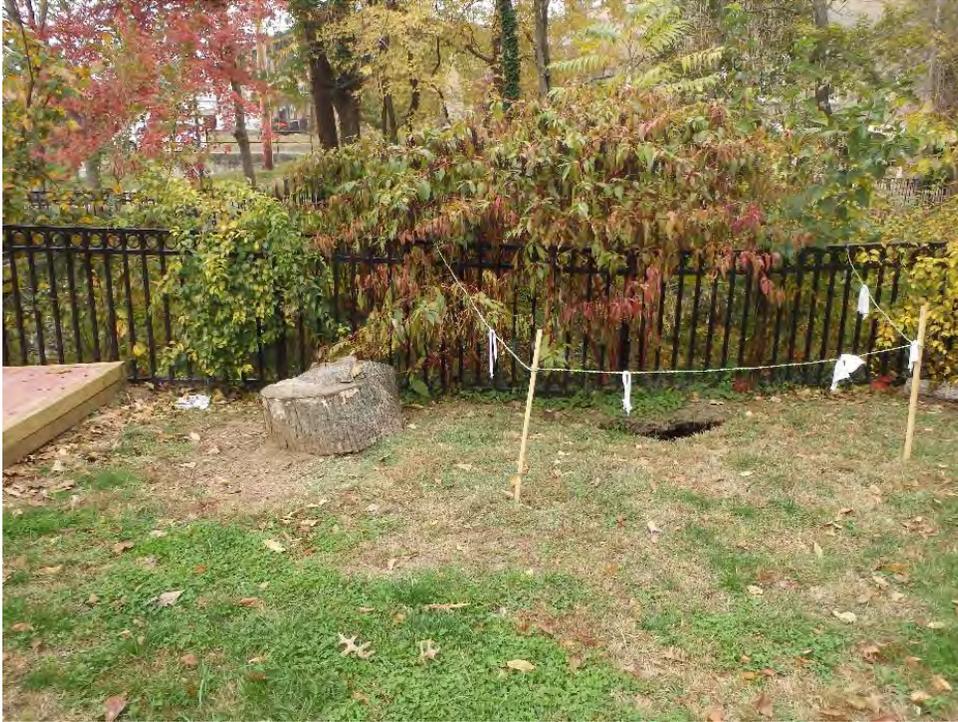
In Section 1, behind the wall, there is a grass area that serves as a courtyard for several businesses. A patio has been constructed, positioned so that the north edge of the patio is 3'-0" from the front face of the retaining wall. The north edge of the patio (1'-0" wide) shows signs of settlement towards the channel (see Photo 6). There is a sinkhole behind the retaining wall located 32'-0" from the west end of the wall. The hole is 3'-0" in diameter on the surface, but extends at least 10'-0" in either direction underground (see Photo 7). There was evidence of a broken drain pipe in the hole. This area was noted in a Critical Findings Memo to Howard County on October 30, 2015. The sinkhole has been filled with flowable fill since this inspection based off of the Critical Findings Memo (see Photo 8).

*Photo 7 – View of Erosion Hole behind Section 1, Looking North.*

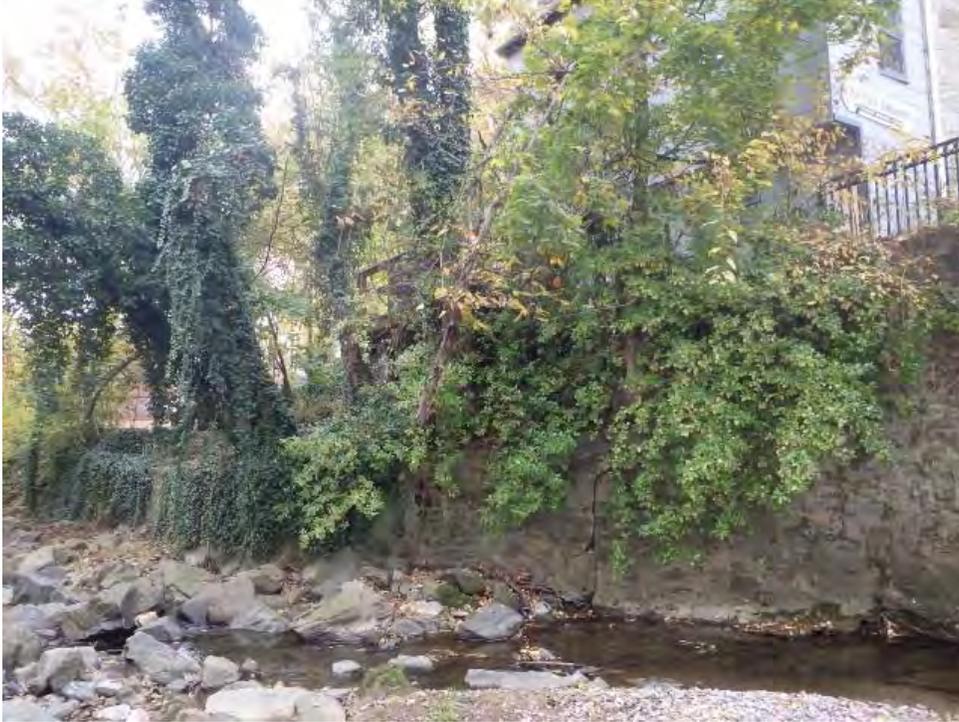
Section 2 extends from 53' to 152' from the west end of the wall and is comprised of stone masonry. There is heavy vegetation/vine growth throughout (see Photos 9 and 10). Located 10' from the west end, there is a full-height fracture open up to 1" wide and 1'-0" diameter tree at the top of the wall (see Photo 11). There is a large area of missing mortar with vine and root growth in the joints, in the top half of the wall at the east end.

*Photo 9 – Elevation at West End of Section 2, Looking Southeast.*

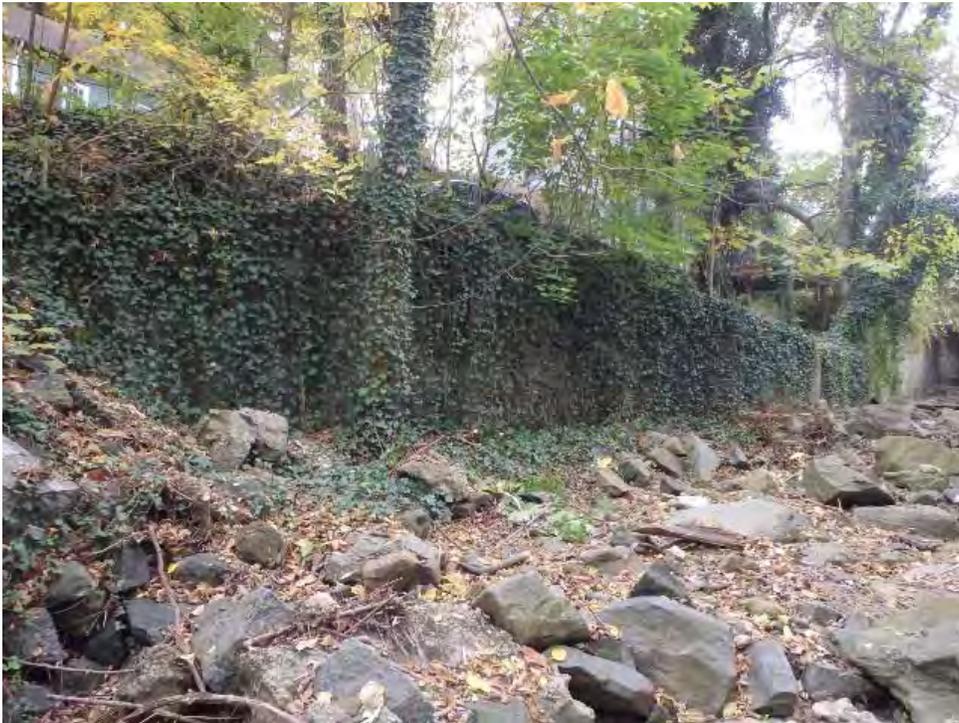
*Photo 10 – Elevation at East End of Section 2, Looking Southwest.  
Note Vegetation Growth.*

**VEGETATION REMOVAL** (Designated as "V") - This item includes the removal of vegetation growth, including mature trees, from the vicinity of the retaining walls. These repairs should be completed as funds become available; however, vegetation will continue to impact the retaining walls until removed.

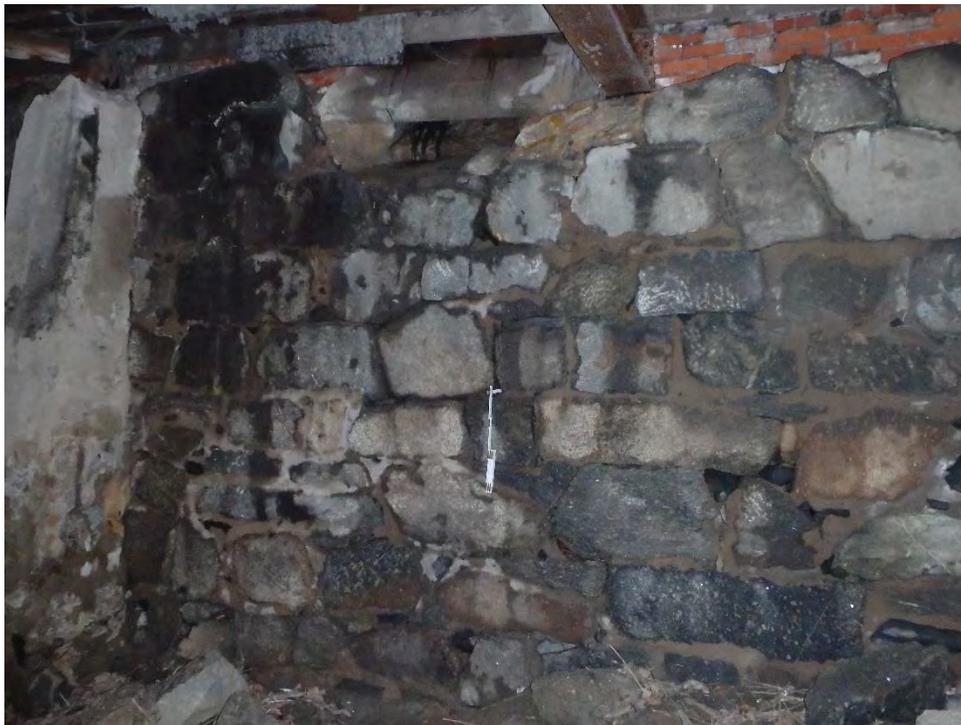
wide x 2'-0" high x 2'-0" deep drainage opening at the top of the wall. There are random isolated areas of loose/missing mortar throughout which can be probed up to 2'-0" deep to the fill. The worst area is within the west 20', where the stones are misaligned horizontally up to 4" (see Photo 14).

*Photo 14 – Mortar Loss in Section 4.*

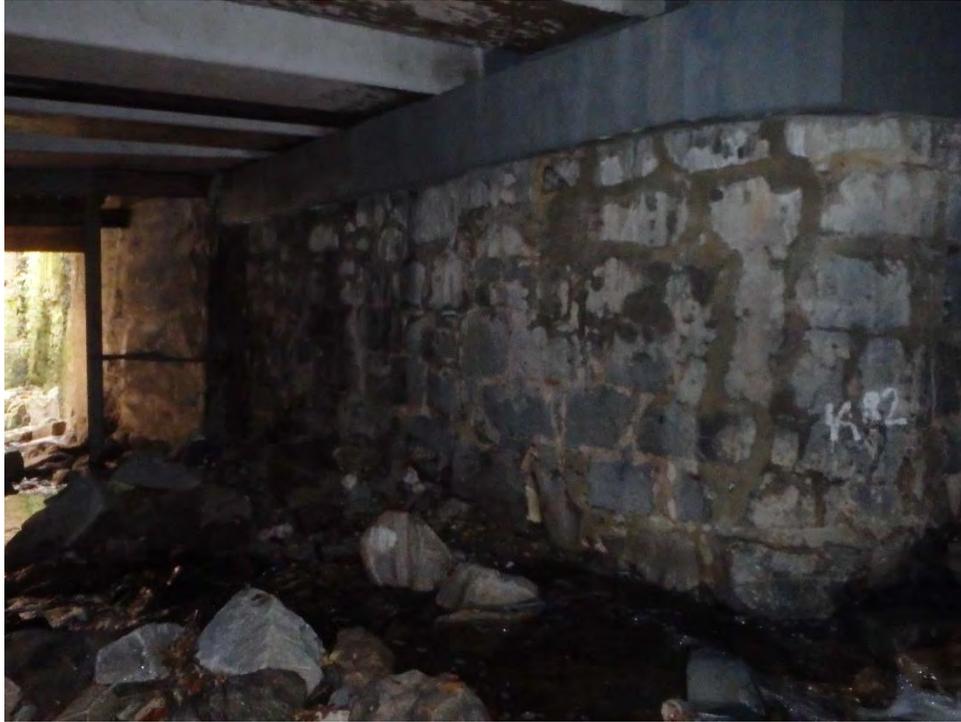
Section 5 extends from 340' to 435' from the west end of the wall and is comprised of stone masonry with a concrete cap at the west 31', concrete wall in the middle 39', and stone masonry at the east 25' (see Photos 15-18). There is up to 6" deep scaling throughout the 39' long concrete wall (see Photo 16). There is missing mortar with small voids that can be probed to 3'-0" deep and minor vegetation growth throughout between 410' and 435' from the west end of the wall (see Photo 17). Approximately 15' from the east end, there is a 2'-0" diameter tree growing out of the top of the wall (see Photo 17). The east end of the stone masonry wall extends behind the Section 6 concrete wall (see Photo 18).

*Photo 15 – Elevation at West End of Section 5, Looking Southeast.*

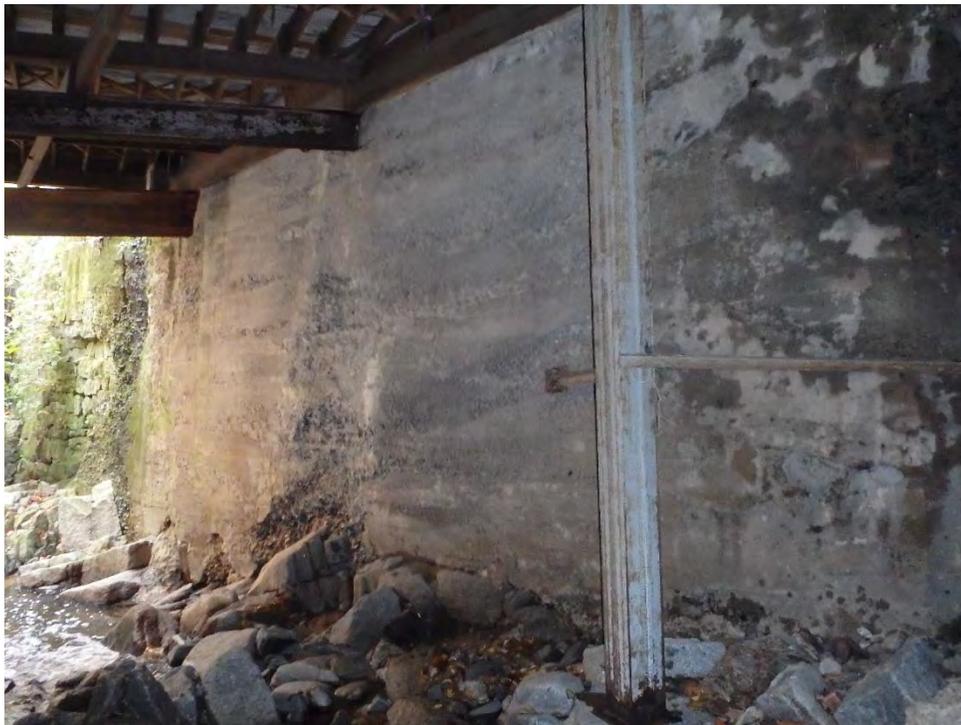
*Photo 16 – Elevation of Middle Portion of Section 5, Looking Southeast.  
Note Scaling Near Base.*

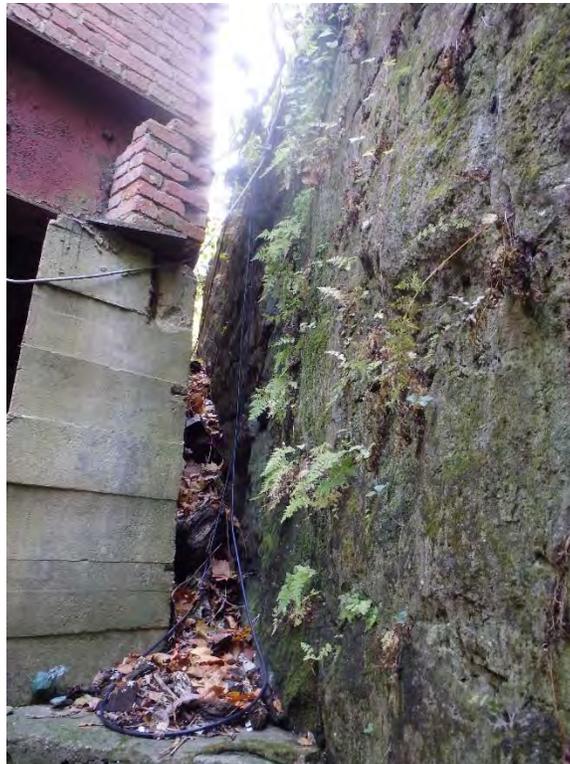
*Photo 18 – Elevation at East End of Section 5, Behind Section 6, Looking Southeast.*

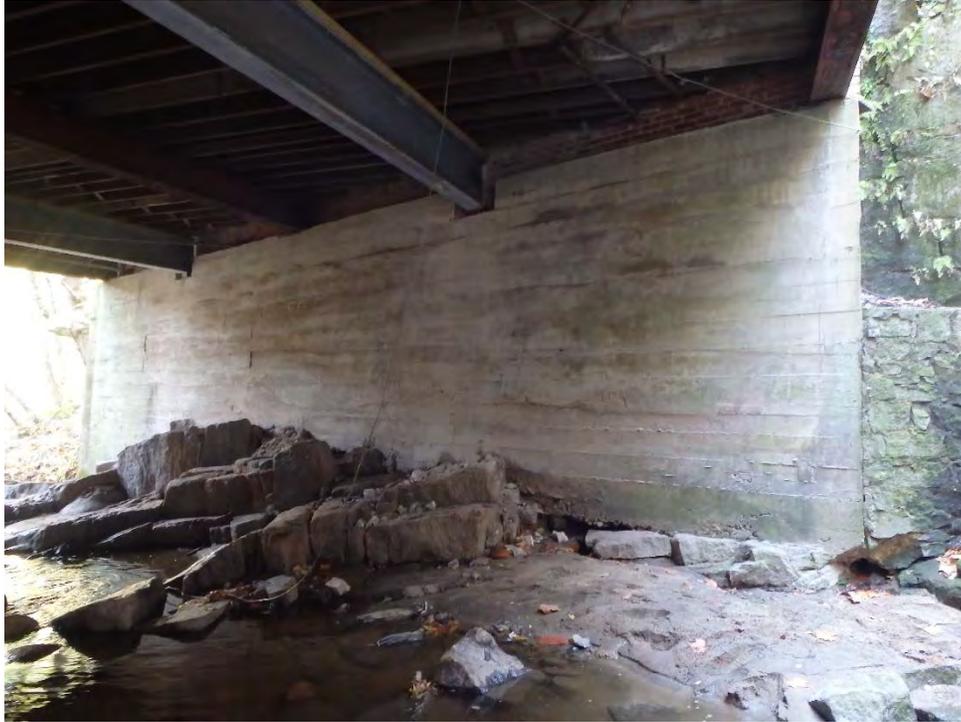
Section 6 extends from 435' to 485' from the west end and is comprised of concrete with typical minor scaling along the bottom 1'-0" (see Photo 19). The bottom of the wall at the west end has a 6'-0" long x 9" high x 9" deep area of undermining (see Photo 20). Starting 15' behind the east end of the wall, there is 35' long x 15' high x 15' wide area of erosion (see Photo 21).

*Photo 19 – Elevation of Section 6, Looking Southeast.*

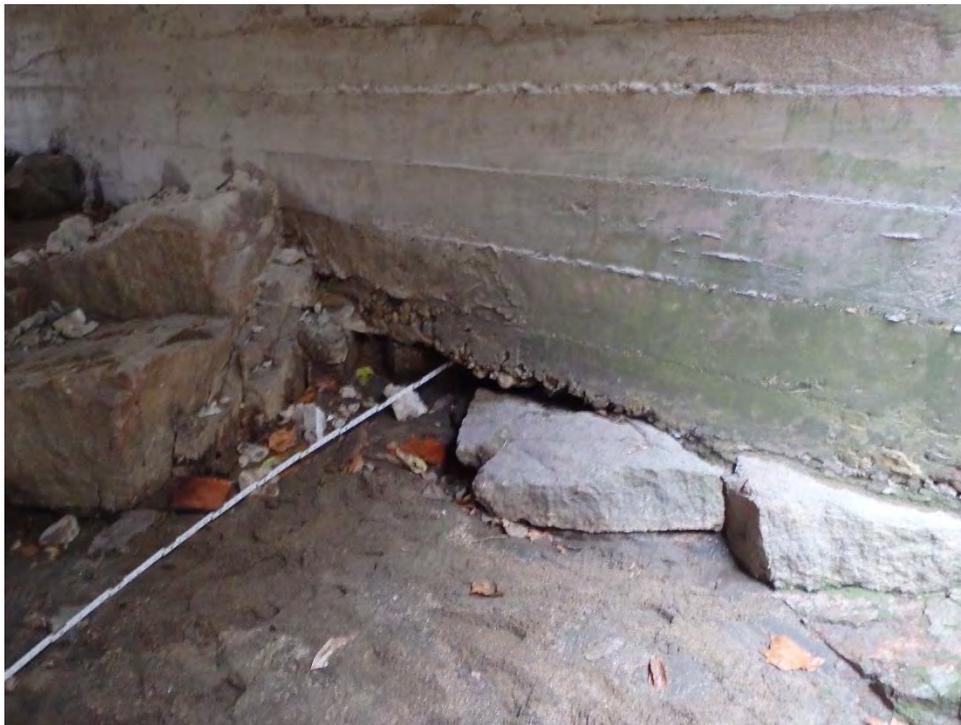
*Photo 20 – Undermining at West End of Section 6, Looking Southeast.*

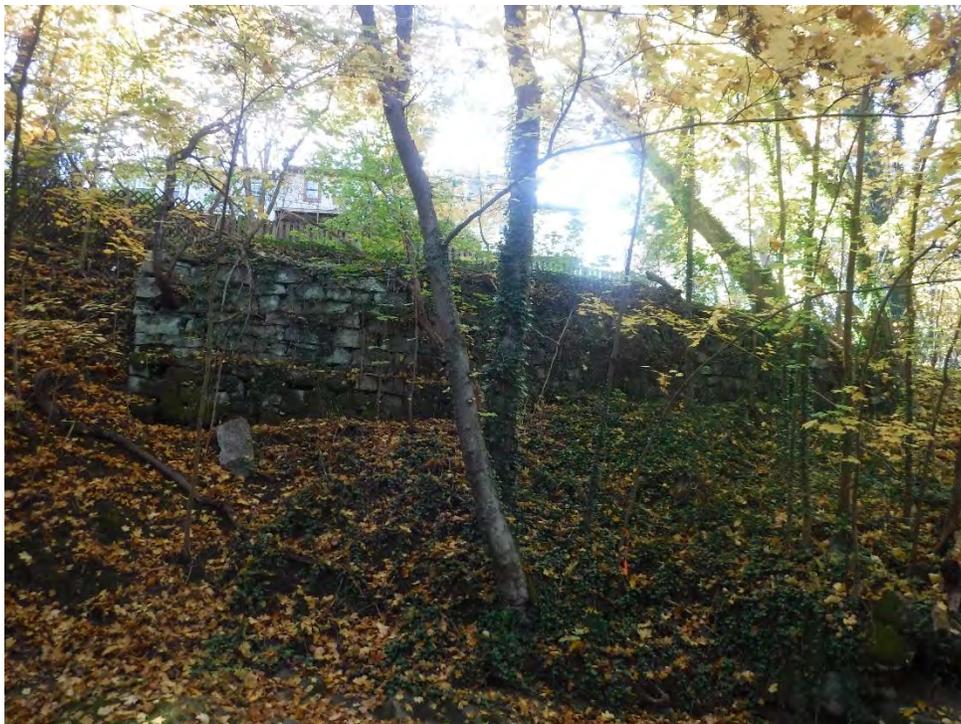
Section 8 extends from 685' to 722' from the west end, located approximately 15' above the stream bed, and is comprised of stone masonry (see Photo 22). There is missing mortar and small stones throughout, vine growth, and a few random small trees growing along the top of the wall (see Photo 23). There are random large missing stones throughout the western 20' length of Section 8. There is a 2'-0" diameter tree growing at the west end and a 1'-0" diameter tree growing through the wall near the east end (see Photo 23).

*Photo 22 – Elevation of Section 8, Looking South.*

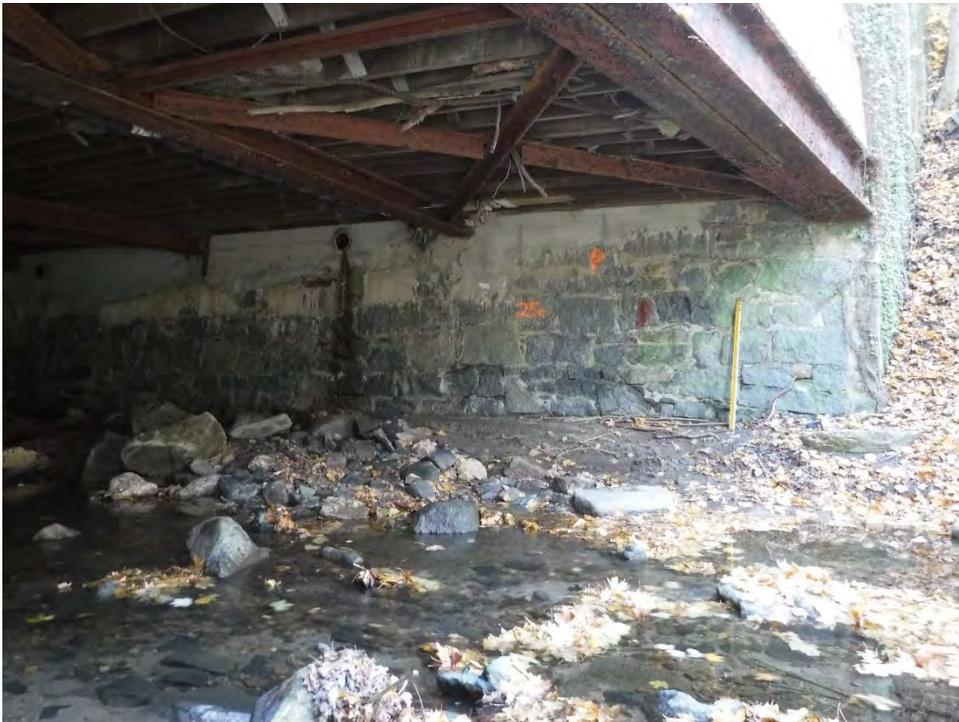
Section 10 extends from 837' to 932' from the west end of the wall. The portion between 837' and 894' from the west end (beneath 8125 Main Street) is comprised of stone masonry with a concrete cap (see Photos 24-27). There are random areas of missing and/or deteriorated mortar throughout the joints, mostly along the bottom 1'-0" height. There is a 2'-1" wide x 1'-2" high x 1'-3" deep square drainage opening along the bottom of the wall, located at 874' from the west end. Just below the drainage opening, there is a 2'-10" wide x 9" high area of missing mortar and small stones with minor loss of fill, which could be probed to 1'-0" deep (see Photo 26). There is a 1'-6" wide x 1'-6" high x 3'-9" deep square drainage opening along the bottom of the wall, located 10' from the east end, with visible water leaking just below the drainage opening. The portion of wall between 894' and 932' from the west end (beneath 8109/8111/8113 Main Street) is comprised of bedrock, stone masonry, brick, and concrete. There are random areas of missing and/or deteriorated mortar throughout the joints. Within the open area at 894' from the west end, there is a large tree growing out of the top of the wall and active water leaking from an above gutter. There

*Photo 24 – Elevation at West End of Section 10, Looking Southeast.*

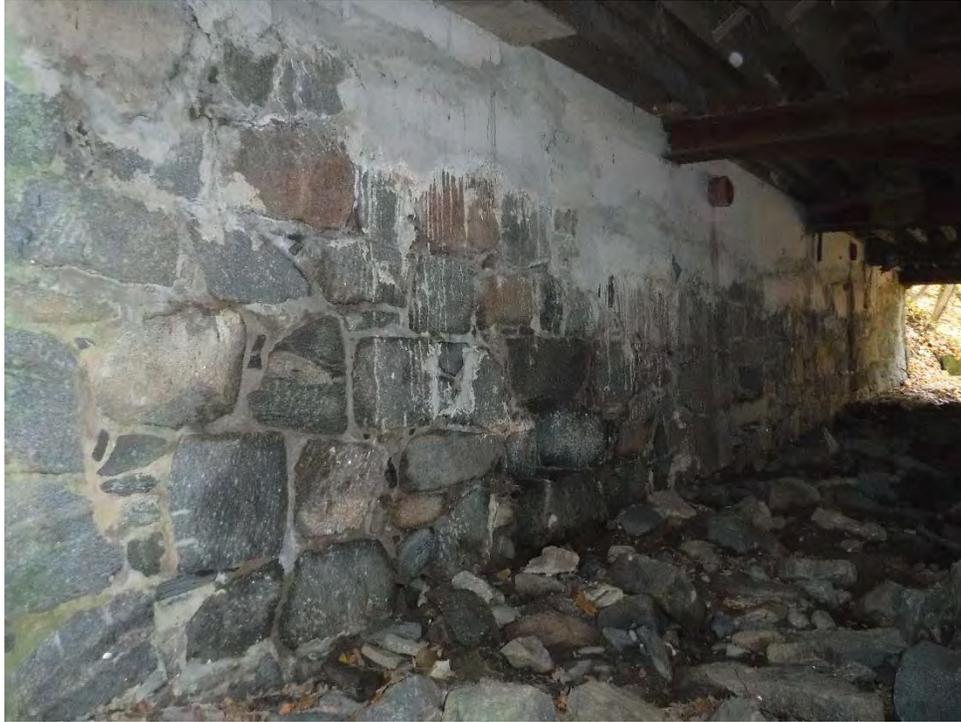
*Photo 25 – Elevation from Middle of Section 10, Looking Southwest.*

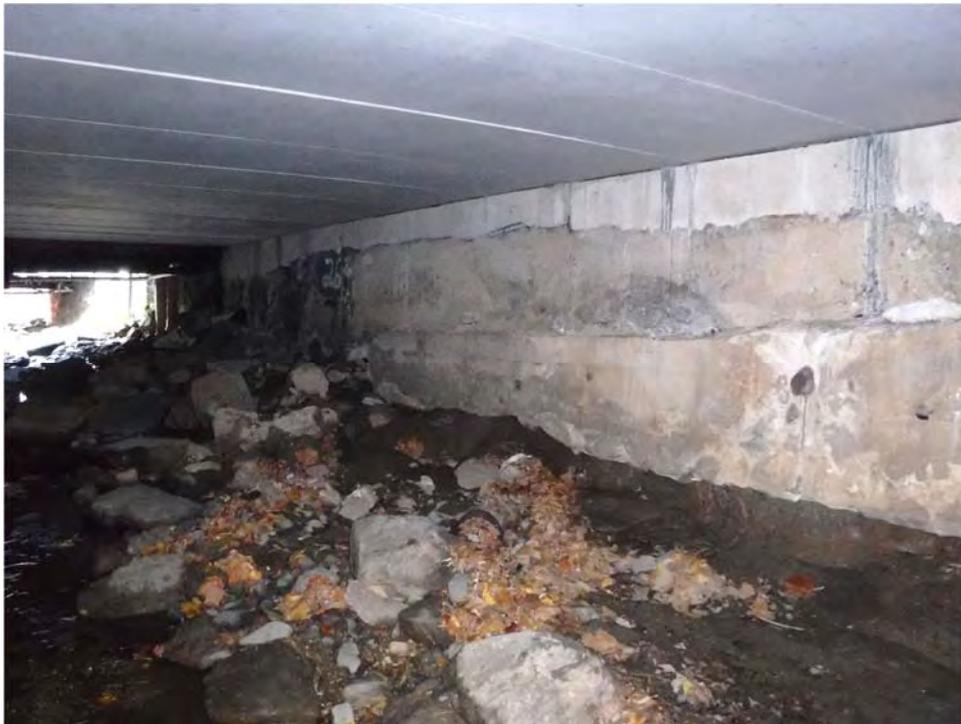
Section 11 extends from 932' to 1,148' from the west end of the wall. The portion between 932' and 995' from the west end (beneath 8095/8101 Main Street) is comprised of bedrock, concrete, and stone masonry (see Photo 28). There is a 2'-0" wide x 2'-0" high area of loose stones with missing mortar, which could be probed to 9" deep, at the top west end (see Photo 29) and a 2'-0" wide x 1'-0" high area of loose stones with missing mortar, which could be probed to 9" deep, approximately 7'-0" from the west end at mid-height. The bottom of the wall is undermined at the west end of Section 11, 30' long x 1'-0" high x up to 1'-5" deep (see Photo 30). The portion of wall between 995' and 1,024' from the west end (beneath 8085 Main Street) is comprised of stone masonry and concrete. There is a 3'-0" wide x 5'-0" high failed wall with missing stones and loss of fill, which could be probed up to 7'-0" deep, at the bottom west end (see Photo 31). There is a broken drainage pipe and a 1'-10" wide x 1'-2" high area of loose stones, which could be probed to 1'-6" deep, approximately 13'-0" from the west end at the top. The retaining wall is missing between 1,024' and 1,032' from the west end of the wall. Riprap has been placed in this area (see Photo 32). The portion of wall between 1,032' and 1,072' from the west end (beneath 8081 Main Street) is comprised of stone masonry. There are random small areas of missing and/or deteriorated mortar throughout the joints, which could be probed up to 1'-0" deep, mostly along the bottom 1'-0". There is a 1'-8" wide x 2'-0" high x 2'-0" deep square opening in the top of the wall for a drain pipe at 1,065' from the west end. The portion of wall between 1,072' and 1,148' from the west end (beneath 8069 Main Street) is comprised of stone masonry. There is a pedestrian bridge at the east end of Section 11 (see Photo 33).

*Photo 28 – Elevation at West End of Section 11, Looking Southeast.*

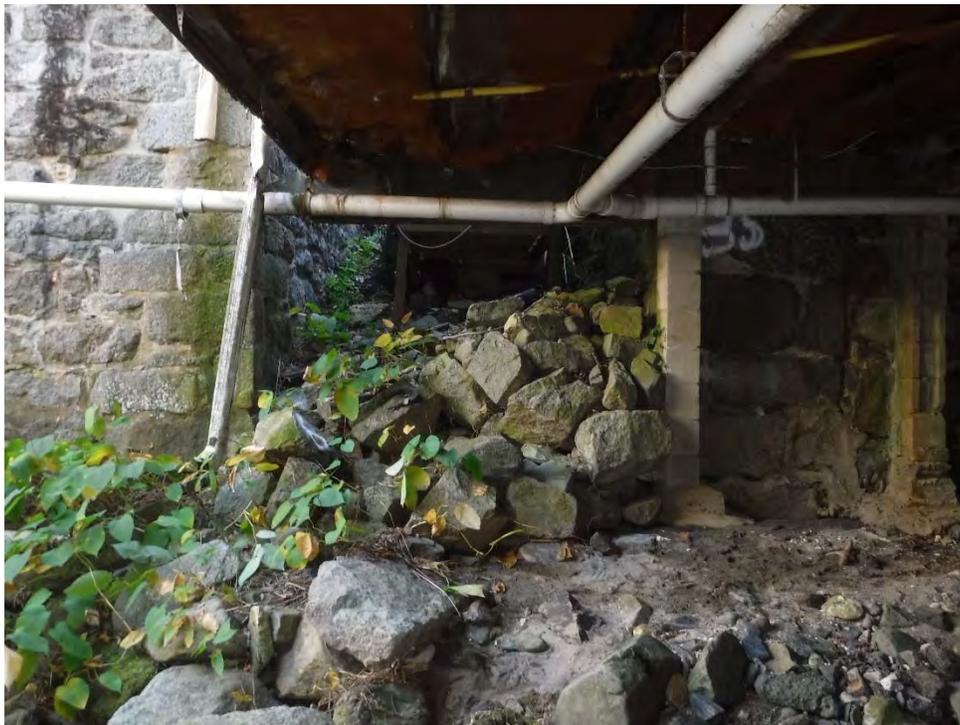
*Photo 32 – Rip-Rap between 1,024' and 1,032' from the west end of the wall (Section 11).*
