# ELLICOTT CITY RETAINING WALLS INSPECTION REPORT

## STREAM WALLS

## HISTORIC ELLICOTT CITY, MARYLAND

MAY 2016

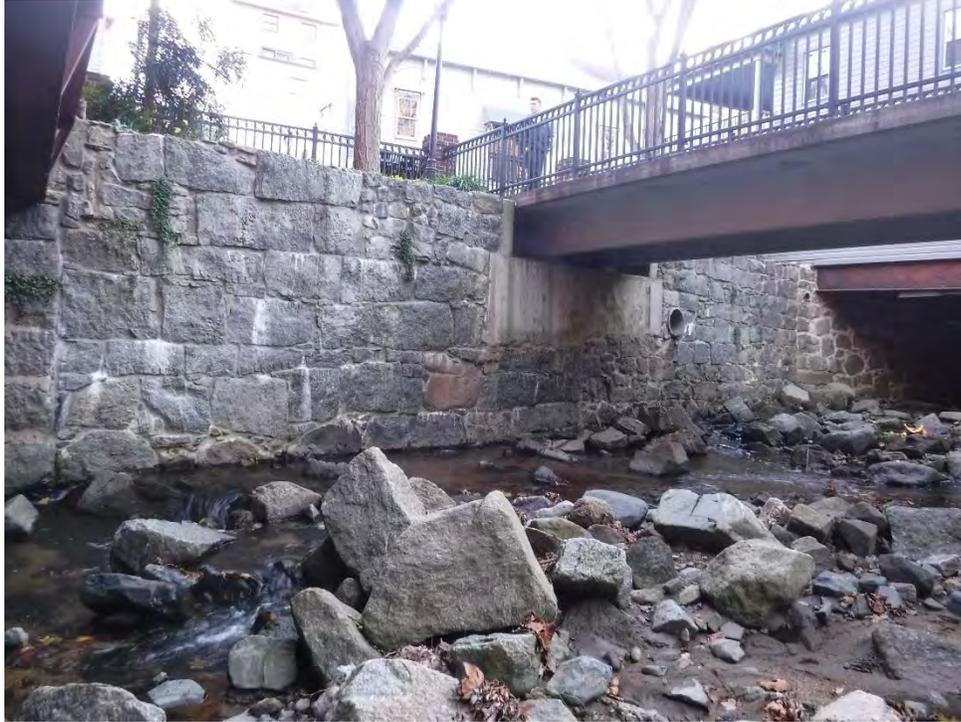
Section 11 extends from 932' to 1,148' from the west end of the wall. The portion between 932' and 995' from the west end (beneath 8095/8101 Main Street) is comprised of bedrock, concrete, and stone masonry (see Photo 28). There is a 2'-0" wide x 2'-0" high area of loose stones with missing mortar, which could be probed to 9" deep, at the top west end (see Photo 29) and a 2'-0" wide x 1'-0" high area of loose stones with missing mortar, which could be probed to 9" deep, approximately 7'-0" from the west end at mid-height. The bottom of the wall is undermined at the west end of Section 11, 30' long x 1'-0" high x up to 1'-5" deep (see Photo 30). The portion of wall between 995' and 1,024' from the west end (beneath 8085 Main Street) is comprised of stone masonry and concrete. There is a 3'-0" wide x 5'-0" high failed wall with missing stones and loss of fill, which could be probed up to 7'-0" deep, at the bottom west end (see Photo 31). There is a broken drainage pipe and a 1'-10" wide x 1'-2" high area of loose stones, which could be probed to 1'-6" deep, approximately 13'-0" from the west end at the top. The retaining wall is missing between 1,024' and 1,032' from the west end of the wall. Riprap has been placed in this area (see Photo 32). The portion of wall between 1,032' and 1,072' from the west end (beneath 8081 Main Street) is comprised of stone masonry. There are random small areas of missing and/or deteriorated mortar throughout the joints, which could be probed up to 1'-0" deep, mostly along the bottom 1'-0". There is a 1'-8" wide x 2'-0" high x 2'-0" deep square opening in the top of the wall for a drain pipe at 1,065' from the west end. The portion of wall between 1,072' and 1,148' from the west end (beneath 8069 Main Street) is comprised of stone masonry. There is a pedestrian bridge at the east end of Section 11 (see Photo 33).

*Photo 33 – Elevation at East End of Section 11, Looking Southwest.*

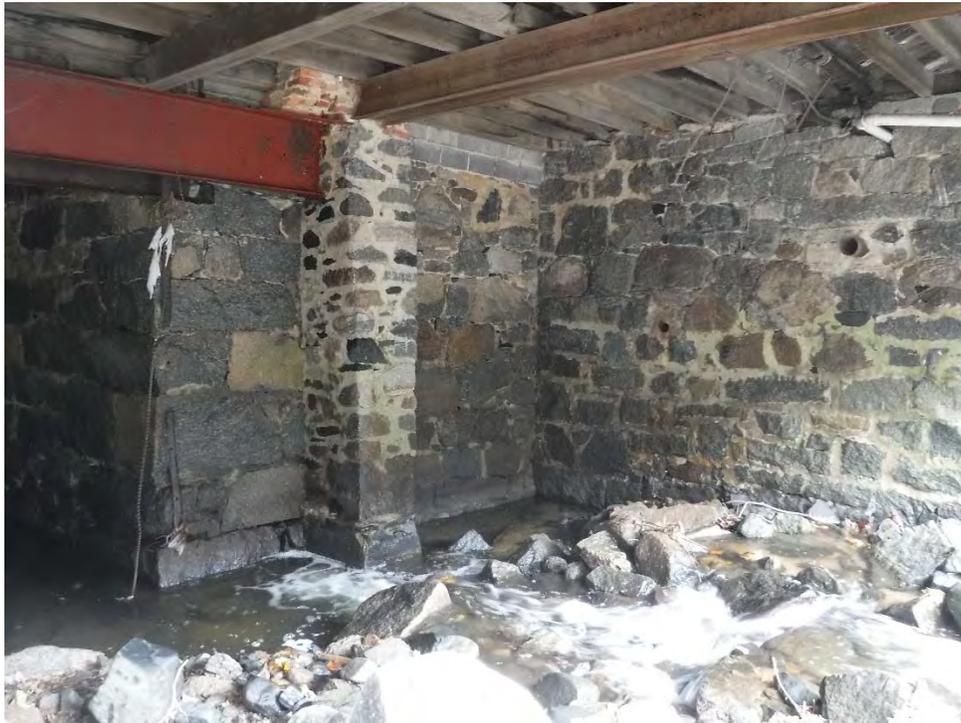
Section 12 extends from 1,148' to 1,239' from the west end of the wall. The portion between 1,148' and 1,171' from the west end (beneath 8059 Main Street) is comprised of stone masonry (see Photo 34). There is an 8" wide x 1'-0" high square opening in the top of the wall for a drain pipe, at mid-length. The bottom of the wall at the east end has a 5'-0" long x 1'-0" high area of missing mortar, which could be probed up to 1'-0" deep. The portion between 1,171' and 1,239' from the west end (beneath 8055/8049 Main Street) is comprised of stone masonry. There are random areas of missing mortar and small stones throughout 40% of the joints, which can be probed up to 2'-0" deep (see Photo 35). The remaining mortar is in good condition. Typically, there is missing mortar along the bottom 1'-0" height and undermining up to 5" high x 10" deep along the full length. There is a displaced stone at the bottom of the wall, protruding 1'-0" outward, 1,187' from the west end (see Photo 36). Above the displaced stone, there are gaps up to 3'-0" wide x 6" high x 1'-0" deep. There is up to 3'-0" deep scour adjacent to the wall at this location. The bottom of the wall, starting at 1,197' from the west end, has a 3'-0" long x 1'-6" high x 1'-0" deep area of undermining/missing stone (see Photo 37). There is a 1'-4" wide x 1'-0" high x 2'-0" deep void/missing stone, 3'-0" from the base of the wall, at 1,203' from the west end (see Photo 38).

*Photo 34 – Elevation at West End of Section 12, Looking Southeast.*

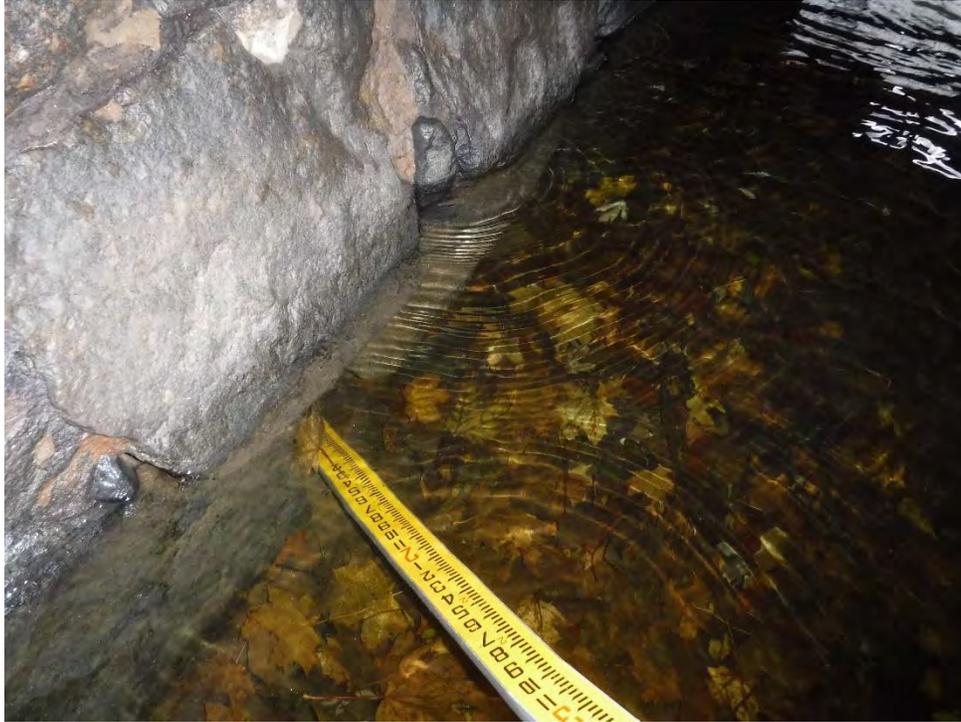
*Photo 37 – Undermining in Section 12.*

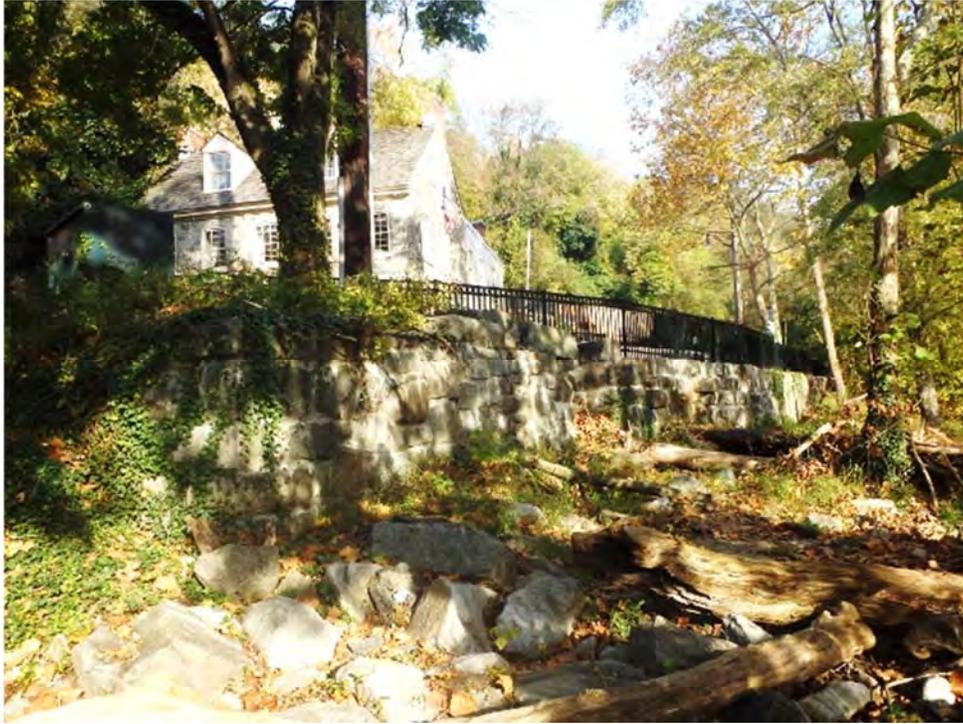
*Photo 1 – Elevation from South End, Looking Northwest.*

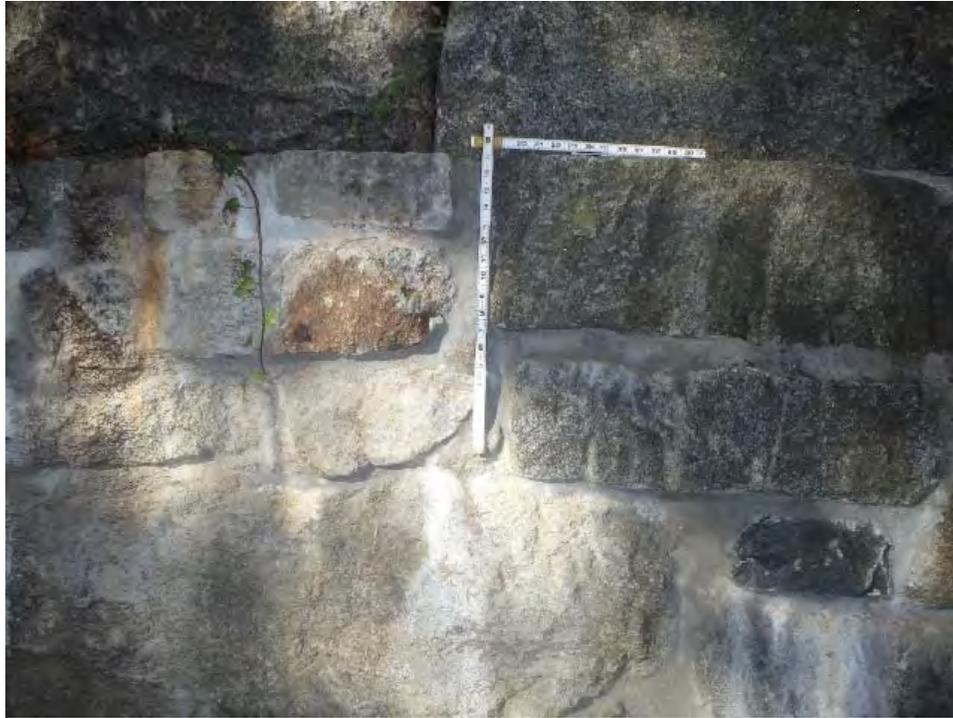
Overall, the retaining wall is in good condition. There is typically light efflorescence throughout the wall (see Photo 3). There were small isolated areas of mortar loss in the joints throughout the wall (see Photo 4). Approximately 30' from the north end of the wall, there is a 6'-0" long cracked mortar joint, open up to ½" wide (see Photo 5). The northernmost 20' length of the wall has mortar loss throughout the joints. There are two large areas of loose and missing stones within the northern 10' length of the wall (see Photo 6). Fill was visible in the voids. There are a few mature trees growing along the top of the wall; however, they are not visibly affecting the wall.

*Photo 3 – Typical Light Efflorescence throughout Wall.*

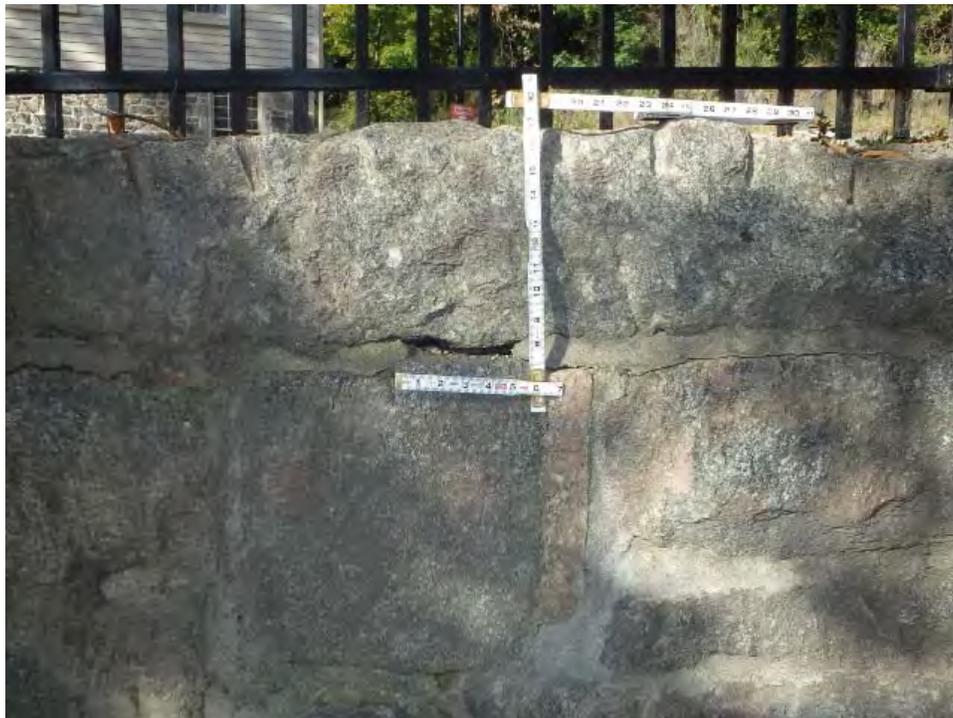
*Photo 4 – Typical Isolated Mortar Loss throughout Wall.*

The missing stones should be replaced. The mortar joints should be repointed throughout the wall. The mature trees growing along the top of the wall should be monitored for encroachment / effect on the wall.

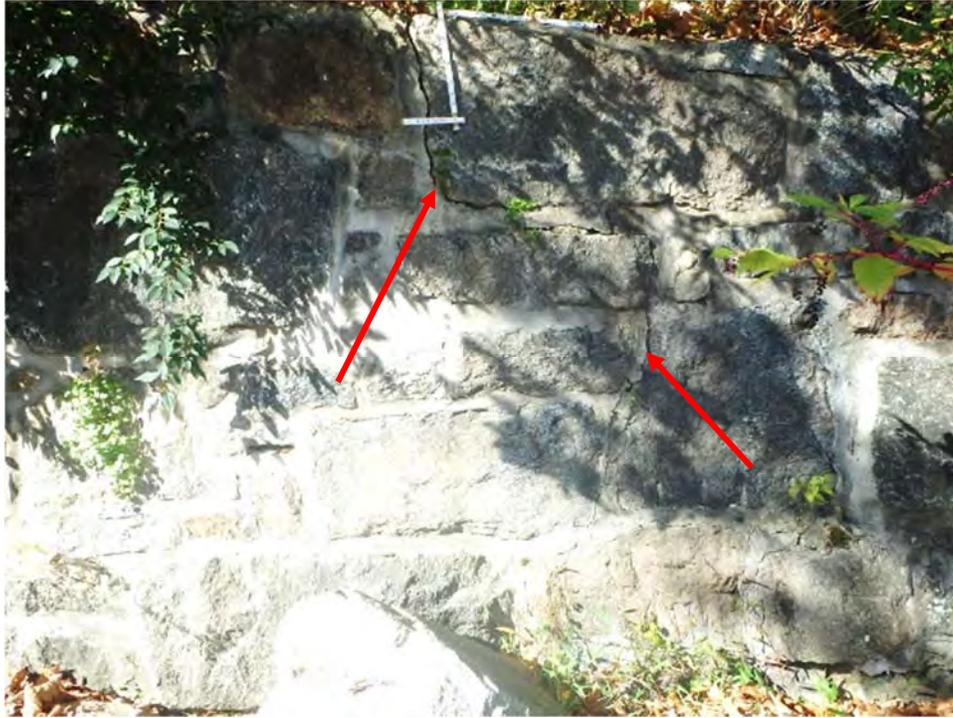
*Photo 5 – Cracked Mortar Joint at 350' from South End of Wall.*

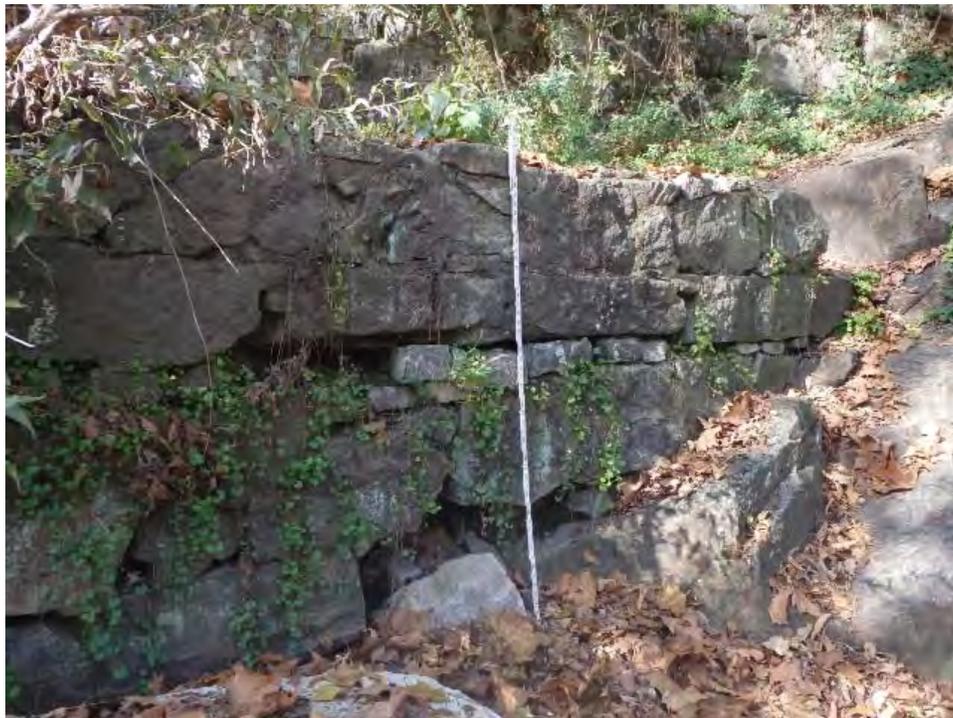
*Photo 6 – Loose and Missing Stones at North End of Wall.*

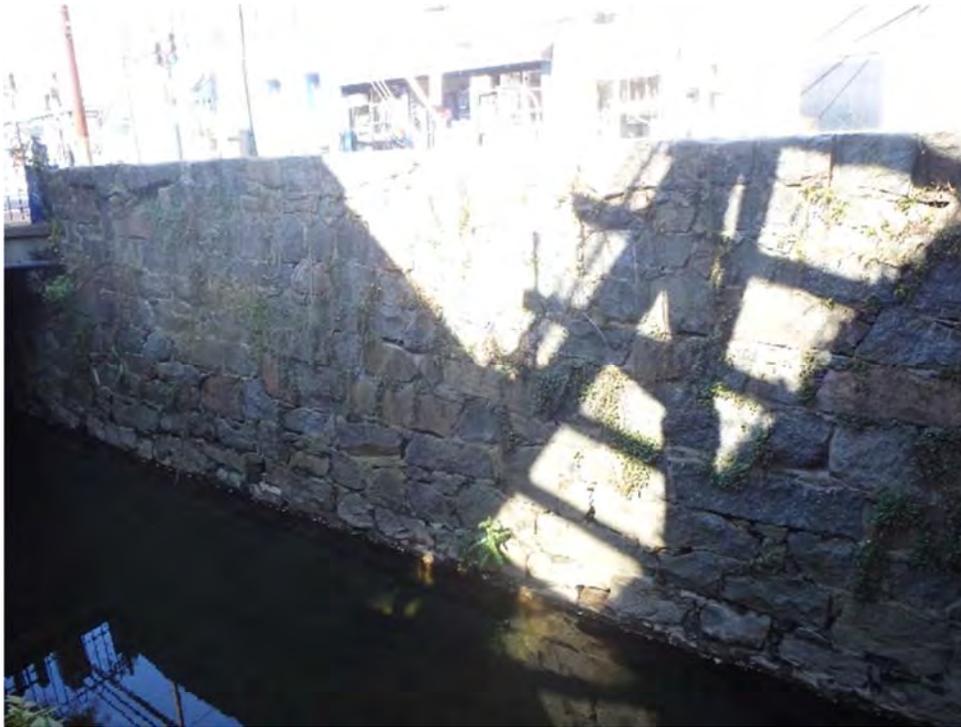
*Photo 1 – Elevation, Looking Northwest.*

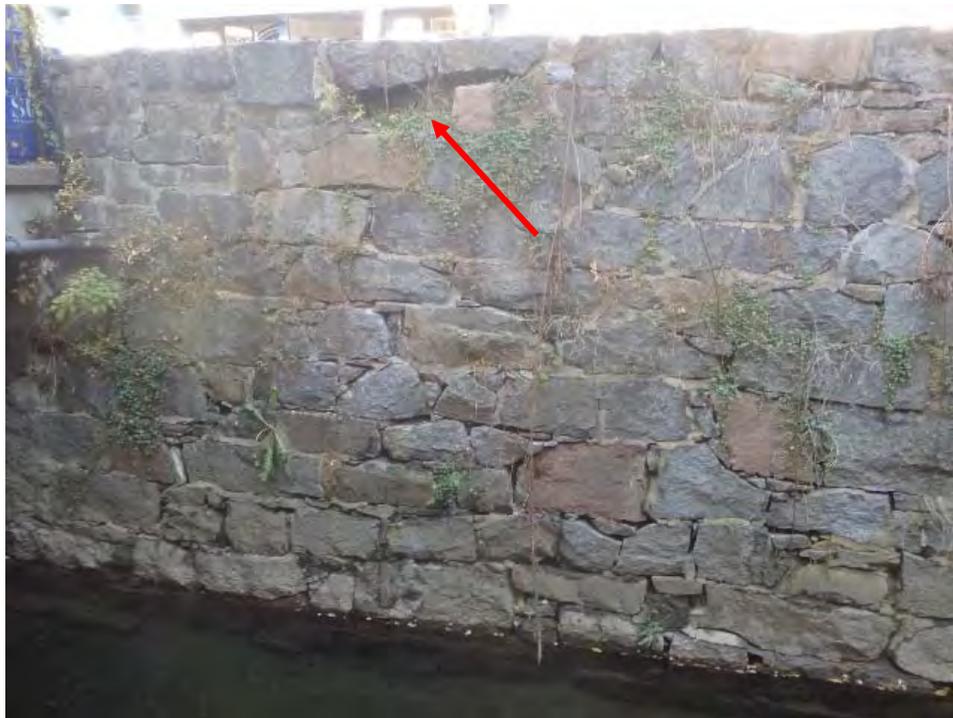
Overall, the retaining wall is in fair condition. There is mortar loss throughout the joints, with vegetation growth present (see Photo 2). There are typically loose small stones adjacent to the failed joints. There is an area of missing stones at the top of the south face of the wall, 7' from the west end, measuring 4'-6" long x 1'-6" high (see Photo 2).

*Photo 2 – Area of Missing Stones at Top of South Face.  
Note Missing Mortar throughout Joints*

The upper 3'-6" of the retaining wall (pedestrian barrier) should be repaired, due to loose and missing stones. The remaining height of the wall (south face) should be repointed at the masonry joints.

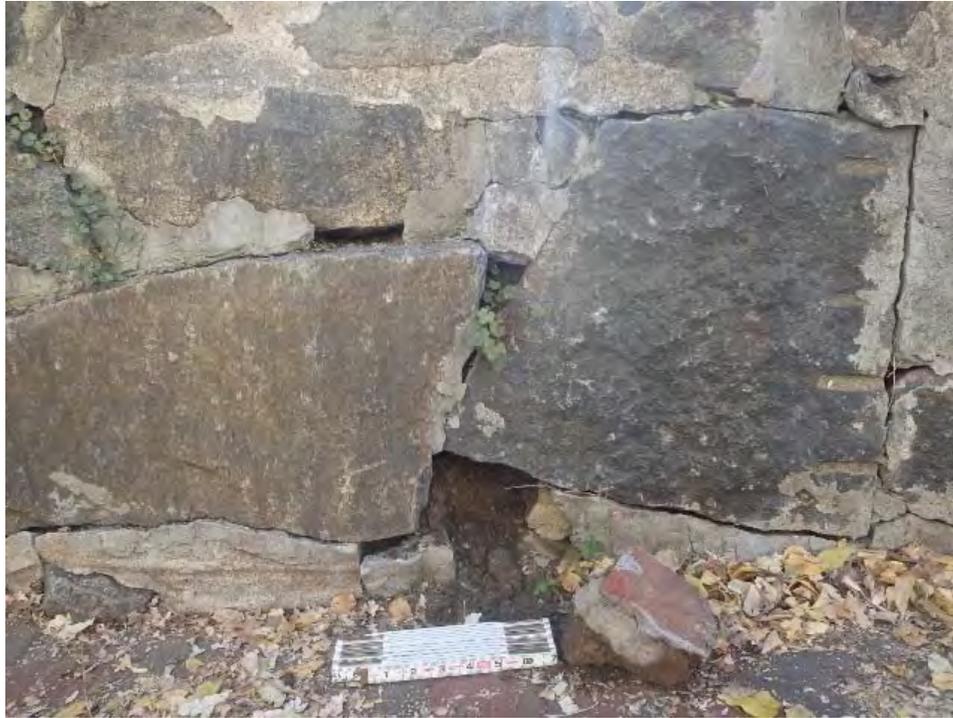
On the north face of the wall (pedestrian side), there are loose stones within the bottom 1'-0" height, throughout the length of the wall. Some stones are missing, with fill visible and penetration up to 1'-0" deep (see Photos 3-6).

*Photo 3 – Failed Mortar Joints and Missing Stones in North Face.*

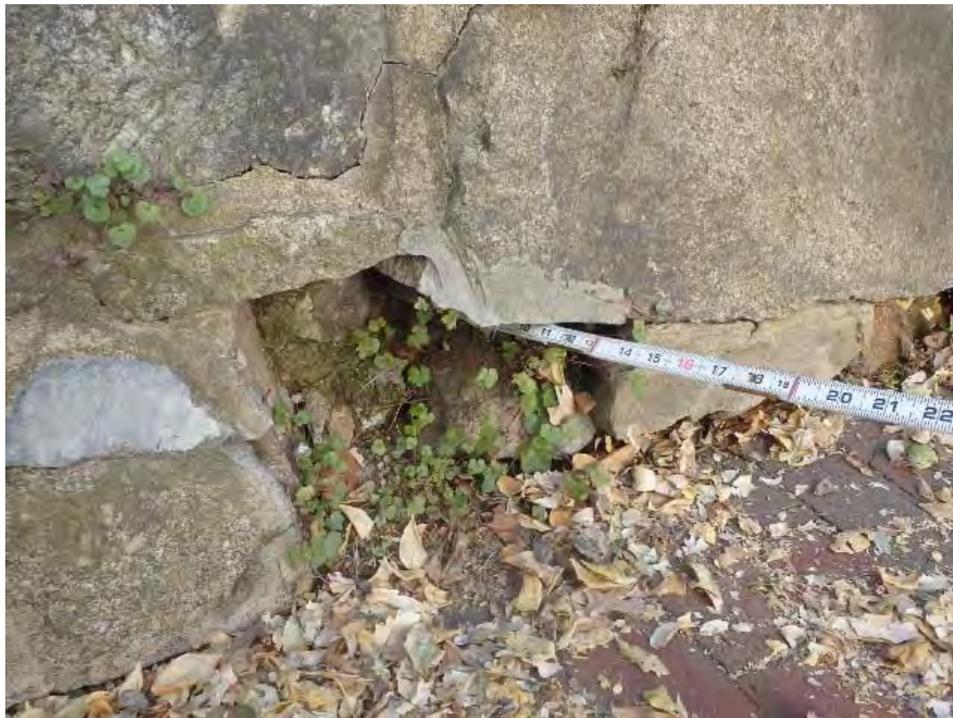
*Photo 4 – Loose and Missing Stones at Base of North Face at Mid-Length, Looking South.*

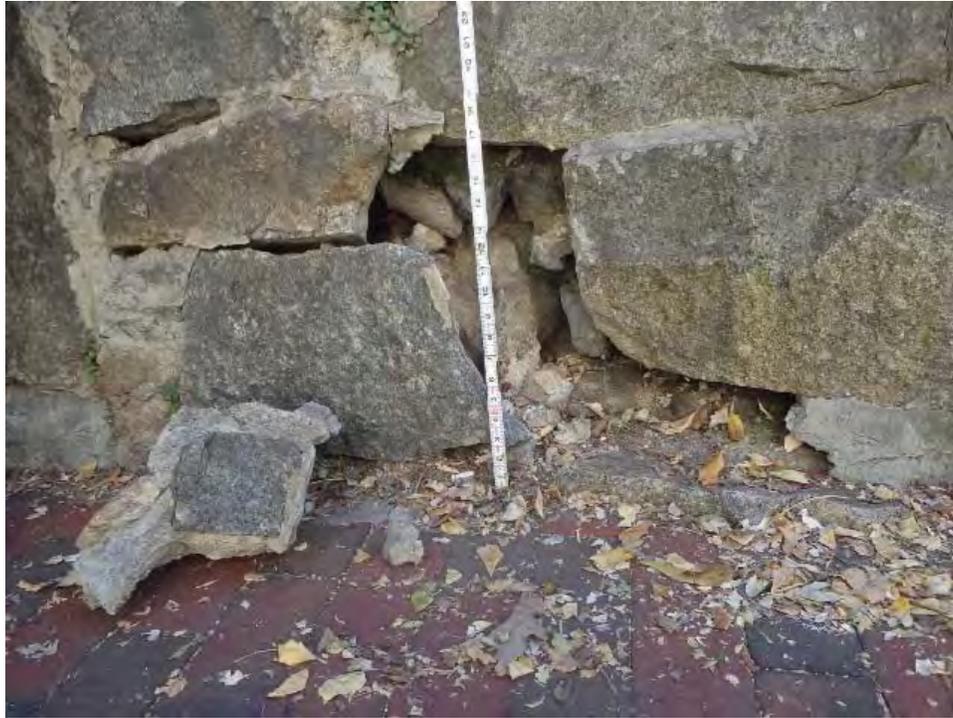
*Photo 5 – Loose and Missing Stones at Base of North Face at 15' from East End, Looking South.*

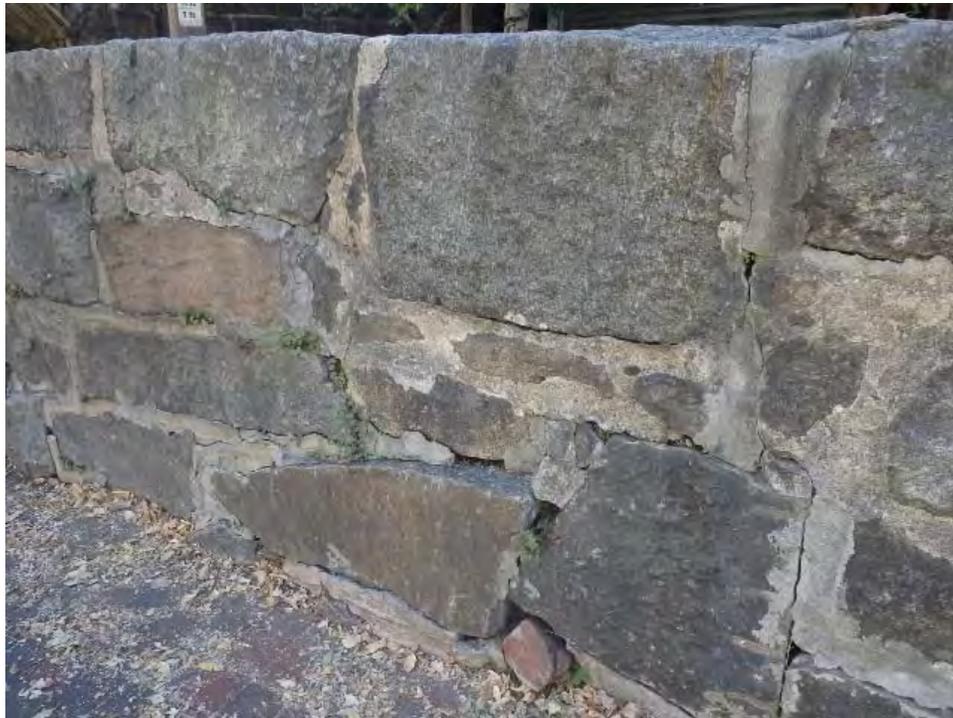
*Photo 6 – Large Loose Stone at Base of North Face near West End, Looking South.*

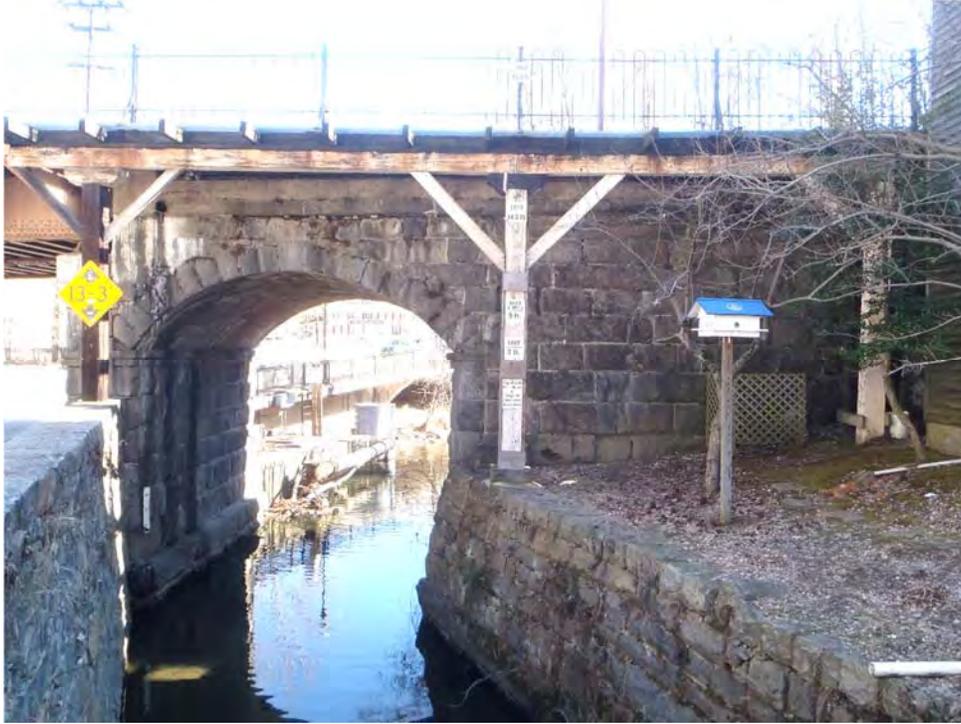
*Photo 1 – Retaining Wall and CSX Railroad Bridge, Looking East.*

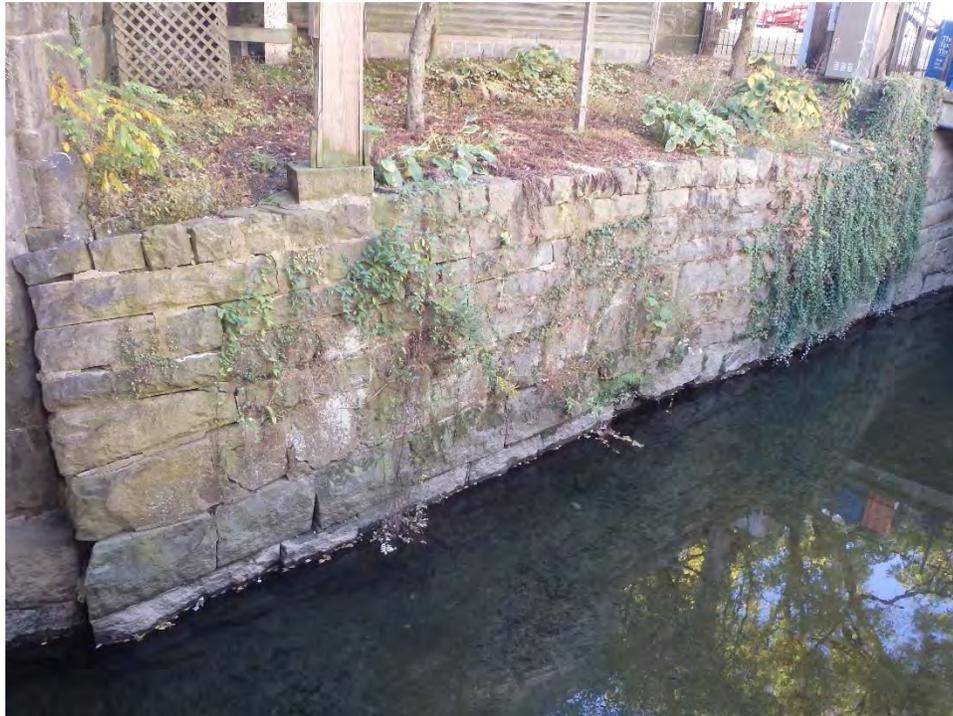
*Photo 2 – Elevation, Looking South.*

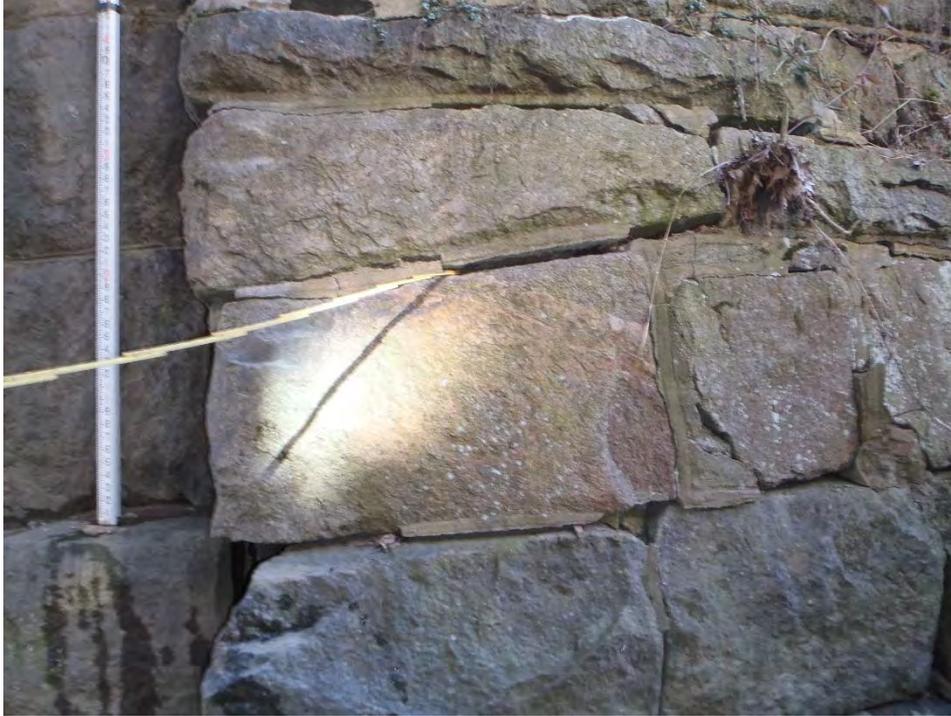
*Photo 3 – Typical Loose and Missing Mortar in Joints between Stones.*

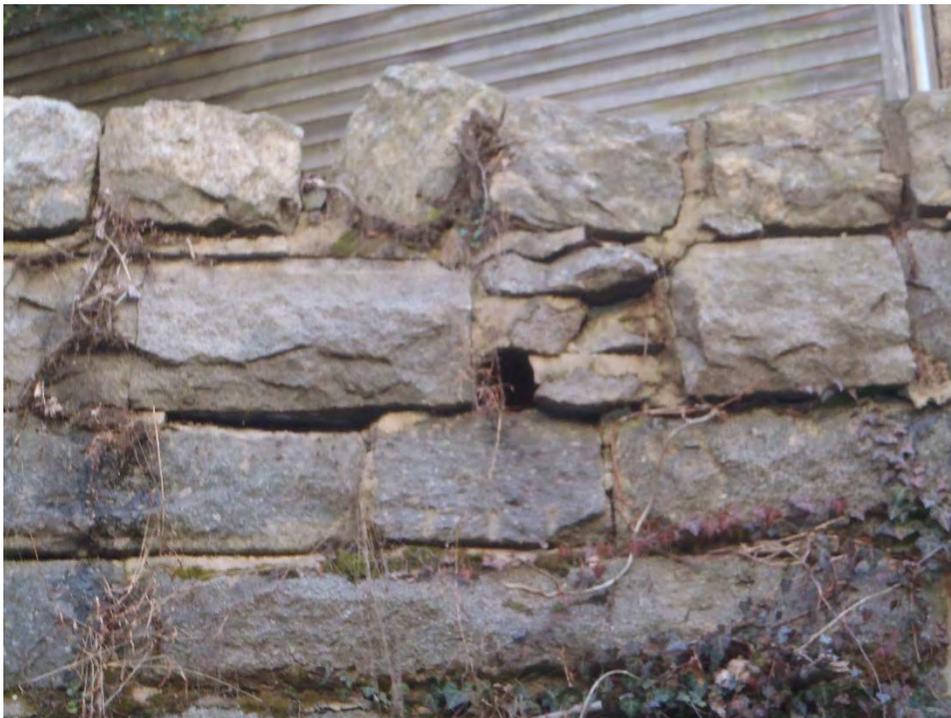
*Photo 4 – Area of Shifted Stones at Top of Wall, 5' From West End.*

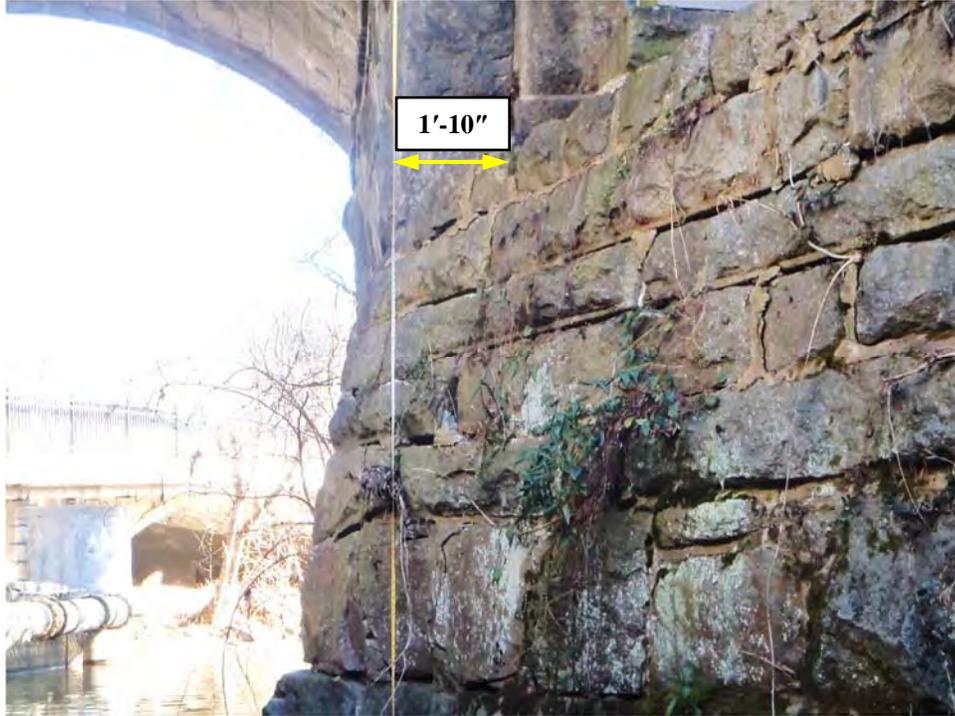
Overall, the retaining wall is in poor condition. The east end of the wall is bulging outward for a 10'-0" length, with a large area of missing stones and settled soil above the wall.

*Photo 5 – Bulge at East End of Wall, Looking East.*

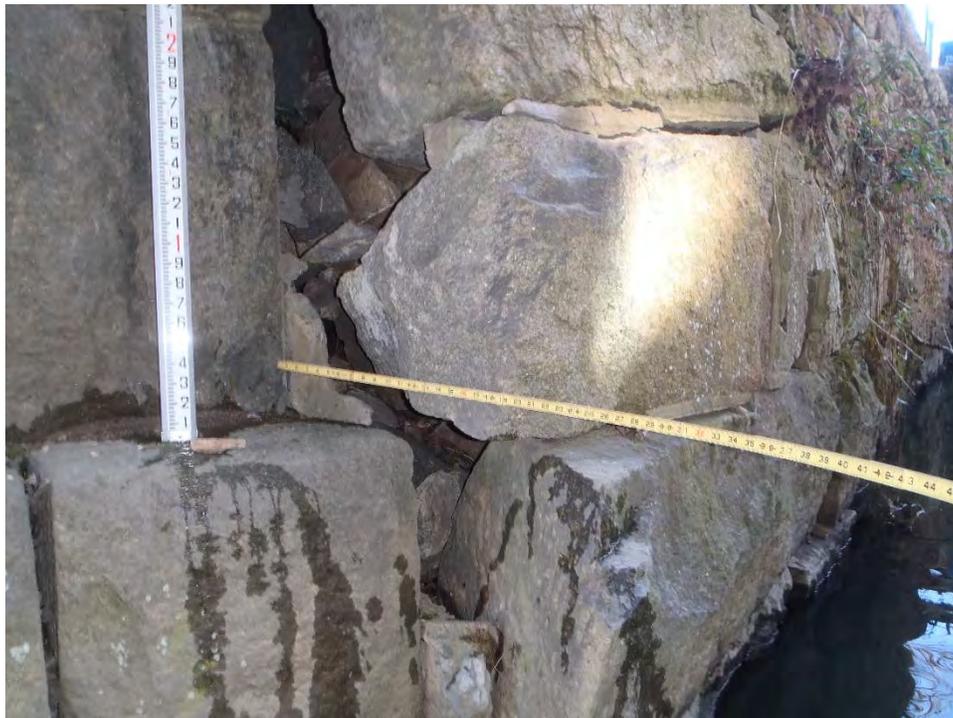
*Photo 6 – Bulge and Void at East End of Wall, Looking West.*

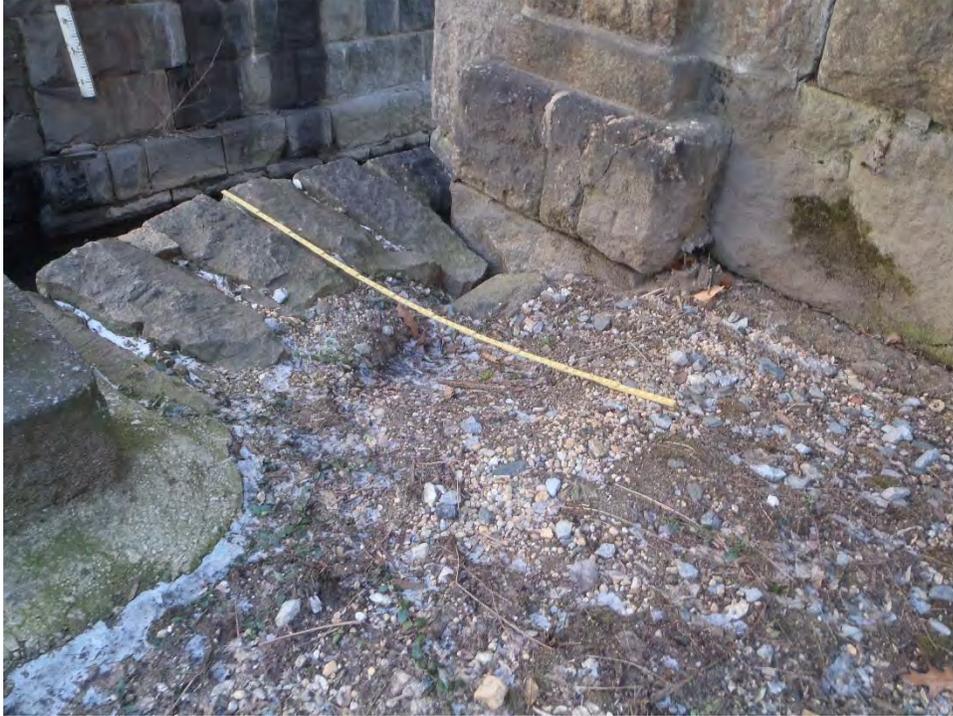
*Photo 7 – Settlement at Top East End behind Wall, Looking Northeast.*

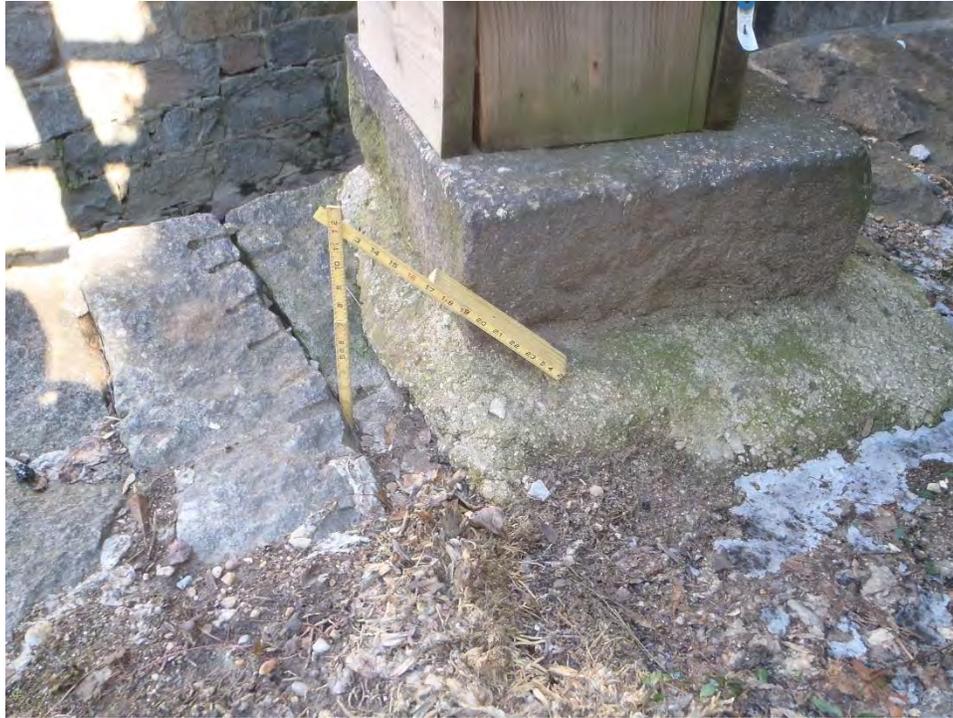
*Photo 9 – 2" Vertical Misalignment between Stones at Southwest Corner of Catwalk Support Post.*

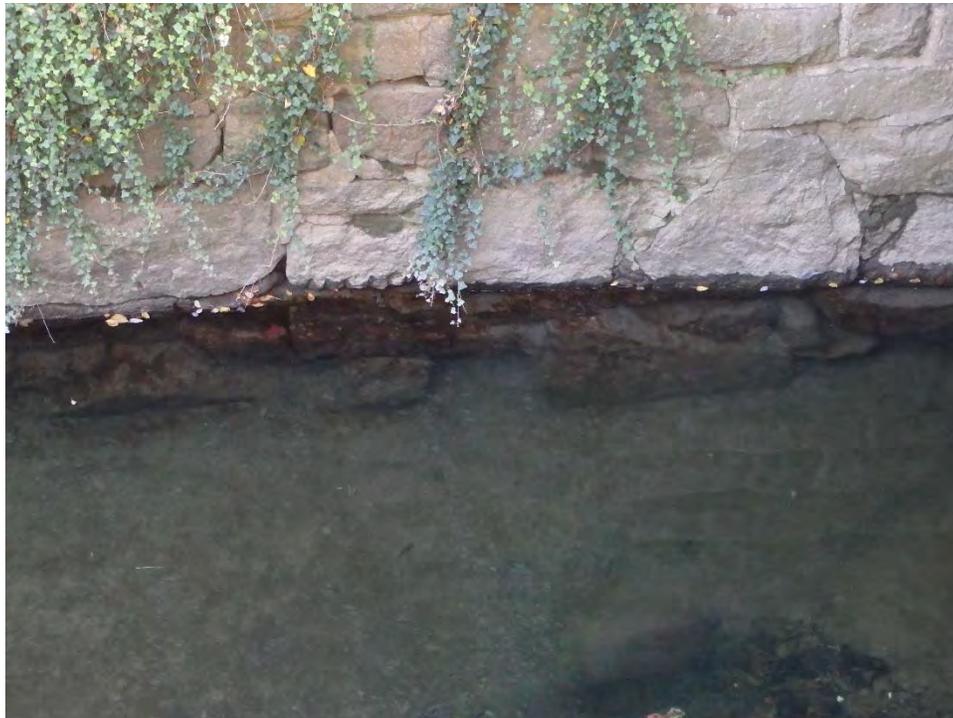
The stream channel bottom is comprised of small rocks, gravel and sand. There are several small missing stones along the base of the wall; however, there is no evidence of scour or undermining (see Photo 10).

*Photo 10 – Typical Missing Stones along Base of Wall.*

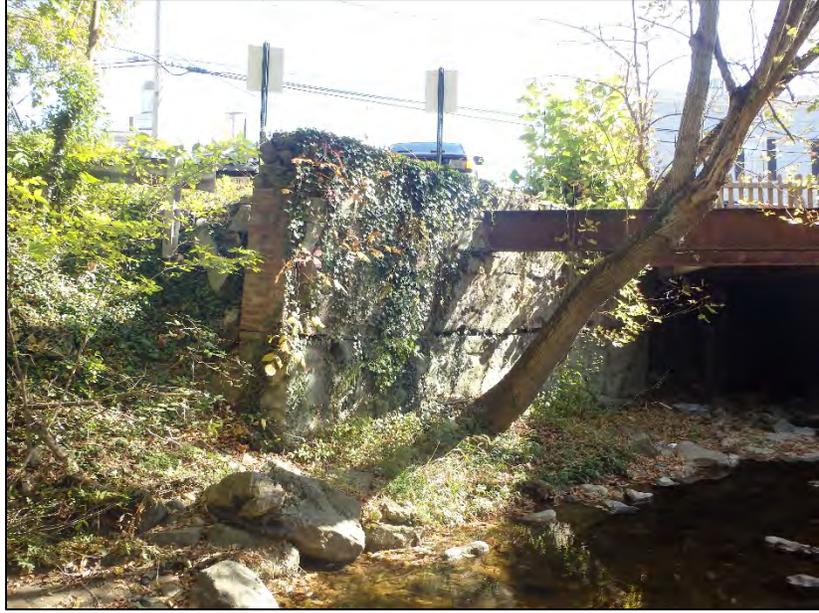
Photograph 1. Overall View of RW9, Looking Northeast.

The wall should be removed and rebuilt. The steel I-beams and timber deck may need to be temporarily supported during this work.

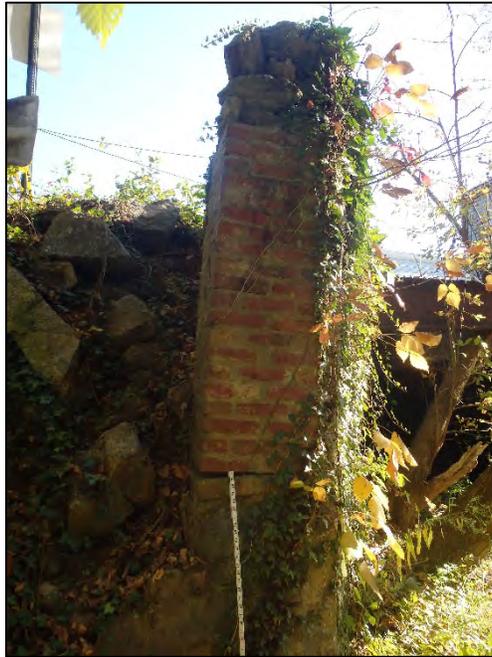
Photograph 2. RW9 Leaning Toward Channel, Looking East.

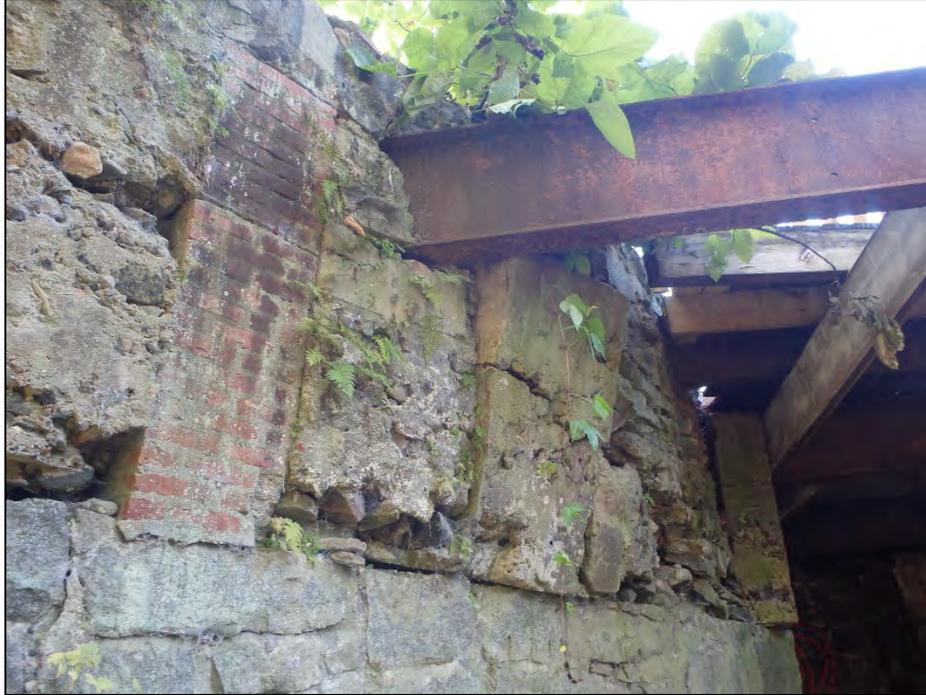
Photograph 3. Loose Stones in RW9, Looking Northeast.

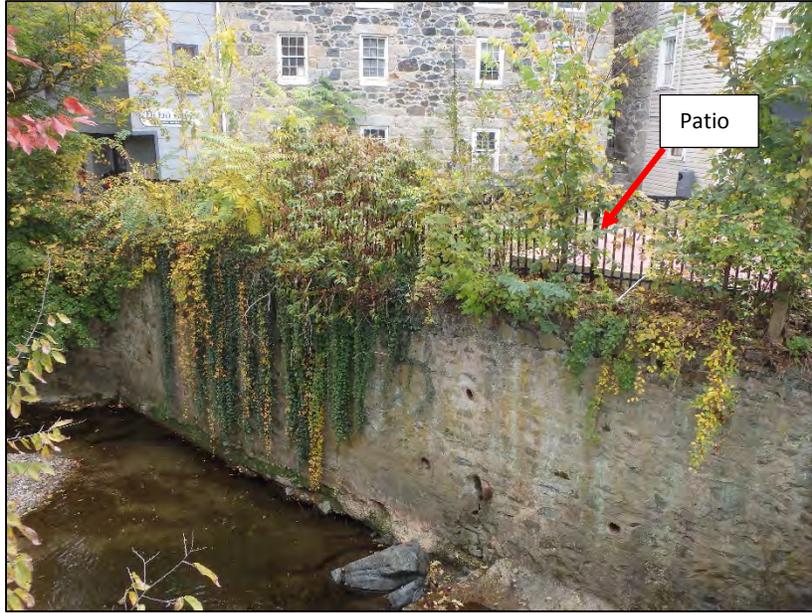
Retaining Wall 17B is positioned along the south bank of Tiber Creek, just east of Parking Lot D (between parking lot and Old Columbia Pike). The wall is undermined along its length along the channel, up to 2 feet high, and could be probed up to 4 feet deep. There was an area of loose stones measuring 2 feet high x 4 feet wide around a drain pipe at the top right corner of the wall.

Photograph 1. Overall View of RW17B (S.Wall), Looking Southeast.  
Wall is Undermined, Up to 4'-0" Back

As an immediate measure, the patio and area behind the wall should be roped off or fenced in to prevent public access. The eroded area behind the wall should be backfilled, possibly with flowable fill. The drain pipes should be repaired or replaced to allow for proper drainage. The undermined area below the wall should be backfilled with grout or grout bags and scour countermeasures, such as a concrete apron, should be installed. To dissipate the flow energy that has undermined the wall, a plunge pool should be constructed with large boulders at the downstream end of the adjacent bridge apron.

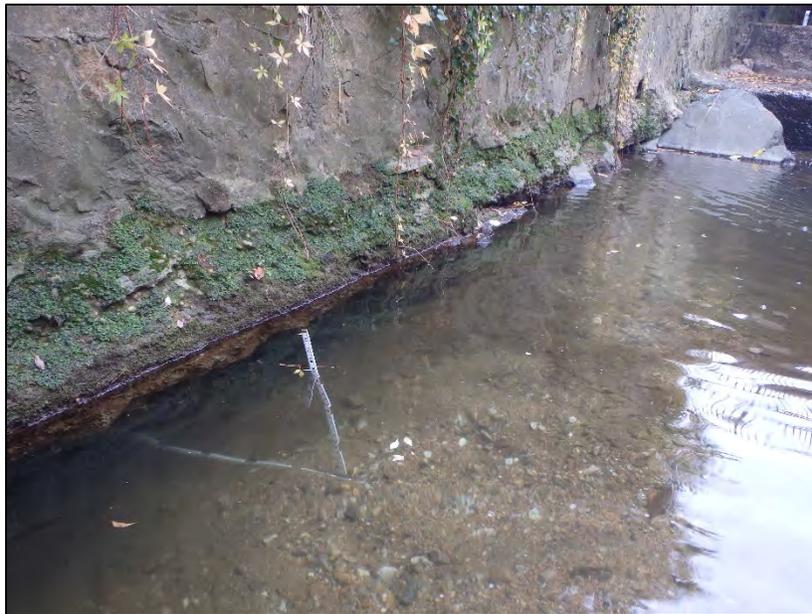
Photograph 2. View of Undermining Along Wall, Looking Southwest.

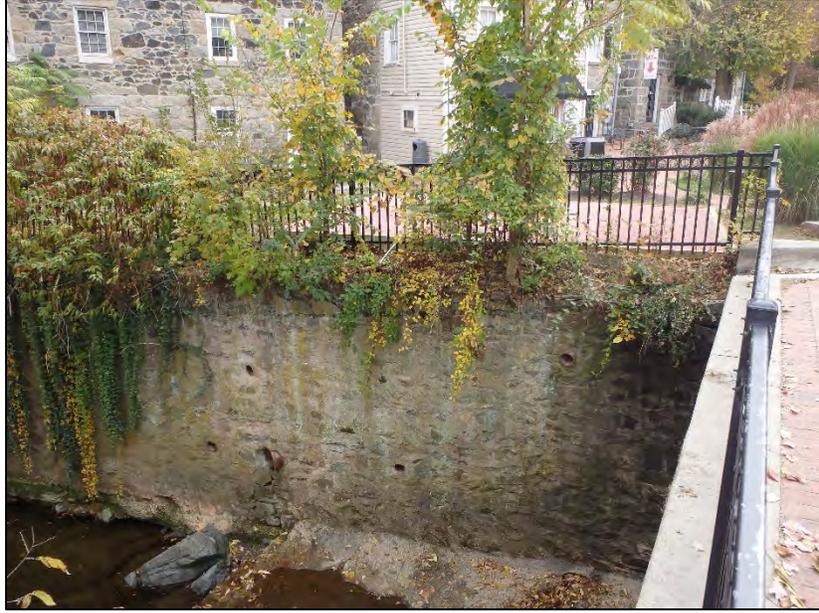
Behind the wall, there is a grass area that serves as a courtyard for several businesses. A patio has been constructed, positioned so that the north edge of the patio is 3 feet from the front face of the retaining wall. There is an erosion hole behind the retaining wall located 32 feet from the west end of the wall. The erosion hole is 3 feet in diameter on the surface, but extends at least 10 feet in either direction underground. There was evidence of a broken drain pipe in the erosion hole. The extent of the erosion could not be determined; however, it can be assumed that the erosion is encroaching upon the patio at the west end of the wall. The north edge of the patio (1 foot wide) shows signs of settlement towards the channel.

Photograph 3. View of Patio above Wall, Looking South.

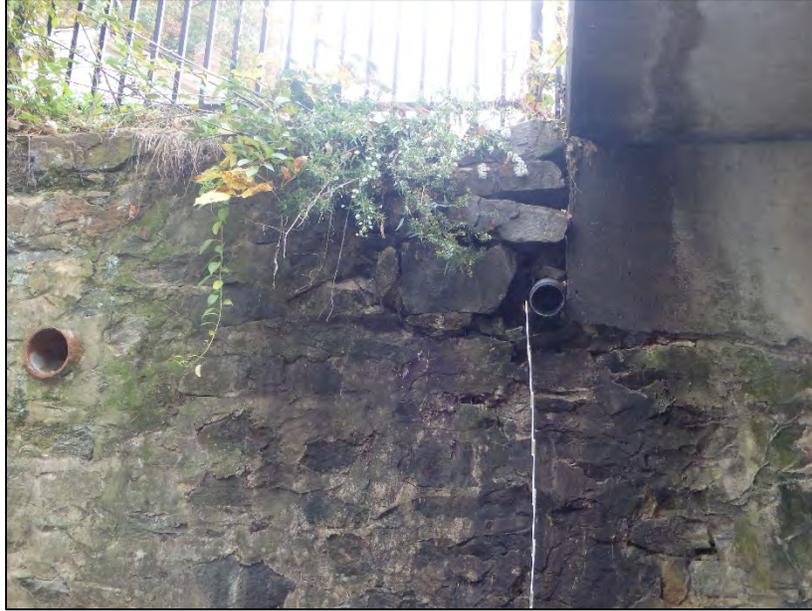
Photograph 5. Top Right Corner of Wall - Drain Below Patio with Loose Stones, Looking South.

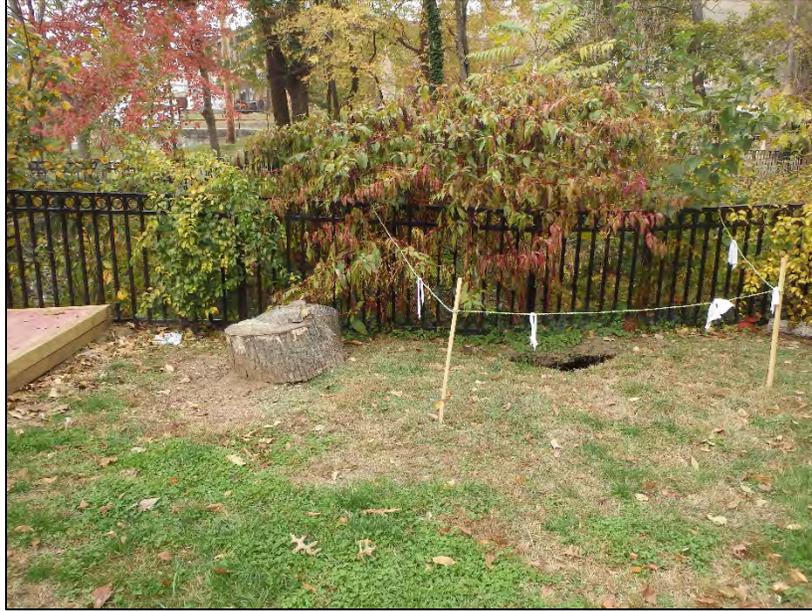
While the ends of the wall are supported and connected to adjacent walls, erosion behind the wall may continue without affecting the wall itself. The erosion hole behind the wall is a safety hazard to pedestrians and has been marked off with rope by the local business owner. The patio poses a safety hazard to pedestrians and could continue to settle as erosion continues.

Photograph 7. View of Erosion Hole behind Wall, Looking North.
