# ELLICOTT CITY RETAINING WALLS INSPECTION REPORT

## STREAM WALLS

## HISTORIC ELLICOTT CITY, MARYLAND

MAY 2016

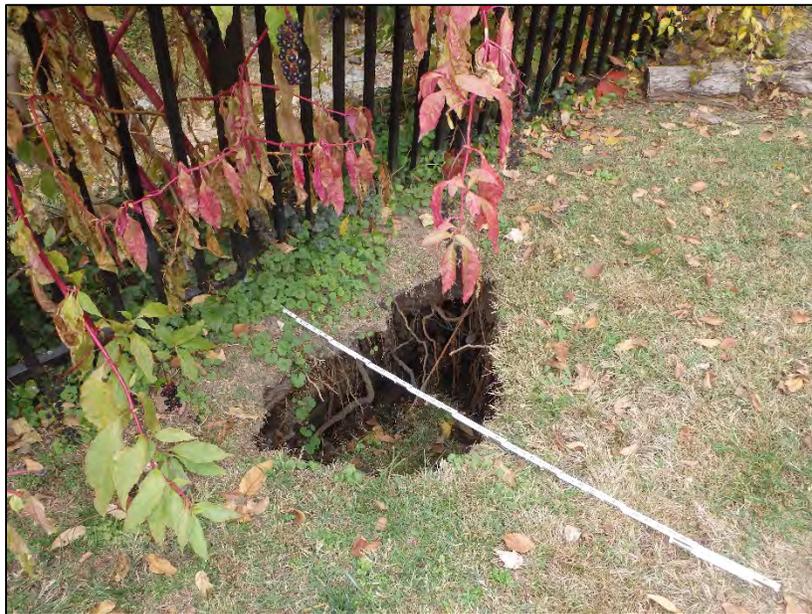
While the ends of the wall are supported and connected to adjacent walls, erosion behind the wall may continue without affecting the wall itself. The erosion hole behind the wall is a safety hazard to pedestrians and has been marked off with rope by the local business owner. The patio poses a safety hazard to pedestrians and could continue to settle as erosion continues.

Photograph 8. View of Erosion Hole behind Wall, at Location of Broken Drain Pipe

As an immediate measure, the patio and area behind the wall should be roped off or fenced in to prevent public access. The eroded area behind the wall should be backfilled, possibly with flowable fill. The drain pipes should be repaired or replaced to allow for proper drainage. The undermined area below the wall should be backfilled with grout or grout bags and scour countermeasures, such as a concrete apron, should be installed. To dissipate the flow energy that has undermined the wall, a plunge pool should be constructed with large boulders at the downstream end of the adjacent bridge apron.

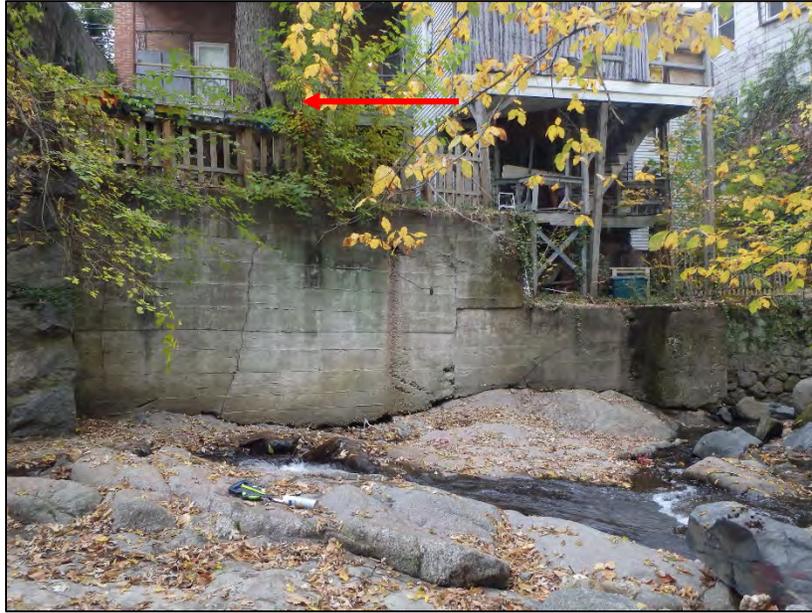
The retaining wall along the back of this property is constructed of concrete. The wall exhibits a full-height fracture at mid-length, open up to ¼ inch wide. There is a large tree (~2 foot diameter trunk) located behind the wall, in line with this fracture, that could be impacting the wall. The bottom of the wall was undermined 10 feet long x 6 inches high and could be probed up to 1 foot deep. The top right corner of the wall (5 feet high x 4 feet wide) has fractured and is leaning up to 4 inches towards the channel. The portion of the wall perpendicular to this corner (running north-south towards house) was leaning to the east. This portion of the wall supports a timber column at the corner of the house. The column is out of plumb, although measurements were not taken due to lack of access. The presence of erosion behind the wall was not investigated.

Photograph 1. View of RW17A (N.Wall), Looking Northeast.  
Note Tree Behind Wall.

- The portions of the buildings above the retaining wall should be inspected for structural integrity. These buildings may require temporary support during this work.
- Remove and rebuild the bulging portions of the stone masonry wall.
- Remove and replace the leaning portions of the concrete wall.
- Remove all trees and vegetation from the top and back of the wall.
- Fill all undermined areas and voids with grout.
- Replace all missing stones.
- Repoint all areas of missing mortar.

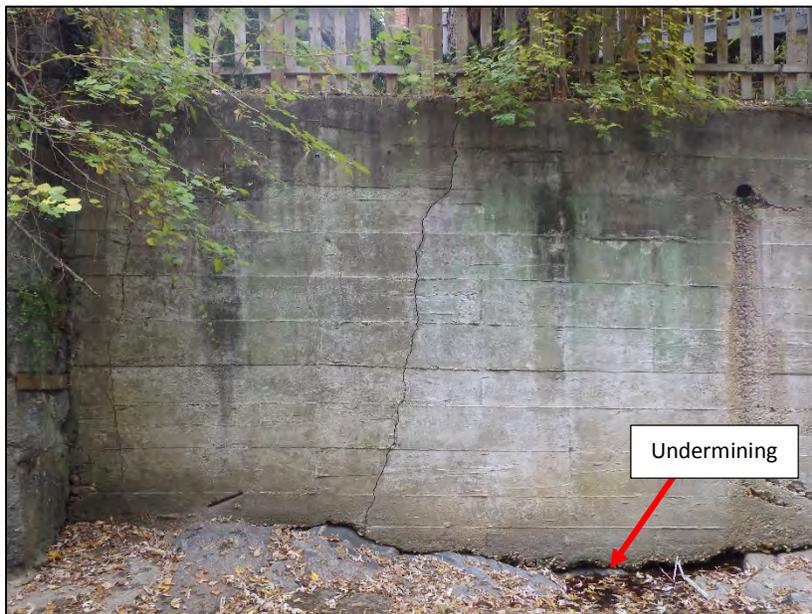
Photograph 2. Full-Height Fracture and Undermining, Looking North.

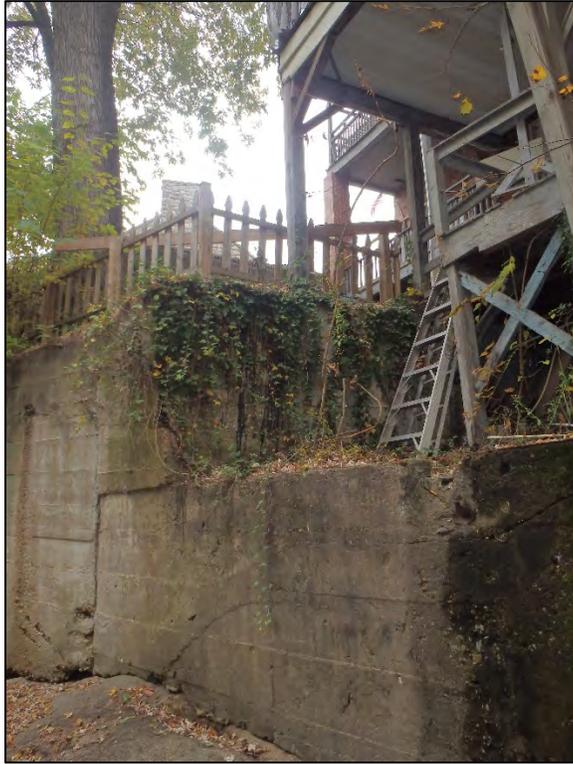
Photograph 3. View of Portion of Wall Supporting the Building Column, Looking Northwest.

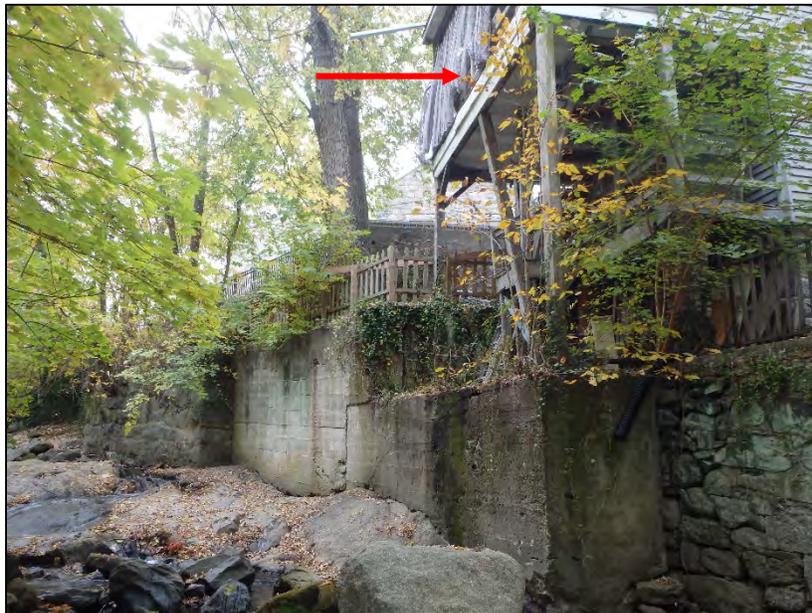
Photograph 4. View of Cantilevered Portion of Building over Wall, Looking West.

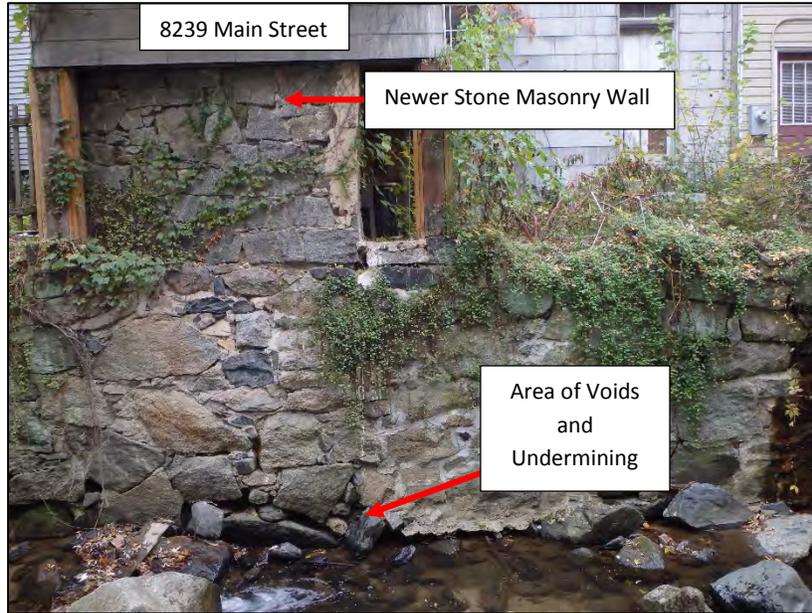
The retaining wall along the back of this property is constructed of stone masonry. There is a 10 foot long stone masonry wall which has been constructed on top of the original wall, under the back portion of the house. The base of the original retaining wall exhibits loss of mortar at the joints, with a 9 foot long x 2 foot high area with voids that could be probed 2 feet deep to fill. A 5 foot wide portion of the wall at the east edge of the property is bulging with up to 4 inches of horizontal displacement. The bulging is worse at the top of the wall. The presence of sink holes or erosion behind the retaining wall was not investigated due to lack of access. There is vegetation growth with root systems at the top of the wall and randomly throughout the mortar joints.

Photograph 1. View of RW17A (N.Wall), Looking North.

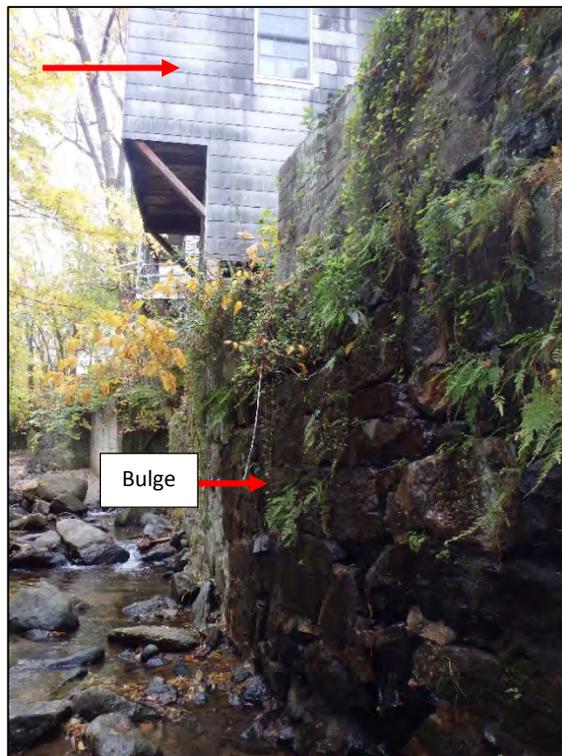
Photograph 2. View of Cantilevered Portion of Building over Wall, Looking West. Note Bulging Wall.

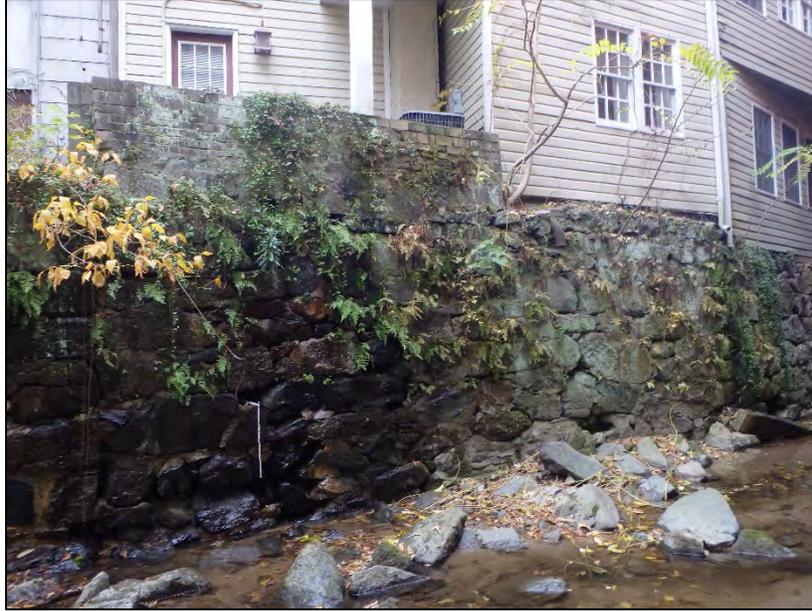
The retaining wall along the back of this property is constructed of stone masonry. There is a 10 foot long portion of the wall along the west half of the property with active water leakage through the open joints (weather was clear at time of inspection). The voids at the joints could be probed up to 5 feet deep to fill. There is a brick wall bearing on top of the stone masonry wall, and a building column which bears on this brick wall at the west corner of the building. The back face of the building bears on the stone masonry wall in the eastern half of the property.

Photograph 1. View of RW17A (N.Wall), Looking Northeast.

The source of the water leakage should be investigated prior to performing any wall repairs. The recommendations for the wall in this area are as follows:

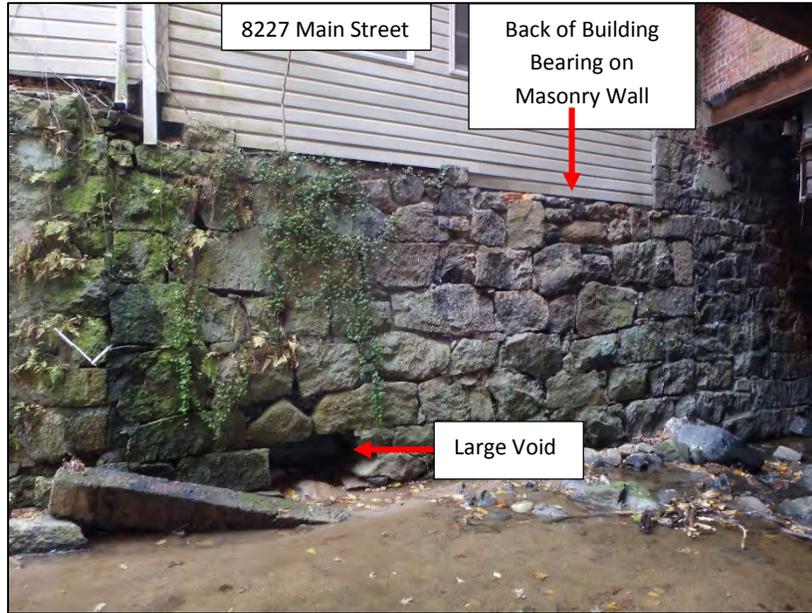
The retaining wall along the back of this property is constructed of stone masonry. There are typically voids probed 2.5 feet deep to fill with vegetation growth. There is a large void at the base of the wall, measuring 2 feet high x 3 feet wide x 2.5 feet deep (missing stone). The back face of the building bears on the stone masonry wall.

Photograph 1. View of RW17A (N.Wall), Looking Northeast.
