## APPENDIX A: HOWARD COUNTY COUNCIL BILL #56-2018

# PLUMTREE BRANCH WATERSHED ASSESSMENT AREA P01

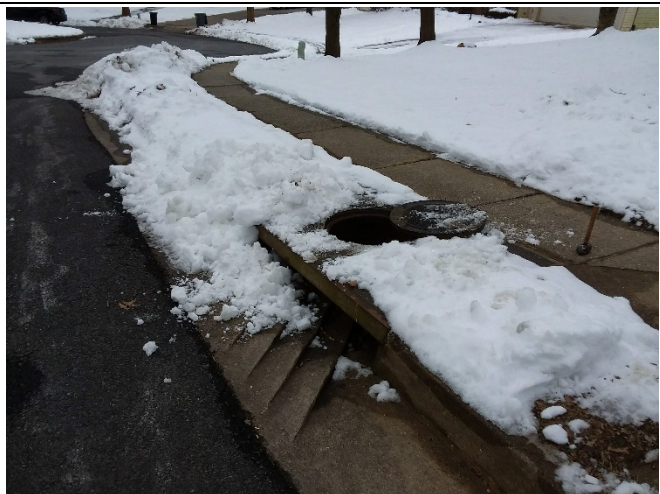
Figure 1: Typical inlet along Old Dragon Path.

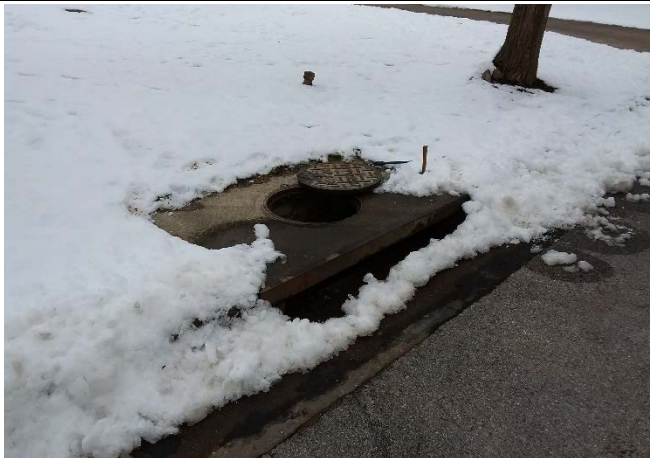
Figure 1: Typical inlet along Gray Rock Drive.

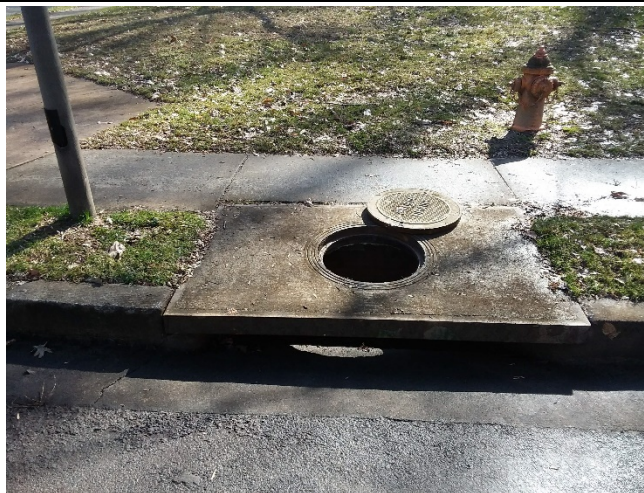
**Figure 1: Typical inlet along Hemlock Cone Way.**

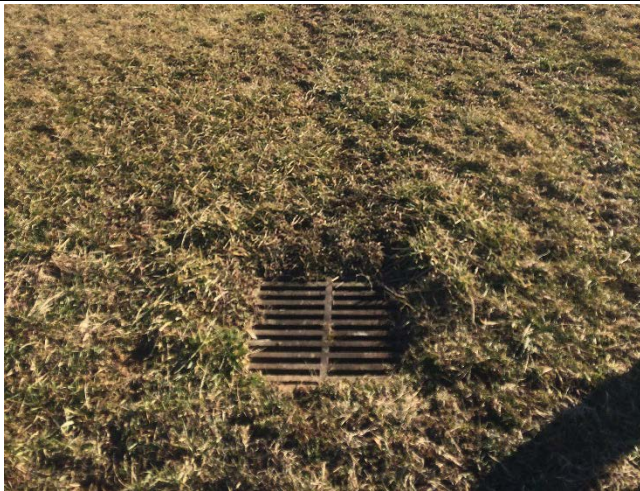
**Figure 1: Typical inlet located within Dunloggin Middle School athletic field.**

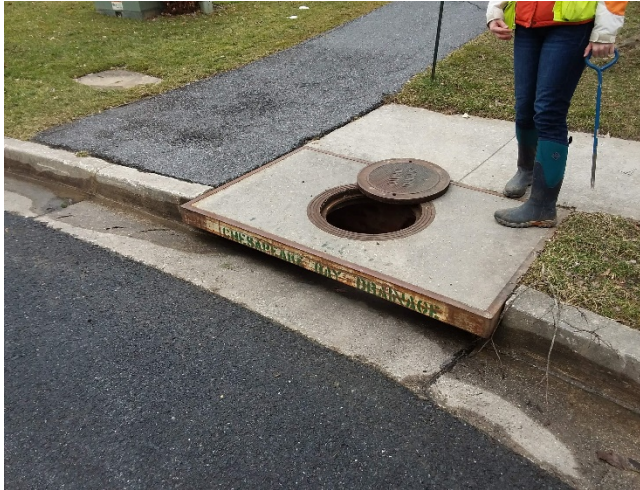
**Figure 1: Typical inlet along Speedwell Court.**

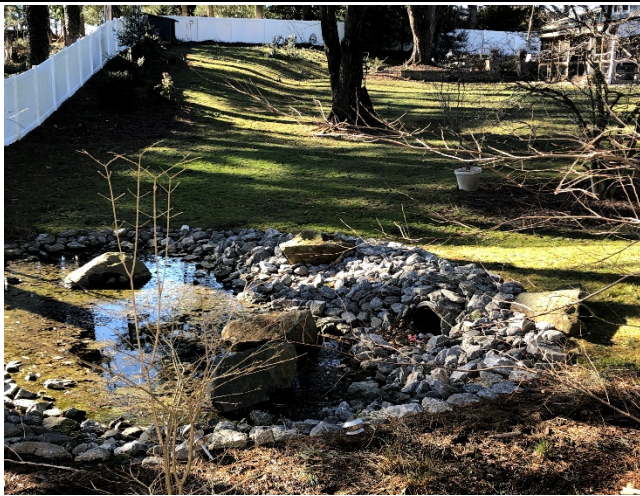
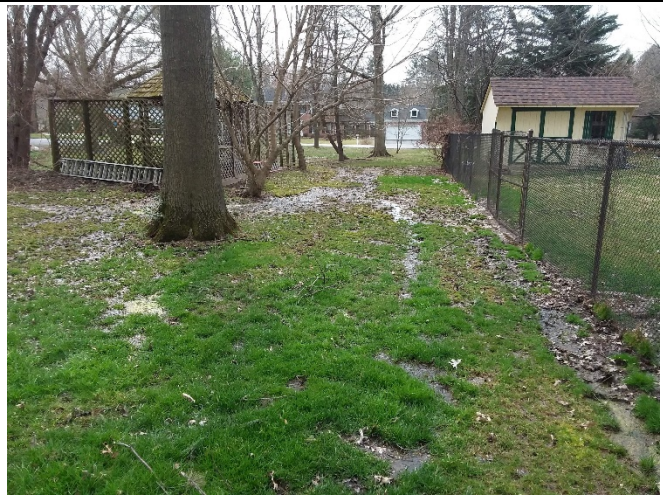
Survey responses, field observations, and homeowner interactions suggested that flooding is an issue every time it rains. Capacity and condition of downstream conveyance systems should be considered in any further analysis or improvements.

**Figure 1: Opportunity to install new conveyance system.**

**Figure 2: Opportunity to install new conveyance system.**

| Type | ID No. | Description & Discussion |
|---|---|---|
| Conduct More Detailed Analysis of Storm Drain Network | N/A | The major storm drain network(s) within the assessment area is likely not functioning as intended. More detailed analysis is recommended to determine if improving the network with modified infrastructure is necessary. |

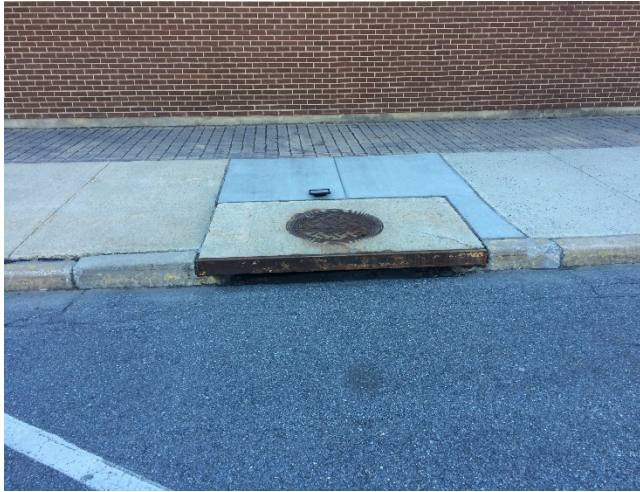
**Figure 1: Typical inlet on the campus of Dunloggin Middle School.**

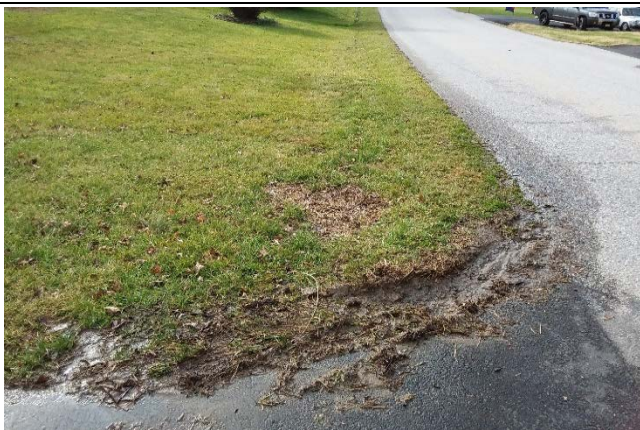
**Figure 1: Opportunity to install new conveyance system.**

**Figure 2: Opportunity to improve existing conveyance system.**

**Figure 3: Opportunity to improve existing conveyance system.**

| Type | ID No. | Description & Discussion |
|---|---|---|
| Conduct More Detailed Analysis of Storm Drain Network | N/A | The major storm drain network(s) within the assessment area is likely not functioning as intended. More detailed analysis is recommended to determine if improving the network with modified infrastructure is necessary. |

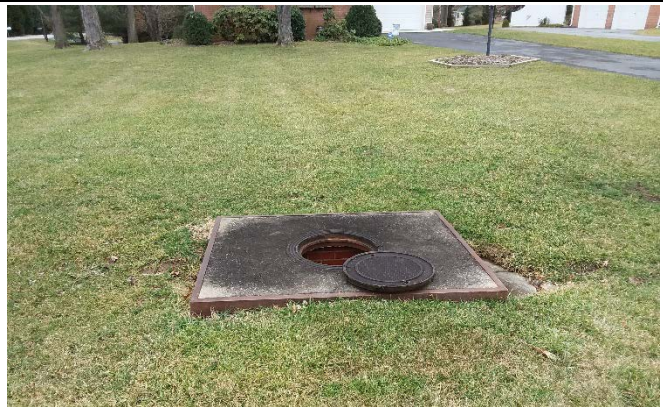
**Figure 4: Typical inlet along Woodley Road.**

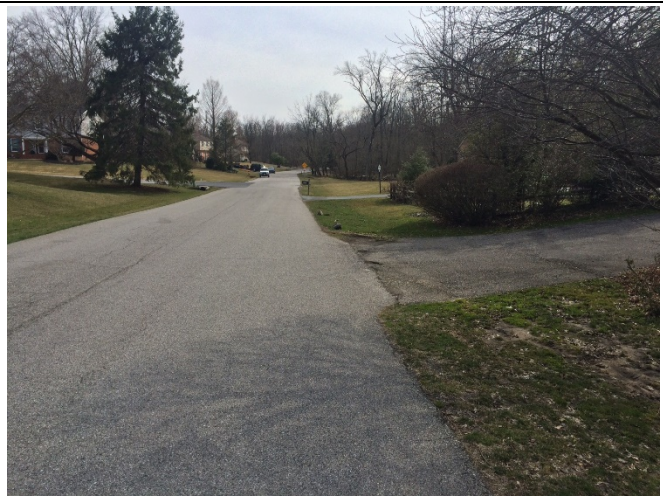
| Improve Existing Conveyance System | P15-04 | Existing conveyance system is likely not functioning as intended. Field observation notes a culvert under a private driveway carrying Plumtree Branch as potentially being a constriction point. Both field observations and survey responses suggest frequent and significant flooding. Analyze system and, if necessary, improve system with modified infrastructure within available open space. |

**Figure 1: Opportunity to improve existing conveyance system.**

**Figure 2: Opportunity to install new conveyance system.**

**Figure 3: Opportunity to improve existing conveyance system.**

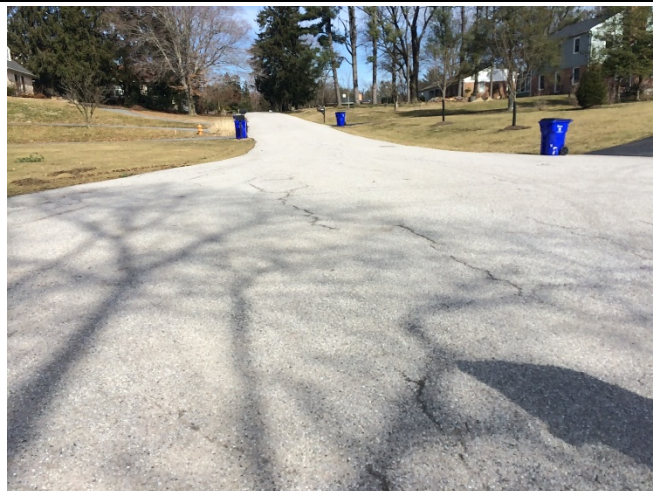
**Figure 2: Opportunity to install new conveyance system along Crownwood Road.**

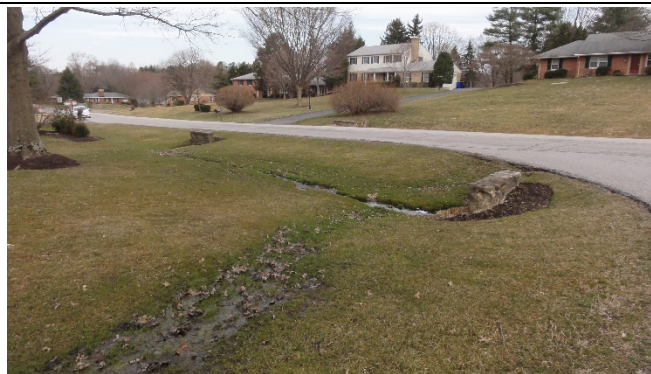
**Figure 4: Opportunity to improve existing conveyance system.**

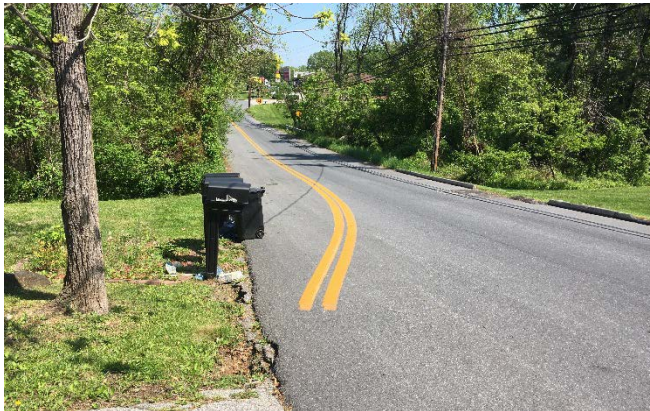
Figure 1: Opportunity to install new conveyance system.

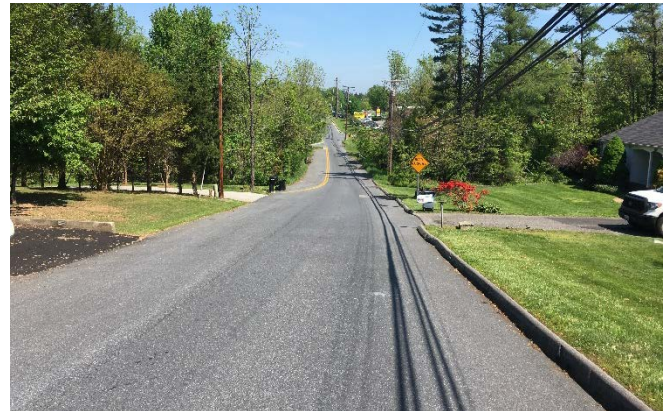
Figure 2: Opportunity to install new conveyance system.

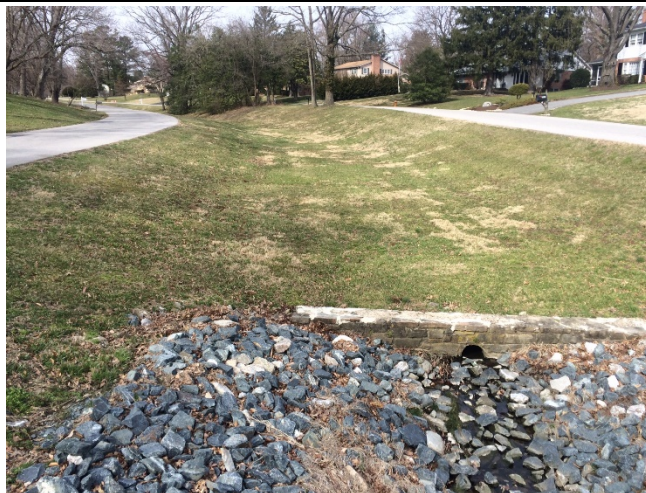
**Figure 1: Opportunity to install detention practice.**

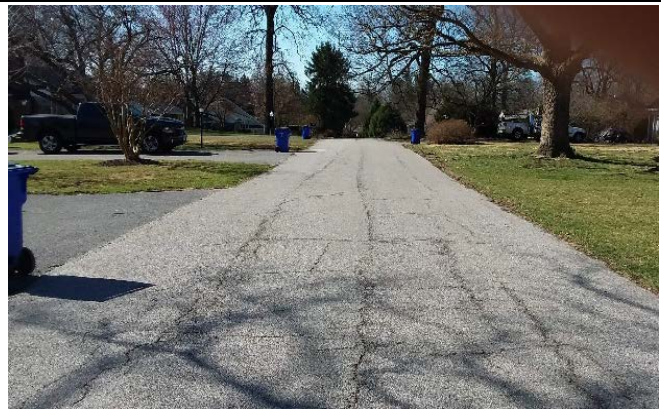
**Figure 4: Opportunity to install new conveyance system along Ligon Road.**

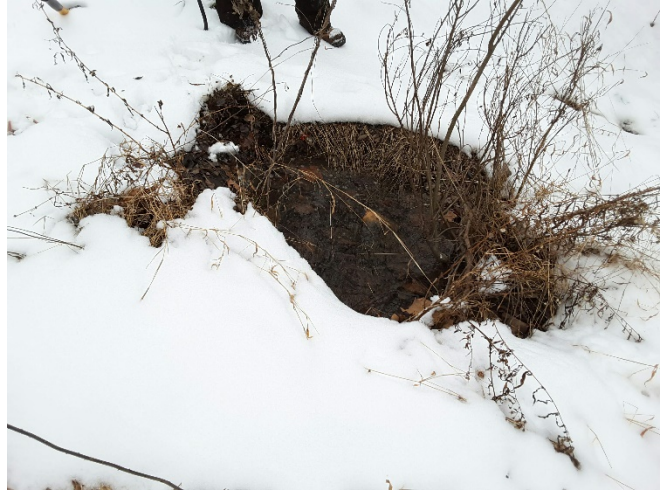
**Figure 2: Submerged outfall within the Ellicott City Senior Plus development.**

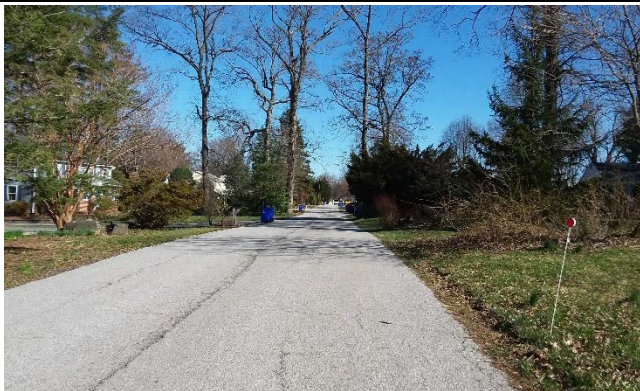
**Figure 3: Opportunity to install new conveyance system along Ligon Road.**

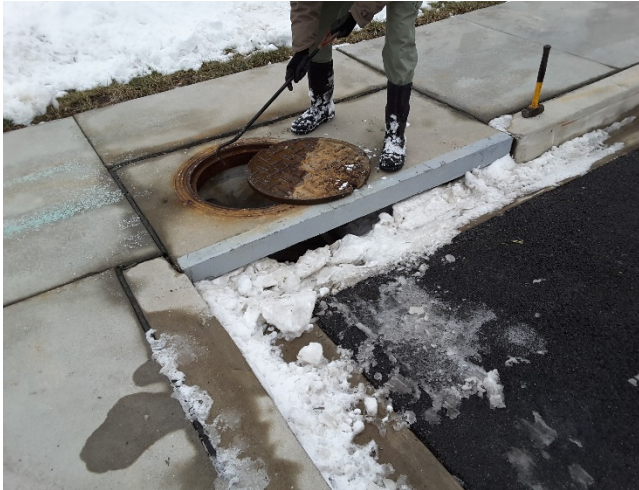
**Figure 1: Typical inlet within The Lutheran Village at Miller's Grant development.**

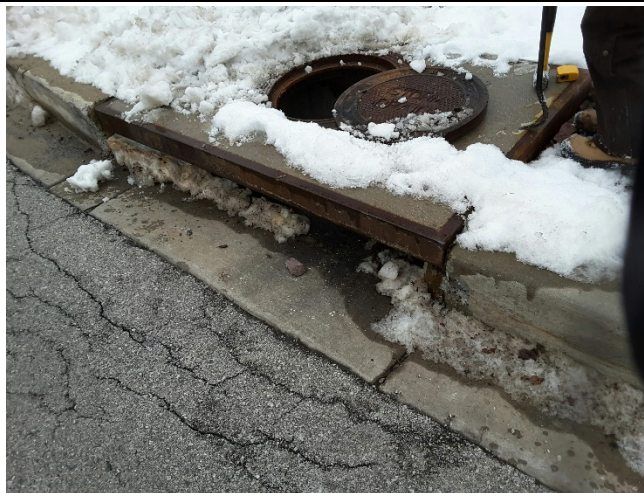
**Figure 1: Typical inlet within the Miller Branch Howard County Library.**

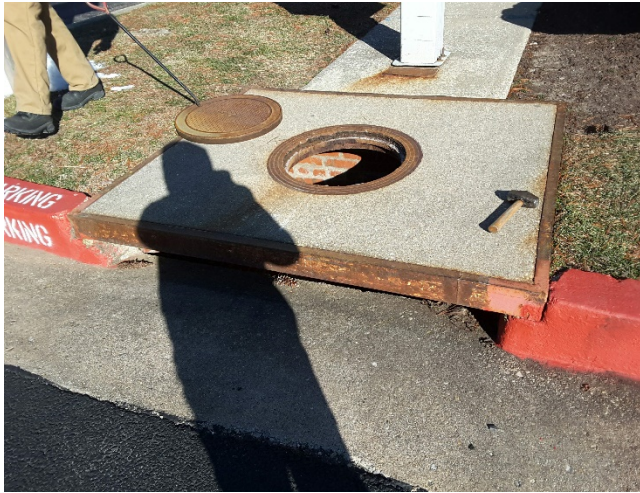
**Figure 1: Typical inlet along Lowlen Court.**

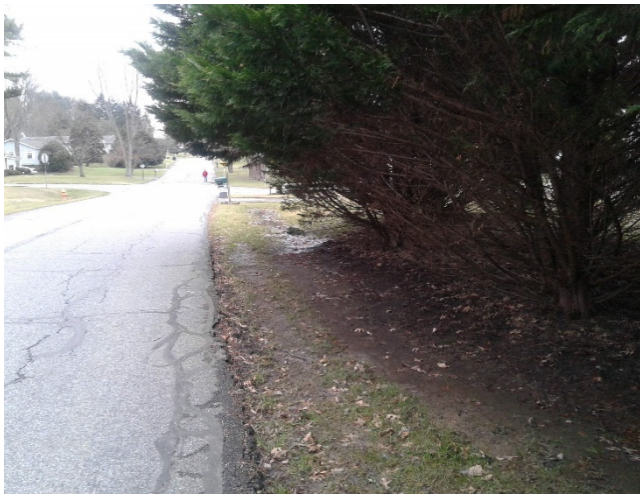
Figure 1: Standing water along Joey Dr.

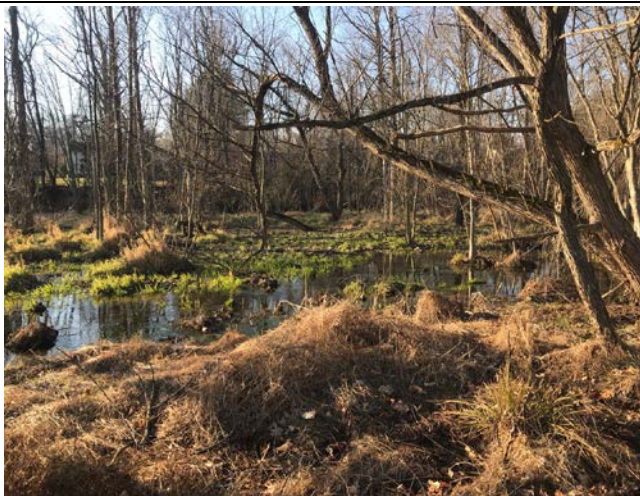
**Figure 5: Stream channel behind houses on Joey Dr. Stream meanders and has various flow paths.**

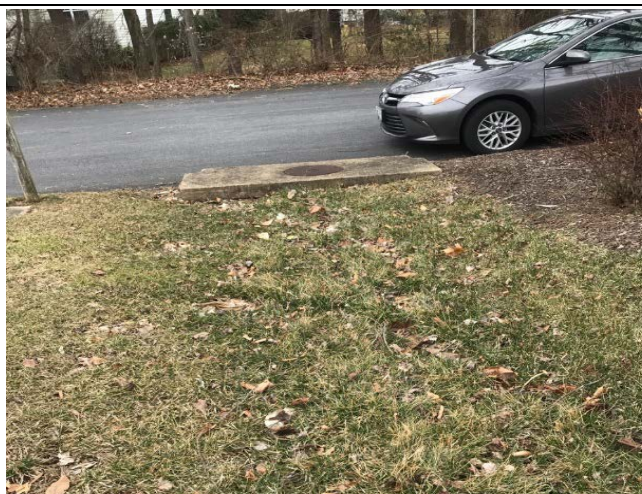
**Figure 1:** Back of inlet could be opened to allow existing conveyance ditch to outfall.

| Type | ID No. | Description & Discussion |
|---|---|---|
| Improve Existing Conveyance System | P60-001 | Field observations and survey response suggest ponding water is an issue in this area. Possibly cut opening into back of existing inlet to allow flow to enter from back side. |
